**FIELD TESTS USING GEOSYNTHETICS IN FLEXIBLE AND RIGID
PAVEMENTS TO REDUCE REFLECTION CRACKING**

Report 0-1777-2

Project 0-1777

Project Title: Field Synthesis of Geotextiles in Flexible and Rigid Pavement Rehabilitation
Strategies Including Cost Consideration

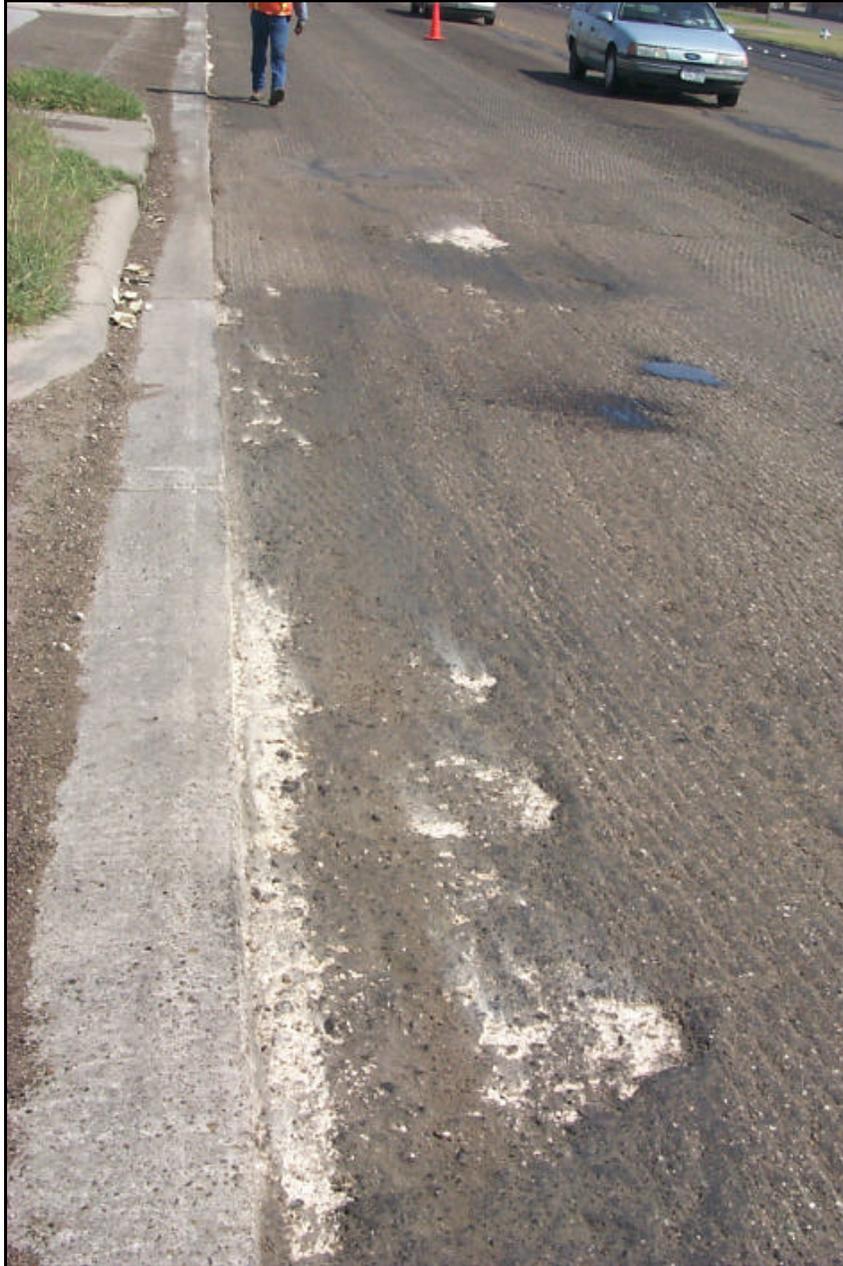
Figure 3. View of Exposed Base due to Milling Operation.

Because so few cracks were visible at the writing of this report, no maps showing the progression of cracks were prepared for the Pharr test pavements. This test sections were laid out on a lane with very thin asphalt layer due to the milling operation to match the curb and gutter ([Figure 3](#)) which may have contributed to very little amount of reflected cracks.

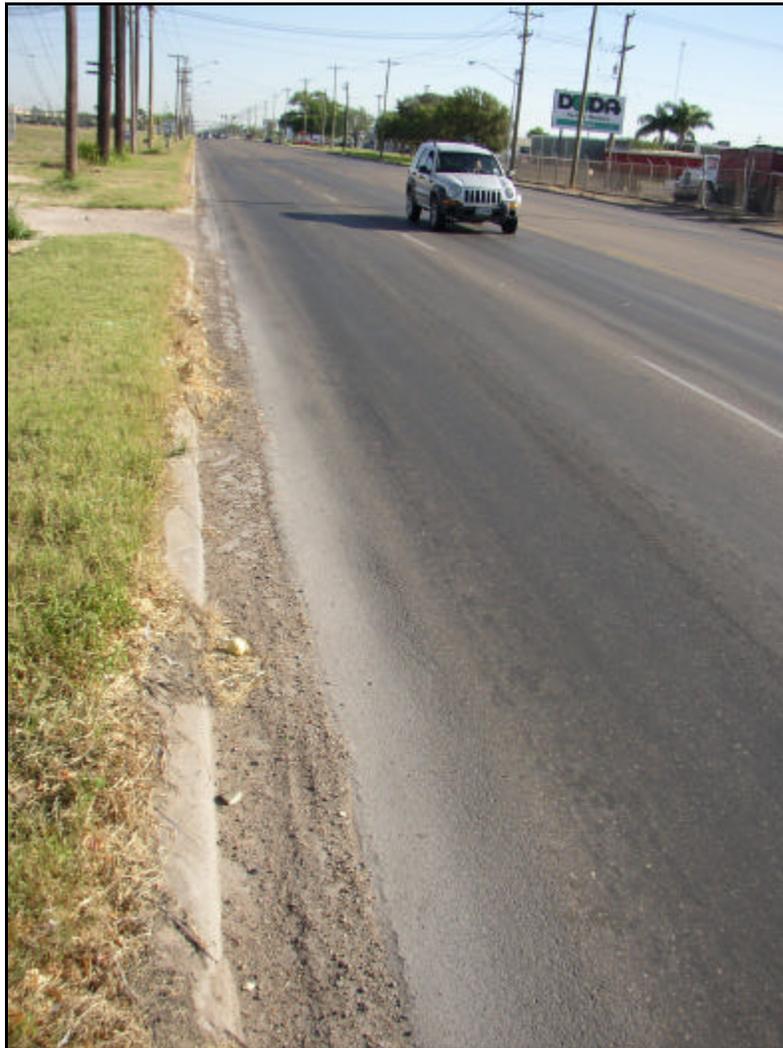
In April 2005, no cracking was observed nor were any other significant forms of pavement distress. Generally, the pavement surface exhibited a slight flushed appearance in the wheelpaths, but this is not significant. The transverse strips of flushing and a few isolated spots of shoving in the outer wheelpath at the approach of a couple of intersections were still visible. [Figure 4](#) shows a general view of one of the test pavements in 2005. [Figure 5](#) depicts an example of shoving near an intersection approach.

Figure 4. View of Typical Test Pavement in McAllen in 2005.

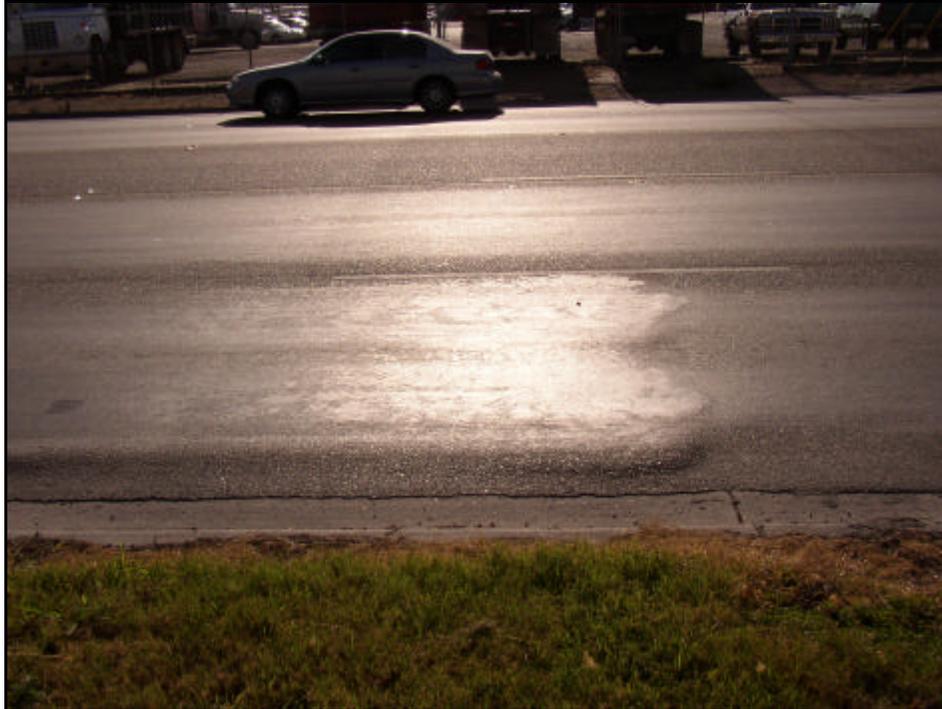
Figure 5. Shoving with Flushing at an Intersection Approach in McAllen.

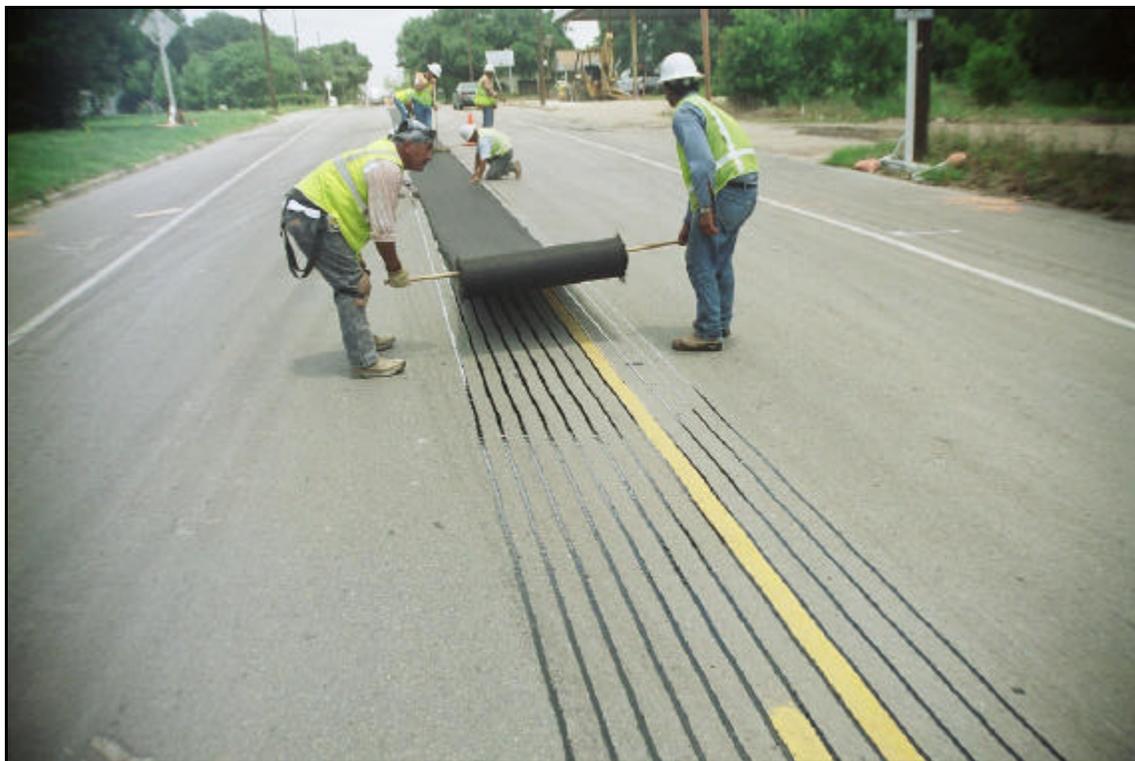
The contractor placed the PetroGrid 4582 composite in strips over the joints and major cracks by hand. Again, there was extreme variability in tack rate, ranging from dribbled streams to obvious excess. Visibly less tack was used in the southbound lane than in the northbound lane. PetroGrid in the northbound lane was exposed to traffic for several hours before overlaying. PetroGrid in the southbound lane was placed several days later and the researchers were unable to observe this operation. On July 28, 2003, TxDOT required the contractor to remove and replace HMA overlay from Station 133+87 to Station 135+87 in the northbound lane because the overlay was disintegrating (apparently slipping and tearing). This activity will significantly reduce the validity of this portion of this test section.

Figure 9. Example of Dribbled, Insufficient Asphalt Tack.

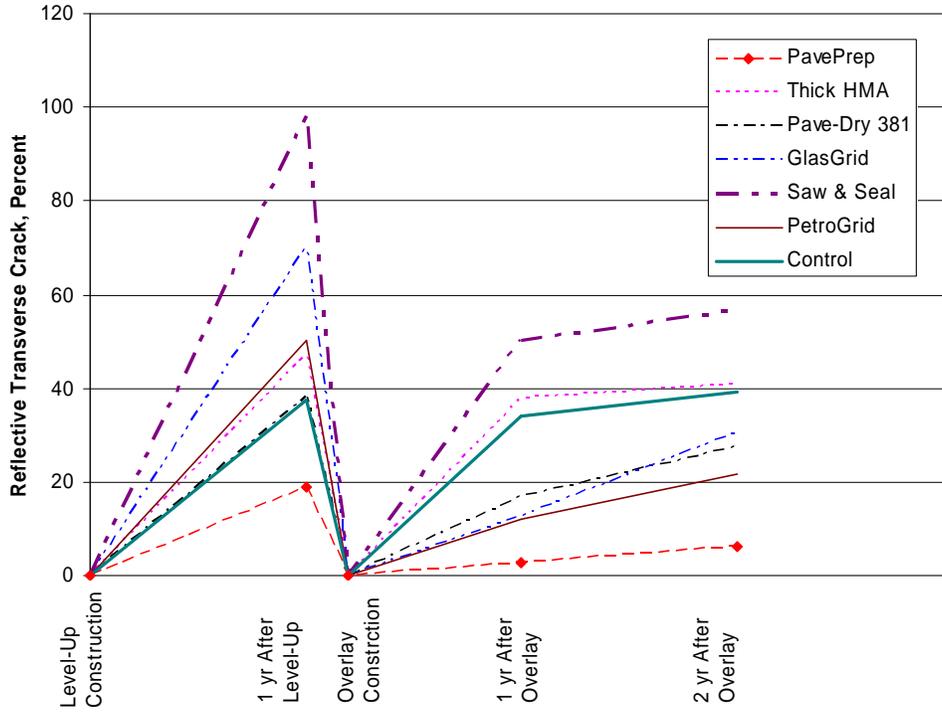
Plots of percentage reflection cracking (transverse, longitudinal, and total) versus time (Figures 10, 11, and 12, respectively) illustrate that most of the reflection cracking is from the transverse joints in the underlying concrete pavement. Recall that the geosynthetic products, except for PavePrep, were placed approximately one year after placement of the leveling course. Therefore, the first points on the graphs represent only the leveling course and the PavePrep. The PavePrep has shown the least reflective cracking from the beginning. Two years after placement of the remaining geosynthetic products, all four geosynthetic products (PavePrep, PetroGrid, Pave-Dry, and GlasGrid) are showing less than about 40 percent reflection of the transverse joints, whereas, those sections without a geosynthetic product (control, thicker section, and saw & seal) are exhibiting approximately 40 percent or more reflection of the transverse cracks.

Figure 10. Reflective (Transverse) Cracking vs. Time — Waco District.

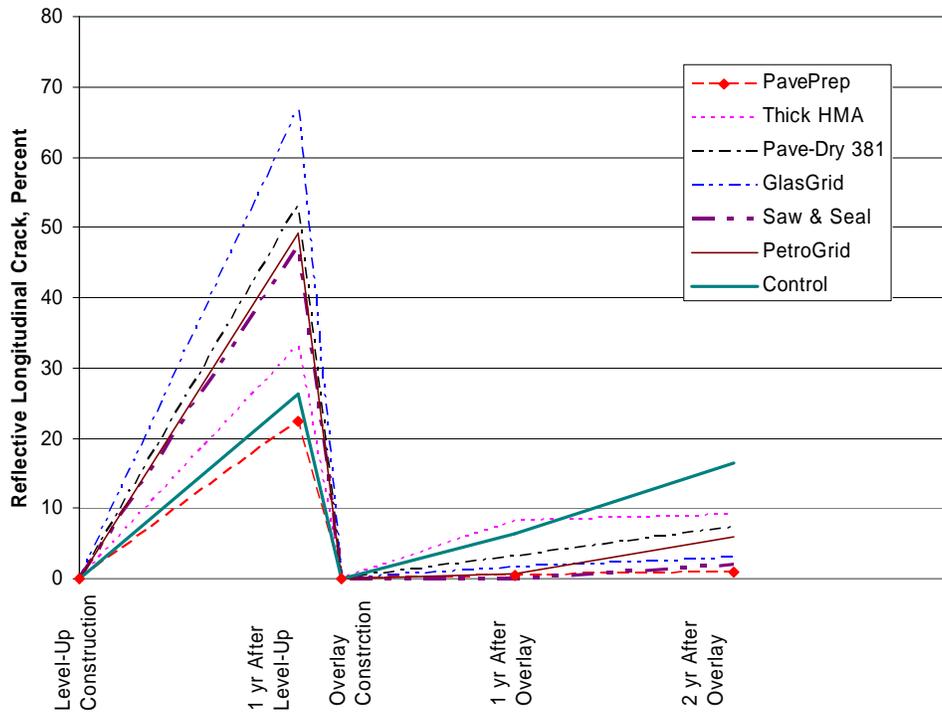
Regarding reflection of longitudinal cracks (Figure 11) two years after placement of the geosynthetic products, all of the geosynthetic products exhibited less reflection cracking than the control section. All geosynthetic test pavements exhibited less than 10 percent reflection of the longitudinal cracks, whereas, the control section exhibited greater than 15 percent.

Figure 11. Reflective (Longitudinal) Cracking vs. Time — Waco District.

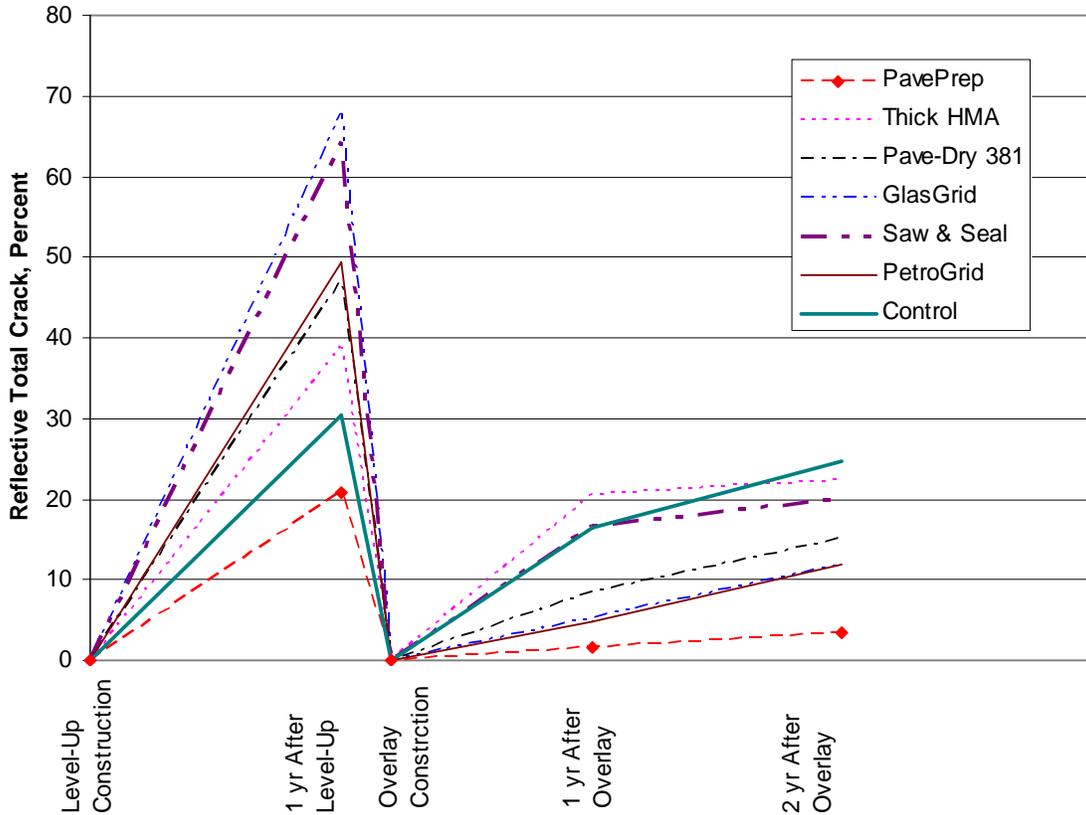
Figure 12. Reflective (Total) Cracking vs. Time — Waco District.

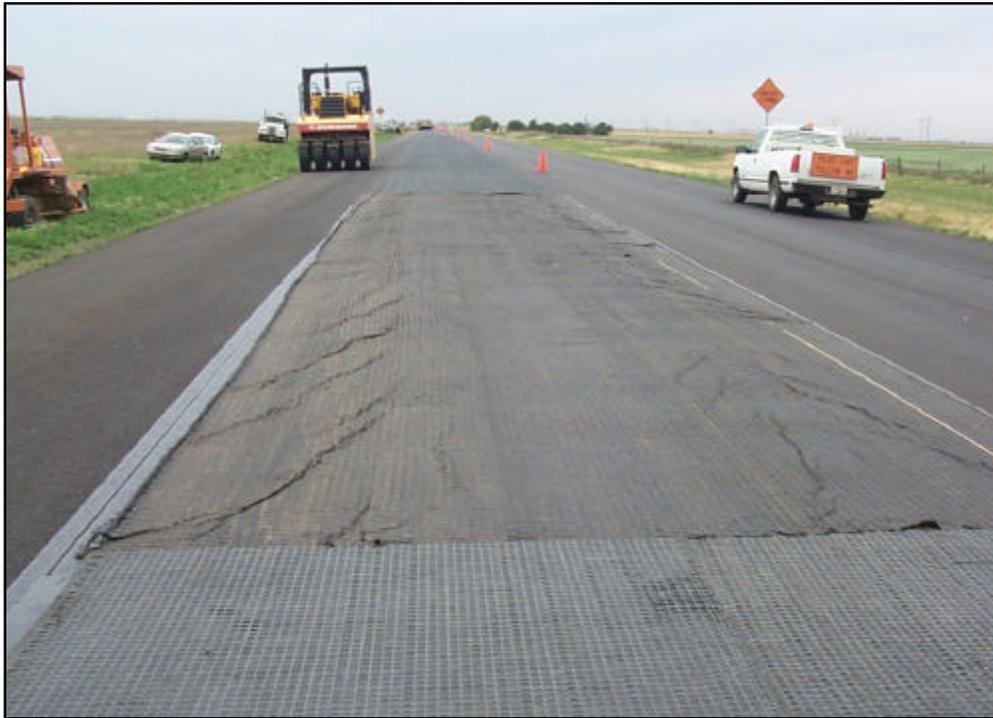
The contractor made a second attempt to place HaTelit. Tack coat was applied at a rate of 0.1 gallons/yd² and at 375°F. Placing the fabric was again very difficult, and there were excessive wrinkles in the mat. The contractor gave up on this material after placing 80 feet (Station 600+00 to Station 600+80) in the northbound lane. The roll width was 13 feet, which resulted in the material extending 1 foot into the southbound lane. About one hour was required to place this segment of fabric. [Figure 16](#) depicts wrinkles in the HaTelit.

Figure 16. Wrinkles in 80-foot HaTelit Section.

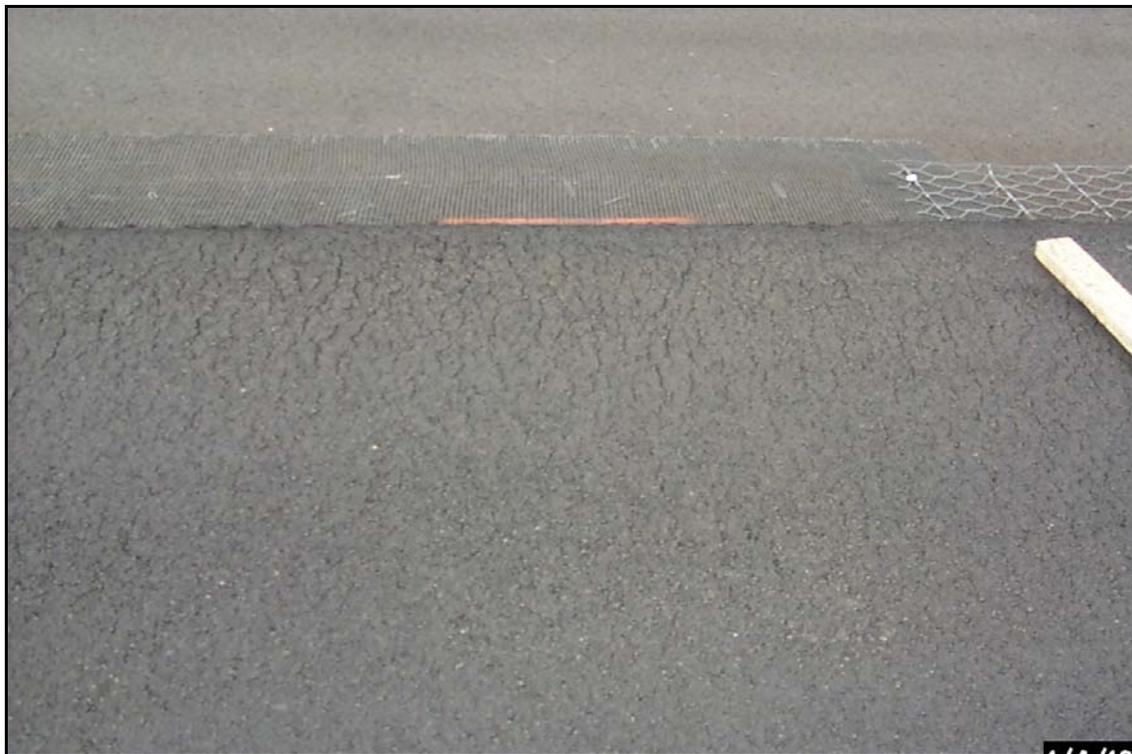
Operations resumed on the following morning in the southbound lane starting from south to north. The morning was cloudy with very light intermittent rainfall. Following the suggestion of the manufacturer, the contractor applied GlasGrid using a tack rate of 0.10 gallons/yd² in an attempt to offset the dampness of the pavement surface. Two rolls were placed side by side to cover the remaining width of the southbound lane (Station 590+00 to 595+00).

Figure 17. Checking (or Crazing) Observed During Portions of Overlay Paving.

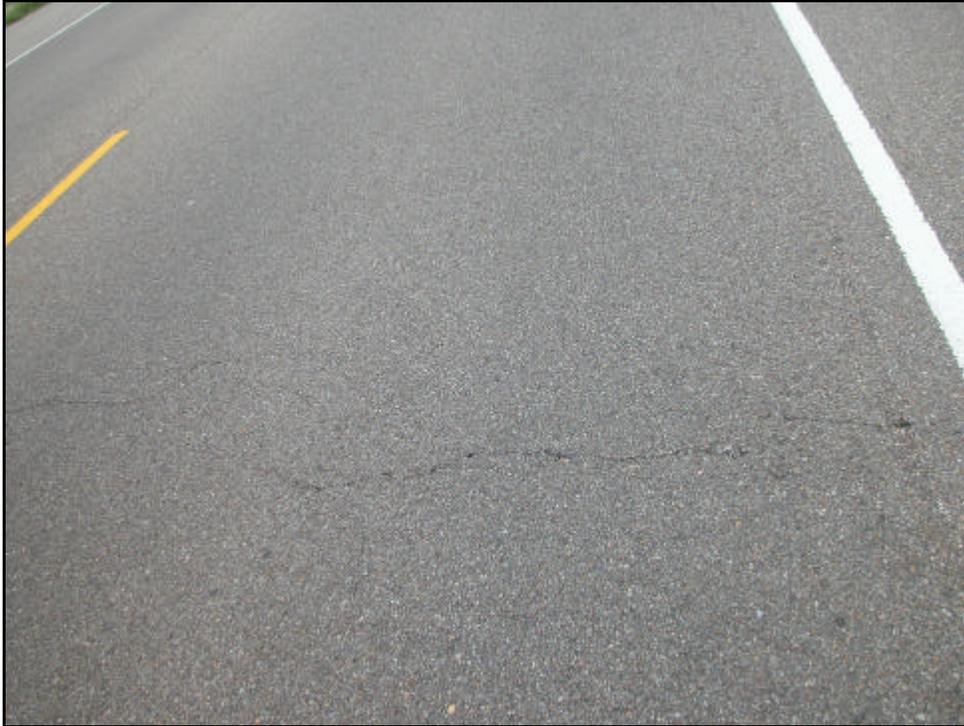
Figure 18. Transverse Crack Observed in 2004 in Hot-In-Place Recycled Section.

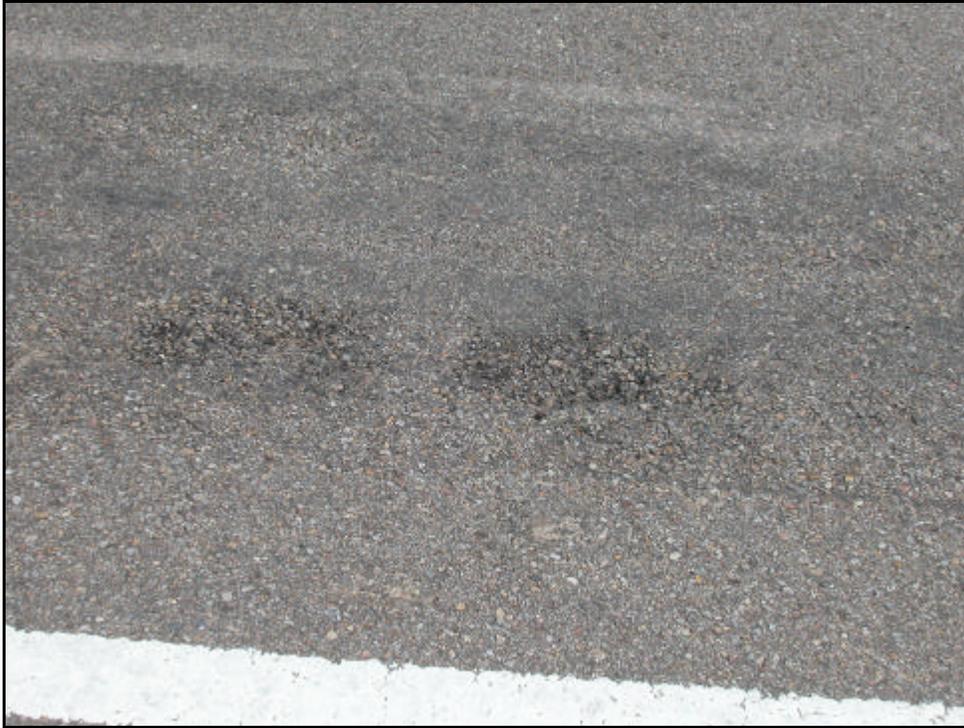
Figure 19. Raveling Observed in the PaveTrac Section in 2004.

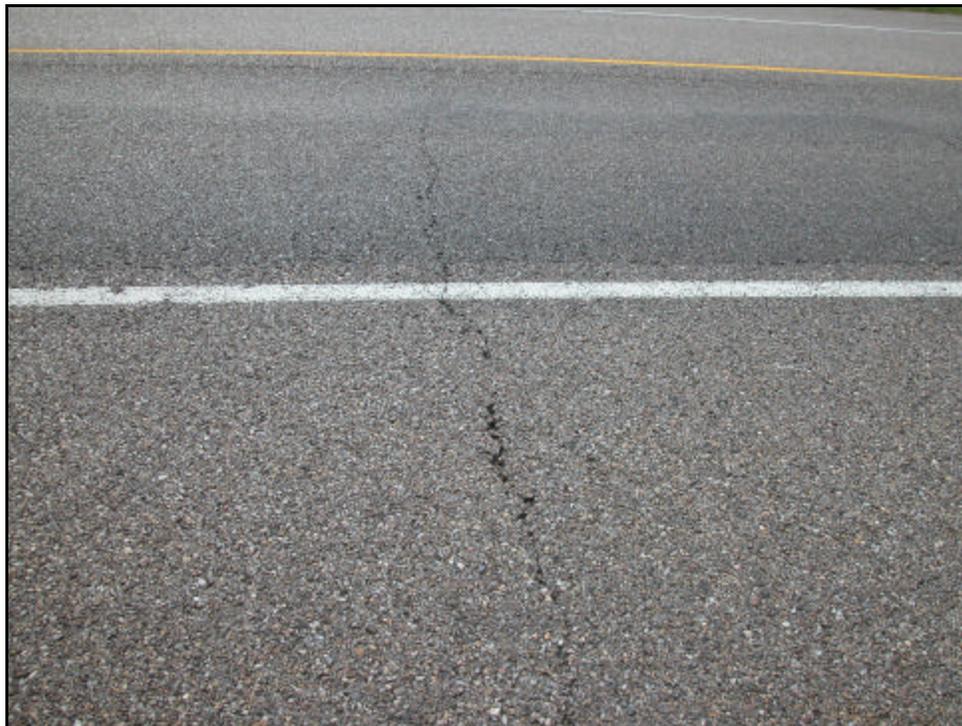
Figure 20. A Transverse Crack in PFC with Leveling Course Test Section.

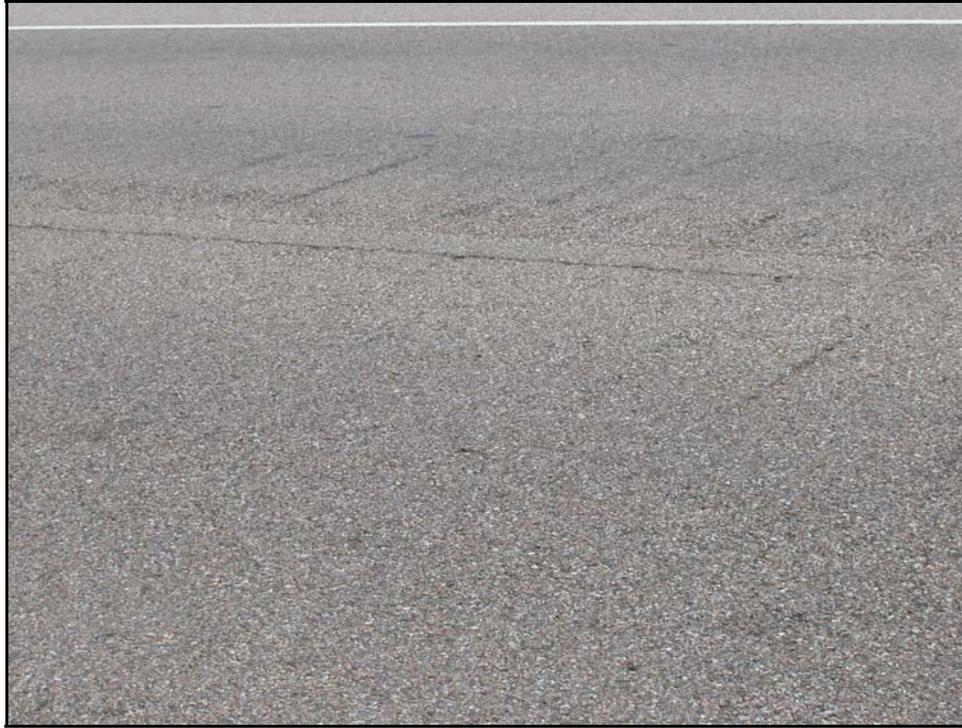
No new cracks developed in the short HaTelit section. The transverse crack that originally developed two years ago grew somewhat longer. A few new short, narrow transverse cracks initiated during the past year in the PaveTrac section. The longitudinal joint along the centerline was quite prominent. A few longitudinal cracks were observed in the southbound shoulder. Raveling was observed in the southbound lane of the PaveTrac section. The PaveTrac section exhibited several short, parallel transverse cracks in a short segment that appeared to have initiated from the centerline (Figure 21). Most likely, these cracks developed due to lateral movement of wire mesh underneath during the construction. The PaveTrac surface was not as good as the other sections.

Figure 21. Short Parallel Transverse Cracks Radiating from the Centerline of the PaveTrac Section.

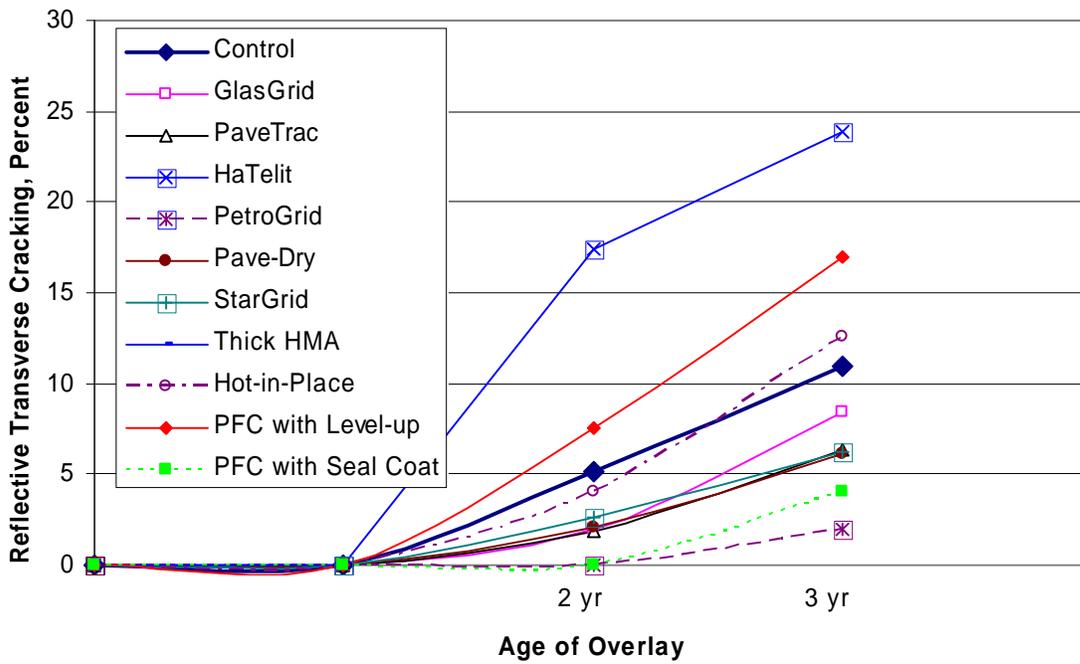
Measured crack lengths were used to calculate the percentages of reflective cracks for each year of evaluation. Figures 22 through 24 present the growth of transverse, longitudinal, and total reflective cracks, respectively. The highest percentage of reflective cracks was observed in the PFC plus leveling course section. PFC plus seal coat is performing better than PFC without seal coat (with level-up). Generally, the sections with a geosynthetic product are performing slightly better than the control section. The control section experienced approximately 7 percent total reflective cracking three years after overlay construction; whereas, during the same period, total reflection cracking of the geosynthetic sections was less than 4 percent. The hot-in-place recycling section is performing essentially identical to the control section.

Figure 22. Reflective (Transverse) Cracking vs. Time after Placement of the Overlay.

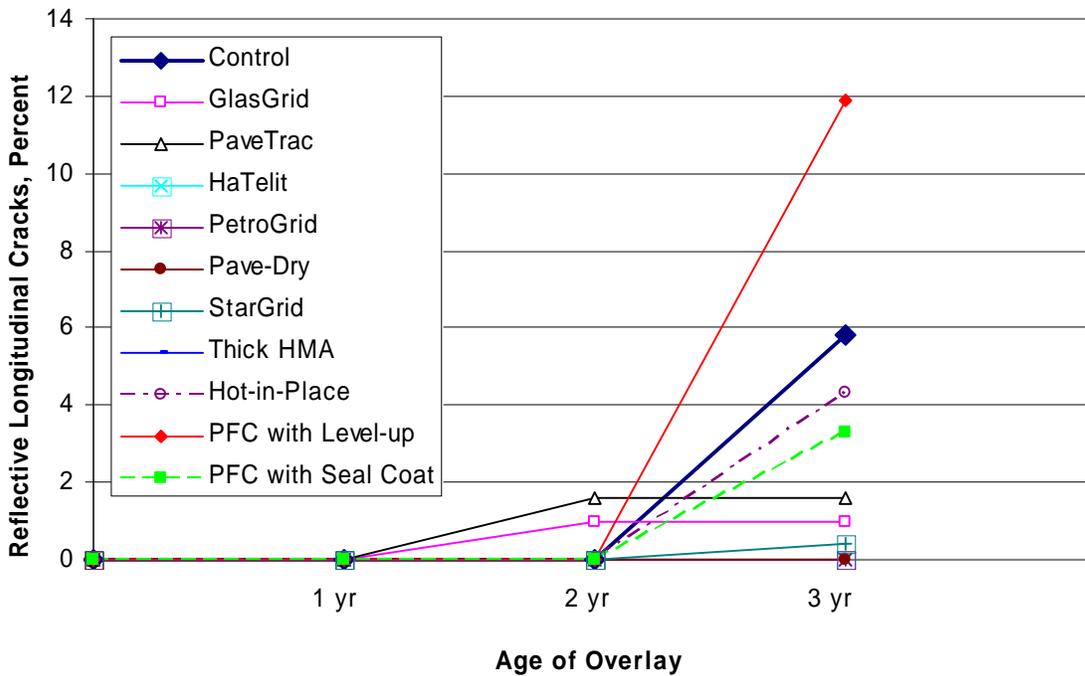
Figure 23. Reflective (Longitudinal) Cracking vs. Time after Placement of the Overlay.

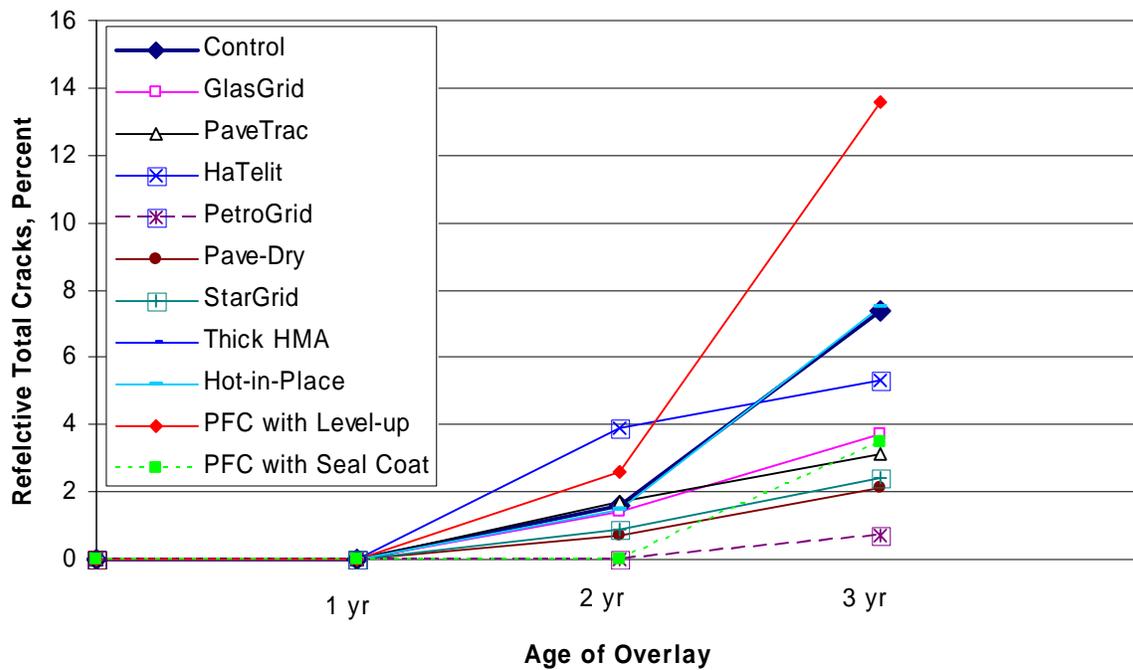
Figure 24. Reflective (Total) Cracking vs. Time after Placement of the Overlay.
