1. Report No. FHWA/TX-10/0-5270-1	2. Government Accession No.	3. Recipient's Catalog No.
4. Title and Subtitle <b>SEAL COAT DAMAGE EVALUATION DUE TO SUPERHEAVY LOAD MOVES BASED ON A MECHANISTIC-EMPIRICAL APPROACH</b>		5. Report Date December 2009 Published: March 2010

11. Contract or Grant No. <b>Project 0-5270</b>
12. Sponsoring Agency Name and Address Texas Department of Transportation Research and Technology Implementation Office P.O. Box 5080 Austin, Texas 78763-5080	13. Type of Report and Period Covered <b>Technical Report:</b> September 2007–August 2009

**SEAL COAT DAMAGE EVALUATION DUE TO SUPERHEAVY  
LOAD MOVES BASED ON A MECHANISTIC-EMPIRICAL  
APPROACH**

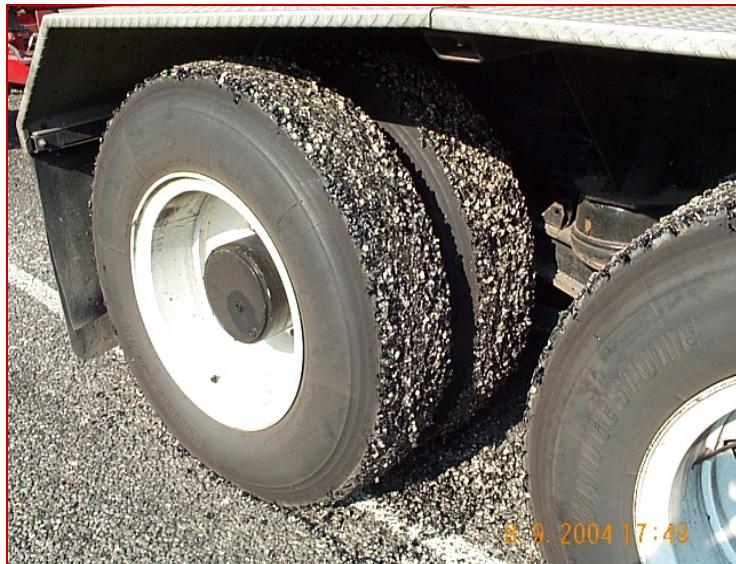
Field monitoring on SHL moves in the past 5 years revealed that the moves primarily caused damage on fresh seal coat pavements typically less than 5 weeks after seal coated as shown in Figure 1. Structural failure rarely occurred from a weak load bearing capacity of underlying layers induced by a sudden increase of moisture content level from considerable amount of rainfall prior to SHL moves made, unsupported pavement edge conditions, and structurally poor condition. Regulating SHL moves travelling along with fresh seal coat pavements has been a challenging task due to the lack of statewide seal coat scheduling and streamlined procedure to evaluate expecting seal coat damage potential. Considering huge mileage of seal coat placed annually (around 20,000 mile/year) by TxDOT for a pavement preservation means, it is imperative to establish an effective guideline to regulate and route SHL moves to mitigate further seal coat damages resulting in significant reducing the cost to repair deteriorated routes. Tentatively, TxDOT adopted a criterion that reroute SHL moves to 5 weeks or older pavements based on the limited field monitoring (1).

**Figure 1. Seal Coat Damage due to SHL Moves.**

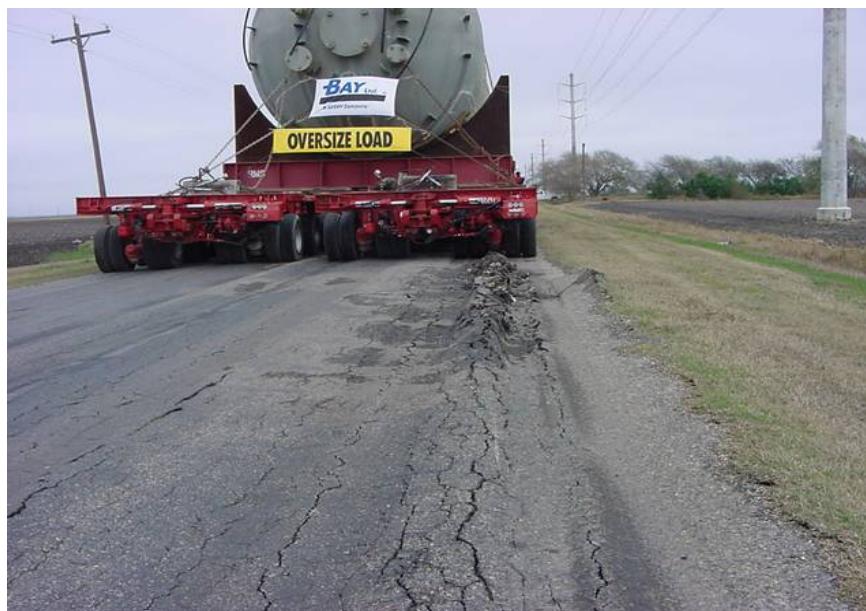
During this move, 8-in of wood mats were placed over culverts and bridges to prevent any damage. Severe pavement damage did occur, however, on FM 796 as shown in Figure 5. According to TxDOT engineers, the area received consecutive rainfall events close to moving day, thus the damage might be due to the loss of load bearing capacity of underlying materials induced by unexpectedly high moisture content. It

indicates that it is extremely important to take into account weather conditions to reduce the likelihood of structural damage, particularly for routes where exhibiting a relatively weak structural capacity or routes built on expansive clay soils that susceptible to moisture.

**Figure 5. Severe Damage on FM 796.**

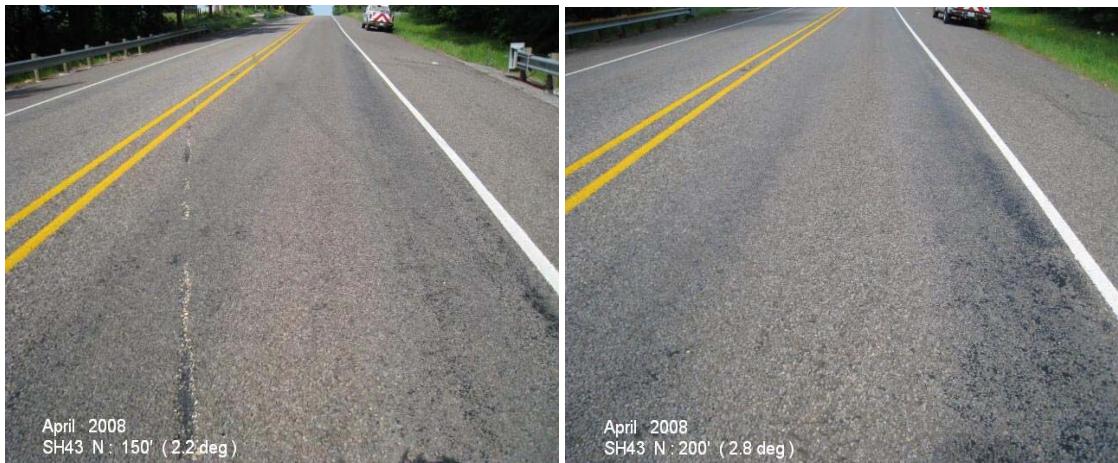
Recent field observations conducted on FM 109, FM 1371, FM 2210, SH 43, and SH 56 showed most of the seal coat damage took place near vertical grades under high pavement temperatures as shown in Figure 8.

**Figure 8. Seal Coat Damage along with Slope.**

It should be also noted that FM 2210 route where placed with seal coat composed of CRS-2P and limestone aggregate in 2003 experienced seal coat damage due to SHL moves made in 2004 along with high pavement surface temperature. This indicates that

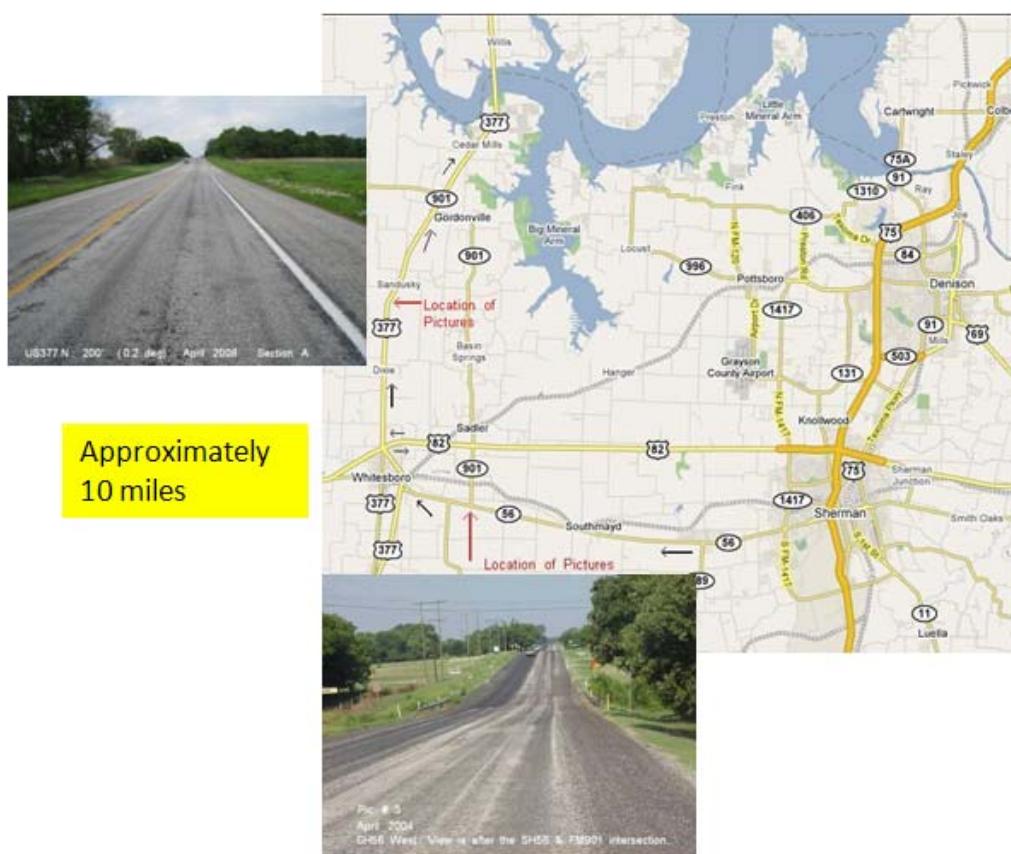
Chen monitored SHL damages that occurred from 2002 to 2005 (20). SH56 and US377 in Paris District experienced fresh seal coat damage during summer in 2005 as shown in Figure 9. Consequently, it was reported that the carrier paid \$265,717 for the damage repair. Considering mileage associated with seal coat damage, which is approximated 10 miles, the estimated repair cost turned out to be \$250,000 based on FY 09 unit cost indicating that the assessment appears reasonable. In June 2005, FM1371 in Bryan District had a mild scraping of seal coat that has been several years old due to SHL moves with 6500 lbs of maximum tire load and 792 kips of gross vehicle weight. The maintenance forces fixed all damaged locations and sent two bills to the carrier. The total bill was \$4,575.78.

**Figure 9. SH56 and US377 Seal Coat Damaged Sections.**

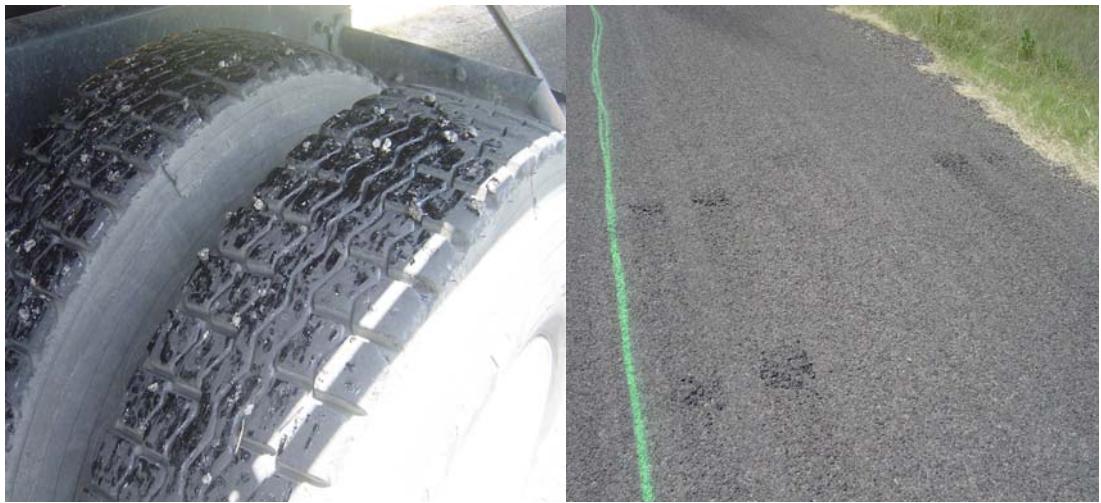
Precise visual surveys were conducted whenever each run was made to rate the extent of damage before and after the truck passage with taking pictures. Three levels of damage were categorized: N for No damage, L for Low damage, and H for High damage. While a low level of damage causing little aggregate segregation accompanied with insignificant bleeding, a case where indicating larger number of aggregate segregation along with severe bleeding of binder was rated a high level of damage as illustrated in Figures 28 and 29.

**Figure 28. Low Level of Damage.**

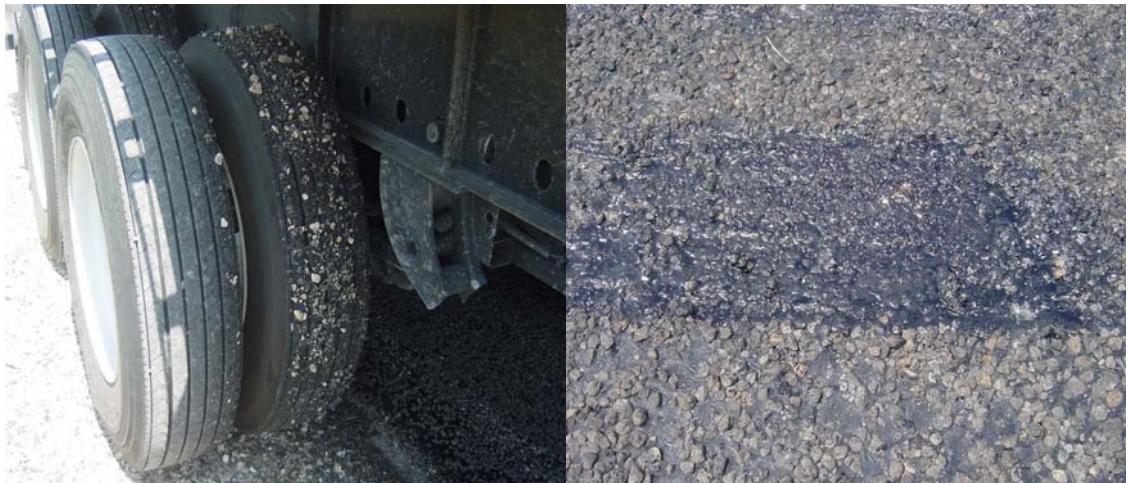
**Figure 29. High Level of Damage.**

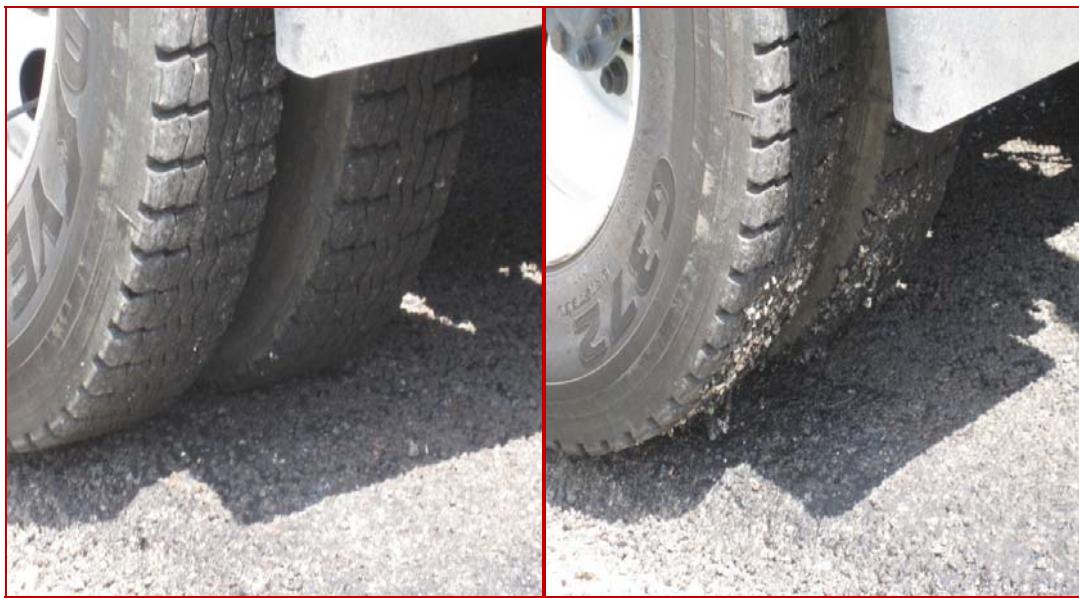
regardless of temperature and slope or from brake-applied driving when pavement surface temperature was below 110 °F as shown in Figure 31.

**Figure 31. Seal Coat Damage (a) Normal Drive (b) Brake-Applied Drive.**

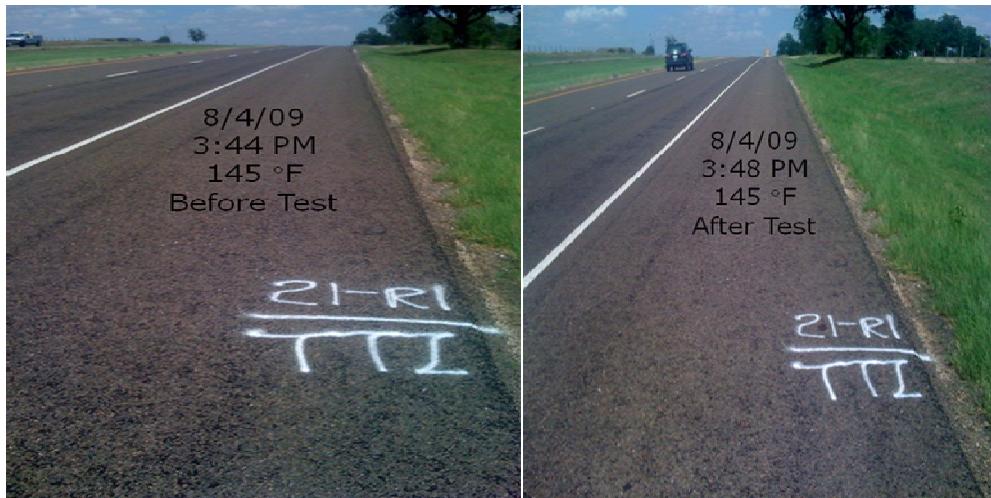
From additional field validations, researchers confirmed that pavement surface temperature is the most critical factor in influencing seal coat damage. It should also be noted that the curing period is associated with the extent of damage. In particular, in spite of hot pavement surface temperature, tests sections on SH 21 that have been aged 1 year rarely revealed any specific damages as illustrated in Figure 38.

**Figure 38. Comparison of Segment Before and After Test.**

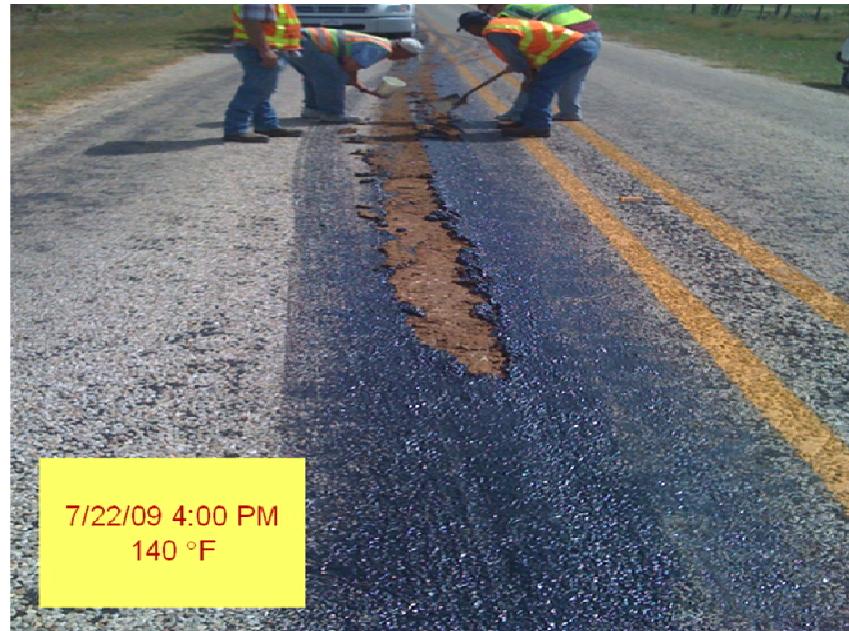
was instead conducted within travel lanes with the permission of the San Antonio District. After the first passage of test truck was made under high pavement surface temperature around 140 °F, several locations along with wheel path came to flushing. During the back up of the test truck to an original location, the surface treatments severely failed as shown in Figure 39. It strongly indicated that special care needs to be taken to the surface treated load zoned roads for routing SHL moves particularly in the event of high pavement surface temperature and steep slope. It is interesting to report that no damage took place when the testing was conducted at the same location in the morning in the event of pavement surface temperature ranging from 80 to 100 °F.

**Figure 39. Severe Damage of Surface Treatments.**

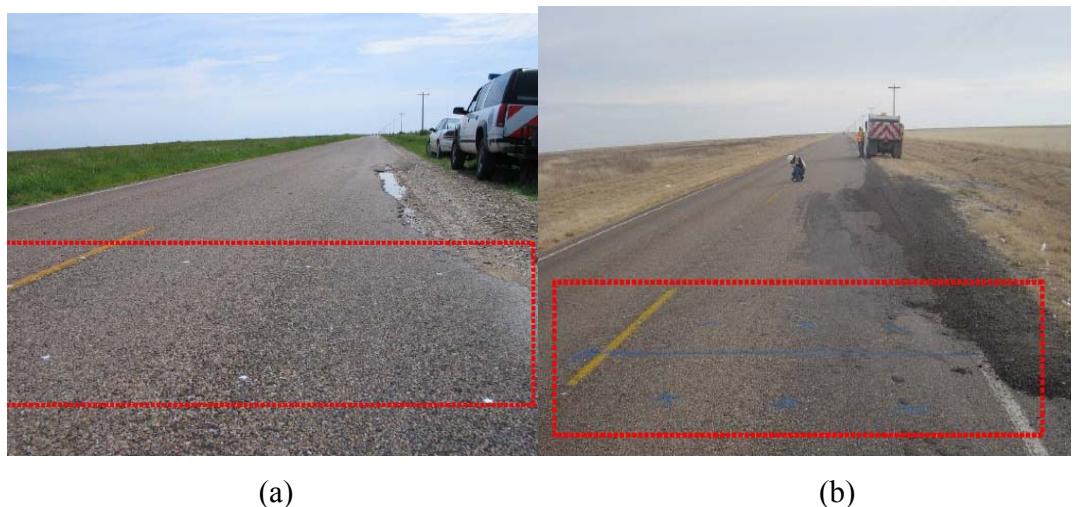
- an increased number of haul trucks during construction of wind turbine contributed to the majority of pavement damage such as rutting and edge failure;
- excessive rainfall during the early stage of construction appeared to cause the damage by weakening soil bearing capacity; and
- repeated loads transporting turbines and cranes during the construction did not cause additional rutting between July and December during the period that data had been collected. No discernable damage was detected from field survey. This indicates that pavement structural failure is highly related to the moisture condition that controls load bearing capacity of underlying materials especially in surface treated pavements.

**Figure B2.** FM 97 Location 1 on Milepost 336. (a) July 11th; (b) December 6th.

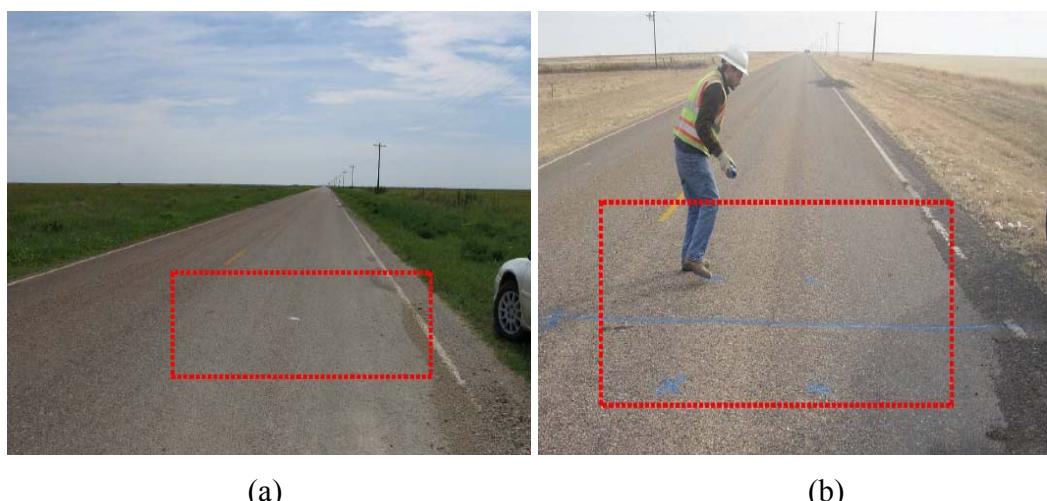
**Figure B4.** FM 97 Location 2 on Milepost 336+60. (a) July 11th; (b) December 6th.

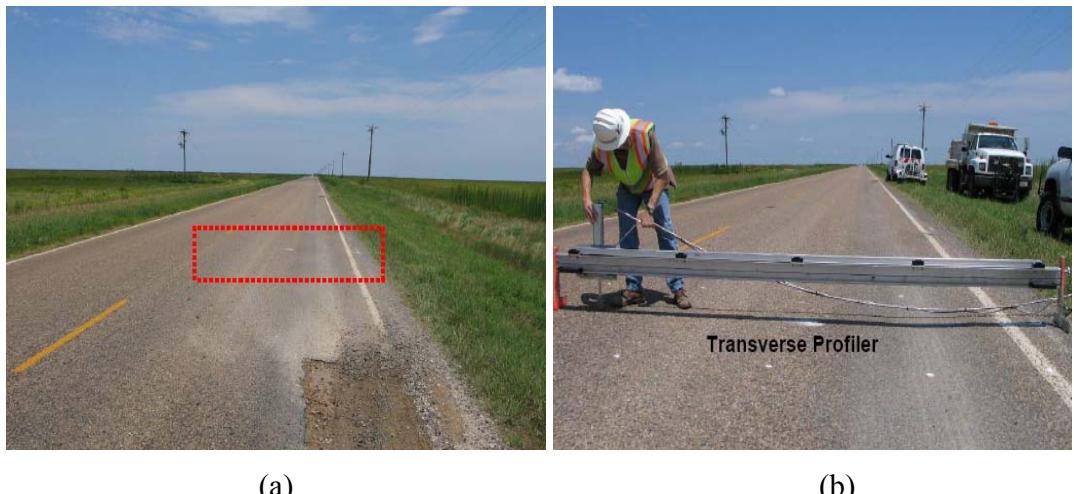
**Figure B6. FM 97 Location 3 on Milepost 336-2040'.** (a) July 11th;  
(b) December 6th.

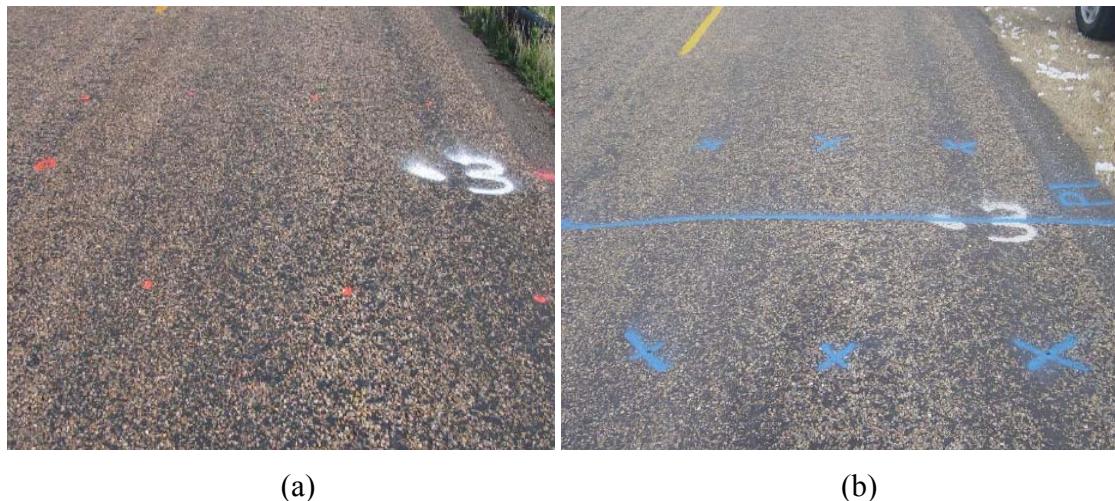
**Figure B8.** FM 28 Location 1 on Milepost 186+900' (a) July 11th; (b) December 6th.

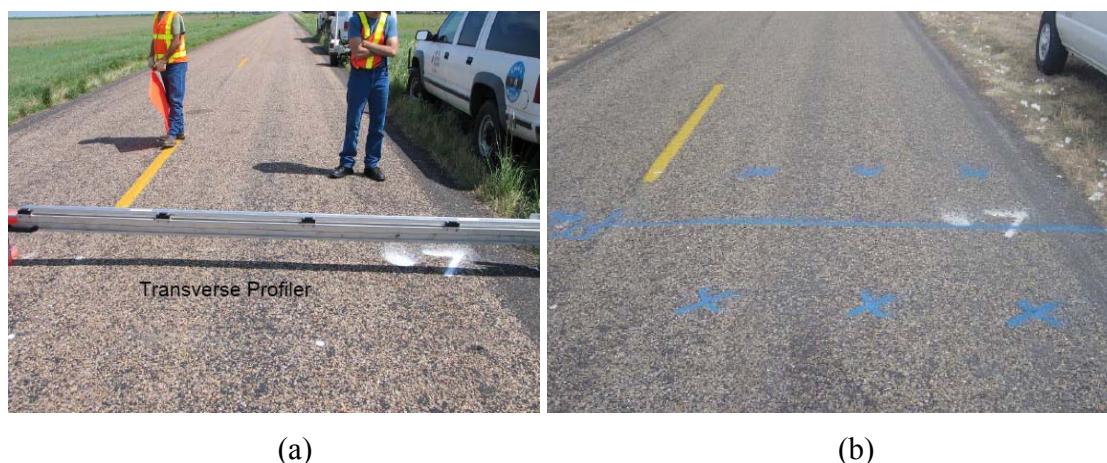
**Figure B10.** FM 28 Location 2 on Milepost 182+2100' (a) July 11th; (b) December 6th.

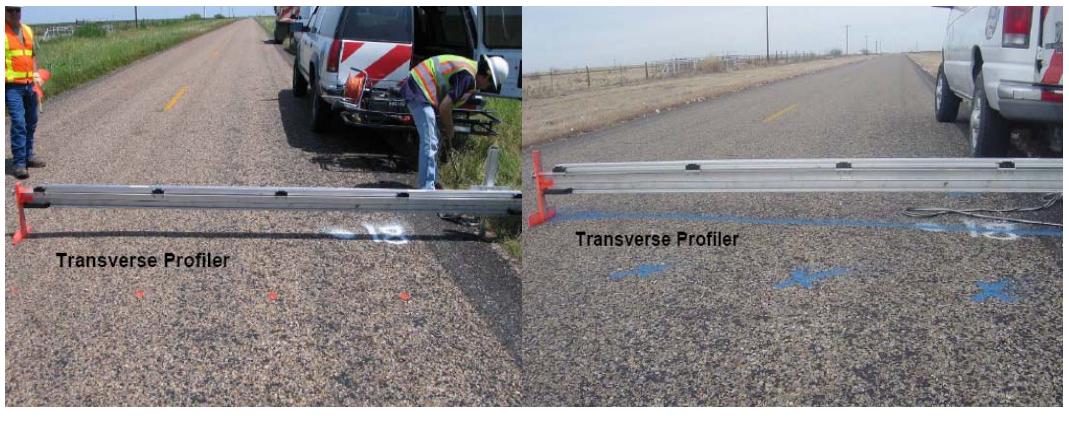
**Figure B12.** FM 28 Location 3 on Milepost 182+5400' (a) July 11th; (b) December 6th.
