| 1. Report No. FHWA/TX-11/0-6589-1 | 2. Government Accession No. | 3. Recipient's Catalog No. | |
| 4. Title and Subtitle PAVEMENT REPAIR STRATEGIES FOR SELECTED DISTRESSES IN FM ROADWAYS | | 5. Report Date Published: June 2012 | |

Project Title: Pavement Repair Strategies for 2R and Routine Maintenance (RMC) Projects

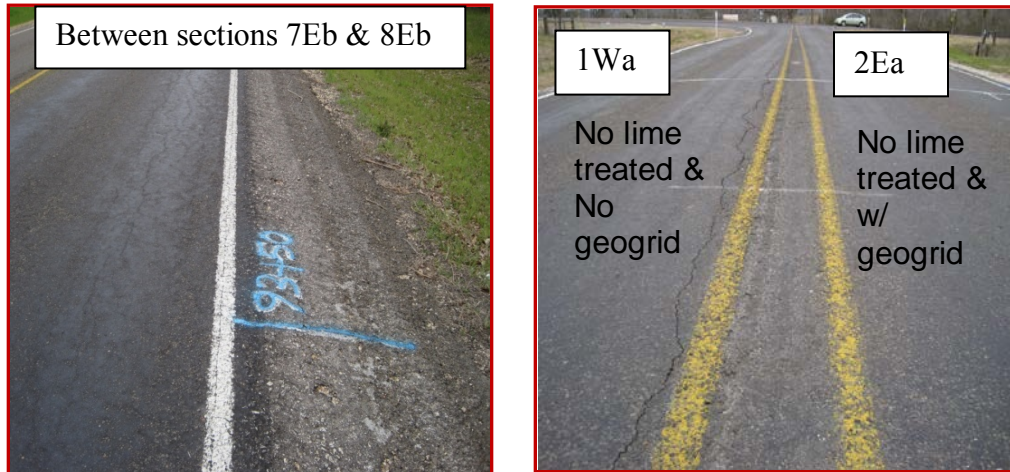
were detected at several locations (Figure 4.9), the section in both directions has performed well based on the review of video log files taken during the GPR survey and several visual surveys. Detail of the survey can be found in Appendix C. Researchers also reviewed PMIS data of corresponding segment and found that the test segment has exhibited excellent performance history since 2005 (Table 4.5).

Figure 4.9. Longitudinal Cracks Detected in FM 2.

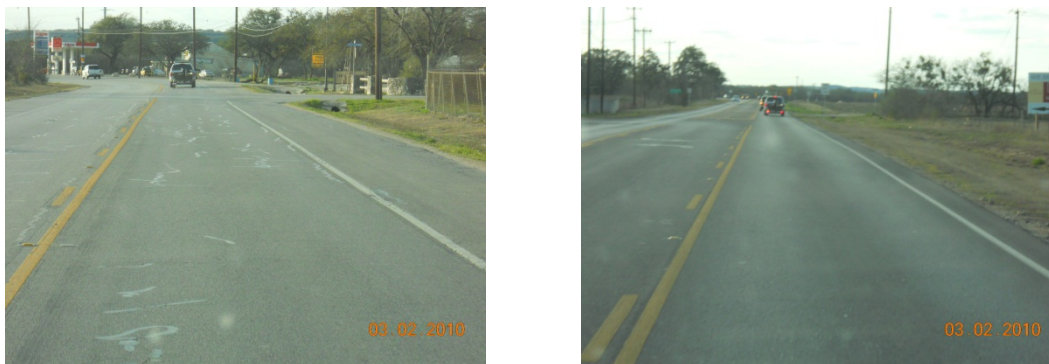
(shown in Figure 4.11) while cracks (sealed) and rutting was noticed in the control section particularly along the wheel paths.

Figure 4.11. Surface Condition Showing Rutting and Cracking in the Wheel Path at the Control (left) and Distress-Free at the Reconstructed (right) Sections.

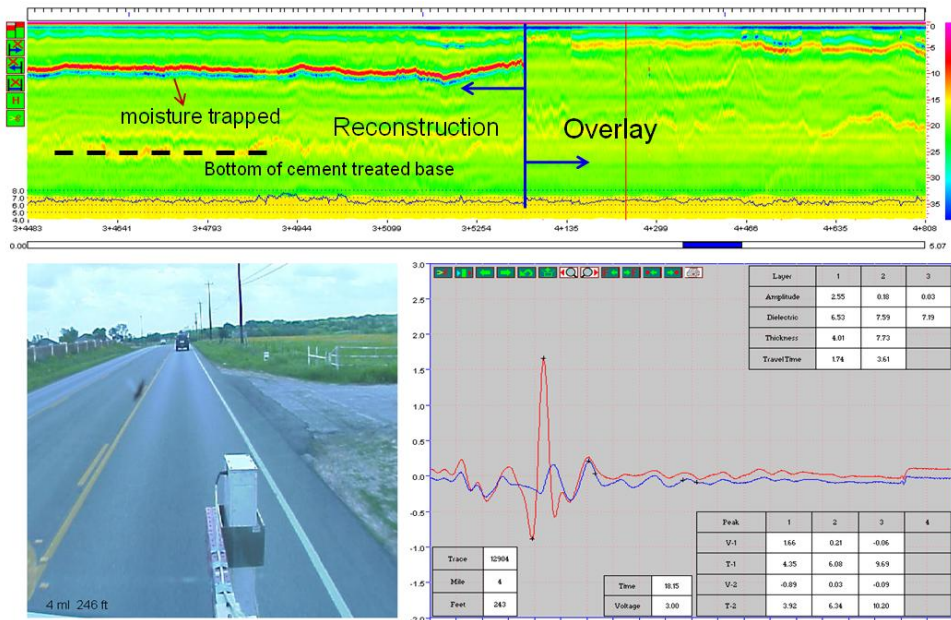
treated base layers that may result in moisture induced damage of the asphalt pavement. There was no evidence that this damage was reflected on the surface during the field evaluation.

Figure 4.12. GPR Data between Reconstruction and Overlay Section.

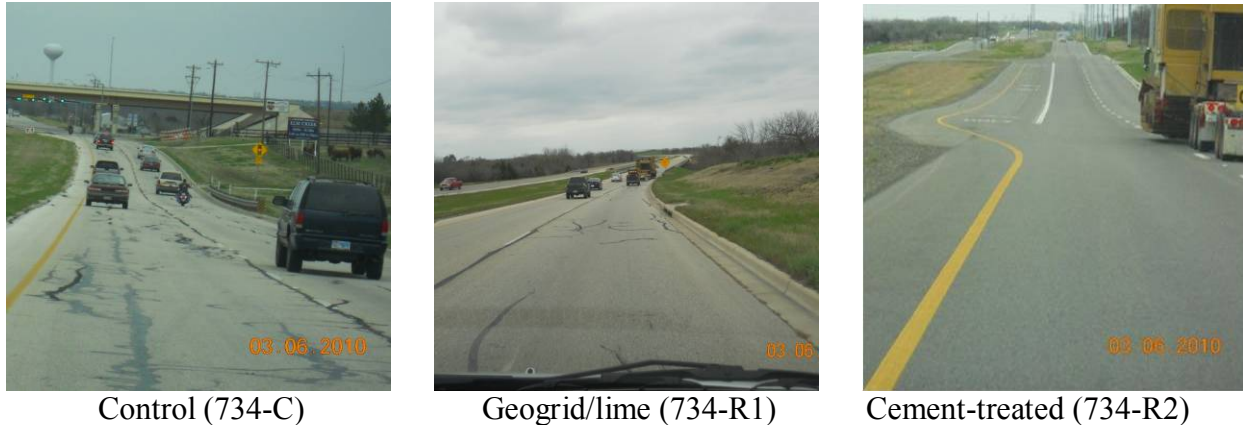
Severe surface cracking is evident in the control section with poor ride quality while the geogrid section has only minor surface cracking. There was no sign of distresses at the cement treated reconstructed section as shown in Figure 4.14.

Figure 4.14. FM 734 Test Sections Surface Conditions.

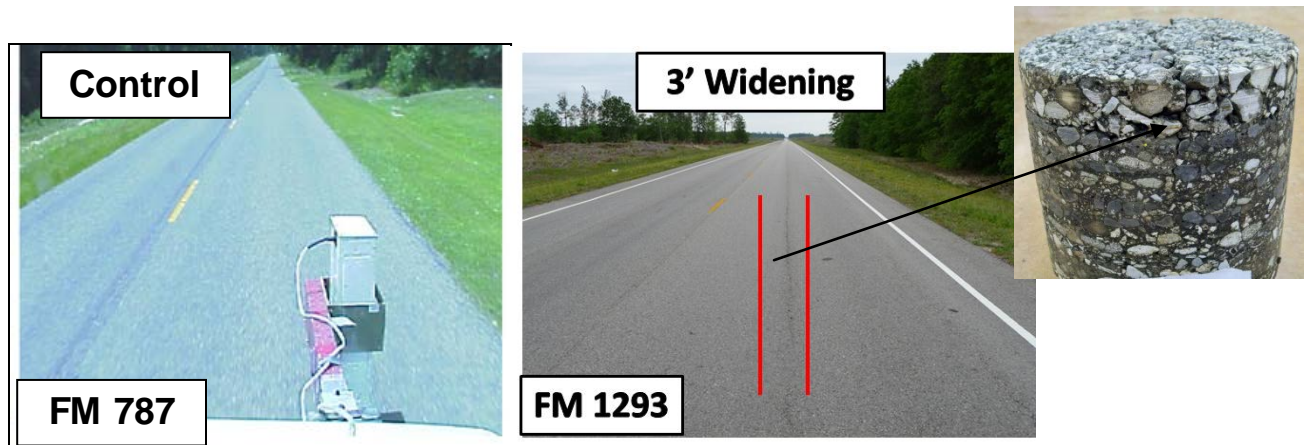
Visual survey indicated that the control section (787-C) experienced shallow rutting and fatigue cracking at the wheel path. The widened section (1283-W) experienced surface cracking that is attributed to segregation of the 1.5" overlay (Figure 4.16). No evidence of cracking in the 787-W section.

From the GPR survey, it was recognized that the widened section in FM 1293 exhibited better ride quality than the control FM 787. However, the GPR images suggested that the pavement could become rougher in the near future due to a possible moisture infiltration in the asphalt layer, as denoted by the GPR signals (Figures C-17 to C-18). The DCP was not performed in this site due to the granular nature of the base and subgrade materials. Table 4.14 shows the FWD backcalculation results. It was found that the layer moduli of 1293-W was higher than the 787-W sections. This could explain the structural-related damage in the form of rutting and fatigue cracking in the wheel path of the widened section 787-W.

Figure 4.16. Surface Condition Indicated Distress-Free Narrow Pavement at Control Section and Longitudinal Cracking at Widened Section.

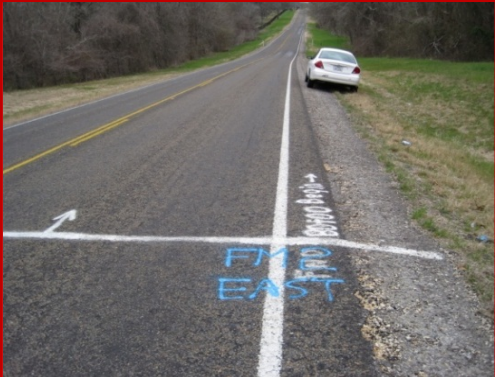
| Station * | Description | Pictorial Description |
|---|---|--|
| 80+00 ~ 89+00 | <p>Area surveyed: 5Eb: No geosynthetic w/lime treatment 6Eb: Geogrid 1 w/lime treatment 7Wb: Geogrid 2 w/lime treatment 8Wb: Geotextile w/lime treatment</p> <p>No cracks or ruts – good performance. Some extent of flushing detected from chip seal application.</p> | |

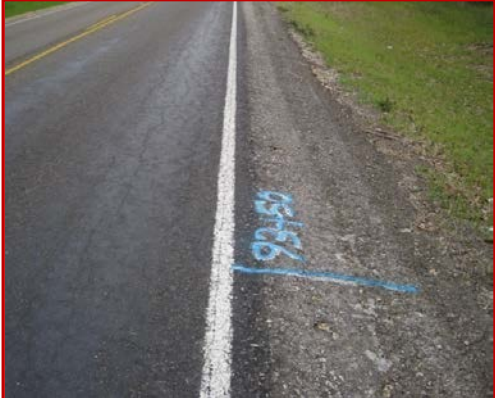
| Station * | Description | Pictorial Description |
|---|---|--|
| 89+00 ~ 98+00 | <p>Area surveyed: 5Wb: No geosynthetic w/lime treatment 6Wb: Geogrid 1 w/lime treatment 7Eb: Geogrid 2 w/lime treatment 8Eb: Geotextile w/lime treatment</p> <p>There were some longitudinal (edge) cracks which were repaired on eastbound lane, no cracks are on westbound lane.</p> | |

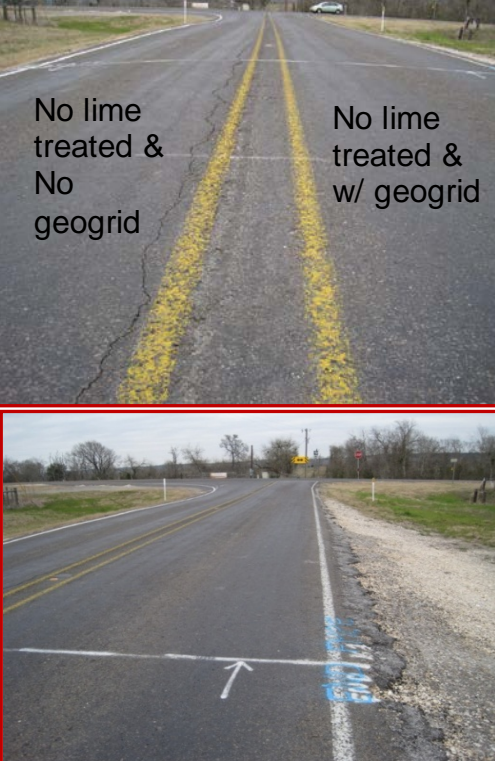
| Station * | Description | Pictorial Description |
|---|---|--|
| 203+00 ~ 221+00 | <p>Area surveyed: 1Wa/1Ea: No geosynthetic w/o lime treatment 2Wa/2Ea: Geogrid 1 w/o lime treatment 3Wa/3Ea: Geogrid 2 w/o lime treatment 4Wa/4Ea: Geotextile w/o lime treatment</p> <p>There are no edge cracks on both lanes; however, longitudinal cracks were found on a joint of both east and west bound lanes. The cracks length was about 27-ft with medium severity, initiated from 1Wa.</p> | |
