VEHICLE CRASH TEST AND EVALUATION OF
MEDIAN BARRIERS FOR
TEXAS HIGHWAYS

Research Report Number 146-4
Studies of Field Adaptation of Impact Attenuation Systems

September 1972
Texas Transportation Institute
Texas A&M University
College Station, Texas

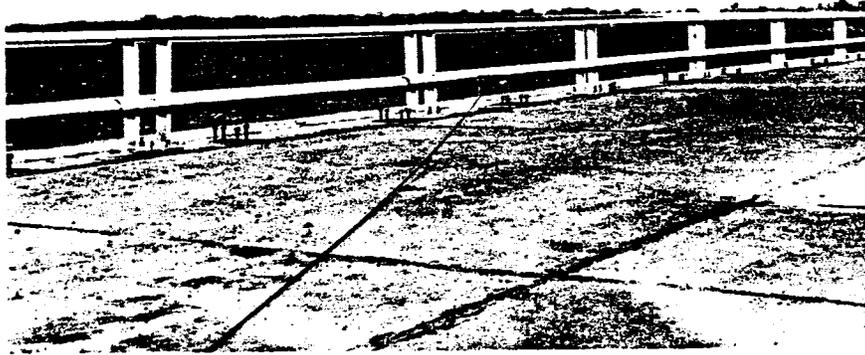
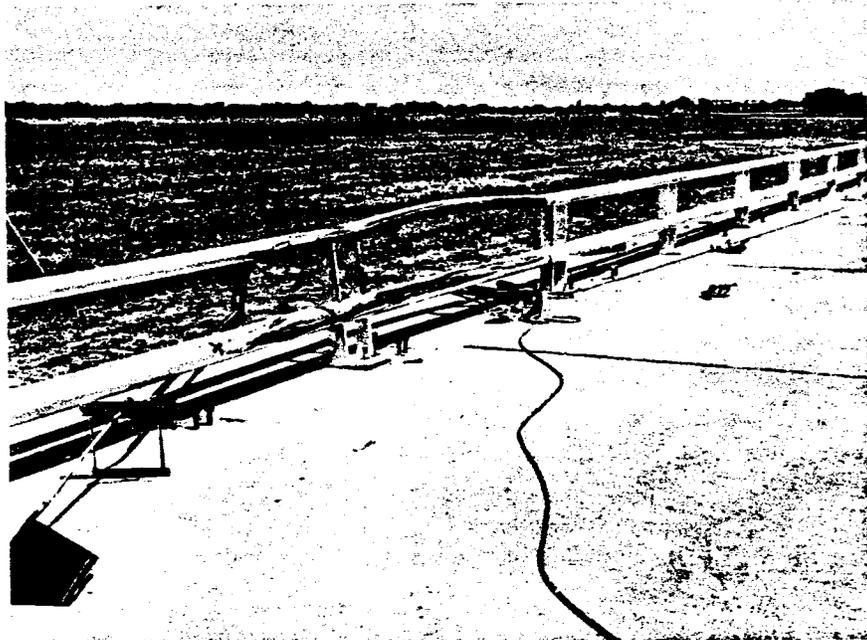
FIGURE 7, E3 BARRIER BEFORE AND AFTER TEST.

It can be seen in Figure 7 that the barrier remained intact and was not extensively damaged under the severe imposed test conditions. Maintenance would require the replacement of one 10 ft. length of upper rail member, straightening of one support post, and a paint touchup. It appears that the damaged barrier would, prior to repair, be functional under a possible second collision.

A noticeable amount of snagging occurred on a post of the E-3 barrier as the result of the vehicle front wheel mounting the lower rail member. It appears that snagging could be greatly reduced by increasing the height of the lower rail member. Also, the splice sleeve in each rail member of the E-3 barrier, adjacent to a post support, functions largely as a shear connection distributing the lateral load on a rail member to one or at most two posts. Failure of a splice would allow the colliding vehicle to penetrate the barrier or abruptly snag on the exposed rail member end and the post. It is therefore important that the 1/2-in. diameter bolt connecting the rail member and splice sleeve shown on the shop drawings be *securely tightened*.

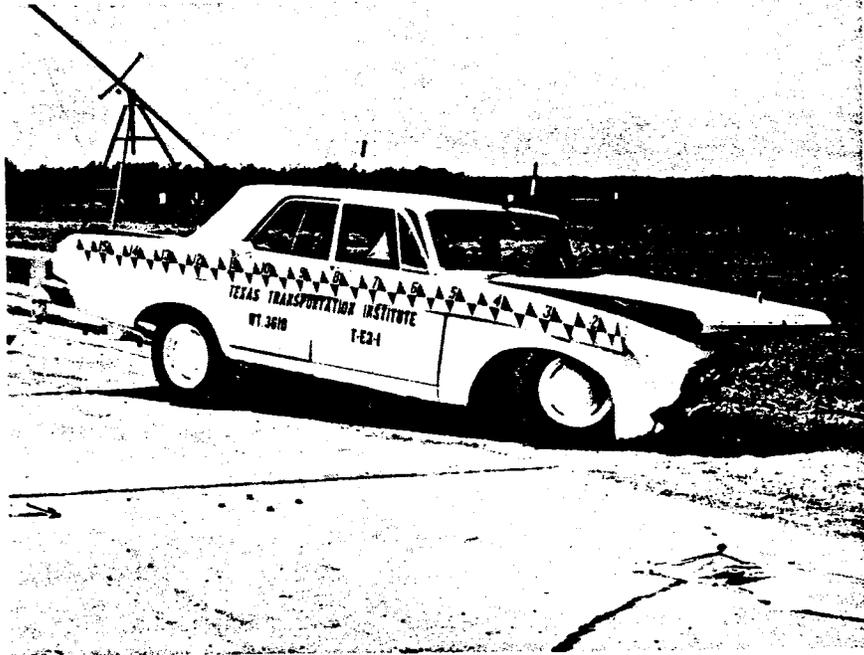
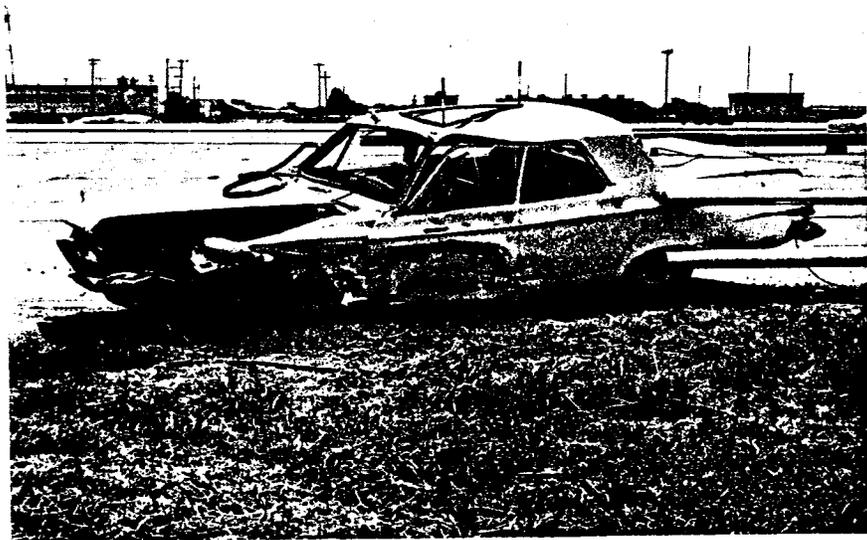
FIGURE 11, VEHICLE AFTER E-3 BARRIER TEST.

The damaged test vehicle is shown in Figure 11. It can be seen that the left front quarter and wheel are severely damaged, the windshield is knocked out, and the passenger compartment area is slightly warped.

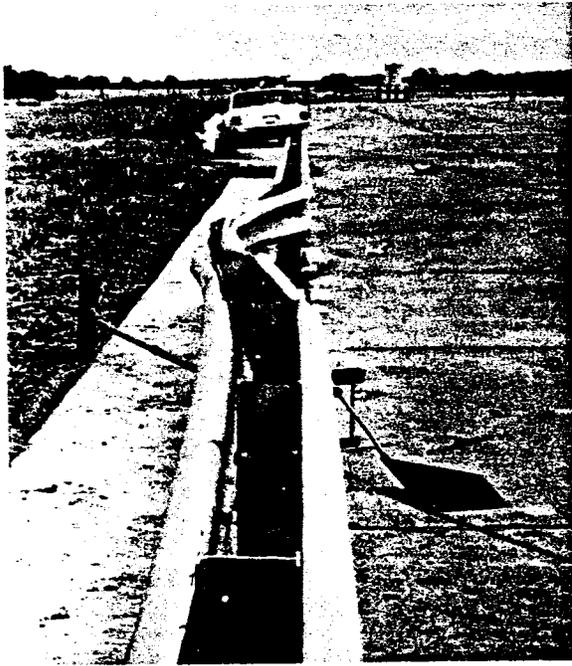
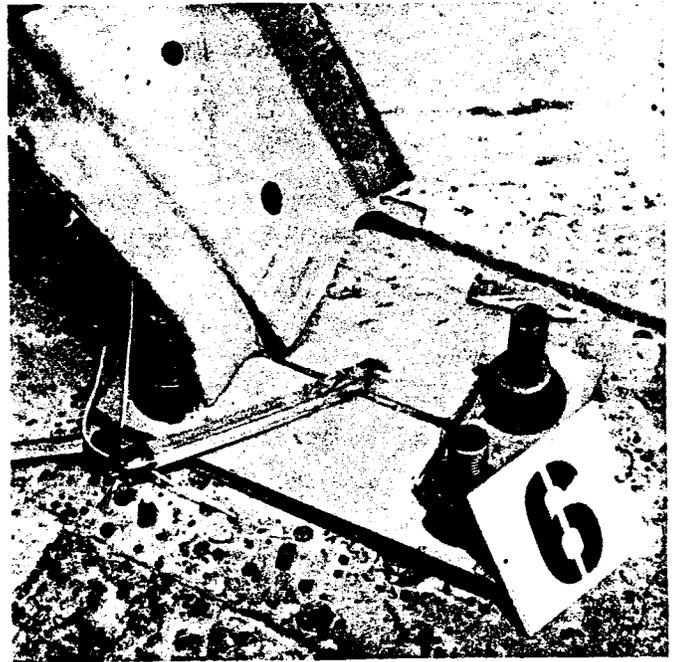
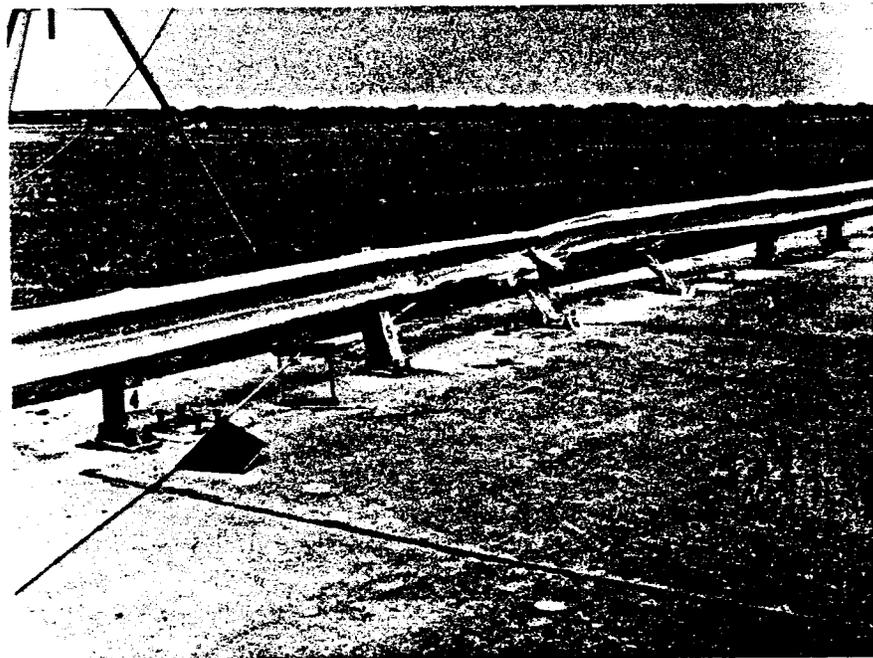
FIGURE 15, DAMAGE TO MBGF BARRIER.

The effectiveness of the breakaway fillet welded post connection in allowing the posts to displace laterally without pulling the rail member down, and thereby, preventing any tendency of the vehicle to ramp is evident in the photographs of the damaged barrier in Figure 15.

It can be seen in Figure 15 that the MBGF barrier remained intact under the severe imposed test conditions. Maintenance would essentially require the replacement of three posts and one 25 ft. length section of the two back-to-back W-beam guardrails. It appears that the damaged barrier would, prior to repair, be functional under a possible low-angle second collision.

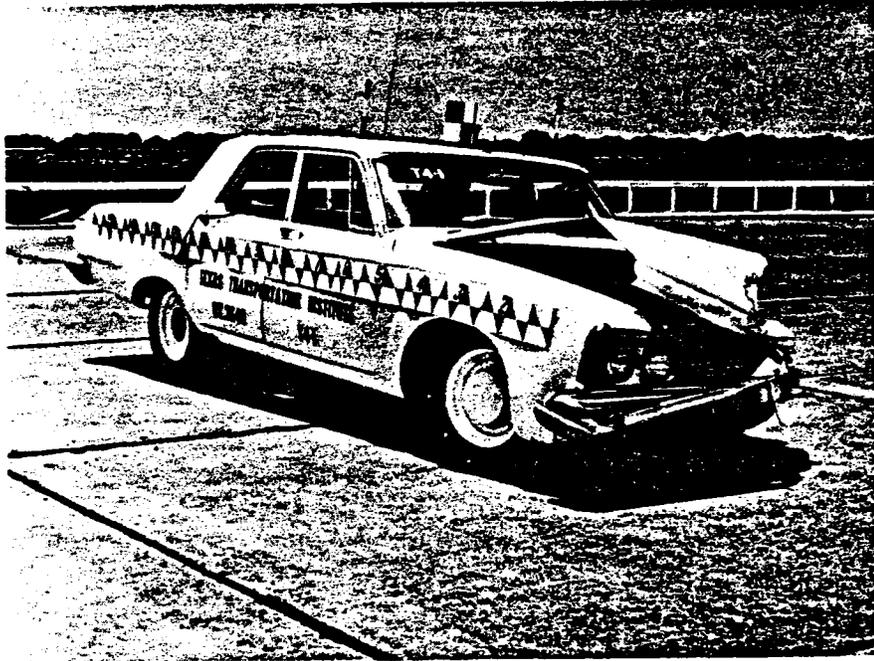
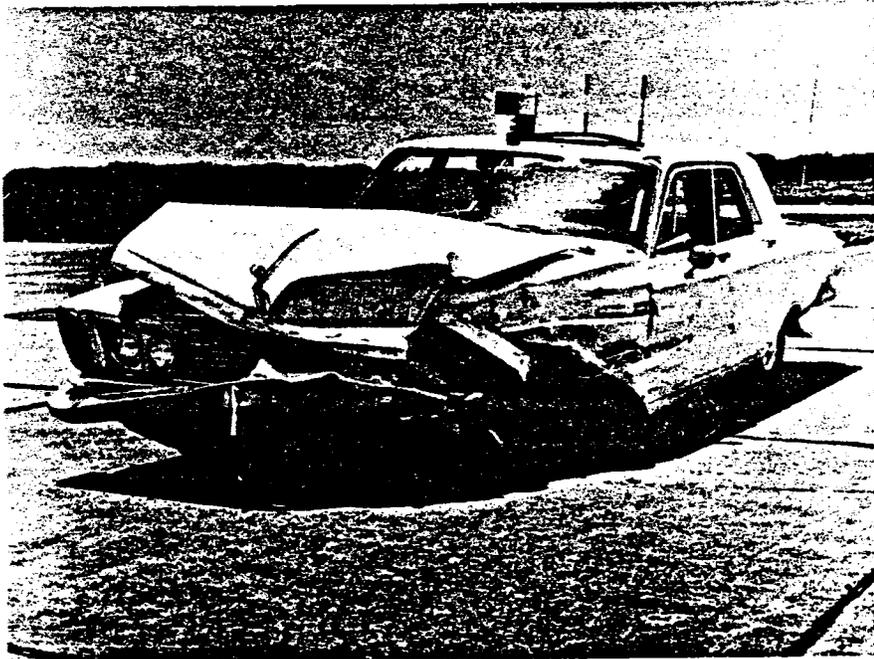
FIGURE 16, VEHICLE AFTER MBGF BARRIER TEST.

The damaged test vehicle is shown in Figure 16. It can be seen that the damage is less severe than the E-3 barrier test vehicle. The left front quarter is severely damaged, but the windshield remained intact and the passenger compartment area is not warped.

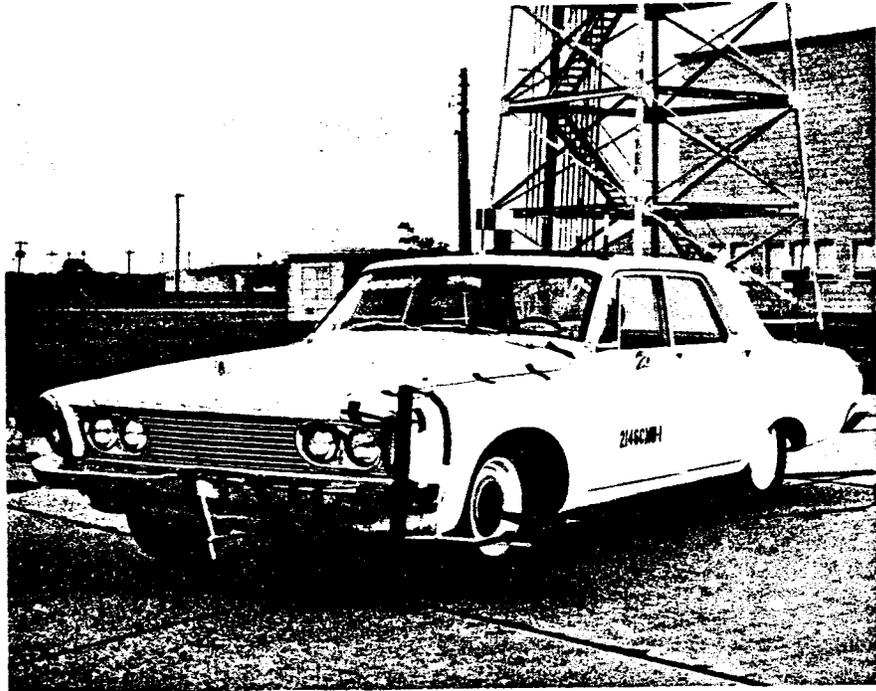
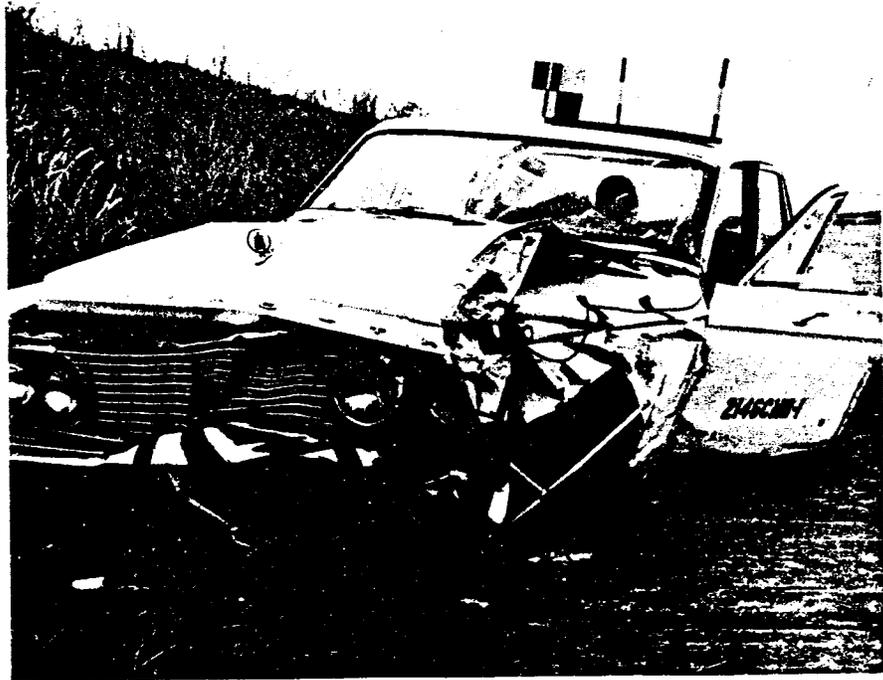
FIGURE 18. VEHICLE BEFORE AND AFTER TEST CMB-1.

The damaged vehicle is shown in Figure 18. As can be seen the front quarter and wheel were severely damaged, the door on the driver's side was sprung open, and the windshield was cracked.

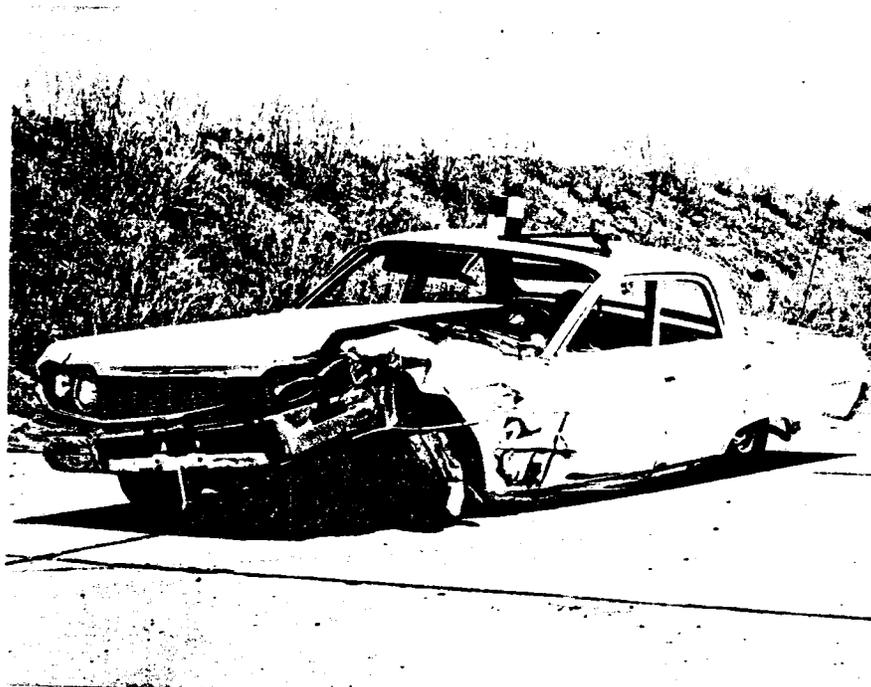
FIGURE 23. VEHICLE AFTER TEST CMB-2.

The damaged vehicle is shown in Figure 23. It can be seen that the 6 mph lower impact speed in this test also resulted in slightly less vehicle damage than that encountered in the previous CMB-1 test. For instance, the door is not sprung open in this test, whereas, in the CMB-1 test the door was sprung open.

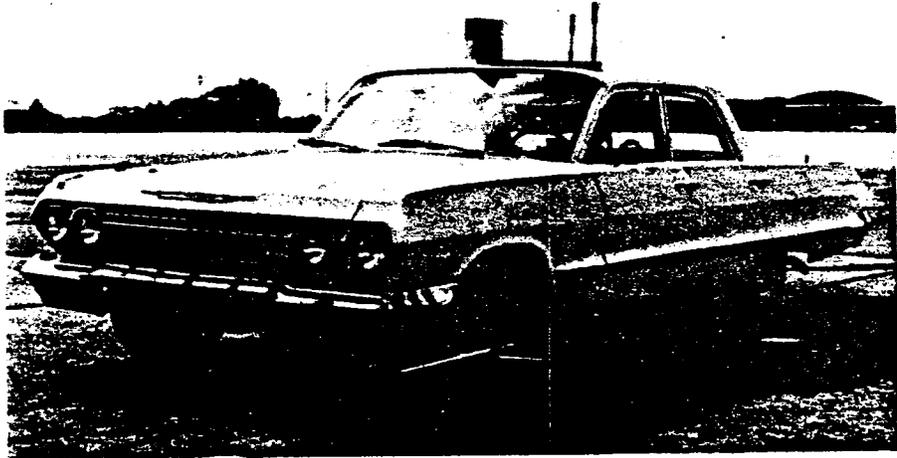
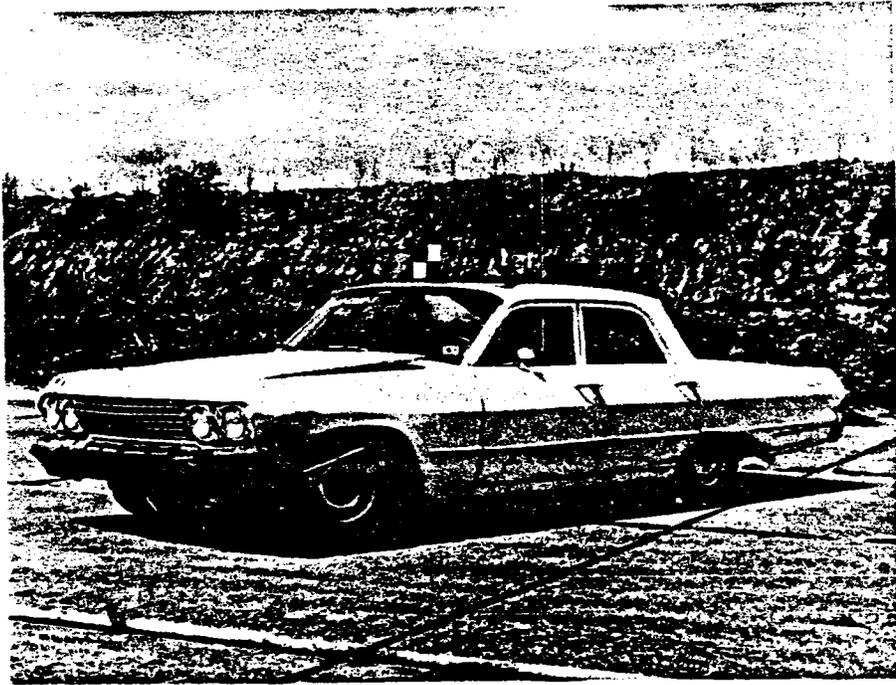
FIGURE 26. VEHICLE BEFORE AND AFTER TEST CMB-3.

The damaged test vehicle is shown in Figure 26. The relatively minor damage consisted of bumper and sheet metal crushing.

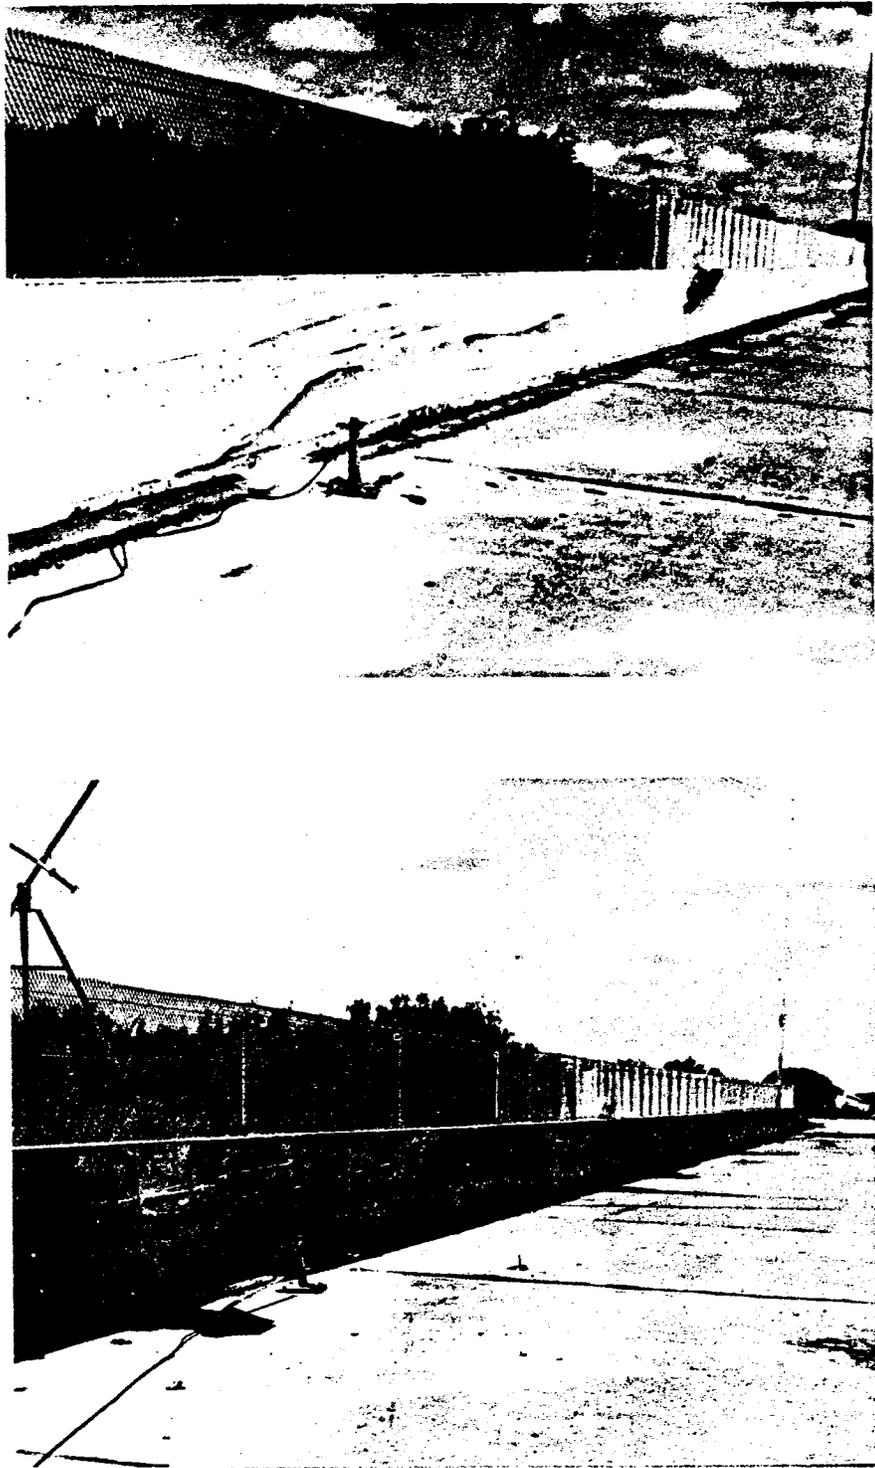
FIGURE 29. CONCRETE MEDIAN BARRIER BEFORE AND AFTER TEST CMB-4.

Sequential photographs of the vehicle collision and redirection are shown in Figures 31 and 32. The sequential photographs and the photograph of the tire scrub markings in Figure 29 show that the vehicle climbed all the way to the top of the barrier. Sheet metal contact caused relatively minor damage to the fence as can be seen in Figure 29. After losing contact with the barrier, the vehicle took two more severe bounces, alternately lifting the right side and the back end off the ground.

vehicles because the drag forces of the damaged front wheel pulled the vehicle back toward the barrier as can be seen in Figure 29.

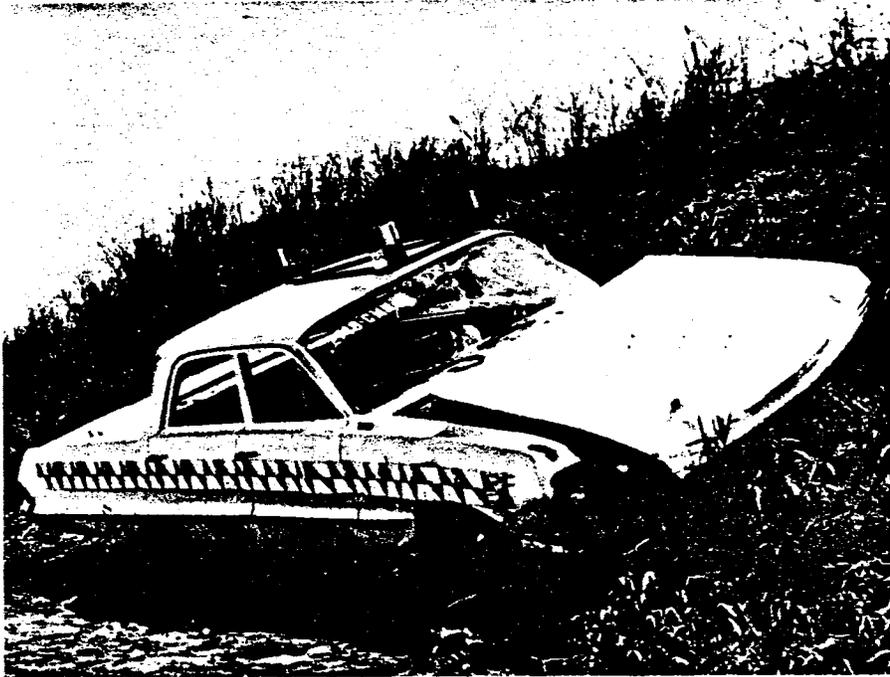
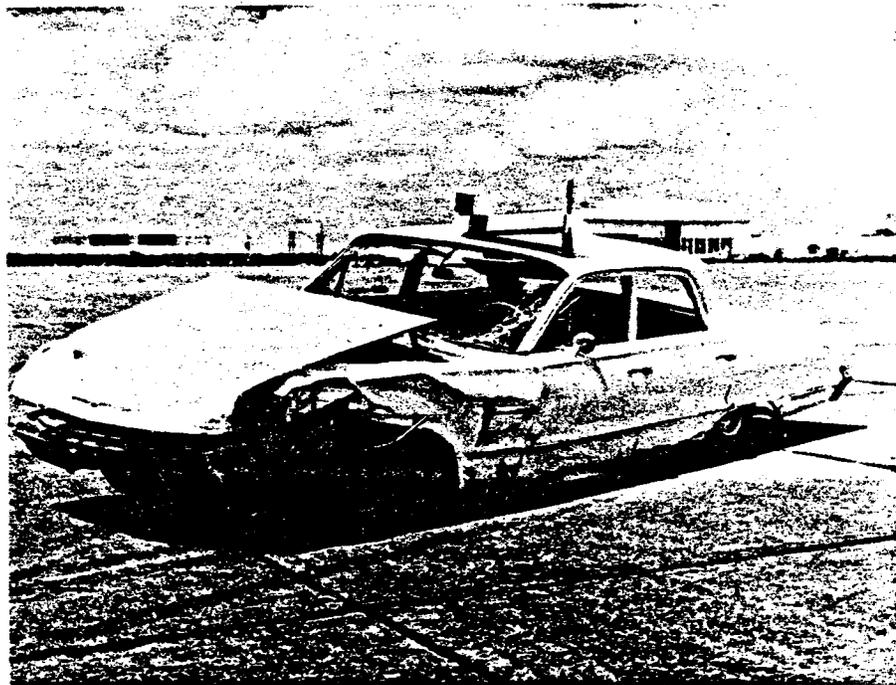
FIGURE 30. VEHICLE DAMAGE AFTER TEST CMB-4.

The damaged vehicle is shown in Figure 30. The damage to the vehicle in this test was somewhat less than the damaged vehicles in the previous CMB-1 and CMB-2 tests which were run at larger impact angles.
