1. Report No.		2. Government Accession No.		3. Recipient's Catalog No.	
4. Title and Subtitle <b>TRUCK TESTS ON TEXAS CONCRETE MEDIAN BARRIER</b>				5. Report Date <b>August 1972</b>

TRUCK TESTS  
ON  
TEXAS CONCRETE MEDIAN BARRIER

Research Report 146-7  
Studies of Field Adaptation of Impact Attenuation Systems

Texas Transportation Institute  
Texas A&M University  
College Station, Texas

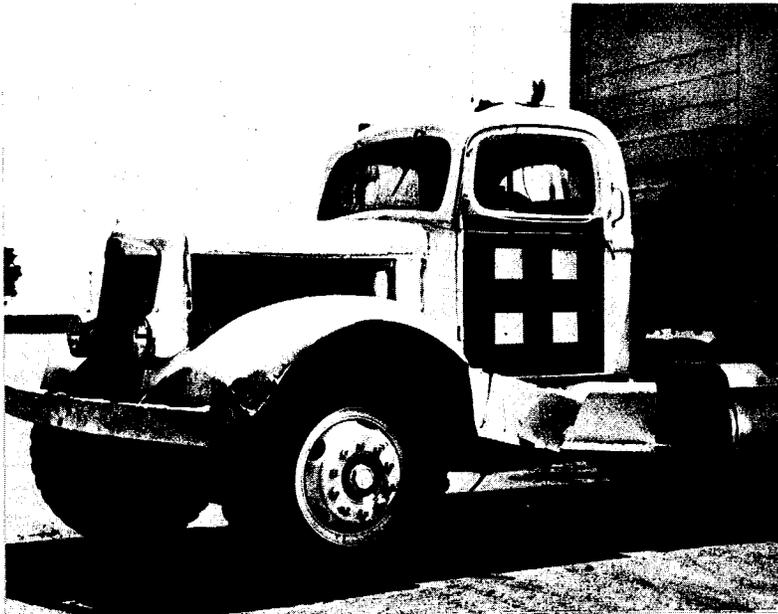
FIGURE 16 a  
TRACTOR DAMAGE  
AFTER CMB-5 TEST

The damage to the truck was relatively minor. The sheet metal damage of the tractor after the CMB-5 test is shown in Figure 16a. And, the sheet metal and bumper damage of the tractor after the CMB-5, CMB-6 and CMB-7 tests is shown in Figure 16b. Damage to the trailer consisted of several small indentations near the rear tandem wheels. The window on the side of the passenger was damaged prior to testing.

The estimated cost required to repair the fender, bumper and running board of the tractor would be most likely less than 200 dollars.
