Investigation of Longitudinal Cracking and Pavement Structural Load Carry Ability on FM 443

Technical Memorandum TM-14-02

Prepared for Texas Department of Transportation
Maintenance Division

Prepared by
Texas A&M Transportation Institute

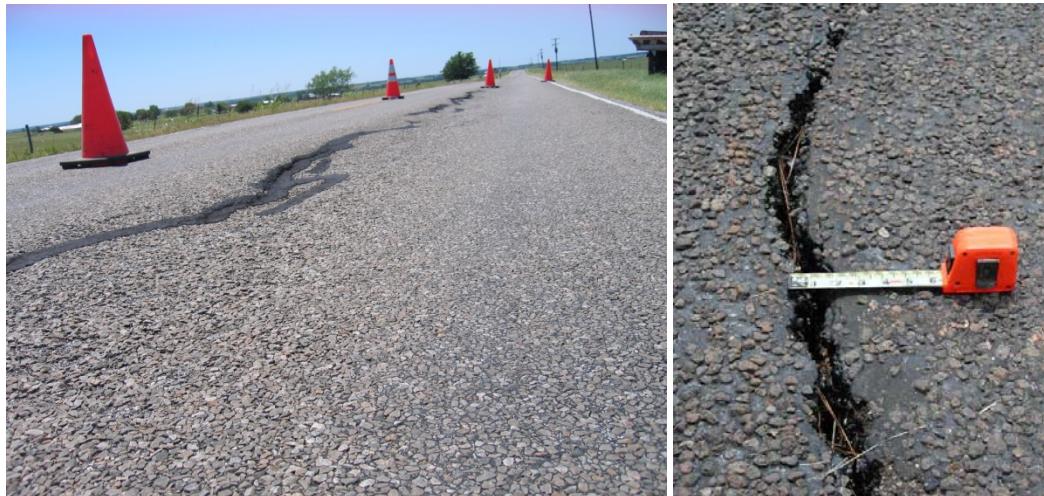
Figure 1. Longitudinal Cracking.

The primary cause of this type of longitudinal cracking is the presence of highly plastic clay soils as the subgrade material and changes in the moisture content of these soils due to climatic changes. Highly plastic clay soils undergo significant volume changes when subjected to moisture changes.

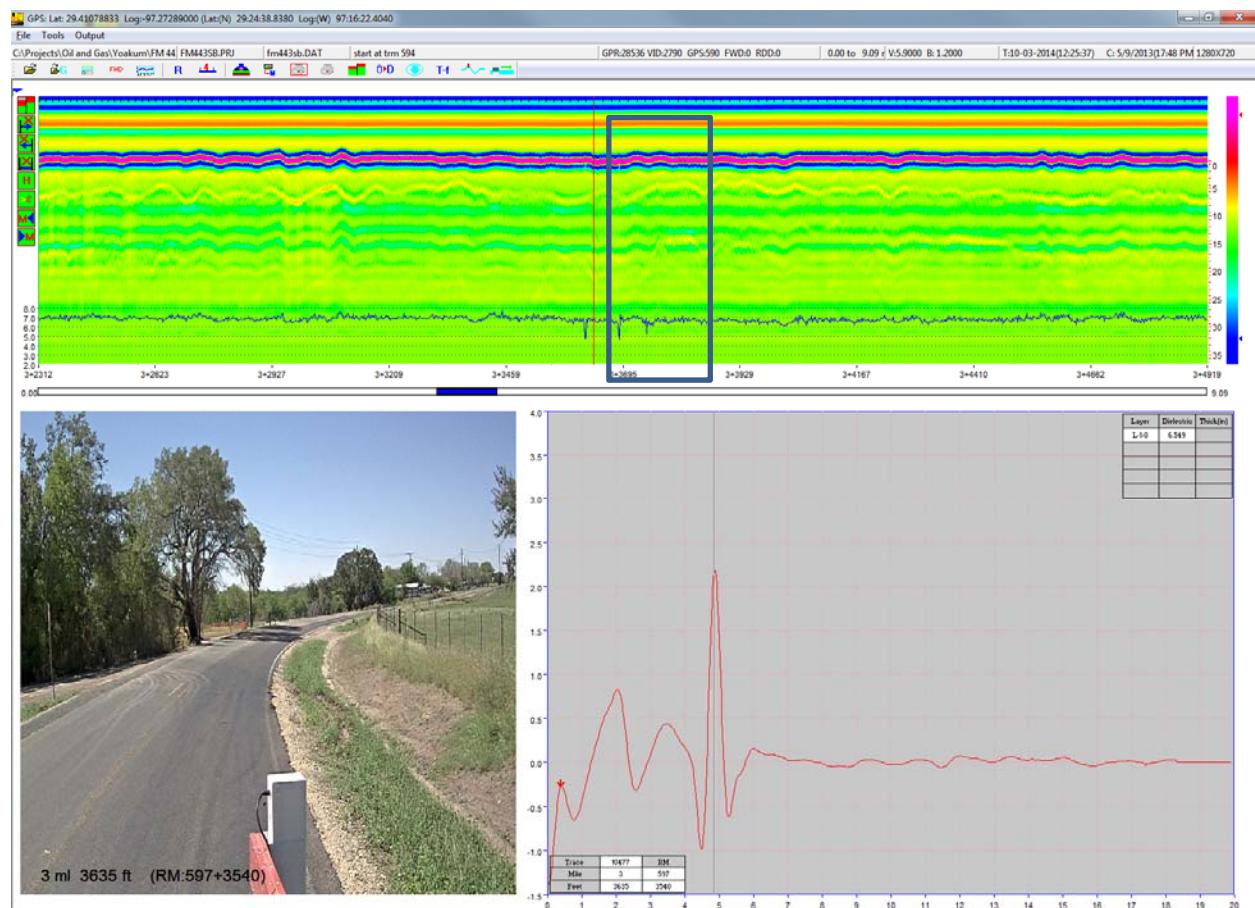
TTI used ground-penetrating radar (GPR) and falling weight deflectometer (FWD) analysis to evaluate the pavement structure. The GPR data were analyzed to determine abnormal subsurface reflections associated with changes in structural section depths and moisture contents in the pavement materials. Figure 2 and Figure 3 show SB and NB views of the location and illustrate that the GPR data from the focus zone in the curve show no unusual traces as compared to the rest of the pavement.

Figure 2. SB FM 443 GPR at Curve near CR 368.

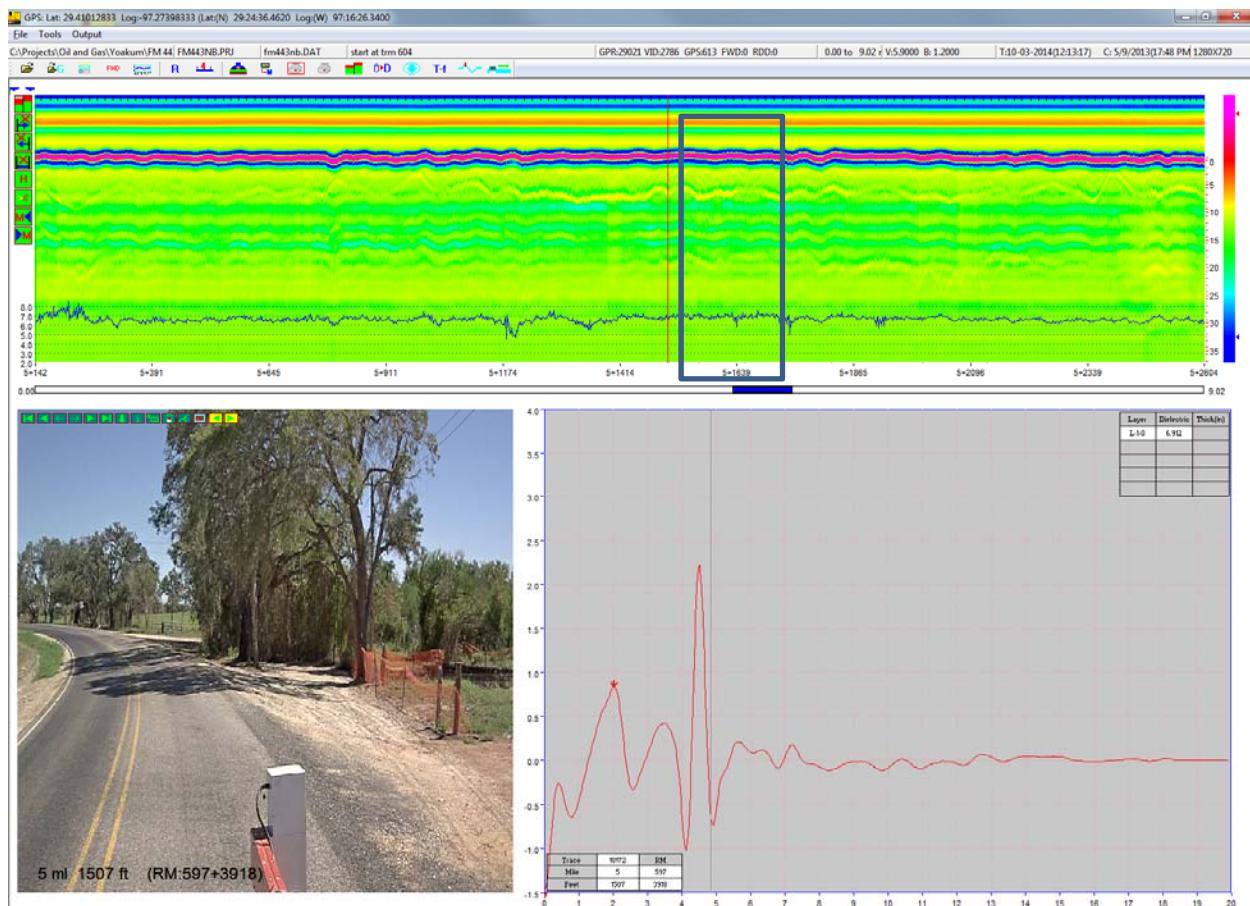
Figure 3. NB FM 443 GPR at Curve near CR 368.

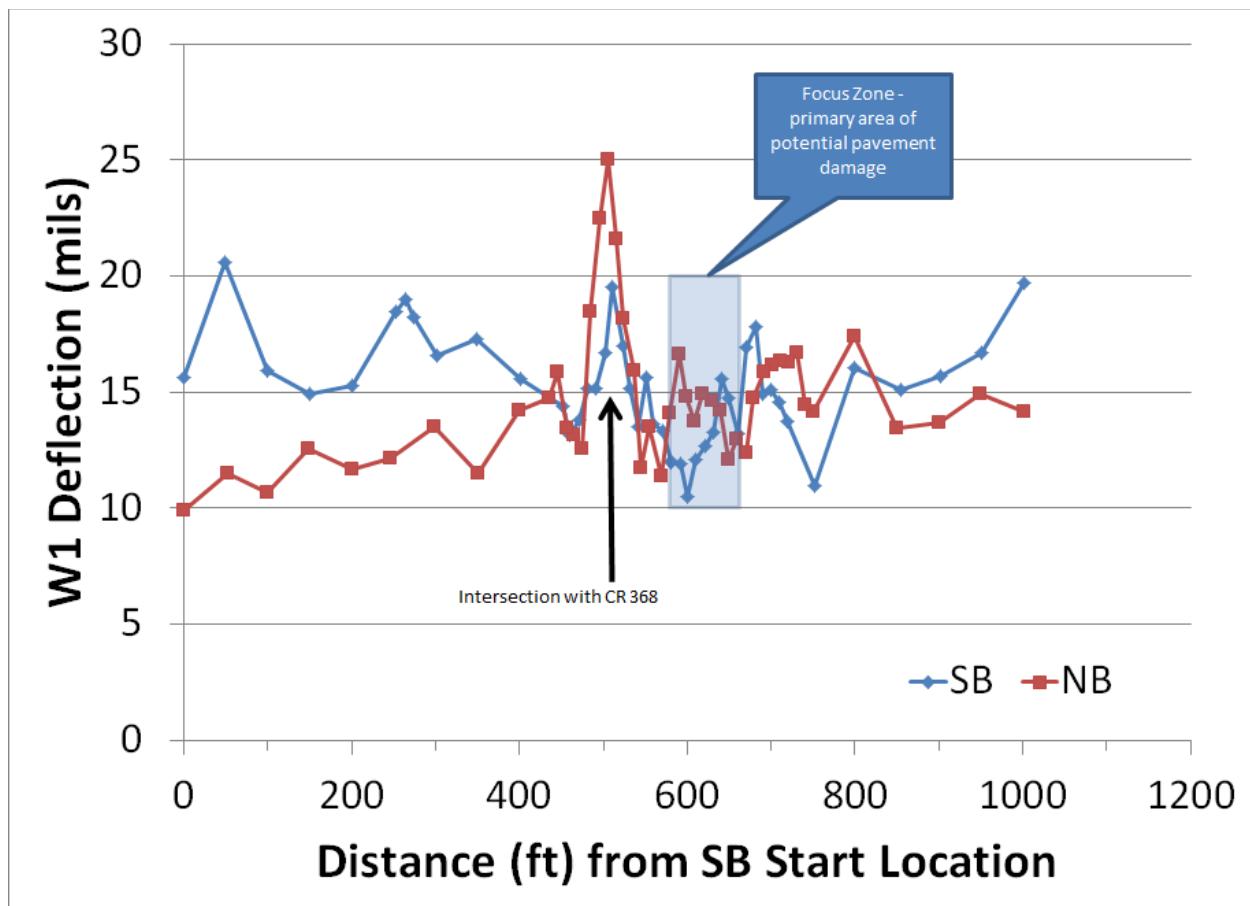
TTI collected FWD data at 50-ft intervals approaching and exiting the curve and collected FWD data at 10-ft intervals through the focus zone in the curve. Figure 4 illustrates the first sensor (W1) deflection through the tested area. Figure 4 suggests the focus zone does not exhibit pavement structure weakness. Statistical F and t tests confirm this observation as the mean deflection in the focus zone is statistically the same as the mean deflection of the pavement approaching and exiting the curve. Note that in the North Bound Lane (NBL), the mean deflections are equivalent for the study area versus the general roadway. In the South Bound Lane (SBL), the mean deflection in the focus zone is less than the mean deflection in the surrounding pavement area but not statistically different.

In summary, the data show no indication of pavement structure weakness or damage in the curve.

Figure 4. FWD Data through Curve on FM 443.

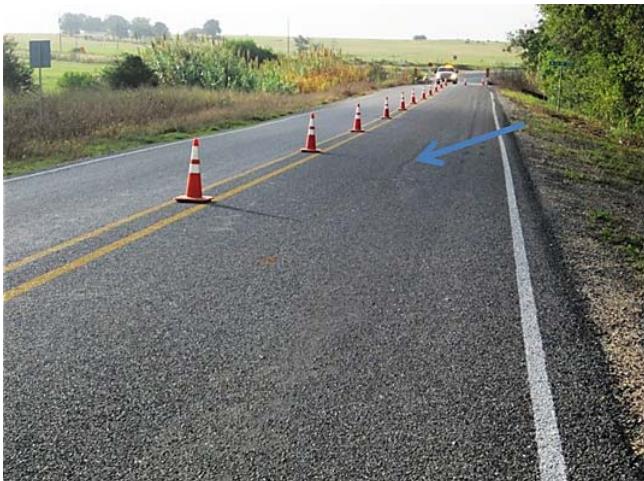
Figure 5 illustrates that longitudinal cracks were observed in locations that should not have been within areas of the contractor's scope of subgrade work. Subgrade soils collected on FM 443 (shown in

Near Kokernot bridge, crack location seems not within limits of subgrade widening

Due to the cause of the problem, for this project these cracks should be sealed and treated with appropriate maintenance treatments for non-load associated longitudinal cracking. In the future, potential ways to avoid recurring similar problems include:

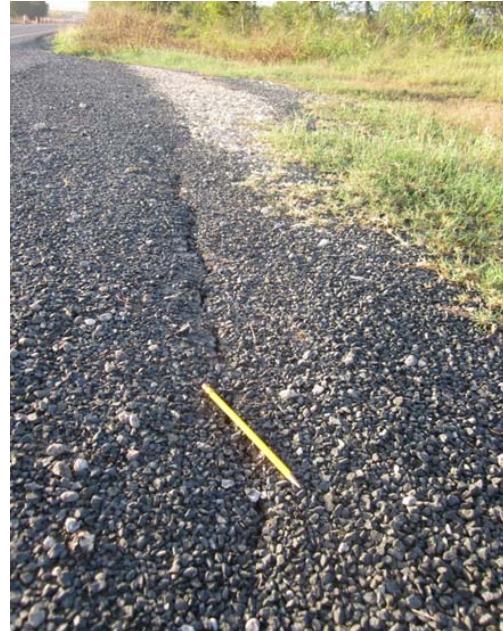
Locations of cracking observed well outside of pavement limits

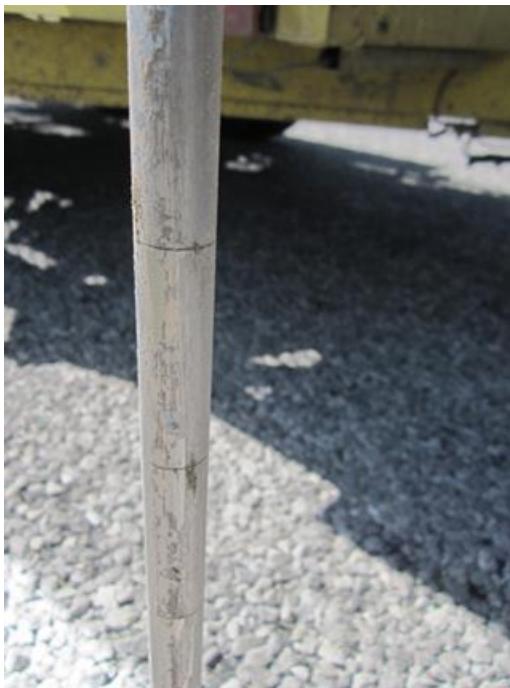
Figure 6) were observed to be a black clay material. Additionally, on surrounding pavements (Alt-90), numerous observations of longitudinal cracking were made. The distress of longitudinal cracking seems quite common in the geographic area of the project.

Clayey soil sticks to DCP rod during testing

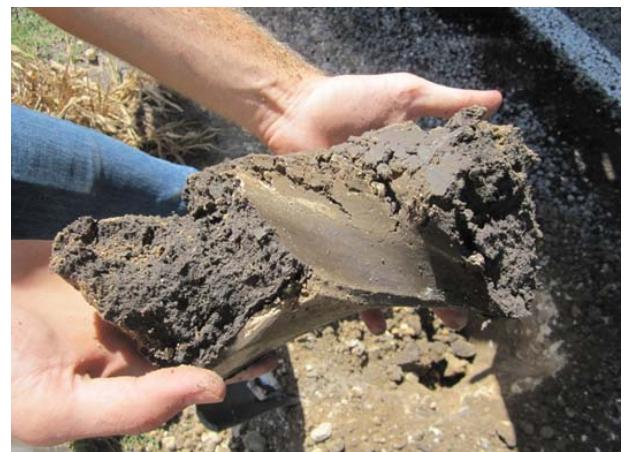
Black clay soil collected from drilling rig

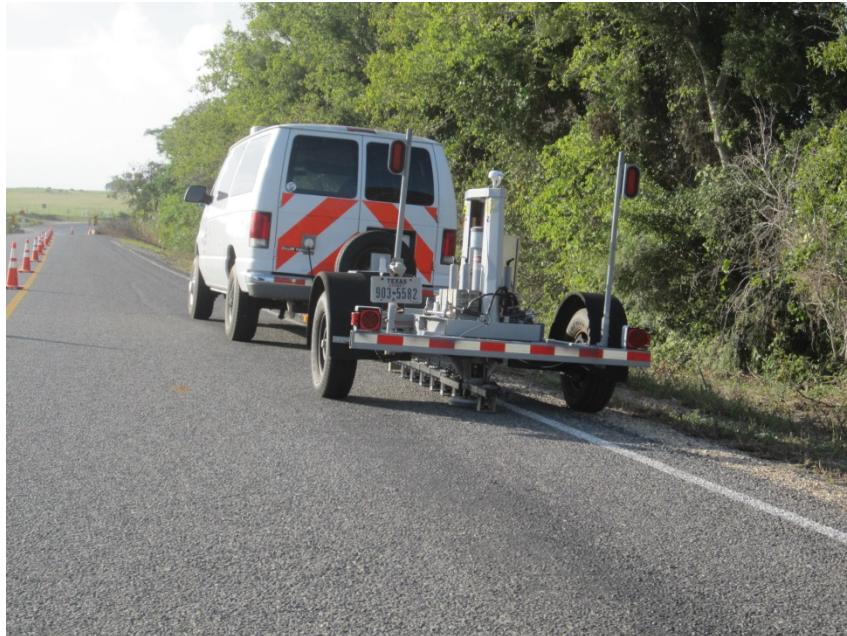
TTI performed FWD testing both inside and outside the longitudinal crack from STA 418 to 415 as Figure 7 illustrates. The purpose of this FWD work was to evaluate whether the widened subgrade, which only called for ordinary compaction, provided similar support to the existing subgrade.

Table 2 show that, whether evaluated based on W7 or backcalculated subgrade modulus, no statistical difference in subgrade support existed between the existing and widened subgrade.

Figure 7. Performing FWD Testing outside Crack on Widened Subgrade.

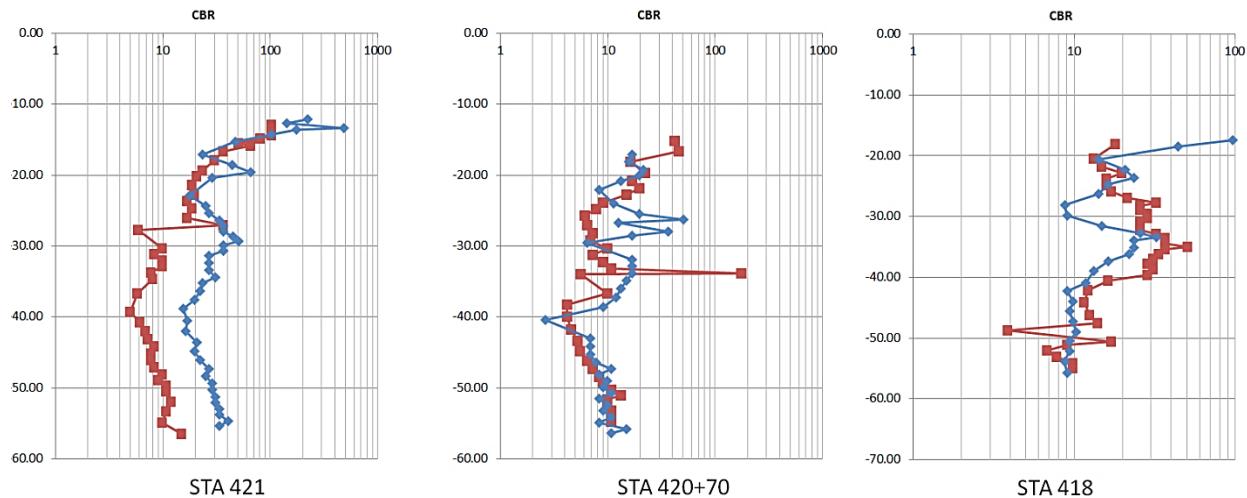
Figure 8 illustrates an overlay of the DCP profiles from the widened subgrade with their corresponding DCP profile from the existing subgrade at stations 421, 420+70, and 418. These data illustrate no major differences in support in the upper portion of the widened subgrade as compared to the existing. The results agree with the FWD and indicate the subgrade widening is not offering inferior support as compared to the existing subgrade.

Figure 8. DCP Profiles Comparing Existing (Blue Line) and Widened (Red Line) Subgrade Support.

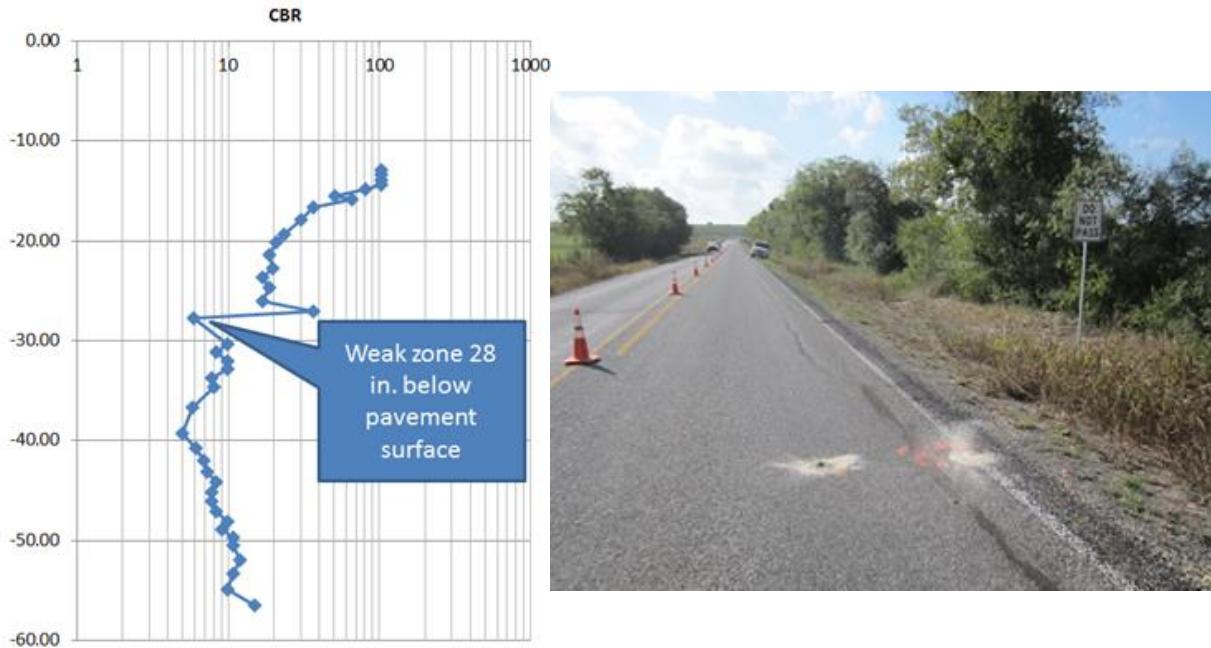
In addition to providing information to evaluate the adequacy of the ordinary compaction, the DCP data also serve to evaluate the originating cause of longitudinal cracking. Figure 9–Figure 11 illustrate DCP profiles from Stations 421, 420+70, and 418, all of which have longitudinal cracking distress. In each case, the DCP profile shows a localized significantly weak zone within the subgrade. The location of these localized weak zones in the DCP profile likely indicates the depth through which the longitudinal crack is passing through or originating.

Figure 9. DCP Profile Showing Localized Weak Subgrade Zone at STA 421.
Note: DCP profile shown is from test conducted outside the crack on the white stripe.

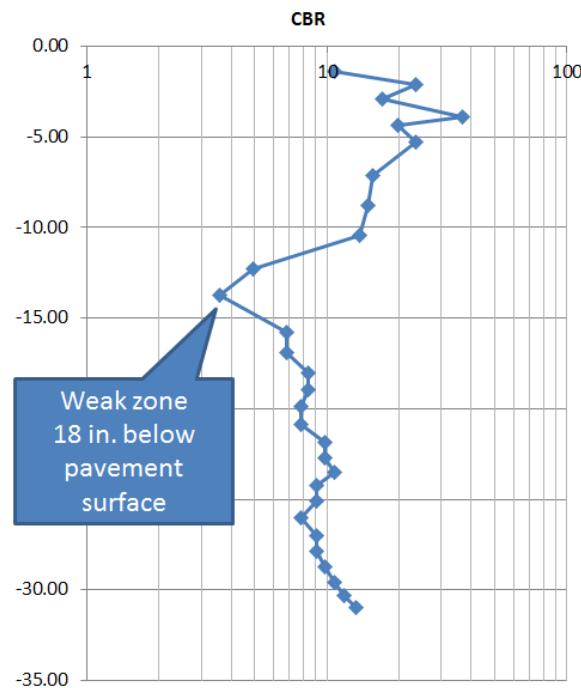
Figure 10. DCP Profile Showing Localized Weak Subgrade Zone at STA 420+70.
Note: DCP profile shown is from test conducted on the front slope, so the zero point on this DCP profile is ~ 4 in. below the pavement surface.

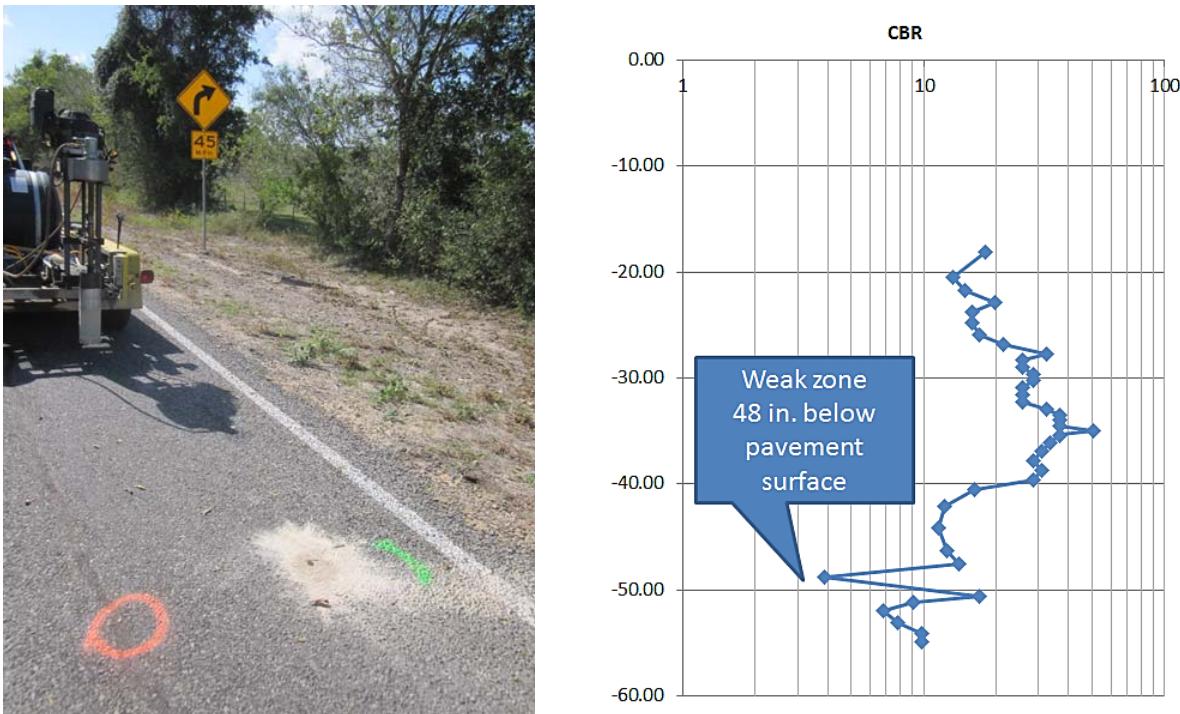
Figure 11. DCP Profile Showing Localized Weak Subgrade Zone at STA 418.
Note: DCP profile shown is from test conducted between longitudinal crack and white stripe.

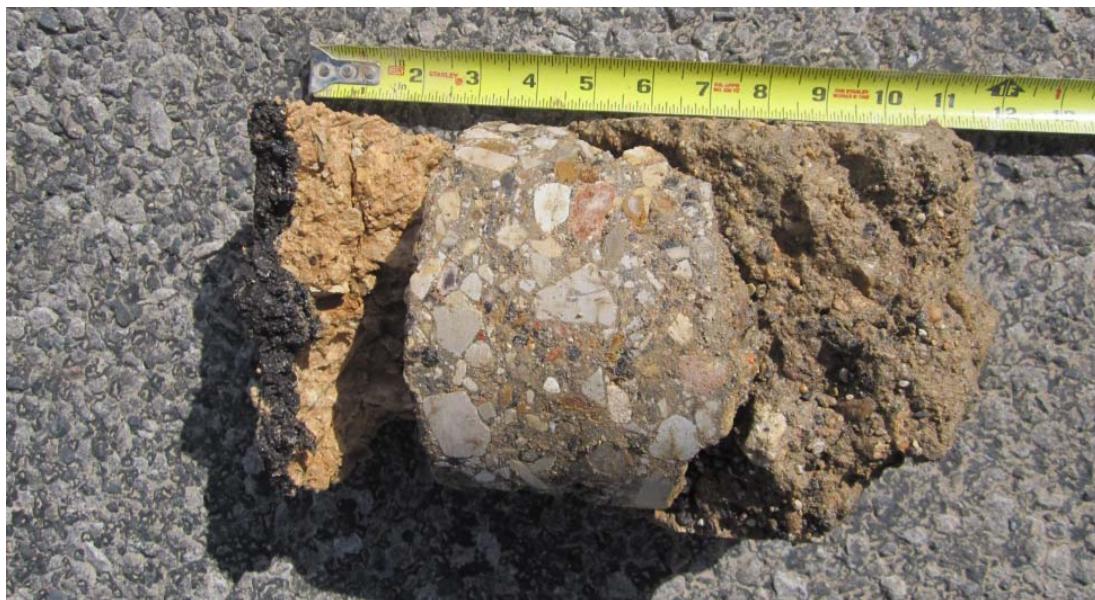
Figure 12. Coring Result at STA 421.

TTI conducted coring directly over the longitudinal crack at Stations 421, 418, and 475. Figure 12 and Figure 13 show that at Stations 421 and 418 the crack clearly went through the entire depth of the Cement Treated Base (CTB) base. At Station 475, shown in Figure 14, the fines pumped out during coring, and no recoverable material existed after coring. Staff could not see the pathway of the crack in the core hole.
