Rehabilitation Recommendations for FM 97 in Gonzales County

Technical Memorandum TM-14-04

Prepared for Texas Department of Transportation
Maintenance Division

Prepared by
Texas A&M Transportation Institute

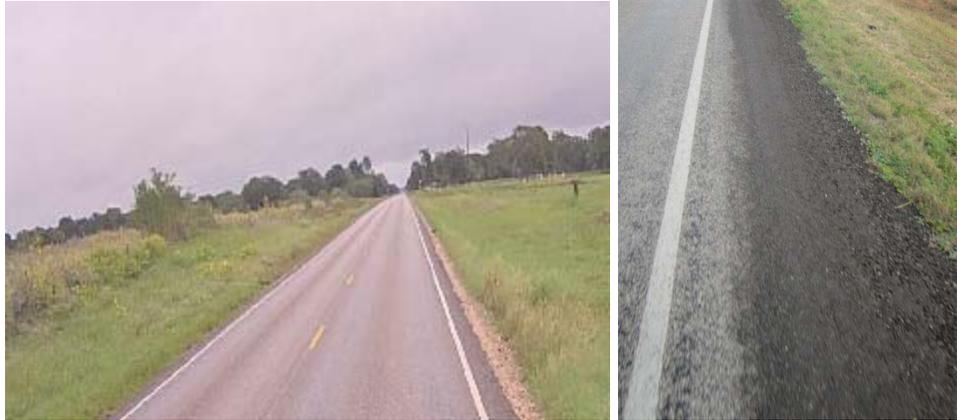
| Distress: The pavement structure is in good condition. Edge failures exist due to lack of shoulder. | | |
| Cause of Problem: The lack of shoulders is causing the edge failures to occur. The photo above shows the District is performing repairs in problem locations. The pavement has good structure, where FWD backcalculations show the base modulus to be 123 ksi and the lime-stabilized base 191 ksi. The subgrade modulus from the FWD is 16 ksi. | | |

| Recommended Rehabilitation Approach: Confirm the existing structure meets FPS requirements with current traffic projections. Perform shoulder widening and then apply a surface treatment or overlay. Options for this shoulder widening include undercut and add flexible base, undercut and stabilize the existing soil and then add flexible base, or match the existing section of flexible base over a stabilized base. The soils maps suggest the native subgrade in this section is free of gypsum, low in organic content, and generally low plasticity. Soil samples should be collected and tested to confirm the soil properties, and then alternative shoulder designs checked with FPS for meeting triaxial thickness requirements. | | |

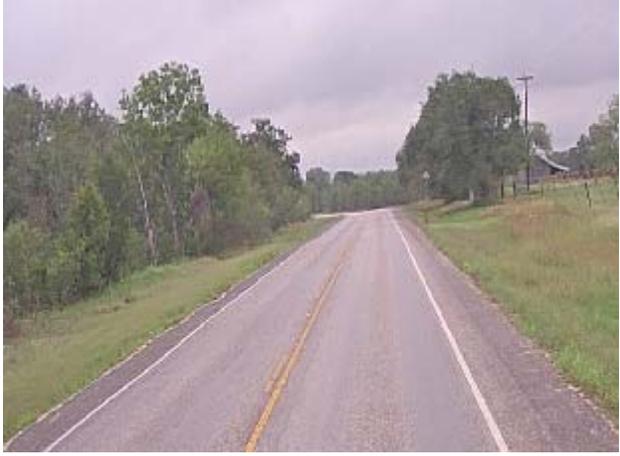
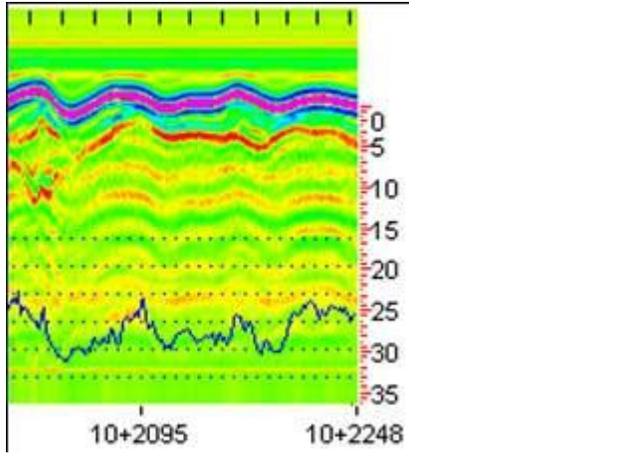
| Distress: Some localized roughness and surface patching. | | |
| Cause of Problem: Based on plans and information gathered from District staff, this section has probably exceeded its original design life. The FWD shows reasonable lime-treated base and flexible base modulus values of 170 and 41 ksi, respectively. The subgrade modulus averaged 13 ksi. | | |

| Recommended Rehabilitation Approach: Given the excellent performance of section 1, apply a flexible base overlay with surface treatment or overlay. Constructing the flexible base overlay on top of the lime stabilized layer will enable the District to realize a higher modulus value from locally sourced aggregates. FWD results on similar sections suggest 100 ksi can be used in FPS for the flexible base layer over the stabilized layer. Widened shoulders already exist in this section, so no shoulder widening is needed. | | |

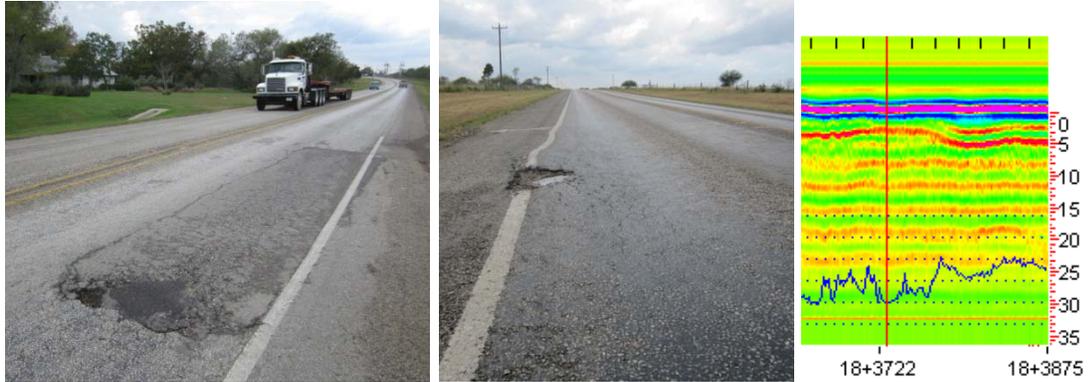
| Distress: Many failures exist with deep ruts and alligator cracking. Substantial maintenance activity exists. This section exhibits the worst distress on SH 97. | | |
| Cause of Problem: This section has also likely exceeded its original design life. The soils maps suggest the native subgrade in this section is relatively poor for roads and streets due to shrink-swell and low strength. The pavement structure could thus be thin for this subgrade and the pavement structure does not have a stabilized base or subbase layer. The FWD shows the gravel base modulus averaging 24 ksi, with a subgrade modulus of 10 ksi. | | |

| Recommended Rehabilitation Approach: Perform full depth recycling (FDR) with a flexible base overlay and new final surfacing. Lime or cement should be considered for the stabilizing agent used in FDR. Use lab results of roadway material samples to determine the best suited stabilizer: <ul style="list-style-type: none"> • Measure plasticity index. • Based on PI, select cement or lime as the most likely candidate stabilizer. • Perform laboratory tests using Tex 120-E or 121-E as appropriate to determine the required stabilizer content. • Alternatively, the Texas A&M Transportation Institute has developed mix design methodology using the Texas Gyrotory Compactor, where multiple potential mixture designs can be screened with a small quantity of roadway material. Once the potential mixture designs are screened, the most promising design can be verified with 6×8 in. sample molds. | | |

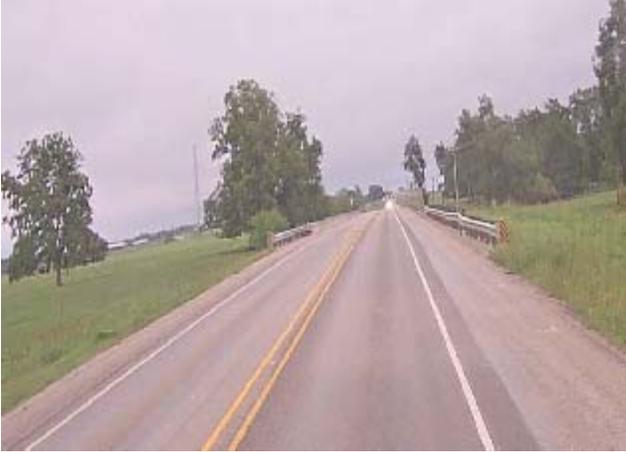
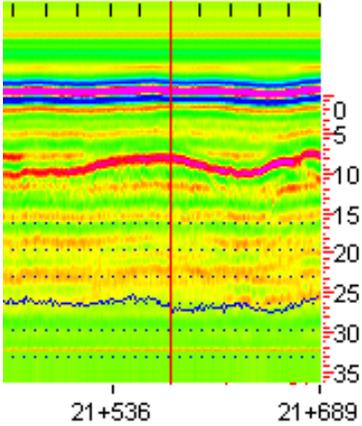
| Current Condition: <div style="display: flex; justify-content: space-around; align-items: center;"> </div> <p>Distress: Good condition.</p> | | |
| Cause of Problem: No problems were observed in this section. The section is structurally sound and substantially thicker than other sections of SH 97. | | |

| Recommended Rehabilitation Approach: This section contains several bridge structures and has thick asphalt cover. Continue preventive maintenance program. | | |
