FULL-SCALE CRASH TESTS  
OF  
MOTORIST AID CALL BOX SYSTEM

Prepared for  
Delaware Department of Transportation  
DDOT Contract No. IR-95-2(67)C  
Dover, Delaware

Texas Transportation Institute  
Safety Division  
College Station, Texas

May 1986

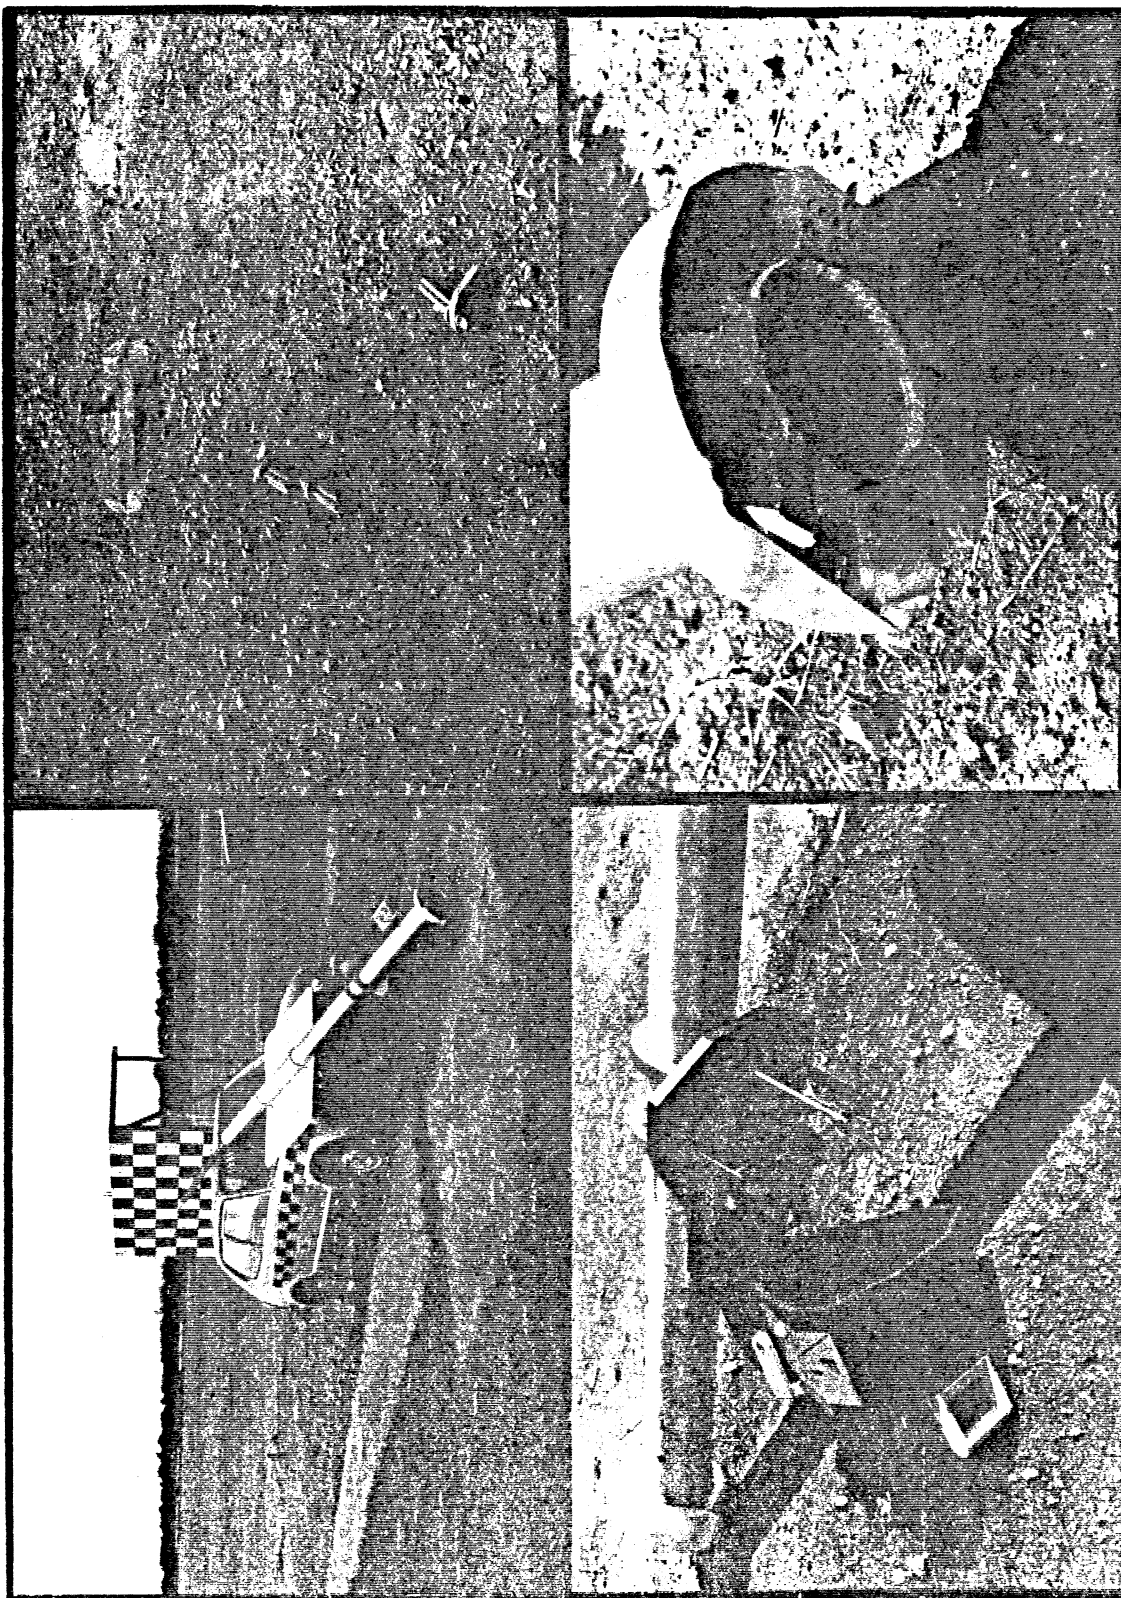
Figure 11. Call box installation after test 0335-1.

Note any damage to vehicle prior to test:  
 The vehicle's center of gravity was approximately 30 ft (9.2 m) from the pole base. The couplings that separated from the base by the shearing of the anchor bolts came to rest approximately 7 ft (2.1 m) from the base. The vehicle broke into two major pieces. The lower portion of the coupling remained on the anchor bolt. The upper part traveled with the pole attached to the remaining pole flange. Sequential photographs of the test are shown in figure 10. Figure 11 shows the installation after test 0335-1.

The installation readily activated by breaking away. The manner of activation was not completely expected, however, due to the nature of breakaway devices. The flange and anchor bolts at three of the four supports fractured rather than the breakaway couplings. A similar activation would be predicted in a duplicate test. The detached elements from the test article did not penetrate nor show potential for penetrating the passenger compartment, nor presented undue hazard to other traffic due to the off-road location of the elements. The vehicle remained upright during and after the collision. The calculated longitudinal occupant impact velocity against the vehicle interior was below the limit of 15 ft/s (4.6 m/s). The absolute value of the measured maximum 0.010-second average longitudinal occupant ridedown acceleration was below the limit of 15 g. After collision, the vehicle trajectory and final stopping position was such that the vehicle did not intrude into adjacent traffic lanes. The vehicle trajectory behind this test article was acceptable.

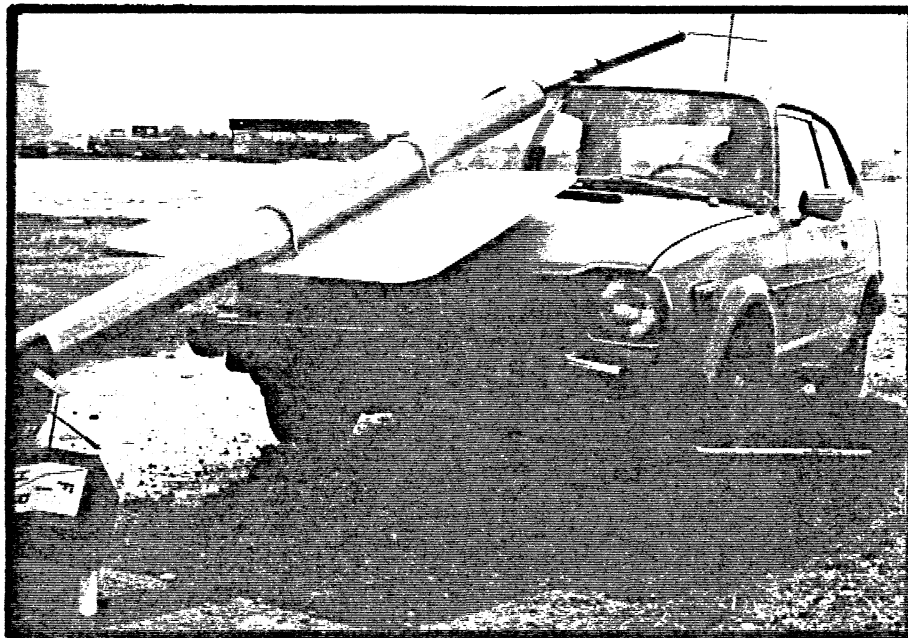
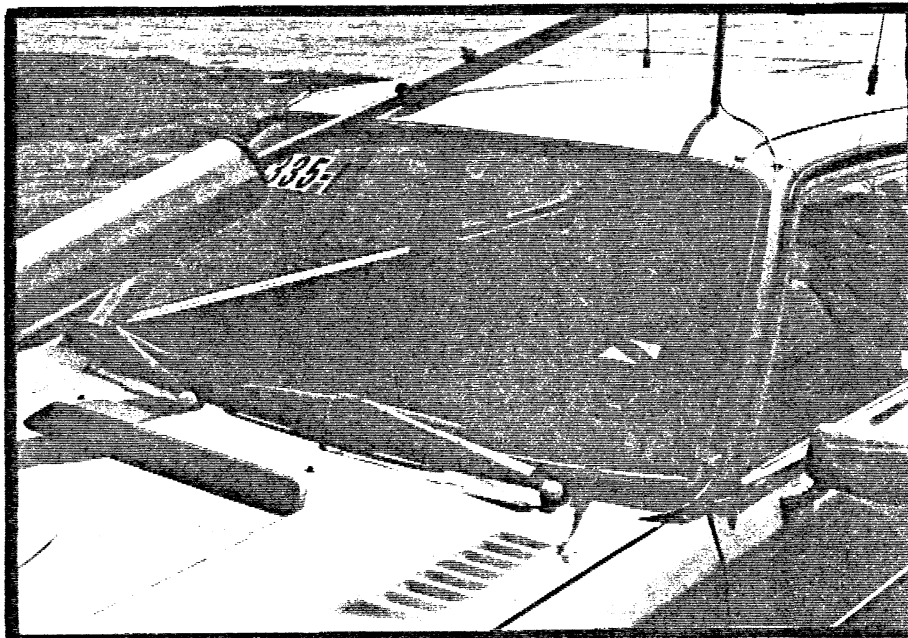
Figure 12. Vehicle after test 0335-1.

The test vehicle sustained minor damages to the front end as shown in figure 12. Maximum crush to the frontal plane of the vehicle at bumper height was 9.3 in (23.6 cm). The hood was crushed inward about 3 in (7.6 cm). The grill was broken into two pieces. The front valance panel was also bent. The front windshield was undamaged. After the test, the anthropomorphic dummy was observed to be in the driver seat in approximately its original position.

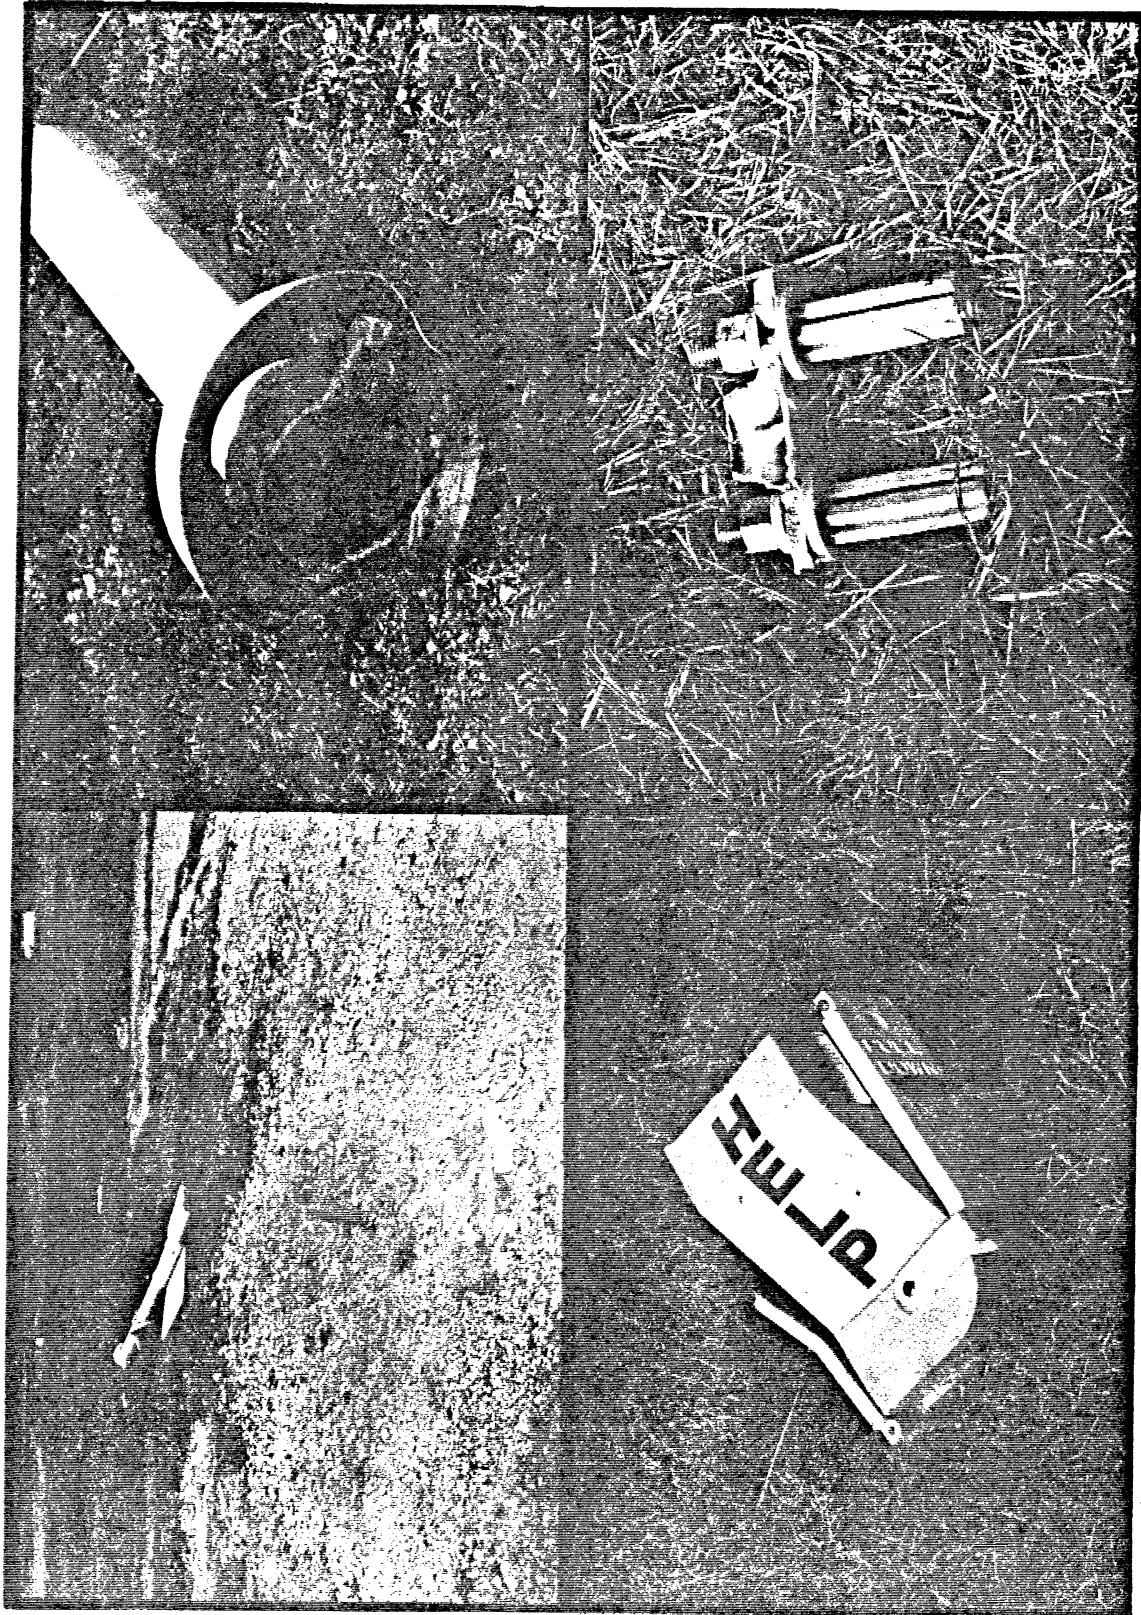
Figure 18. Call box installation after test 0335-2.

The center of gravity of the vehicle at final rest was approximately 225 ft (68.6 m) in the longitudinal direction and 43 ft (13.1 m) to the right of the pole base. The pole landed approximately 21 ft (6.4 m) from the base. Two of the four breakaway couplings that separated from the base by the shearing of the anchor bolts came to rest approximately 60 ft (18.3 m) from the base. These two couplings were connected by one piece of the broken flange. Another coupling came to rest about 35 ft (10.7 m) from the base. The fourth coupling was not located. The call box housing was found 125 ft (38.1 m) from the base. The call box generator was located 65 ft (19.8 m) from the base. The antenna landed 3 ft (0.9 m) from the base. Sequential photographs of the test are shown in figure 17. Figure 18 shows the installation after test 0335-2.

The installation readily activated by breaking away. The manner of activation was not completely expected, however, due to the nature of breakaway devices. The flange and anchor bolts at the four supports fractured rather than the breakaway couplings. A similar activation would be predicted in a duplicate test. The test article displayed structural inadequacy as detached call box housing penetrated the occupant compartment. The detached elements did not show potential for presenting undue hazard to other traffic due to the off-road location of the elements. The vehicle remained upright during and after the collision. The calculated longitudinal occupant impact velocity against the vehicle interior was below the limit of 15 ft/s (4.6 m/s). The absolute value of the measured maximum 0.010-second average longitudinal occupant ridedown acceleration was below the limit of 15 g. After collision, the vehicle trajectory and final stopping position was such that the vehicle did not intrude into adjacent traffic lanes. The vehicle trajectory behind this test article was acceptable.

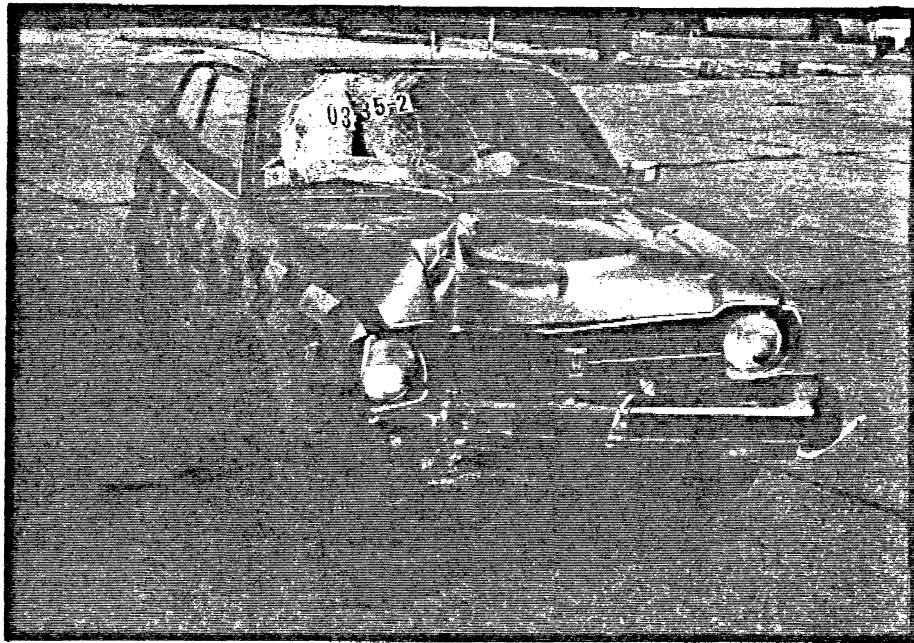
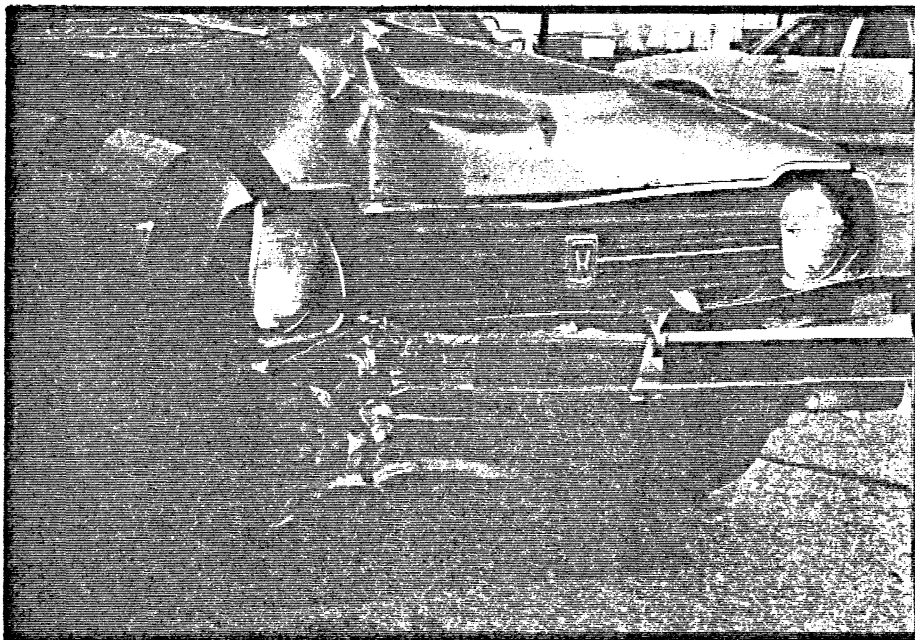
Figure 19. Vehicle after test 0335-2.

The test vehicle sustained major damages to the front end and windshield as shown in figure 19. Maximum crush to the frontal plane of the vehicle at bumper height was 15.3 in (38.7 cm). The hood was crushed inward about 10 in (25 cm). The grill was broken into two pieces. The front valance panel was crushed inward. The right half of the front windshield was shattered and torn. The radiator was punctured and leaked fluid. After the test, the anthropomorphic dummy was observed to be in the driver seat leaning toward the door. The dummy had contacted the sun visor.

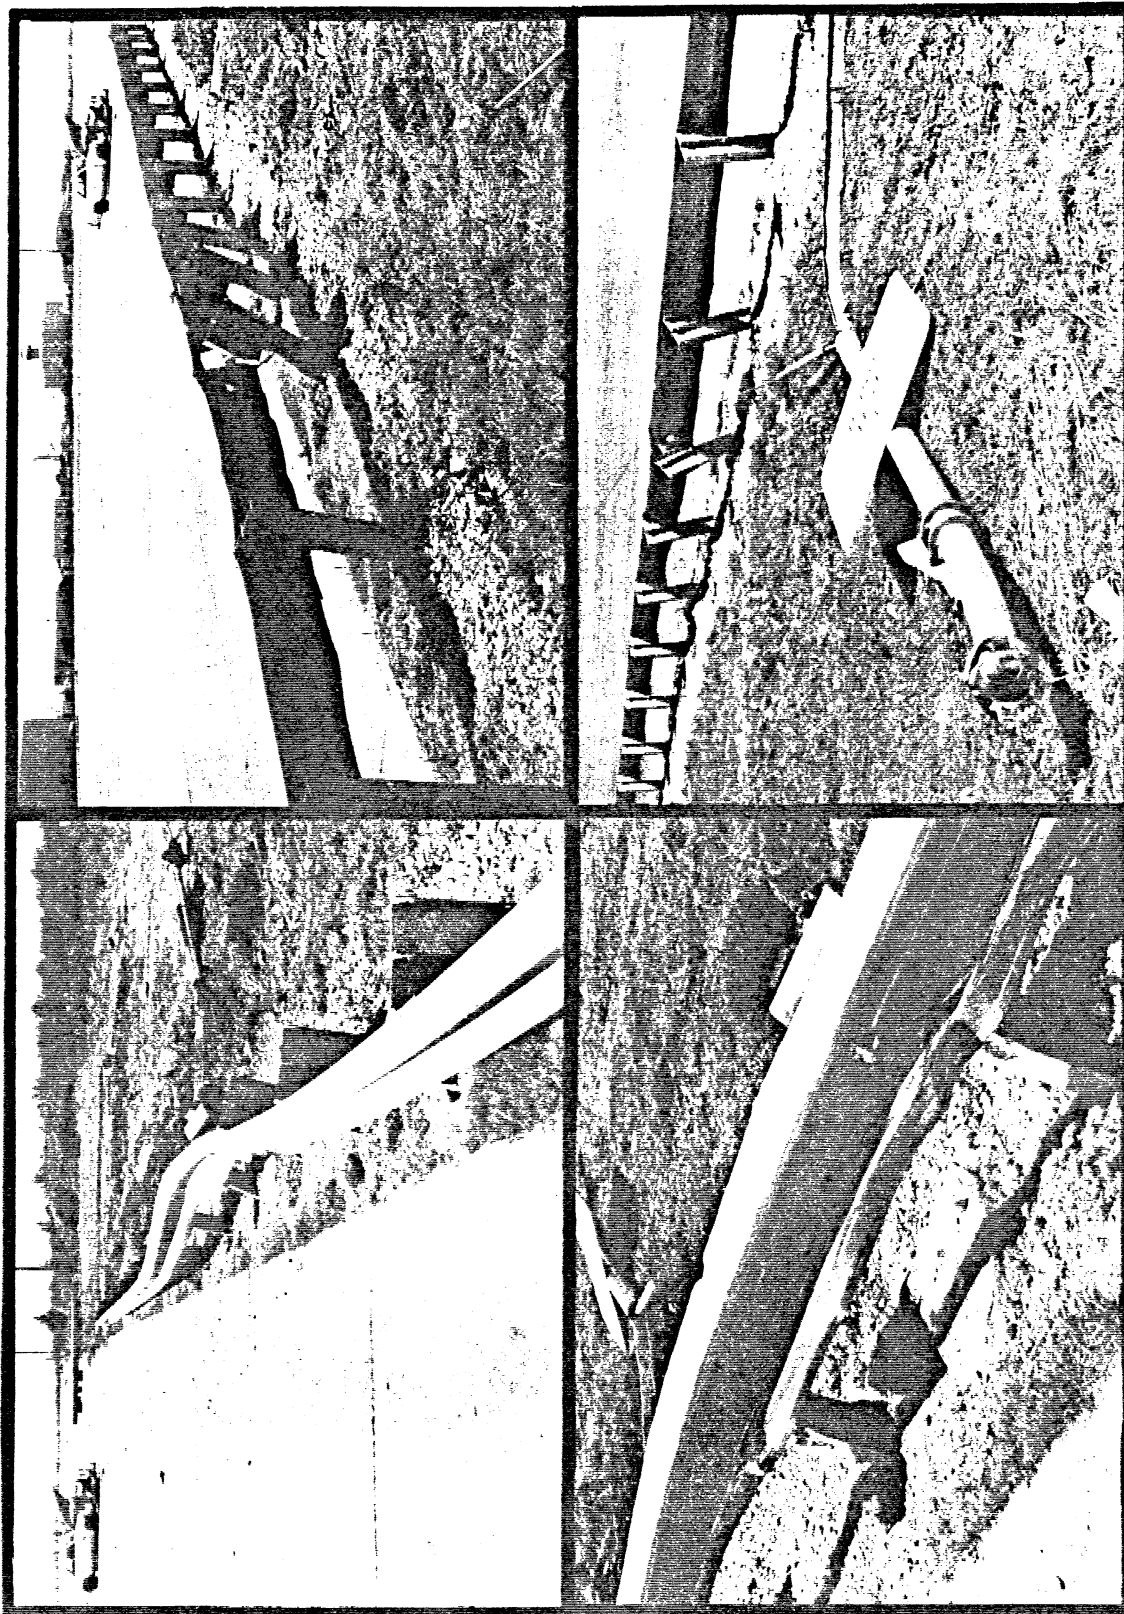
Figure 26. Guardrail after test 0335-3.

A maximum permanent rail deflection of 22.3 in (56.5 cm) was measured midway between posts 8 and 9. The dynamic rail deflection obtained from the overhead high speed film was 38.5 in (97.8 cm). The rail remained deformed over a 44 ft (13.4 m) length between posts 5 and 12. Posts 8 and 9 showed evidence of vehicle snagging. Posts 8, 9 and 10 showed tire rubbing marks. The bolt head and washer that fastened the rail to the offset block at post 8 had torn through the rail. Figure 26 shows the guardrail after test 0335-3.

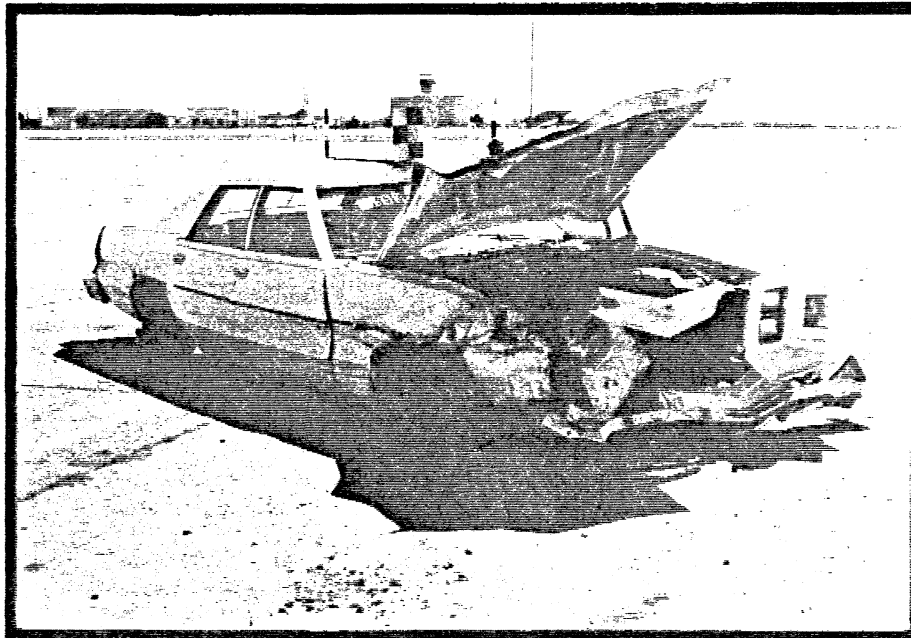
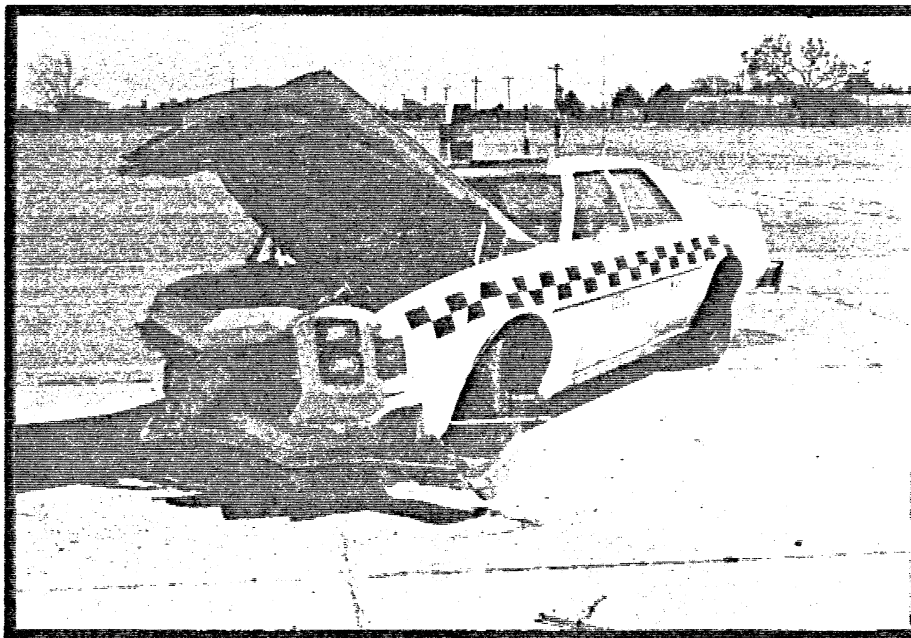
Figure 27. Vehicle after test 0335-3.

The test vehicle sustained extensive damage to the front end and right side as shown in figure 27. Maximum crush to the frontal plane of the vehicle at bumper height was 26.5 in (67.3 cm). Vehicle exterior items that were damaged were the hood and latch, front end panel, grill, front bumper, right head lights and turn signal, right and left front fenders, right front and rear doors, right rear quarter panel, rear bumper, rear tail light, and windshield. The frame was slightly bent. The right upper ball joint was separated. The radiator and support, fan and front bumper shocks were all damaged. The right front and rear tires were punctured and the rims were bent.

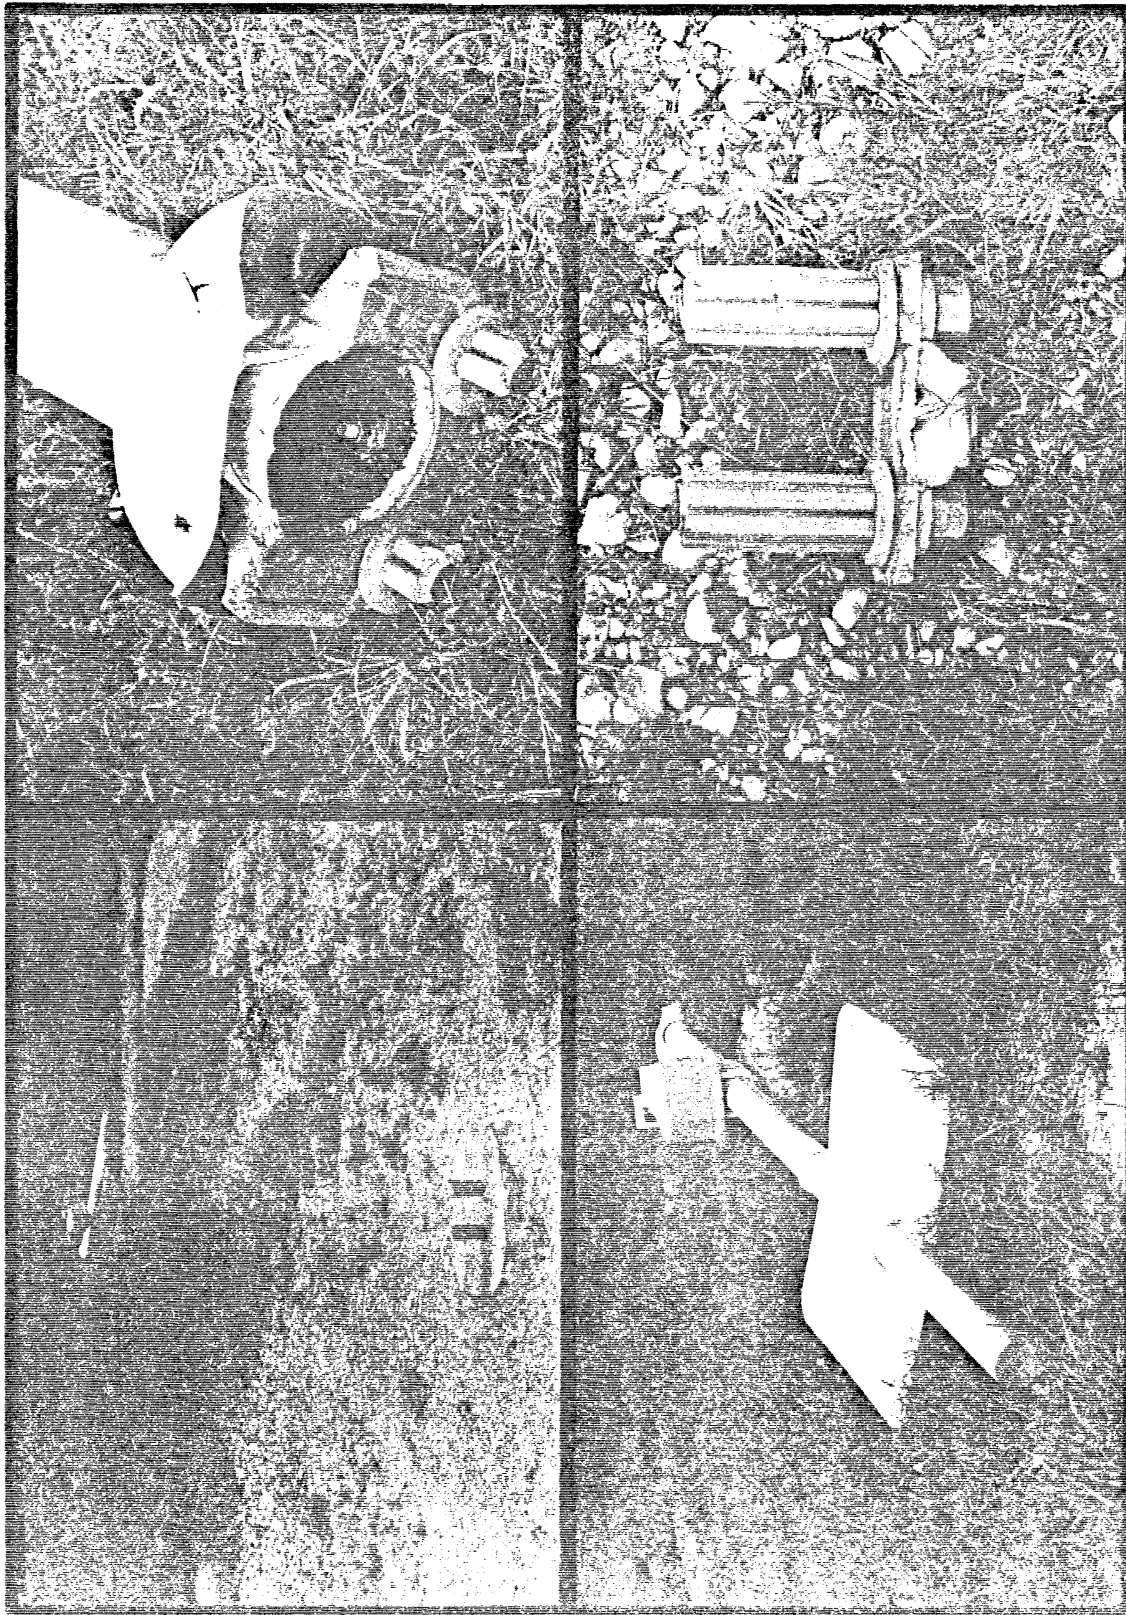
Figure 33. Call box installation after test 0335-4.

The center of gravity of the vehicle at final rest was approximately 230 ft (70 m) in the longitudinal direction. The pole landed approximately 43 ft (13 m) from the base. Two of the four breakaway couplings that separated from the base by the shearing of the anchor bolts came to rest approximately 235 ft (72 m) from the base. These two couplings were connected by one piece of the broken flange. The antenna landed 15 ft (4.6 m) from the base. Sequential photographs of the test are shown in figure 32. Figure 33 shows the installation after test 0335-4.

The installation readily activated by breaking away. The manner of activation was not completely expected, however, due to the nature of breakaway devices. The flange and anchor bolts at two of the four supports fractured rather than the breakaway couplings. A similar activation would be predicted in a duplicate test. The detached elements from the test article did not penetrate nor show potential for penetrating the passenger compartment, nor presented undue hazard to other traffic due to the off-road location of the elements. The vehicle remained upright during and after the collision. The calculated longitudinal occupant impact velocity against the vehicle interior was below the limit of 15 ft/s (4.6 m/s). The absolute value of the measured maximum 0.010-second average longitudinal occupant ridedown acceleration was below the limit of 15 g. After collision, the vehicle trajectory and final stopping position was such that the vehicle did not intrude into adjacent traffic lanes. The vehicle trajectory behind this test article was acceptable.

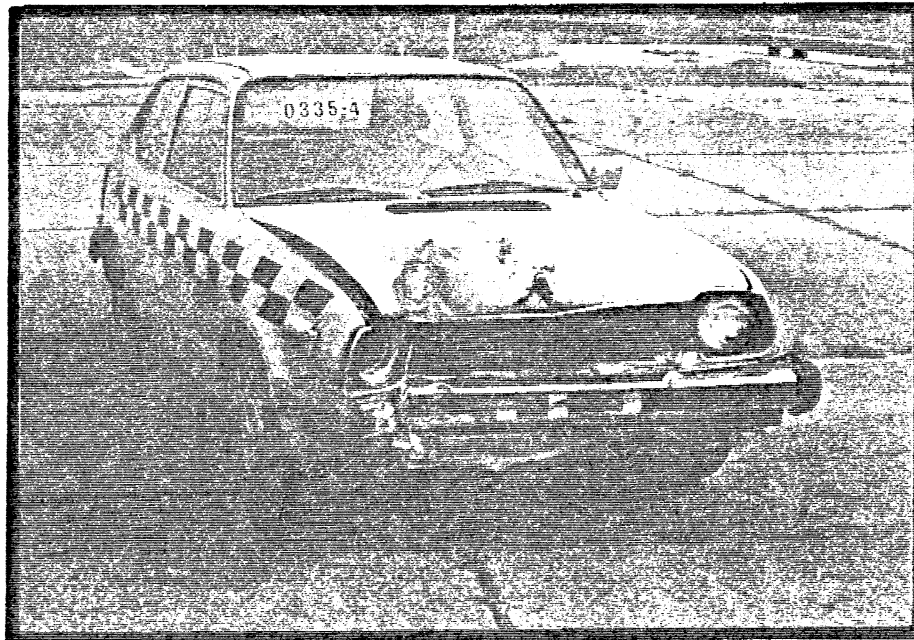
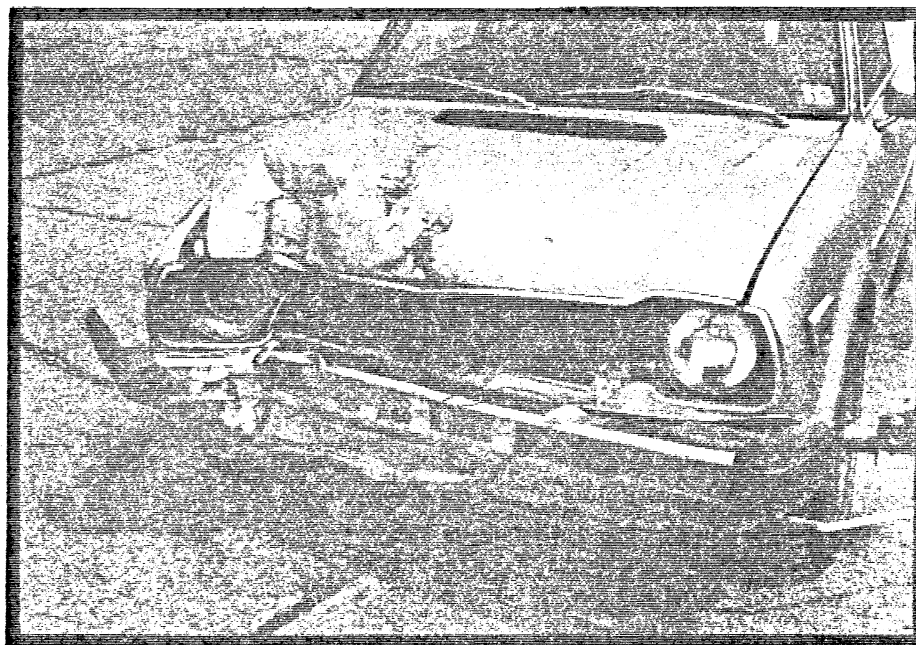
Figure 34. Vehicle after test 0335-4.

The test vehicle sustained major damages to the front end as shown in figure 34. Maximum crush to the frontal plane of the vehicle at bumper height was 13.7 in (34.8 cm). The hood was crushed inward about 8 in (20.3 cm). The grill was broken into two pieces. The front valance panel was crushed inward. The radiator was punctured and leaked fluid. After the test, the anthropomorphic dummy was observed to be in the driver seat laying toward the passenger seat. Dummy movement was mainly due to after test vehicle braking.
