CRASH TESTING A REUSABLE POLYETHYLENE NARROW IMPACT ATTENUATION SYSTEM

Project No. 472380
Polyethylene Cylinder Crash Cushion
Test 472380-6

Prepared for
Vanderbilt University
Nashville, Tennessee

Texas Transportation Institute
Texas A&M University System
College Station, Tx 77843

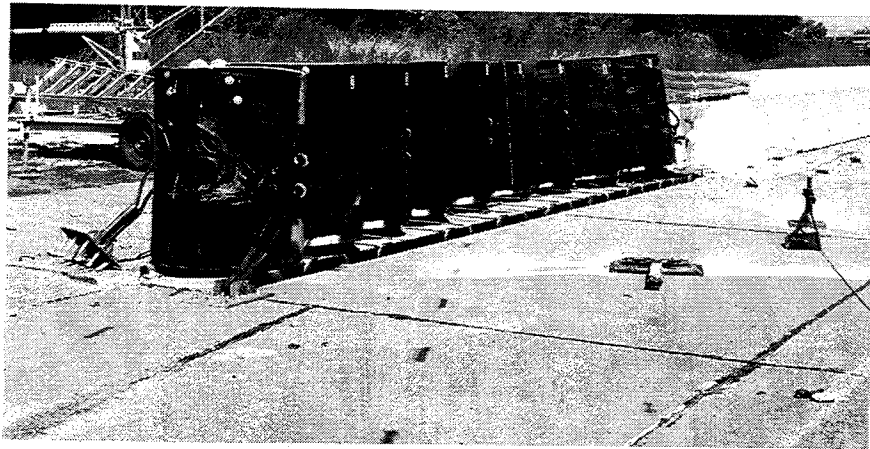
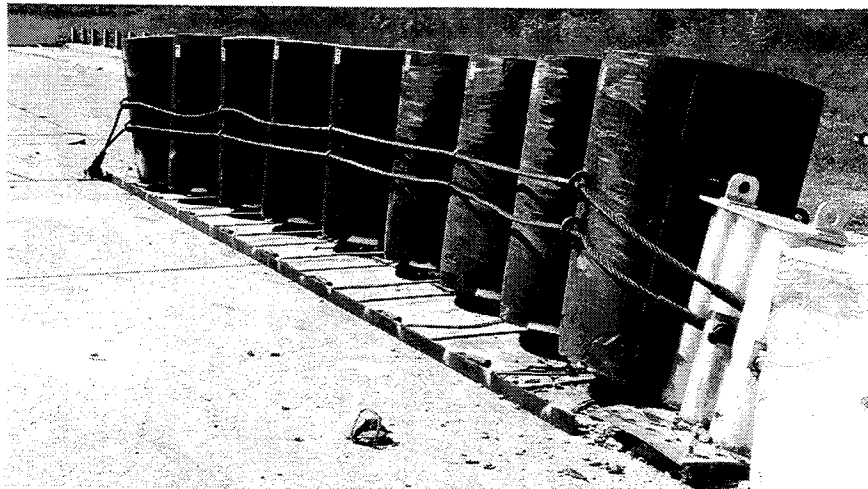
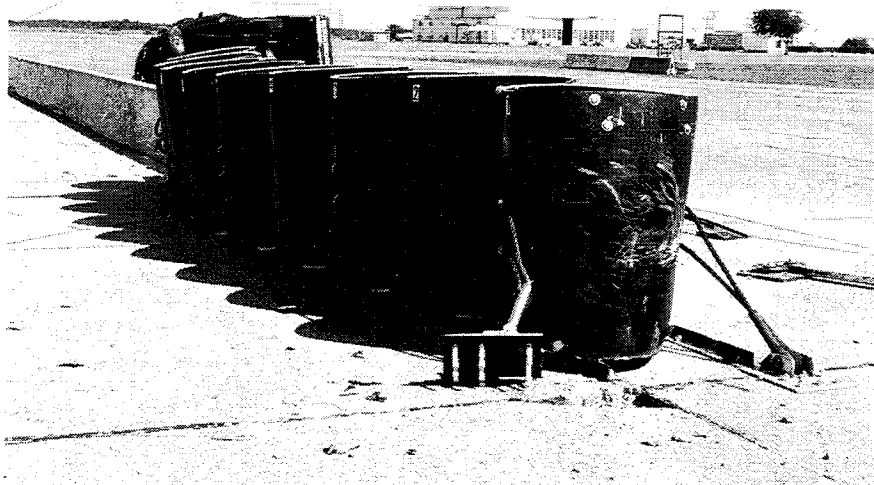
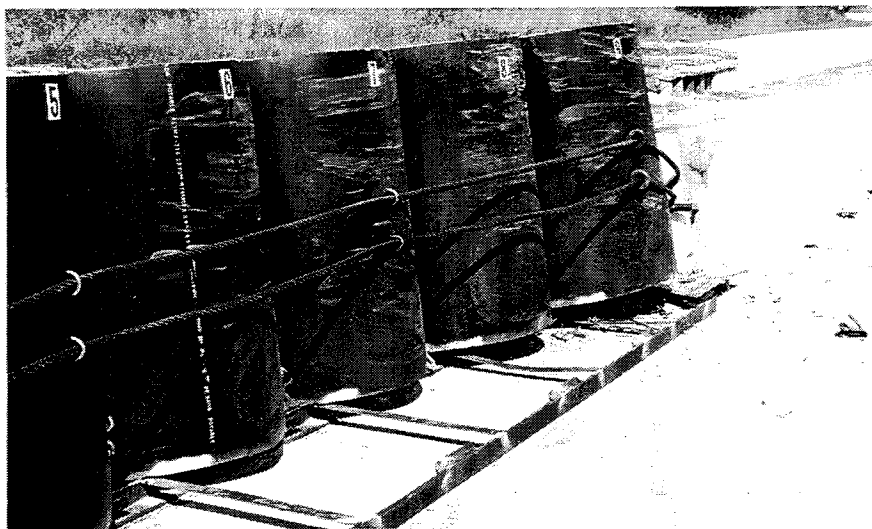
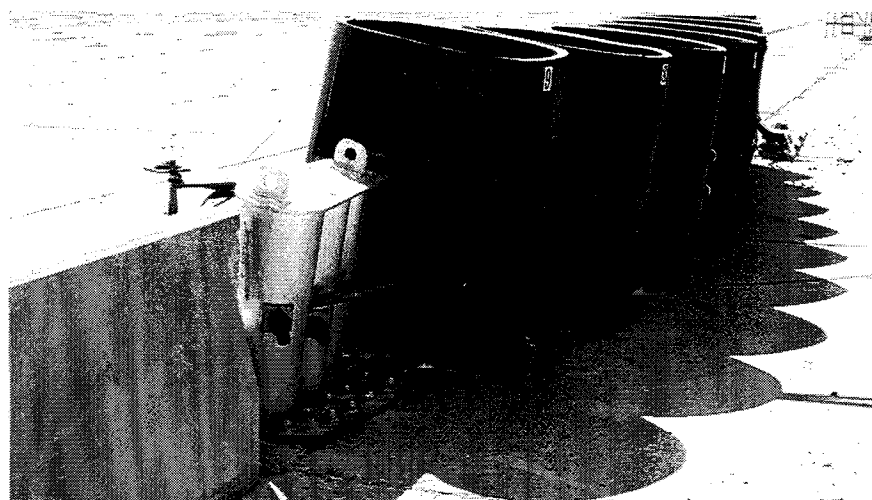
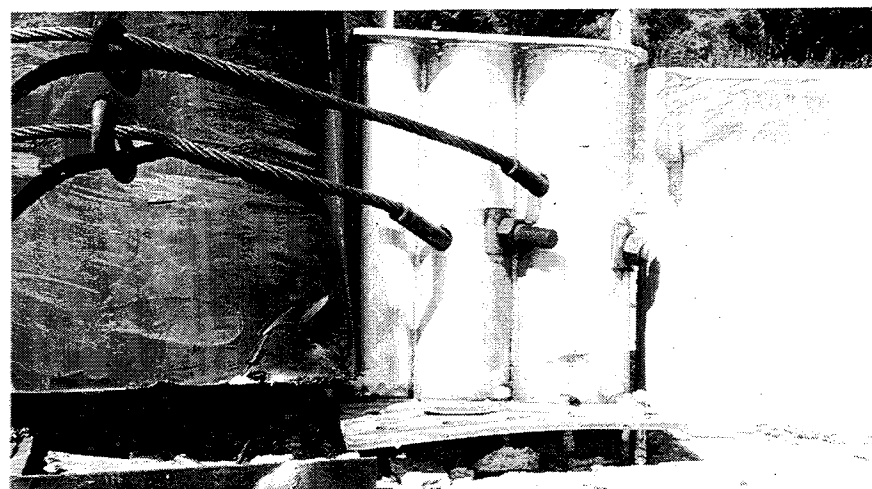
Figure 11 . Installation after test 472380-6.

As can be seen in Figures 10, 11, and 12, the backup assembly received considerable damage. Concrete around the anchor bolts at both the front and rear anchors failed allowing the assembly to rotate away from the impact. The base plate for the assembly was bent during rotation. The maximum post test residual deformation was 0.74 m (2.43 ft) at cylinder 6 in the lateral direction. Immediately after the test, the installation length was 7.98 m (26.17 ft).

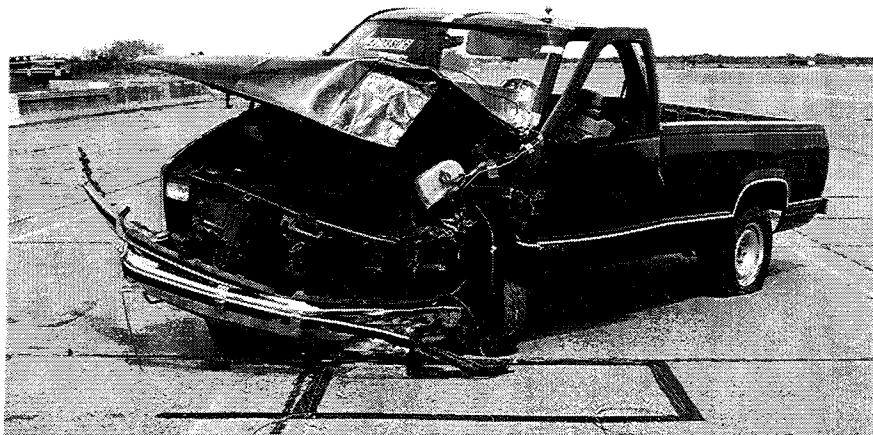
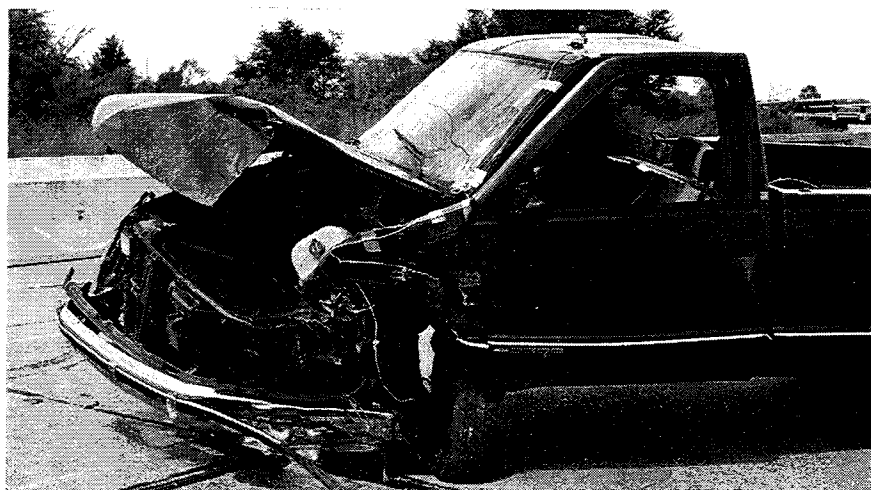
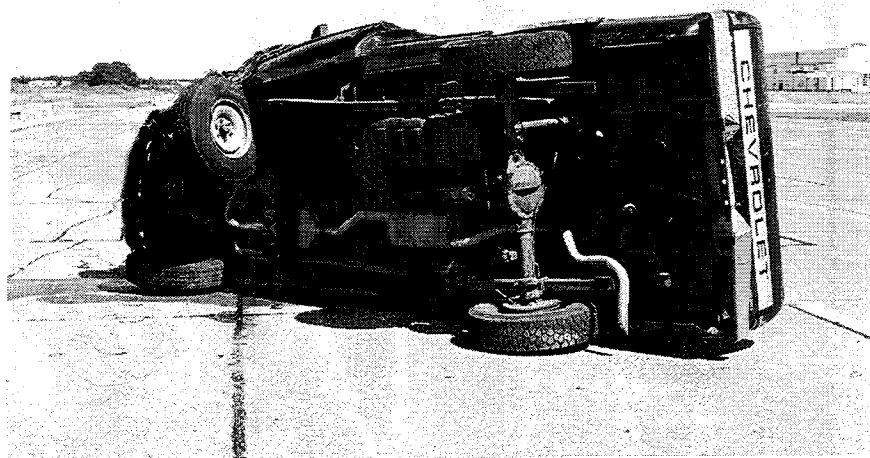
Figure 13 . Vehicle after test 472380-6.

The vehicle sustained significant damage to the left front corner as shown in Figure 13. Maximum deformation at the left front corner of the vehicle was 690 mm (27.2 in). As a result of this large deformation the occupant compartment was shortened by 192 mm (7.6 in). Additional damage was sustained by the front bumper, hood, grill, radiator and fan, both front fenders, roof, windshield, entire left and right side sheet metal, left front tire and rim, left rear tire and rim, drive shaft, rear transmission mount and roof.

D. Detached elements should not penetrate the occupant compartment, or present an undue hazard to other traffic, pedestrians, or personnel in a work zone. Deformations of the occupant compartment that could cause serious injuries should not be permitted.		There were no detached elements from the CRNIAS. There was deformation into the occupant compartment.	Fail
