**NCHRP REPORT 350 COMPLIANCE TESTS
OF THE ADIEM**

December 1995

1. Report No. FHWA-RD-95-		2. Government Accession No.		3. Recipient's Catalog No.	
4. Title and Subtitle NCHRP REPORT 350 COMPLIANCE TESTS OF THE ADIEM				5. Report Date December 1995

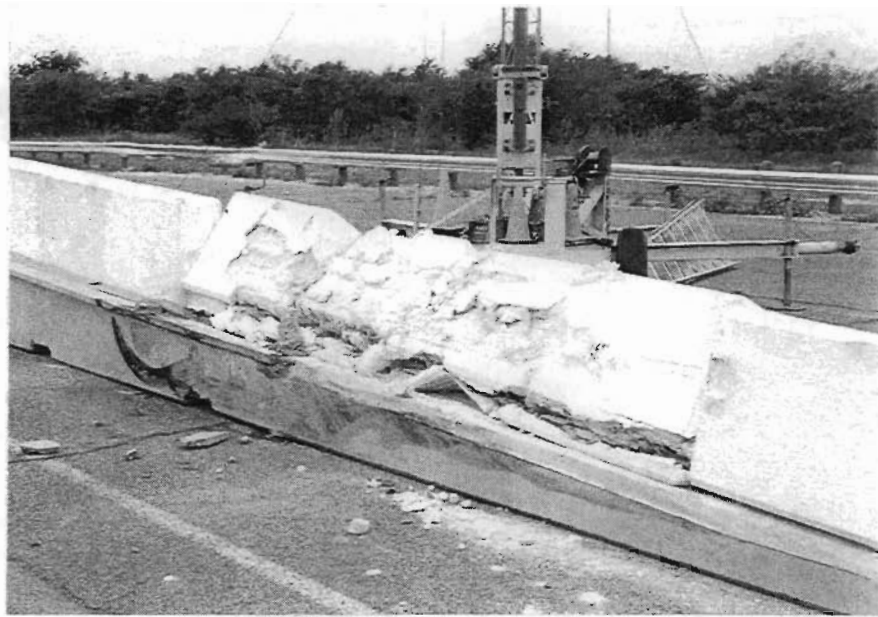
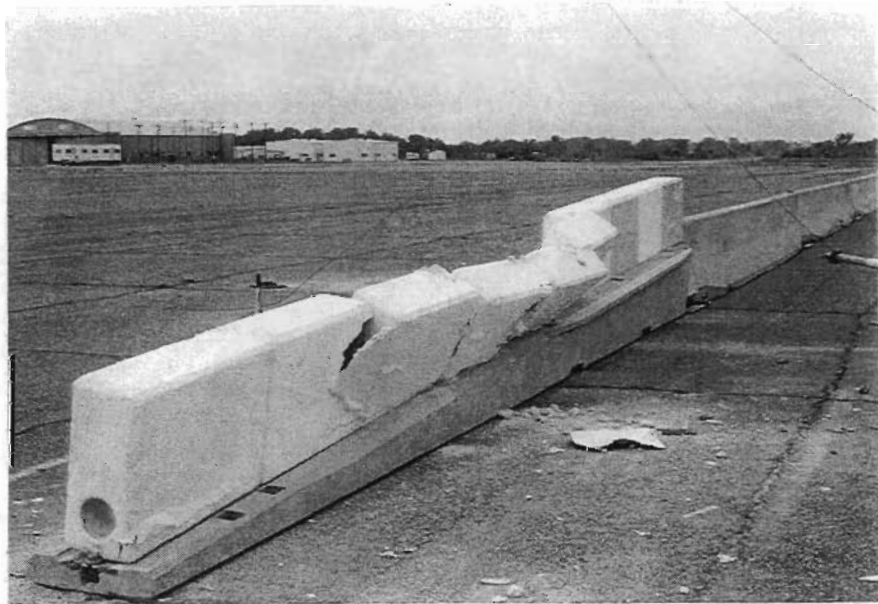
Figure 7. Installation after test 220517-8.

Modules 1 thru 6 were damaged in the reverse direction hit. Additionally, there was some concrete spalling adjacent to the square tubular member in the impact area. Structural integrity of the carrier arm base was not compromised. As can be seen in figures 6 and 7, there was contact to the base starting next to module 6 and continuing to the nose of the device.

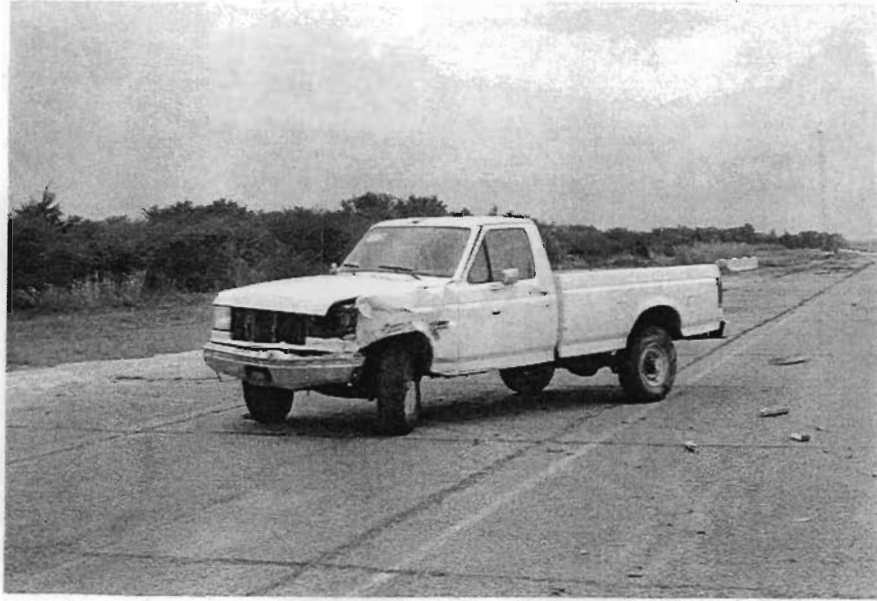
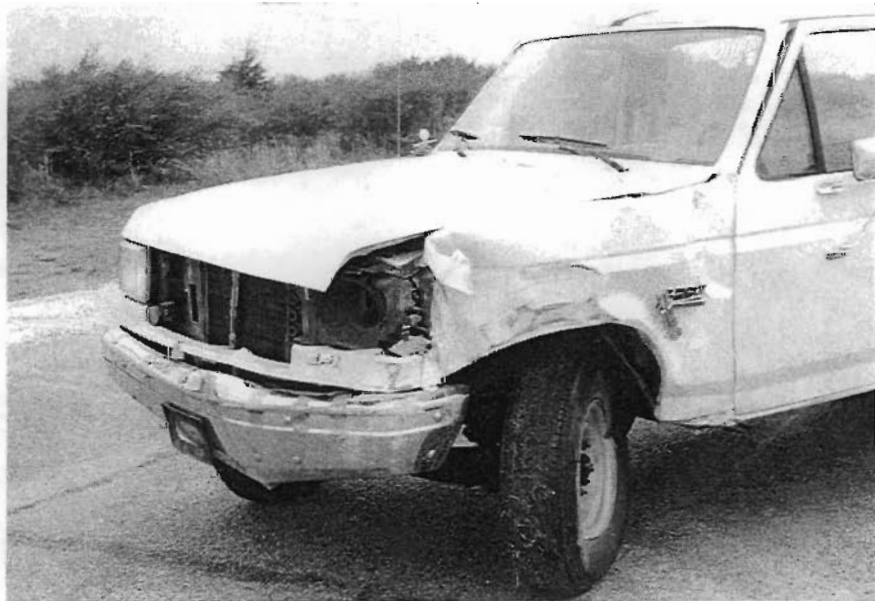
Figure 8. Vehicle after test 220517-8.

The vehicle received minimal damage as shown in figure 8. The left side twin I-beam and tie rods were bent and the floorpan was buckled. The bumper, grill, fan, radiator, left front quarter panel, left door, and left front wheel were damaged and the windshield was stress cracked. Maximum exterior crush was 180 mm at the left front corner at bumper height. Maximum deformation into the occupant compartment was 21 mm at the left side floorpan.

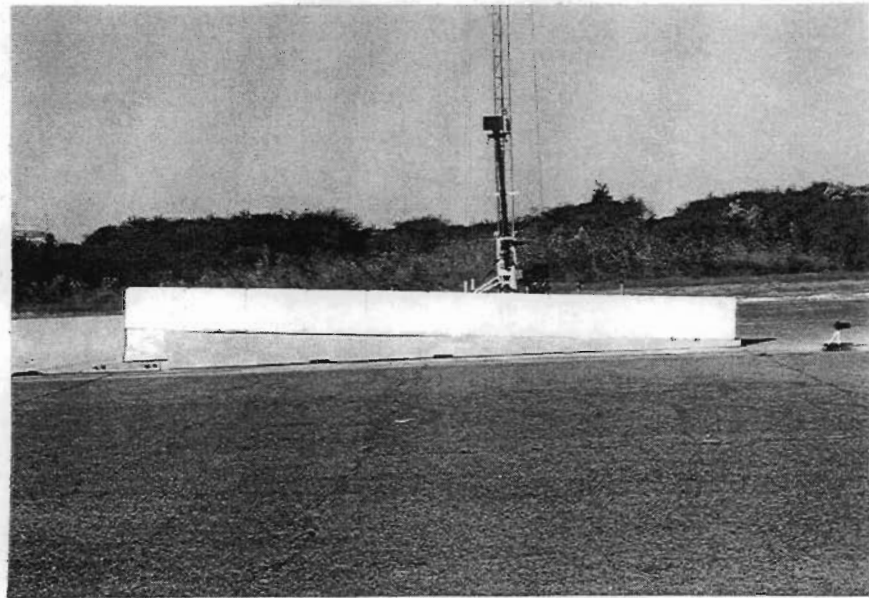
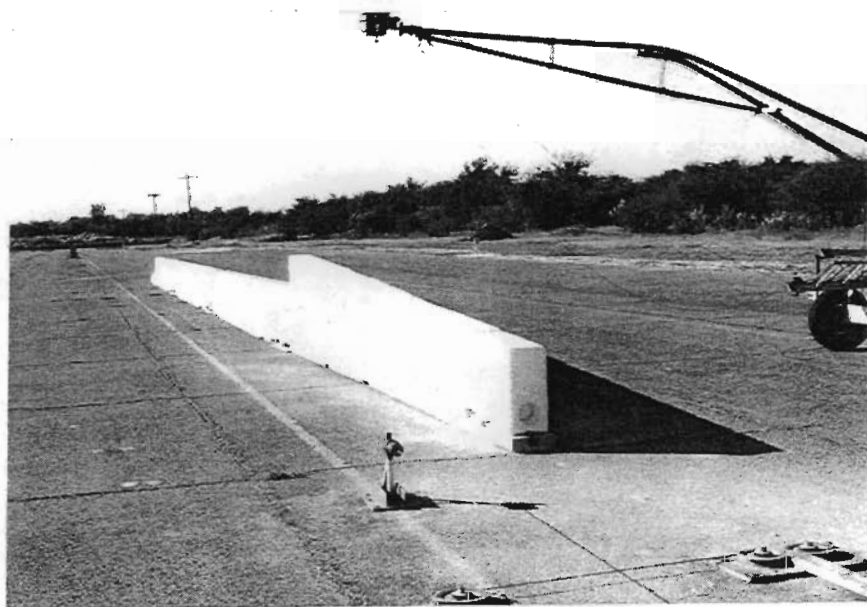
Figure 10. ADIEM installation before test 220538-9.

The ADIEM installation was repaired as shown in figure 10 and used for the second test. A 1989 Ford F-250 pickup truck, shown in figures 11 and 12, was used for this crash test. Test inertia weight of the vehicle was 2000 kg, and its gross static weight was 2000 kg. The height to the lower edge of the vehicle bumper was 425 mm and it was 690 mm to the upper edge of the bumper. Additional dimensions and information on the vehicle are given in Appendix A, figure 25. The vehicle was directed into the installation using the cable reverse tow and guidance system, and was released to be freewheeling and unrestrained just prior to impact.

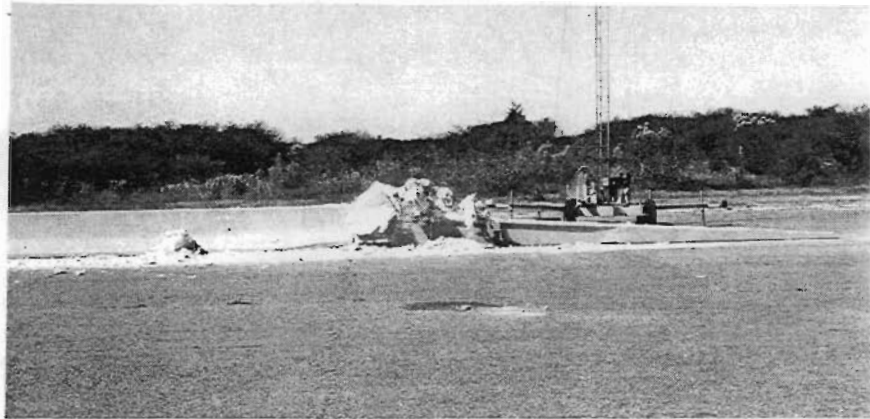
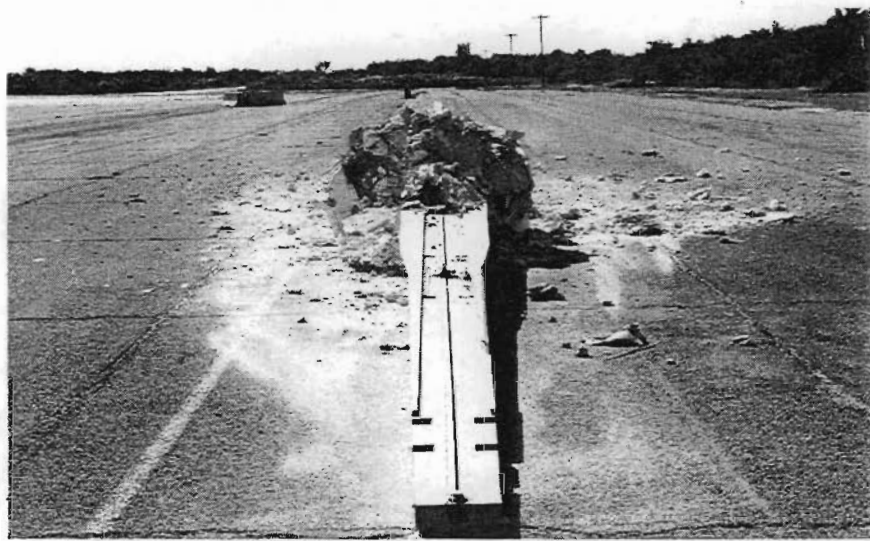
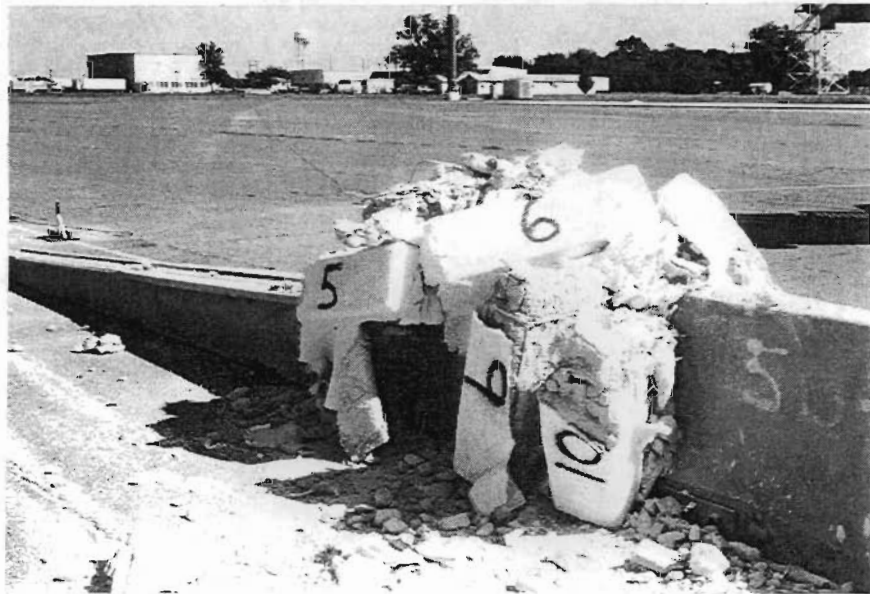
Figure 14. Installation after test 220538-9.

Damage to the ADIEM installation is shown in figures 13 and 14. All ten modules were consumed in absorbing the kinetic energy. There was minor contact from the undercarriage of the pickup to the top face of the carrier arm base. The base was used on the subsequent test. One module was wedged free of the carrier arm and moved 3.5 m to the rear of the base and adjacent to the median barrier.

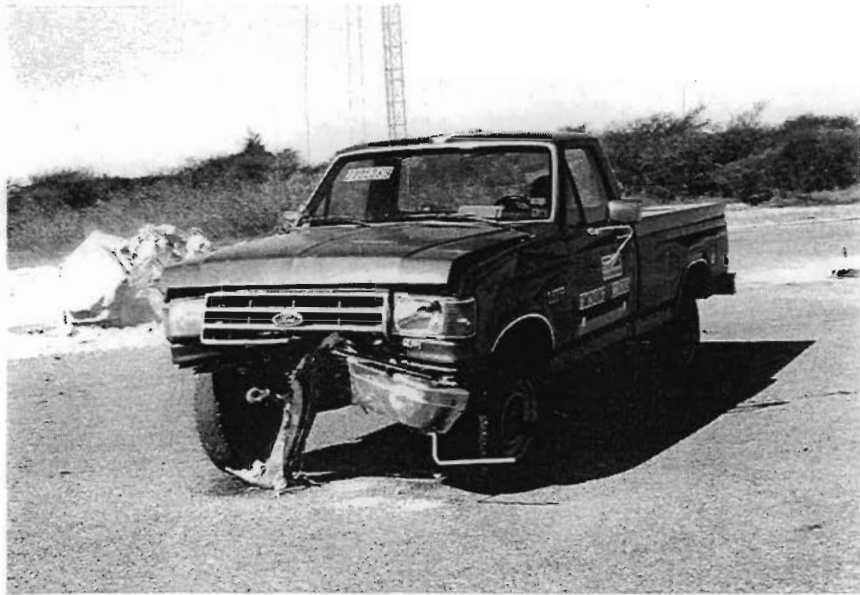
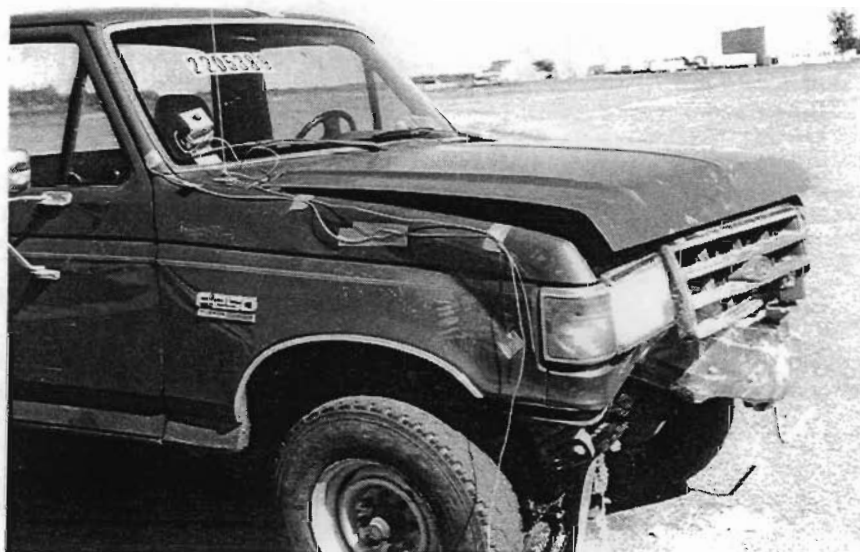
Figure 15. Vehicle after test 220538-9.

The vehicle received moderate damage as shown in figure 15. The twin I-beam and right side frame were bent and the rode ends and center link were damaged. Also damaged were the bumper and supports, grill, fan, radiator, hood, and left and right doors. Maximum crush to the center front of the vehicle was 550 mm. Maximum deformation into the occupant compartment was 25 mm at the center of the instrument panel.

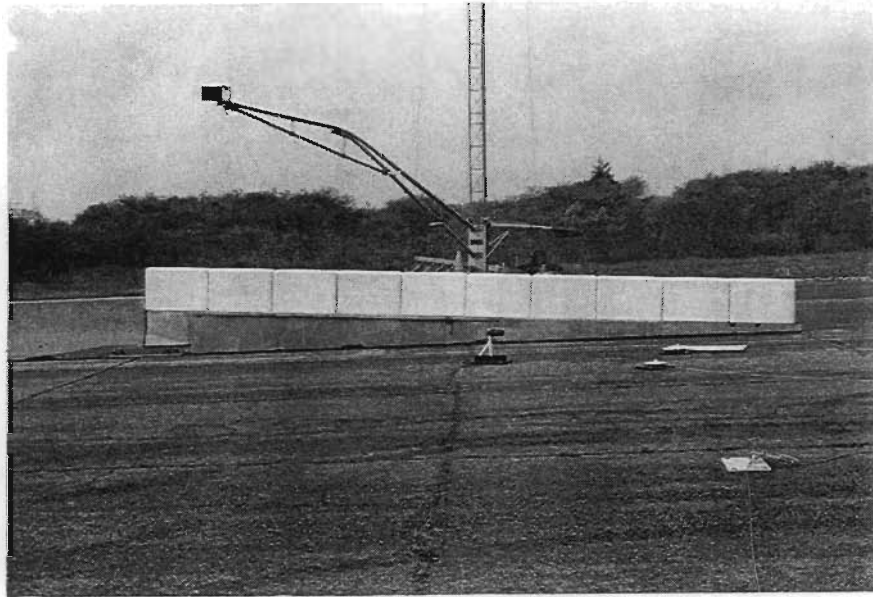
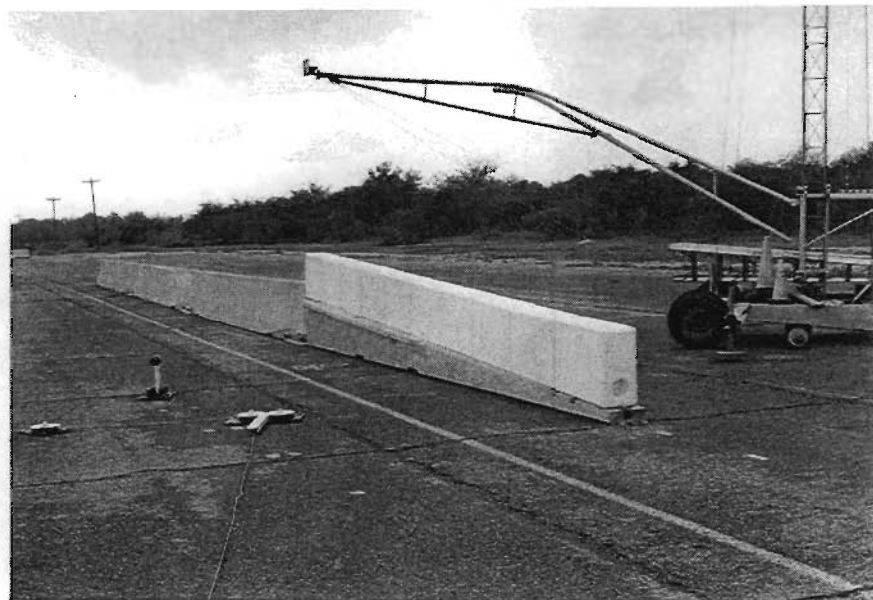
Figure 17. ADIEM installation before test 220538-10.

The ADIEM installation was repaired as shown in figure 17 and used for the third test. A 1990 Ford F-250 pickup truck, shown in figures 18 and 19, was used for this crash test. Test inertia weight of the vehicle was 2000 kg, and its gross static weight was 2000 kg. The height to the lower edge of the vehicle bumper was 460 mm and it was 720 mm to the upper edge of the bumper. Additional dimensions and information on the vehicle are given in Appendix A, figure 26. The vehicle was directed into the installation using the cable reverse tow and guidance system, and was released to be freewheeling and unrestrained just prior to impact.

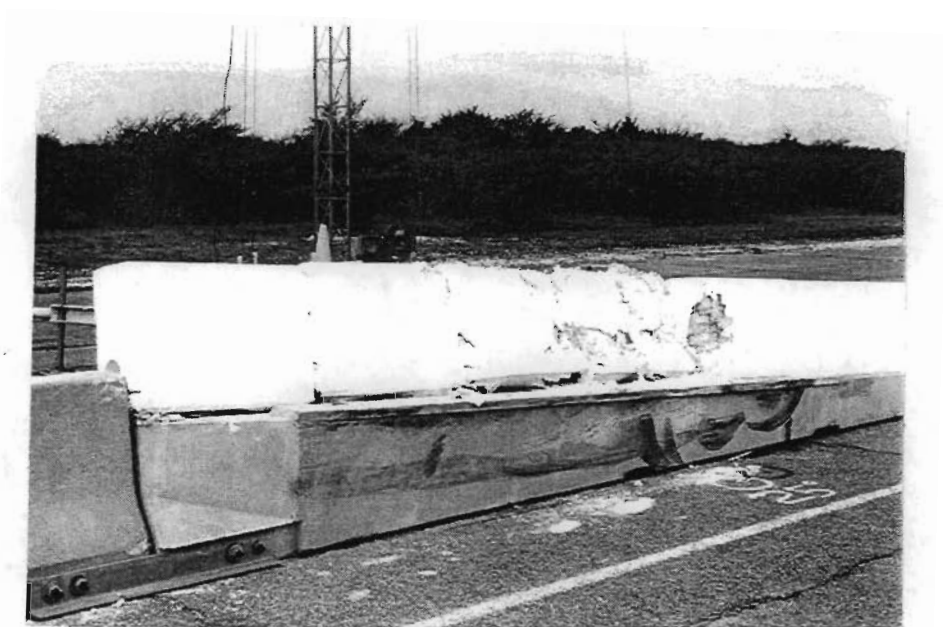
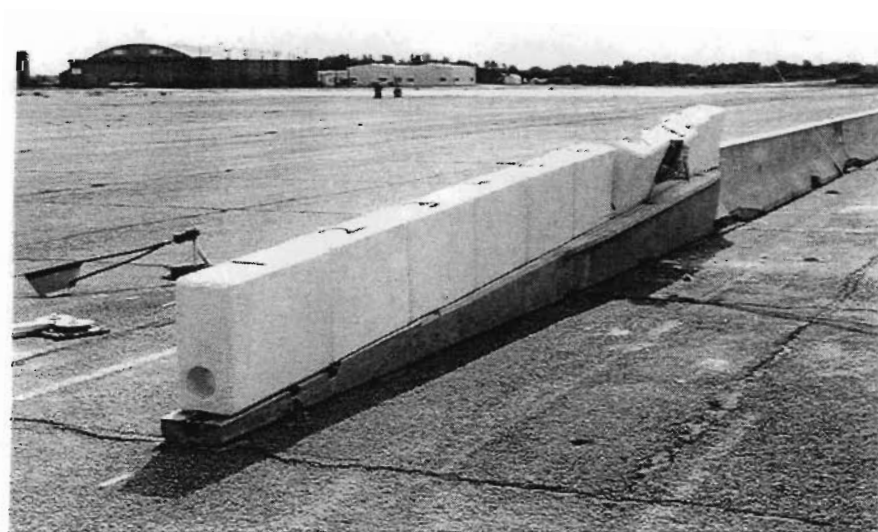
Figure 21. Installation after test 220538-10.

As can be seen in figures 20 and 21, modules 6 through 10 were damaged during the impact. Concrete adjacent to the base of several anchor pins was chipped when the installation rotated slightly due to impact. Structural integrity was not compromised. Additionally, some cosmetic damage was sustained on the concrete impact face of the base.

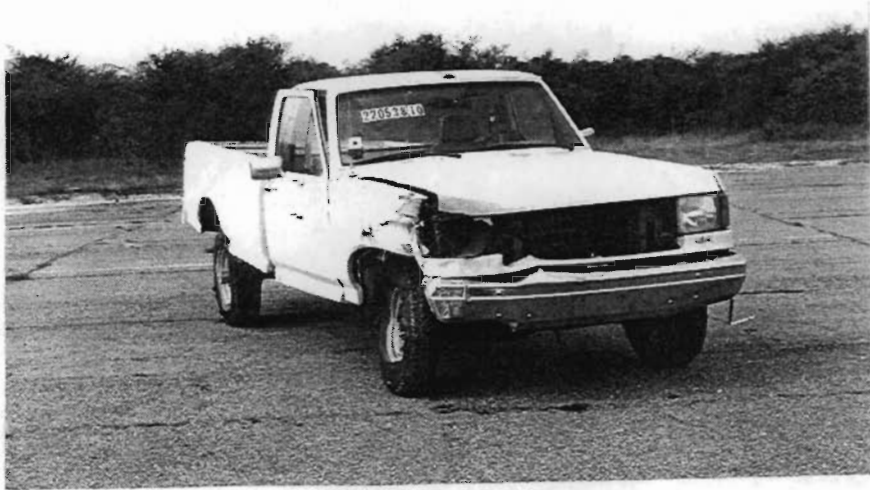
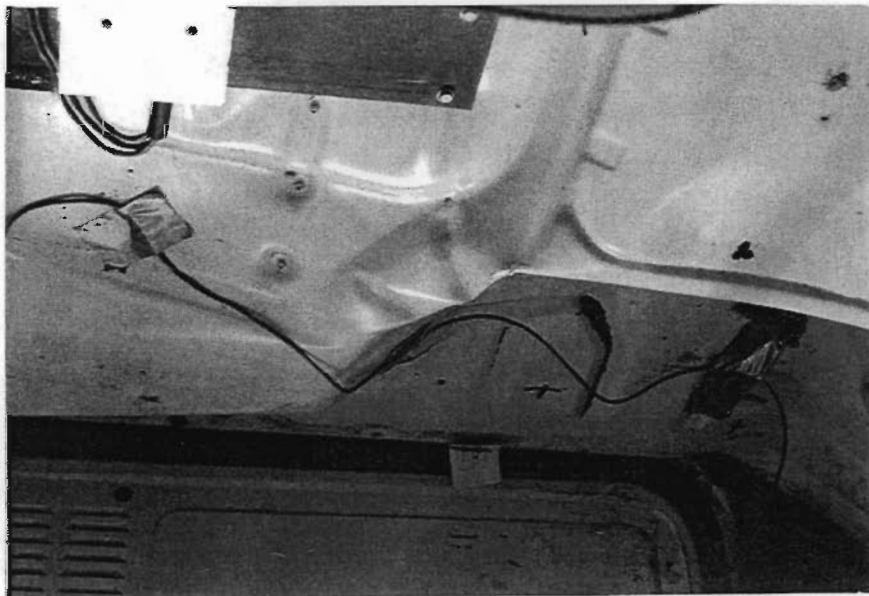
Figure 22. Vehicle after test 220538-10.

The right front corner of the vehicle received moderate damage as shown in figure 22. The right twin I-beam and frame rail were bent. The front bumper, hood, grill, right front quarter panel, right front and rear rims, and right door were damaged and the windshield was stress cracked. Maximum exterior crush to the right front corner at bumper height was 260 mm. Maximum deformation into the occupant compartment was 18 mm on the right side firewall area.
