WYOMING TEST LEVEL 4 BRIDGE RAILING

**Research Agreement No. 48251
TTI Project No. 472610
Bridge Railing Crash Test Program**

Wyoming Department of Transportation
Cheyenne, Wyoming 82003

January 1996

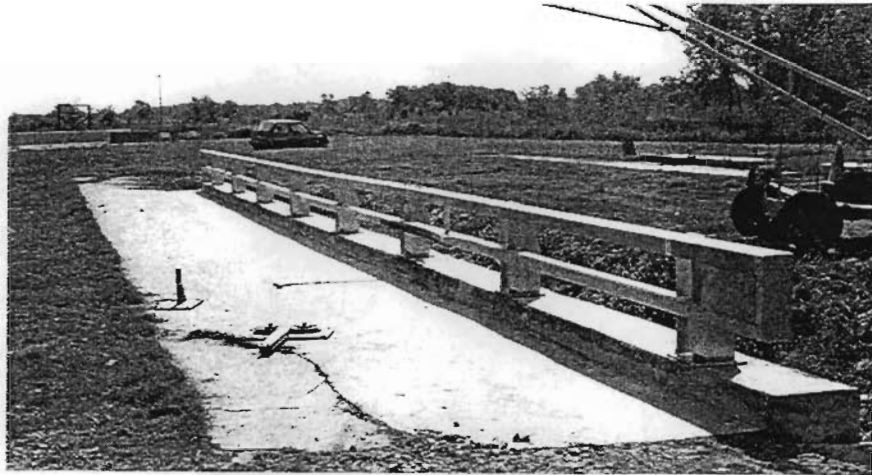
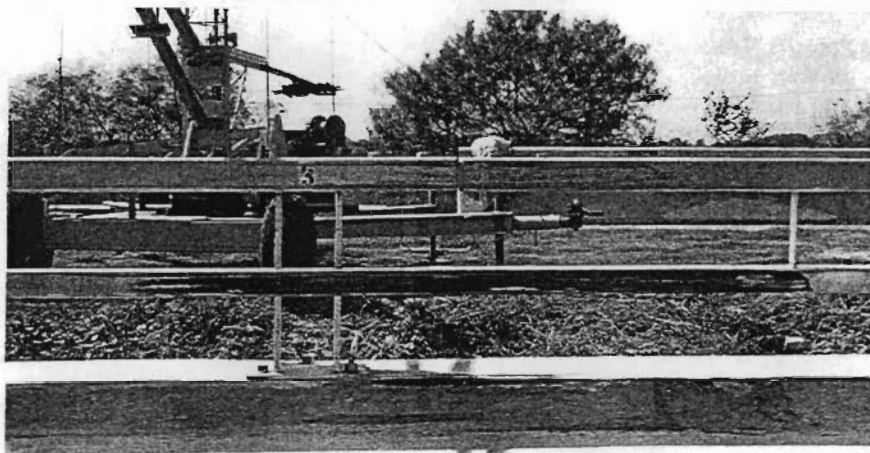
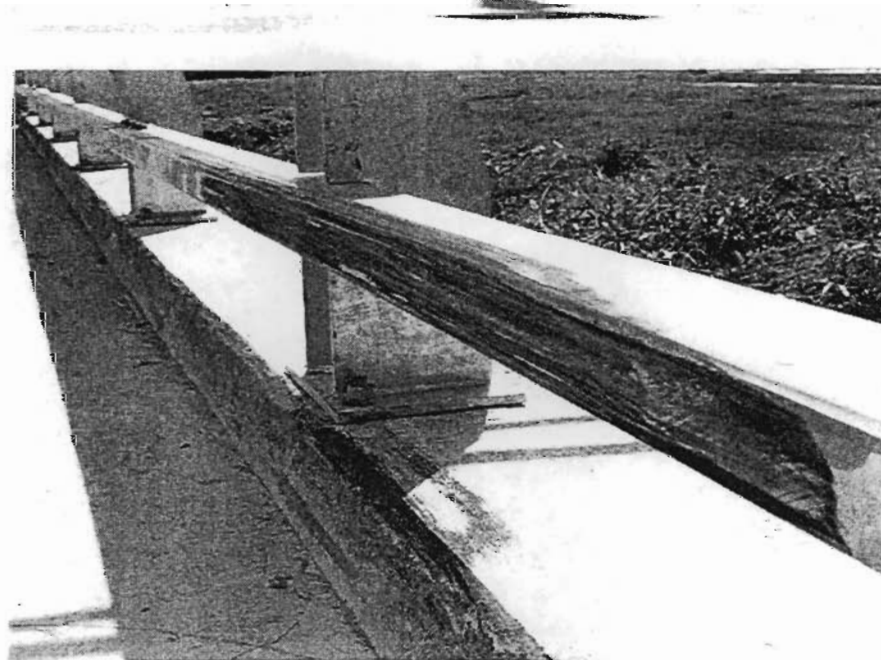
Figure 6. Installation after test 472610-1.

The bridge railing received minimal damage as shown in figure 6. There were tire marks on the lower rail element (2.5 m in length) and the curb (2.2 m in length). The upper rail element was scraped by the body of the vehicle (2.5 m in length). Bumper marks were found on the impact side of post 3 between the upper and lower metal rail elements and the plate was bowed. Tire overlap on the lower part of post 3 measured 76 mm (or 114 mm from the curb).

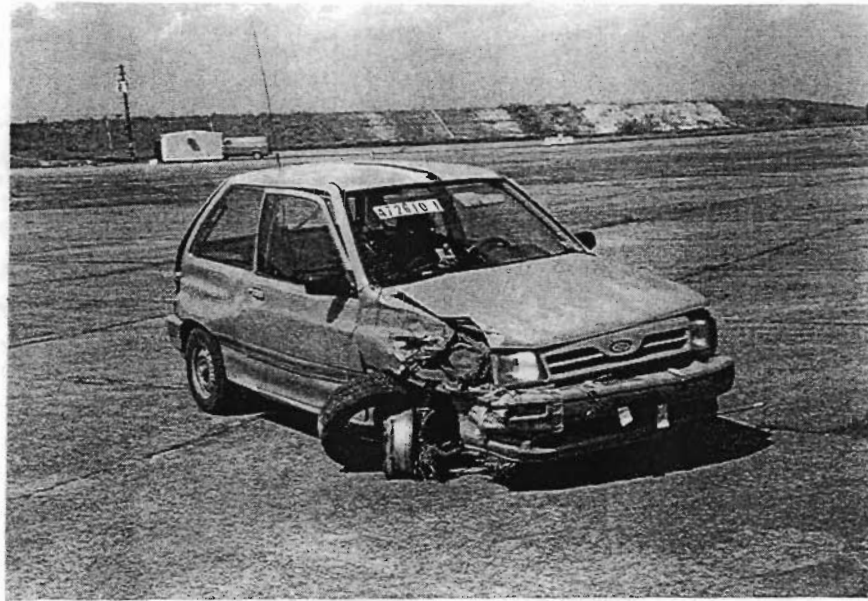
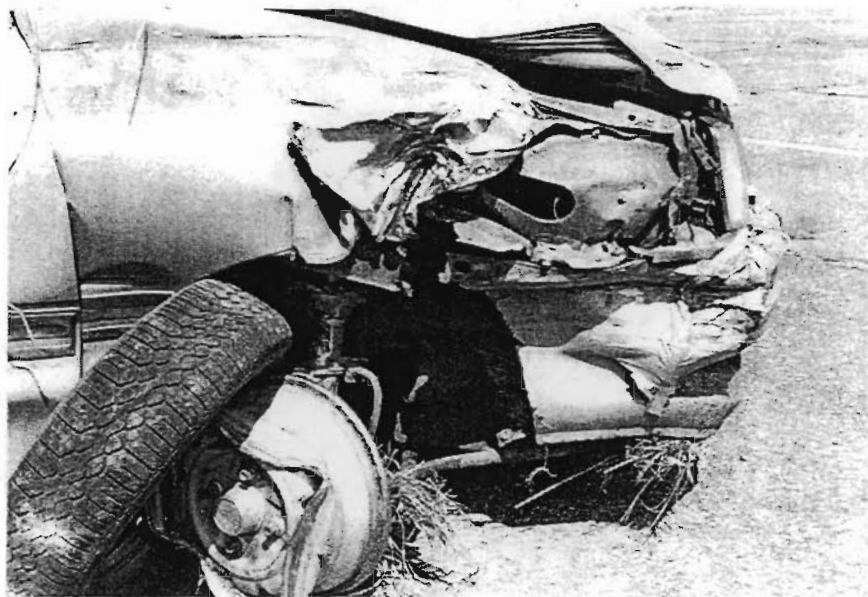
Figure 7. Vehicle after test 472610-1.

Most of the damage sustained by the vehicle was to the right front corner as shown in figure 7. The right side lower A-arm, tie rod, strut, axle, and stabilizer bar were bent and the bumper, hood, right front quarter panel, right front tire and rim, right door, and right rear quarter panel were damaged. The windshield received stress cracks in the lower corner on the right side and the right side B-pillar was buckled. Maximum exterior crush at the right front corner of the vehicle at bumper height was 120 mm. Maximum deformation into the occupant compartment was 19 mm at the beltline interior width near the front passenger area.

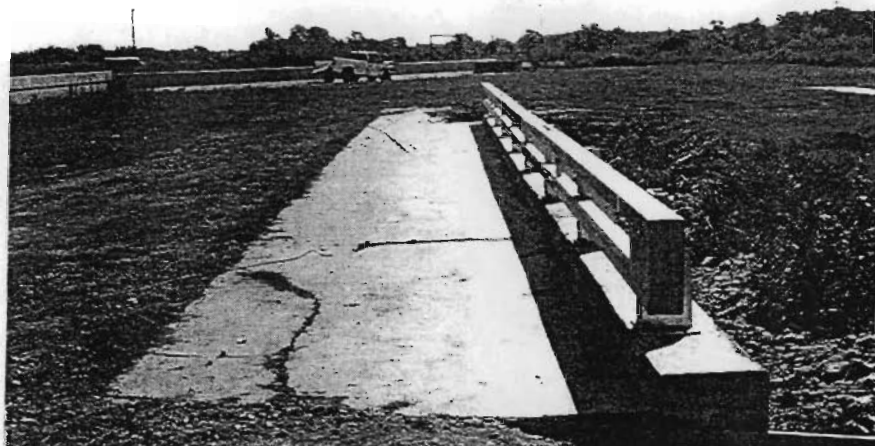
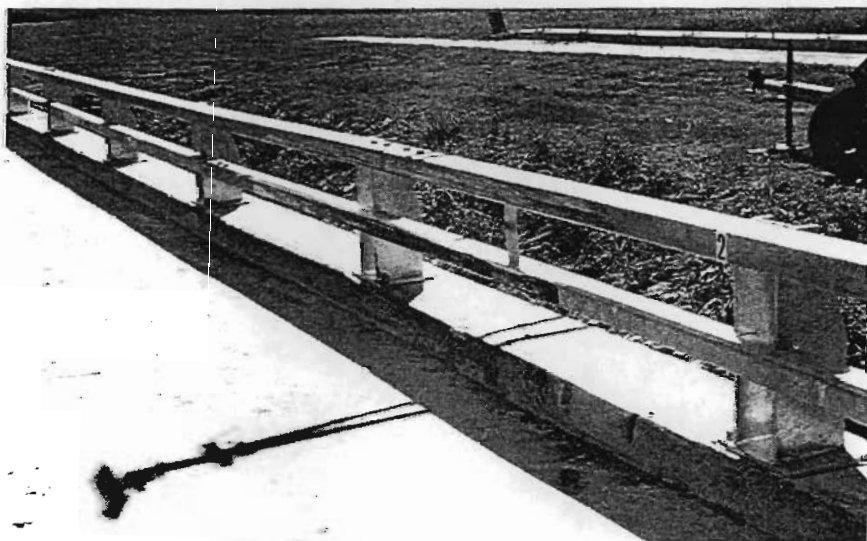
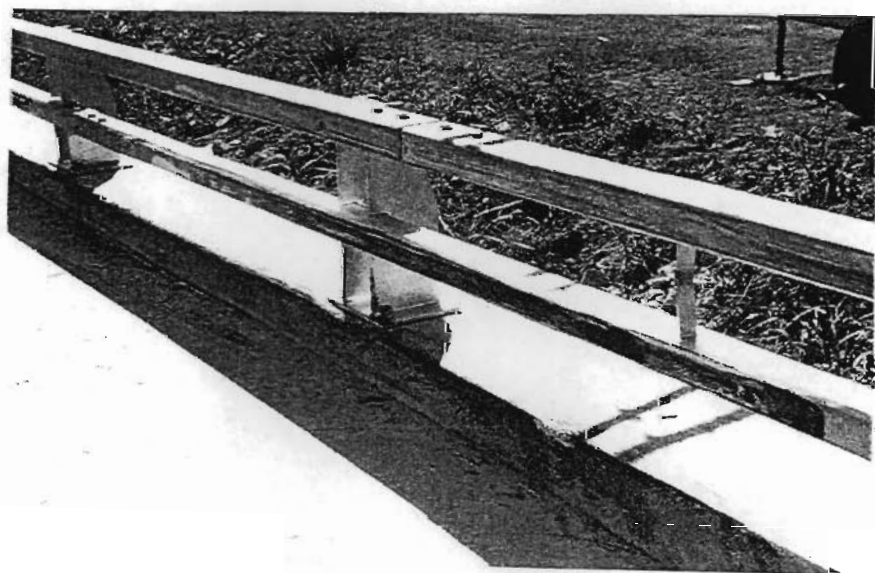
Figure 12. Installation after test 472610-2.

The bridge railing received minimal damage as shown in figure 12. The lower rail element received a maximum deformation of 3 mm near the impact area. There were tire marks on the lower rail element (3.5 m in length) and the curb (3.5 m in length). The upper rail element was scraped by the body of the vehicle (3.5 m in length). Bumper marks were found on the impact side of post 3 between the upper and lower rail elements. Tire overlap on the base plate of post 3 measured 51 mm (or 102 mm from the face of the curb) and on the side of post 3 it was 19 mm. There was also a surface crack in the curb radiating out from the left front bolt behind post 3.

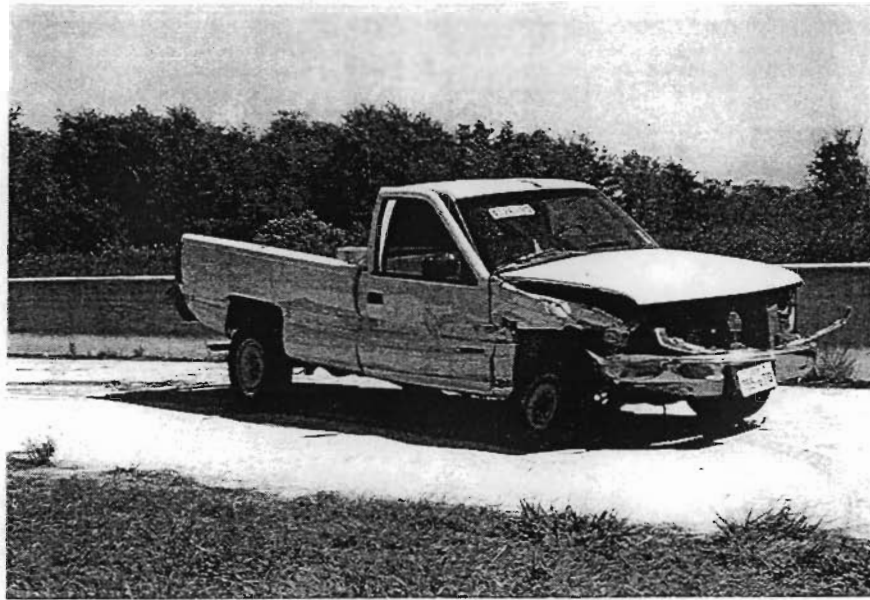
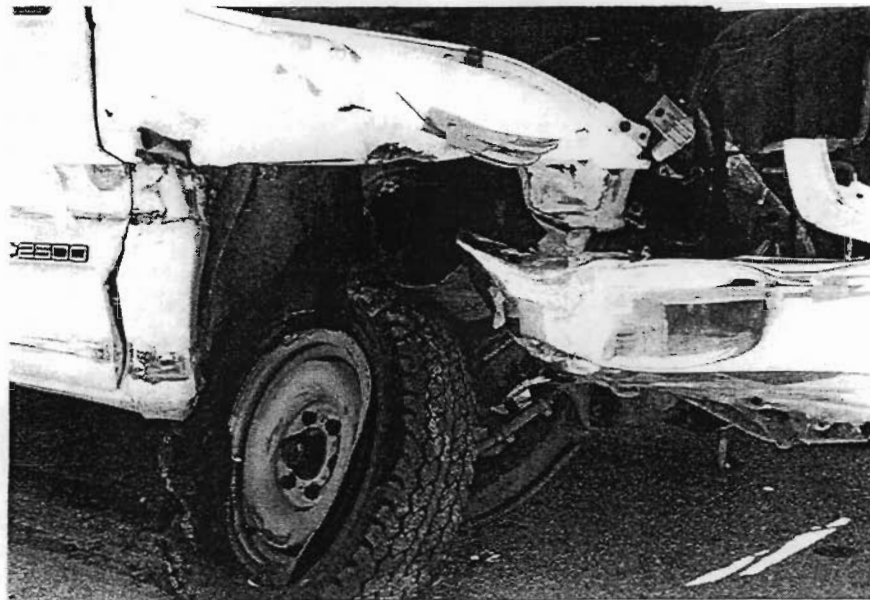
Figure 13. Vehicle after test 472610-2.

Most of the damage sustained by the vehicle was to the right front corner as shown in figure 13. The right side A-arm, tie rod, stabilizer bar, and frame were deformed and the drive shaft, transmission tunnel, and floorpan were twisted. The front bumper, hood, grill, right front

quarter panel, right front tire and rim, right door, right rear quarter panel, right rear rim, rear bumper, and tailgate were damaged. The windshield received stress cracks in the lower corner on the right side. Maximum exterior crush at the right front corner of the vehicle at bumper height was 330 mm. Maximum deformation into the occupant compartment was 79 mm in the floorpan area of the right passenger area.

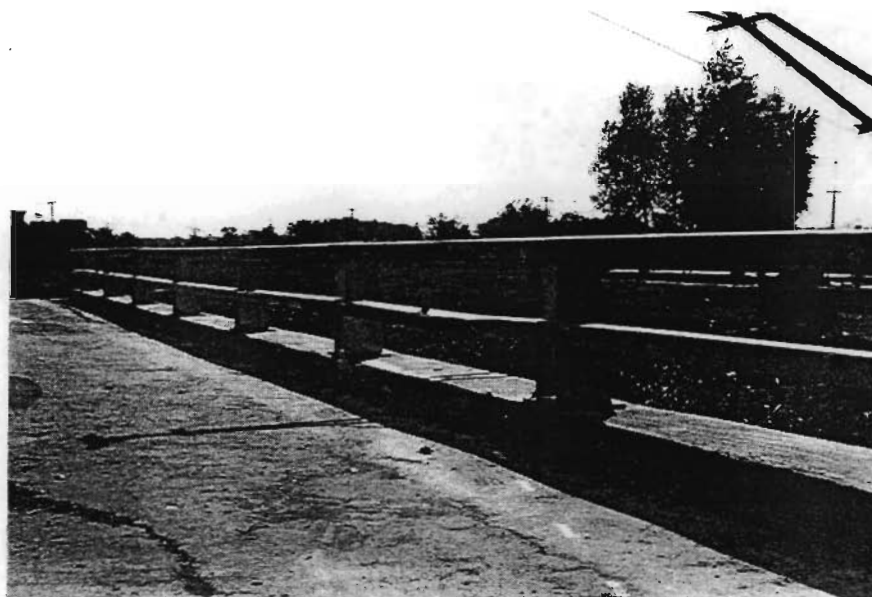
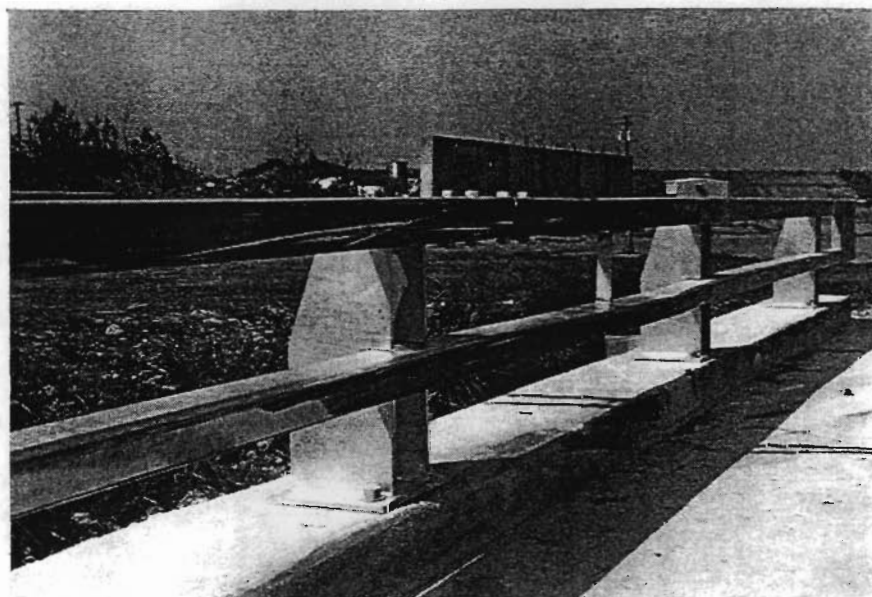
Figure 19. Installation after test 472610-3.

The bridge railing received minimal damage as shown in figures 18 and 19. There were tire marks on the upper and lower rail elements and the curb (1.2 m). The vehicle remained in contact with the rail from 279 mm downstream of post 2 until the end of the bridge railing. Maximum deformation of the upper rail element was 16 mm and the lower rail element was 22 mm. There was a gouge in the lower metal rail element near the point of initial impact and the spacer between post 2 and 3 was pulled up. A surface crack radiated from the right front bolt at post 2 and also from the center rear bolt at post 3.

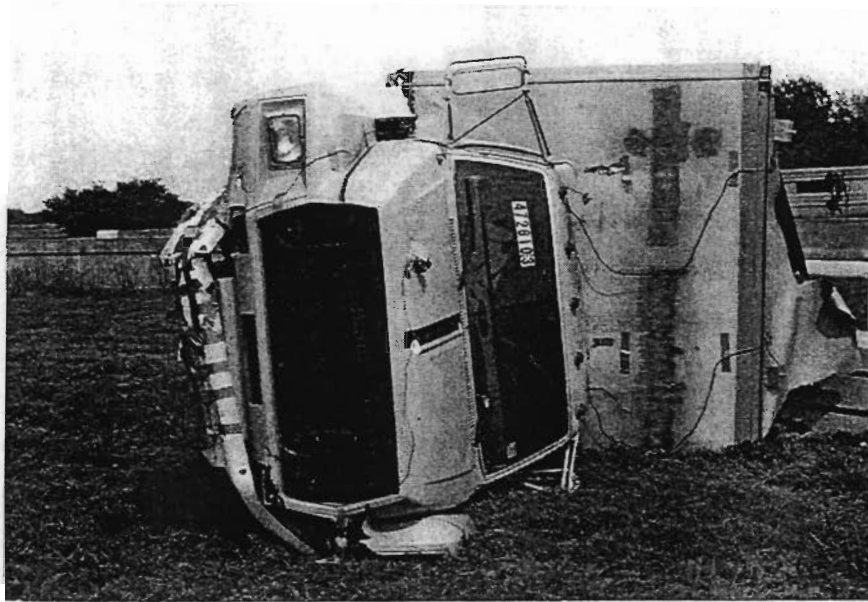
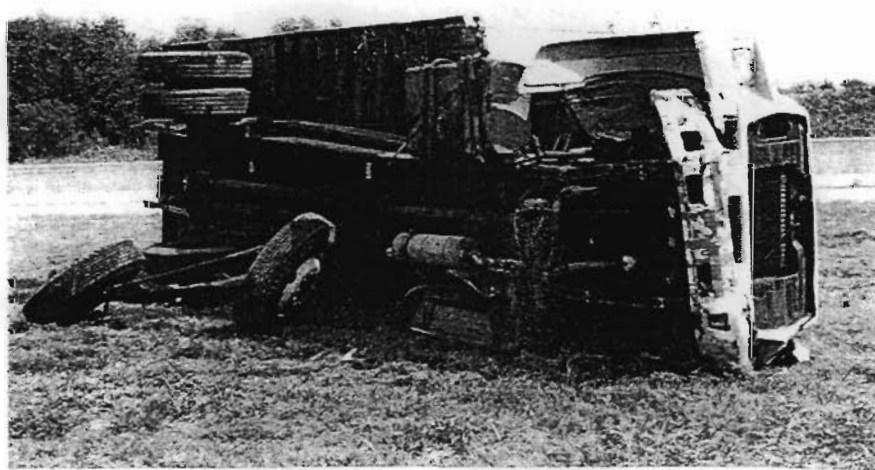
Figure 20. Vehicle after test 472610-3.

Most of the damage sustained by the vehicle during the collision was to the right side as shown in figure 20. The springs, shackles, shocks, suspension, and steering were damaged and the front axle was separated from the vehicle. The bumper, hood, front quarter panels and fuel tank were also damaged. Maximum exterior crush at the right front corner of the vehicle at bumper height was 590 mm.
