**Test Report No. 440822-01**

## **EVALUATION OF ATTACHMENTS TO CONCRETE BARRIER SYSTEMS TO DETER PEDESTRIANS**

Texas Department of Transportation  
<https://tti.tamu.edu/documents/0-7082-R1-Vol2.pdf>

| 4. Title and Subtitle<br>EVALUATION OF ATTACHMENTS TO CONCRETE BARRIER SYSTEMS TO DETER PEDESTRIANS—VOLUME 2: CRASH REPORT | | 5. Report Date<br>Published: August 2023 | |

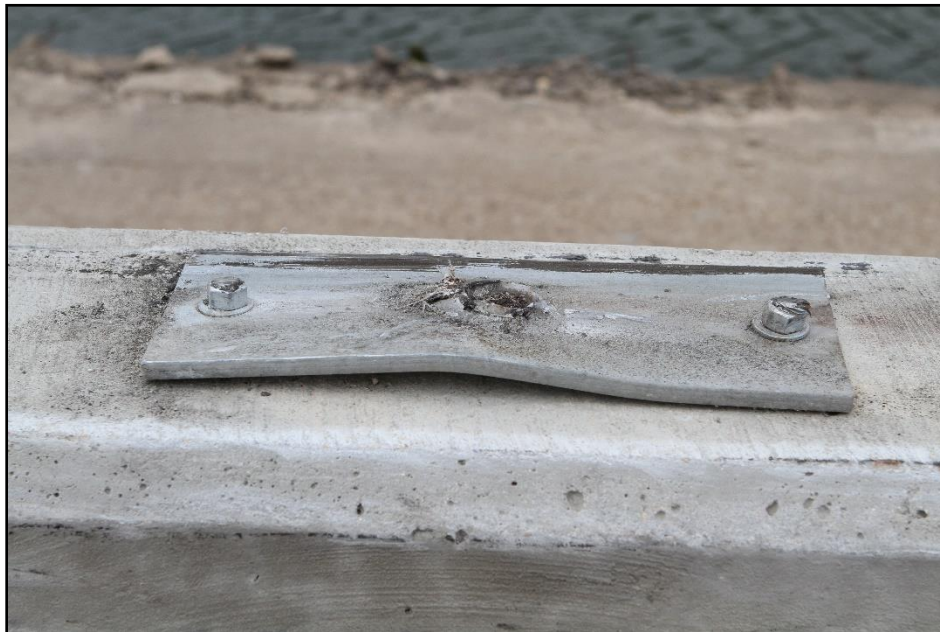
There was some scuffing and gouging at impact on the concrete barrier. Panels 6–20 were removed from the parapet. Panels 6 and 7 landed behind the parapet, and the others landed from 195 to 240 ft downstream. The pipe-to-plate connection failed at panels 7, 11, 15, and 16. The anchor bolts failed on the others.

**Figure 5.8. Armorcast® Gawk Screen on Single-Slope Barrier after Test at Base Plate with Missing Post, Test 440822-01-1.**

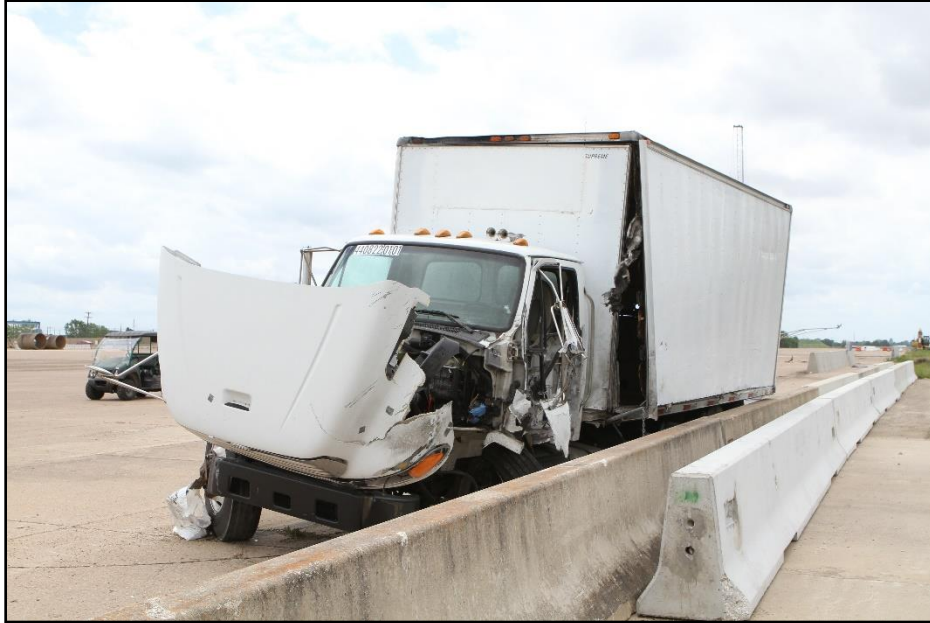
**Figure 5.9. Impact Side of Test Vehicle after Test 440822-01-1.**

| Description of Damage to Vehicle: | The front bumper and hood, left headlight, left front U-bolts and spring assembly, left front tire and rim, outer fiberglass skin of left front door, left door glass and window track, left mirror, left cab corner, left fuel tank, left battery box, and left rear inner tire and rim were all damaged. The windshield had a 3½-inch diameter break, but there was no damage to the laminate. |

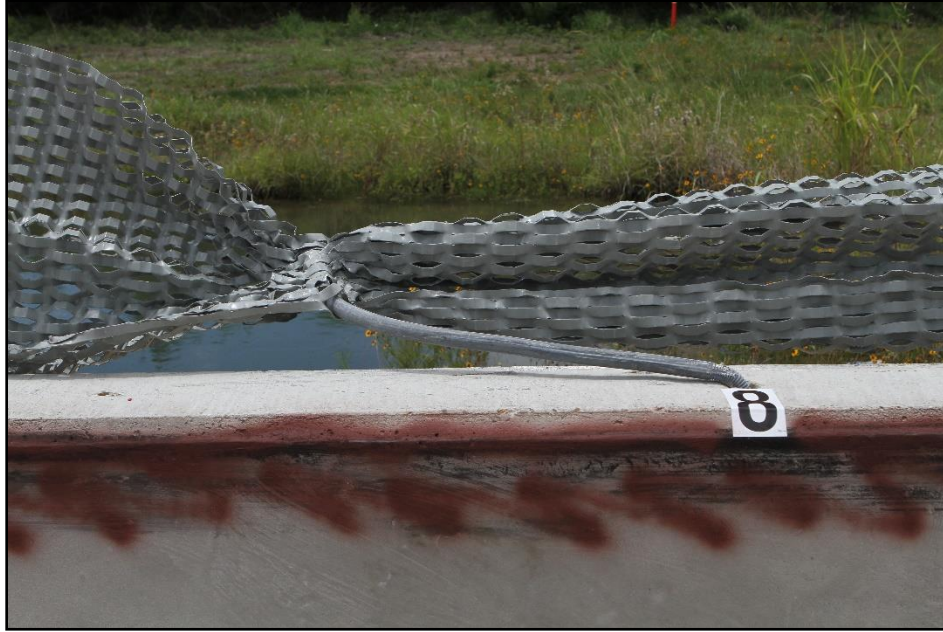
**Figure 6.7. Screen-Safe® Glare Screen on Single-Slope Barrier after Test at Post 8, Test 440822-01-2.**

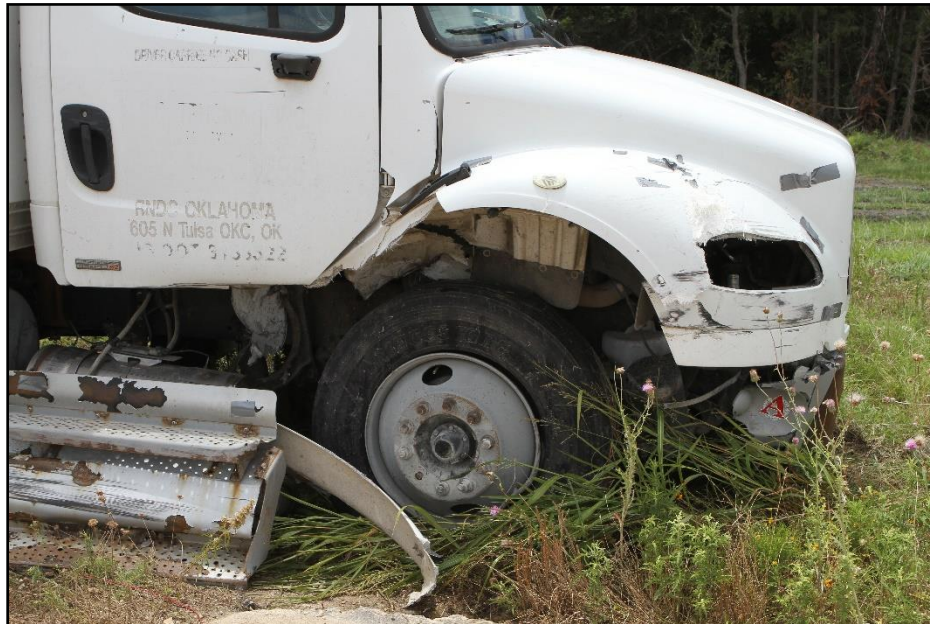
**Figure 6.8. Impact Side of Test Vehicle after Test 440822-01-2.**

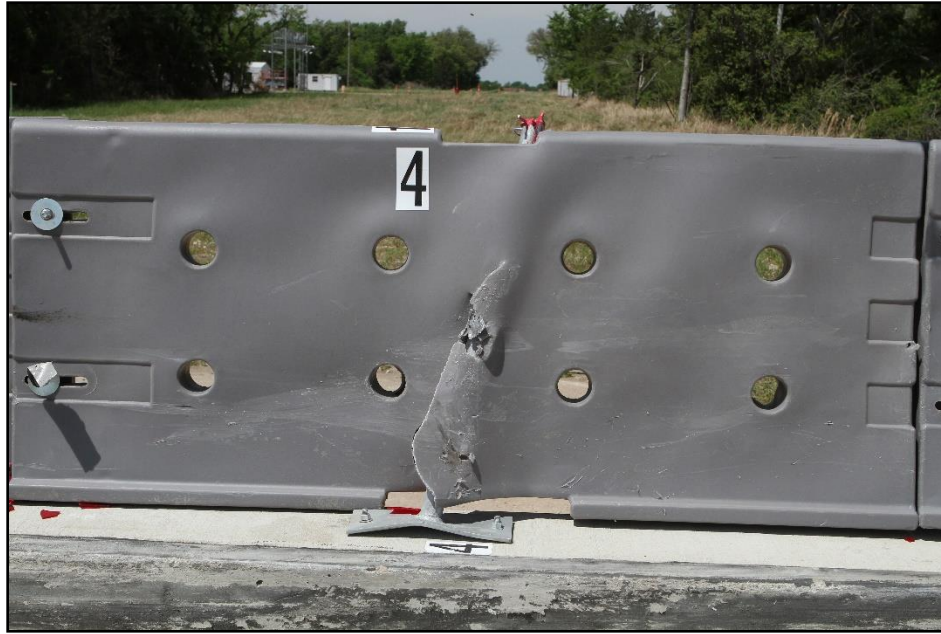
**Figure 7.7. Armorcast® Gawk Screen on F-Shape Barrier after Test at Post 4, Test 440822-01-3.**

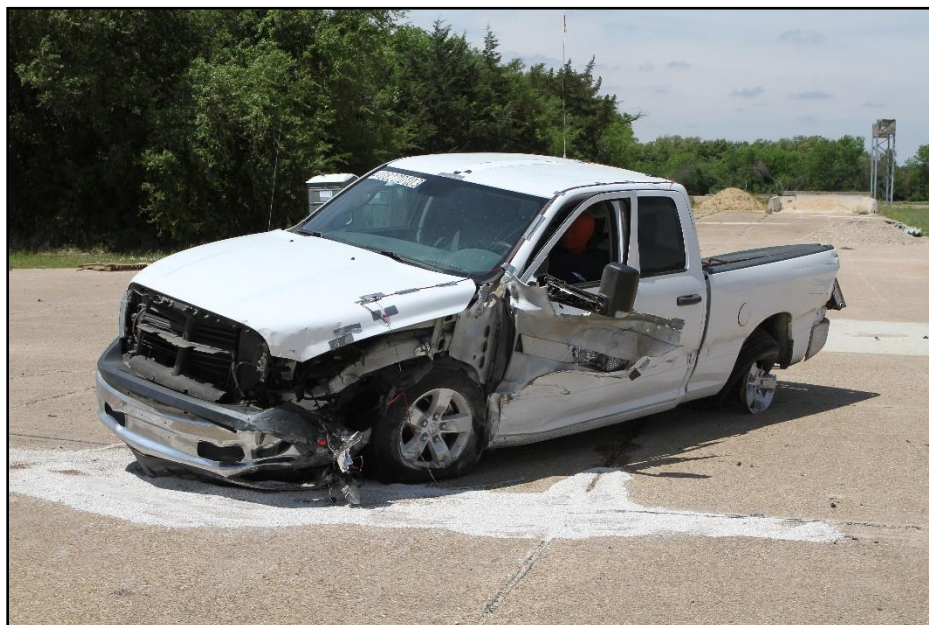
**Figure 7.8. Impact Side of Test Vehicle after Test 440822-01-3.**

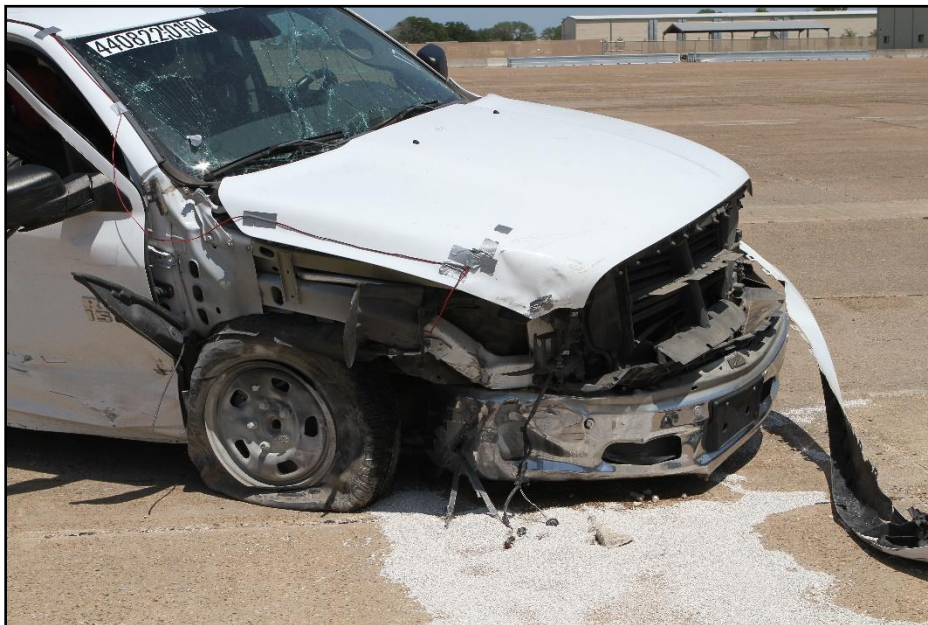
**Figure 8.8. Impact Side of Test Vehicle after Test 440822-01-4.**

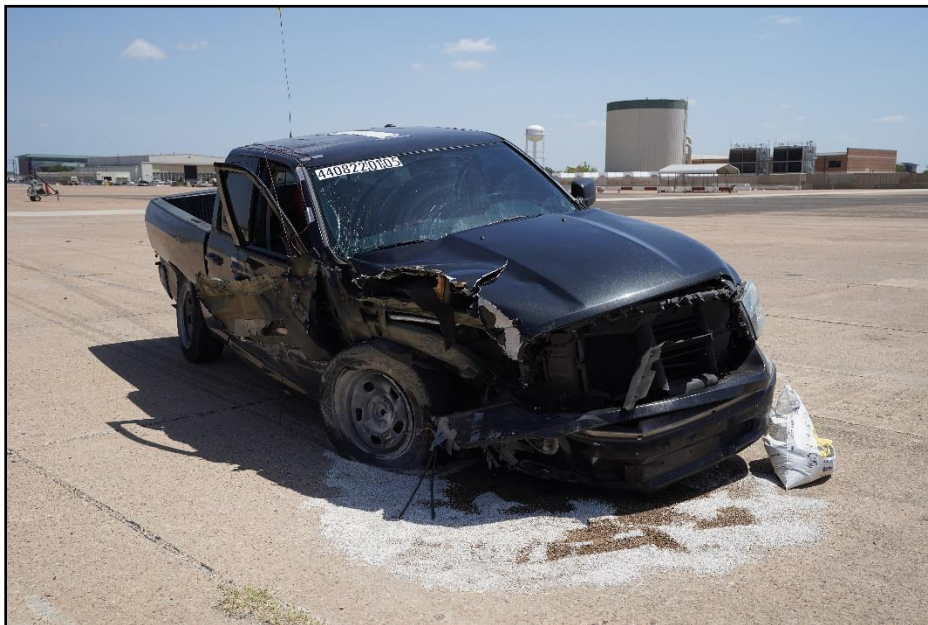
**Figure 9.8. Impact Side of Test Vehicle after Test 440822-01-5.**
