IMPROVING SAFETY AT SIGNALIZED INTERSECTIONS NEAR VERTICAL CURVES

Report 0-4084-1

Project Title: Countermeasures to Reduce Crashes
at Signalized Intersections near Vertical Curves

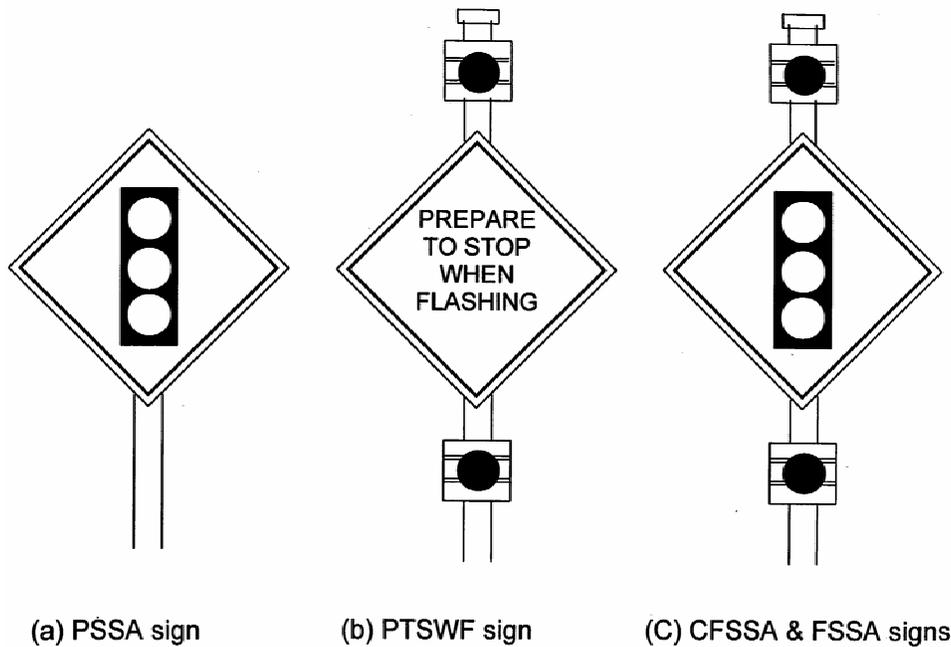
Figure 1. Advance Warning Signs Used in Ohio Study (2).

A study in Ohio compared driver’s reaction to the existing Passive Symbolic SIGNAL AHEAD sign (PSSA), a Prepare To Stop When Flashing sign (PTSWF), a Flashing Symbolic SIGNAL AHEAD sign (FSSA), and a Continuously Flashing Symbolic SIGNAL AHEAD sign (CFSSA). Examples of the signs used are presented in Figure 1. In this study the flashers on the PTSWF and FSSA signs were tied to the traffic signal and would begin to flash a few seconds before the yellow interval until the end of the red interval. The warning flashers on the CFSSA sign would always flash regardless of the state of the traffic signal (2).

The study found that the CFSSA produced results similar to the standard PSSA sign. The PTSWF and FSSA signs were effective in reducing approach speeds during the red interval and reducing red-light violations; however, the use of these signs tended to increase approach speeds during the green interval when the signal state was clearly visible from the sign location (2).

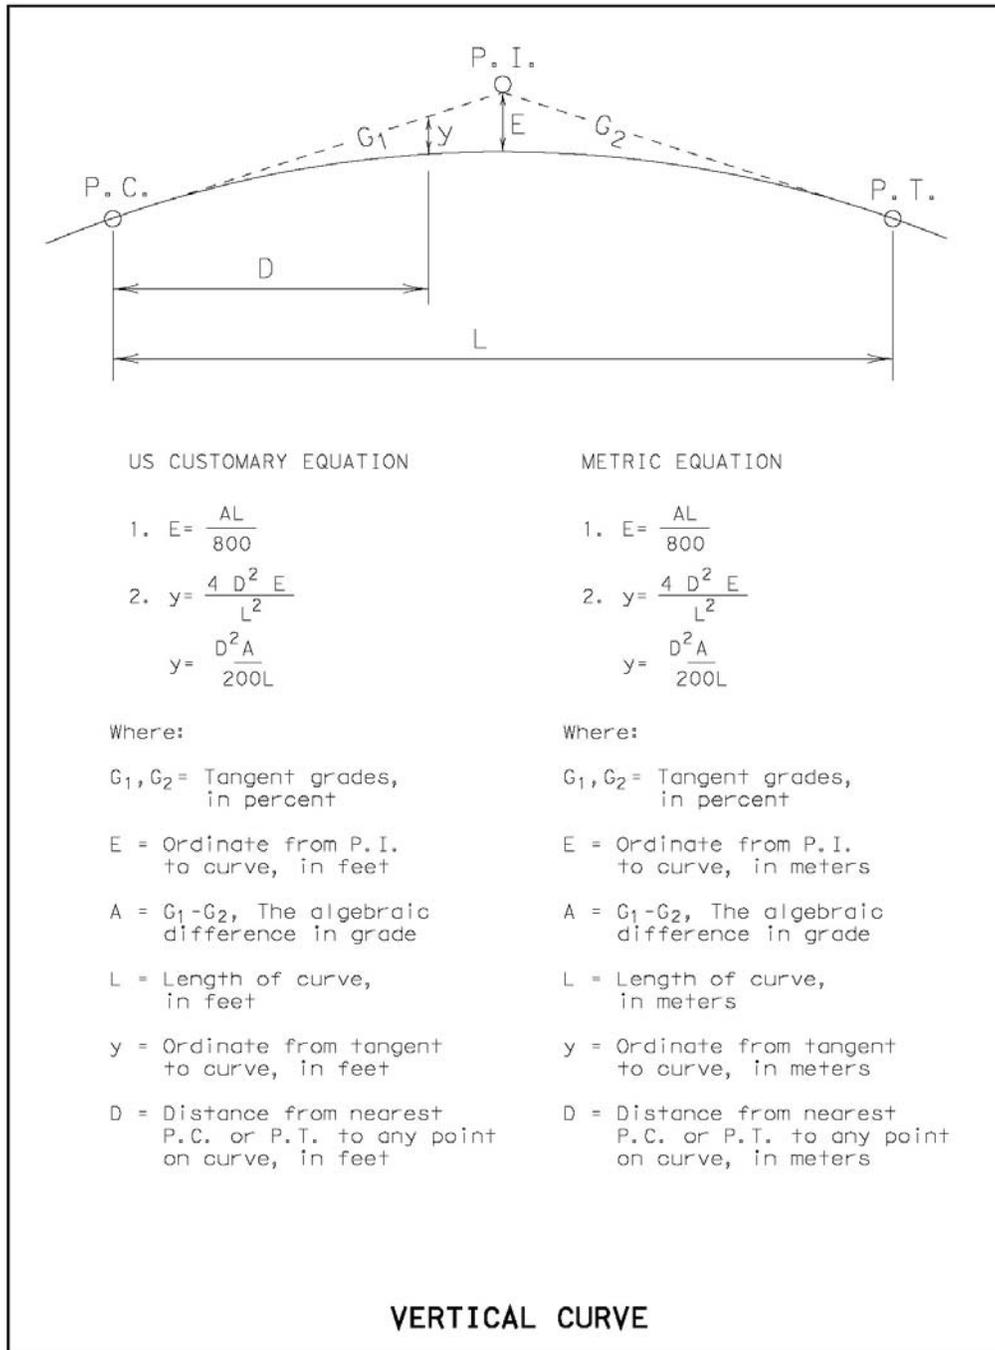
Figure 3. Design of Typical Vertical Curve from TxDOT Roadway Design Manual (11).

The AASHTO *Green Book (10)* provides guidelines for the design of vertical curves on highways and streets. The TxDOT *Roadway Design Manual (11)* follows the same guidelines as those presented in the *Green Book*. Vertical curves are designed as simple parabolas such as the one shown in [Figure 3](#). Restrictions are placed on the minimum length of vertical curve, L , that can be used to connect two given grades at a given design speed. These restrictions are based on ensuring that SSD is provided at all points along the curve. [Figure 4](#) is the chart that is used to determine the minimum length of vertical curve, L , that can be used for a given design speed, V , and algebraic difference in grade, A (*11*).

Vertical curves that are designed based on the minimum values provided in Figure 3 are adequate in most situations because they ensure that SSD is provided. However, in those locations where signalized intersections (or other areas of high complexity and visual noise) are located in close proximity to the vertical curve, there will be portions on the approach to those intersections where the recommended DSD is not provided.

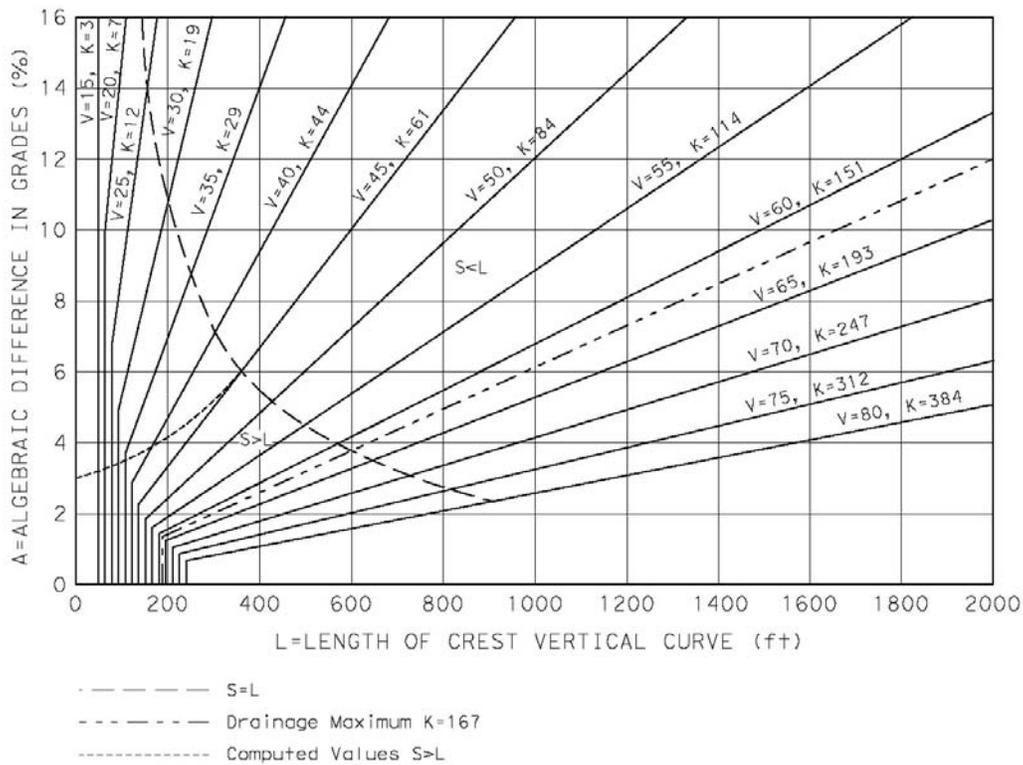
Figure 4. Minimum Lengths of Vertical Curves to Provide Stopping Sight Distance from TxDOT Roadway Design Manual (11).

Design Controls for Crest Vertical Curves (US Customary)

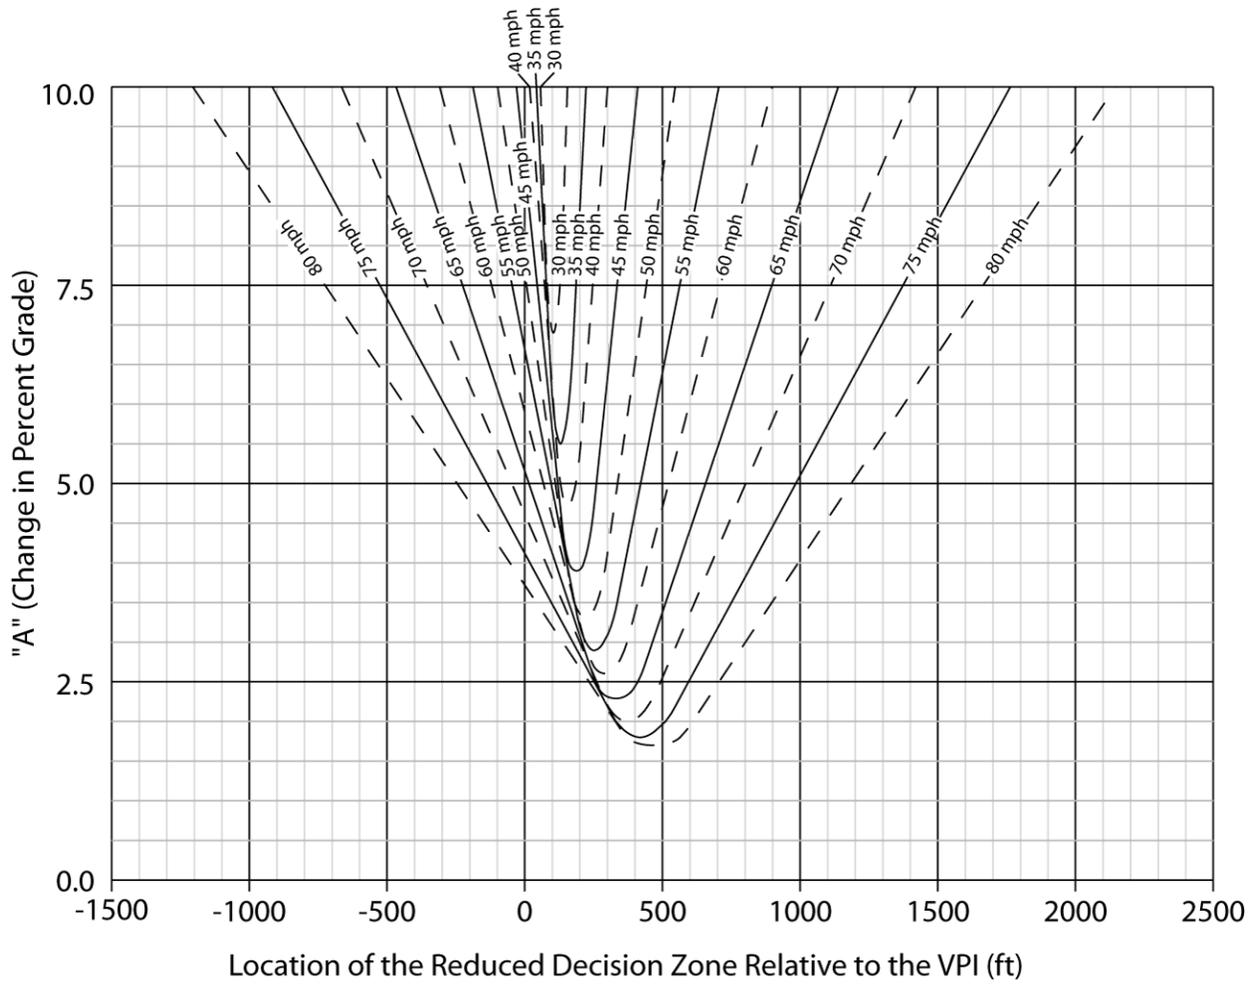
Figure 5. Reduced Decision Zone Location for Rural Roadway Applications.

The charts and methodology used above for roadway design could also be applied in operational and safety analyses of signalized intersections. The charts can be used to identify those locations where an intersection or back of queue has been located within the RDZ on an approach to the intersection. Those locations in which DSD is not provided to the intersection would be candidates for additional countermeasures (to be discussed in the [next chapter](#)) to alert motorists at the appropriate location of the presence of the downstream signal or back of queue.

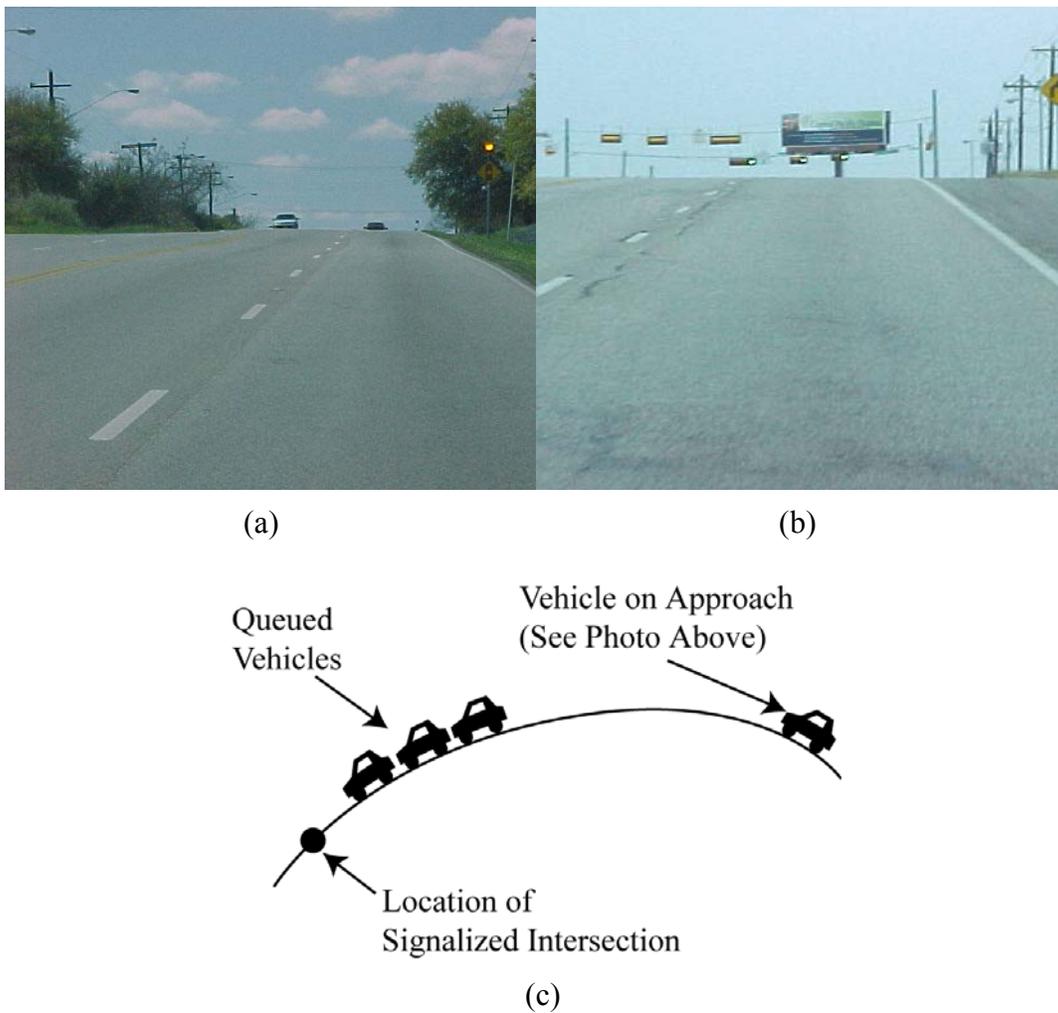
Figure 7. Reduced Sight Distance on the Approach to Signalized Intersections near Vertical Curves.

Signalized intersections located at or near the bottom of a crest vertical curve have the potential to experience higher crash rates than other similar signalized intersections. Two common effects that occur when signals are located near vertical curves are a reduction in the sight distance to the signal heads and a reduction in the sight distance to the back of the queue waiting at a signal. If the traffic signal heads and/or the end of the queue are not visible due to the crest of the curve, drivers may not have sufficient time to react in order to avoid a crash. [Figure 7](#) demonstrates these issues from the driver's perspective. In [part a](#) of the figure, the driver cannot see the signal heads for the approaching intersection. In [part b](#), the driver can see the signal heads but not the back of queue. The waiting vehicles are illustrated in [part c](#).

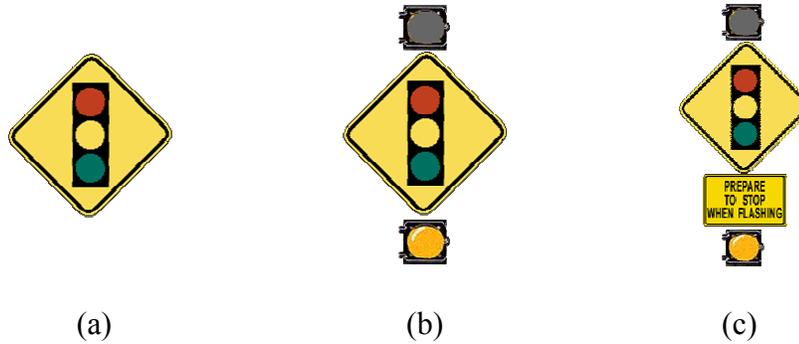
Figure 8. Uses of the Symbolic SIGNAL AHEAD Warning Sign.

The use of the SIGNAL AHEAD warning sign is thoroughly covered in the TMUTCD. This sign may be used by itself (Figure 8a), with continuously flashing or actuated beacons (Figure 8b), or with actuated flashing beacons and a supplemental plaque warning motorists to be prepared to stop (Figure 8c). When actuated beacons are used, these beacons should begin to flash just prior to the signal’s change to yellow and should remain flashing until the signal turns green.

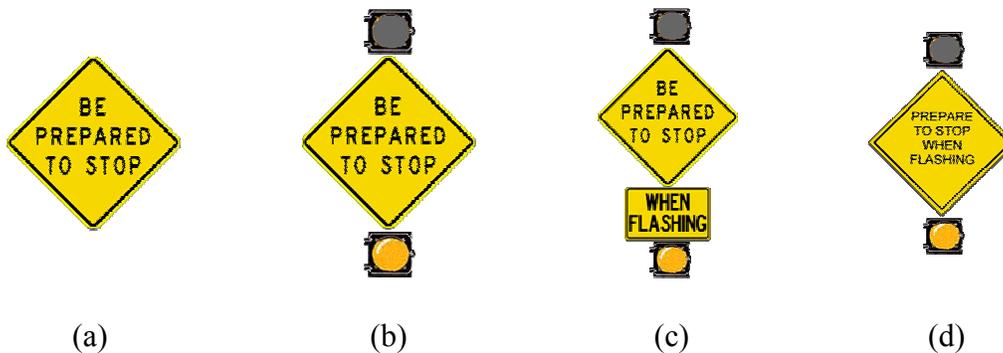
Figure 9. Uses of the BE PREPARED TO STOP Family of Signs.

A second group of signs warns the motorist that they may have to stop ahead. Again, combinations of static signs, continuously flashing beacons, and actuated beacons can be used as shown in Figure 9. The BE PREPARED TO STOP signs are versatile in that they are applicable in warning the motorist they should be prepared for either a yellow or red signal ahead or a queue of stopped vehicles. Thus, actuated flashing beacons, if used, could be connected to either the traffic signal or a queue detector.

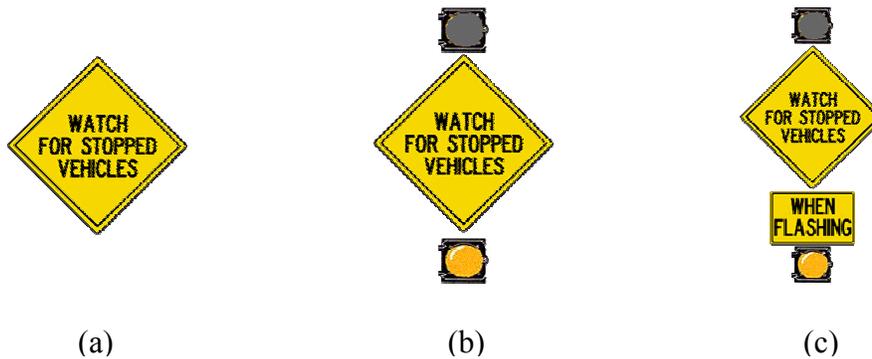
Figure 10. Uses of the WATCH FOR STOPPED VEHICLES Sign.

When the traffic signal heads are visible for an adequate distance but the back of the queue is hidden by the vertical curve, the use of the WATCH FOR STOPPED VEHICLES sign could be considered. This sign could be used with or without continuously flashing or actuated beacons. If actuated beacons are used, they should be connected to a queue detector and not to the active signal phase. This is to allow for the fact that stopped vehicles may remain for some time after a signal has turned green. Examples of this sign are shown in Figure 10. It should be noted, however, that the WATCH FOR STOPPED VEHICLES sign is not explicitly contained within either the state TMUTCD (1) or the national MUTCD (9).

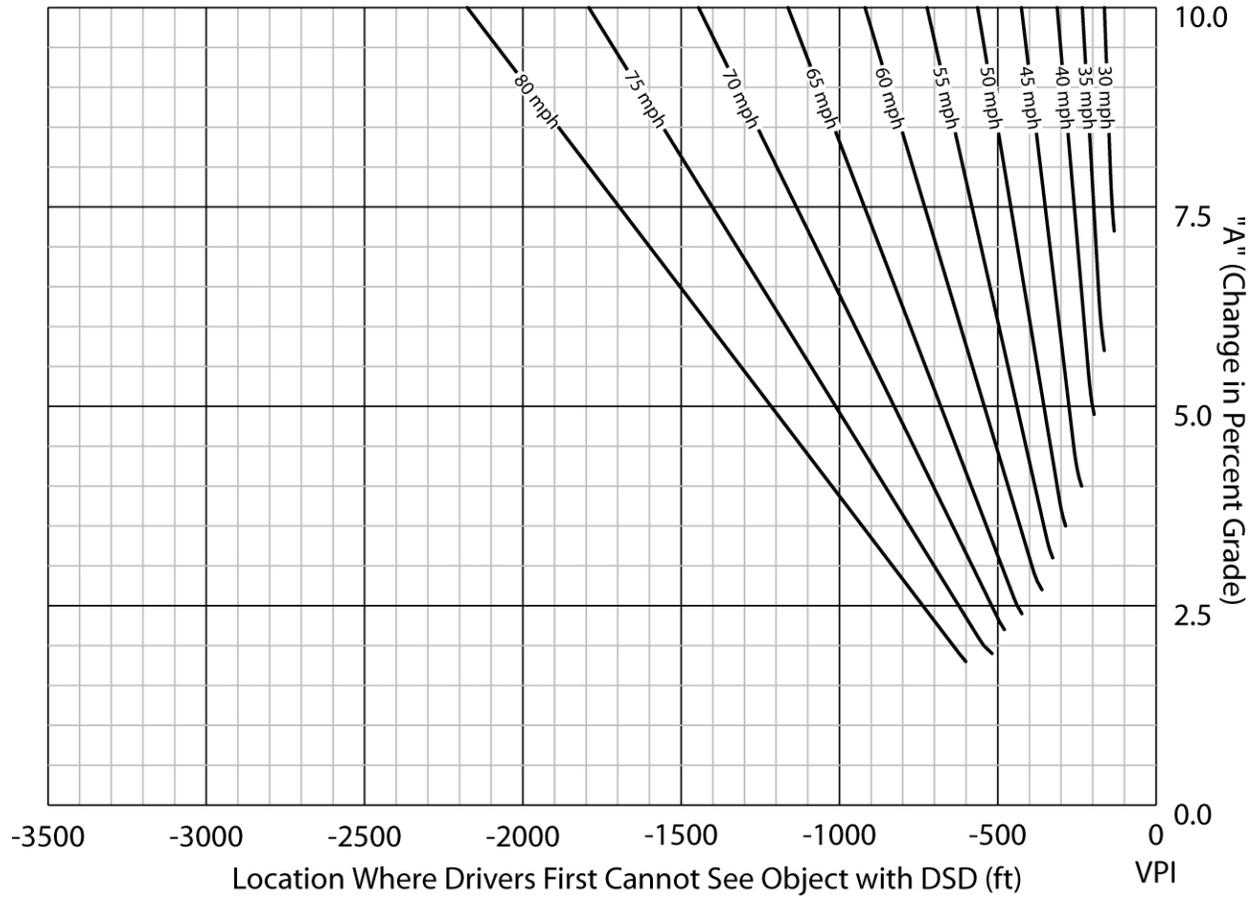
Figure 11. Countermeasure Placement Location for Rural Roadway Applications.

The BE PREPARED TO STOP sign should be used in conjunction with the SIGNAL AHEAD sign as described in the TMUTCD. The SIGNAL AHEAD sign should be located on the approach following the guidelines for placement that are available in the TMUTCD ([Table 1](#)). The additional countermeasure, the BE PREPARED TO STOP sign, should be located such that it is legible at the beginning of the RDZ on the approach. Since the RDZ is dependent upon the geometry of the vertical curve, it is once again useful to refer to charts to determine the sign placement location. The chart shown in [Figure 11](#) should be used to locate signs on rural roadways. The chart in [Figure 12](#) should be used in urban locations. In both cases, the figure

identifies the beginning of the RDZ. Since standard signs are visible at 175 feet (*I*), the actual sign location will be 175 feet closer to the VPI than Figure 11 or Figure 12 indicate.

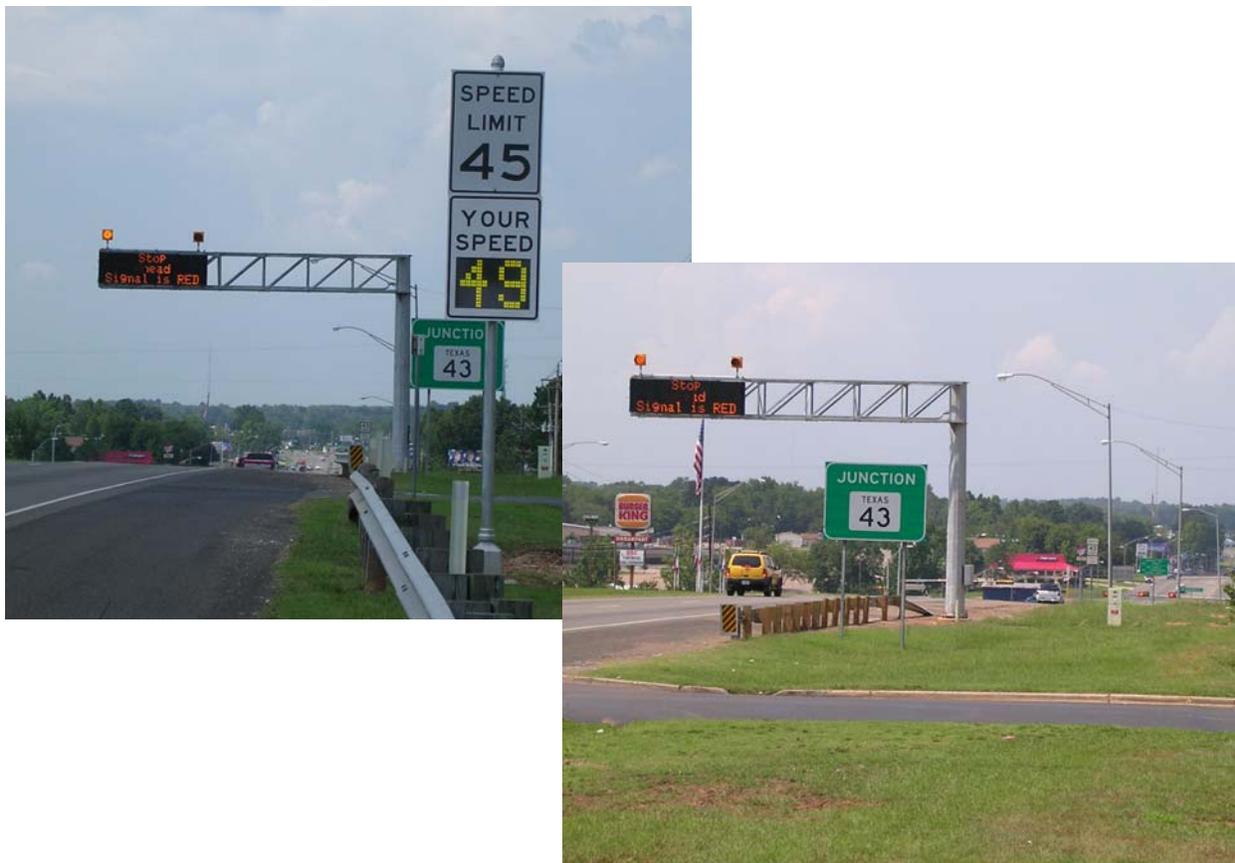
Figure 13. Dynamic Message Sign as Advance Warning of a Signalized Intersection near a Vertical Curve.

An initial list of field sites (see [Table 3](#)) based on responses to a survey mailed to each of the 25 TxDOT districts was found too limiting to allow for the variety of experiments anticipated in the testing of advance warning devices along vertical curves upstream of signalized intersections. Some of the sites suggested in the survey of TxDOT district personnel around the state already included some form of treatment, including a unique application of a dynamic message sign along a vertical curve approaching a signalized intersection in Marshall, Texas (see [Figure 13](#)). Active speed monitoring with speed display is also used at this location to inform motorists about their driving activity along the approach to the signal. Utilizing the DMS, a “Be Prepared to STOP” message is displayed when the downstream signal (located in a sag vertical curve upstream of the DMS location) is yellow, and a “Stop Ahead Signal is RED” message is displayed when the downstream signal is red. However, due to implementation cost concerns, this warning method was not included for further study.

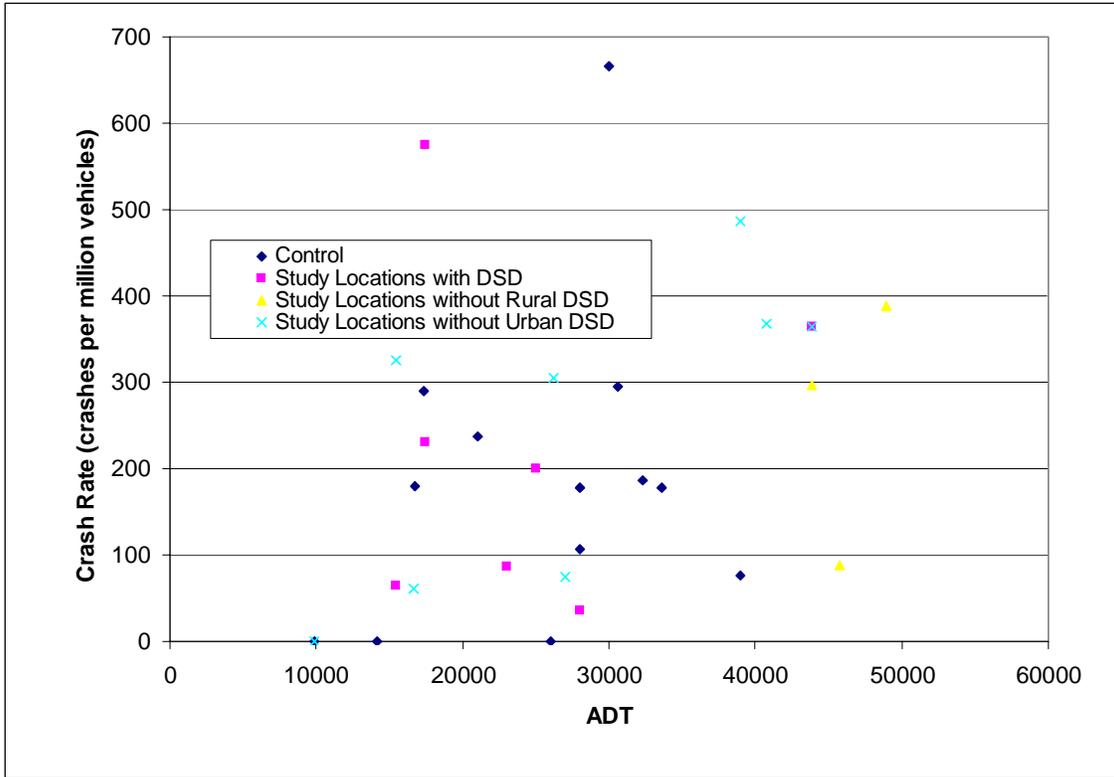
Figure 14. Crash Rate Comparison for Sites with and without Decision Sight Distance.

Crash statistics from the DPS database were examined for each site in [Table 6](#). In the case of some sites, the exact cross-street location could not be consistently matched with information in the crash database. In these instances, the crash totals were left blank rather than estimating a total number of crashes on insufficient reference data. Subsets of the sites found in [Table 6](#) were created based on whether or not the site provided DSD and, if DSD was not provided, if the site was located in a rural or urban setting.

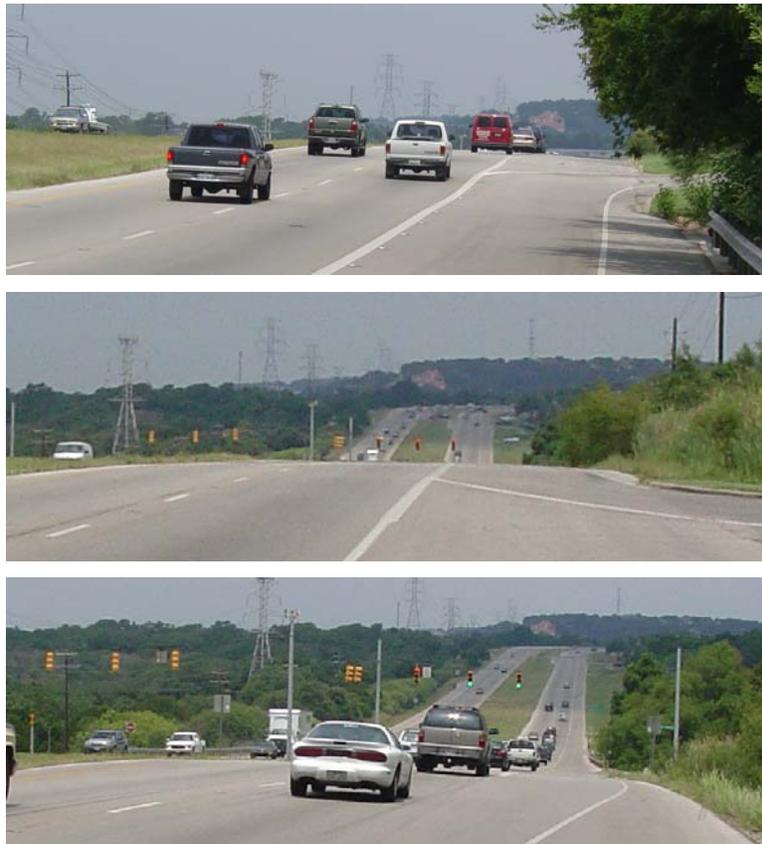
Figure 16. Northbound Loop 360 at Walsh-Tarleton.

Loop 360 is a circumferential major arterial divided highway around western Austin, Texas. The signalized intersection of Loop 360 and Walsh-Tarleton is in southwestern Austin and is close to Barton Creek Mall, a large retail center in southern Austin. Average daily traffic (ADT) on Loop 360 is approximately 44,000 vehicles per day according to 2001 data from TxDOT. Conditions along the northbound approach of Loop 360 to Walsh-Tarleton are shown in [Figure 16](#). As can be seen in the successive images, sight distance to the signal heads, vehicles in queue at the signal, and the intersection itself is limited because the intersection is located in a small valley.

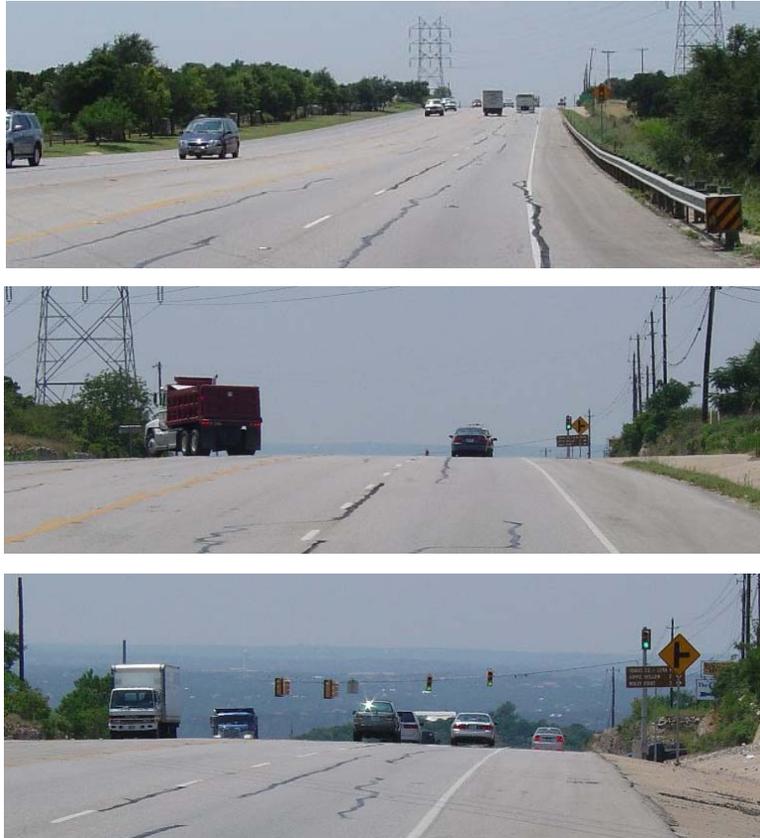
Figure 17. Westbound RM 620 at Comanche Trail.

Like Loop 360, RM 620 is a circumferential route around western Austin, Texas. However, RM 620 is further away from downtown Austin and passes through more rural settings than Loop 360. The intersection of RM 620 and Comanche Trail is located north and to the west of Austin and is located near a developing junction known as Four Points (i.e., the junction between RM 620 and FM 2222). ADT on RM 620 near this intersection is approximately 27,000 vehicles per day according to 2001 data from TxDOT. [Figure 17](#) contains photographs along the westbound RM 620 approach to Comanche Trail as a vehicle approaches the intersection.

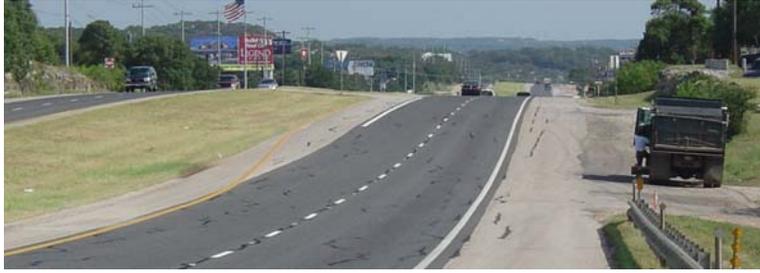
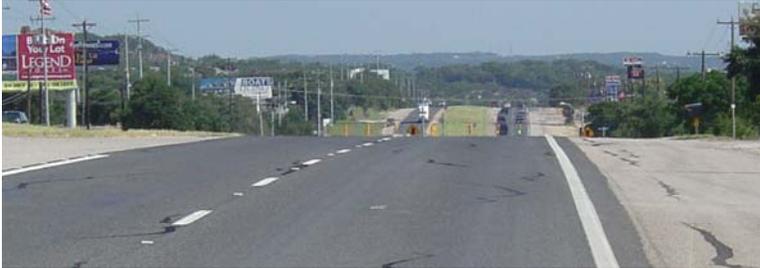
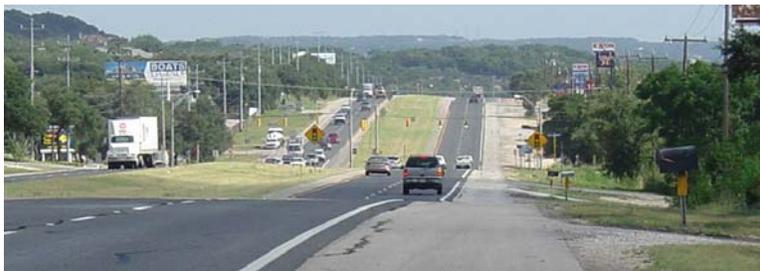
Figure 18. Northbound US 281 at Bulverde Road.

US 281 is a radial major arterial in north central San Antonio, Texas. Inside of San Antonio's outer loop (Loop 1604), US 281 is a freeway with frontage roads. Outside of Loop 1604, US 281 is a divided highway that eventually turns into a two-lane undivided highway further away from San Antonio. Near its junction with Bulverde Road, US 281 carries approximately 30,000 vehicles per day according to 2001 volumes from TxDOT. While this site has substantial sight distance to the intersection and signal heads (see [Figure 18](#)), queuing in the northbound direction often backs into the RDZ; many instances of hard deceleration were observed in the field.

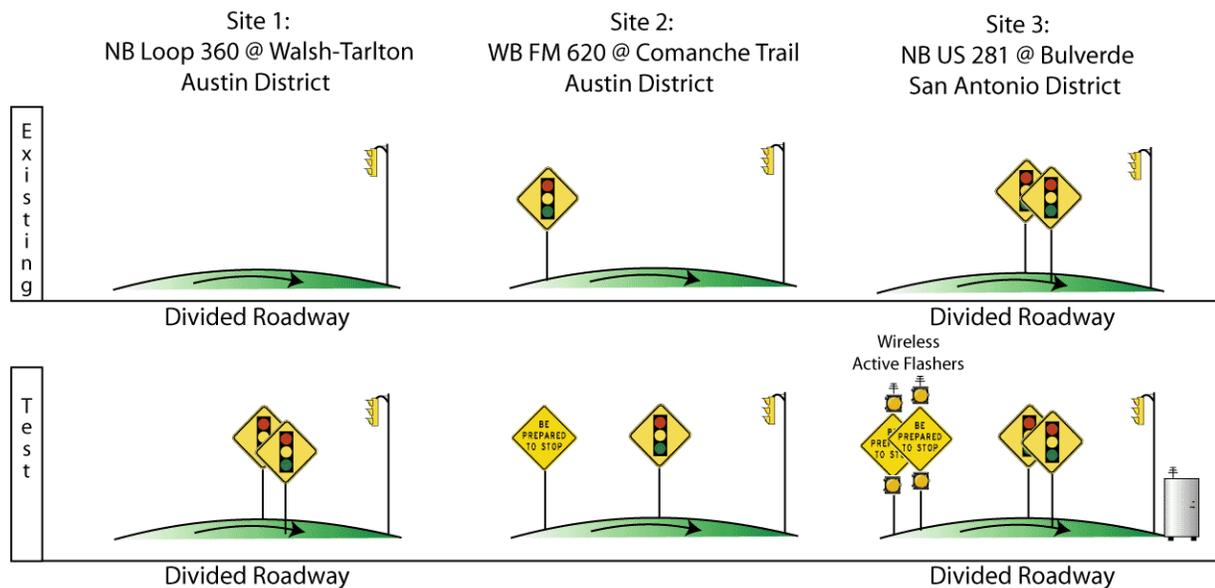
Figure 19. Study Sites and Deployed Countermeasures.

A field study data collection plan was developed to test three different types of countermeasures for vertical curvature in advance of signalized intersections. The first tested countermeasure included dual (i.e., either side of the directional roadway on a divided highway) symbolic SIGNAL AHEAD signs (see Site 1 details in [Figure 19](#)). As with the other countermeasure deployments, the signs were located at the beginning of the RDZ at a location where the driver was able to perceive the sign’s message just as his or her vehicle entered the RDZ. Further detail about the site and signing location can be found in the [appendix](#).

The second countermeasure to be tested was the deployment of a BE PREPARED TO STOP sign upstream of an existing advance warning symbolic SIGNAL AHEAD sign (see Site 2 details in [Figure 19](#)). In the case of the site selected for this treatment, the symbolic SIGNAL AHEAD sign was already located at the appropriate location based on the definition of the RDZ, wherein motorists do not have DSD along the entire approach to the signal. Thus, an intermediate signing location was found based on TMUTCD criteria and the symbolic sign was relocated to this position. The BE PREPARED TO STOP sign was then located at the beginning of the RDZ using the post and foundation originally used for the symbolic sign. Field details of this site, including the location of the RDZ based on the criteria developed in this research, can be found in the [appendix](#).

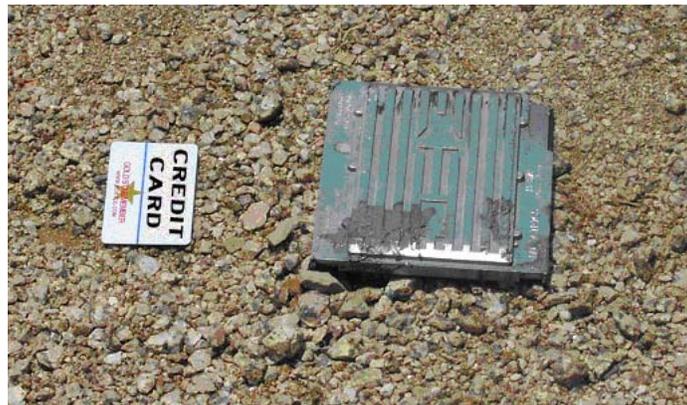
Figure 20. HI-STAR Data Collector (Credit Card as Size Reference).

Both the researchers and the TxDOT Project Monitoring Committee members felt that it was essential that the methods used for site data collection not be overly evident to drivers along the approaches to signalized intersections. Common techniques such as the placement of “road tube” sensors or the use of video equipment would locate devices (and, possibly, data collection staff) that were easily visible to drivers in direct proximity to the countermeasures being studied. Accordingly, researchers used Nu-metrics® HI-STAR® data collectors (see [Figure 20](#)) to obtain count and speed information at evenly-spaced stations along the study approach to each of the three signalized intersections being investigated.

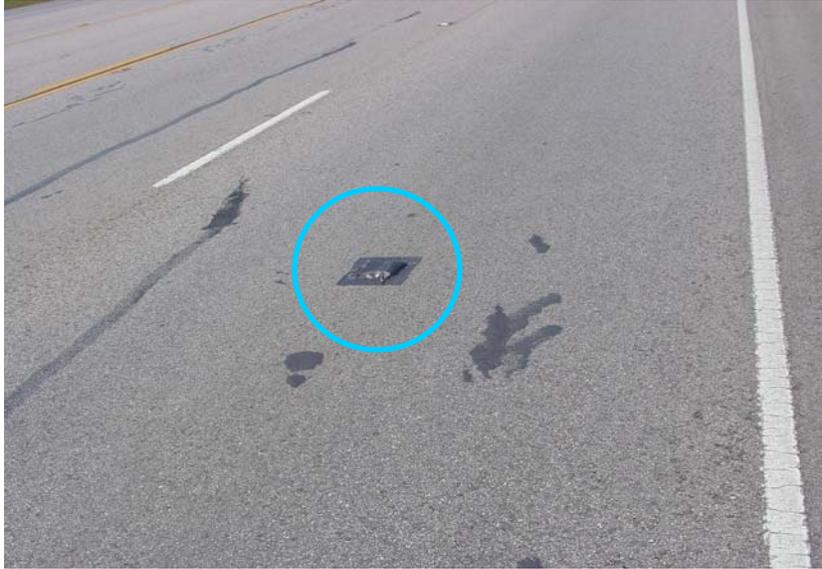
Figure 21. HI-STAR Deployed in a Traffic Lane.

The HI-STAR devices were able to collect the necessary volume and speed data at each station and were located within a lane of traffic using an adhesive tape that secured and protected the device but did not contrast heavily with the roadway pavement (see [Figure 21](#)). These devices were used during both the “before” and “after” (i.e., after countermeasures were deployed) studies and were located at the same station for both studies. Thus, any differences in driver speed between the before and after studies as motorists approach the vertical curve and the signalized intersection were due to the countermeasure being deployed.

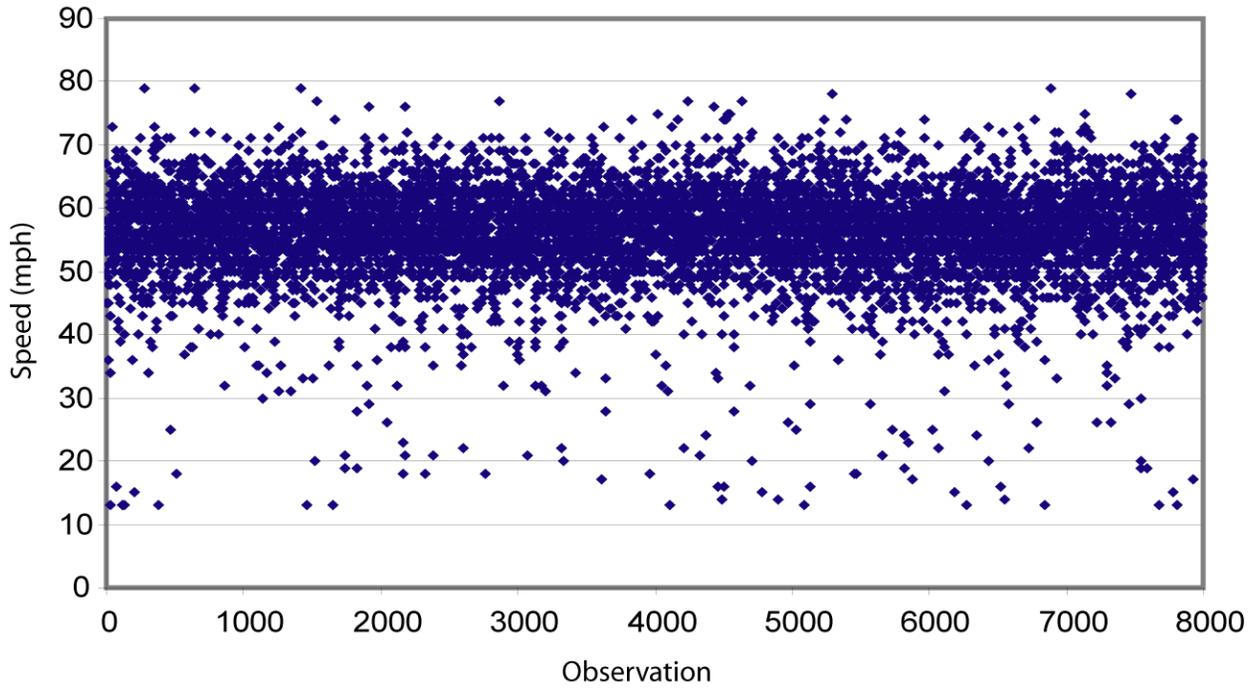
Figure 22. Observation Number versus Observed Speed – Site 1.

After examining speed data collected at the first site on the northbound approach to Loop 360, researchers made the decision to remove the “noise” within the speed data by truncating data points with a speed less than 25 miles per hour from the speed limit. Arguably, these data points represented either driveway traffic close to the data collection station, partially disabled vehicles, or vehicles slowing to access the shoulder for unknown reasons and were not progressing down the roadway at the anticipated speed for prevailing operating conditions. [Figure 22](#) shows an entire station’s data set of observed speeds, including the “noise” found at lower speeds. [Figure 23](#) displays both the entire data set collected at the first station of Site 1 and the data set after the low-speed “noise” was removed from the data set. It is clear that the speed distribution is normal; the low-speed points are non-representative of the overall population and were removed to ensure the validity of the later statistical tests between the before and after conditions.

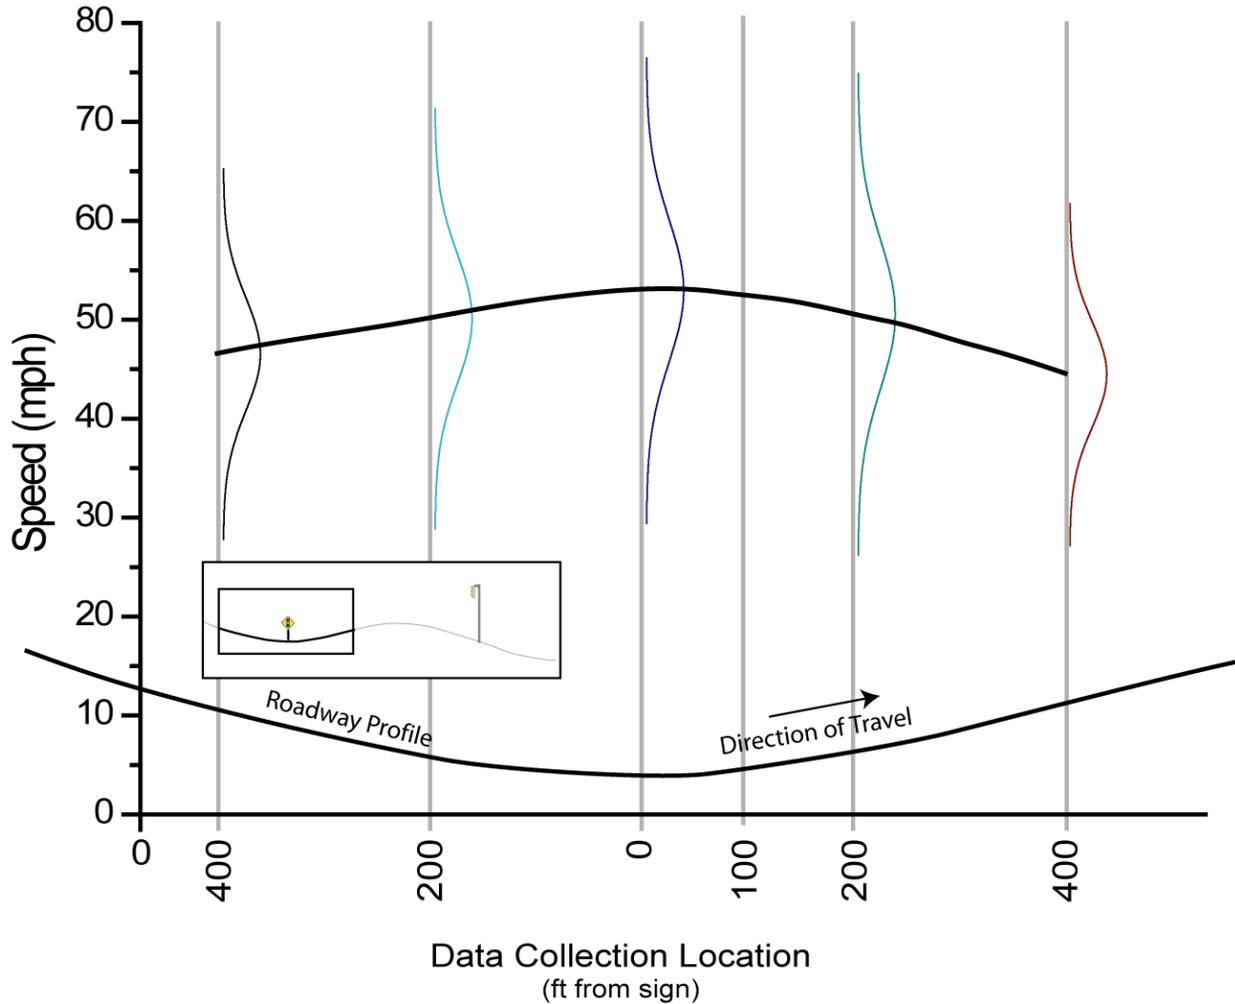
Figure 24. “Before” Speed Data for NB Loop 360 at Walsh-Tarleton.

Figure 24 and Table 7 contain the before data observed along northbound Loop 360 approaching the signalized intersection with Walsh-Tarleton. As shown in the figure, the roadway approach in this direction includes a sag vertical curve. The location of the sign tested at this site is shown in the figure for reference. At each data collection station, the vertical curved line represents the actual speed distribution observed as a histogram. The bottom horizontal curved line represents the roadway profile, and the upper curved line that connects the histograms represents an average speed profile along the approach. Actual average speeds and standard deviations at each station are provided in the table.

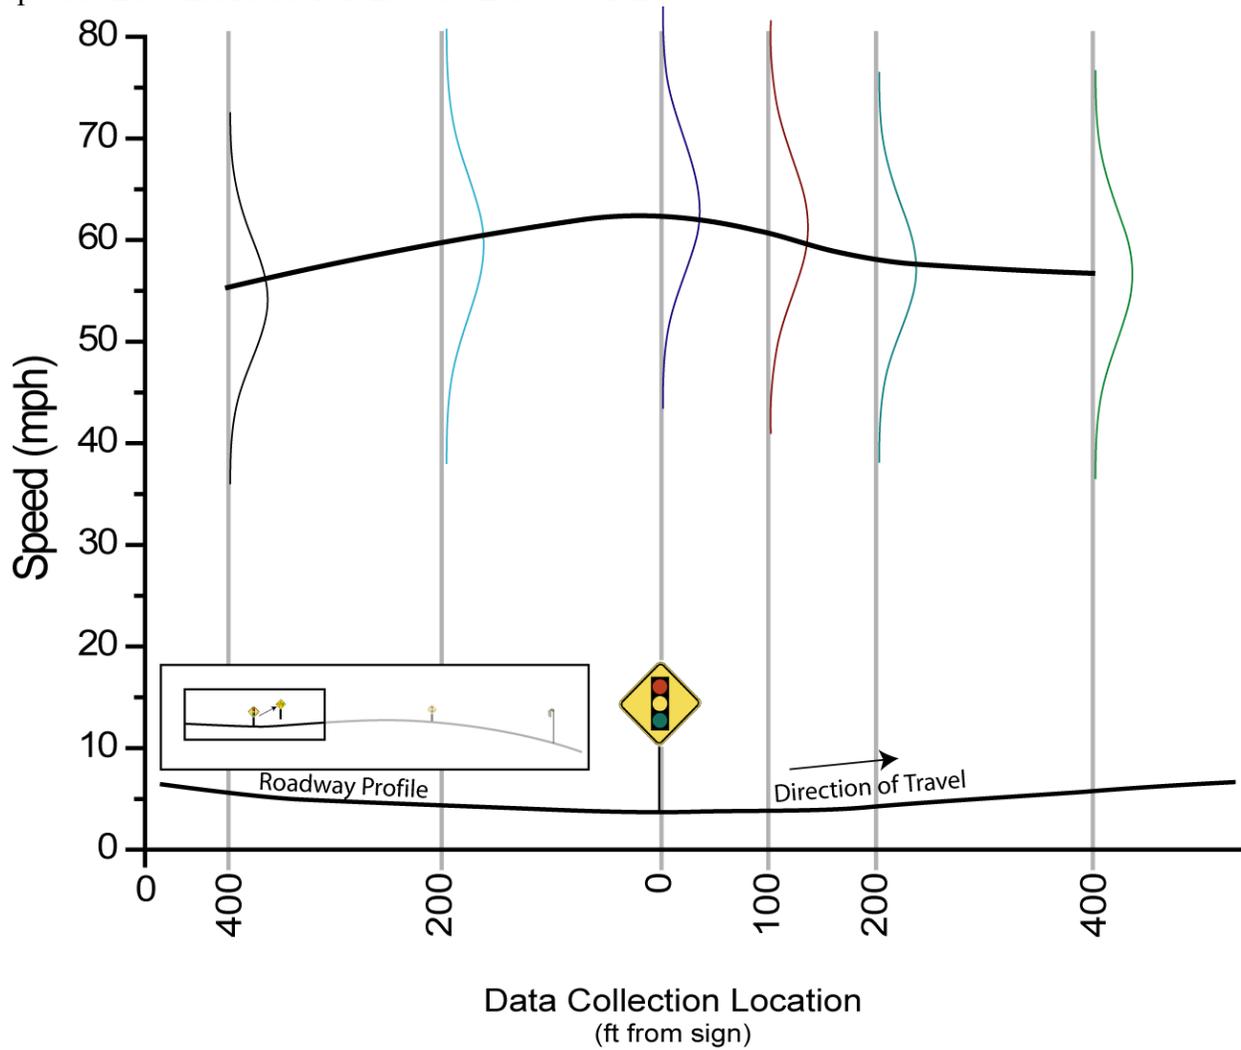
Figure 25. “Before” Speed Data for WB RM 620 at Comanche Trail.

Before statistics for westbound RM 620 approaching Comanche Trail are shown in [Figure 25](#) and [Table 8](#). The figure contains an average speed profile, and the table contains actual average speeds and standard deviations at each data station.

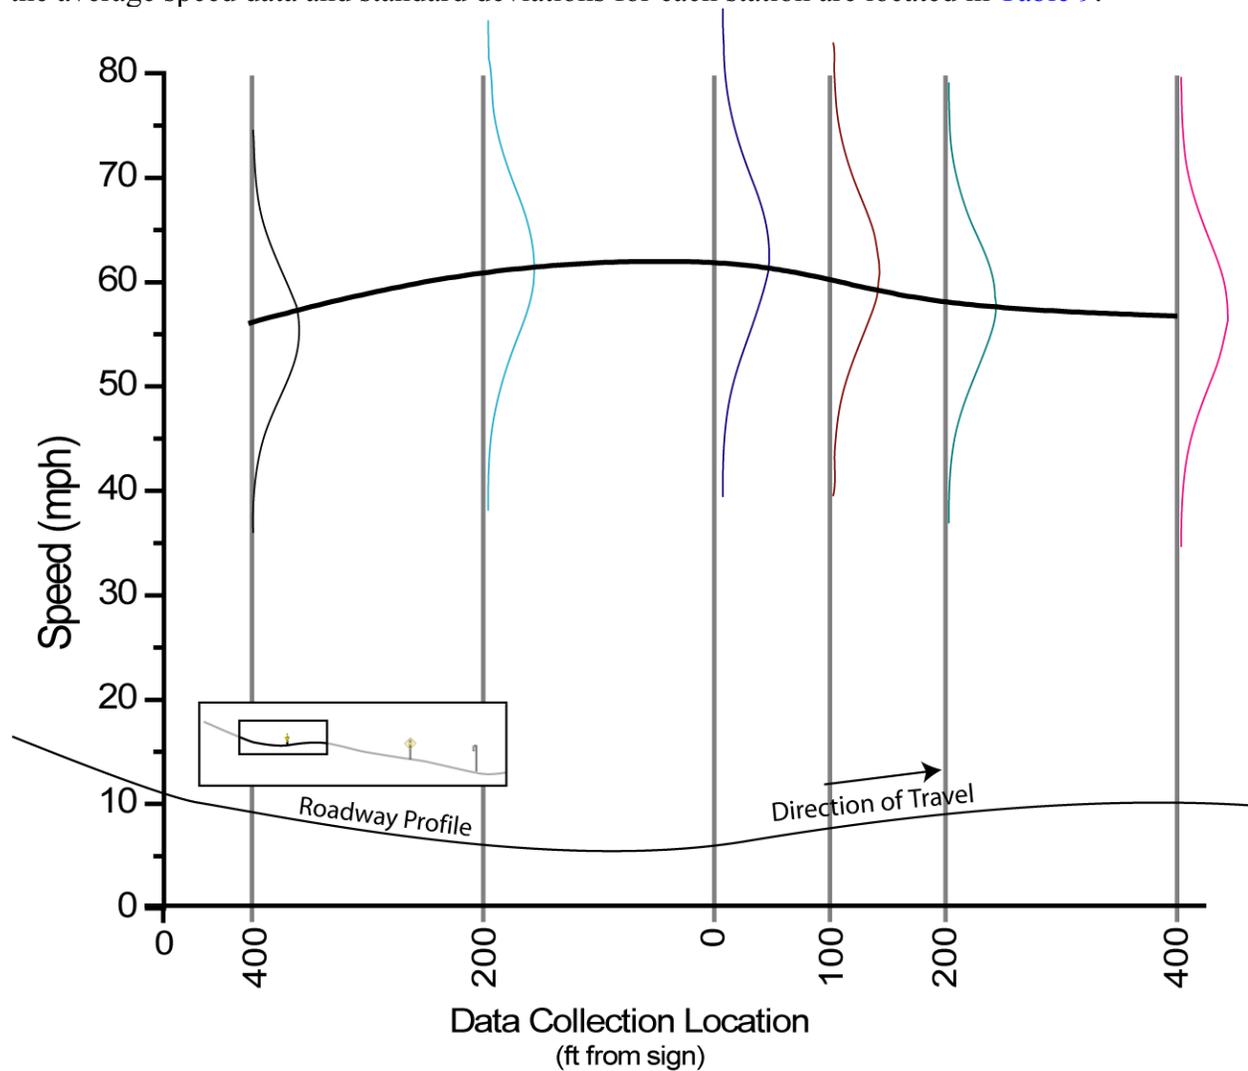
Figure 26. “Before” Speed Data for NB US 281 at Bulverde Road.

Similar to the other two sites, the average speed profile for Site 3 can be found in [Figure 26](#), and the average speed data and standard deviations for each station are located in [Table 9](#).

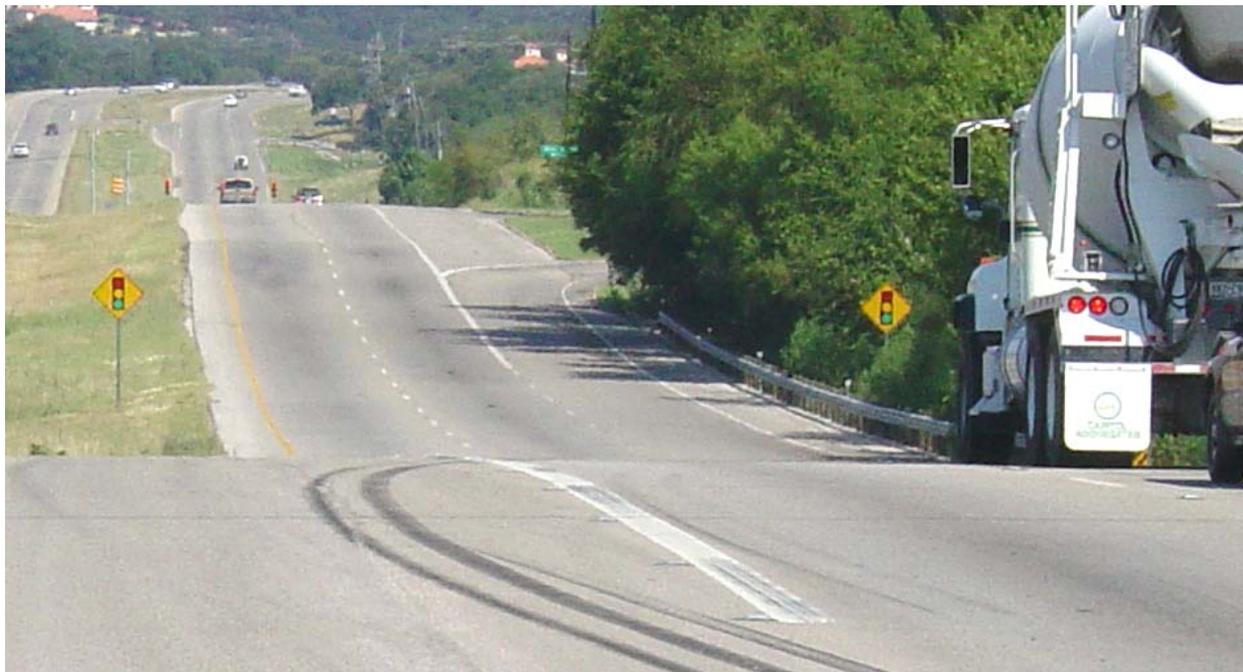
Figure 27. Study Signing (Dual Symbolic SIGNAL AHEAD Signs) Installed at Site 1.

Figure 27 contains a photograph of the northbound Loop 360 at Walsh-Tarleton study site with the advance warning signs installed. In this case, the signs are installed approximately 1400 feet upstream of the signalized intersection. It is clear from the figure that vehicles stopped at the signal are located in a reduced decision zone; these vehicles cannot be seen by the approaching motorist even though the signal heads can be seen from the location where the photograph was taken. Data from each of the data collection stations for this site can be found in Figure 28, and average speeds and standard deviations for each station can be found in Table 10.
