IMPROVING SAFETY AT SIGNALIZED INTERSECTIONS NEAR VERTICAL CURVES

Report 0-4084-1

Project Title: Countermeasures to Reduce Crashes
at Signalized Intersections near Vertical Curves

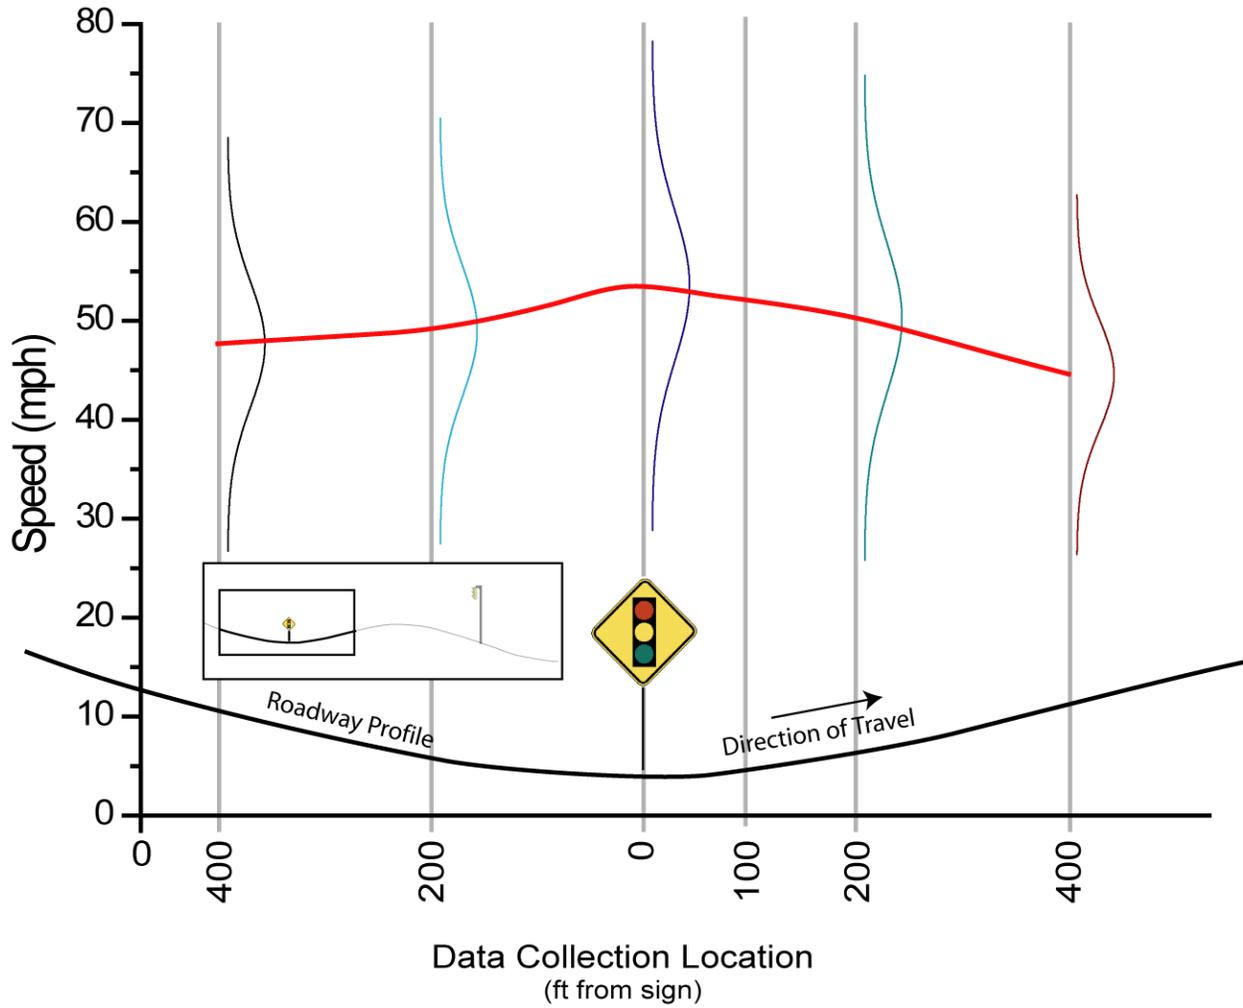
Figure 28. “After” Speed Data for NB Loop 360 at Walsh-Tarleton.

Figure 27 contains a photograph of the northbound Loop 360 at Walsh-Tarleton study site with the advance warning signs installed. In this case, the signs are installed approximately 1400 feet upstream of the signalized intersection. It is clear from the figure that vehicles stopped at the signal are located in a reduced decision zone; these vehicles cannot be seen by the approaching motorist even though the signal heads can be seen from the location where the photograph was taken. Data from each of the data collection stations for this site can be found in Figure 28, and average speeds and standard deviations for each station can be found in Table 10.

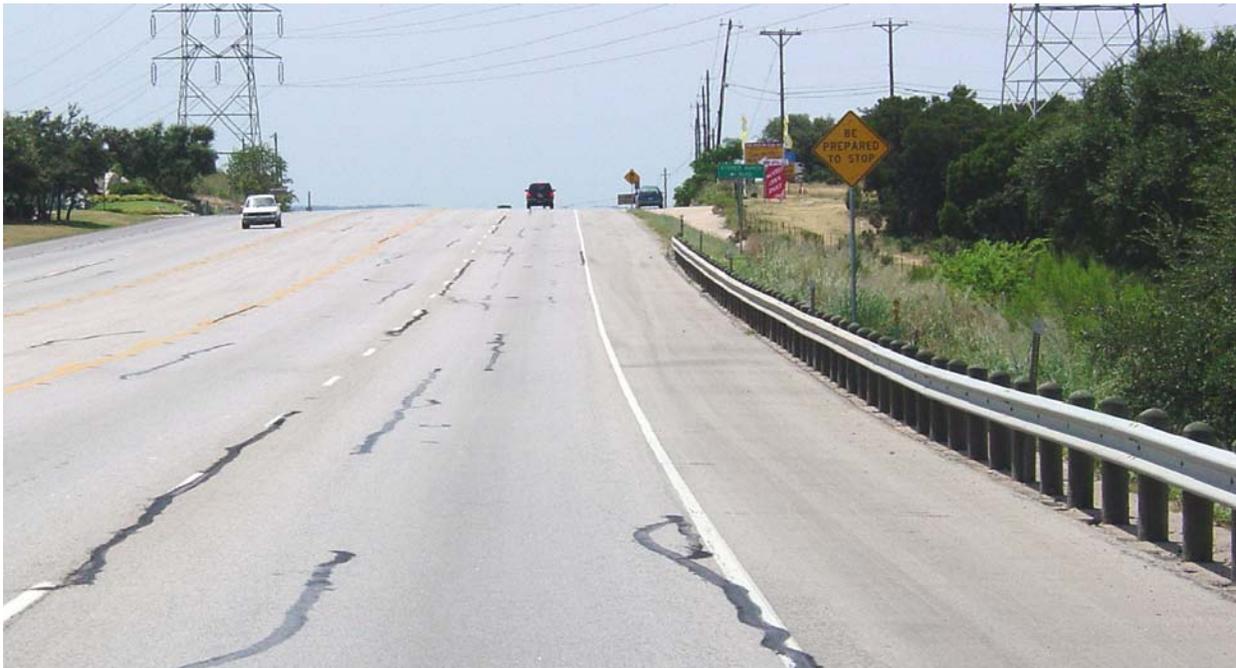
Figure 29. Study Signing (BE PREPARED TO STOP) Installed at Site 2.

Figure 29 depicts conditions along westbound RM 620 approaching the signalized intersection at Comanche Trail. The BE PREPARED TO STOP advance warning sign has been installed on an existing pole that only served as the mounting for a SIGNAL AHEAD sign. This location is approximately 1550 feet upstream of the signal and is between the points defining the urban and rural beginning of the RDZ – the location where a motorist is along this approach when they cannot see a 2-foot high object on the other side of the vertical curve. The SIGNAL AHEAD sign was relocated to a point 550 feet upstream of the signal. Figure 30 displays the speed profile for this site, and Table 11 contains the average speeds and standard deviations of those speeds at the data collection stations bracketing the installed BE PREPARED TO STOP sign.

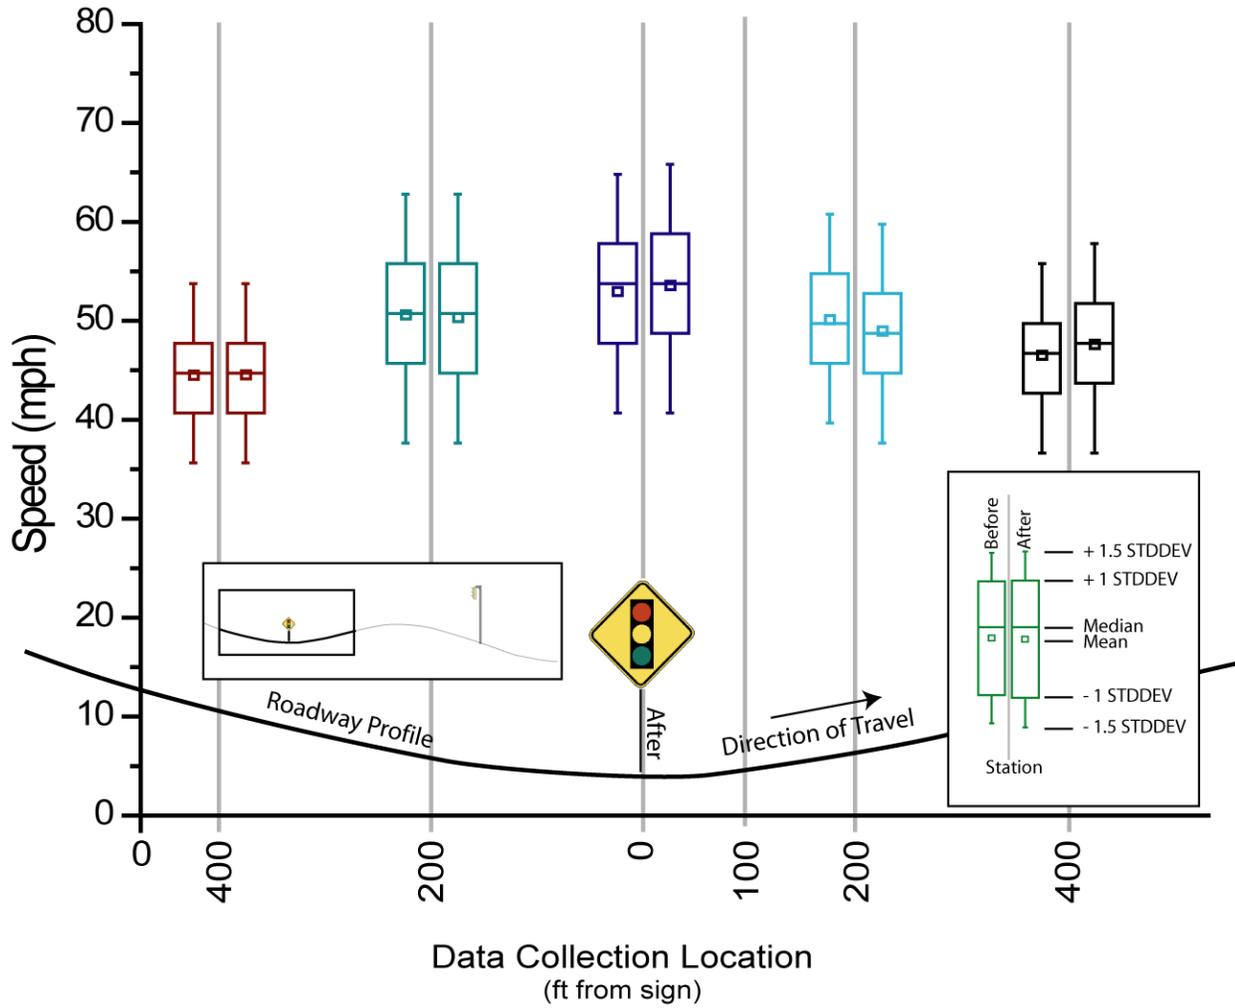
Figure 31. Before-and-After Speed Comparison at Site 1.

Before and after results from northbound Loop 360 at Walsh-Tarlton (Site 1) are shown along the roadway profile in [Figure 31](#) and details of the statistical test at each station is shown for both the overall data set and the subset of vehicles with headways greater than 5 seconds in [Table 12](#). Similar data from Site 2 for westbound RM 620 approaching Comanche Trail are shown in [Figure 32](#) and [Table 13](#), respectively.

Figure 31 and Figure 32 can be used to get a general understanding of driver behavior and response to the installed signing. In Figure 31, motorists approaching the vertical curve and signal are traveling from the right side (of the page) to the left, and motorist speeds for the before-and-after conditions appear very similar approaching the tested sign installation. After the sign, speeds decrease up to a point 400 feet after the sign, where the after speed appears higher than the before speed. In Figure 32, motorists are traveling from the left to the right, and after speeds appear slightly lower before the sign, slightly higher immediately after the sign, and lower again 400 feet downstream of the new sign.
