1. Report No. FHWA/TX-06/0-4358-4	2. Government Accession No.	3. Recipient's Catalog No.	
4. Title and Subtitle HEAVY-DUTY FLEXIBLE BASES: FIELD PERFORMANCE AND DRAFT SPECIFICATIONS		5. Report Date June 2006 Published: December 2007

**HEAVY-DUTY FLEXIBLE BASES:
FIELD PERFORMANCE AND DRAFT SPECIFICATIONS**

Report 0-4358-4
Project 0-4358

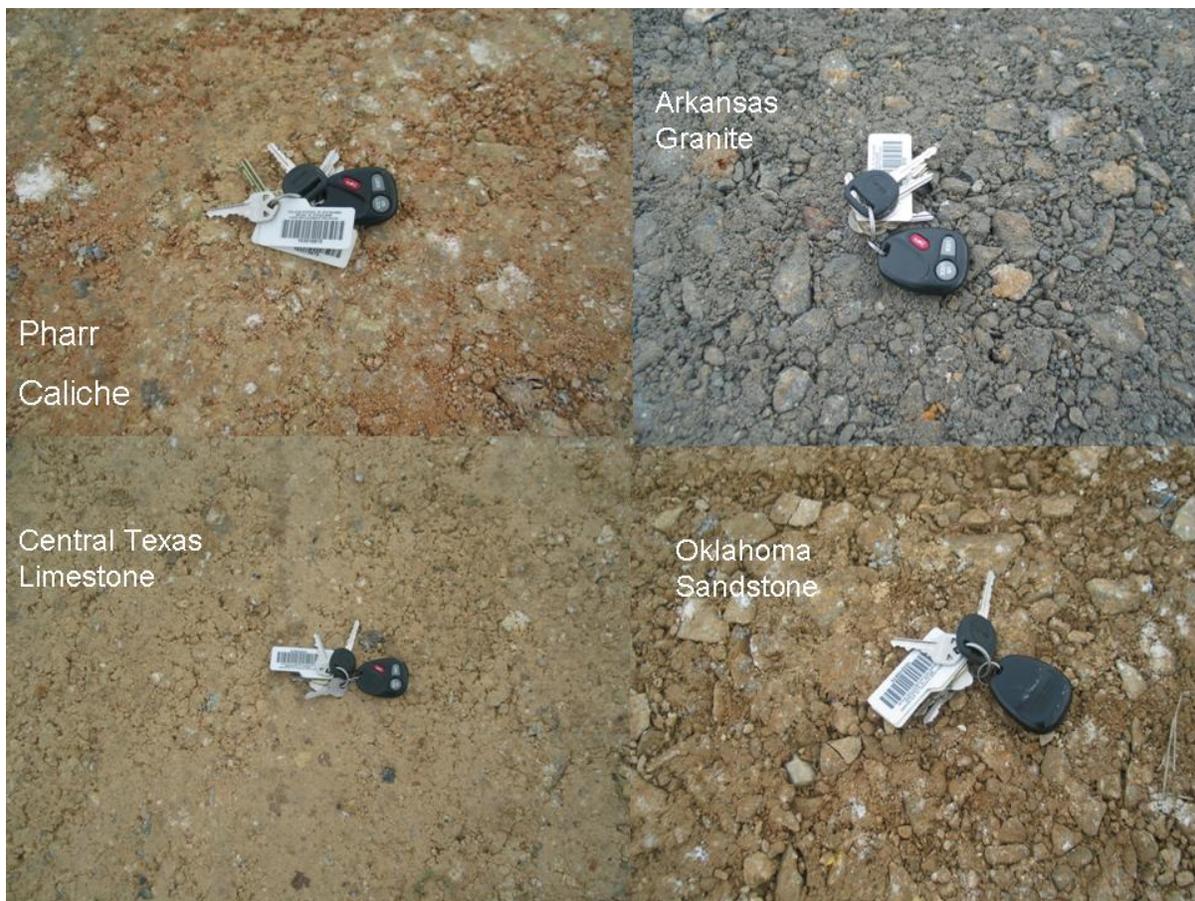
Figure 1. Visual Appearance of Existing Item 247 (left) and Item 245 Bases.

During the course of this project several bases matching the Item 245 requirements were placed in Texas with minimal construction problems. The difference in surface finish is shown in Figure 1.

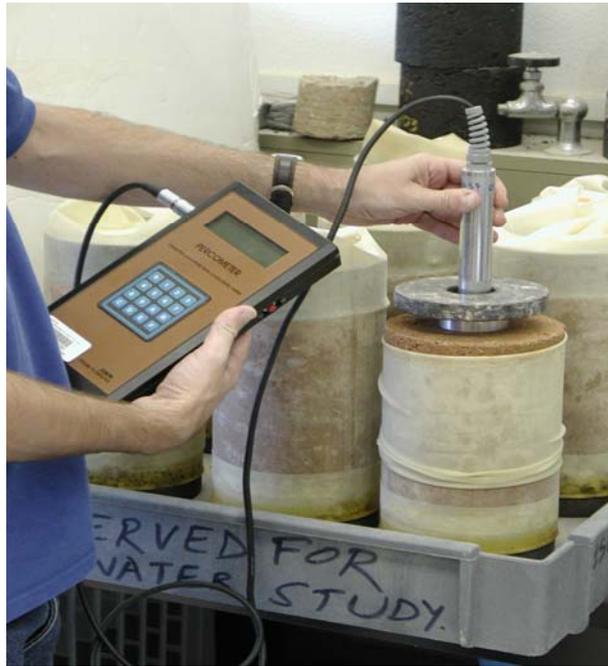
Figure 14. Percometer Used for the TST.

The equipment used for the TST consists of a percometer equipped with a capacitance-based dielectric surface probe with a head diameter of 50 mm and a measuring frequency of 50 MHz (Figure 14). The dielectric values are measured at the surface of the sample at specific time intervals for 10 days.

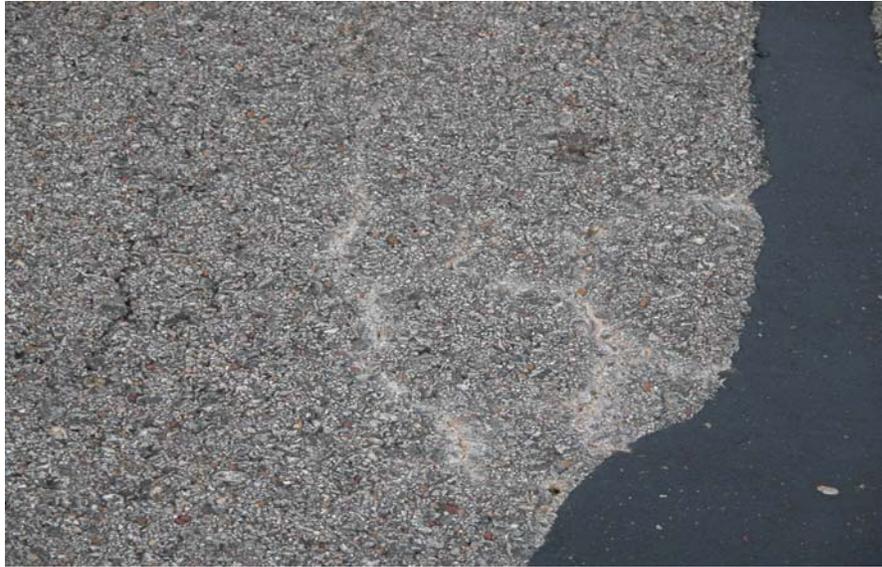
Figure 21. Initial Distress Shown on SH 6.

The failure of the newly constructed lanes on SH 6 was attributed to the quality of the Type C hot mix surface layer, a non-functioning underseal, and a moisture-susceptible base.

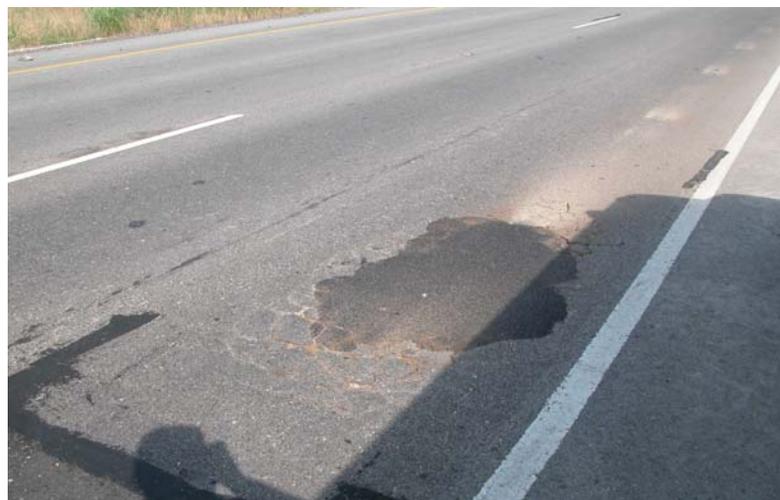
Figure 22. Rapid Deterioration to Structural Failure.

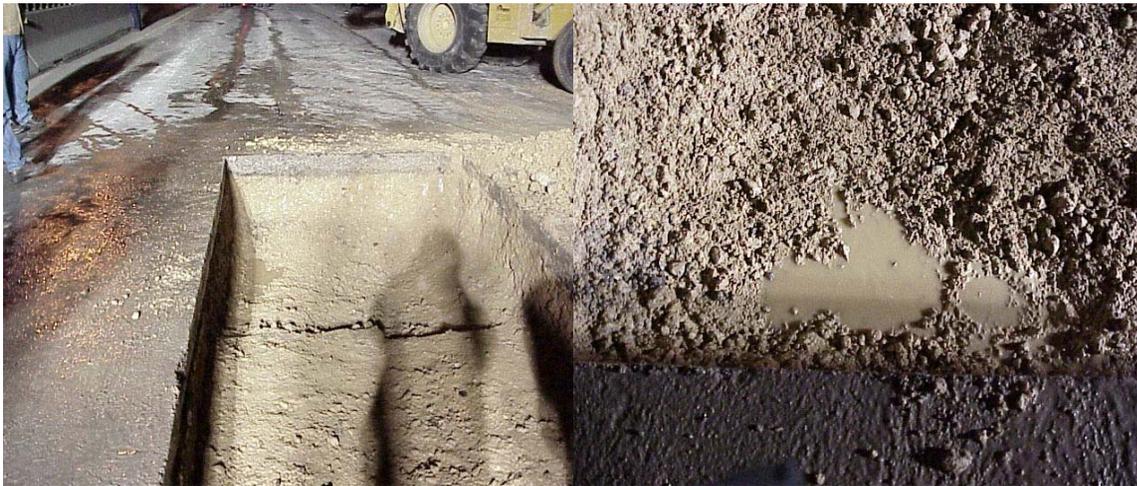
Figure 26. Trench in Failed Area of IH 35 (Chen, 2004).

The implication from the radar was that the base on this section was excessively wet. This was further investigated by digging a test trench. A diamond saw was used to cut the asphalt in the test area, the surface was dried as well as possible, and a backhoe was used to remove the surface and base layers. The test pit is shown in [Figure 26](#).

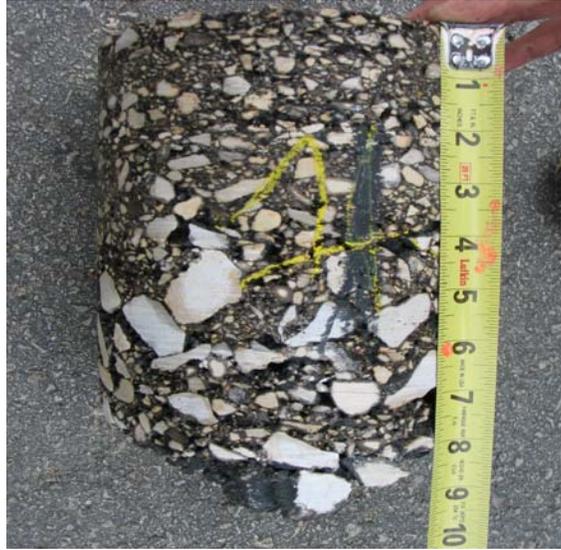
Figure 27. Poorly Compacted Core from the IH 35 Detour Failure.

Two possibilities were investigated as the cause of the moisture entering the base. The first was via the surface through poorly compacted asphalt layers, and the second was via capillary rise from the support select fill material. The asphalt layer in this detour section was found to be poorly compacted. This was evident in the GPR data and in cores taken from the site. A typical core is shown in [Figure 27](#).

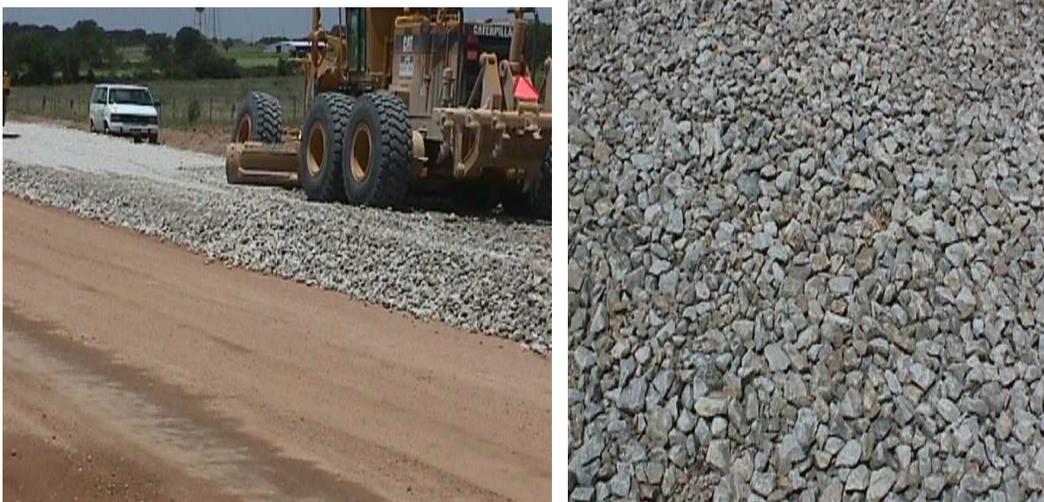
Figure 31. Construction of the Large Stone Base on FM-1810.

The section was placed using ordinary compaction, which required proof rolling with a loaded water truck. These test sections were experimental, and after the segregation experience the district recommended that more fines should be added to keep the large rocks at the surface from “shelling out” under traffic. The gradation for the large rock is essentially a zero fines.

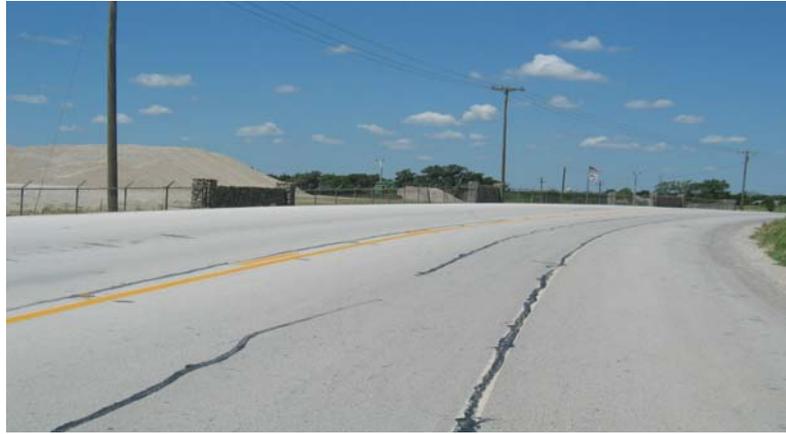
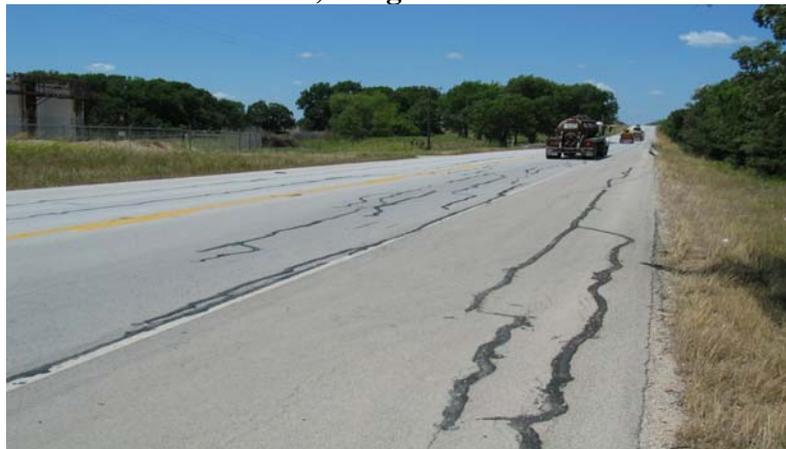
a) Large Stone Base

b) Regular Type A Base

A visual condition survey was made in July 2005. As shown in [Figure 32](#), at that time the large stone base section was showing some longitudinal cracking along construction joints; substantially more cracking was found in the section with regular high fines base. However, there was no indication that this cracking was caused by either base. Coring over cracks in the large stone base section found that this cracking did not propagate through the entire HMA layer; it appeared to be confined to the top surface layer.

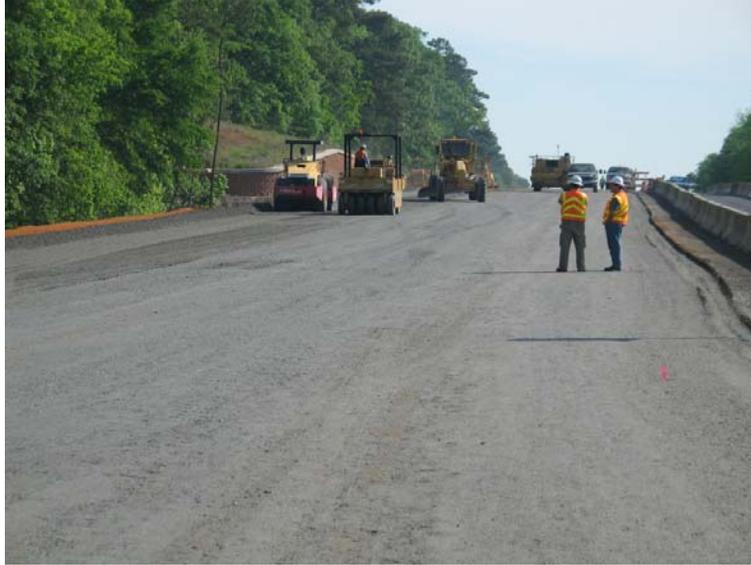
Figure 35. Arkansas Granite Base Being Placed on SH 31.

In April 2005 the Tyler District constructed a short section of SH 31 using the Arkansas Granite flexible base. The section under construction is shown in Figure 35.

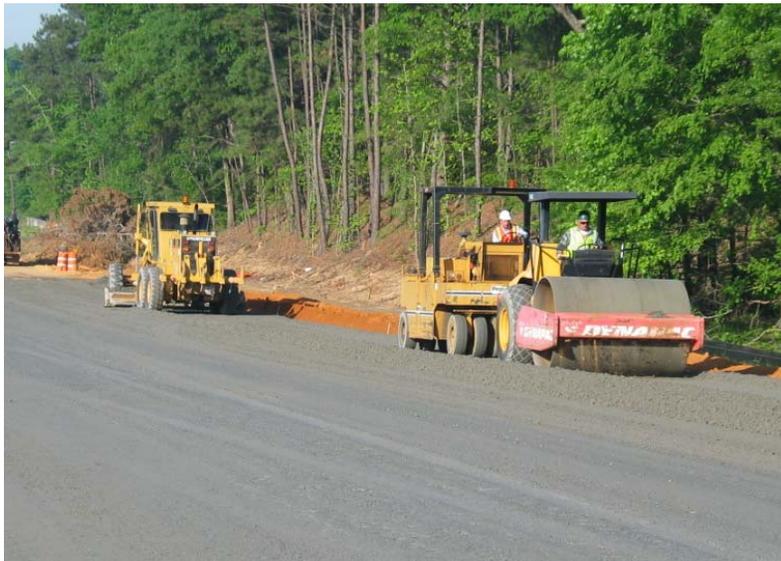
Figure 36. Compaction Sequence on SH 31.

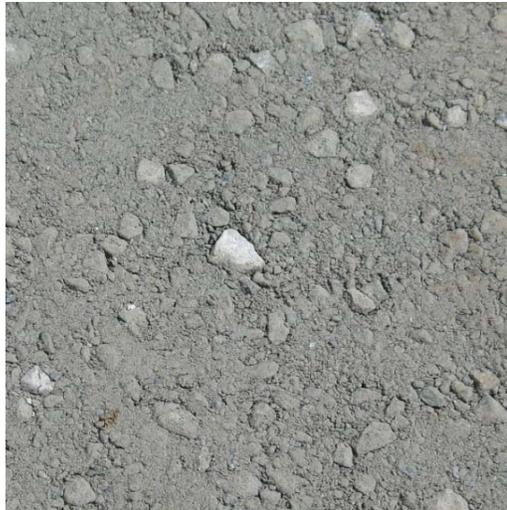
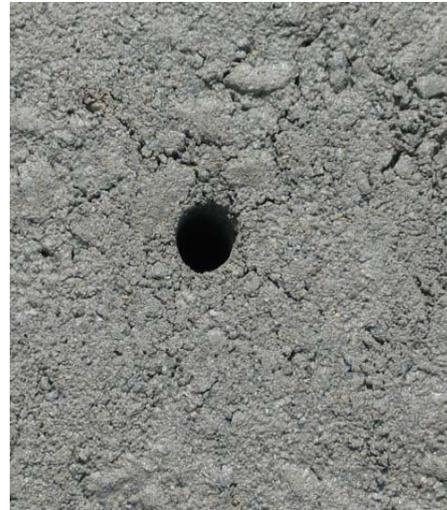
a) finished base

b) cracks induced before density test

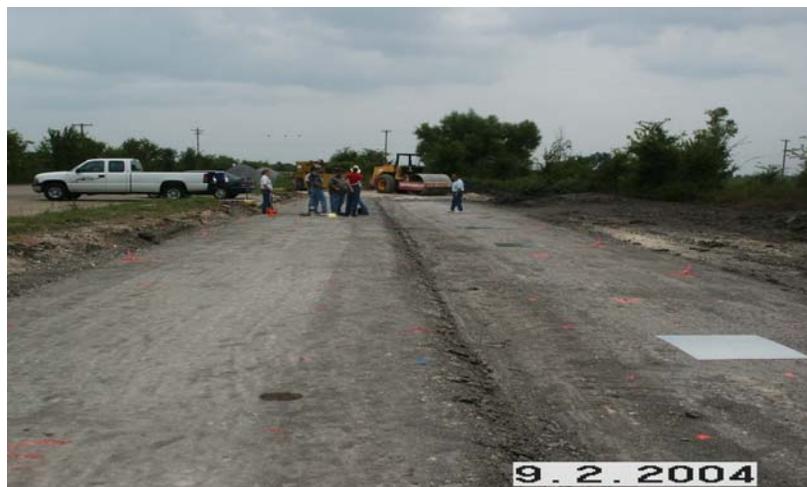
Figure 43. Subgrade Just Prior to Base Placement.

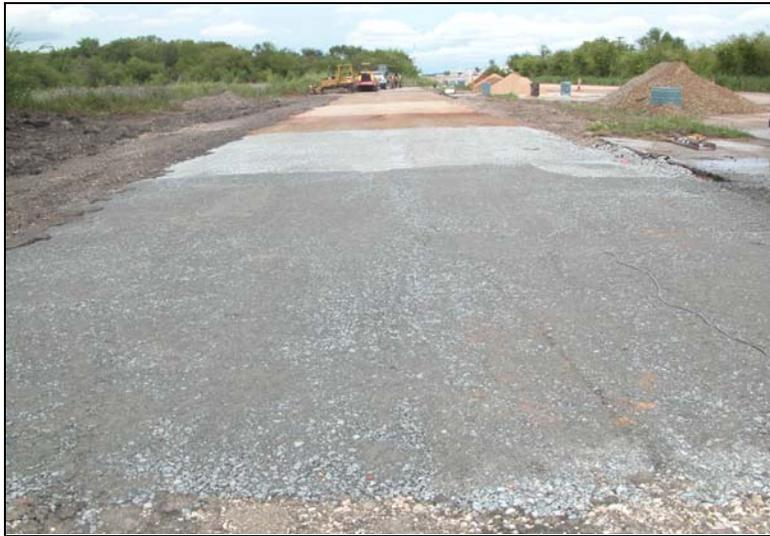
Figure 44. Completed Base Section at TTI's Riverside Campus.

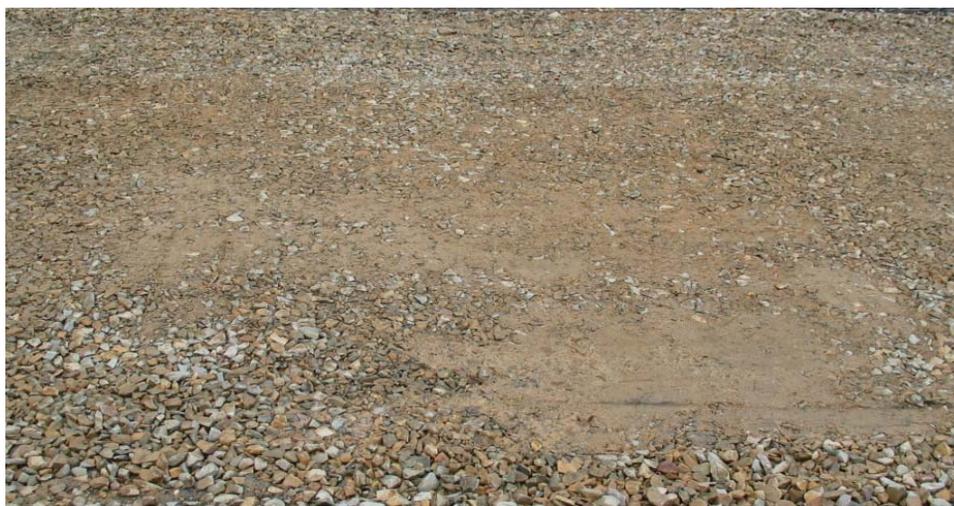
Figure 45. Segregation in the Sandstone Section.

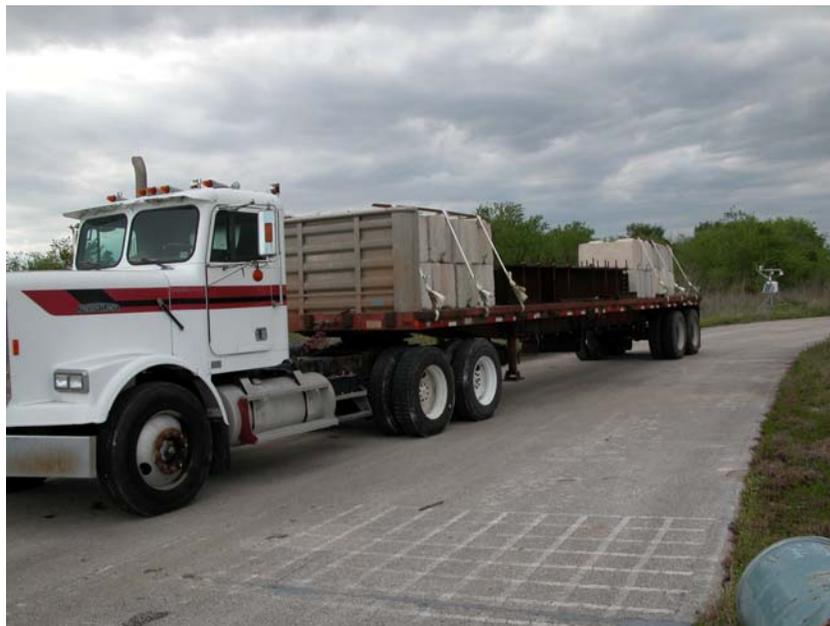
Figure 48. Flatbed Truck for Rut Determinations.

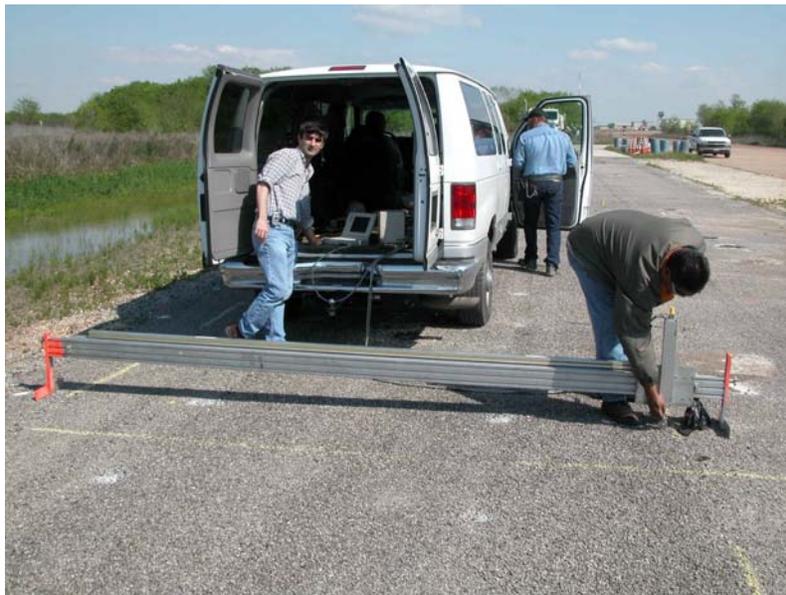
Figure 49. Rut Determination on Test Sections.

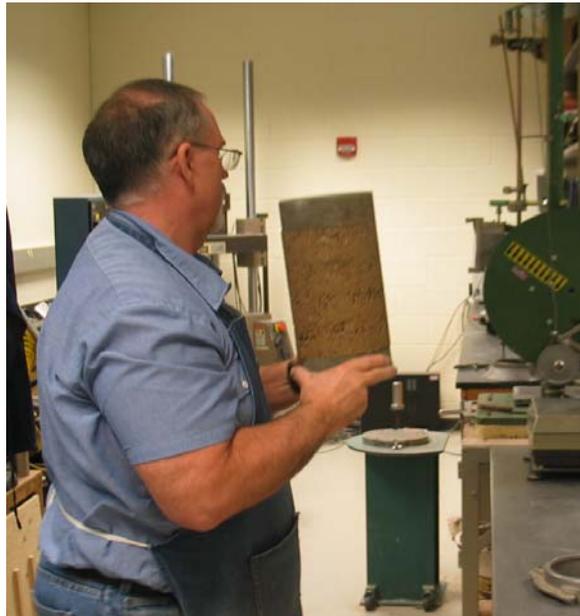
Figure 51. Handling Compacted (Item 247) Bases.

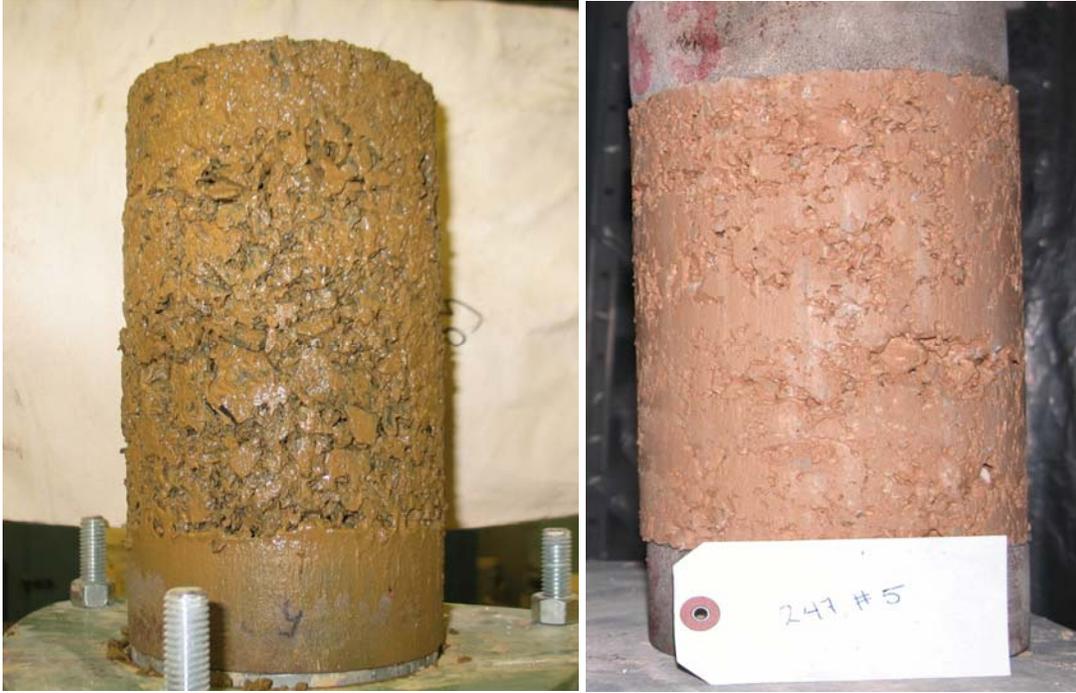
Figure 52. Comparing Item 245 and 247 Bases.

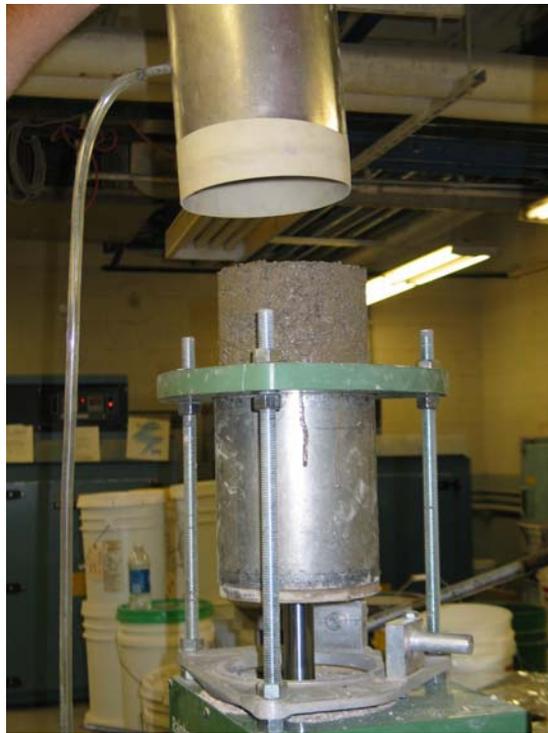
Figure 53. Extruding Item 245 Bases Directly into Membranes.

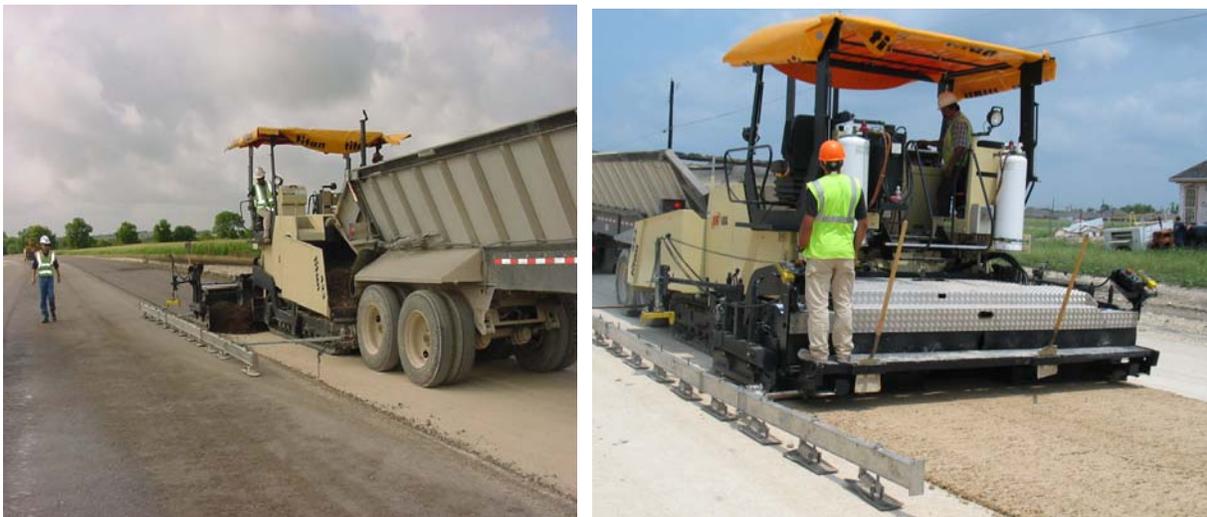
Figure 57. Base Paver Operations in the Waco District.

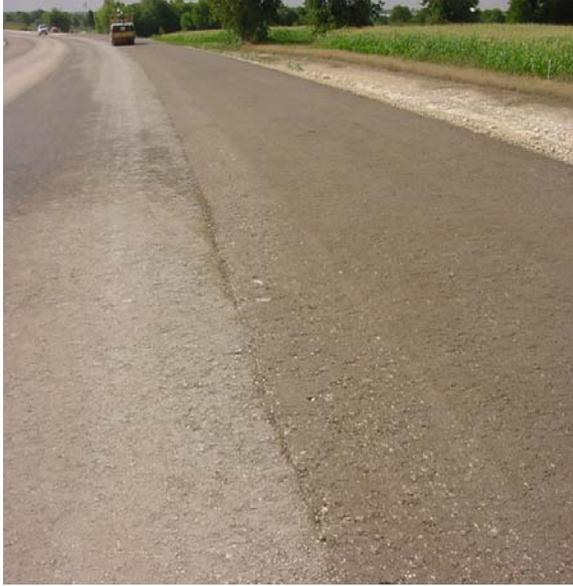
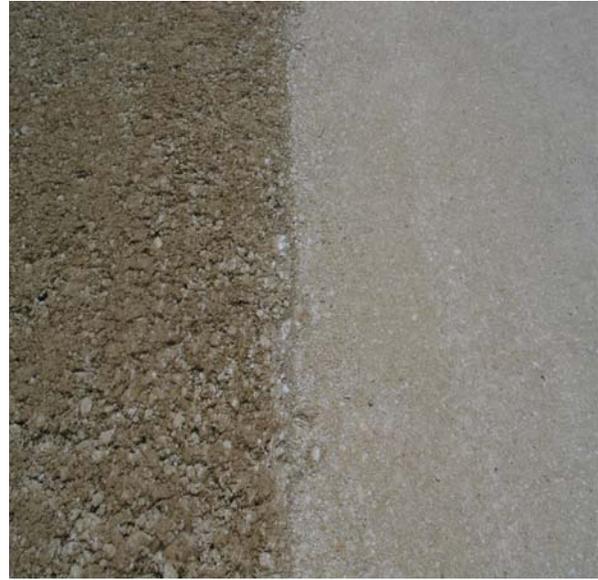
a) Overall View

b) Joint in placed base

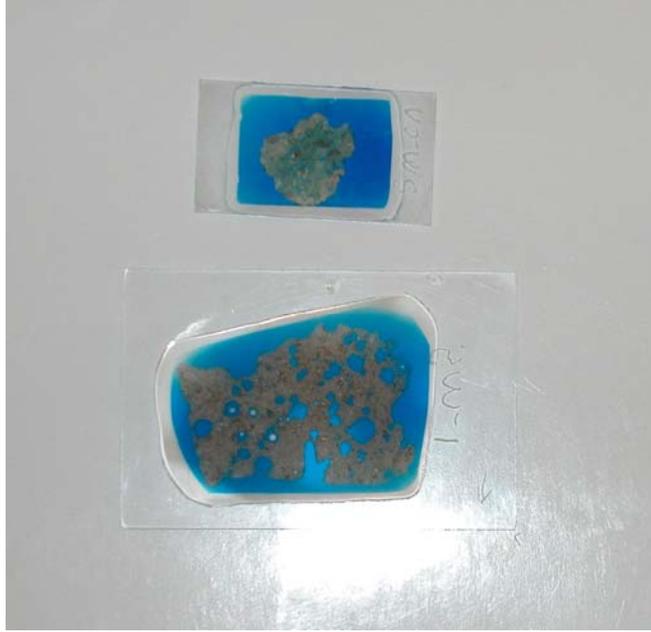
Figure A1. Typical 1 X 2 Inch and 2 X 3 Inch Thin Sections.

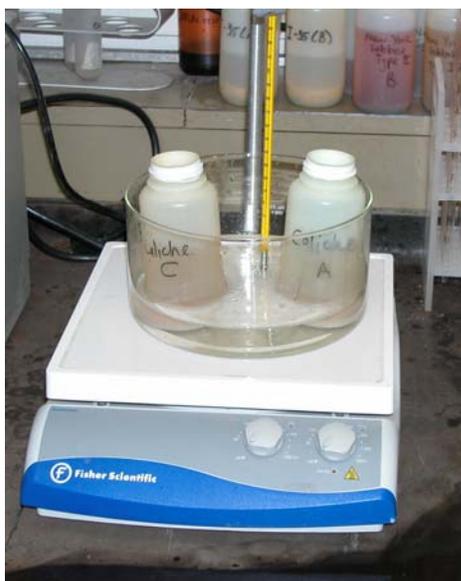
Figure A3. Caliche Sample in Water Bath for Carbonate Removal.

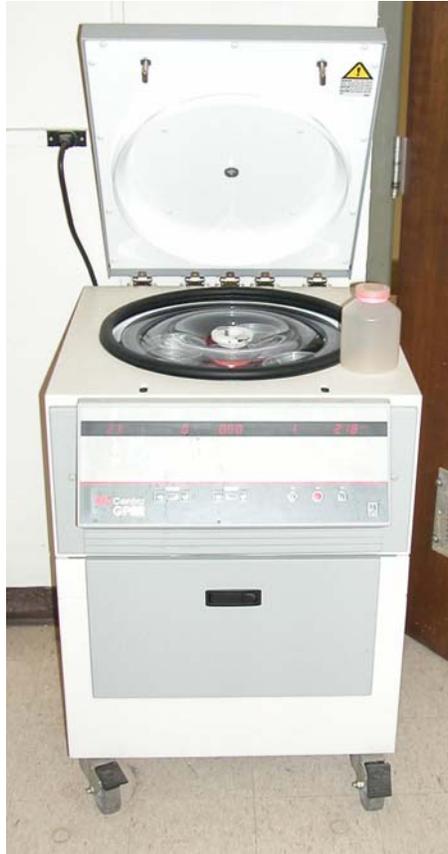
Figure A7. IEC Centra GP8R Centrifuge Used to Separate Silt and Clay Fractions.

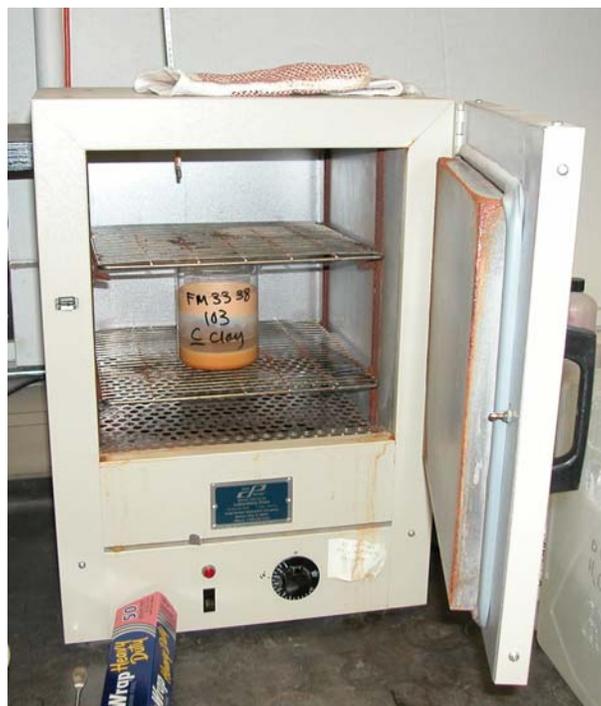
Figure A8. Oven Set at 60 °C for Drying Sand, Silt, and Coarse Clay Fractions.

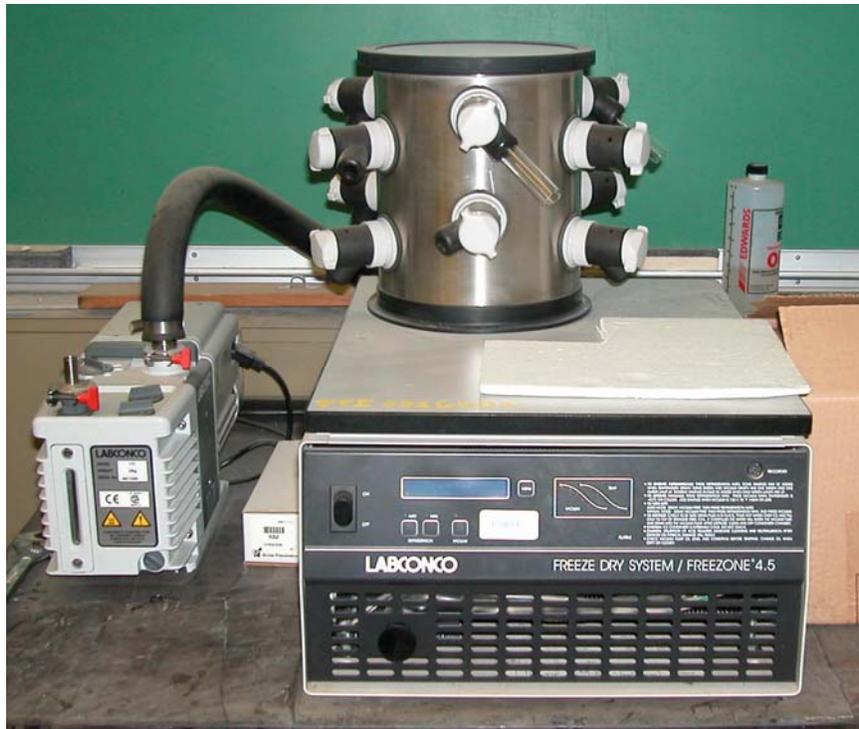
Figure A11. Freeze Dryer Used to Remove Water from the Fine Clay Fraction of Samples.

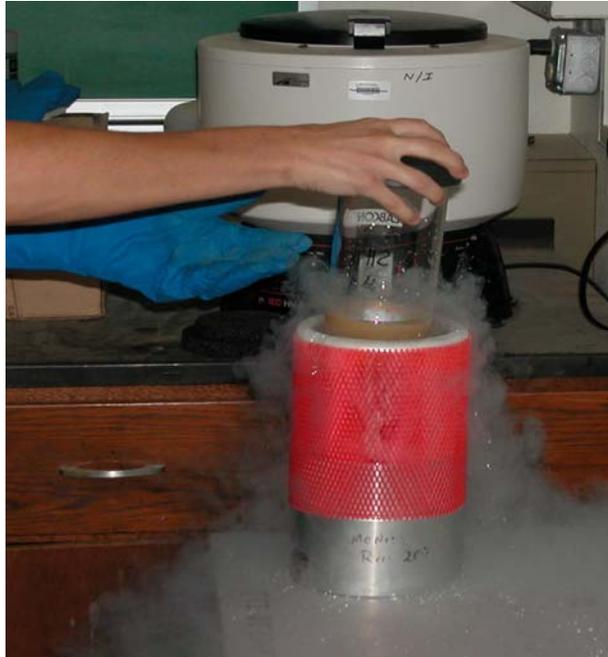
Figure A13. Freezing Clay-Water Suspension Using Liquid Nitrogen.

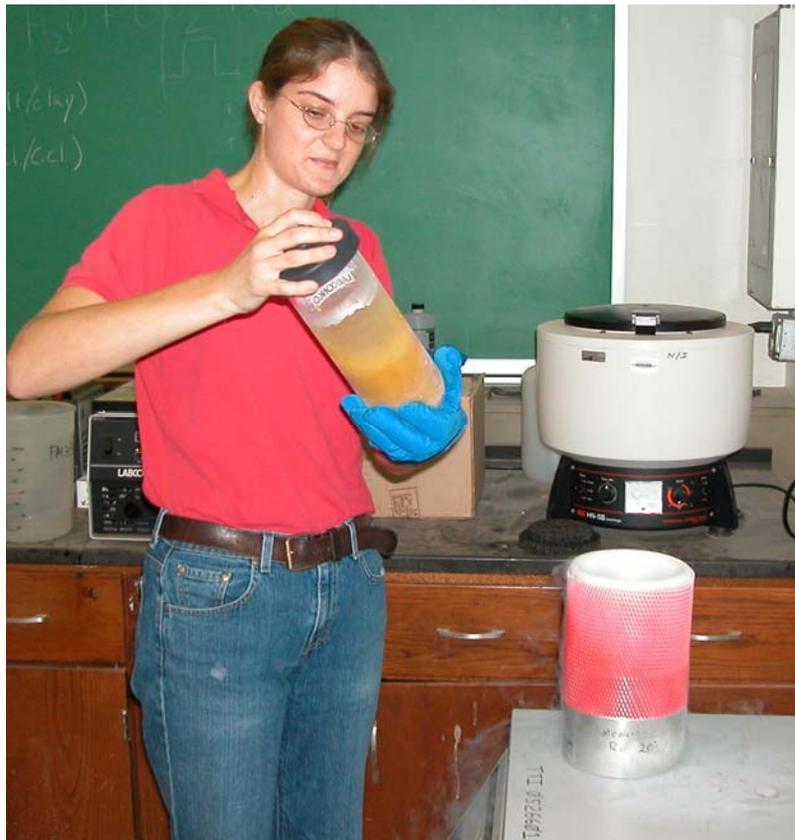
Figure A14. Rotation of Freezing Suspension to Achieve Inverted Cone Shape.

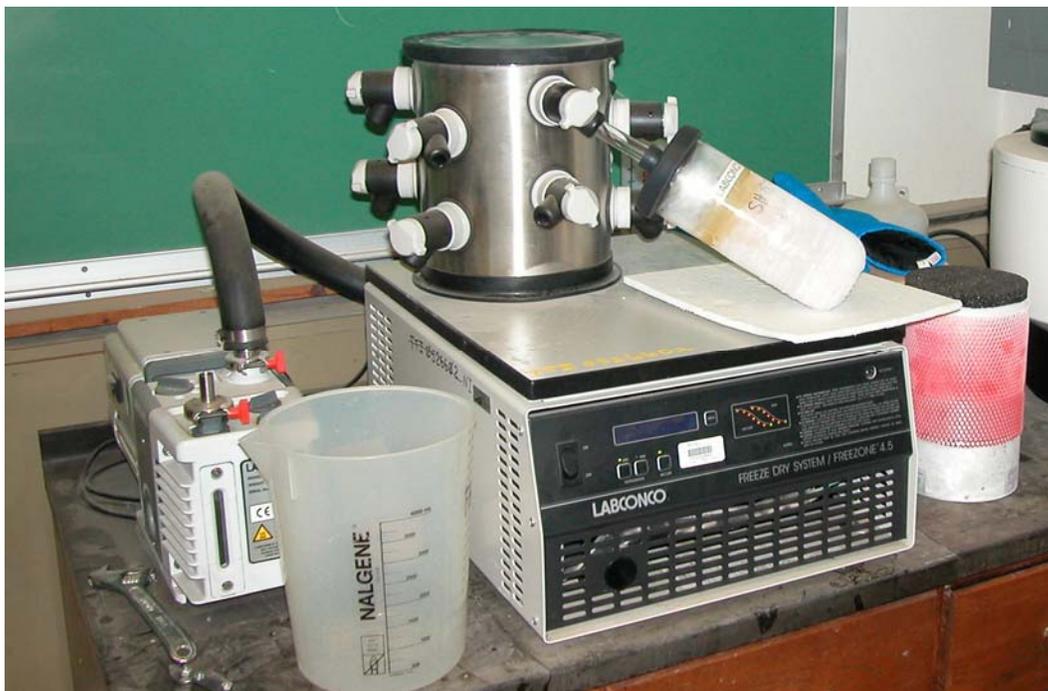
Figure A15. White Coating of Ice on the Flask, Indicative of a Successful Freezing Job.

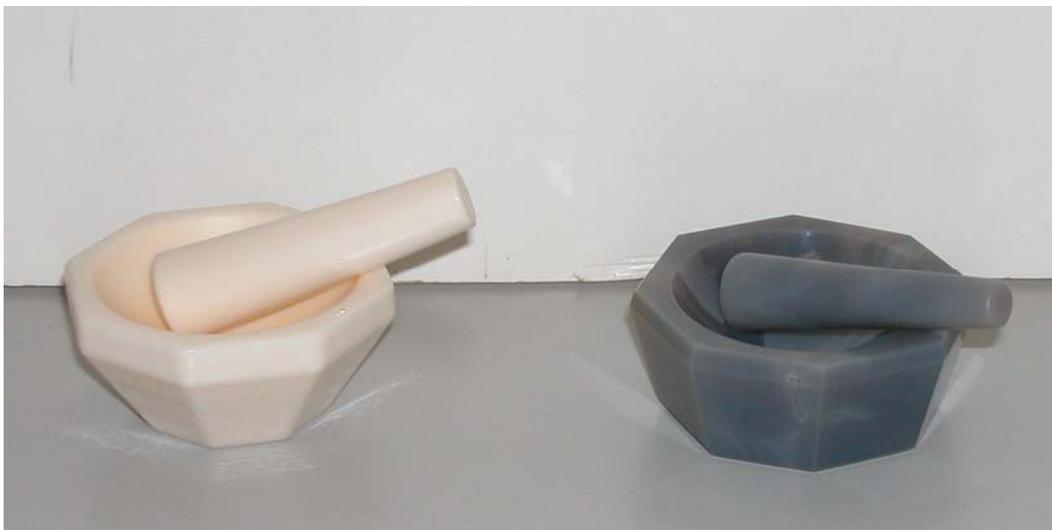
Figure A16. Aluminum Oxide (left) and Agate Mortars and Pestles for Sand Reduction.

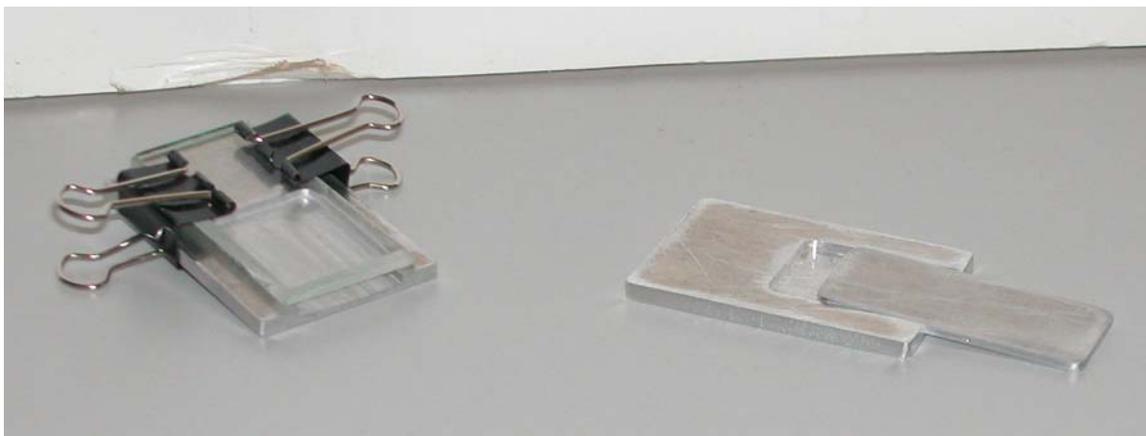
Figure A17. Aluminum Holders Used for Side Loading Sand and Silt into X-Ray Unit.
