Project Summary Report O-4391-S

Project O-4391: Develop Guidelines for Placing an Underseal

Guidelines for the Use of Underseals as a Moisture Barrier: Summary Report

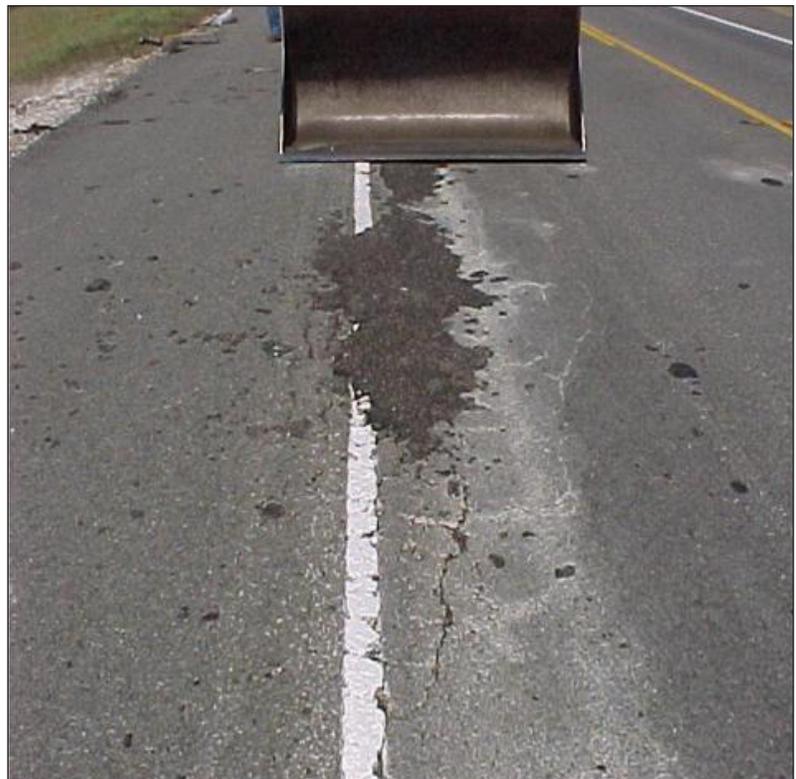
Figure 1. Premature Cracking Associated with Damaged Underseal.

- Base materials should be adequately cured prior to prime and surface treatment. This helps to ensure a good bond of the surface treatment and prevent highway traffic or construction traffic from damaging the surface treatment prior to overlay. Any damaged areas should be repaired. Even small and isolated areas associated with a damaged underseal have led to failure of the underlying base and HMAC overlay.

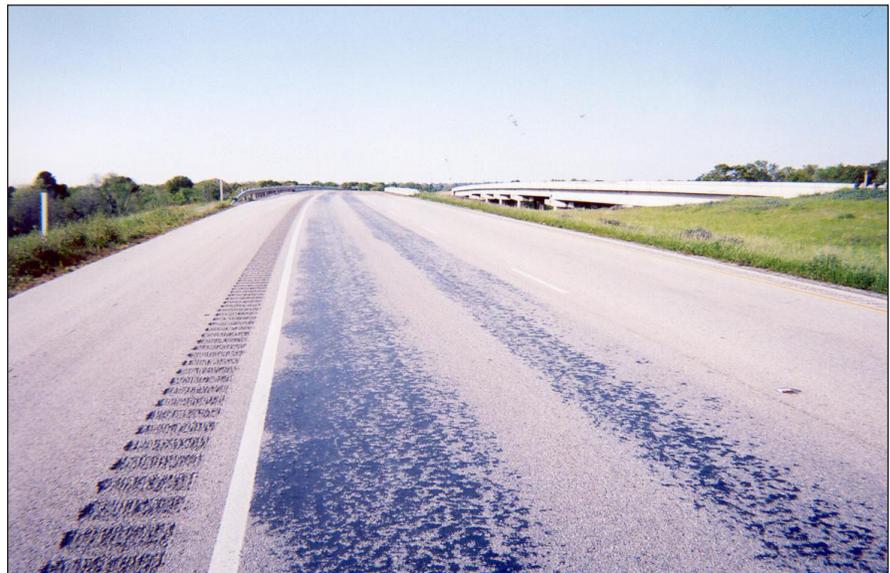
Figure 2. Underseal Bleeding through the Asphalt Concrete Overlay.

- The main problems or failures experienced with underseals include: asphalt binder from the underseal bleeds through to the surface of the overlay; underseals (on aggregate bases) sometimes get damaged by traffic or construction operations prior to overlay, allowing water to leak into the base; and the underseal traps moisture in a moisture-susceptible layer, causing it to fail.
- Excessive binder application rates for underseals can cause the binder to bleed through to the surface of the HMAC overlay. This is true for both very high-viscosity asphalt

binders, such as asphalt rubber, as well as low-viscosity binders. There is some evidence to suggest that low-viscosity binders (even when applied at appropriate application rates) have a propensity for bleeding.
