**TESTS TO IDENTIFY POOR QUALITY COARSE LIMESTONE
AGGREGATES AND ACCEPTABLE LIMITS FOR SUCH AGGREGATES
IN BITUMINOUS MIXES**

Report 0-4523-2

Project 0-4523

February 2005

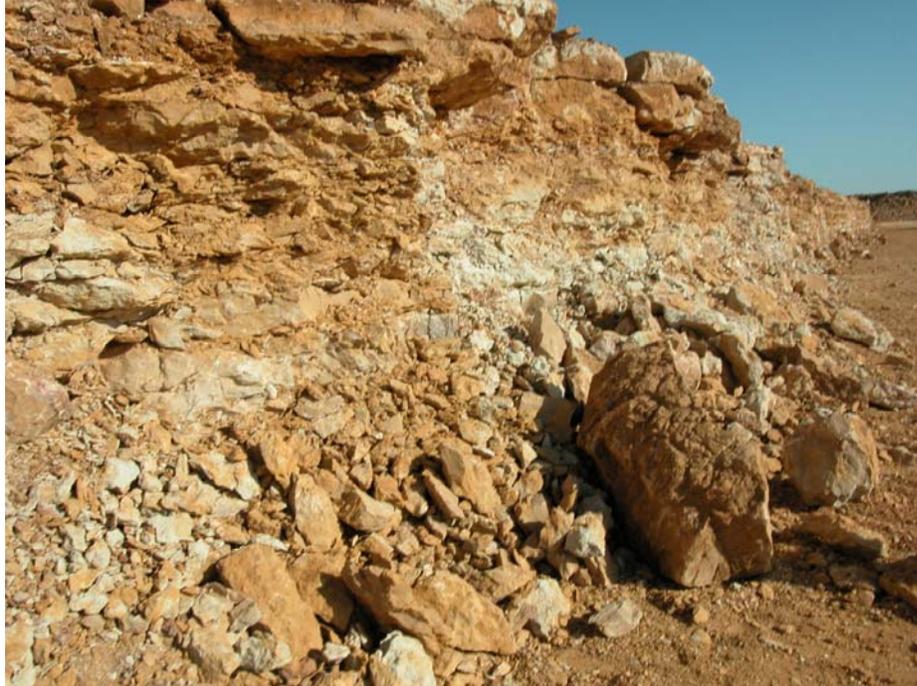
Figure 2. Ten-Foot Working Face at the Baird Quarry Illustrating Resistant Limestone Intercalated with Fissile Shale and Sandstone Lenses.

Following is a detailed description of observations made at the five quarries examined in depth. The first quarry is operated by Vulcan Materials Company and is located in the Abilene District. It is named the Baird Pit. The rock they are quarrying consists of the Jagger Bend Formation deposited in the Permian Period. The rock is composed of thin, well-cemented limestones intercalated with fissile shale and poorly indurated sandstone lenses (Figure 2). The 10-foot high working face will be important when considering economical options for decreasing the amount of poor quality aggregate in this quarry. Much of the material mined in the quarry is composed of lower quality shale and sandstone lenses as depicted in Figure 3. The stratigraphic column shown in Figure 4 represents the aggregates observed on the working face at the time the researchers visited the quarry. Figure 4 illustrates how the top and base of the working face contain good quality limestone aggregate, but the middle 6 feet of the section consists of discontinuous limestone, sandstone, and shale beds. It is the 6 feet in the middle that contains all of the rock that yields poor quality aggregate.

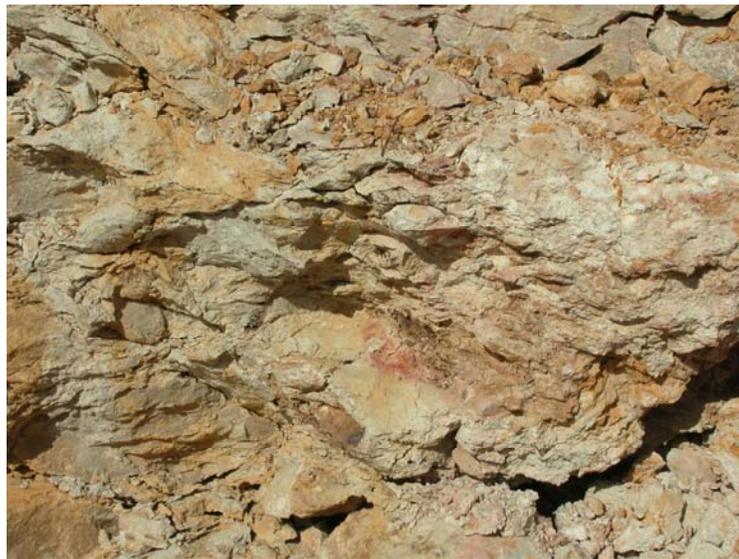
Figure 3. Close-Up of Fissile Shale and Sandstone Lenses.

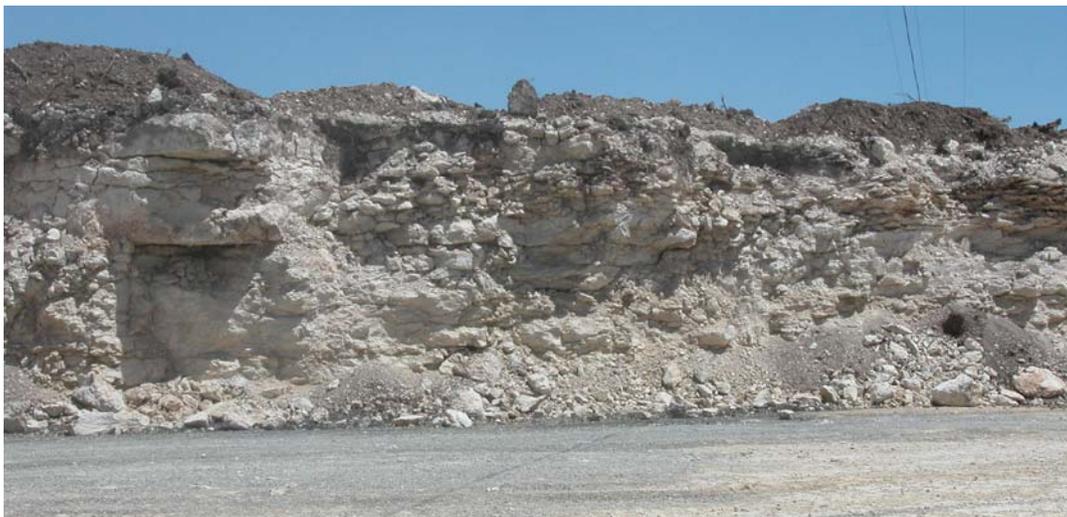
Figure 5. Working Face of the Black Pit Showing Four Different Units That Vary in Quality as an Aggregate.

The second quarry the researchers investigated was the Black Pit. It is in the Abilene District as well, but it consists of limestone deposited in the Cretaceous Period, which is younger than the Baird aggregates by approximately 150 million years. This difference in age is a good indicator of limestone quality. The younger rock typically is more poorly cemented and softer, resulting in less durable aggregate. [Figure 5](#) shows four distinctive units in the working face of the Black Pit. Two of the less durable units are represented in [Figure 6](#). Note the large pores (vugs) in the left-hand image that are the result of water-dissolving fossil fragments. The right-hand image contains thin, tan-colored seams of clay minerals that can cause durability problems. The argillaceous limestone observed in the stratigraphic column in [Figure 7](#) is a poor quality aggregate.

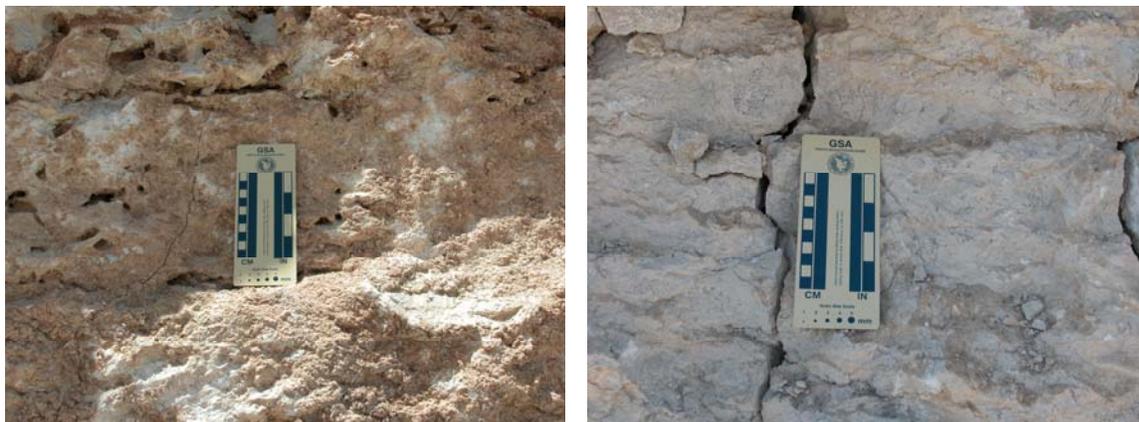
Figure 6. Image on Left Shows Vugs in the Limestone, and Image on the Right Shows Stylolites That Contain Clay Minerals.

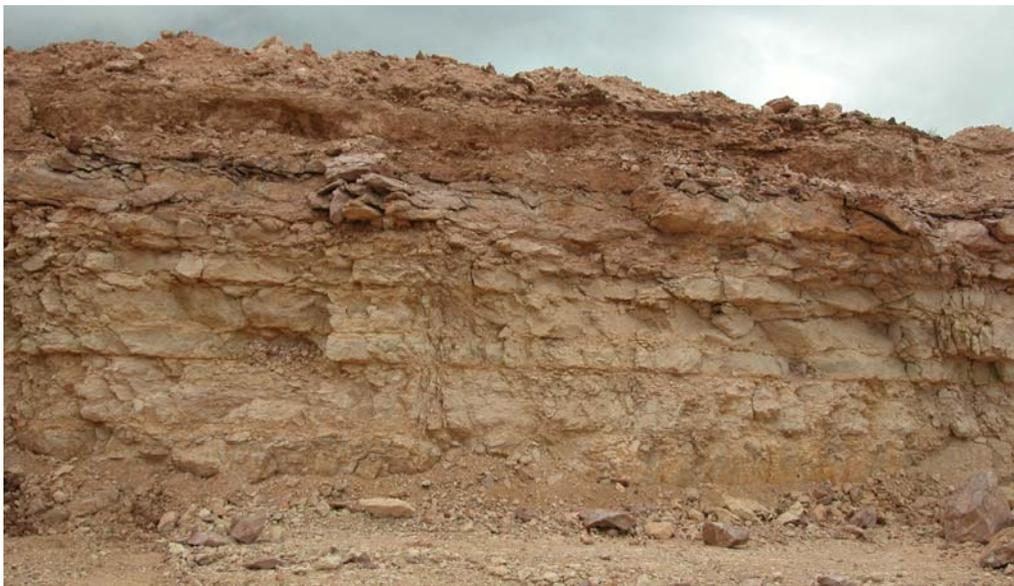
Figure 8. Working Face at the Clements Pit Showing Thin, Laterally Extensive Limestone Beds.

The researchers performed a detailed investigation of the Clements Pit in the San Angelo District (Figure 8). The quarry is in the Fort Terrett Formation, which was deposited in the Cretaceous Period. This quarry is quite extensive with aggregate being produced from several benches. One bench was investigated where the state stockpile was being generated. The working face was about 15 feet high and was composed of several thin, laterally continuous limestone beds intercalated (sandwiched between) with thin sand/silt and shale stringers (Figures 8, 9, and 10). Bioturbation (burrows) was abundant in good quality aggregate (Figure 9), and there was very little poor quality rock in this particular section of the quarry.

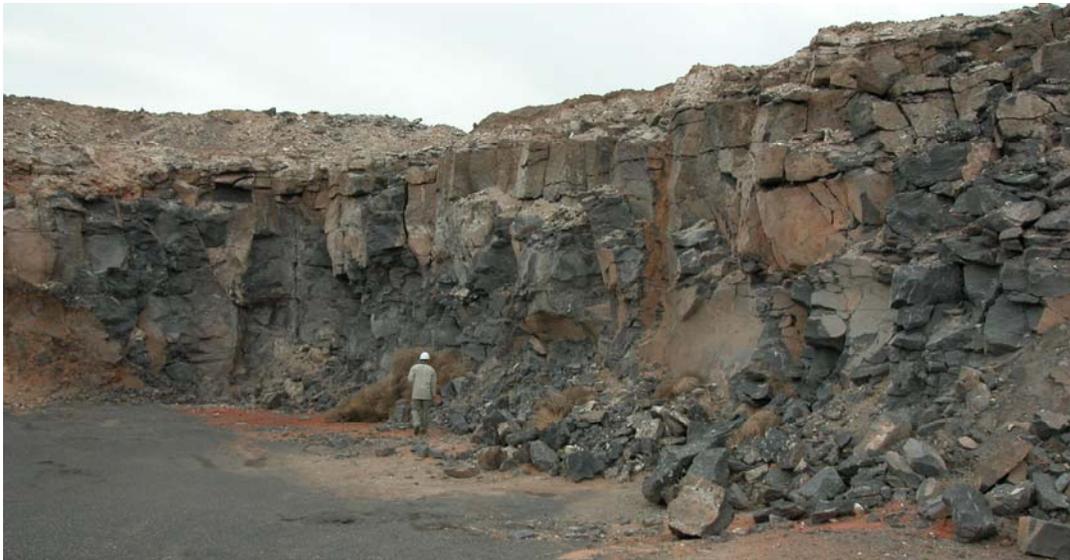
Figure 11. Thirty-Foot High Working Face at the Behne Pit.

The first quarry is called the Behne Pit, and the working face is about 30 feet thick. It is more weathered (red color in [Figure 11](#), and [Figure 12](#)) along fractures and near the top of the quarry where the rock is exposed to the elements (i.e., rain, wind, etc.). The working face appears to be a single lava flow due to the vertical vents where hot gases escaped from the flow ([Figure 12](#)), vesicles (air bubbles) near the top ([Figure 13](#)), and variation in grain size of the phenocrysts (large mineral grains).

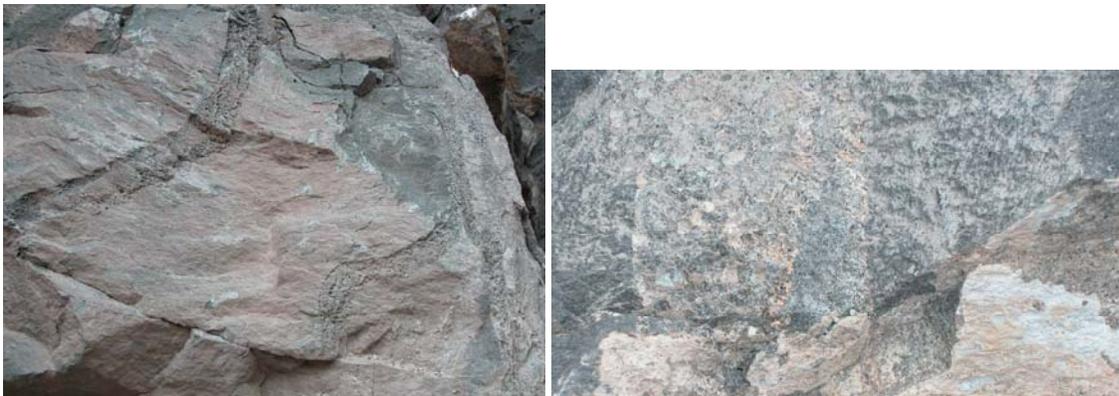
Figure 12. The Left-Hand Image Shows a Vent in the Quarry Wall, and the Right-Hand Image Shows Weathering Products Developed along Fracture Surfaces.

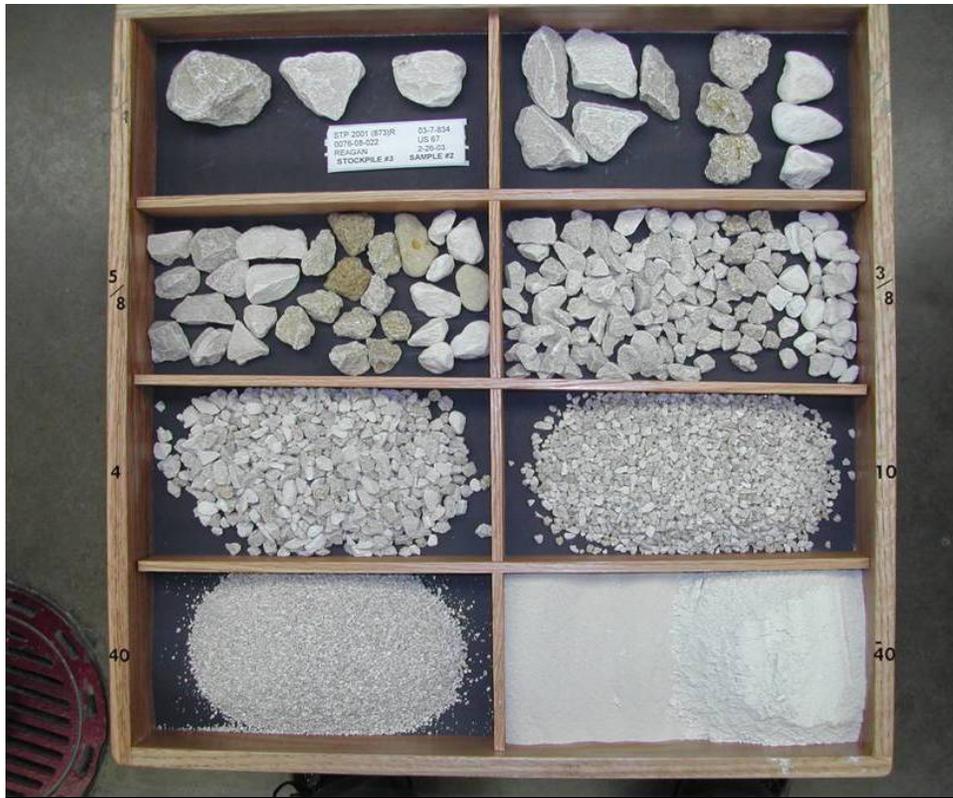
Figure 16. Aggregate Fractionation Used by James Bates and Recommended by the Researchers.

Following the sample reduction by riffing, to get a good indication of the percentages of different rock types at a quarry, the researchers recommend a technique used by James Bates (TxDOT – retired) where 3000 g is weighed out, a washed sieve analysis is performed, and the sample is placed in a box that has been partitioned off by sieve size ([Figure 16](#)). A digital photo is taken of the sample for documentation purposes. Following the digital photo, the aggregate pieces from the 5/8 inch, 3/8 inch, and #4 sieve partitions are further subdivided into like groups based on outward physical appearance (i.e., color, roundness, sphericity, relative density, and absorption). Aggregates with similar physical characteristics are placed on a sample mat, and a digital photo is taken ([Figure 17](#)). The percent of each constituent can be calculated based on the number of pieces in each grouping. There should be at least 150 particles in each of these size ranges to obtain a representative sample ([Mielenz, 1994; Langer and Knepper, 1998](#)).

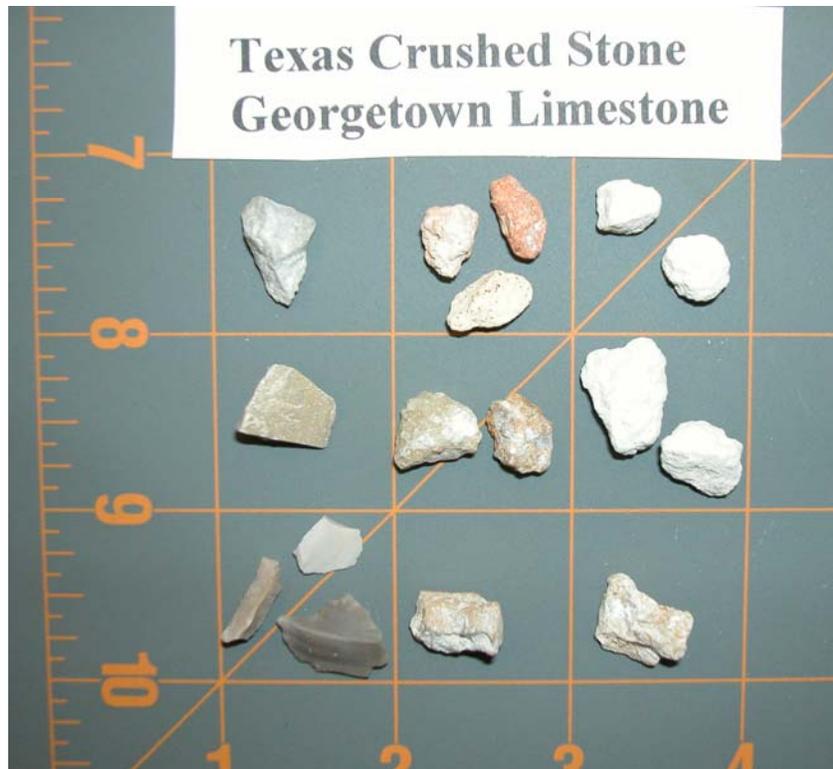
Figure 18. Partitioning of Aggregates Based on Textural Variations.

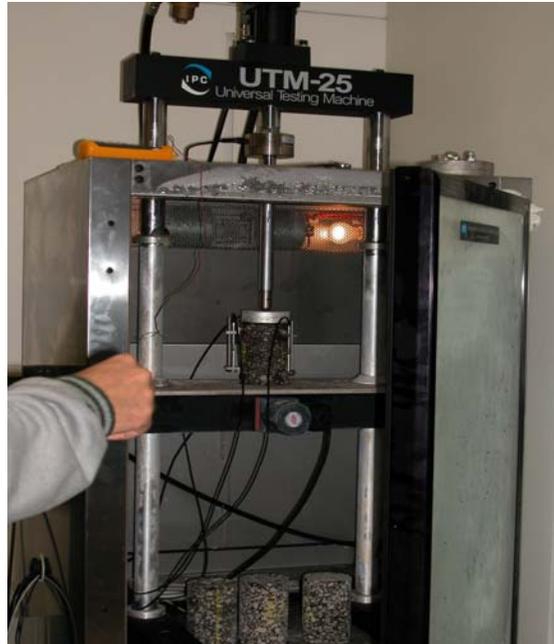
Figure 31. Dynamic Modulus Test Setup.

frequency of loading at each temperature to minimize specimen damage. [Figure 31](#) shows the test equipment.
