1. Report No. FHWA/TX-11/0-6022-2		2. Government Accession No.		3. Recipient's Catalog No.	
4. Title and Subtitle RECOMMENDATIONS FOR DESIGN, CONSTRUCTION, AND MAINTENANCE OF BRIDGE APPROACH SLABS				5. Report Date September 2011 Published: May 2012

# **RECOMMENDATIONS FOR DESIGN, CONSTRUCTION, AND MAINTENANCE OF BRIDGE APPROACH SLABS**

Project 0-6022  
Report 0-6022-2  
Project Title: Recommendations for Design, Construction, and Maintenance of  
Bridge Approach Slabs

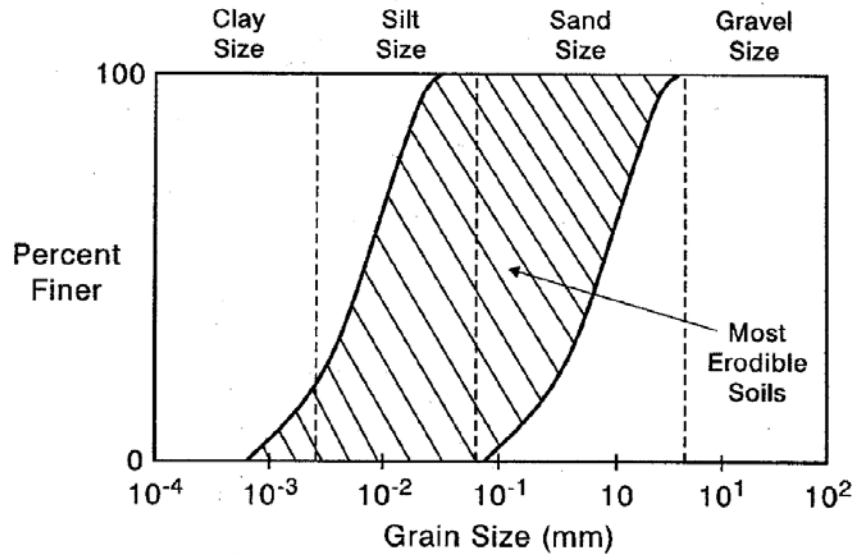
The erodability of soils is based on their grain size distribution. Some soil gradation guidelines can be found for soils that are erosion resistant and those that are prone to erosion (Briaud et al., 1997; Hoppe, 1999). As indicated in Figure 2.3, a gradation band of material in the sand to silt size materials is a bad choice for embankments and backfill unless additional preventive actions, such as providing appropriate drainage design or erosion control systems, are taken (Briaud et al., 1997).

Figure 2.3. Range of Most Erodible Soils (Briaud et al., 1997).

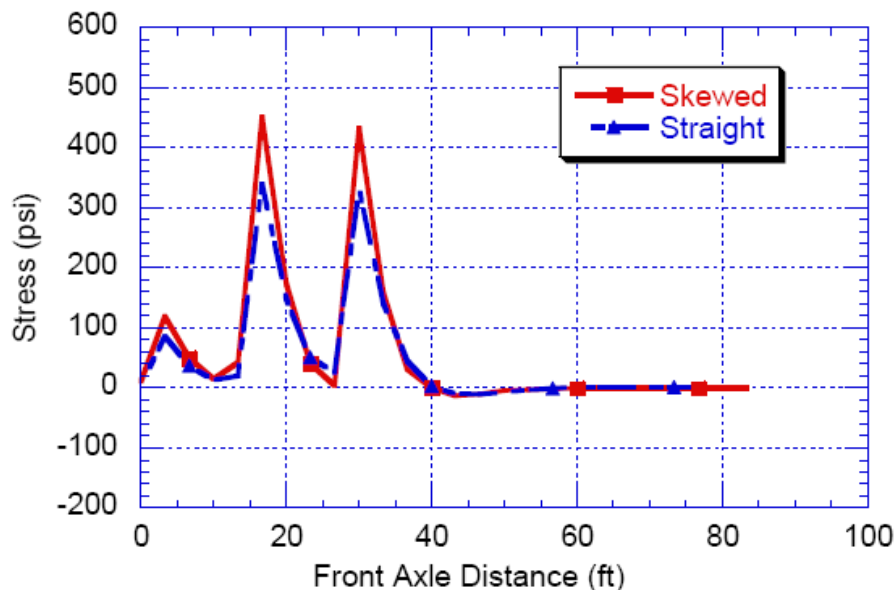
Additionally, higher rates of settlements at the bridge exit were considered to be accountable to the effect of the skew angle of the approach slab as well as improper compaction conditions in hard-to-reach soil areas close to the abutments (Nassif, 2002).

**Figure 2.7. Variation of Tensile Axial Stress with Front Axle Distance for Skewed and Straight Approach Slabs (Nassif, 2002).**

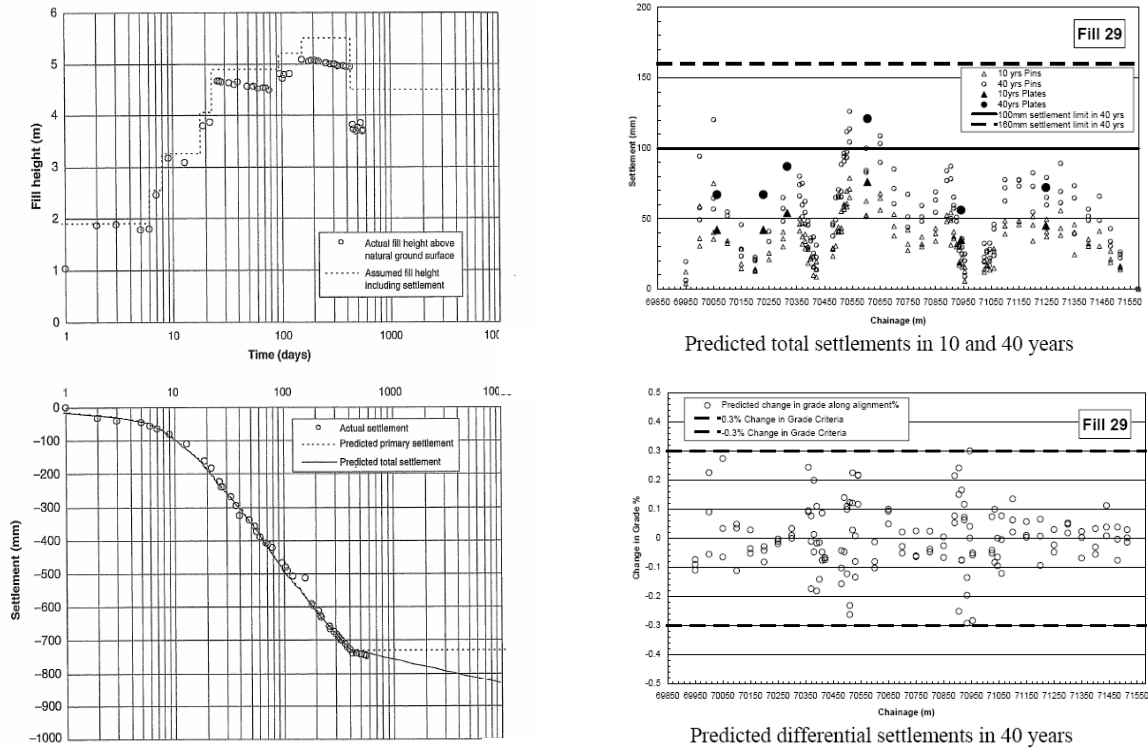
Figure 2.14 presents the measured and predicted settlements in the soft foundation soil during and after the construction stages. In this figure, the long-term settlements were predicted based on the ratio  $(c_a/1+e_0)$ , where  $c_a$  is the secondary compression index and  $e_0$  is the initial void ratio. The long-term differential and total settlements are predicted from back-calculated analysis of measured data from settlement plates also presented in the same figure. From this graph, note the reduced rate of long-term creep settlements after the removal of the surcharge and after the completion of construction (Hsi and Martin, 2005).

**Figure 2.14. Measured and Predicted Settlements with Time (Hsi and Martin, 2005) (a) during Construction Stages and (b) after Construction Stages.**

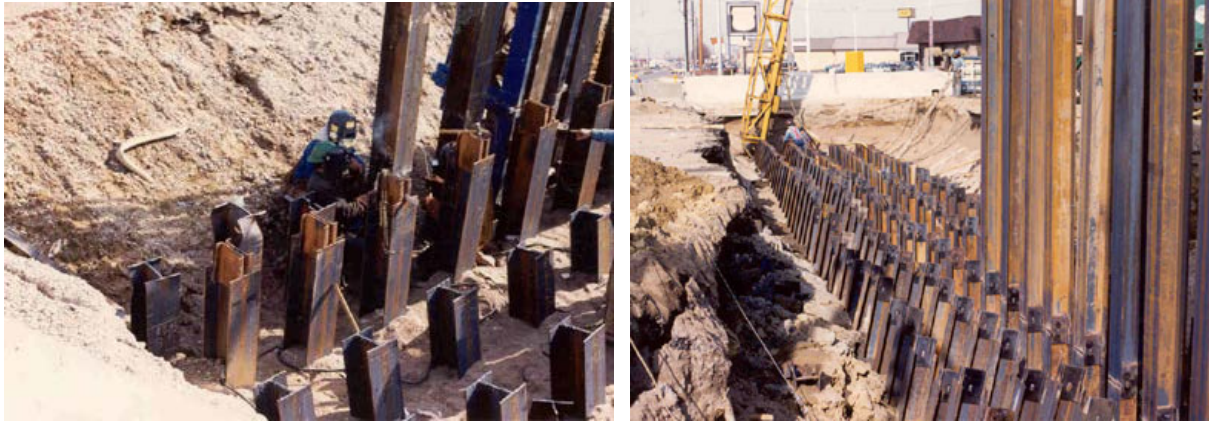
**Figure 2.43. Example of Bridge Foundation Using Steel H-Piles.**

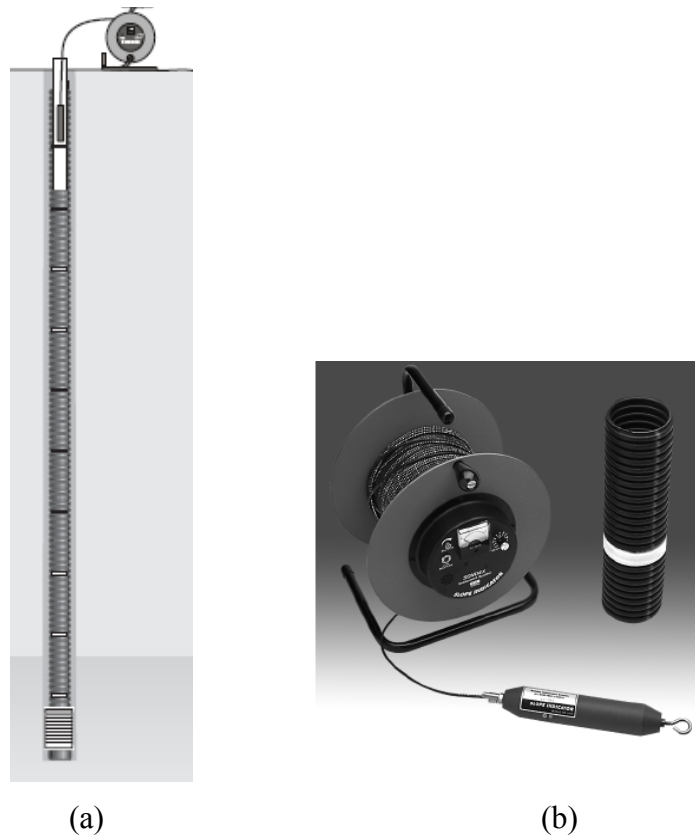
**Figure 6.22. (a) A Typical Sondex Installation (b) Sondex System Components (Slope Indicator, 2004).**

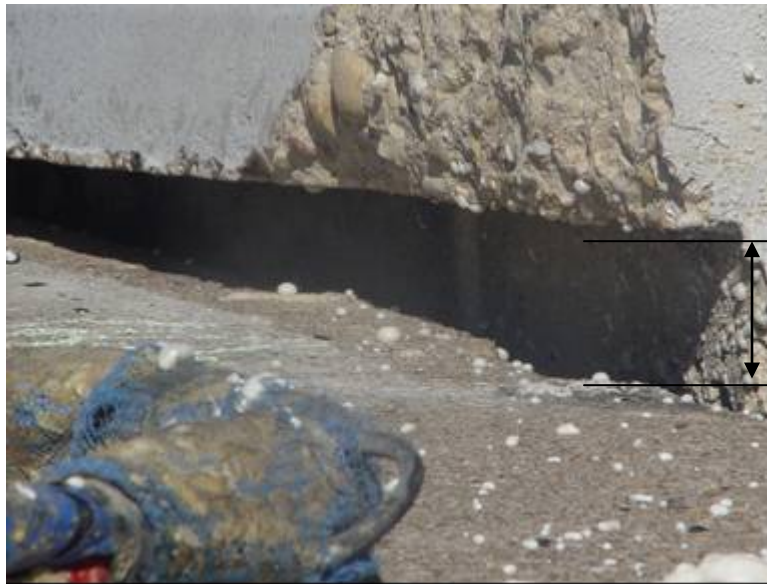
**Figure 9.3. Settlement of the Approach Slab.**
