Evaluation, Presentation and Repair of Microbial Acid-Produced Attack of Concrete

Technical Report 0-6137-1
Cooperative Research Program

TEXAS STATE UNIVERSITY—SAN MARCOS
DEPARTMENT OF ENGINEERING TECHNOLOGY
SAN MARCOS, TEXAS

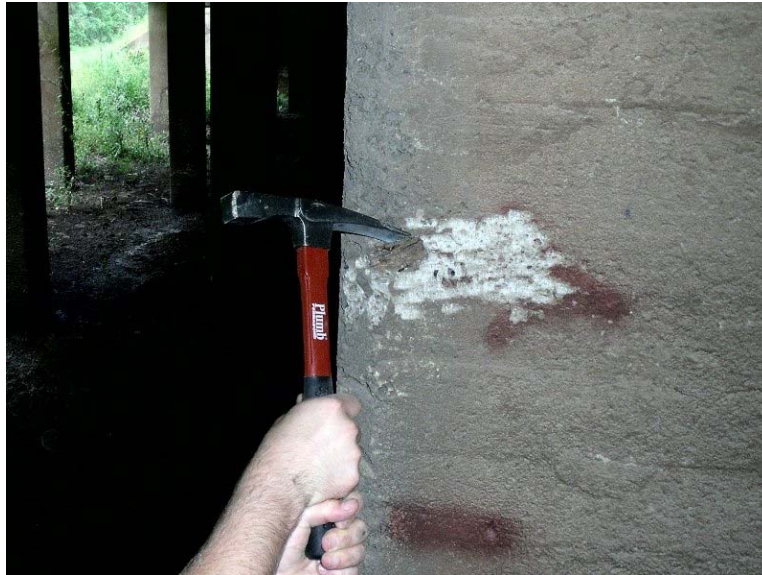
Figure 4. Hammer Test of Concrete Condition.

soundness of the surface and near-surface concrete; the test involved striking areas of surface delamination. Information such as visual evidence of concrete cracking, spalling, delamination, efflorescence, softening of concrete and corrosion of steel were recorded. Based on the visual inspections, locations for *in situ* testing and specimen extraction were determined, and generally three to four representative columns from each bridge were selected.

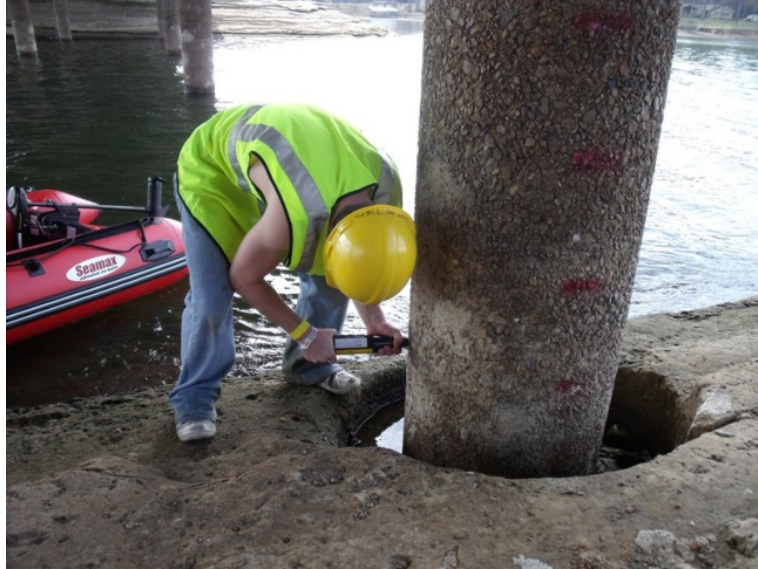
Figure 5. Schmidt Rebound Hammer Test.

In order to evaluate the level of deterioration under a variety of conditions, a number of *in situ* tests were performed on selected bridge columns. Most tests including Schmidt rebound hammer, half-cell corrosion potential, and covering thickness were generally performed at twelve inch intervals, starting at six inches above water or ground level and up to seven feet above (depending upon accessibility). At each measured height, five to seven measurements (with intervals of at least six inches) were taken, outliers (results with differences equal to or greater than 20% of the average value) were removed, and the average reading from each nominal height were reported. The ultrasonic pulse velocity (UPV) and *in situ* phenolphthalein pH tests were performed only at selected locations. An abrasive stone was used to remove the loss (soft) mortar on concrete columns prior to testing on an as-needed basis, in order to expose the underlying concrete.

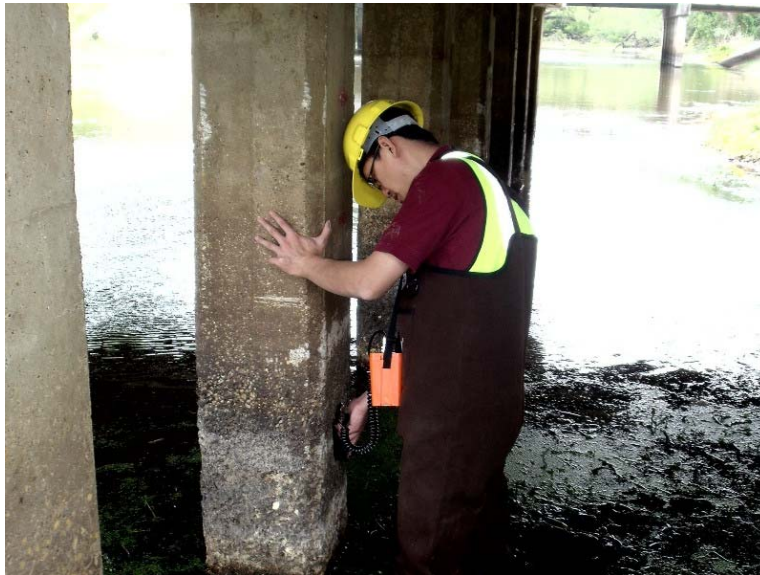
Figure 7. Covermeter (Rebar Locator) Test.

A covermeter (rebar locator) as shown in Figure 7 was used to locate rebar underneath concrete. The covering thickness of the concrete encircling the rebar was estimated through the measurement based upon an electromagnetic pulse-induction method. It should be noted that the measurements were only performed in the direction parallel to the main reinforcement direction (i.e., vertical direction) in this study.

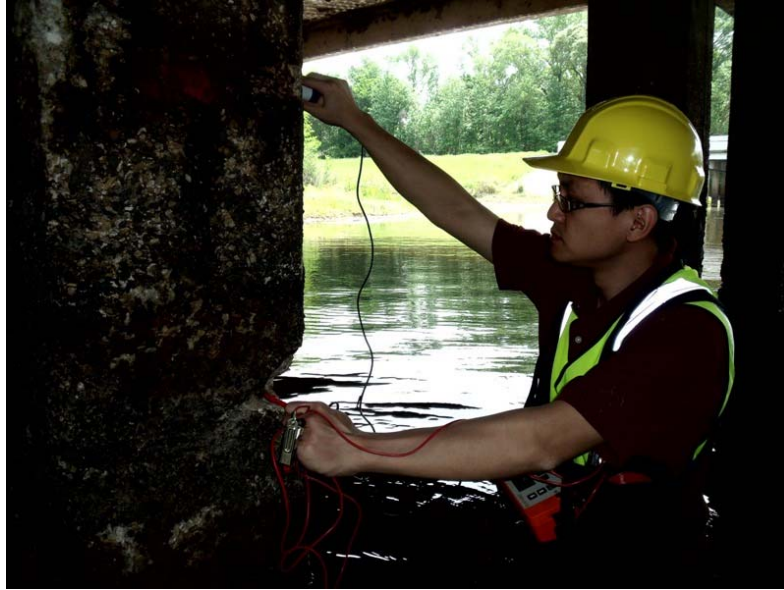
Figure 8. Half-Cell Corrosion Potential Test.

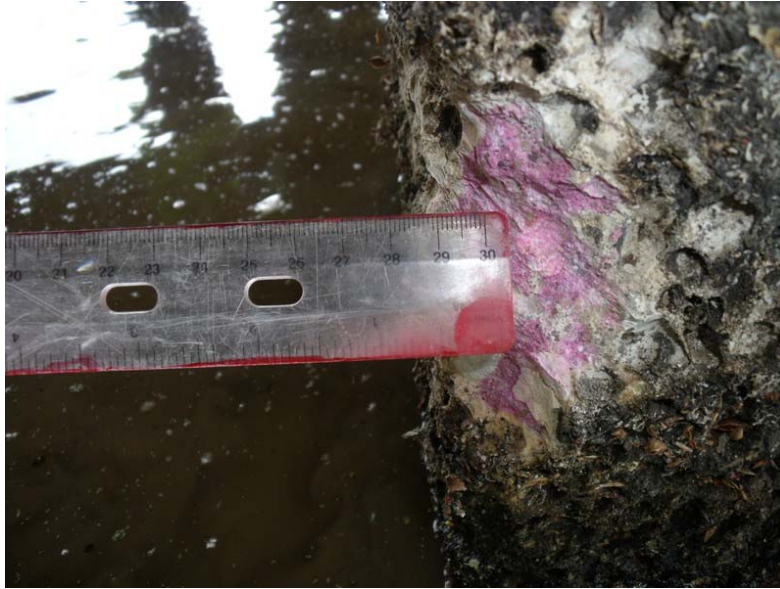
Figure 9. *In Situ* Phenolphthalein pH Test.

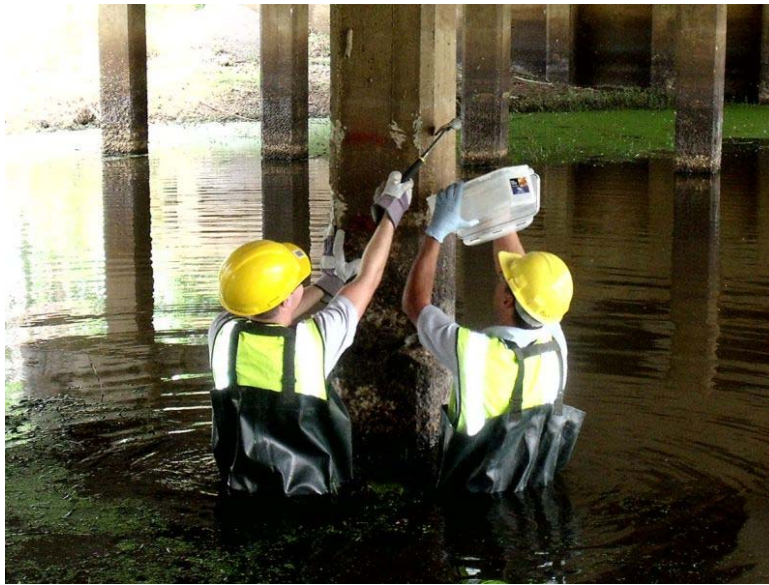
Figure 10. Chemical and Microbial Specimen Collection.

deteriorated and non-deteriorated organic surface scrapings were obtained from selected bridge columns supporting the bridge span. Generally, deteriorated specimens were taken at approximately 6 inches to 12 inches above water level, non-deteriorated specimens were taken at approximately 4 feet to 6 feet above the water level (depending on the accessibility) and semi-deteriorated specimens were taken approximately at a midpoint between the other two heights.

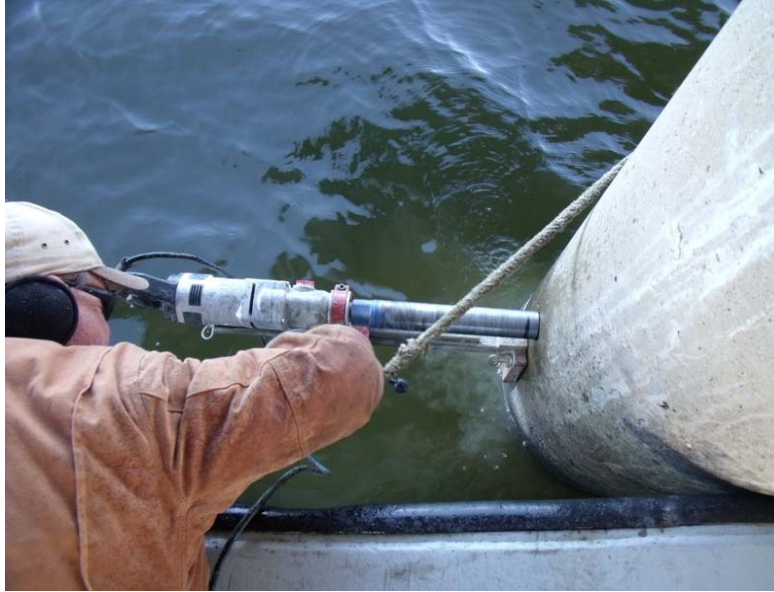
Figure 11. Core Specimen Collection.

As shown in Figure 11, core specimens, one and a half inches in diameter and two to three inches deep were extracted from various columns. It should be noted that nearly all core specimens were in good condition with no sign of crumbling after they were removed from the drill pit. This observation is consistent with the visual observation and hammer tests which demonstrated that most bridge columns appeared to be in fairly good condition with different levels of deterioration on the concrete surface but no sign of internal deterioration or cracking.

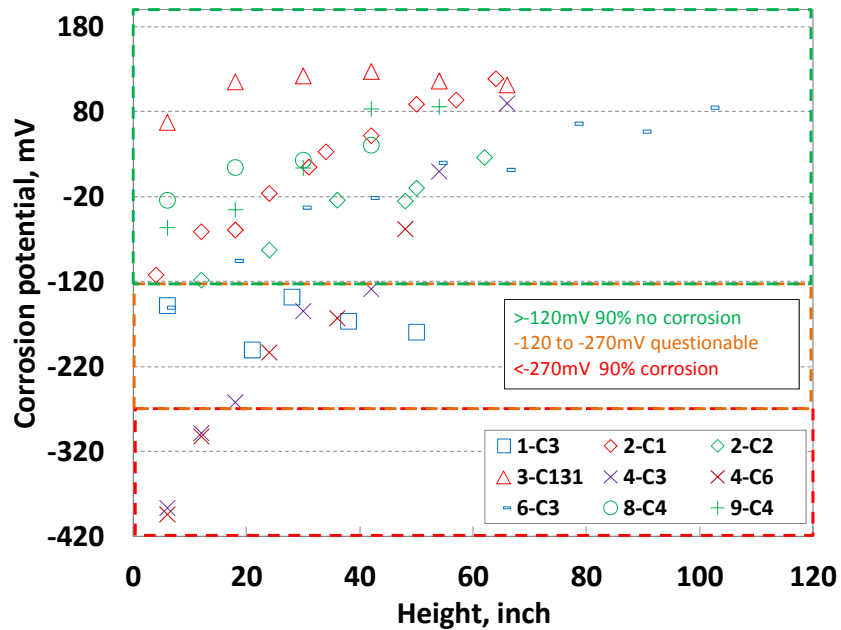
Figure 14. Summary of Half Cell Test Results.

Results from half-cell corrosion potential tests as shown in Figure 14 demonstrate a clear trend of decreasing corrosion potential with an increase in the height of the column. It should be noted that the trend of decreasing corrosion potential is not unexpected as changes in moisture content, dissolved oxygen and changes in the concentration of chloride, sulfate or other ions in the concrete as one progresses upward from the waterline will result in an increase in the corrosion potential readings (i.e., less potential of corrosion), regardless of the present of MID. However, despite the above mentioned parameters that can influence corrosion, most of the bridge columns show only a low to medium level of corrosion potential and only one site (Bridge 4), has a high level of corrosion potential which may have been caused by a significant amount of vertical cracking.

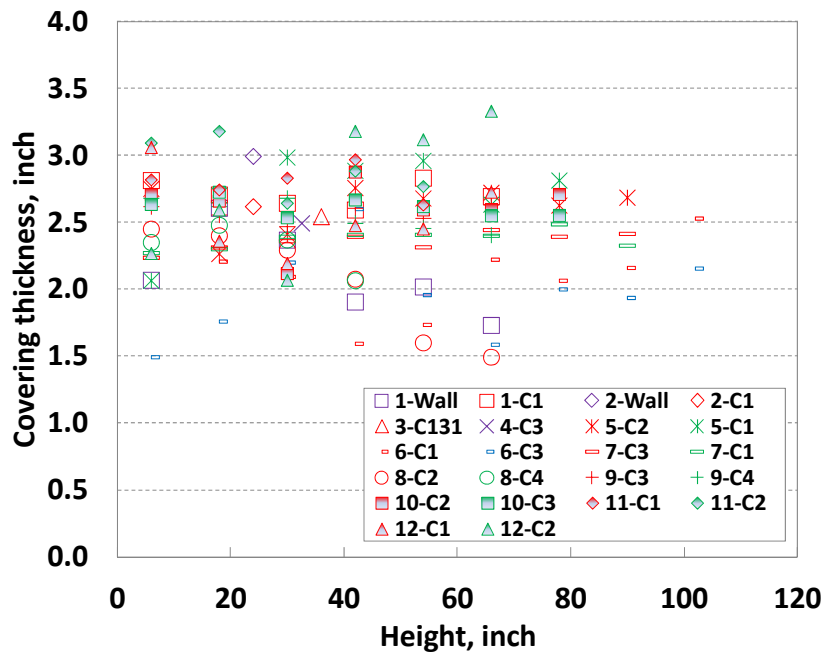
Figure 15. Summary of Covering Thickness Test Results.

Results from the cover meter test as shown in Figure 15 indicate that most of the bridge columns still have more than one and a half inches of concrete covering, with standard deviations mostly less than half an inch, which indicates that the reinforcement is still well protected.

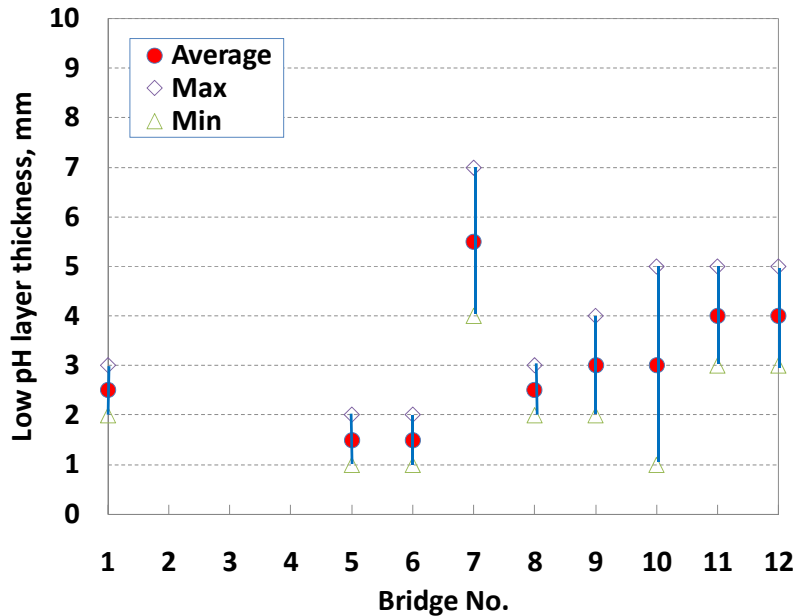
Figure 16. Summary of *In Situ* Phenolphthalein pH Test Results.

Phenolphthalein pH indicator showed acidification of surface concrete in most tested bridge columns. However, results as shown in Figure 16 indicate that for all the columns tested, there was generally less than 5 millimeters of neutralized surface concrete. It should be noted that Figure 16 is presented differently than Figure 12 to Figure 15, as only a couple of measurements were taken at each of the bridges.

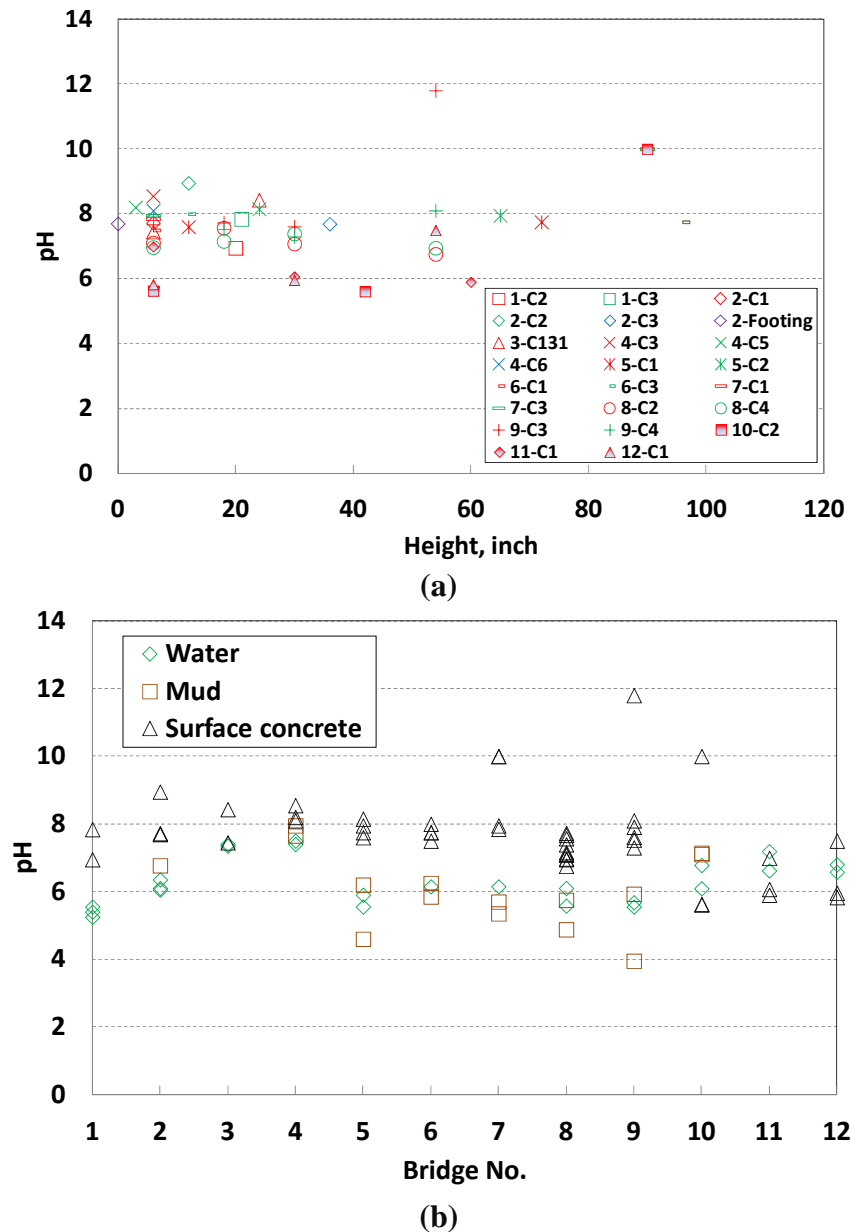
Figure 20. pH of Water, Mud and Surface Concrete Samples. (a) pH at Different Specimen Heights, (b) pH in Different Bridges.

of concrete is not as low as 2 to 3 as found in sewage plants as reported in the literature (Zhang and Zhang 2006; Parande et al. 2006). Results of sulfate concentration measurements from bridges 1 to 12 are summarized in Figure 21; the results indicate traces of sulfate on the concrete surface, which could indicate potential transformations by sulfur-oxidizing bacteria. Similarly, results of chloride concentration from bridge 1 to 12 are summarized in Figure 22. With respect to elevation along a concrete column, no clear trend emerges with respect to the concentration of sulfate or chloride. Details of pH, sulfate and chloride test results can be found in Appendix D.

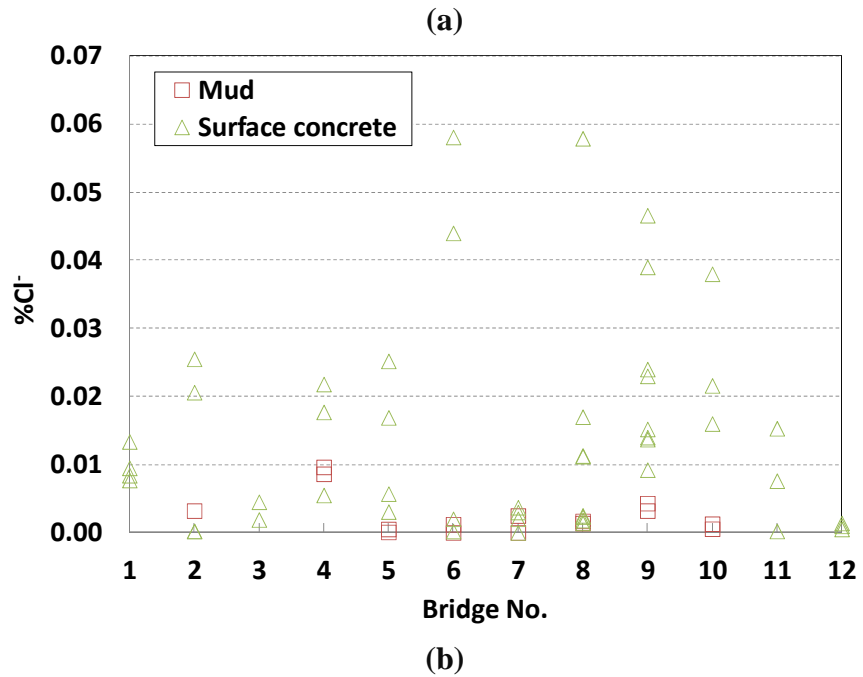
Figure 22. Chloride Content of Mud and Surface Concrete Samples. (a) Chloride Content at Different Specimen Heights, (b) Chloride Content in Different Bridges.

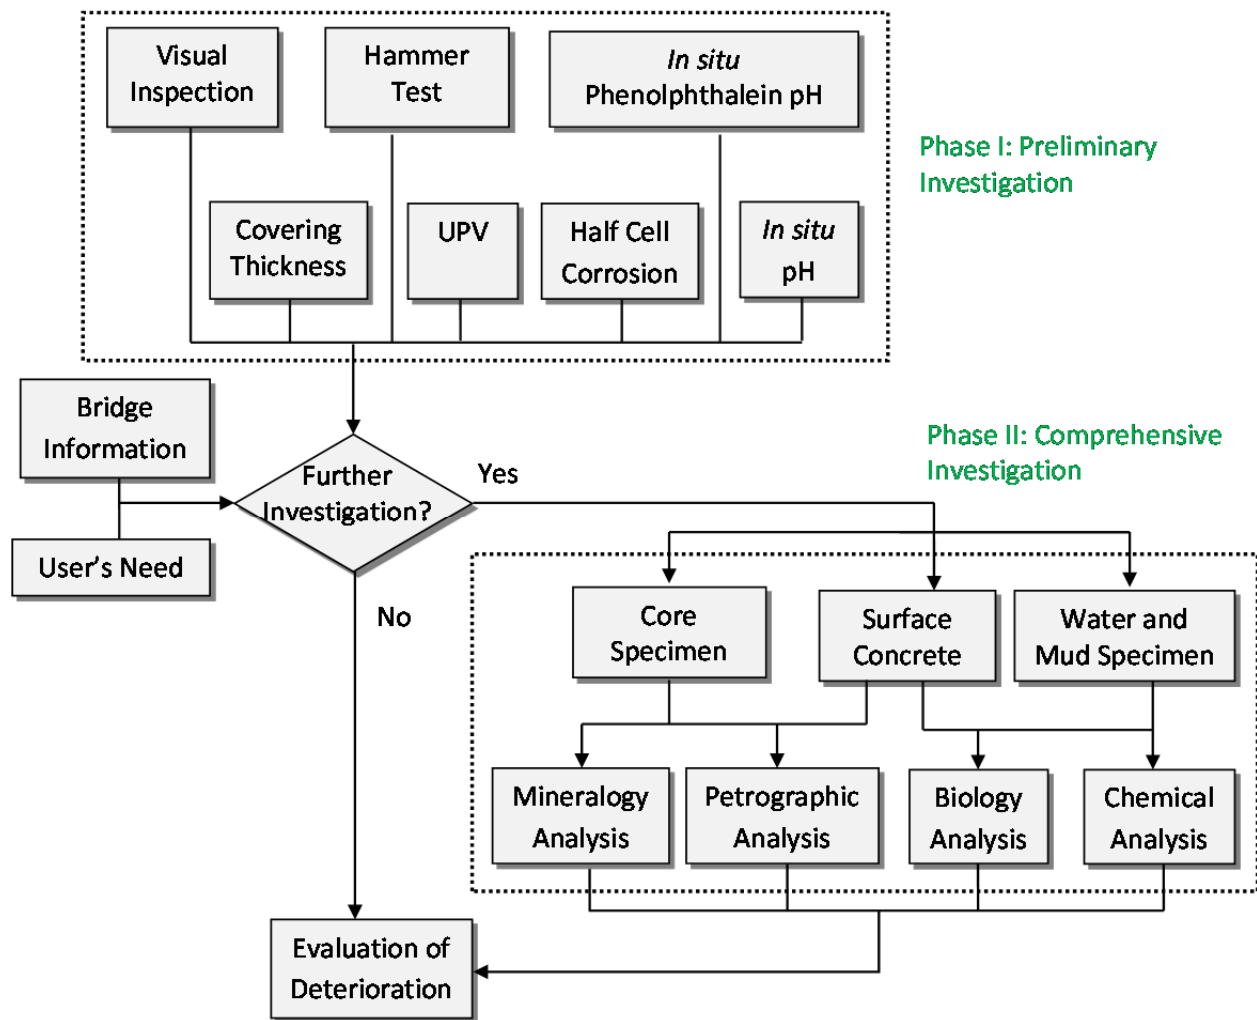
Figure 25. Flow Chart of Recommended MID Identification and Evaluation Procedure.

Based on the effectiveness of each of the tests, a two-stage approach is recommended to identify MID and evaluate the extent of MID for TxDOT structures. With Stage I as a preliminary survey to roughly evaluate the extent of MID, Stage II should serve as an extension of Stage I when needed, in order to confirm the MID and to further identify the extent of defects revealed by Stage I. A flow chart with tests recommended during the different stages is shown in Figure 25:

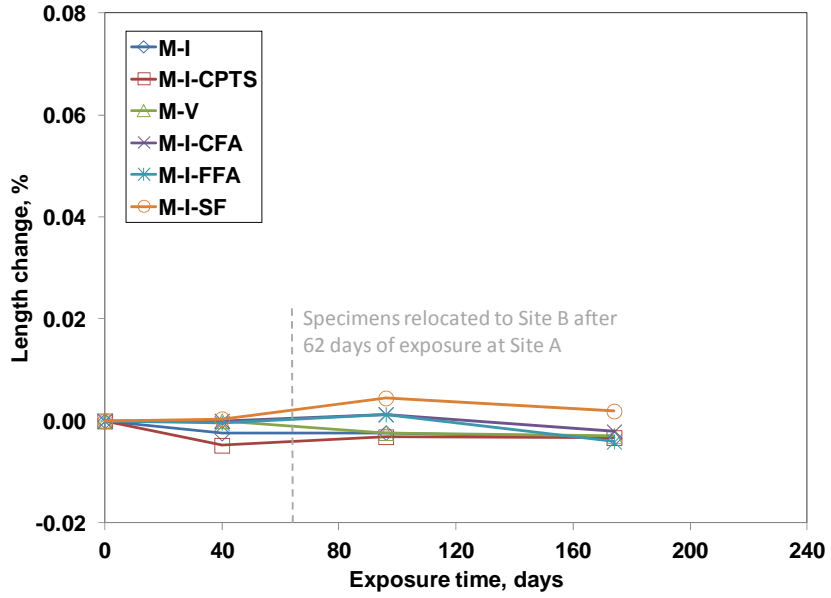
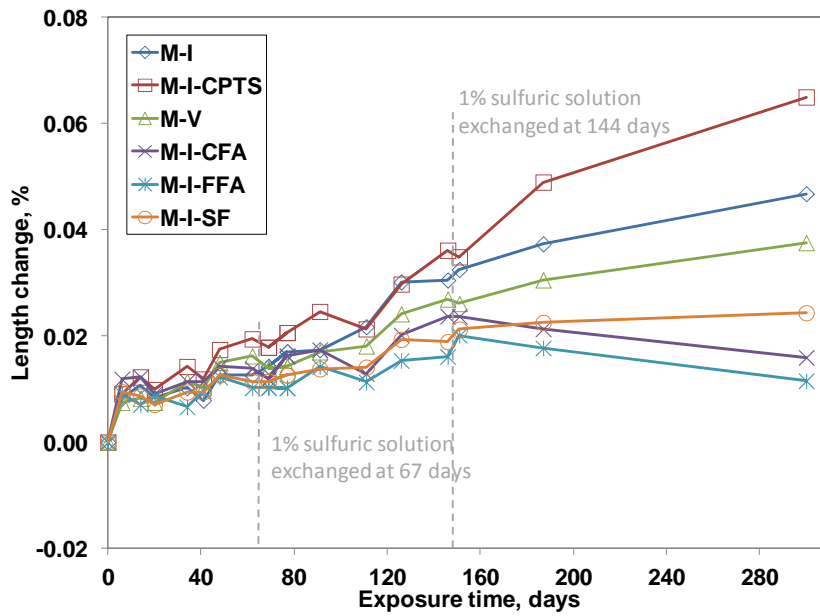
After mortar prism specimens were placed into different scenarios, changes of lengths were measured with a length comparator on a regular basis. Results of length changes of specimens under different exposure conditions are summarized in Figure 29. As expected, all specimens experienced different levels of expansions, which was likely due to reaction between sulfuric acid and cement hydration products, which resulted in the production of ettringite and gypsums and a volume increases.

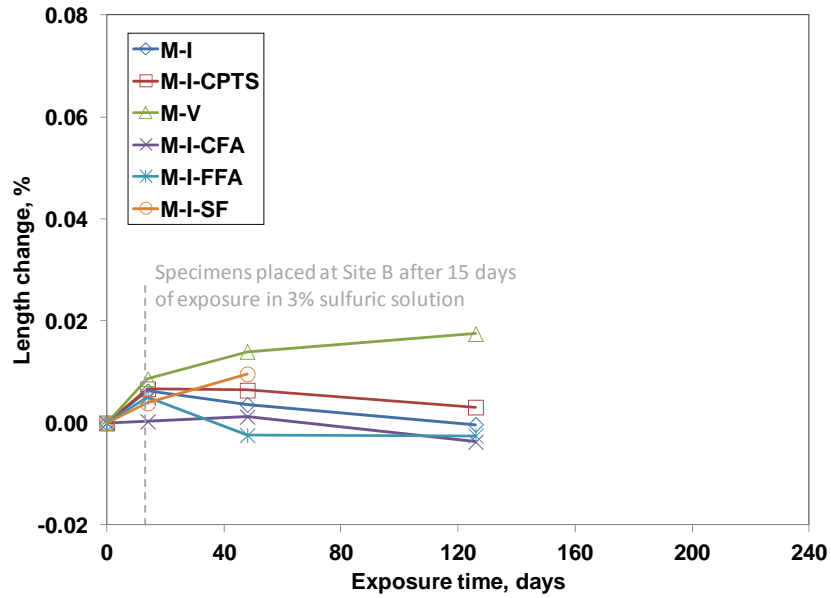
(e)
Figure 29. Length Change of Mortar Prism Specimens under Different Scenarios (continuous). (e). Scenario V.

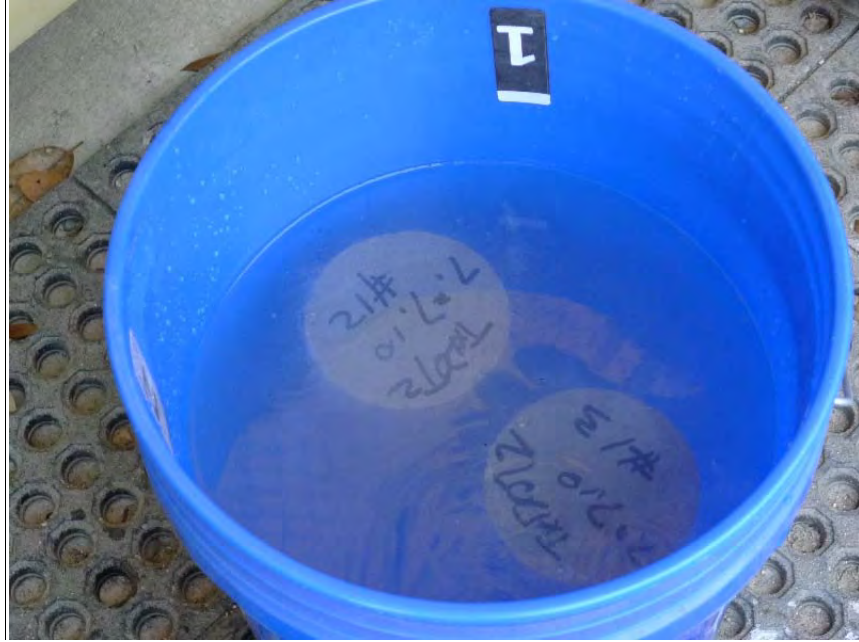
Figure F. 2. Storage of Concrete Specimen in Laboratory Simulation.

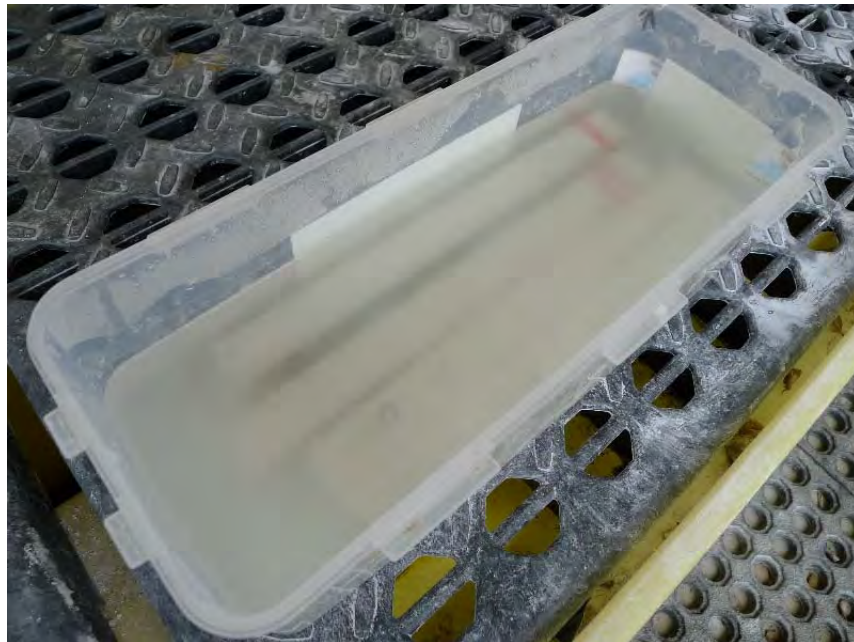
Figure F. 3. Storage of Mortar Specimen in Laboratory Simulation.

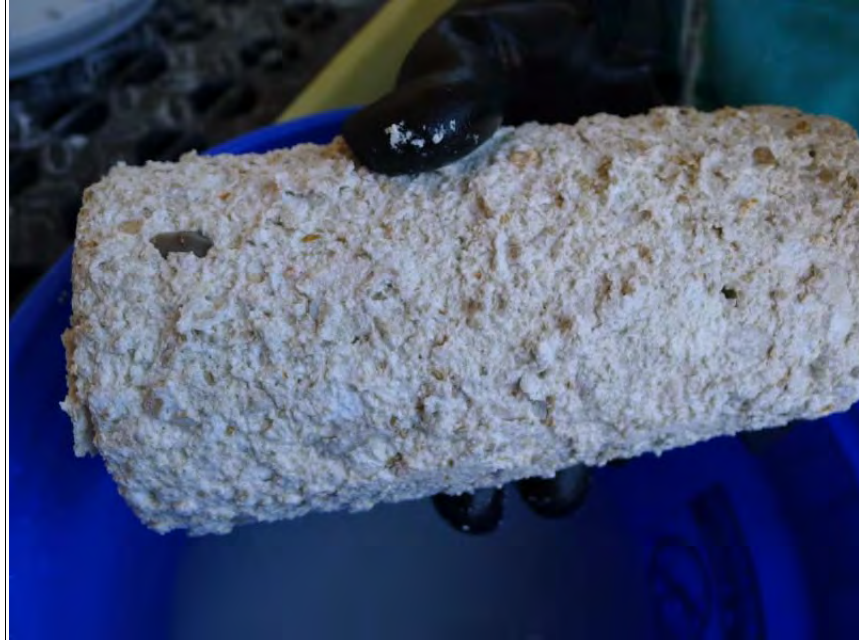
Figure F. 4. Reaction Products on the Surface of Specimen (C-I) after 83 days' Exposure in 3% Sulfuric Solution.
