1. Report No. FHWA/TX-13/0-6152-2	2. Government Accession No.	3. Recipient's Catalog No.	
4. Title and Subtitle SHEAR IN HIGH STRENGTH CONCRETE BRIDGE GIRDERS: TECHNICAL REPORT		5. Report Date Published: April 2013

**SHEAR IN HIGH STRENGTH CONCRETE BRIDGE GIRDERS:
TECHNICAL REPORT**

Project 0-6152

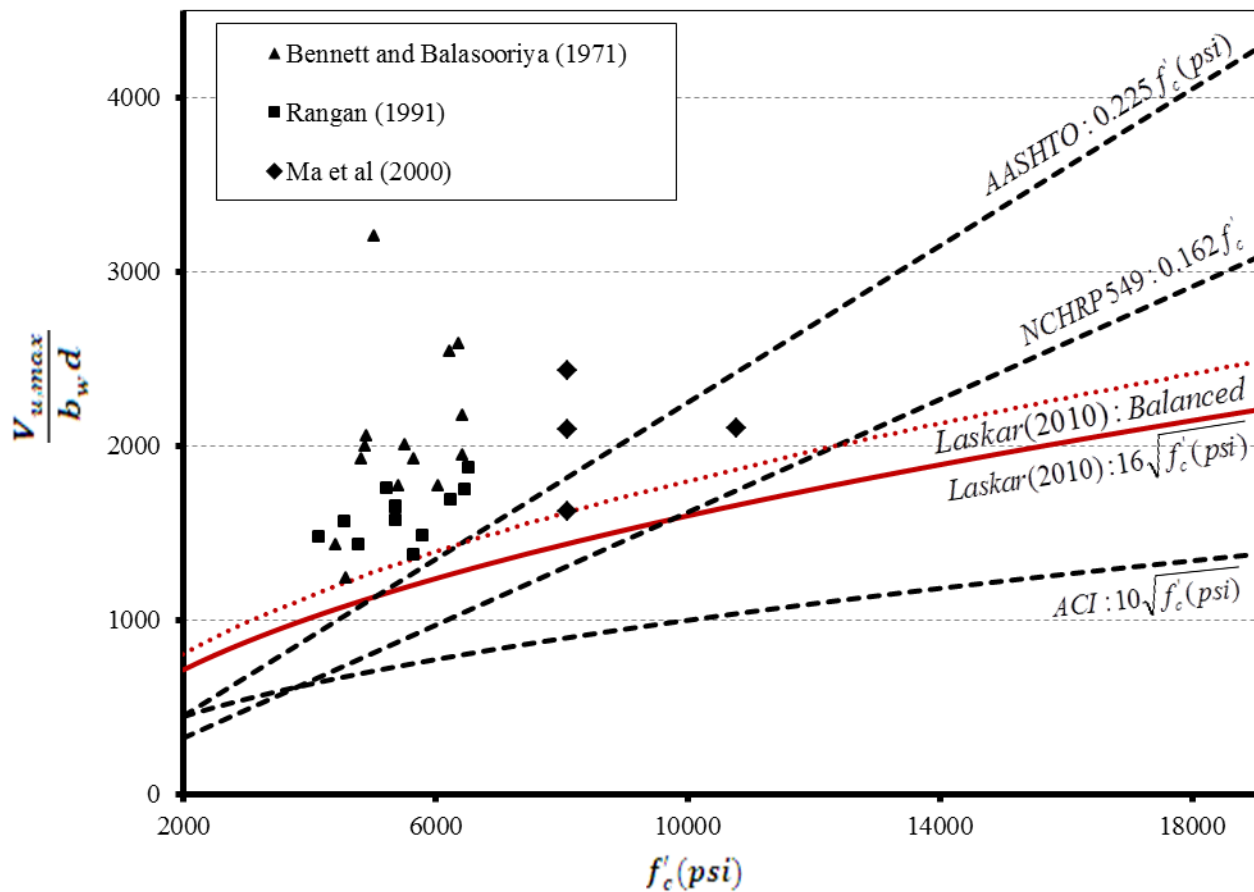
Fig. 1.3 Variation of Maximum Shear Strength $V_{n,max}$ with Concrete Strength f'_c

Fig. 1.3 plots the maximum shear strength, $V_{n,max}$, as given in four available codes or recommendations (AASHTO 2007, ACI 318 2008, NCHRP 549 2007, and Laskar et al. 2010) as a function of concrete strength f'_c , and compares these shear provisions to shear beam tests available in the literature (Bennett and Balasooriya 1971, Rangan 1991 and Ma et al. 2000).

Fig. 1.3 highlights the two basic problems in the shear design of prestressed beams with high strength concrete. First, the shear provisions in the codes and recommendations vary drastically, especially in the regions of high strength concrete. For a concrete strength f'_c of 14,500 psi, AASHTO Specifications allows a $V_{n,max}$ value to be 2.5 times that in the ACI Code. Second,

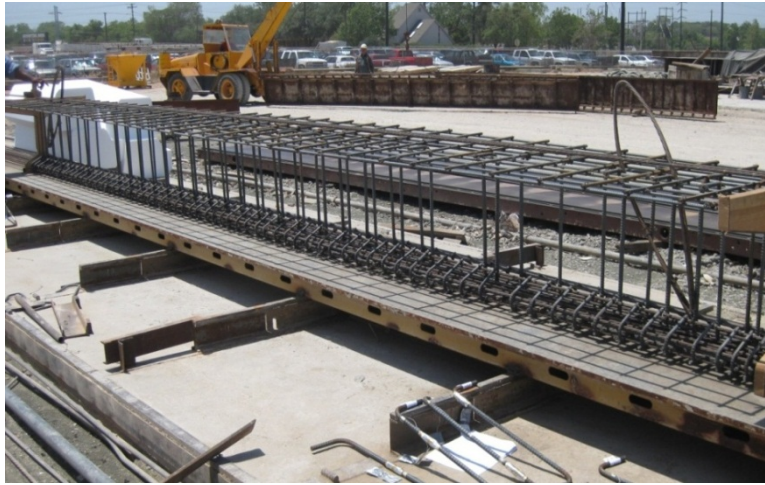
Fig. 3.15 Reinforcement Cage for a Typical Girder

The 10 girders have been manufactured at two different companies. The girders belonging to the Groups A and F were cast at Texas Concrete Company, Victoria, Texas, in July 2009. Group C girders were cast at Flexicore of Texas, Pearland, Texas, in June 2010. The prestressing tendons were pretensioned by hydraulic jacks placed in a prestressing steel platform/bed. Transverse steel, including the rebars were instrumented with strain gauges, along with all the other confining and flexural reinforcements were installed in the girders. Fig. 3.15 shows the reinforcement cage of a typical girder.

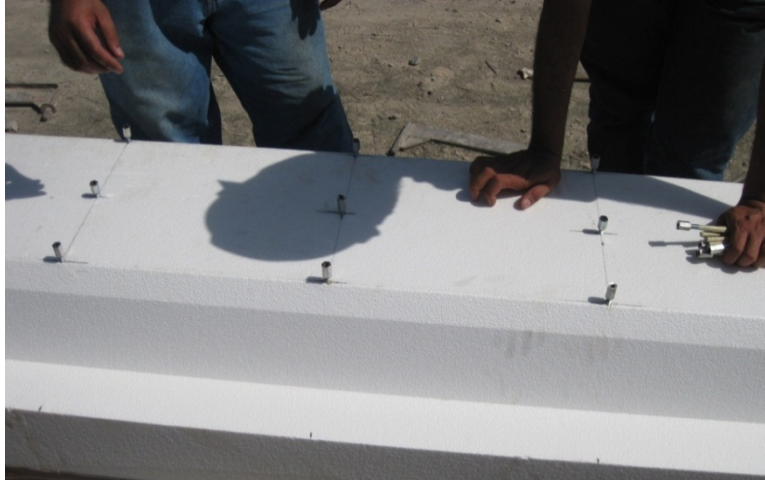
Fig. 3.16 Styro-Foam Forms with LVDT Rods

Specially designed side forms made of styro-foam as shown in Fig. 3.16 and Fig. 3.17 were used to form the required cross-sectional shape of Modified-Tx28 girder. Standard vertical steel side forms rigidly fixed to the prestressing-bed were used to hold the styro-foam forms in place Fig. 3.18.

Steel rods of 6 in. length were installed in the web of each girder on the sides at pre-determined locations as depicted in Fig. 3.16. These steel rods were used to mount the Linear Variable Displacement Transformer (LVDT), which served as instrumentation to measure the average strains in the girders during the load testing.

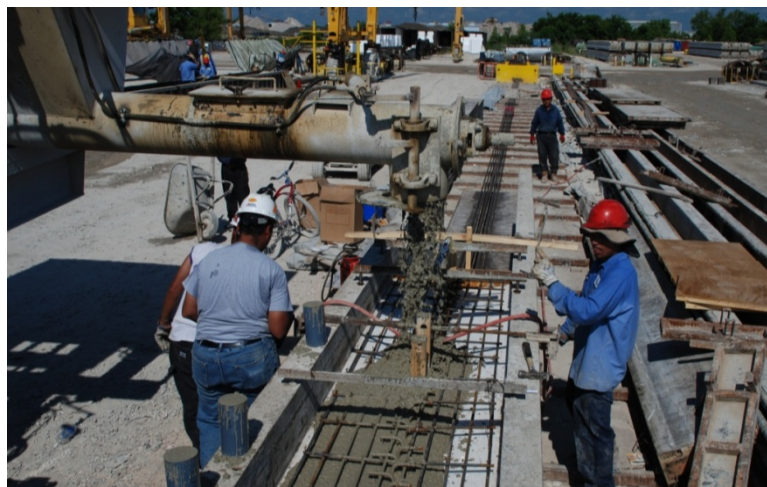
Fig. 3.19 Concrete Placement Using a Hopper

The concrete mix was prepared in a plant mixer, transported to the casting site, and deposited into the formworks using a mobile hopper as shown in Fig. 3.19. During casting, spud vibrators were used to compact the concrete. Standard concrete cylinders were cast per each girder. Just prior to the actual girder tests, the concrete cylinders were tested to get the representative concrete compressive strength of the girder. One day after casting the girders, the prestressing tendons were slowly released, and the girders were transported to the storage yard to remove the formwork, as shown in Fig. 3.20.

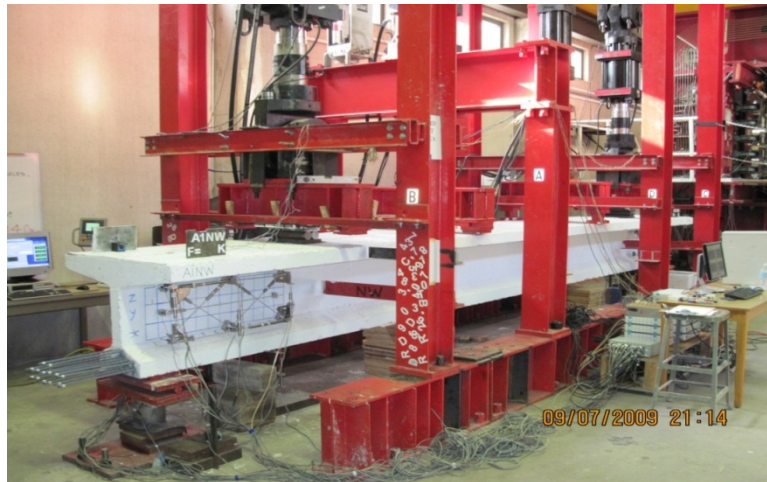
Fig. 3.21 Test Setup for Girders

The girders were subjected to vertical loading up to their maximum shear capacity in a specially built steel loading frame, as shown in Fig. 3.21. Two of the four actuators (namely actuator B and actuator C), each attached to a vertical steel frame, were used to apply the vertical loads on the girders. Each of these two actuators had a capacity of 320 kips in compression. Actuator frames B and C were installed on the north and south end of the girder, respectively. These two actuator frames were sitting on top of two WF18×97 girders, bolted securely to the strong floor. The two WF18×97 girders were 20 ft. long and spaced at 87 in. center to center. Girder was positioned in the middle of this spacing width on top of two load cells placed at north and south ends. The load cells of 500 kips capacity were sitting on top of the steel pedestals fixed to the strong floor. On top of the load cells, bearing plates to support the girders were placed with a roller on the north end and a hinge on the south end, thus allowing the girder to rotate freely at the supports and to expand freely along its length. The actuators were provided with bracings for their lateral stability.

The position of vertical loads and load-cell supports for all girders of Group A, F, and C are shown in Figs. 3.3 to 3.7. Compressive loads from actuators B and C were applied at 42.5 inches from either supports (i.e., north and south supports) to have $a/d = 1.77$ for Girders A1, F1, F3, C1 and C3. Similarly, actuator loads for Girders F2 and F4 were applied at 54 inches from either supports to have $a/d = 2.25$. Girders A2, C2 and C4 were loaded at 72 inches from the supports to have $a/d = 3.00$. Actuator loads were applied through a roller assembly consisting of two 6

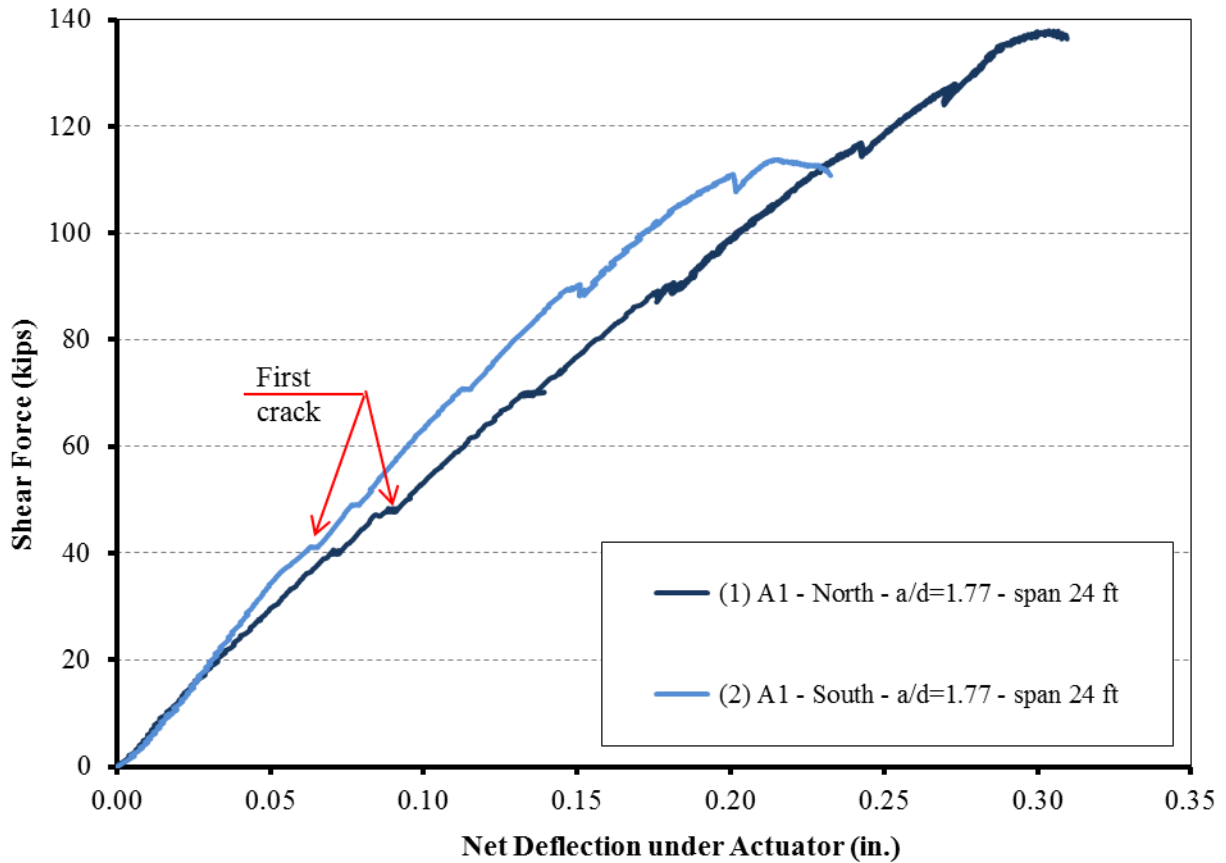
Fig. 4.1 Shear Force vs. Girder Deflection Curves for Girder A1

(b) show that the first crack on the south end had more length than that observed on the north end during the test and both of them are joining the loading point and the support. Having longer crack at lower load at the south end implies weakness of the south end, which resulted in a failure in the south end at a lower shear load than that reached at the north end, as shown in Fig. 4.2 (e) and (f).

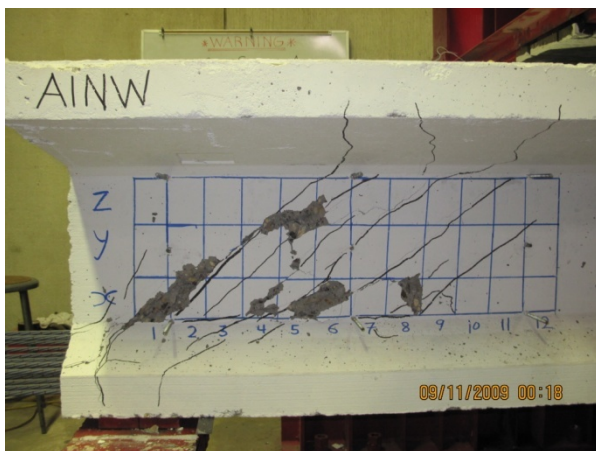
(e) Shear failure at 138.21 kips

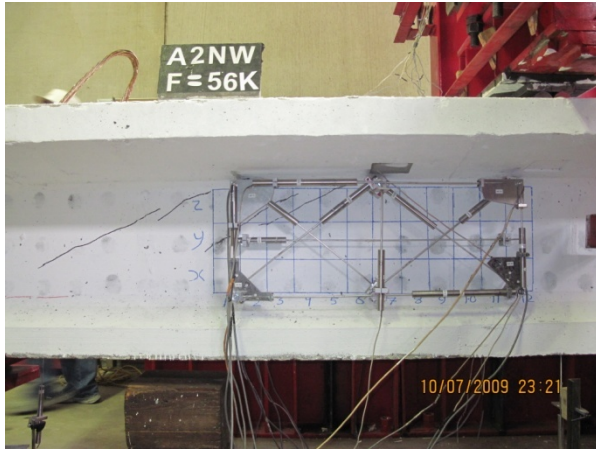
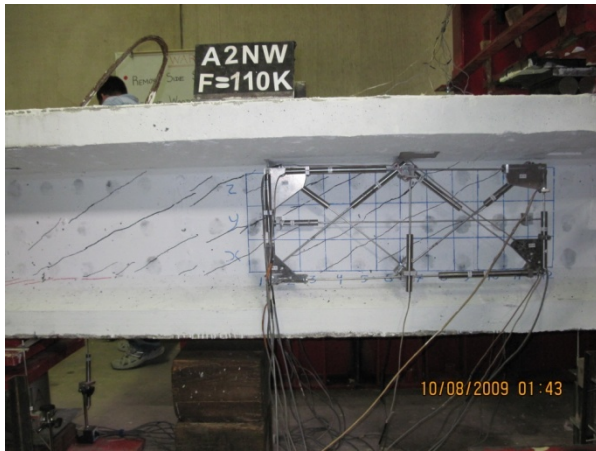
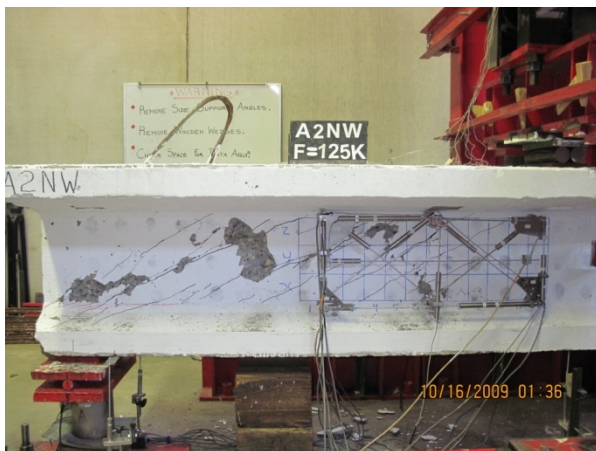
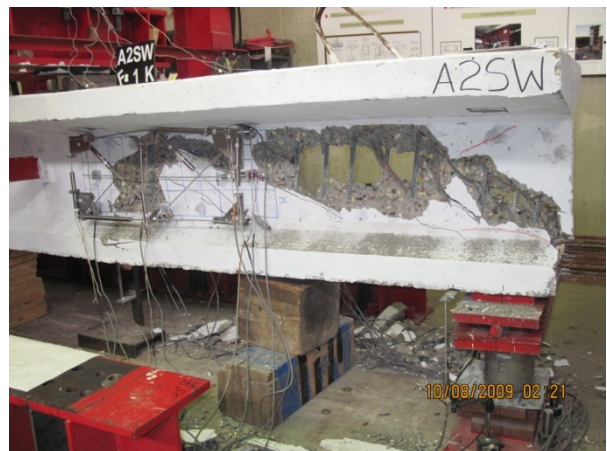
Fig. 4.6 Shear Crack Pattern and Failure Mode of Girder A2

(a) First shear crack at 56 kips

(c) Shear crack pattern before failure

(e) Shear failure at 125.60 kips

(f) Shear failure at 120.40 kips

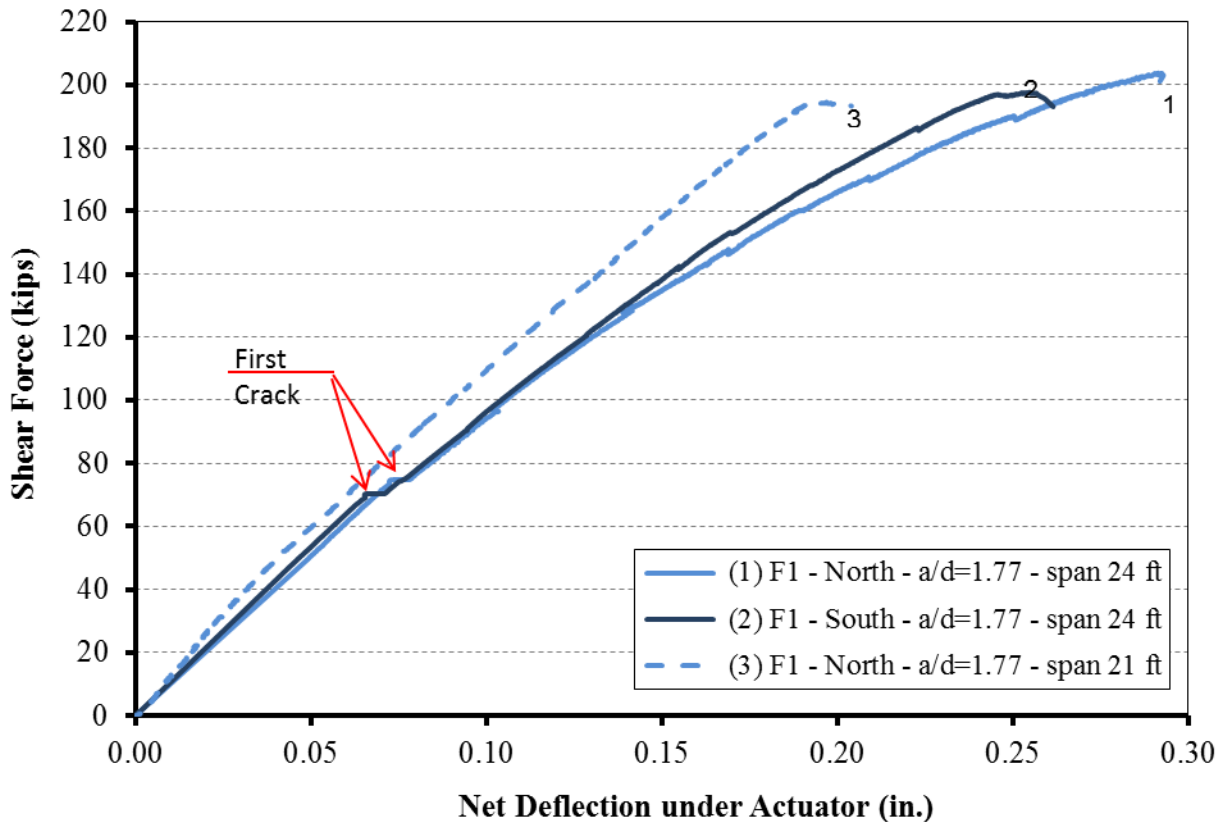
Fig. 4.11 Shear Force vs. Girder Deflection Curves for Girder F1

Girder F1 was loaded simultaneously at both ends with shear span to effective depth ratio $a/d = 1.77$, as shown in Fig. 4.11. The first shear cracks appeared at both the girder ends at the same time under a shear load of 70 kips, Fig. 4.12 (a) and (b). The first crack happened on the line between the loading and reaction points. The cracking load is very clearly shown on all the LVDTs' data.

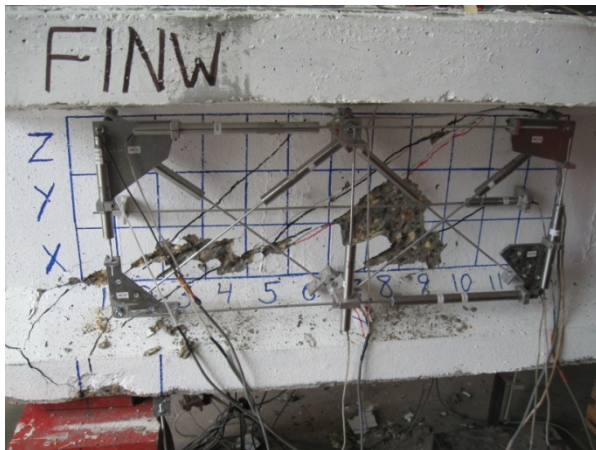
(e) Shear failure at 202.90 kips

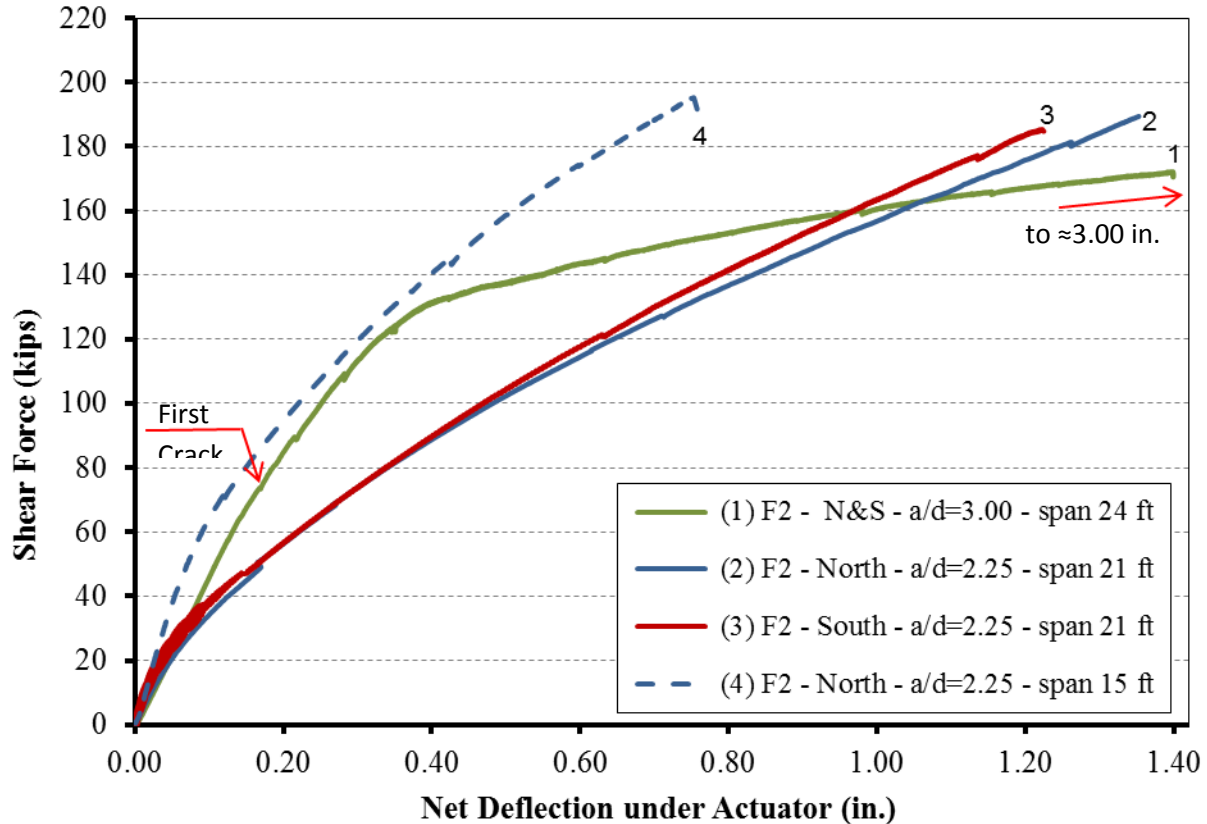
Fig. 4.16 Shear Force vs. Girder Deflection Curves for Girder F2

Girder F2 was tested to fail in flexure shear mode with shear span to effective depth ratio $a/d = 3.00$. The first shear cracks appeared at 63 kips at both ends of the girder, as seen in Fig. 4.17(a) and (b). With increasing the applied load both ends behaved identically. This can be observed from the recorded smeared strains in the different directions. Thus, the curve No (1) in Fig. 4.16 represents the shear load versus the net deflection for both ends.

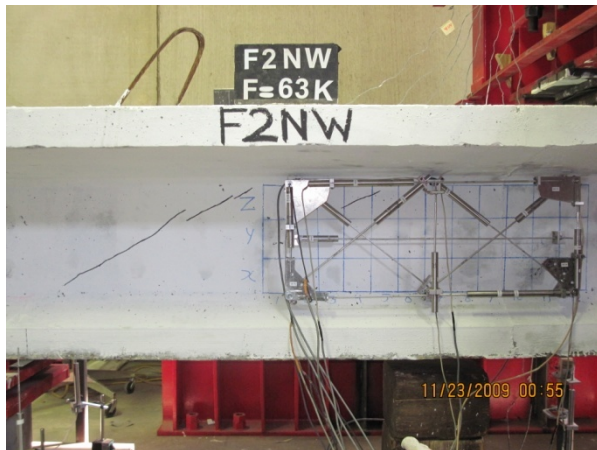
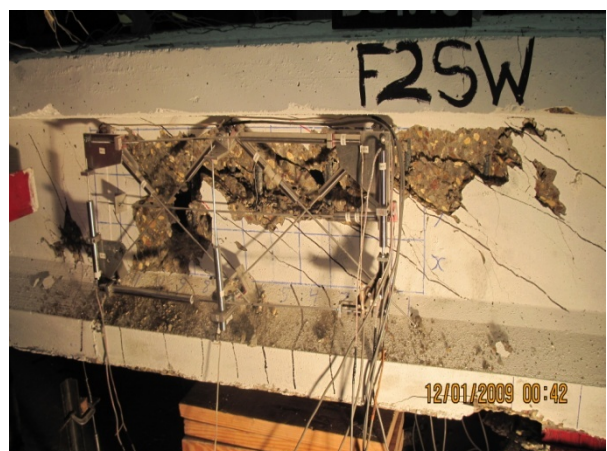
Fig. 4.17 Shear Crack Pattern and Failure Mode of Girder F2

(a) First shear crack at 63 kips

(f) Shear failure at 185.35 kips

After the failure of the south end, the south load cell was moved to get a net girder span of 15 ft., and the north end was retested having the same shear span to depth ratio equals 2.25. The north end finally failed at 195.24 kips shear force, (Curve 4 in Fig. 4.16), having maximum smeared compressive strain 0.0011 closer to the support, Fig. 4.22(b).

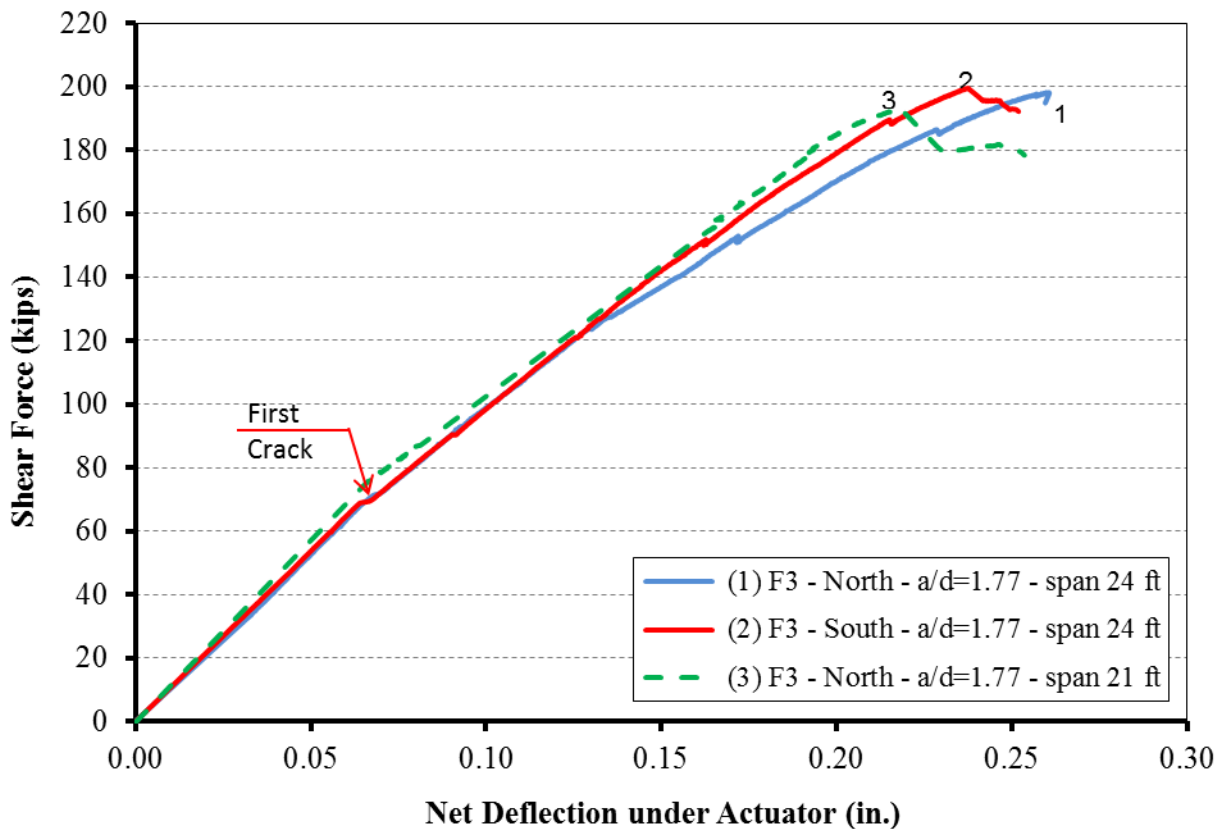
Fig. 4.23 Shear Force vs. Girder Deflection Curves for Girder F3

Girder F3 was designed to fail in web shear mode with shear span to effective depth ratio $a/d = 1.77$. Fig. 4.23 shows the shear load versus net deflection curves at both north and south ends during the first test as well as at the north end in the second test. The first shear crack appeared at both the ends of the girder at the same time under a shear load of 70 kips on the line between the loading and reaction points, as shown in Fig. 4.24 (a) and (b). The smeared strains measured at the north and south ends demonstrated the identical behavior of both ends starting from the cracking load.

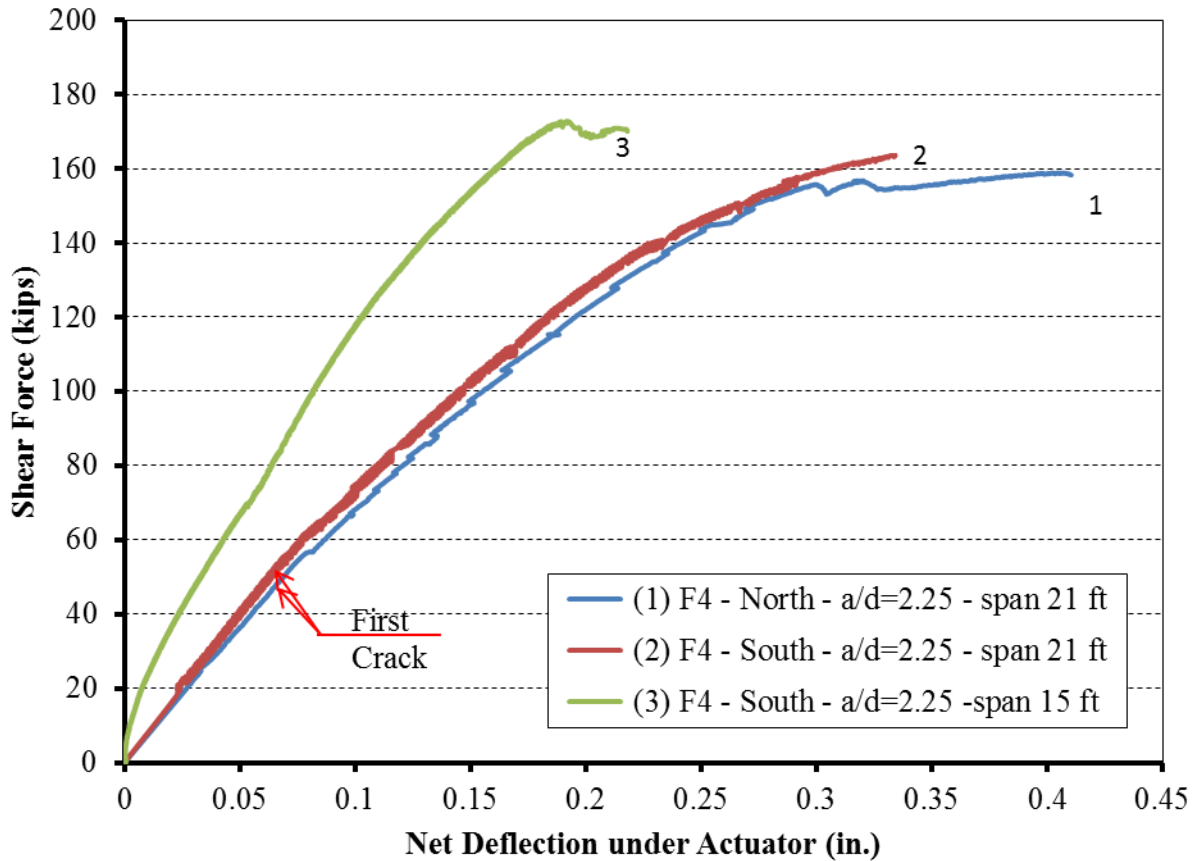
Fig. 4.28 Shear Force vs. Girder Deflection Curves for Girder F4

Girder F4 was tested to fail in flexure shear mode with shear span to effective depth ratio $a/d = 2.25$. The first shear crack appeared at 58 kips and 67 kips at north and south ends of the girder, respectively, as can be seen from the load deflection curves in Fig. 4.28. The first cracks appeared at the same location shown in Fig. 4.29 (a) and (b).

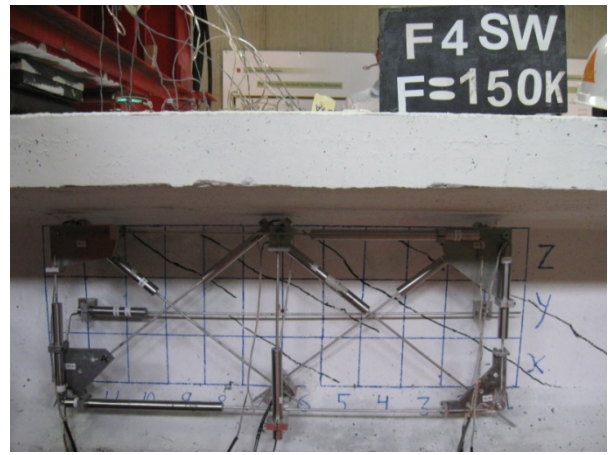
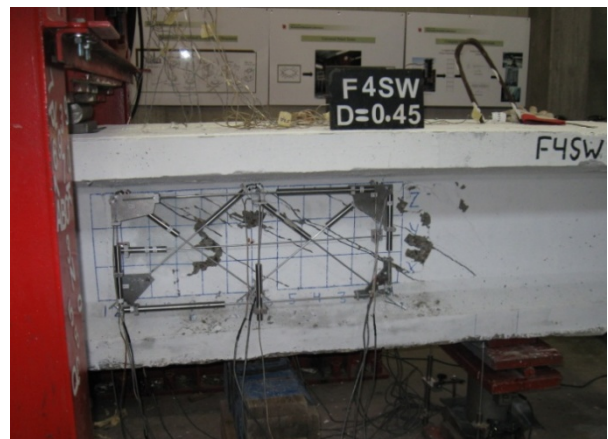
Fig. 4.29 Shear Crack Pattern and Failure Mode of Girder F4

(d) Shear crack pattern before failure

(f) Shear failure at 172.83 kips

From Fig. 4.30 (c), it can be seen that the smeared strain measured by the LVDTs V1 and V2 are almost identical at the south end of the girder. The north end had more cracks crossing LVDT V2 shown in Fig. 4.29 (c) and (d), which is giving higher smeared strain value at a given shear load. The maximum transverse smeared tensile strain was 0.0020 and 0.0014 at the middle of the studied zone at the north and the south end, respectively. The reading from the LVDT V3, which was closer to the loading point, was comparatively small, as it was not intercepted by the shear crack. The web shear behavior and failure of Girder F4 can be supported by the smeared tensile strain in the longitudinal direction of the web which did not exceed 0.0004 at both ends, as shown in Fig. 4.30 (d).

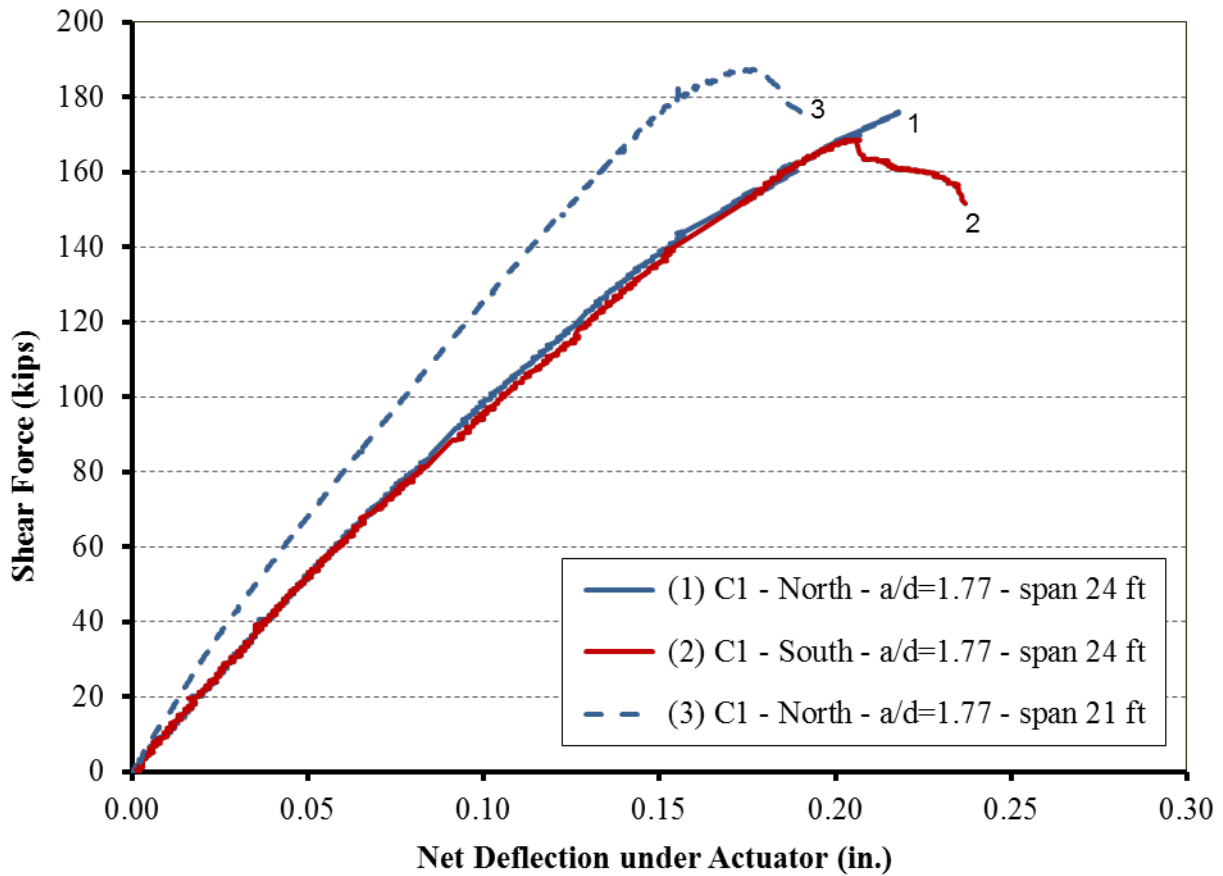
Fig. 4.34 Shear force vs. Net Deflection Curve for Girder C1

The available data showed the same trend of the vertical LVDTs in previous girders. The highest smeared tensile strain was at the middle of the studied zones. The available data indicated that the smeared tensile strain in the longitudinal direction at the middle of the web at both ends was between 0.0005 and 0.0010, which should be expected to be closer to 0.0005 as a web shear girder.

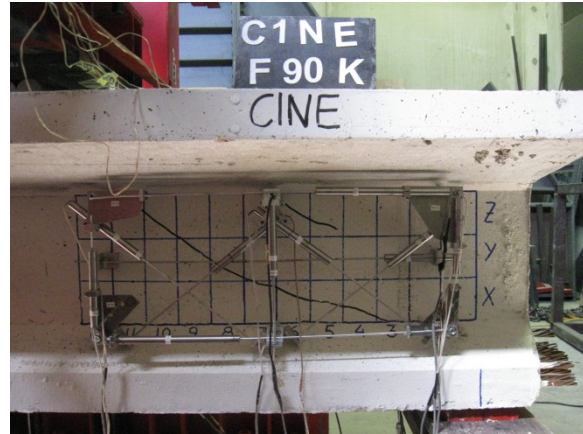
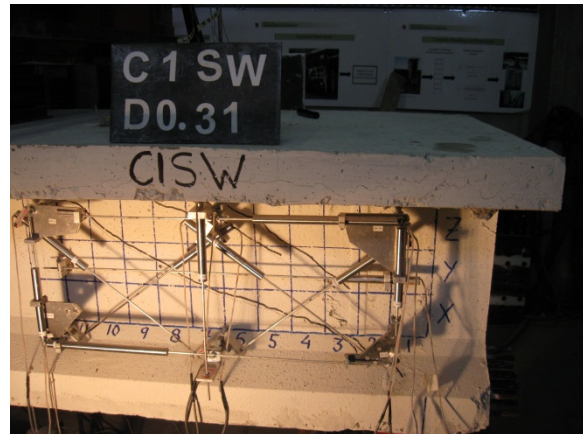
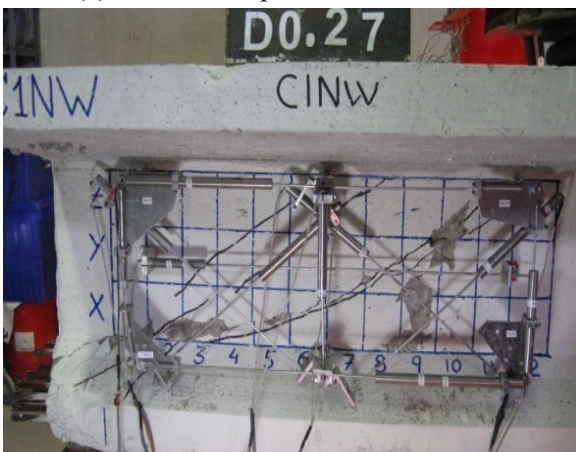
(b) First shear crack at 75 kips

(d) Shear crack pattern before failure

(e) Shear failure at 187.50 kips

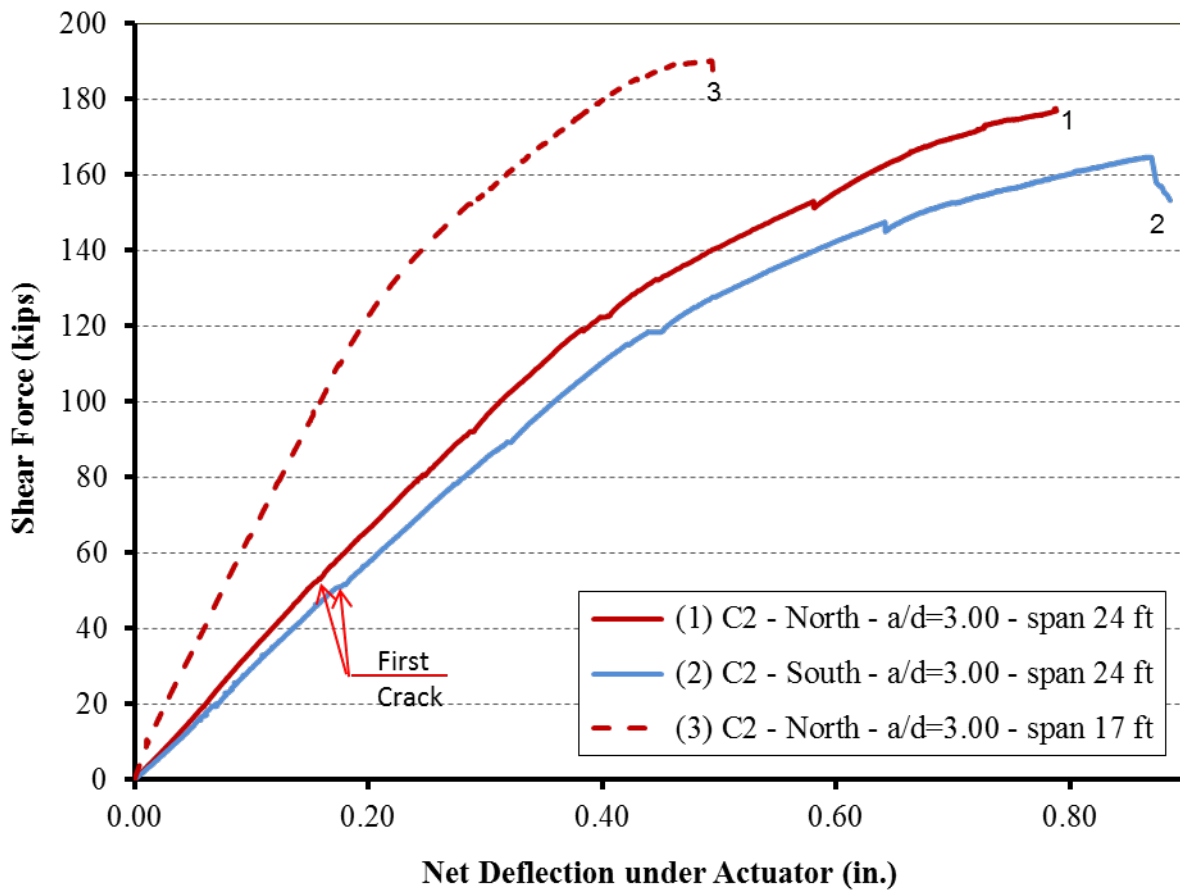
Fig. 4.40 Shear Force vs. Girder Deflection Curves for Girder C2

Girder C2 was tested to fail in the flexure shear mode with a shear span to effective depth ratio $a/d = 3.00$. Fig.4.40 shows the plot of shear force and corresponding girder net deflection during the first and second tests. The first shear crack appeared at 60 and 53 kips at the north and south ends of the girder, respectively, as shown in Fig. 4.41(a) and (b). By increasing the applied loads on both ends, new shear cracks have been shown in the web, as shown in Fig. 4.41 (c) and (d). Owing to a casting problem at the south end of this girder having concrete with higher water-to-cement ratio and higher slump than the north end, and the cracks developed more during the test at the south end, which resulted finally in a failure at the south end first. Also, some flexure cracks have been shown in the bottom flange. Flexure cracks in the bottom flange demonstrated that the girder was going to fail in flexural shear.

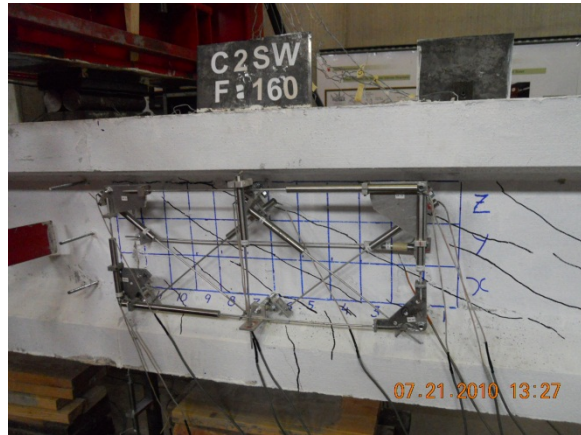
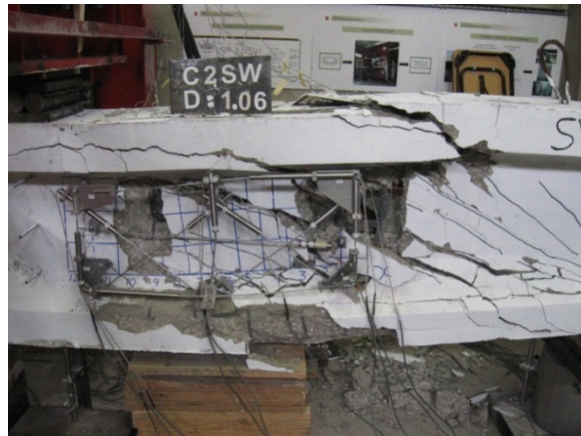
Fig. 4.41 Shear Crack Pattern and Failure Mode of Girder C2

(d) Shear crack pattern before failure

(f) Shear failure at 164.60 kips

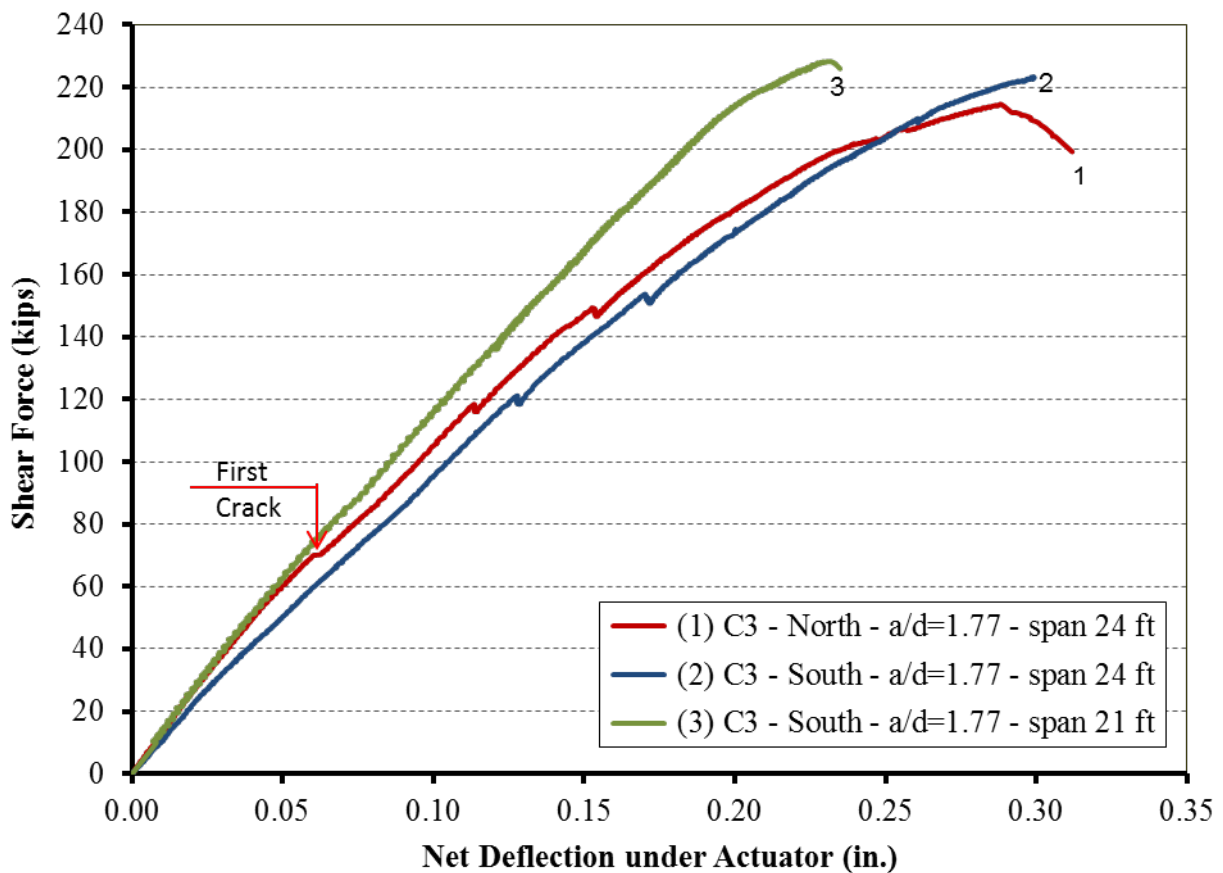
Fig. 4.46 Shear Force vs. Girder Deflection Curves for Girder C3

Girder C3 was tested to fail in web shear mode with a shear span to effective depth ratio $a/d = 1.77$. The first shear crack appeared at the north end was observed at 71 kips, and it is reflected on the shear load versus net deflection, shown in Fig. 4.46-curve 1, while the first crack was observed at the south end at 75 kips, which did not affect the load deflection curve, as shown in Fig. 4.46-curve 2. Fig. 4.47(a) and (b) show the first shear crack at each end of Girder C3.

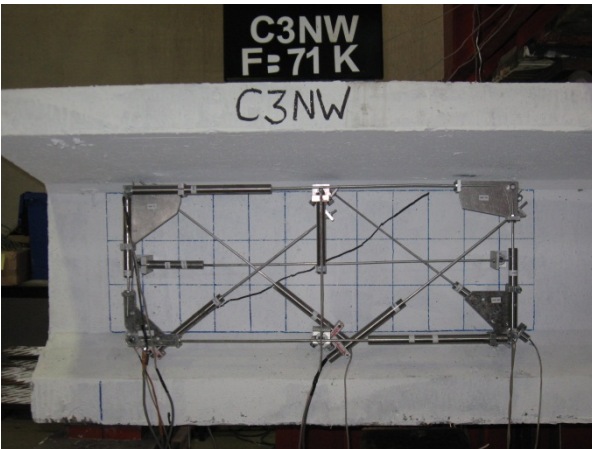
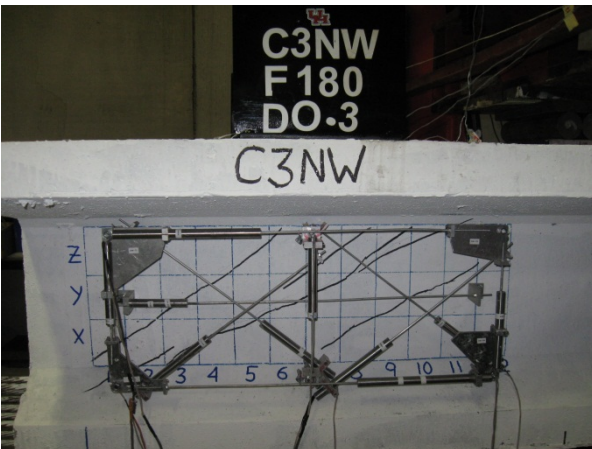
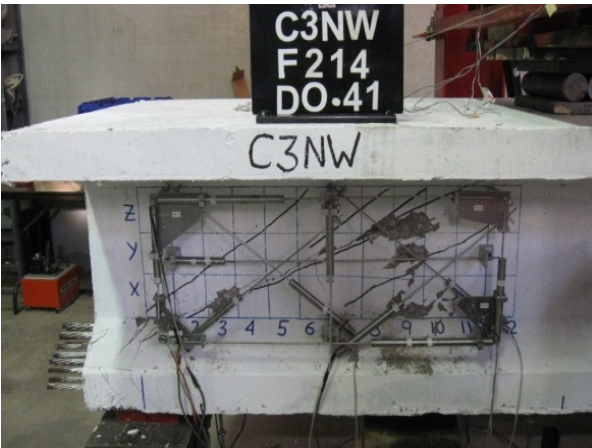
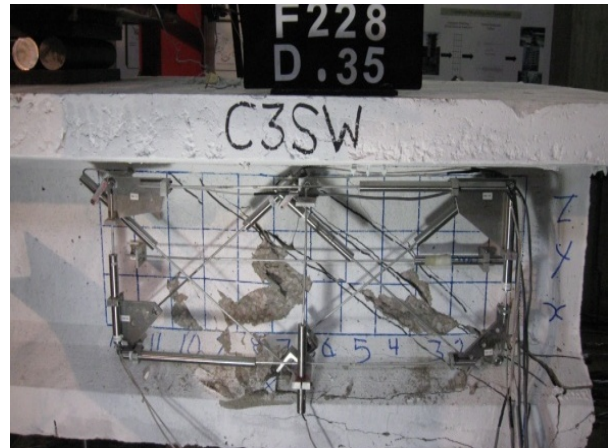
Fig. 4.47 Shear Crack Pattern and Failure Mode of Girder C3

(a) First shear crack at 71 kips

(c) Shear crack pattern before failure

(e) Shear failure at 214.44 kips

(f) Shear failure at 228.24 kips

After the failure of the south end, the south support was moved to get a net girder span of 21 ft., and the south end was retested and failed finally in web-shear, as shown in Fig. 4.47(f), at 228.24 kips shear force, (Curve 3 in Fig. 4.46). In the second test of the south end, the smeared compressive strain nearby the support reached 0.0013 (measured by LVDT D3), as shown in Fig. 4.50(b), and the smeared tensile strain in the perpendicular direction at that region was 0.0033, as shown in Fig. 4.50(a). The measurement of the smeared transverse strain at the middle of studied zone was 0.0037, as shown in Fig. 4.50(c). The increase in the local strain measured by the strain gauges was not as large as in the smeared transverse tensile strain. The average local strain indicated that the average strain in the transverse steel reached $0.90 \epsilon_y$ at failure.

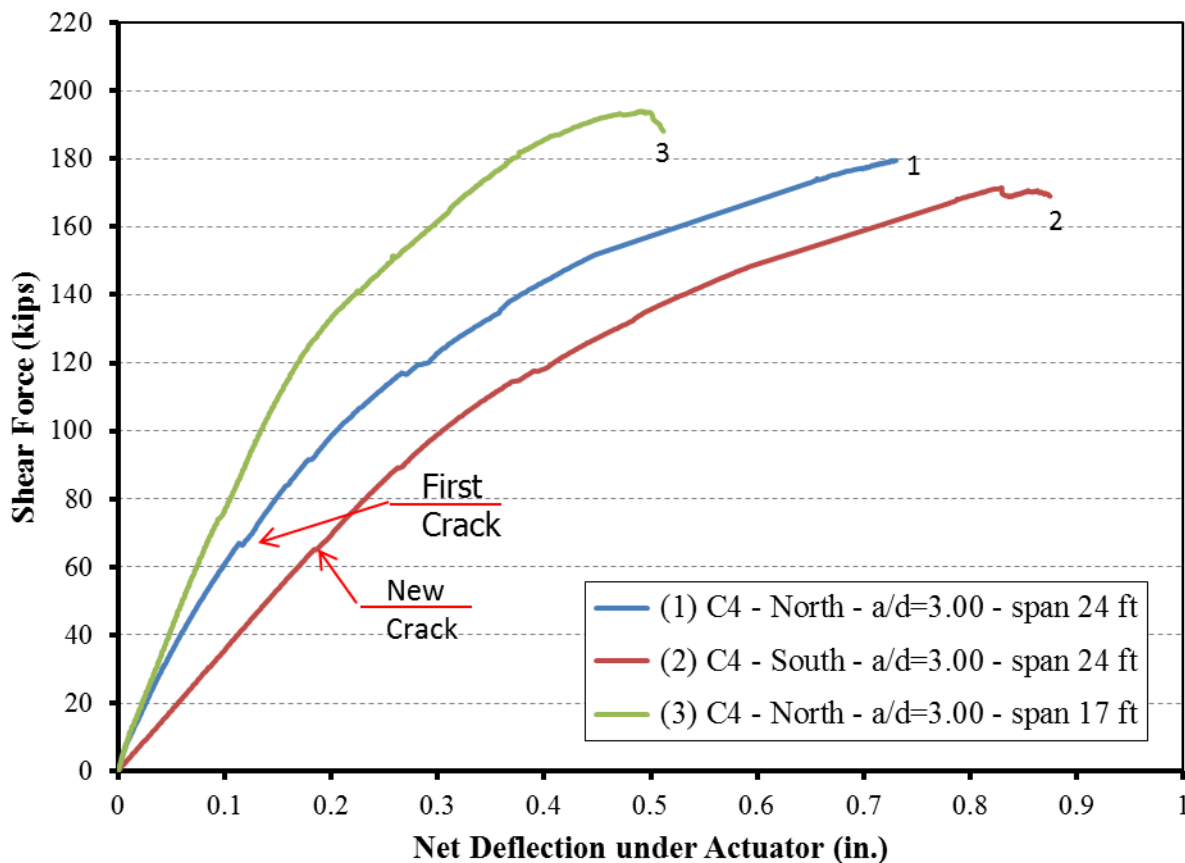
Fig. 4.52 Shear Force vs. Girder Deflection Curves for Girder C4

Then Girder C4 was tested similar to Girder C2 by loading it at both ends simultaneously using a shear-span-to-depth ratio of 3.00. Fig. 4.52 shows the shear load versus net deflection at both ends during the first test until the failure of the south end, and at the north end during the second test. The first shear crack appeared at 65 kips at the north end of the girder, as shown in Fig. 4.53 (a). Due to improper behavior of the south loading actuator at the beginning of the test, a huge load was applied in a few seconds causing the south end to have multiple cracks in the studied zone, as shown in Fig. 4.53(b), and with increasing the load, new crack appeared closer to the loading point. These multiple cracks affected the initial stiffness of the south end and also the web behavior monitored the LVDT rosette posted on the web, as shown in Fig. 4.54.

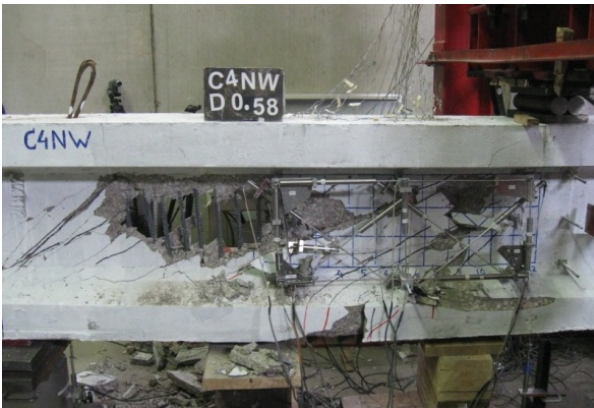
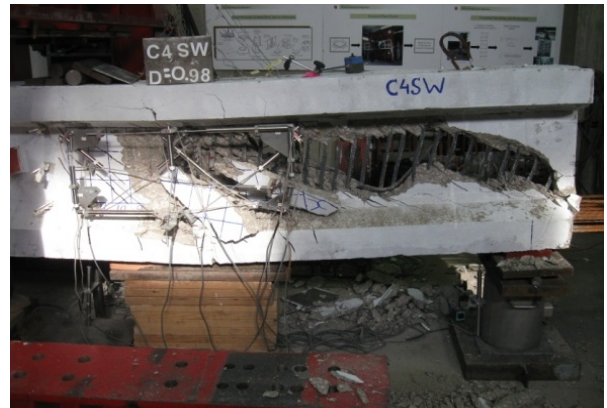
Fig. 4.53 Shear Crack Pattern and Failure Mode of Girder C4

(e) Shear failure at 194 kips

(f) Shear failure at 171.50 kips

However, the first test ended with a flexure shear failure at the south end under a shear load of 171.50 kips, as shown in Fig. 4.53 (e), due to having a maximum smeared compressive strain of 0.0012 measured by LVDT D3, while the corresponding force at the north end was 177.30 kips, with a maximum smeared compressive strain at the same location of 0.0007, as shown in Fig. 4.54 (b). However, the average smeared tensile strains across cracks throughout the studied zone at the peak shear load were very close and having a value of 0.0022 and 0.0024 at the north and south ends respectively, as shown in Fig. 4.54(a).

Consequently, the girder was reloaded after moving the south support toward the interior at the failed end to yield a test span of 17 ft., and the north end was retested and failed at 194 kips, (Curve 3 in Fig 4.52), as shown in Fig. 4.53(f). The maximum smeared compressive strain in the concrete struts was 0.0012 measured by LVDT D3, as shown in Fig. 4.56 (b).

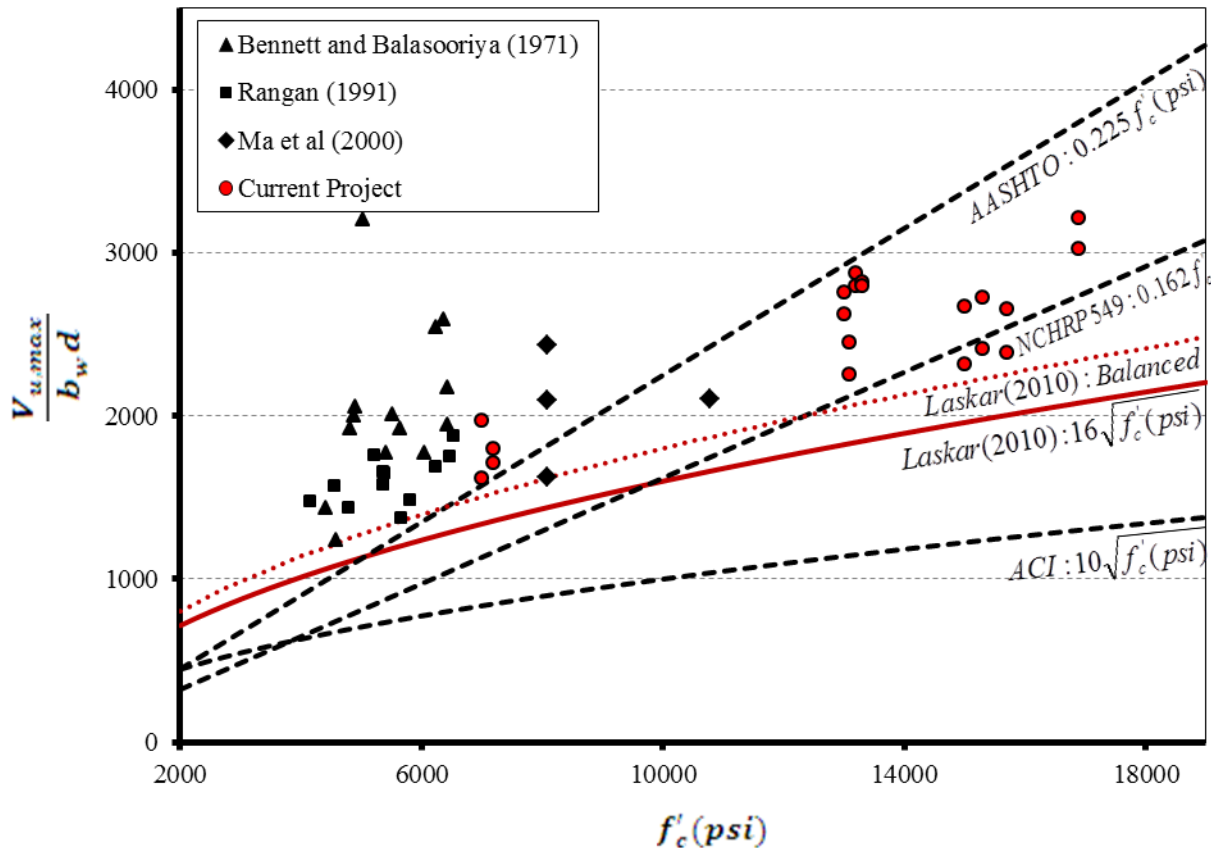
Fig. 4.58 Variation of Normalized Ultimate Shear Strength with Concrete Strength

Girder	a/d	Concrete strength f'_c (psi)	Failure Mode	Experimental Ultimate Shear Strength, (Kips)	
				North	South
A1	1.77	7,000	Web Shear	142.11	116.86
A2	3.00	7,200	Web Shear	129.50	123.23
F1	1.77	13,200	Web Shear	207.67	201.59
F2	2.25	13,000	Web Shear	199.14	189.25
F3	1.77	13,300	Web Shear	202.07	203.45
F4	2.25	13,100	Web Shear	162.70	176.73
C1	1.77	15,700	Web Shear	191.40	172.40
C2	3.00	15,000	Flexure Shear	193.00	167.50
C3	1.77	16,900	Web Shear	218.34	232.14
C4	3.00	15,300	Flexure Shear	196.90	174.40
