1. Report No. FHWA/TX-13/0-6152-2	2. Government Accession No.	3. Recipient's Catalog No.	
4. Title and Subtitle SHEAR IN HIGH STRENGTH CONCRETE BRIDGE GIRDERS: TECHNICAL REPORT		5. Report Date Published: April 2013

**SHEAR IN HIGH STRENGTH CONCRETE BRIDGE GIRDERS:
TECHNICAL REPORT**

Project 0-6152

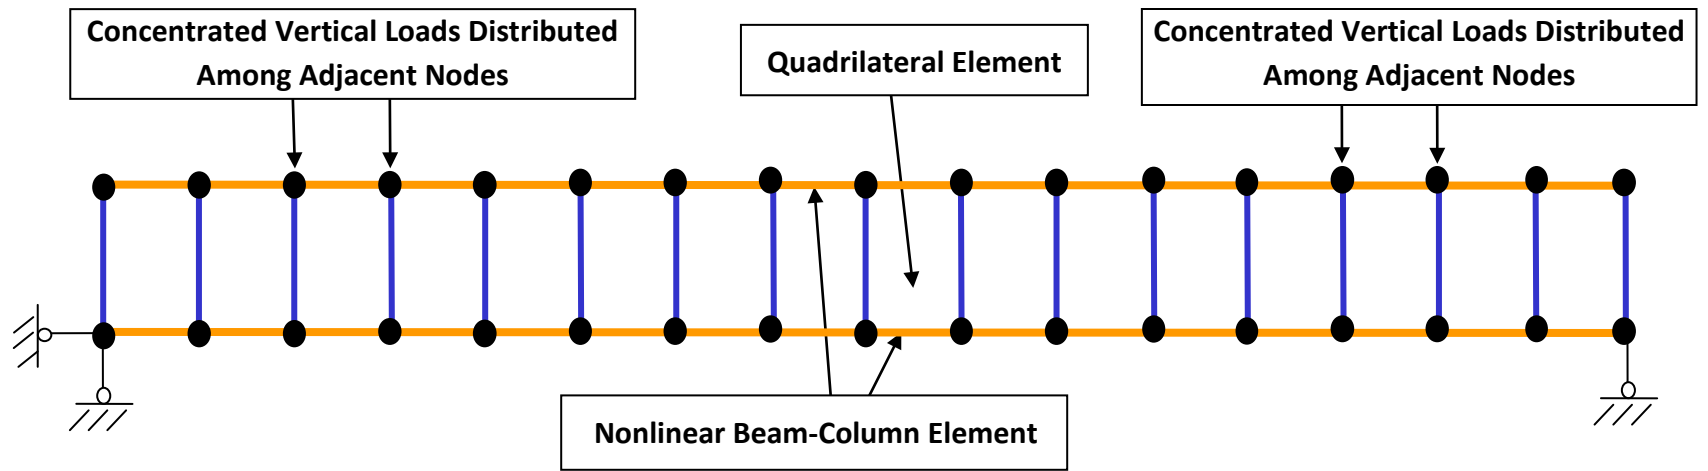
Fig. 5.3 Finite Element Mesh of Girder Specimens A1, F1, F3, C1, and C3

The top flange in these girders is discretized into 84 fibers of concrete and 10 fibers of steel. The bottom flange is discretized into 60 fibers of concrete and eight fibers of prestressing tendons, as shown in Fig. 5.6. In fact, the real girders are reinforced in flexural using 14 prestressing tendons, eight of them are discretized as fibers in the NonlinearBeamColumn elements representing the bottom flange and the remaining six tendons are provided in the PCPlaneStress quadrilateral elements used to represent the webs of these specimens.

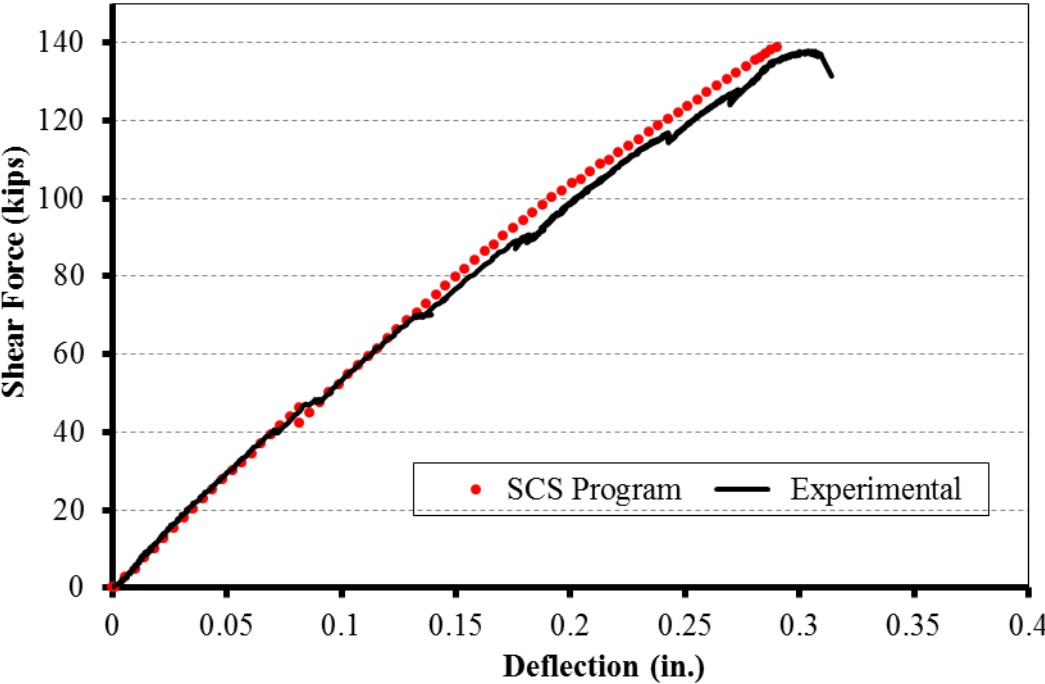
Fig. 5.7 Analytical and Experimental Load-Deflection Curves of Girder A1

Comparison between the analytical and experimental shear force versus net deflections are shown in Figs. 5.7 to 5.13. The comparison shows the capability of the SCS program to accurately predict the cracking shear load, and pre-cracking and post-cracking behavior. In general the predicted capacity is very close to the experimental capacity except in the case of Girder C1 where the experimental capacity is too low comparing to the predicted capacity for the given cylinder concrete strength, which means that the concrete strength of the girder was lower than expected, which might be due to lack of compaction during casting.

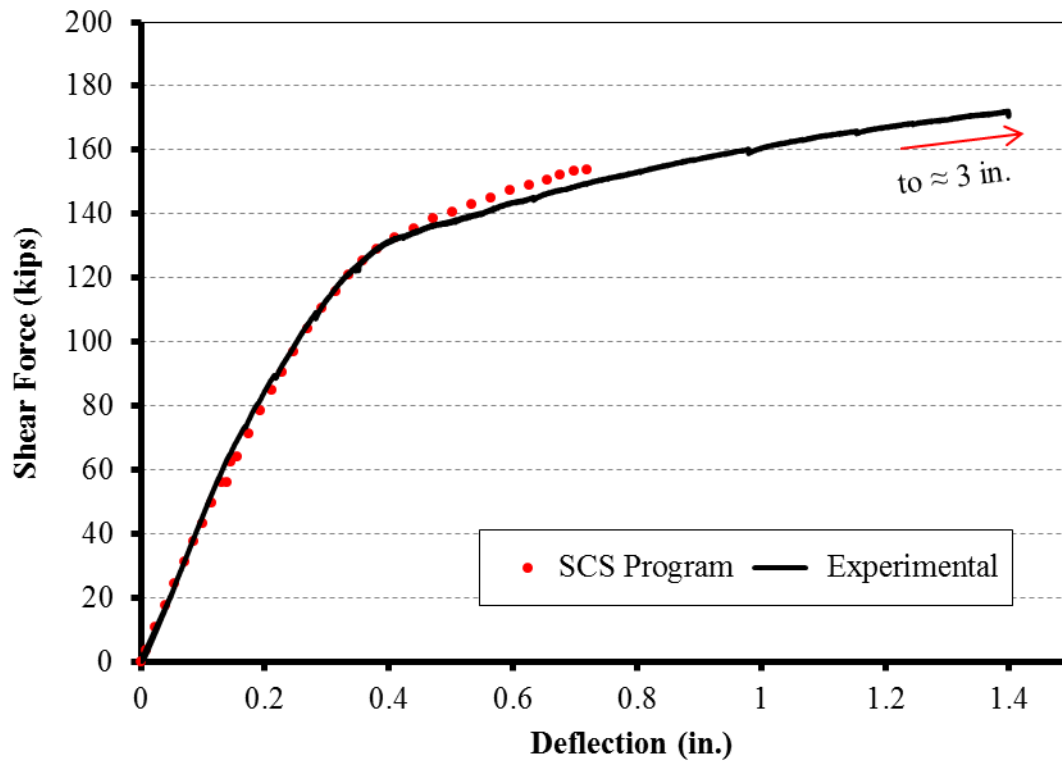
Fig. 5.20 Analytical and Experimental Load-Deflection Curves of Girder F2

The comparison between the analytical and experimental shear force versus net deflections are shown in Fig. 5.20. It can be seen that SCS could not simulate the entire behavior of the girder and stopped earlier, because this girder was going to fail in flexure, which cannot be fully simulated using the current membrane element.

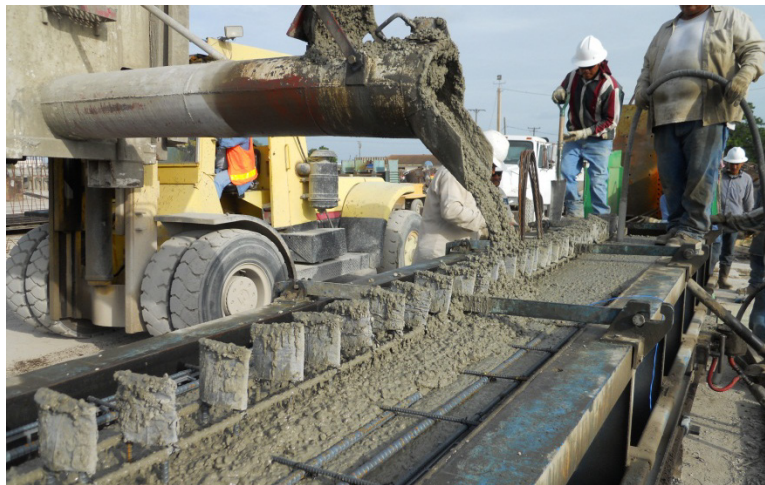
Fig. 6.15 Concrete Placement Using a Hopper

The concrete mix was prepared in a plant mixer, transported to the casting site, and deposited into the formworks using a mobile hopper, as shown in Fig. 6.15. The average slump for the girders was 8.50 inch. During casting, spud vibrators were used to compact the concrete as well as bed vibrator fixed on the side forms, as shown in Fig. 6.16. Seven standard concrete cylinders six inches in diameter and twelve inches in height were cast per girder. Just prior to the actual girder tests, the concrete cylinders were tested to get the representative concrete compressive strength of the girder.

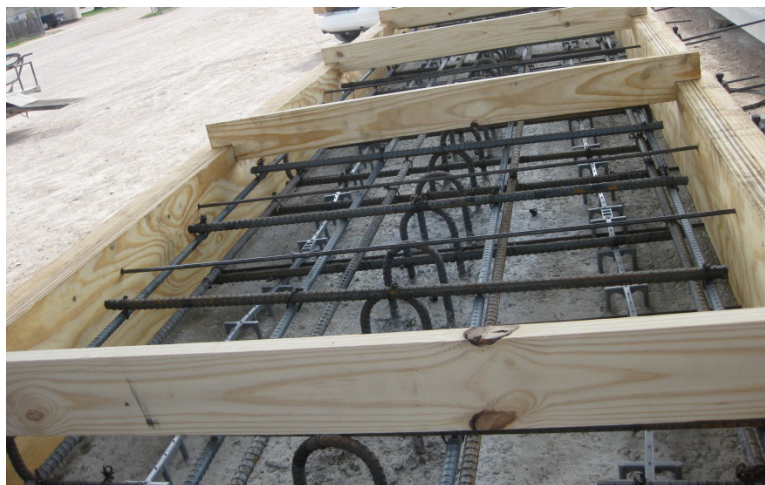
Fig. 6.17 Reinforcement Cage for Top Slab

Then the formwork and the reinforcement cage for the top slab were prepared for the first three girders, as shown in Fig. 6.17. Then the concrete was prepared and placed as explained before and compacted using the spud vibrators. Four standard concrete cylinders four inches in diameter and eight inches in height were cast per each girder's slab. Just prior to the actual girder tests, the concrete cylinders were tested to get the representative concrete compressive strength of the top slab.

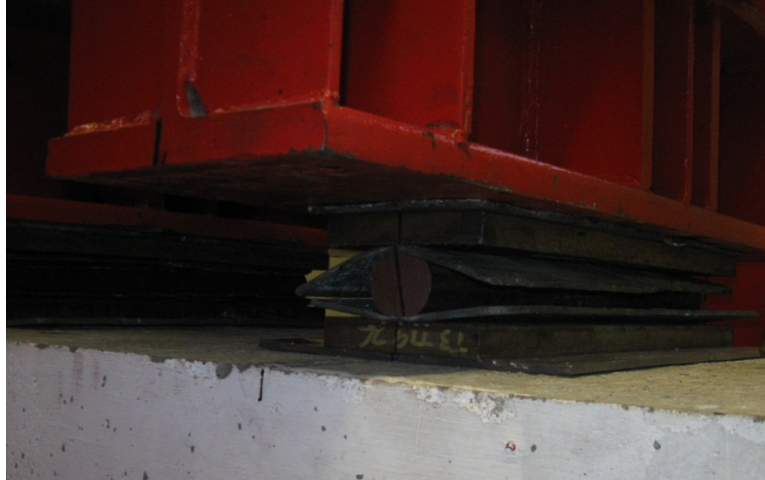
Fig. 6.19 Details of Loading Set-up

Each hydraulic actuator shown in Fig. 6.18 has one horizontal pin that allows the bottom head to rotate due to the girder's curvature, which corresponds to the specimen deflection. The rotation of the bottom head of the actuator results in horizontal force at the top surface of the girder. To compensate this horizontal force, one high strength rod $2\frac{3}{8}$ inches in diameter was used between the actuator and the top surface of the girder. This single rod has been used with two thin lead sheets at top and bottom to minimize the rod's rolling, as shown in Fig. 6.19. This setup works as another hinge at the top of the girder's surface, which helps in transferring the load vertically to the girder and minimizing the horizontal force.

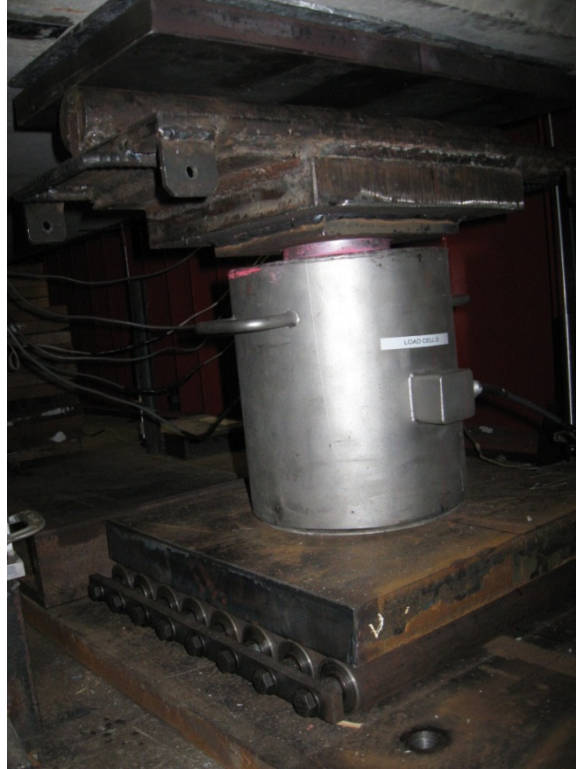
Fig. 6.20 Details of Support

On top of the load cells, bearing plates to support the girder were placed with a hinge on both ends of the girder. Thus, the girder is allowed to rotate freely at both supports and to expand freely along its length.

The bearing plate right underneath the girder has typical dimensions used by TxDOT. For all girders, this plate is 21 inches in length. The plate is 8 inches in width for Tx28 and Tx46 while it is 9 inches in width for Tx62. The thickness of this plate depends on the vertical available clearance. In addition to the precaution taken regarding vertical and longitudinal stability, lateral supports were attached to actuators' frames to provide a lateral stability for the girder in the case of emergency during loading.

Theoretically due to the girder's curvature, the bottom fibers expand toward the support resulting in horizontal force acts on the support. This horizontal force should be eliminated by allowing the support to move with the bottom fiber's expansion, otherwise this horizontal force may result in losing stability because of the girder sliding over the load cell.

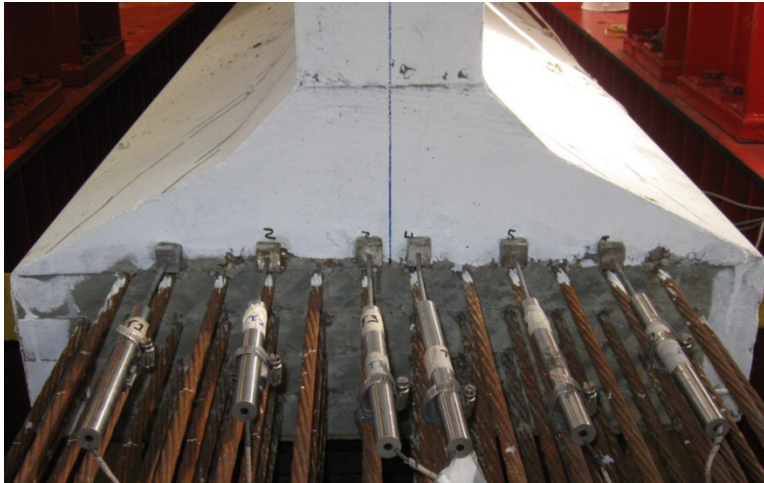
Fig. 6.23 LVDTs to Measure Slip

Eight LVDTs were positioned on selected tendons against the concrete surface to measure their slip. Because the shear bond failure is known for the crushing of concrete at the intersection between the bottom flange and the web, which indicates that the most effective tendons are the closest ones to that location, six LVDTs were posted on selected tendons of the closest row to the web against the concrete surface. Two additional LVDTs were posted on the closest two tendons to the web center in the bottom row. Fig. 6.22 shows the LVDTs' location on both the north and south ends for each girder. These LVDTs were leveled and tied mechanically to the selected tendons against the concrete surface to ensure their free movement with the tendons in the case of any slippage, as shown in Fig. 6.23.

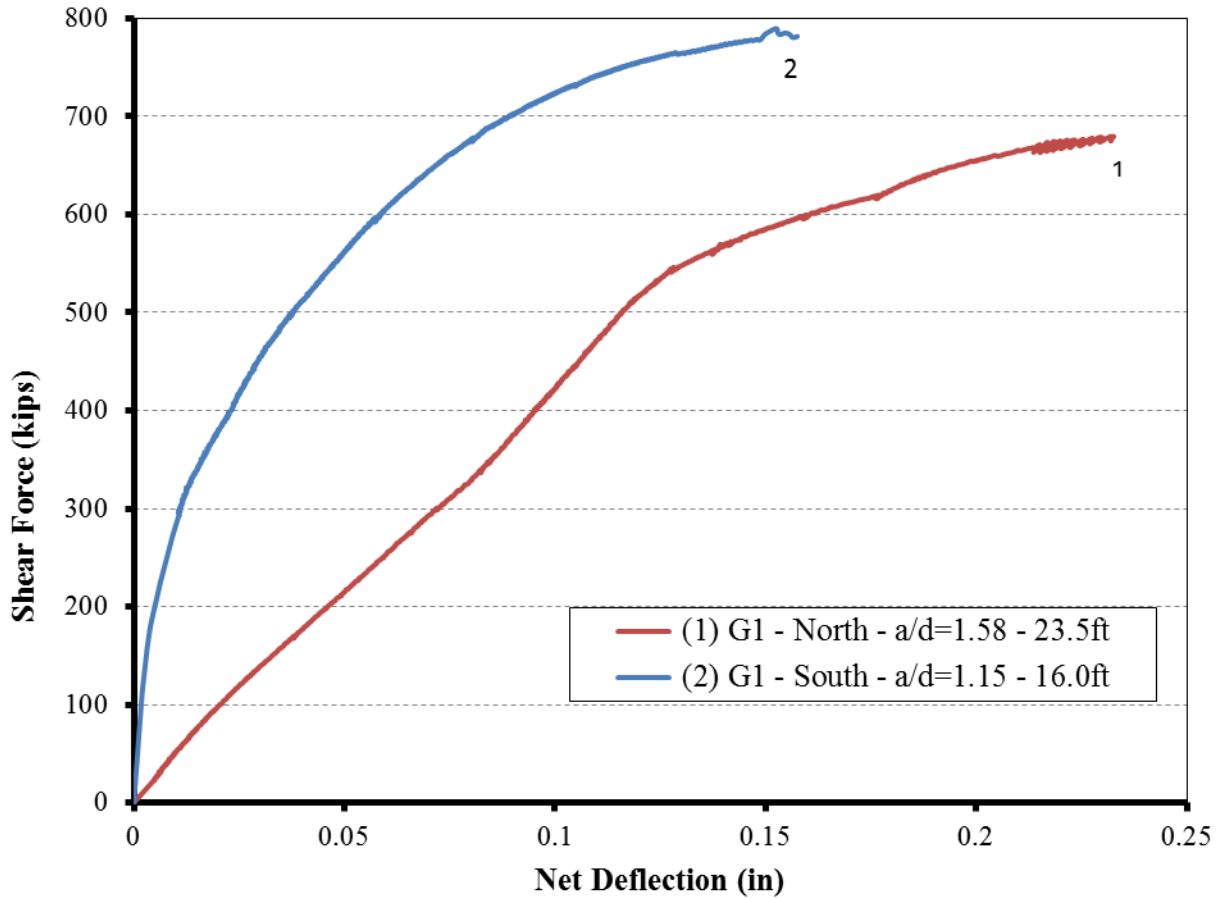
Fig. 7.1 Shear Force vs. Beam Deflection Curves for Girder G1

The north end of Girder G1 was tested first with shear span to depth ratio (a/d) 1.58. Because the failure affected the stability of the girder, it was decided to retest the girder on the south end after moving north support after the zone of failure resulting in a net span of 16 ft. The girder was loaded on the south end having shear span to depth ratio (a/d) 1.15. Fig. 7.1 shows the shear force versus the net deflection for both ends. It can be seen that the south end had a stiffer curve due to using shorter span and smaller shear span to depth ratio.

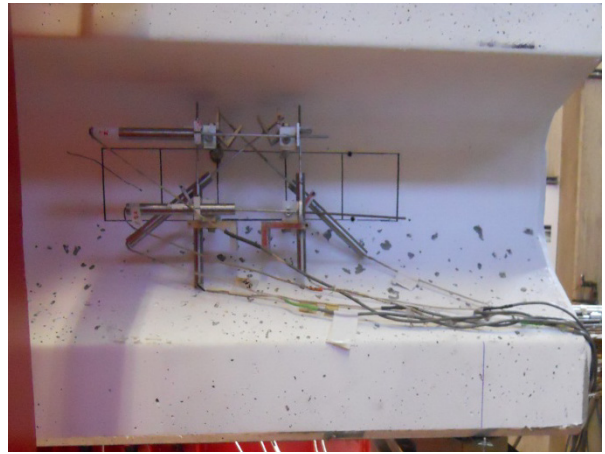
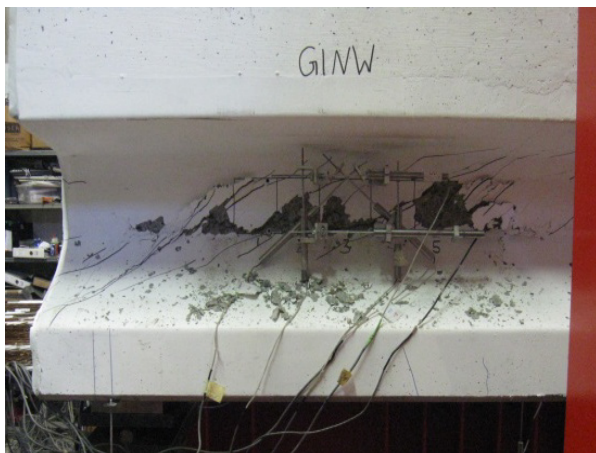
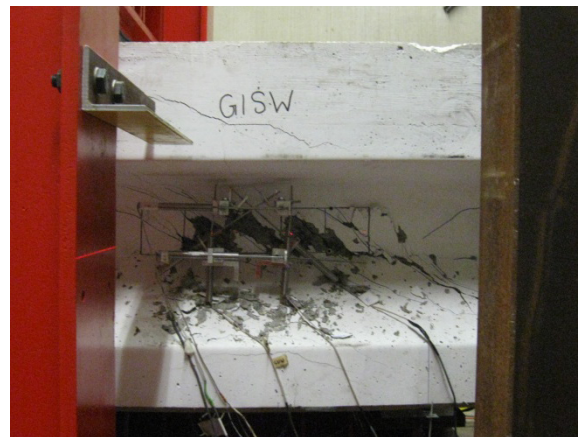
Fig. 7.2 Shear Crack Pattern and Failure Mode of Girder G1

(b) First shear crack at 213 kips

(e) Shear failure at 679.65 kips

(f) Shear failure at 789.66 kips

The first shear crack has been seen at the north end at shear load 206 kips, Fig. 7.2 (a). With increasing the load, cracks were observed on the south end at a shear force on the north end around 500 kips while the corresponding shear force at the south end was around 120 kips. With increasing the applied load on the north end shear cracks were seen at the south end, as shown in Fig. 7.2 (b). After the failure of the north end and moving the north support, the south end was reloaded to have the first new crack at shear force 213 kips. Fig. 7.2 (c) and (d) shows the final crack pattern at each end before failure.

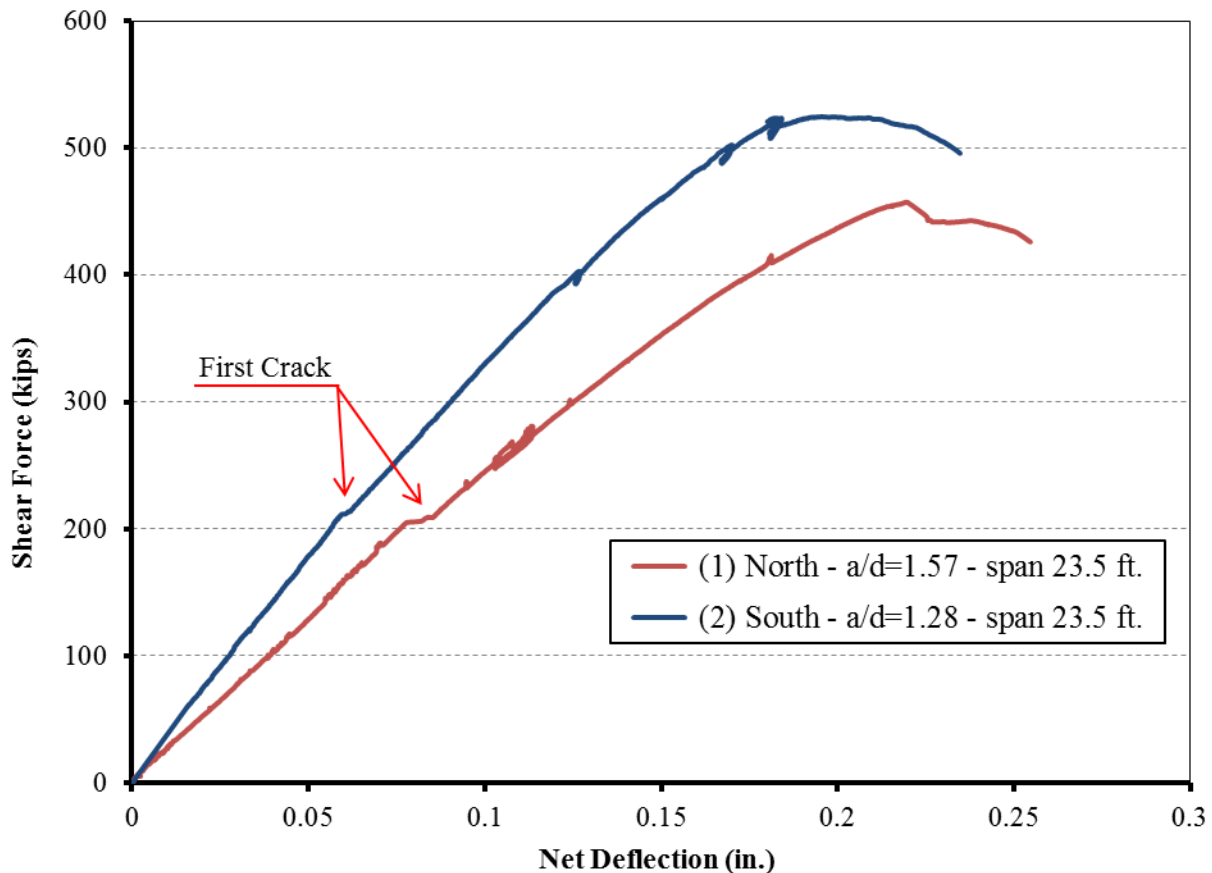
Fig. 7.8 Shear Force vs. Beam Deflection Curves for Girder G2

The north end of Girder G2 was tested first with shear span to depth ratio (a/d) 1.57. Because the failure did not affect the stability of the girder, it was decided to continue retesting the south end having the same net span without moving the north support. The girder was loaded on the south end with a shear span to depth ratio (a/d) 1.28. Fig. 7.8 shows the shear force versus the net deflection for both ends. It can be seen that the south end had a stiffer curve due to using a smaller shear span to depth ratio.

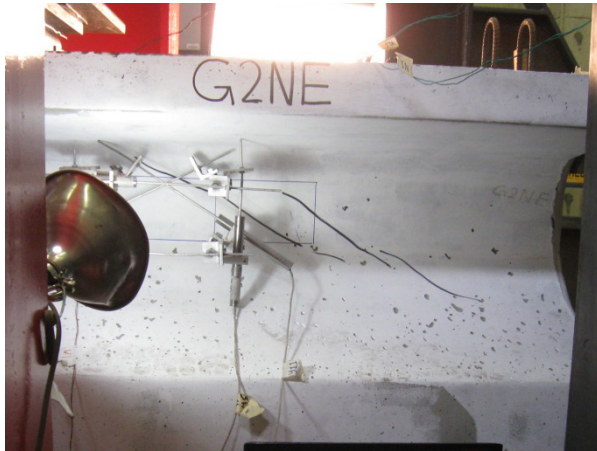
(a) First shear crack at 206 kips

The first shear crack was seen at the north end at a shear load 206 kips, as shown in Fig. 7.9 (a). With increasing load, more cracks were developed in the web as seen in Fig. 7.9 (c) until the girder failed in web-shear at a shear load of 457.22 kips, as shown in Fig. 7.9 (e). During loading the north end no cracks were observed on the south end, which had a first crack at shear load of 213 kips while loading it. With increasing load at the south end, more cracks were developed in

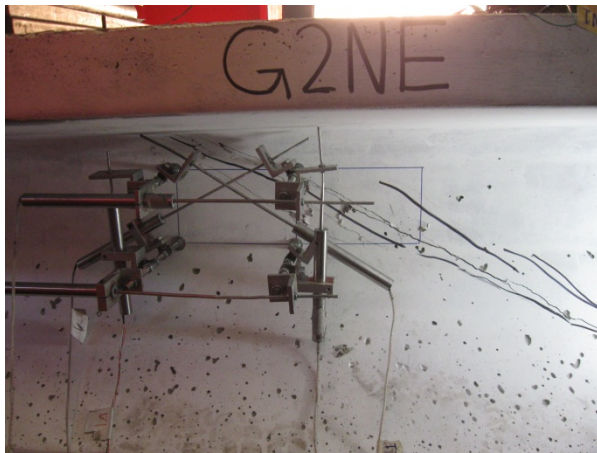
(c) Shear crack pattern before failure

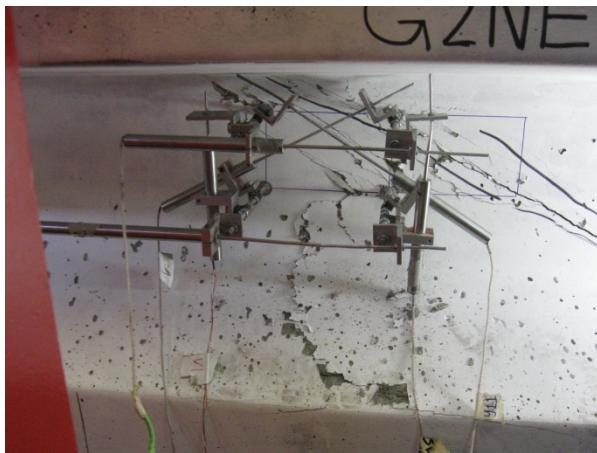
(e) Shear failure at 457.22 kips

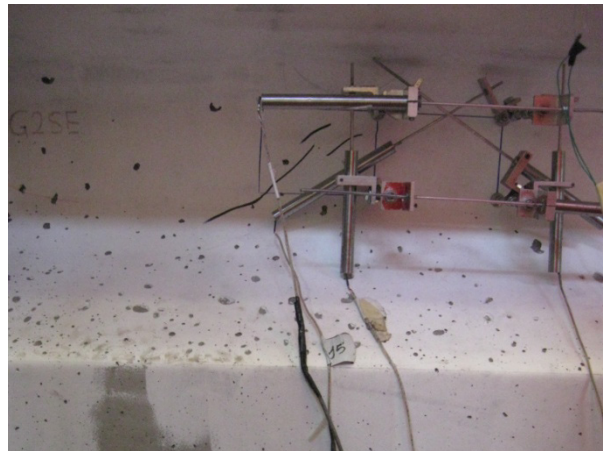
(b) First shear crack at 213 kips

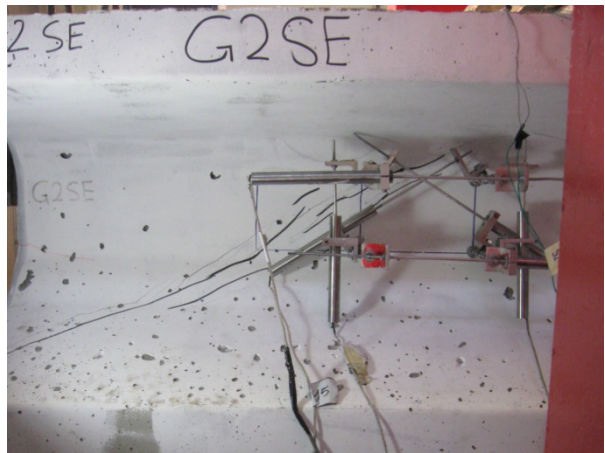
(d) Shear crack pattern before failure

the web as seen in Fig. 7.9 (d) until the girder failed in web-shear at a higher shear load of 524.64 Kips, shown in Fig. 7.9 (f), due to having a smaller shear span to depth ratio.

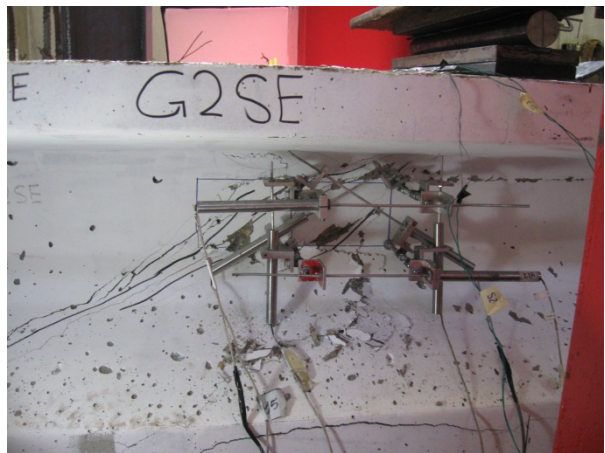
(f) Shear failure at 524.64 kips

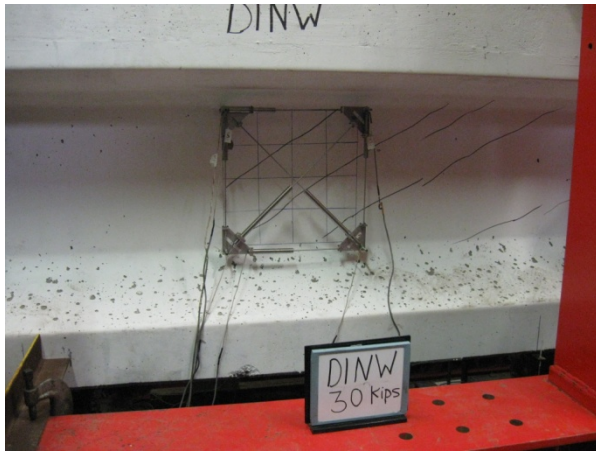
(a) Crack pattern at the start of north end testing

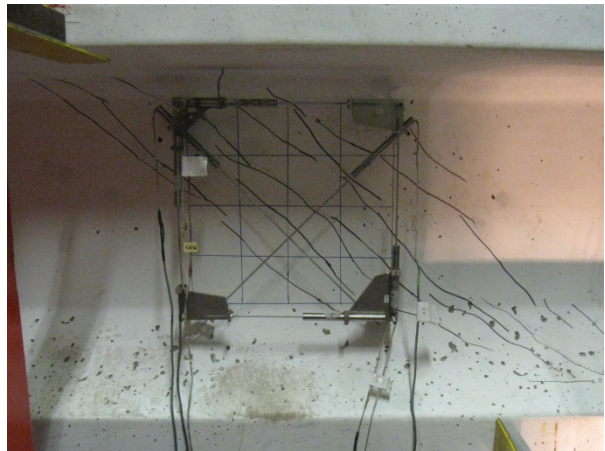
(d) Shear crack pattern before failure

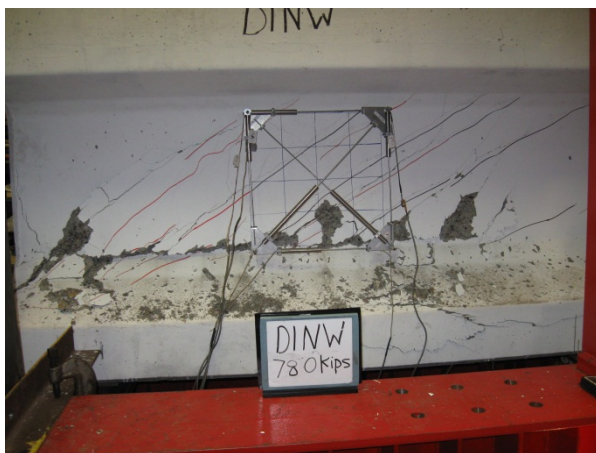
(e) Shear failure at 779.80 kips

The first shear crack was seen at the south end at a shear force of 241 kips, as shown in Fig. 7.16 (b). With increasing the applied loads, new cracks were shown at the north end at a shear force of 170 kips on the north load cell. Fig. 7.16 (c) shows the final crack pattern the south end before the failure happen at a shear force of 912.78 kips. Then the girder was reloaded at the north end; new shear cracks were observed at a shear force of 190 kips, as shown in Fig. 7.16 (f). Fig. 7.16 (a) shows the old cracks due to the south end testing in black and the new crack due to the north end testing in red. Fig. 7.16 (c) shows the final crack pattern at the north end before the web crushing at shear force of 779.80 kips, as shown in Fig. 7.16 (e).

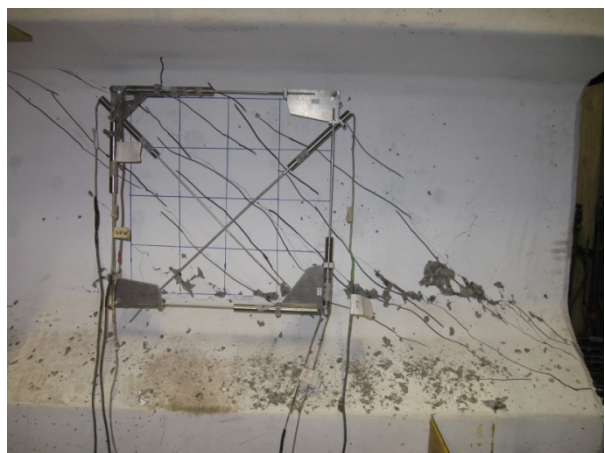
(f) Shear failure at 912.78 kips

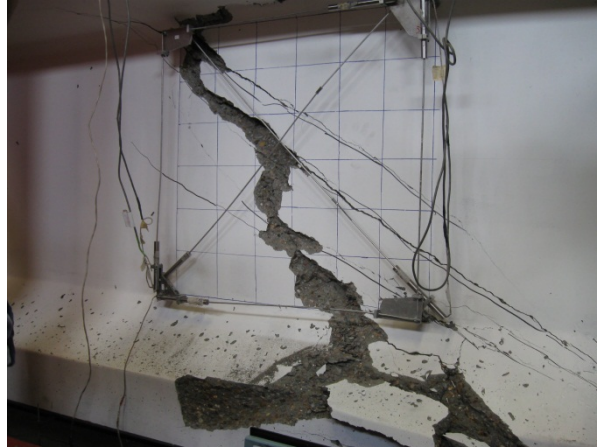
(c) Shear failure at 756.42 kips
