BRIDGE DECK DETERIORATION

A SUMMARY OF REPORTS

Research Report 130-11F

A Study of Reinforced Concrete Bridge Deck Deterioration:  
Diagnosis, Treatment, and Repair  
Research Study 2-18-68-130

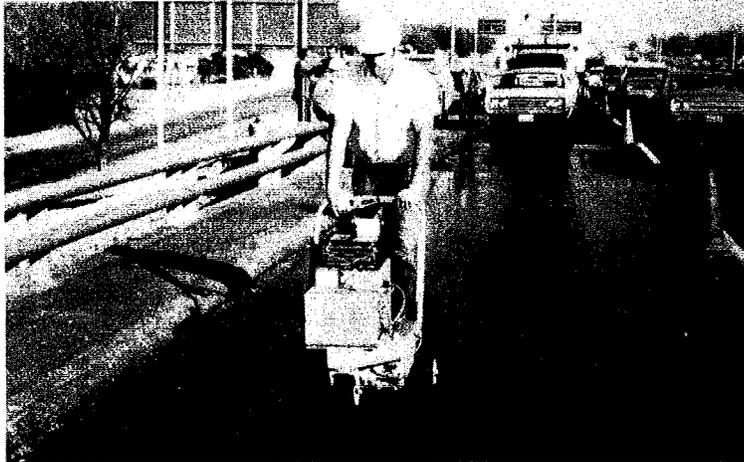
FIGURE 1: Instrument developed to detect delamination on bridge decks. It can be disassembled and stowed in an automobile trunk.

Probably the most serious form of deterioration commonly found in reinforced concrete bridge decks is delamination which ultimately results in large scale spalling. This type of failure occurs most frequently where salt is used for winter deicing and is believed to result chiefly from salt induced corrosion of the reinforcing steel (11, 12, 13, 14). The Delamination Detector, which is a device for locating this type of failure, was developed in this study (4). (See Figure 1). It is roughly the size and shape of a power lawn mower and has been found to be reliable and easy to operate.

Verification of the ability of the Delamination Detector to detect delamination was made by coring two locations in each of ten bridge decks, one in an indicated and another in a non-indicated area. Complete agreement was obtained. The delaminations in these bridge decks varied in depth from 1/2 to 4 1/2 in. Several of the decks had asphaltic surfacing layers which varied in thickness from 1/4 to 3 1/2 in. These successful tests were thought to be very significant because the distinctive "hollow sound" produced by conventional sounding techniques is greatly diminished when delaminations in a deck become deep or when a deck is resurfaced with an asphaltic layer.

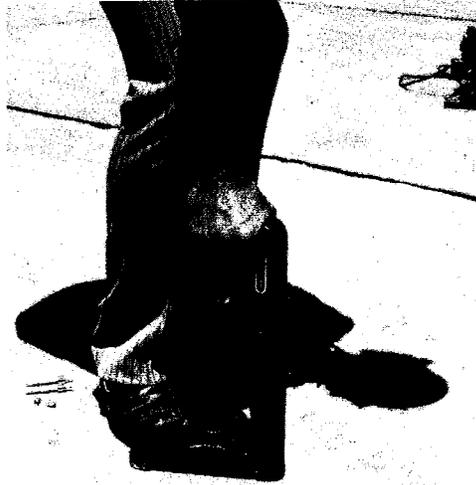
FIGURE 3: A standard stud is shot into concrete with the Windsor Probe Test System to determine concrete quality. The average penetration resistance of three shots is measured using a depth gage and special templates.

The Windsor Probe Test System has been used in field investigations to estimate the in-situ strength of concrete in pavements, bridges, walls, pipes, etc. (15, 16, 17). The device is easy to use and requires no surface preparation prior to testing. Basically the tests consist of shooting a standard probe into the concrete with a standard explosive cartridge. The depth of penetration is determined by measuring the height of the exposed probe. A special gun or driver unit is provided for shooting the probes (Figure 3). Gage plates are also provided to facilitate the measurement of the average height of the exposed probes in a standard group of three shots. The higher the probes, i. e., the more resistant to penetration, the stronger the concrete.

Cores were taken from many different slabs which had been measured with the Windsor Probe. The average probe heights were found to be weakly correlated with the measured compressive core strengths. In a linear

The system is believed to be practical for bridge deck survey measurements to locate deteriorated areas. The test is slightly destructive. In addition to the small hole made by the probe penetration, a spall about 6 in. in diameter and up to 3/4 of an in. deep at the center is often produced by the test.

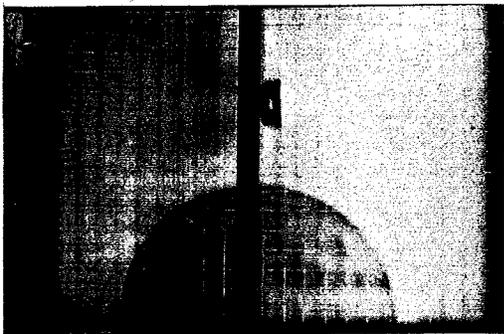
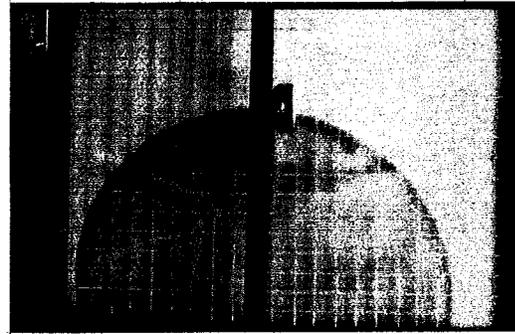
1 minute

3 minutes

5 minutes

10 minutes

Figure 8. Simulated Crack, 0.010 inch, Injection Pressure at 50 psi.
