CYCLIC LOAD TESTS
OF
COMPOSITE PRESTRESSED-REINFORCED CONCRETE PANELS

Research Report No. 145-4F

A Study Prestressed Panels and Composite Action in
Concrete Bridges Made of Prestressed Beams, Prestressed
Sub-deck Panels, and Cast-in-place Deck

TEXAS TRANSPORTATION INSTITUTE
Texas A&M University
College Station, Texas

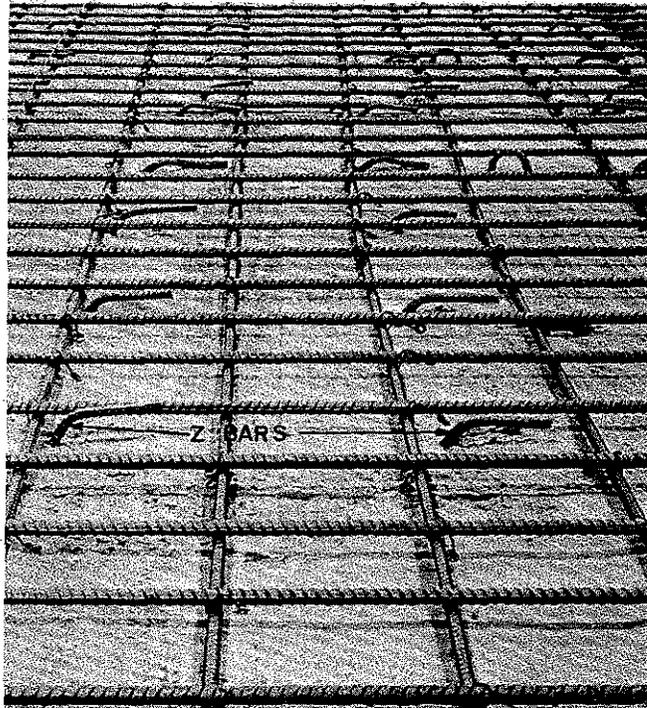
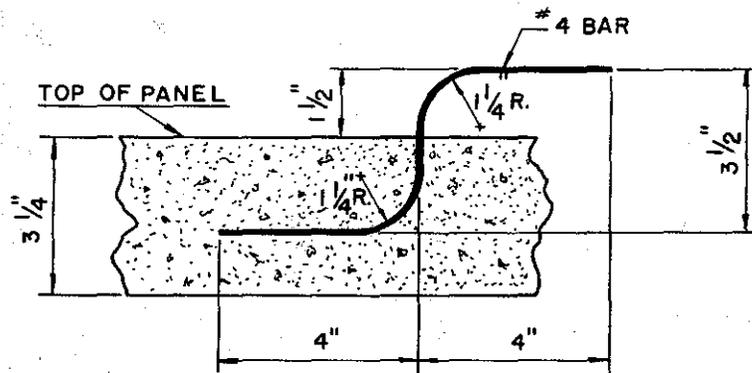
Figure 1. Z-Bars Used in Selected Panels to Aid in Providing Structural Connection Between Panel and Cast-in-Place Deck.

Mechanical interlock was provided between the prestressed panel and the cast-in-place concrete in 3 of the 7 panels. Number 4 reinforcing rods, bent to a rounded Z configuration, were used for the interlock. They were cast in the prestressed panel and were later engaged by the cast-in-place concrete. Details of the interlocking steel elements are shown in Figures 1 and 2. The prestressed panels were given a rough surface finish with a stiff broom. They were cured under wet mat for 6 days after which they were stored in the yard prior to being hauled some 170 miles to the testing laboratory. No curing compound was used on the panels.

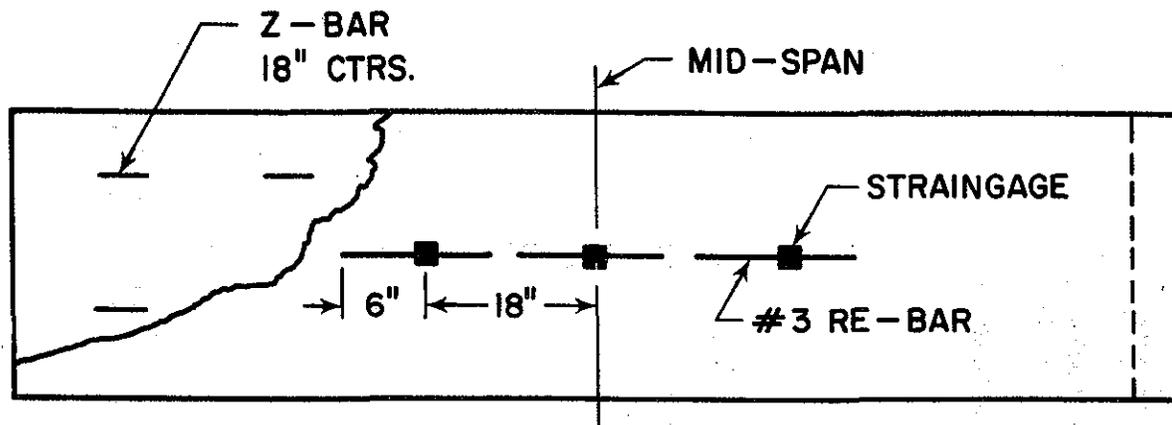
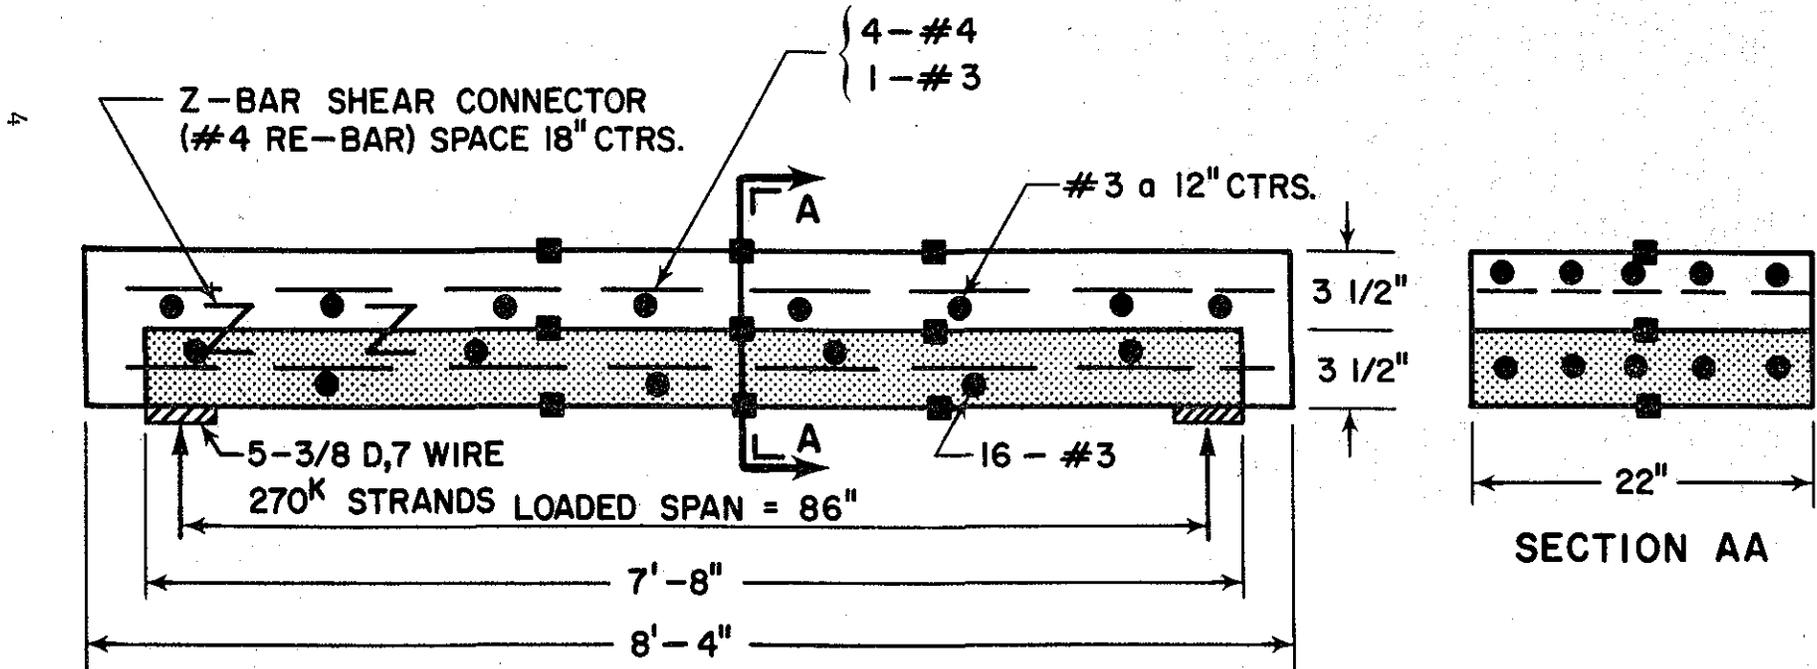
Figure 2. Test Panel Details.

The panels were overlaid with a 3 1/2 inch layer of cast-in-place reinforced concrete when they were 90 days old. The overlay was cured under wet mat for 6 days, and the specimens then remained in open storage until they were tested -- approximately three months after the top layer of concrete was placed. Details of the reinforcing for the cast-in-place concrete are shown in Figure 2. Material properties are shown in Table 1.

the interface of prestressed and cast-in-place concrete and at the top surface of the cast-in-place concrete. They were made by casting a 4 ft long number 3 reinforcing bar in the concrete at these levels. After the concrete cured the embedded rod was ground smooth at its center and 6 in. from each end. The strain gages (6 mm, TML Type FLA-6-11) were then attached and waterproofed, as shown in Figure 2. The output data from the gages were recorded with a Visicorder Recorder.

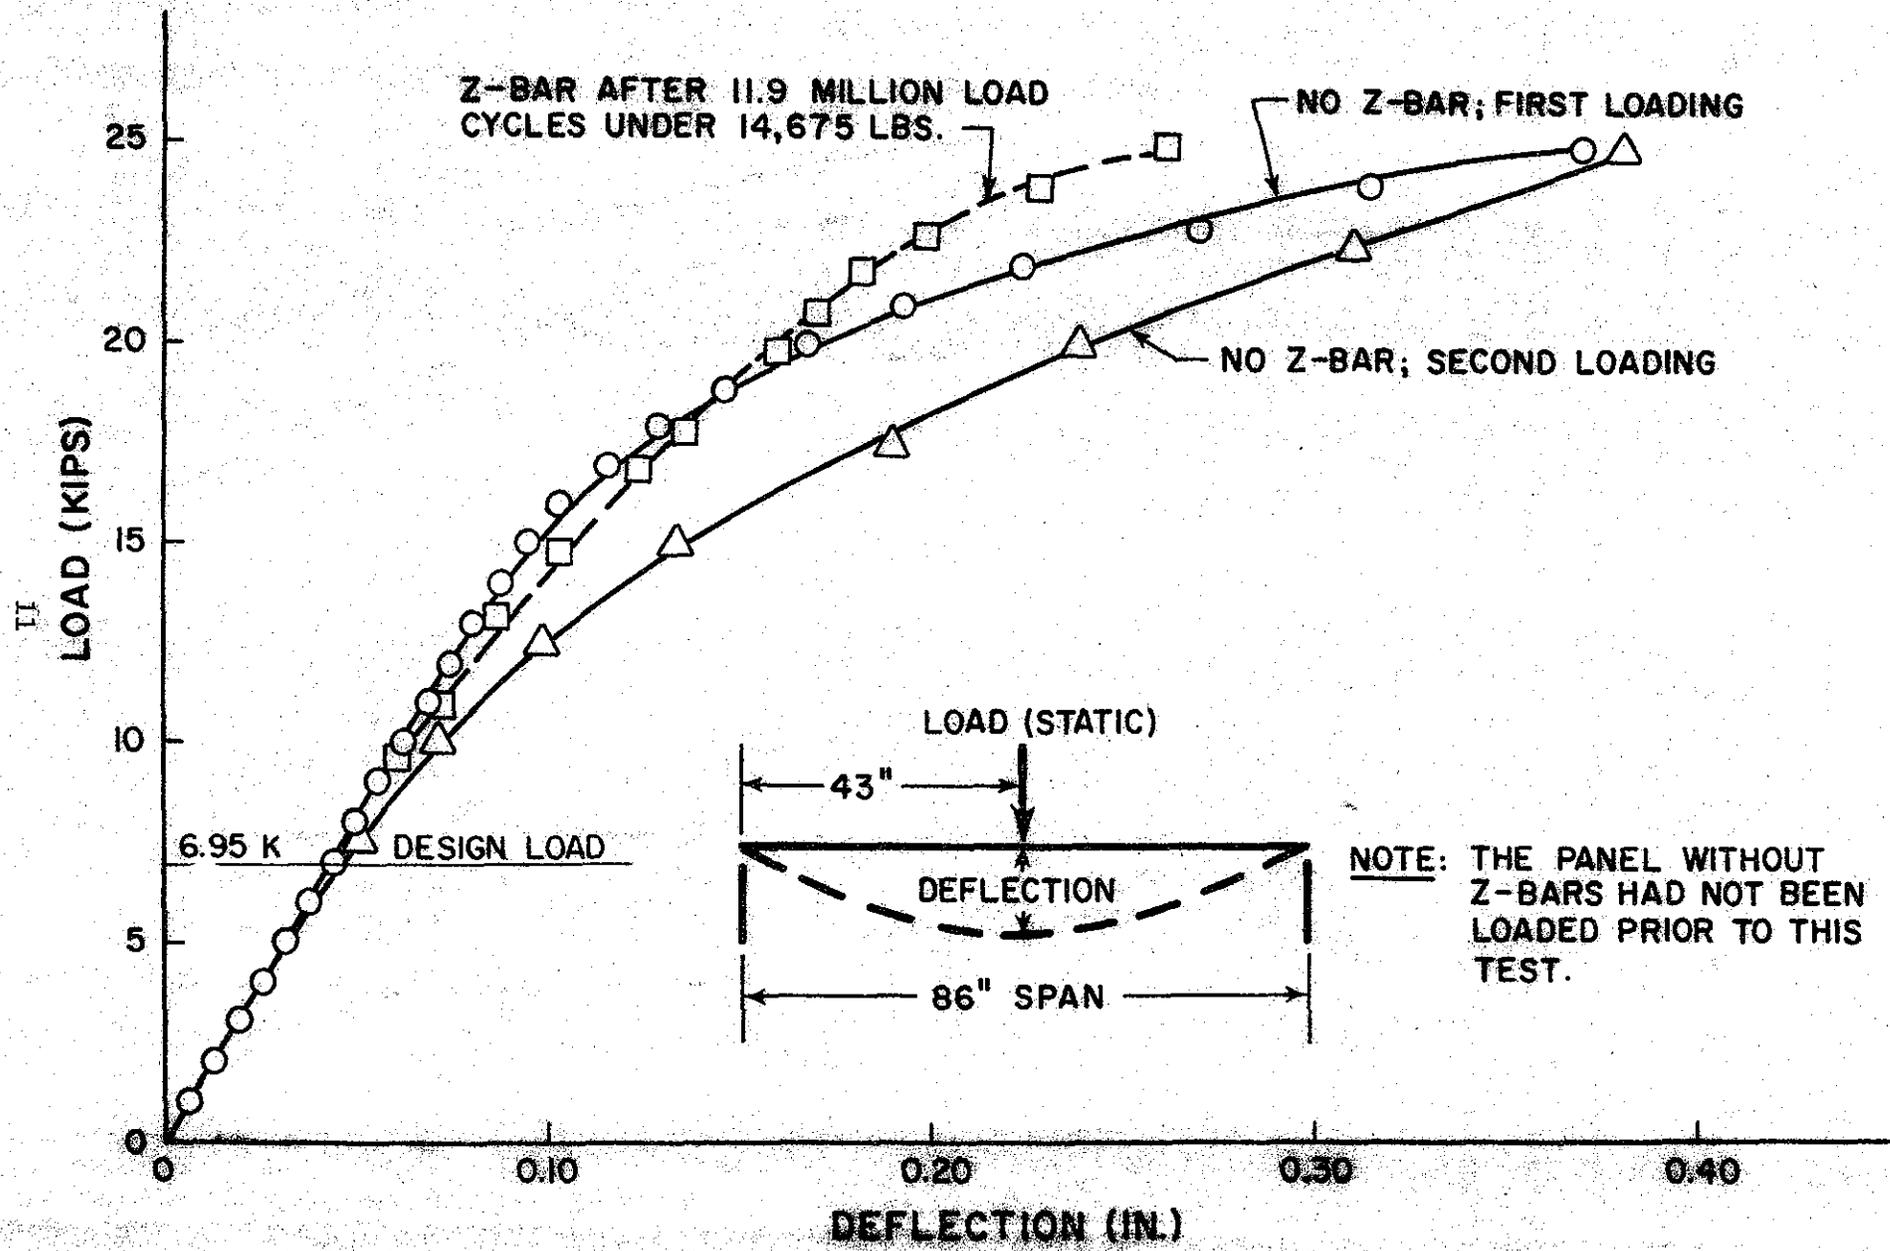
Both panel types behaved essentially the same in static loading up to approximately the design load, Figure 3. At higher loads the panel with Z-bars displayed greater stiffness than the one without Z-bars. The Z-bar slab had previously undergone almost 12 million load cycles at 210 percent of design load. The panel without Z bars had never been loaded before the static tests. Cracks in both panels closed when the load was removed.

Figure 3. Static Load-Deflection Curves.

Closure of tension cracks in the panels indicates that the steel was still elastic. Some additional load could have been carried before a rupture type of failure, but it is not likely that the designer would permit more deflection than the span-to-deflection ratio of $86 \div 1/4 = 344$ that was developed in these tests. The panels would be much stiffer if they were continuous over end supports with other deck panels. Under this latter condition, greater load could be carried for the same deflection, but the horizontal shear at the bonded interface would increase with the load.

deflection had been permitted, greater loads could very likely have been carried. The load deflection curve of the static tests appear to have reached the typical "after cracking" stage (1) with at least some reserve strength for additional load. But, behavior under heavier cyclic loading has not been carried out to a sufficient number of cycles to determine if failure of bond at the interface of the prestressed and cast-in-place concrete will develop.

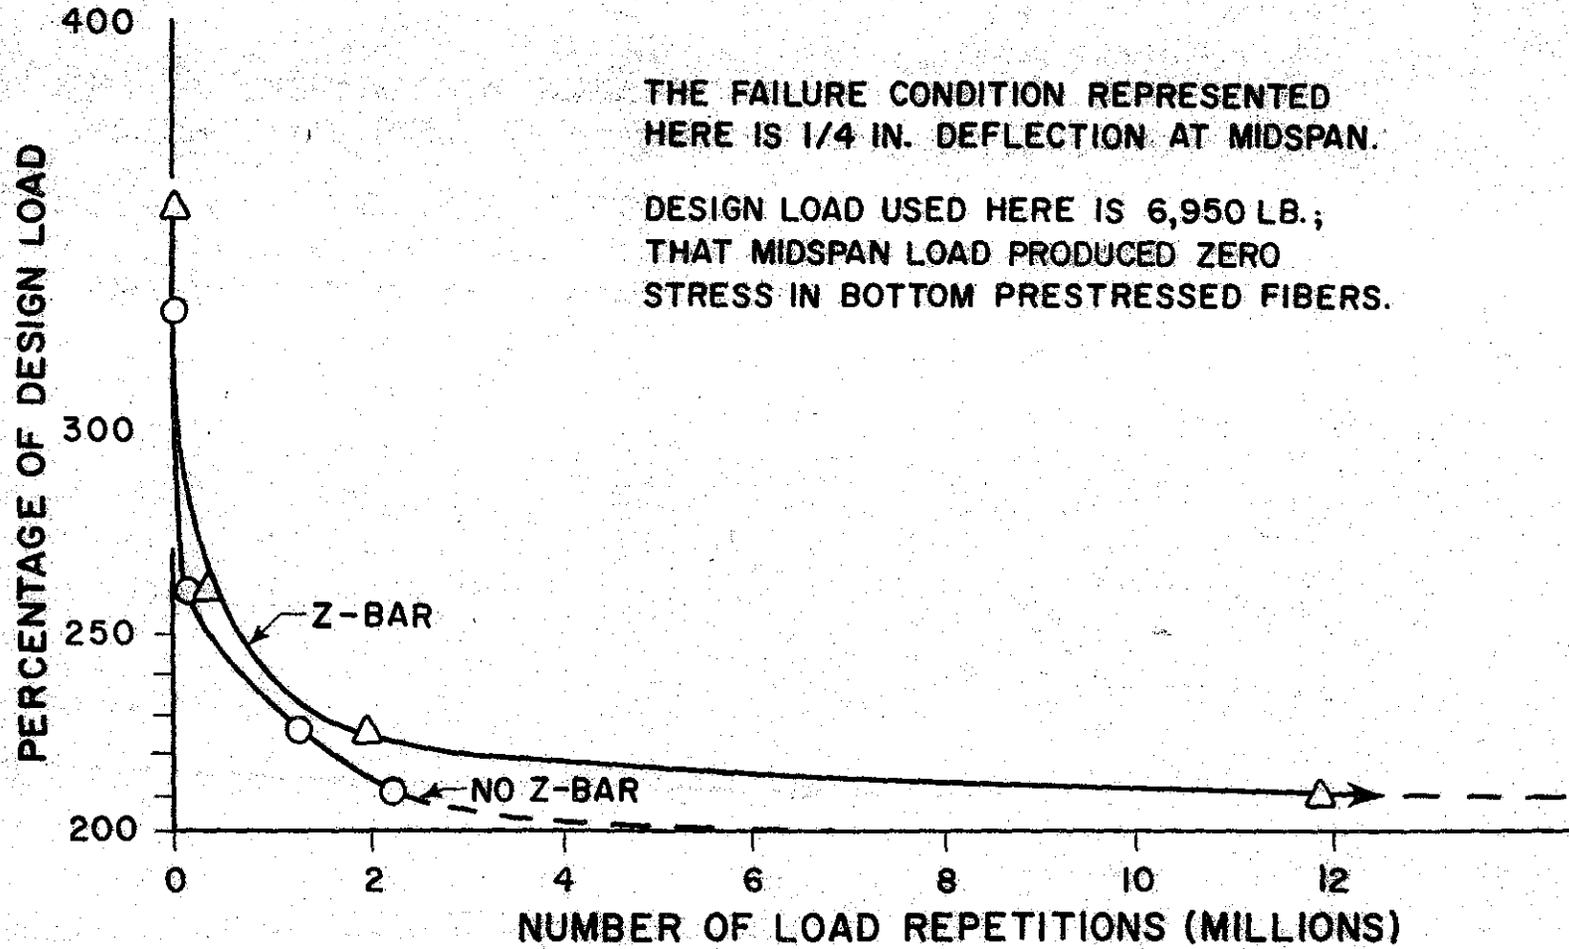
The plot of load versus number of load cycles at failure, Figure 4, indicates that the endurance limit of the panel with Z-bars is a little greater than for the other panel. The Z-bar panel has a limit at some value near 225 percent of its design load whereas the limit for the no Z-bar panel is near 200 percent of design load.

Figure 4. Load versus Number of Load Repetitions at Failure.

Curves of load versus number of load cycles at failure, S-N curves, were developed from fatigue tests. The panel with shear connectors consistently took more load cycles to failure for loads ranging from 210 percent of design load to 260 percent of design load, although the differences were not very great at higher loads. At 210 percent of design load the panel with shear lugs was cycled 11.9 million cycles without failure. The specimen without shear lugs failed by deflection, 1/4 in., at 2.25 million cycles under 210 percent of design load.

Miner's theory (2) was used to determine cumulative fatigue damage. In the Z-bar panel, test 1b, Table 2, the cumulative damage is negligible since all load values, except the failure load, fall below the endurance limit. However, the panel without Z-bars, test 1a, Table 2, has a cumulated damage development in its loadings up to 200 percent of design load. If the S-N curve for the panels with Z-bars is projected out along the abscissa, it will level out at about 10 million cycles at 200 percent of design load. No load lower than about 200 percent of design load, on that basis, will damage the specimen. The 2 million cycles at 200 percent of design load accounts for about 20 percent of the total damage value of the specimen. The 145,000 cycles at 260 percent of design load accounts for the remaining 80 percent of its life. The full cyclic life at 260 percent of design load would then be $1.2 \times 145,000$ or 174,000 cycles. On the scale of the curve of Figure 4 the difference
