C H A N N E L I Z A T I O N

Neilon J. Rowan
and
Thomas G. Williams

Research Report Number 19-4 (Final)

TEXAS TRANSPORTATION INSTITUTE
Texas A&M University
College Station, Texas

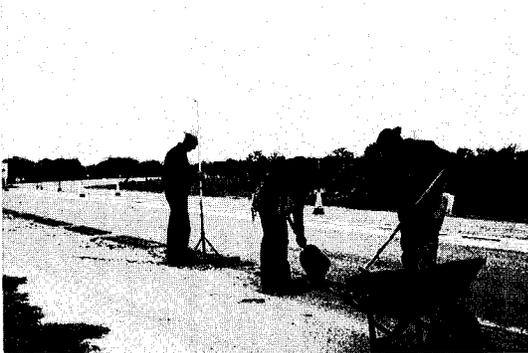
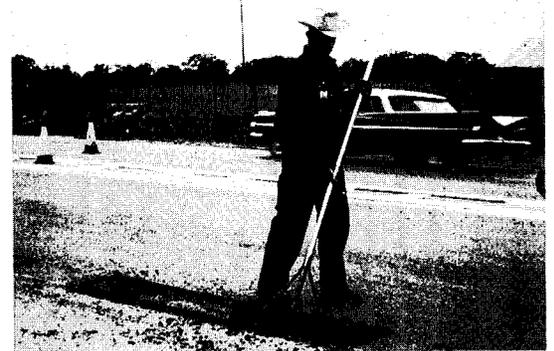
**FIGURE 5 - ILLUSTRATIONS OF MIXING AND PLACING
RAISED STRIPES OF SLURRY SEAL MIXTURE**

Construction of the raised stripes was essentially a manual operation; however, it appears to be a procedure adaptable to mechanization. The materials were combined in the mixer and transferred to the place of installation by wheelbarrows. The mixture was then placed in one-by-seven-foot wooden forms having a height of one-half inch (see Figure 5). The mixture was leveled in the forms and particular care was necessary to avoid segregation of the materials. This segregation would result in some of the stripes having an excessive amount of slurry which would cover the coarse aggregate and provide a smooth surface rather than the rougher surface required for good visibility. After the material was leveled and the proper surface texture obtained, the form was lifted from the stripe and it was permitted to set. The finished stripes were not compacted.

The stripes in the approach-end treatment were placed one day and painted the next. This installation took place in the fall when the weather was cool and slightly damp. Consequently, the stripes were not completely cured when the painting took place. The paint sealed the surface and thus retarded the action

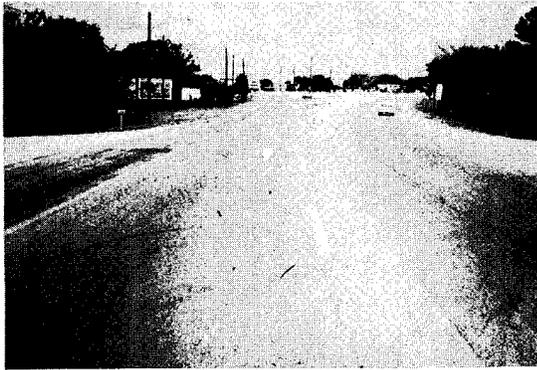
**FIGURE 9 - ILLUSTRATIONS OF PREFABRICATED
RAISED STRIPE INSTALLATION**

The test installation in Bryan is shown in Figure 9. It should be noted that this approach-end treatment extended beyond a side street and thus would be subject to a considerable amount of turning traffic which would give any material a severe durability test.

One thing very strongly in favor of the raised stripe was the simplicity of installation. The normal installation procedure involved laying out the approach-end treatment configuration with a pilot line which would likely be used in any case. The exact position of each section of stripe was then marked with chalk. The markers or stripe segments were placed on the pavement upside down so that the sun would soften the air-blown asphalt filler that was placed on the back of the stripe during the manufacturing process. The crossbars in the configuration were made up of the stripes cut to fit using an ordinary roofing knife or pocket knife.

A cold application mastic material furnished by the manufacturer was then brushed on the bottom surface of the stripe with a paint brush. The stripe was immediately inverted and placed into position. The stripes bonded to the surface

Periodic observations of the experimental installation were made for approximately 18 months. During the first few months it was noted that the surfaces of the stripes were discolored due to weather and dirt. Also, traffic turning across the approach-end treatment had worn the paint from the knobby surfaces which contributed considerably to the discoloration. However, fairly good reflectivity was retained for approximately six months. In the latter part of the observation period, the appearance of the stripes grew progressively worse, and after approximately one year several of the stripes had been lost or broken. In general, the installation was not successful.

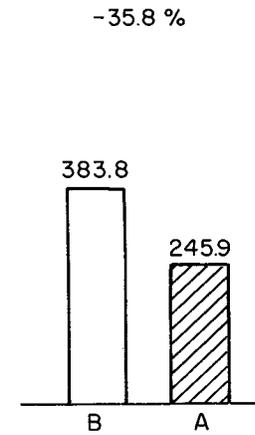
FIGURE 12

COMPARISON OF ACCIDENT RATES
 ACCIDENTS PER 100 MILLION VEHICLE MILES
