A Framework for Historic Bridge Preservation in Tarrant County

Technical Report 409139-1

TEXAS A&M TRANSPORTATION INSTITUTE
COLLEGE STATION, TEXAS

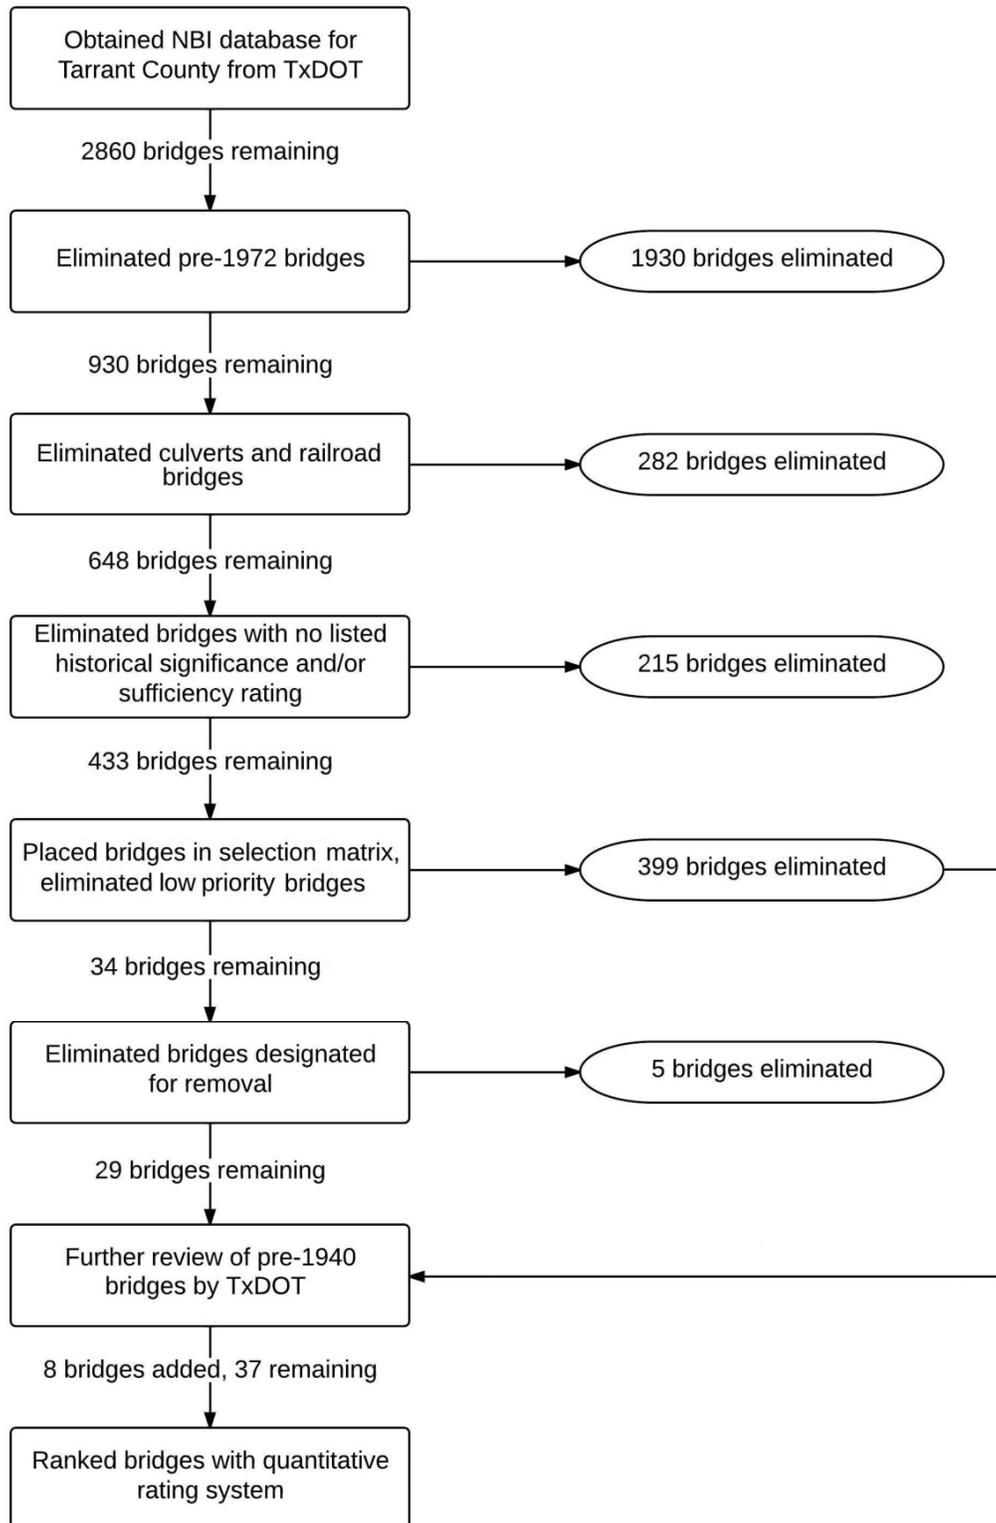
Figure 3-1. Flowchart Depicting the Prioritization Process.

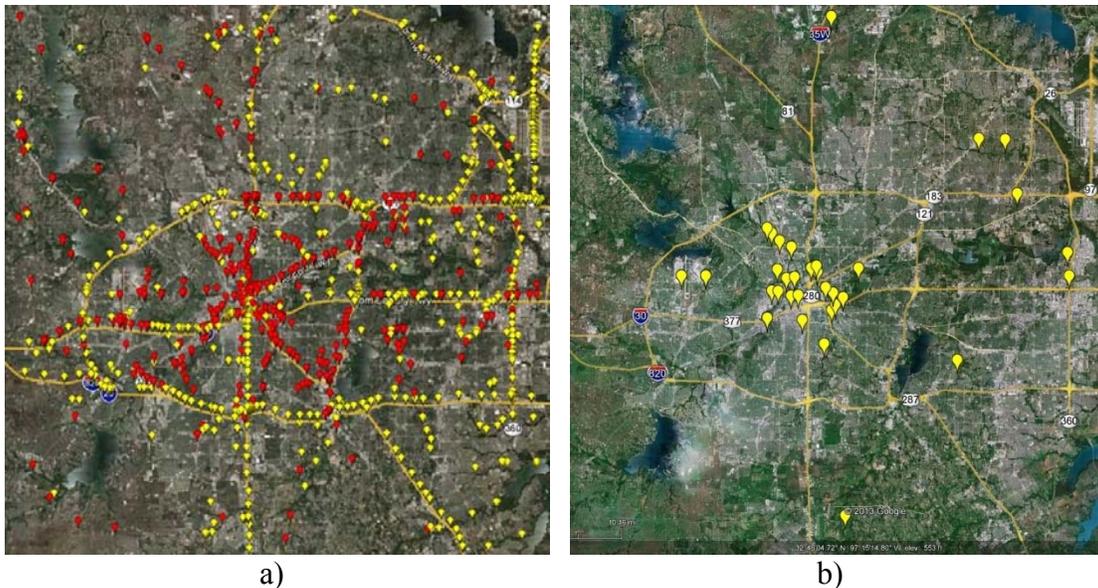
Figure 3-2. (a) All Bridges in Tarrant County (pre-1972 bridges in red); (b) Final 37 Bridges.

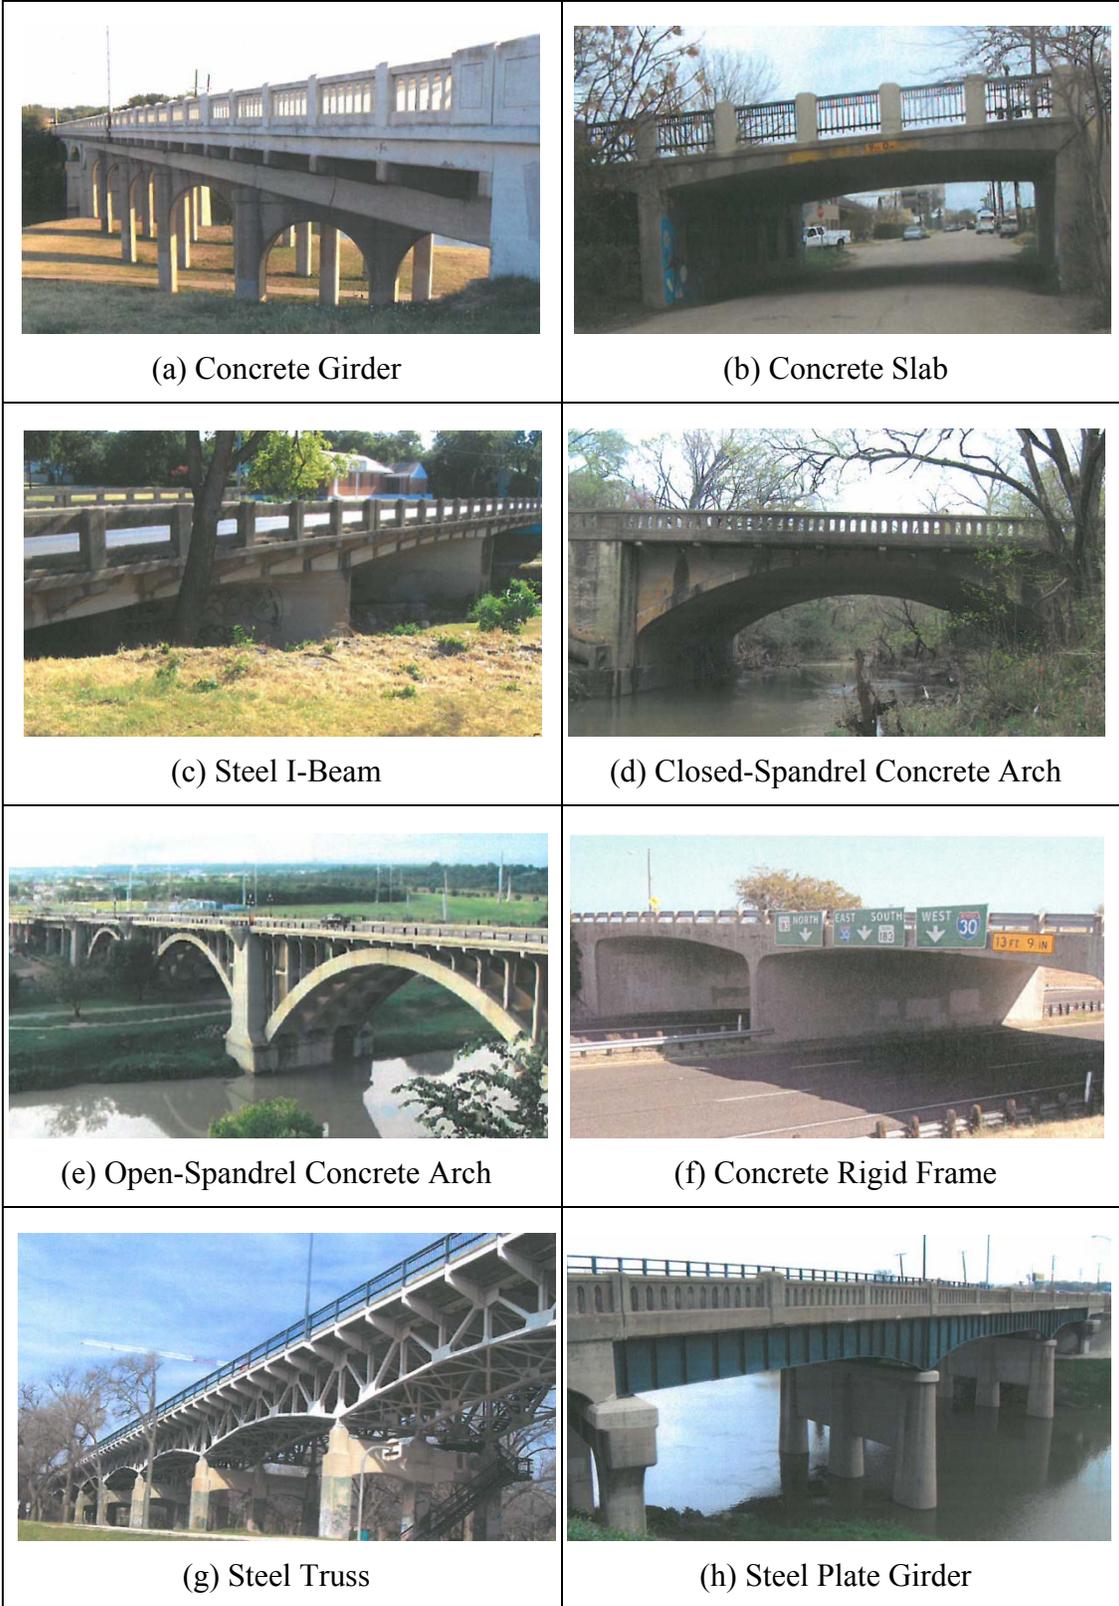
Figure 3-4. Examples of Bridge Types (photos from TxDOT 2012a).

Bridge Type	Main Span Length (ft)	Points	Overall Length (ft)	Points
Concrete Girders	≥ 45	20	≥ 420	4
	40–45	10	100–420	2
	< 40	0	< 100	0
Concrete Slabs	≥ 30	20	≥ 300	4
	25–30	10	200–300	2
	< 25	0	< 200	0
Steel I-Beams	≥ 65	20	≥ 520	4
	50–65	10	340–520	2
	< 50	0	< 340	0
Concrete Arches (Closed Spandrel)	≥ 40	20	≥ 200	4
	30–40	10	80–200	2
	< 30	0	< 80	0
Concrete Arches (Open Spandrel)	≥ 120	20	≥ 750	4
	90–120	10	500–750	2
	< 90	0	< 500	0
Concrete Rigid Frames	≥ 50	20	≥ 200	4
	40–50	10	100–200	2
	< 40	0	< 100	0
Steel Trusses	≥ 100	20	≥ 1000	4
	80–100	10	300–1000	2
	< 80	0	< 300	0
Steel Plate Girders	≥ 80	20	≥ 500	4
	50–80	10	200–500	2
	< 50	0	< 200	0

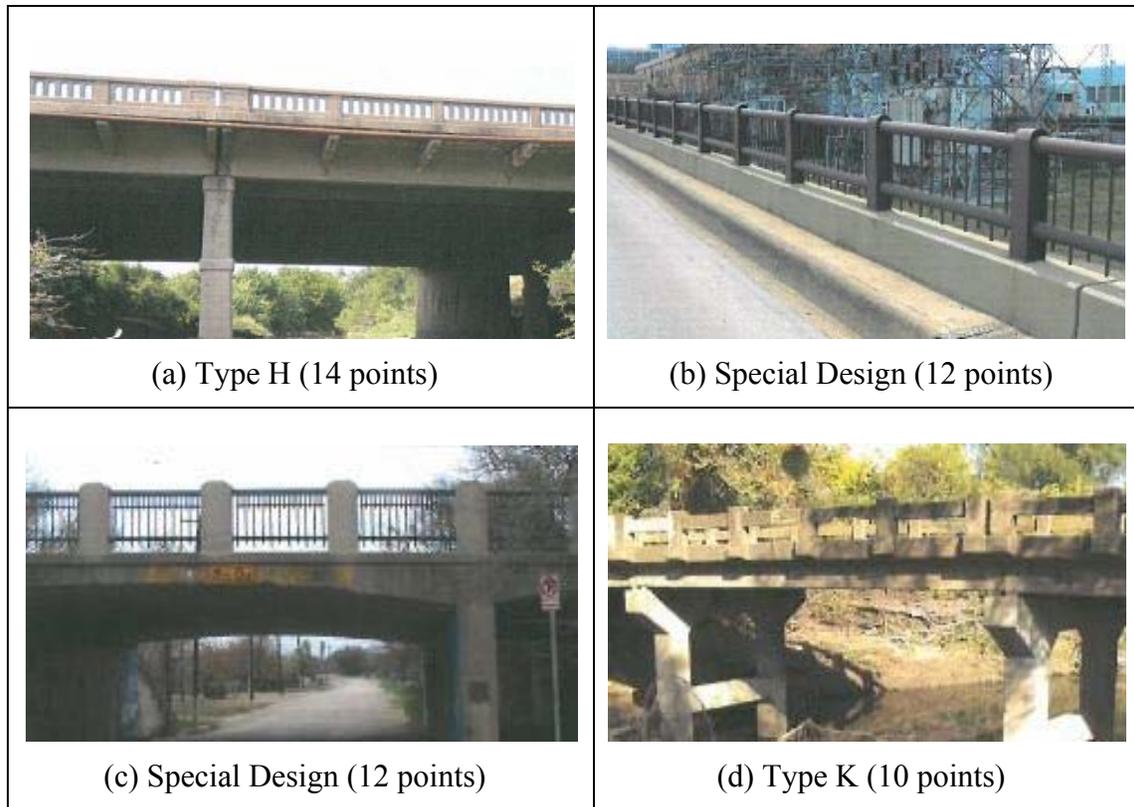
Figure 3-5. Various Rail Types (photos from TxDOT 2012a).

Rail Type	Points
A-J	14
Special Design	12
K, L	10
M	8
P, Q	6
R-8, R-10	4
Other Post-1940 Standard Rail	2

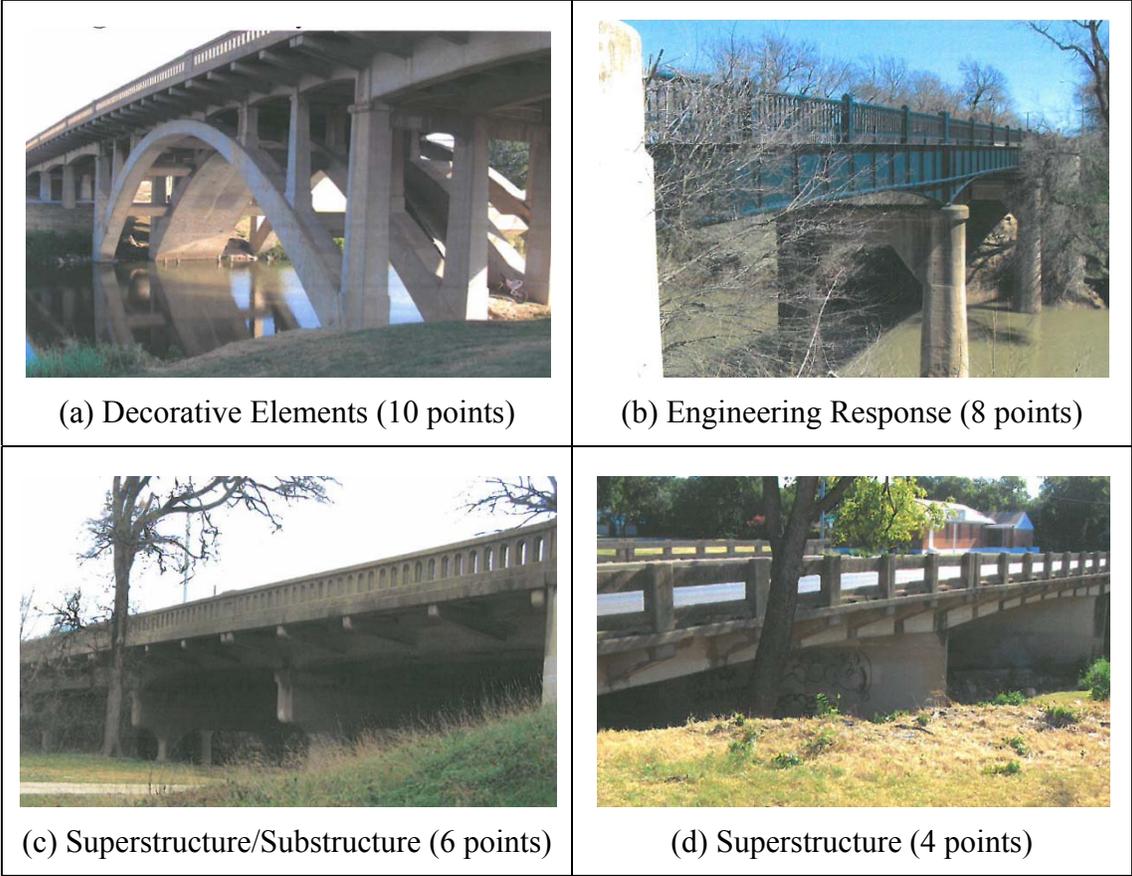
Figure 3-6. Various Levels of Special Design (photos from TxDOT 2012a).

Special Design	Points
Decorative Elements	10
Engineering Response	8
Superstructure/Substructure	6
Superstructure	4
Substructure	2

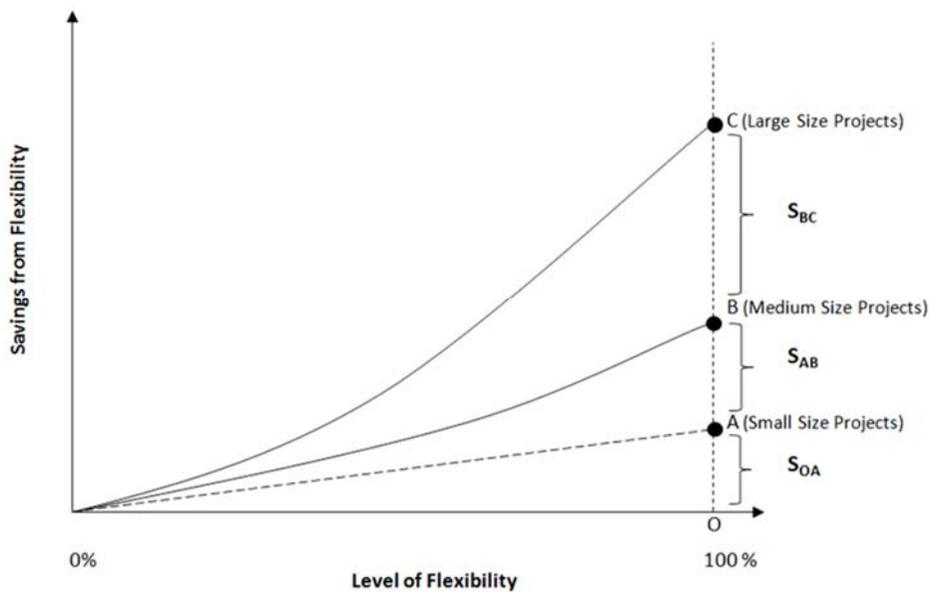
Figure 4-1. Savings from Flexibility versus Level of Flexibility (Damnjanovic and Anderson 2009).

based contracts are long-term. Better budgeting efficiency and innovation cannot produce significant payoffs in a short contract period. This is also true from the perspective of the project size. Only relatively large projects can produce significant savings that can be passed to the owner. Figure 4-1 illustrates this concept. In this figure, the level of flexibility is represented as the sum of contract duration and flexibility in design and construction, two primary economic drivers in projects. As shown by the figure, the savings acquired due to flexibility are amplified by the size of projects. In other words, relative increase in savings increases as a transition occurs from small-sized projects to larger-sized projects ($S_{BC} \gg S_{AB} > S_{OA}$). There also exists anecdotal evidence that the relationship is highly nonlinear, implying that larger contracts yield a greater percentage of savings. It is important to note that agencies can bundle projects together to achieve the required size. In the context of this project, performance-based specifications could provide financing to the owners, as the cost of major rehabilitation could be spread over the contract duration, which is typically longer than 5 years.

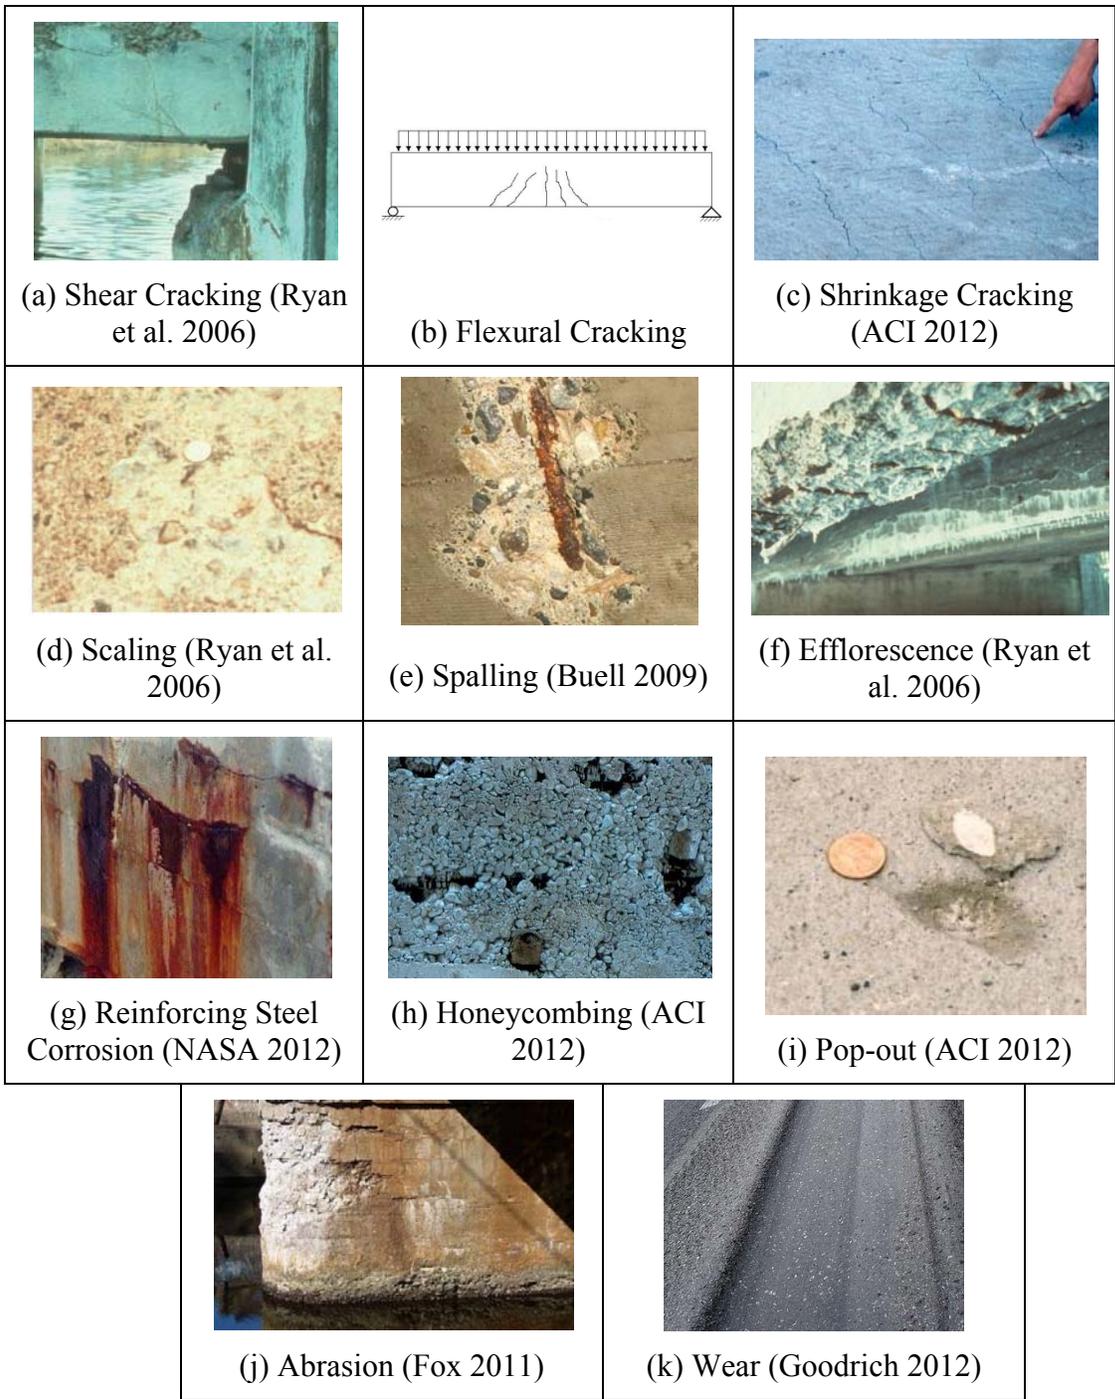
Figure 5-1. Common Defects in Concrete Elements.

Wear (Figure 5-1[k])	<ul style="list-style-type: none"> • Deterioration of concrete caused by traffic • In extreme cases, exposed aggregates can become polished and can be a safety hazard when wet
Collision Damage	<ul style="list-style-type: none"> • Cracking and spalling in components struck by traffic
Overload Damage	<ul style="list-style-type: none"> • Excessive cracking and spalling caused by overstressing of a structural element • Includes cracking and spalling in tension zones and diagonal cracking in shear zones

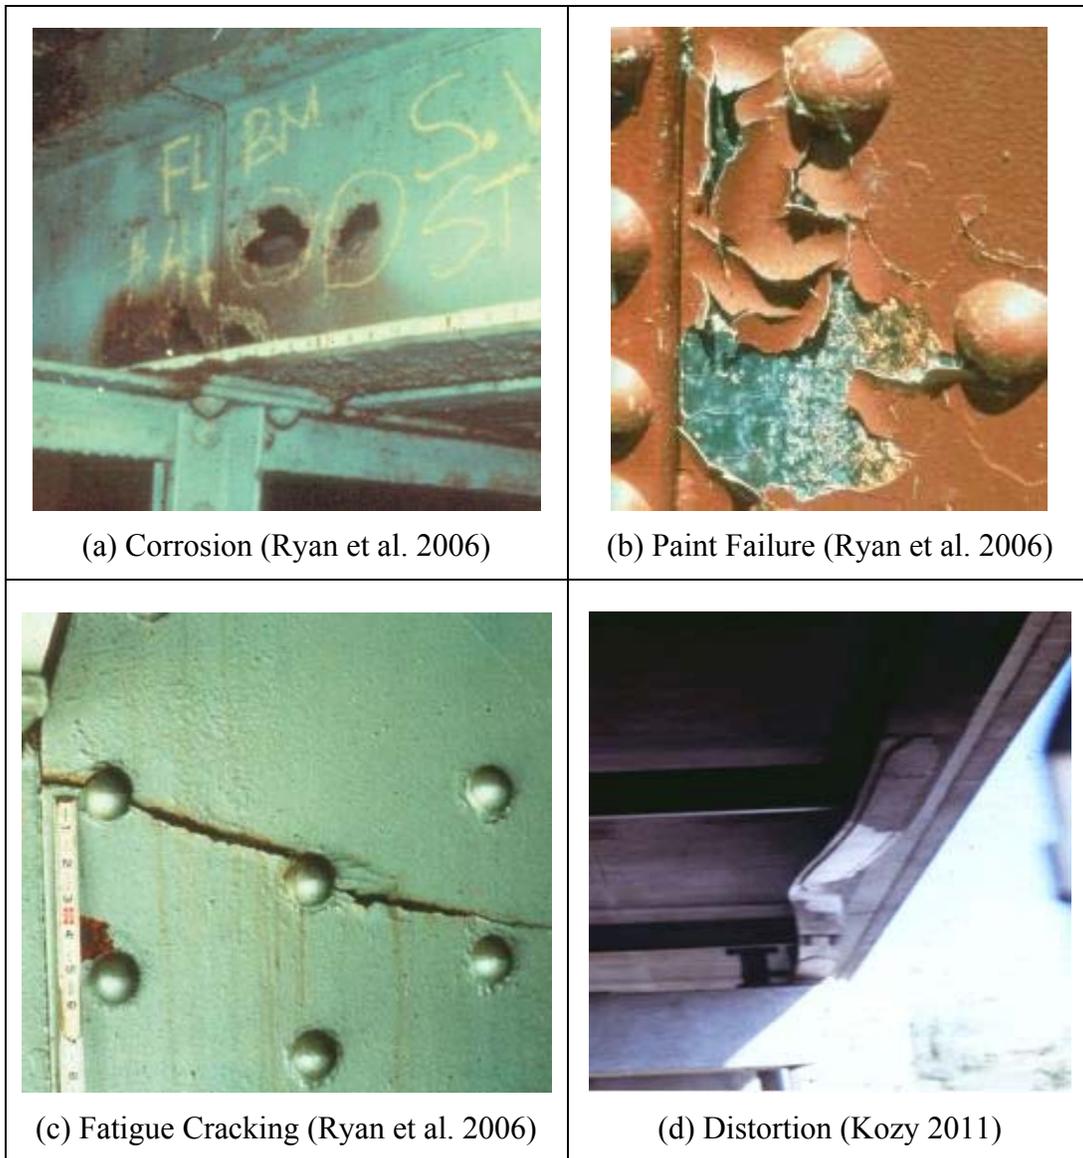
Figure 5-2. Common Defects in Steel Elements.

Distortion (Figure 5-2[d])	<ul style="list-style-type: none"> • Deformation of a steel member's intended plane of bending • Caused by collision, heat exposure (at temperatures in excess of 400 °F), and out-of-plane stresses transmitted from secondary members • Can cause cracking in webs of rolled members

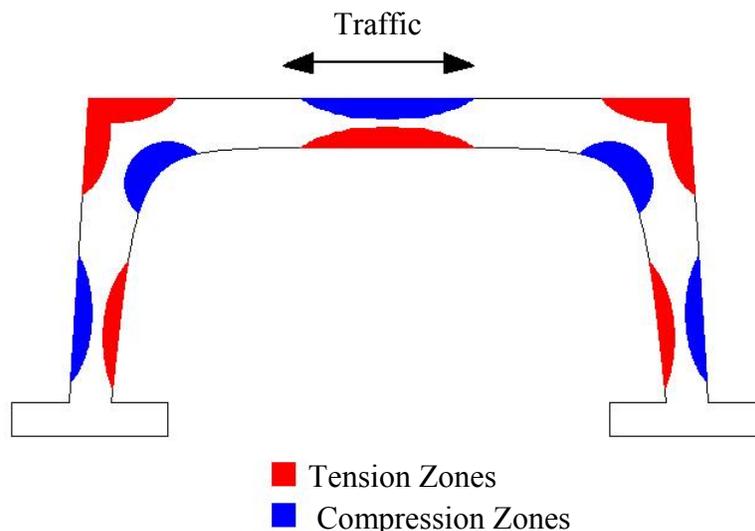
Figure 5-3. Tension and Compression Zones in Concrete Rigid Frame (adapted from Ryan et al. 2006).

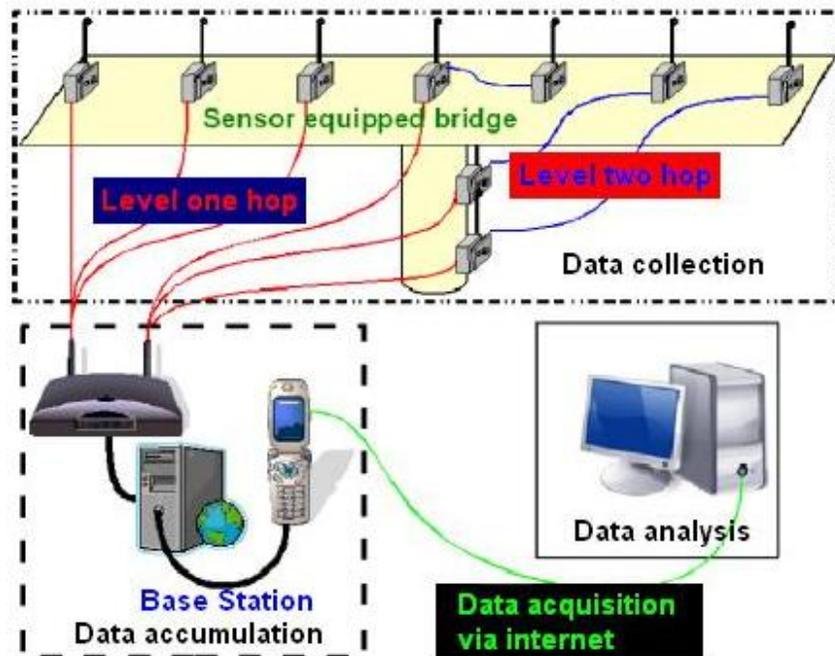
Figure 5-4. General Schematic of Wireless Sensor Network (Reyer et al. 2011).

Reyer et al. (2011) designed a wireless sensor network using sensors that detect magnetic field, temperature, and acceleration. This network uses individually powered and independently operating motes with attached sensor boards to extract measurements from different locations and process them into meaningful results. Each mote contains a sensor board, micro-controller, radio transmission hardware, and memory storage. Figure 5-4 shows a general schematic of the system, and Figure 5-5 shows a mote and sensor board. The sensors take time-stamped measurements and send them via radio waves to an on-site base station. If the base station is within the range of the motes, measurements are sent directly (known as a level-one hop). If motes are out of range of the base station, measurements must be sent to other motes in range, and then from the intermediate motes to the base station (known as multi-hopping). Figure 5-4 shows a level-two hop, in which signals from the out-of-range motes are relayed by intermediate motes closer to the base station. Higher levels of hopping can be achieved, but networks should use as few levels as possible. The base station collects the data from the sensors and transmits

data files to a computer through an Internet connection. The data are then processed and analyzed to form a representation of the behavior of the entire structure. The main advantage of this method is that it can be configured and modified after installation. Sensors can be moved or added at any time, making it a flexible and practical method. The primary drawbacks are energy consumption and complications related to multi-hopping and time synchronization between sensors.

In general, the wireless sensor network developed by Reyer et al. (2011) is representative of most that have been developed. Minor differences between systems exist, such as the type of sensors and data processing software used, but most networks follow the same general schematic.

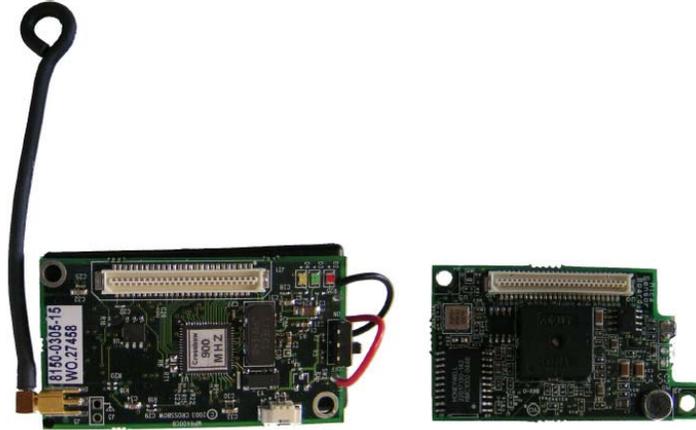
Figure 5-5. Mote (left) and Sensor Board (right; Reyer et al. 2011).

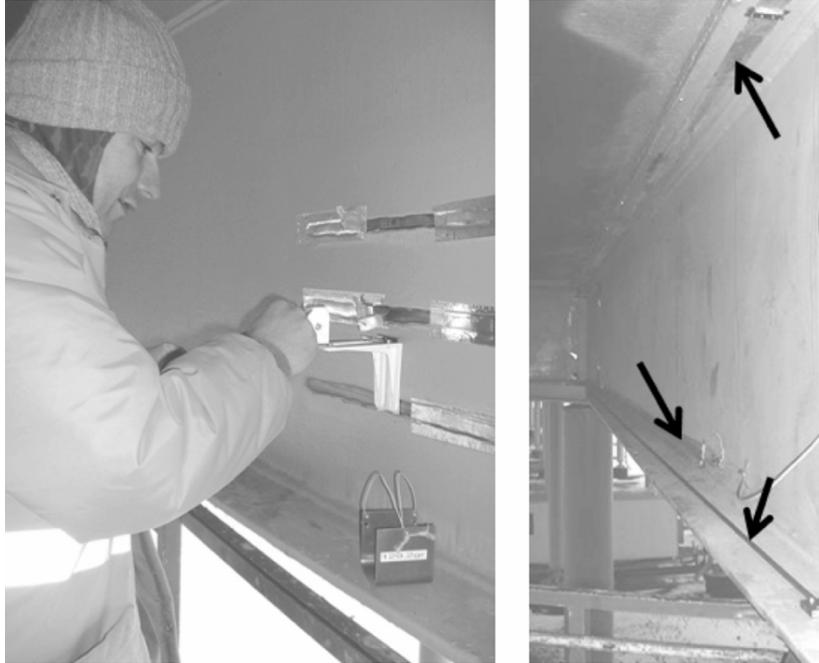
Figure 5-6. Installation of Distributed Sensors (left) and Installed Distributed Sensors (right; Glisic and Inaudi 2010).

This is mostly due to the fact that a distributed sensor requires only one connecting cable to the reading unit, while a network of point sensors requires cables from each sensor. Distributed sensors also have the ability to accurately localize strain and cracks. When installing distributed sensors, a good bond between the material and the fiber is important because slippage can cause inaccurate strain measurements. However, when cracking of the material occurs, the bond should break to avoid damage to the fiber. The SHM system presented by Glisic and Inaudi was employed on a continuous steel girder bridge built in the 1930s in Sweden. Fatigue cracking had been found in the girders and was the primary reason for the implementation of the system. The sensors consisted of polyimide-coated fiber embedded in a composite tape and were available in lengths of 295 ft. This type of sensor is known to have good sensitivity to strain and cracking in relation to other available distributed sensors and cost approximately \$7/ft in 2010. Three sensors could feasibly be connected in series, so each cable had an effective length of 885 ft. The tape sensors were glued to the girders with a wider strip of aluminum tape on top, and a parallel cable was installed with each sensor to detect and compensate for temperature-induced strains. The system has the ability to detect and localize cracks and unexpected strains in girders and transmits measurements every 2 hours. The system can also detect malfunctions and has an expected service life of at least 15 years. Figure 5-6 shows the installation process and fully installed sensors.

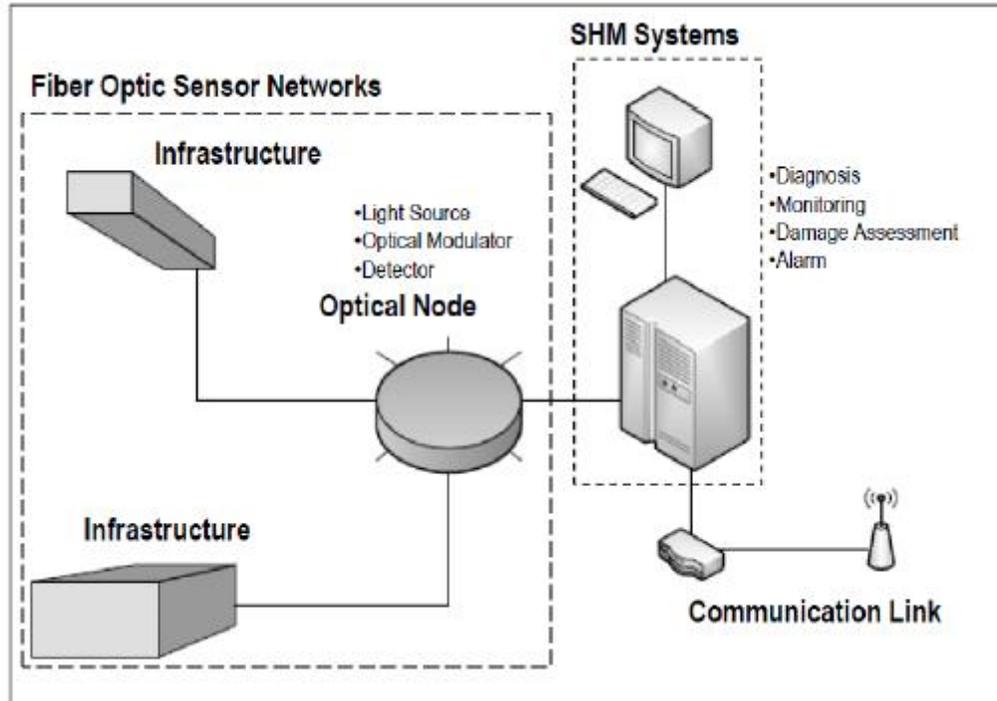
Figure 5-7. General Schematic of a FBG Sensor Network (Chang 2012).

A 2012 study at California State University at Long Beach compared FBG point sensors and distributed sensors for measuring strain, temperature, and deformation (Chang 2012). Both sensor types were shown to have better accuracy than conventional sensors, but FBG sensors significantly outperformed distributed sensors. Chang recommends an FBG sensor network and concludes that further developments should be made in distributed sensors before they are widely used in the field. In the proposed FBG sensor network, strategically placed sensors would transmit signals to a nearby optical node. The optical node collects the measurements and transmits the data to a computer for processing and analysis. Figure 5-7 shows a general schematic of the network.

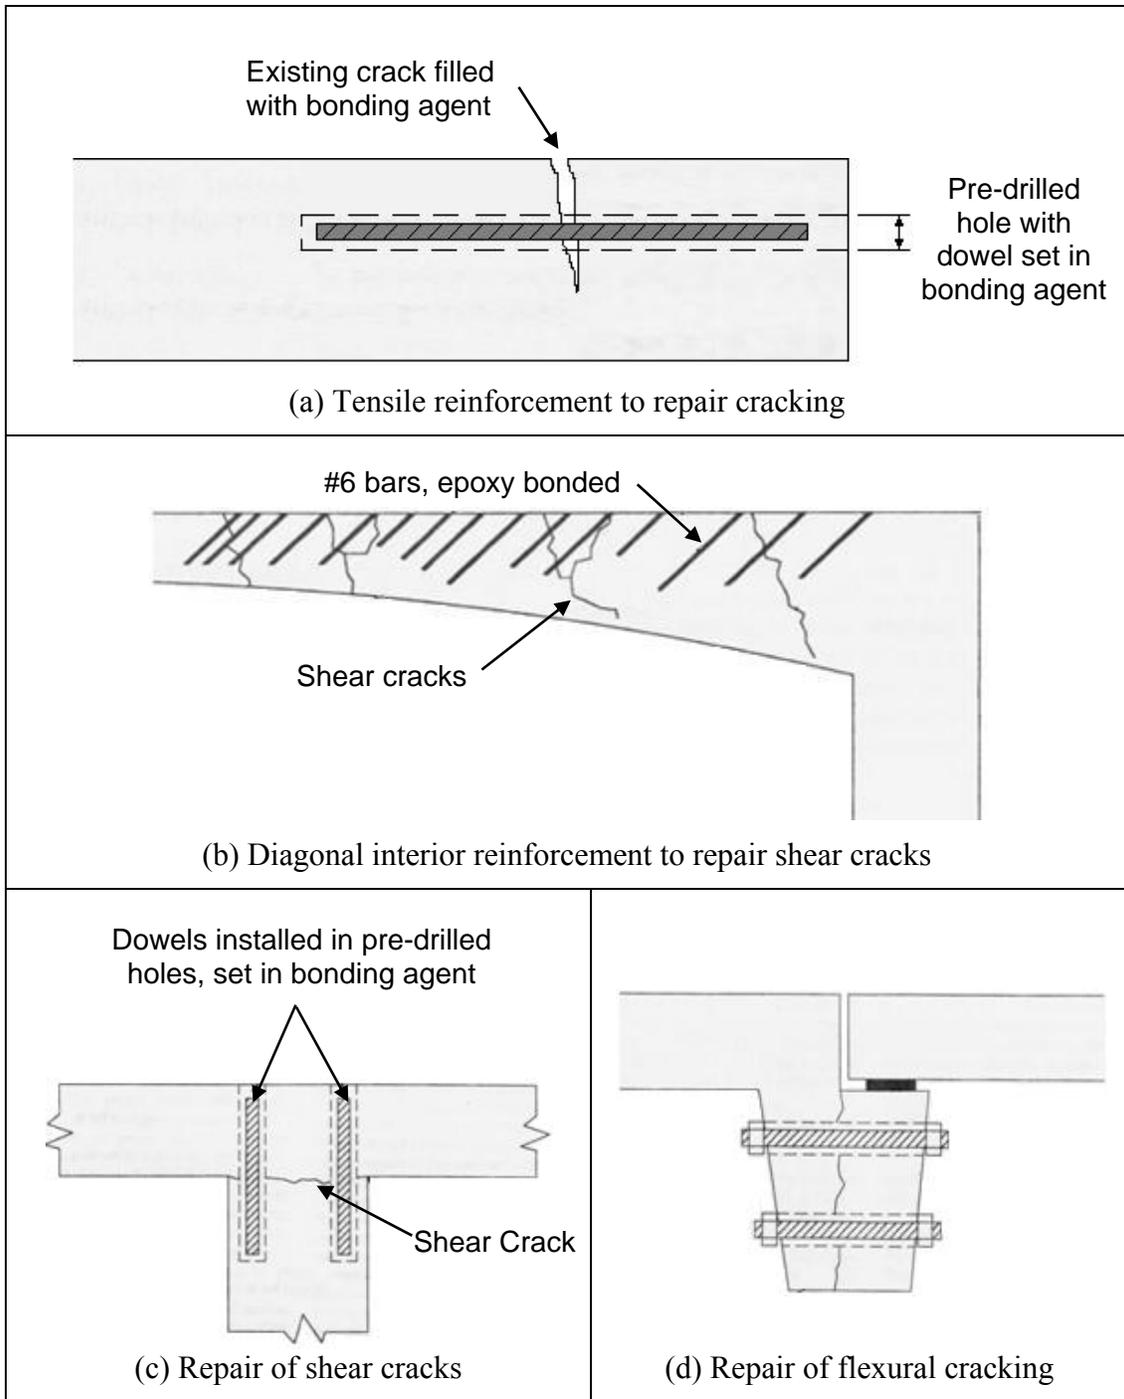
Figure 6-1. Uses of Interior Reinforcement (adapted from ACI Committee 546 1996).

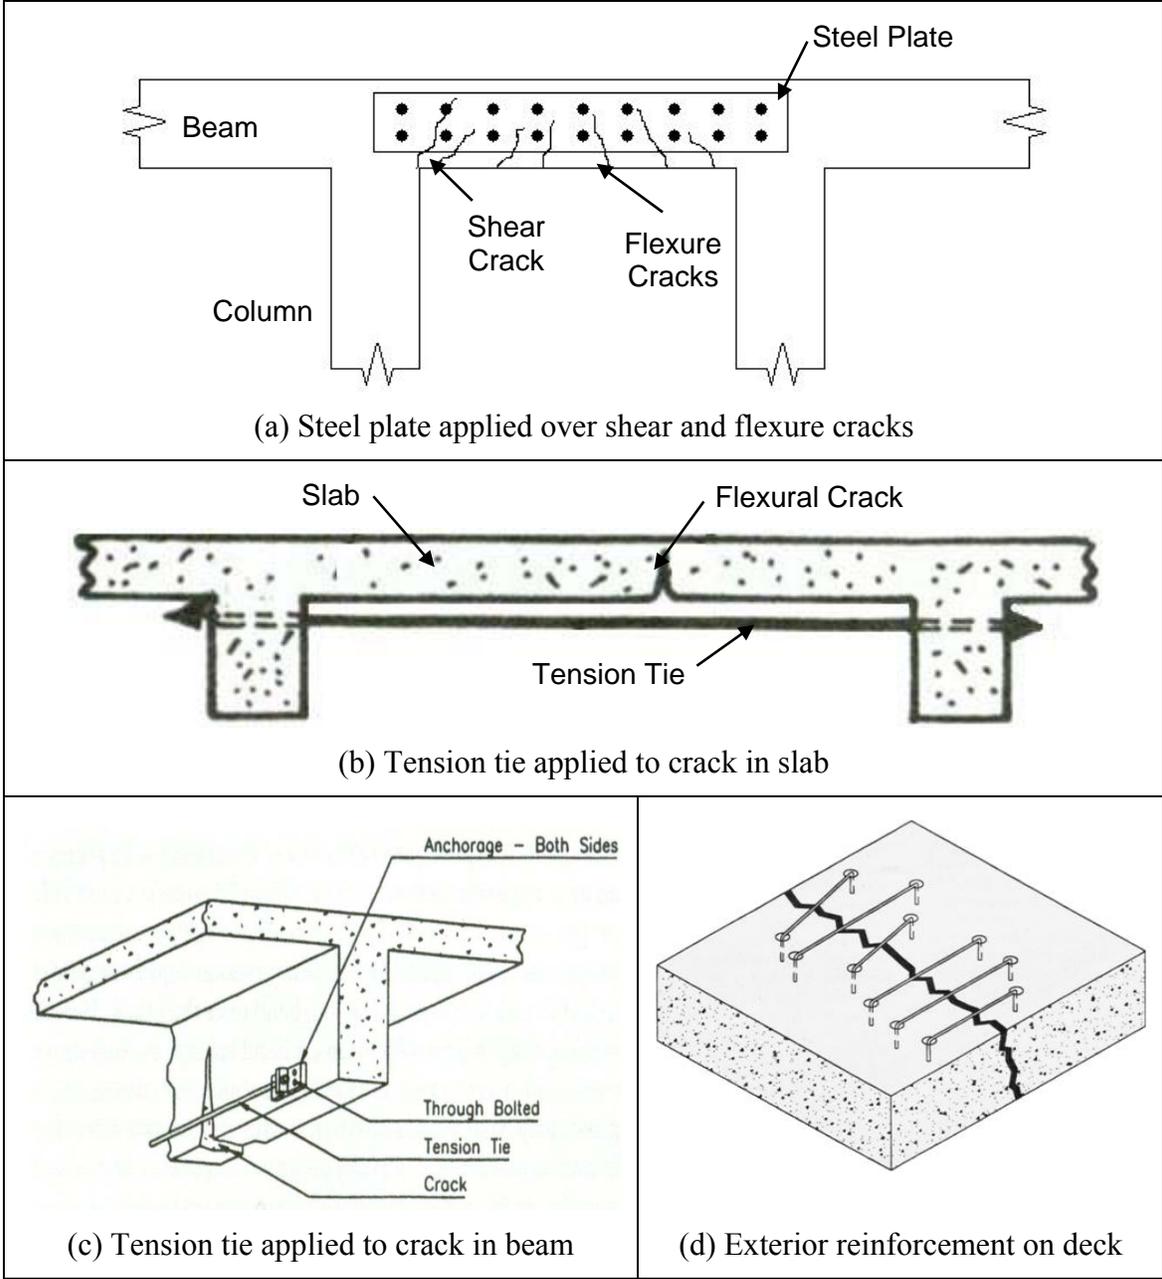
Figure 6-2. Uses of Exterior Reinforcement (adapted from ACI Committee 546 1996).

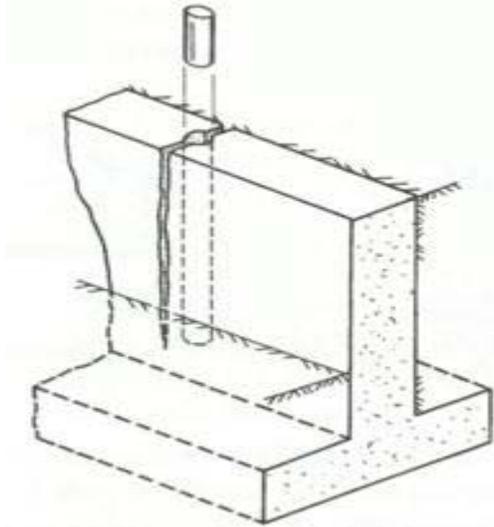
Figure 6-3. Drilling and Plugging a Crack in a Retaining Wall (ACI Committee 224 2007).

Another method of crack repair is drilling and plugging (ACI Committee 224 2007). Figure 6-3 shows an example of drilling and plugging in a retaining wall. This technique uses grout inserted into a drilled hole along the length of the crack. It is most effective on cracks that are in a relatively straight line.

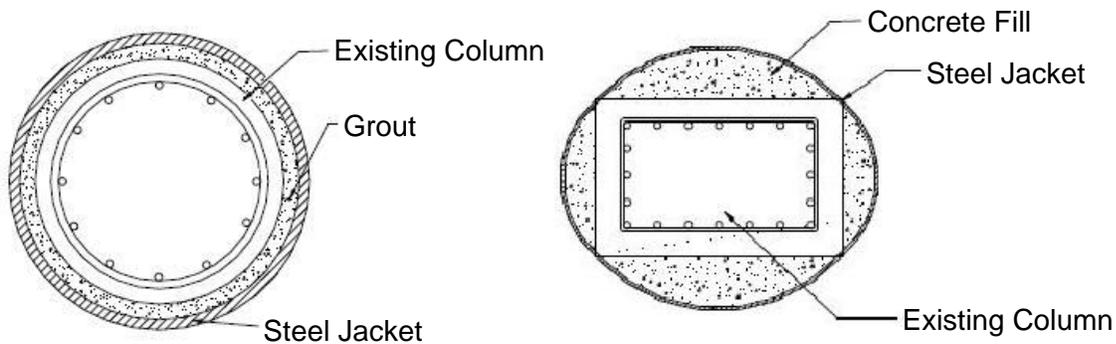
Figure 6-4. Steel Jacketing of Circular and Rectangular Columns (Itani and Liao 2003).

For concrete piers and bents damaged by cracking, spalling, delamination, and abrasion, jacketing can be an effective rehabilitation technique. Steel, concrete, and fiber-reinforced polymers have all been used effectively as jacketing material (Endeshaw et al. 2008). Both rectangular and circular columns can be jacketed, as shown by the example of steel jacketing in Figure 6-4. Jacketing has been shown to improve concrete confinement and thus increase the shear and flexural strength of columns (Itani and Liao 2003). Historic integrity is a concern when using this method, especially in the case of covering rectangular members with round jackets.

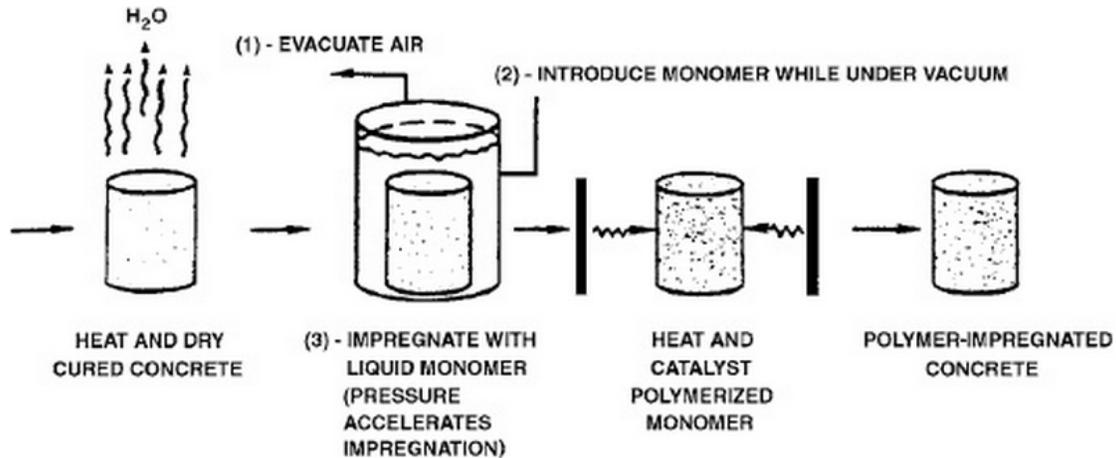
Figure 6-5. Polymer Impregnation Process (ACI Committee 548 2009).

Another way that chloride removal and prevention can be achieved is through impregnation methods. When executed correctly, impregnation makes concrete less permeable and more durable. Hydrophobic impregnation involves application of a water-repellent solution consisting of various silicates at the surface of the concrete (BRE Centre for Concrete Construction 2000). The solution penetrates the concrete and can reduce the number of chloride ions present. Polymer impregnation is a multi-step process that can prevent chloride contamination (ACI Committee 222 2001). The first step of this process is to remove all air and water from the voids in the concrete. The next step is to saturate the voids with monomers, which then transform into solid polymers. Figure 6-5 shows the steps of the polymer impregnation process. Application of surface treatments can also prevent chloride infiltration (in addition to other functions) and is discussed further in the following section.

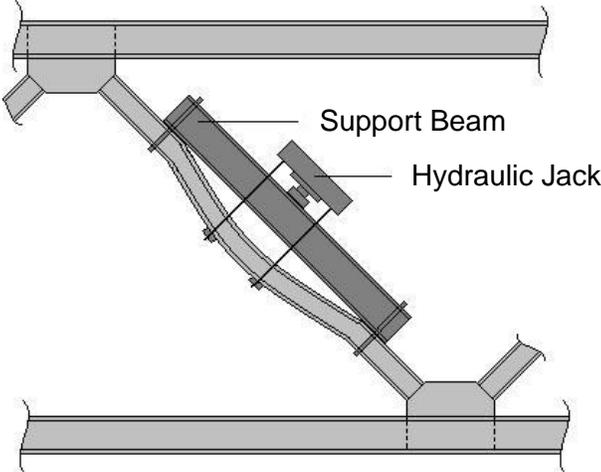
Figure 6-6. Straightening with Hydraulic Jack and Support Beam (adapted from Radomski 2002).

Mechanical repair is the most common method used for straightening deformed steel members (Radomski 2002). In small members, hand tools such as hammers are used, while larger members require jacks, winches, and hydraulics. In most cases, mechanical repair is aided by heat applied with an oxy-acetylene torch. All forces should be applied nearly statically to avoid impact and sustained for at least 15 minutes. Figure 6-6 shows the straightening of a deformed truss member using a support beam and hydraulic jack, and Figure 6-7 shows a tie anchored at a joint to straighten a truss member.

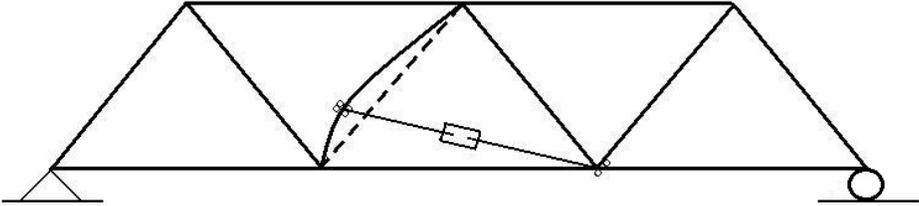
Figure 6-7. Straightening with Tie (adapted from Radomski 2002).

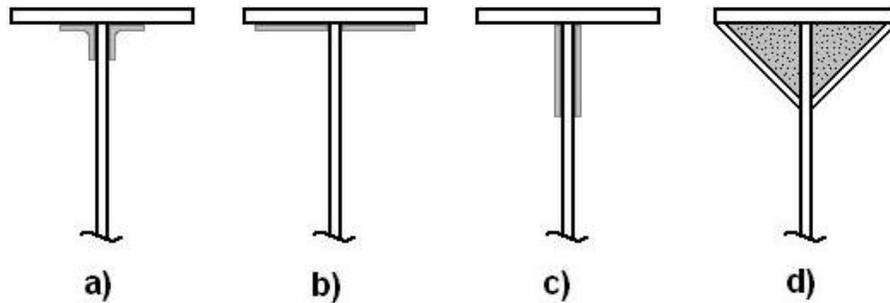
Figure 6-8. Strengthening of a Plate Girder: (a) Angles; (b) and (c) Plates; and (d) Plates and Grout (adapted from Radomski 2002).

The most commonly used method of strengthening steel structures is enlargement of existing members (Radomski 2002). This can be an expensive operation but can be an effective and simple way of increasing the capacity of members where necessary. It can also be done in a relatively inconspicuous manner, preserving the artistic integrity of bridges. Figures 6-8 and 6-9 show several ways that plate girders and truss members can be strengthened using plates, angles, channels, and grout.

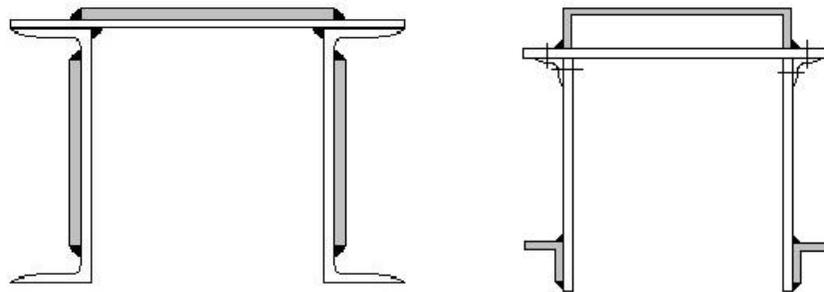
Figure 6-9. Strengthening of Truss Members with Plates, Angles, and Channels (adapted from Radomski 2002).

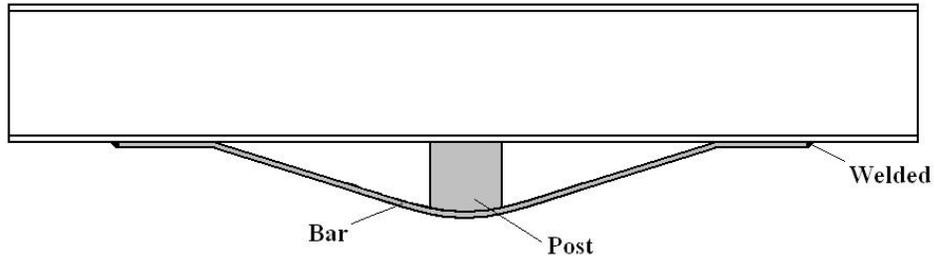
Figure 6-10. Strengthening of Steel Member with Post and Bar (adapted from Radomski 2002).

Another option for strengthening a steel structure is the addition of members (Radomski 2002). This is also an expensive process and construction may be difficult and time consuming, but it has been proven to be successful in redistributing stresses to relieve overstressed members. Historic integrity is a concern when using this method, as newly added members can detract from the aesthetic appeal of bridges. Figure 6-10 shows how a bar and post can be used to strengthen a plate girder or rolled I-beam, and Figure 6-11 shows various ways that trusses can be strengthened using a third chord.

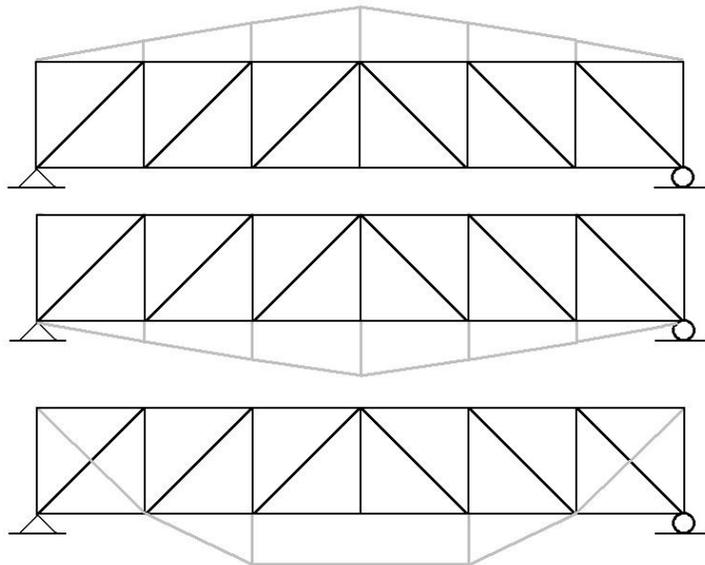
Figure 6-11. Strengthening of Trusses with Third Chord (adapted from Radomski 2002).

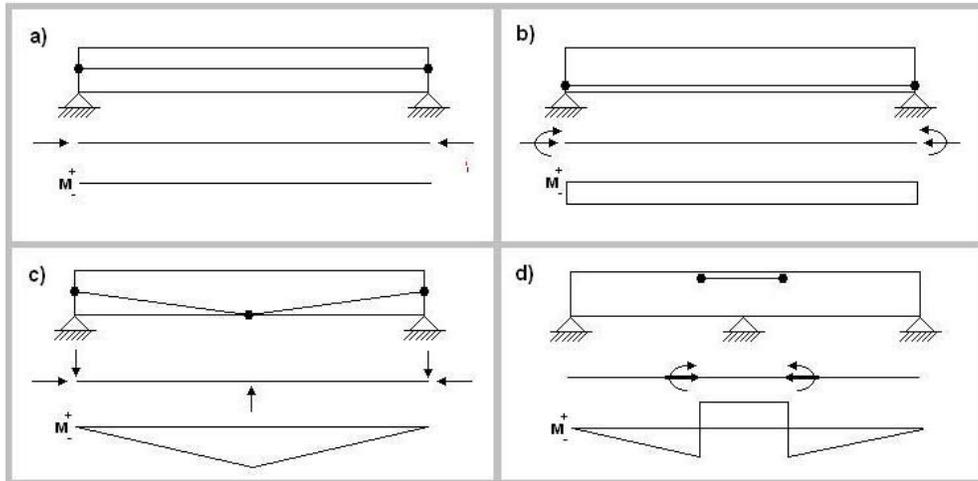
Figure 6-12. Forces and Moments Induced by Tendons: (a) Concentric Tendon, (b) Eccentric Tendon, (c) Polygonal Tendon, and (d) Eccentric Tendon in Two-Span Member (adapted from Xanthakos 1996).

Post-tensioning can also be an effective method of strengthening steel structures (Xanthakos 1996). It can be used locally to strengthen members individually, as shown in Figure 6-12, or on a larger scale to strengthen an entire structure, as shown in Figure 6-13. The disadvantage of post-tensioning is that it can cause high localized stresses where tendons are anchored. Historic integrity is also a concern, and because of this, post-tensioning should be used sparingly on historic bridges.

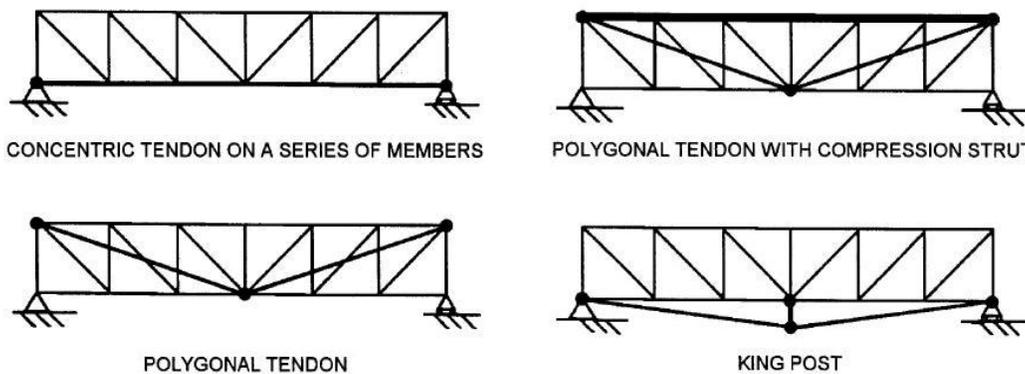
Figure 6-13. Post-Tensioning Options for Trusses (adapted from Thiel et al. 2001).

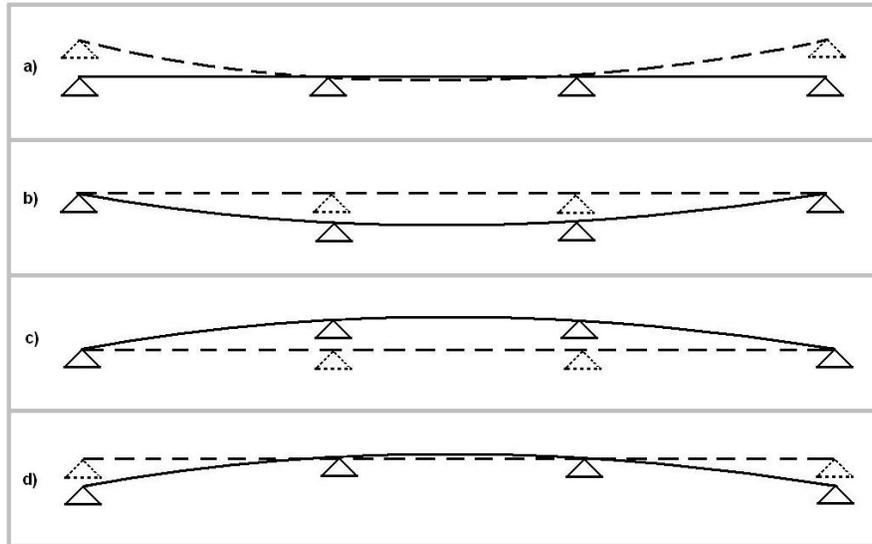
Figure 6-14. Adjustment of Supports to Manipulate Bending Moments (adapted from Radomski 2002).

In the case of continuous span structures, adjusting a bridge's support system can be used as a method of manipulating positive and negative moments (Radomski 2002). Figure 6-14(a)-(d) shows various ways that this can be done. Figure 6-13(a) and (b) shows how negative moments can be reduced by raising the end supports and lowering the intermediate supports, respectively. The configurations shown in Figure 6-13(c) and (d) reduce positive moments by raising the intermediate supports and lowering the end supports, respectively.
