A Framework for Historic Bridge Preservation in Tarrant County

Technical Report 409139-1

TEXAS A&M TRANSPORTATION INSTITUTE
COLLEGE STATION, TEXAS

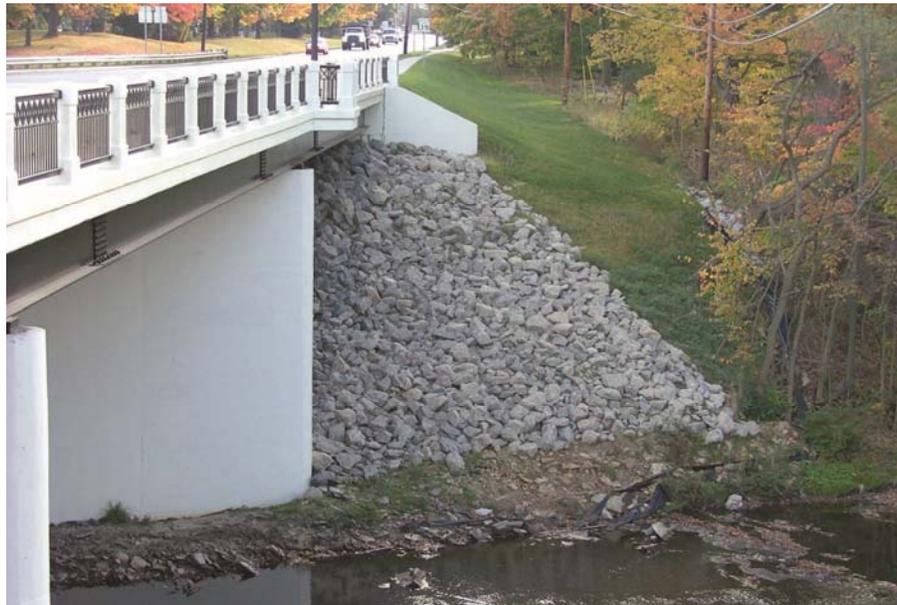
Figure 6-15. Use of Riprap to Prevent Erosion (Ryan et al. 2006).

As discussed in Section 5.7, scour is the primary problem in bridge waterways. For this reason, most mitigation strategies used in waterways involve preventing and repairing the undermining of foundations by scour. Control devices are commonly used as prevention mechanisms. Riprap, a control device shown in Figure 6-15, is a method used to prevent erosion, which can cause contractions and increase stream velocity (Kattell and Eriksson 1998). It is important that riprap is placed properly in order to avoid reducing the width of the stream. Gabions serve a similar purpose to riprap but are used on steeper slopes, as shown in Figure 6-16 (Ryan et al. 2006). Spurs and vanes are used to direct the stream away from erosion-prone banks and prevent shifting of the stream, as shown in Figures 6-17 and 6-18 (Kattell and Eriksson 1998).

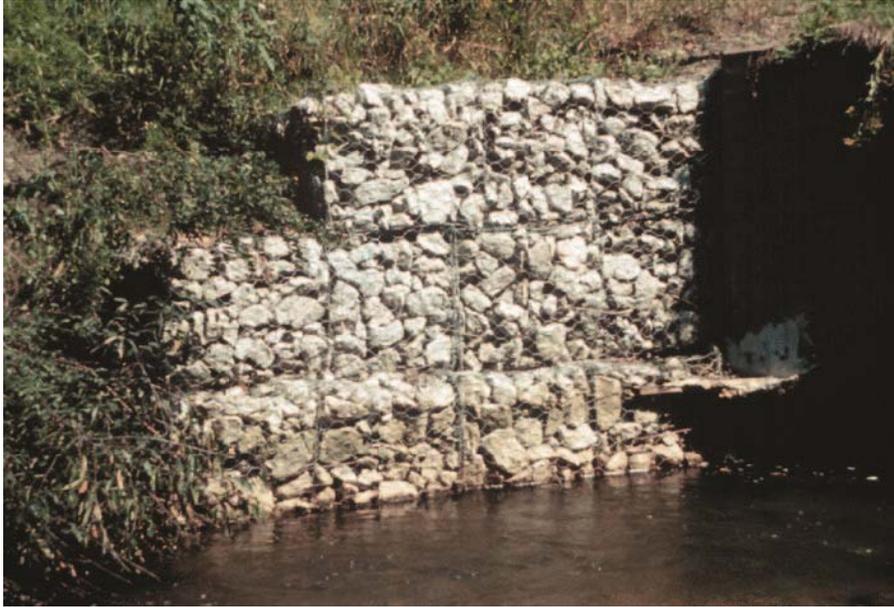
Figure 6-16. Use of Gabion to Prevent Erosion (Ryan et al. 2006).

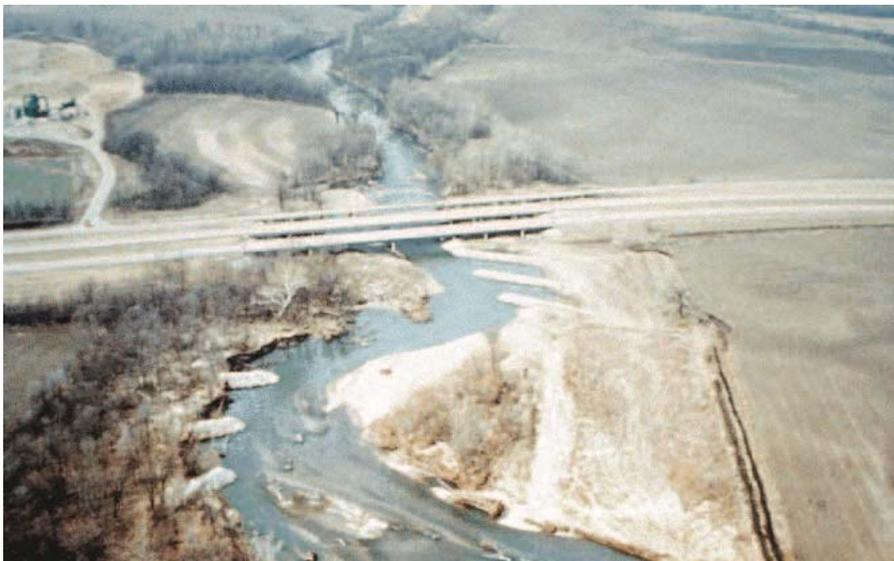
Figure 6-17. Use of Spurs to Redirect Stream Flow (Ryan et al. 2006).

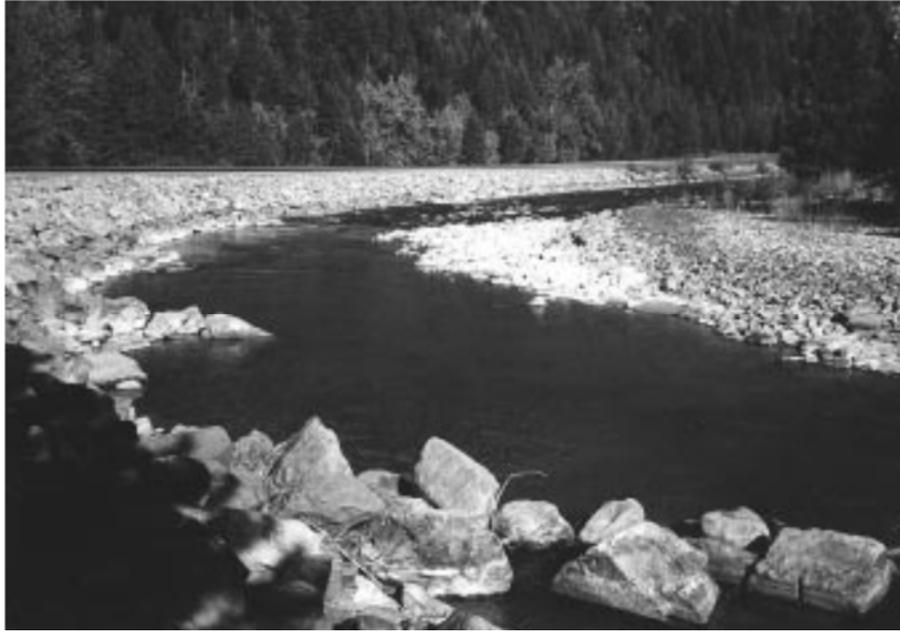
Figure 6-18. Use of Vanes to Redirect Stream Flow (Ryan et al. 2006).

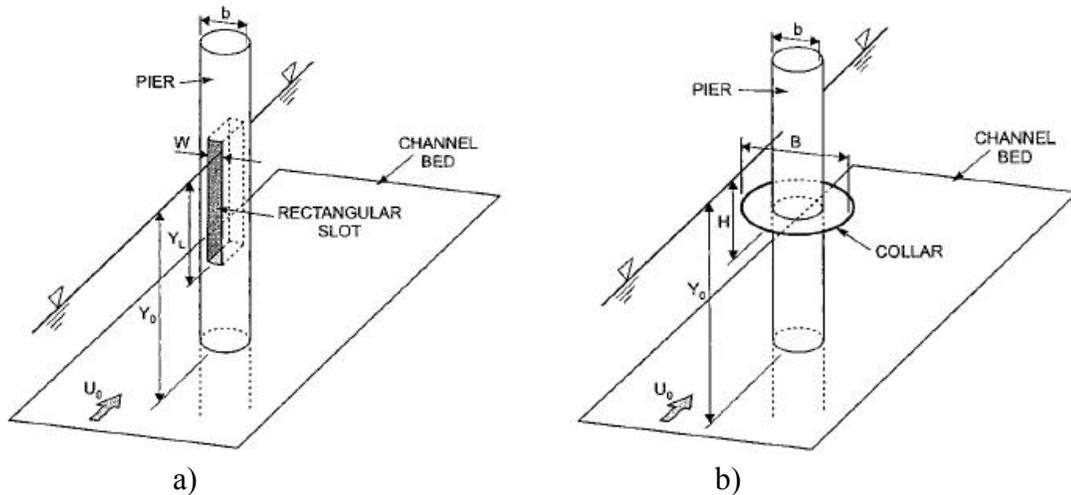
Figure 6-19. Scour Prevention Mechanisms: (a) Slot, and (b) Collar (Kumar et al. 1999).

Other scour prevention mechanisms can be applied directly to substructure elements. Because scour is caused by vortices formed when water collides with the substructure of a bridge, measures have been taken to eliminate these vortices (Kumar et al. 1999). Cutting slots through piers is one method that has been proven to be relatively successful in reducing turbulence (Figure 6-19[a]). This is achieved by allowing water to flow through a slot rather than colliding with piers and creating downward flow. Placement of collars around piers below the surface of the stream is another method that can be used to reduce turbulence (Figure 6-19[b]). The collars redirect the vortices from the stream bed and thus reduce scour and undermining. Placing sandbags at the base of piers, bents, and abutments can also help to prevent scour, as recommended by the FHWA (Rossow 2011a).

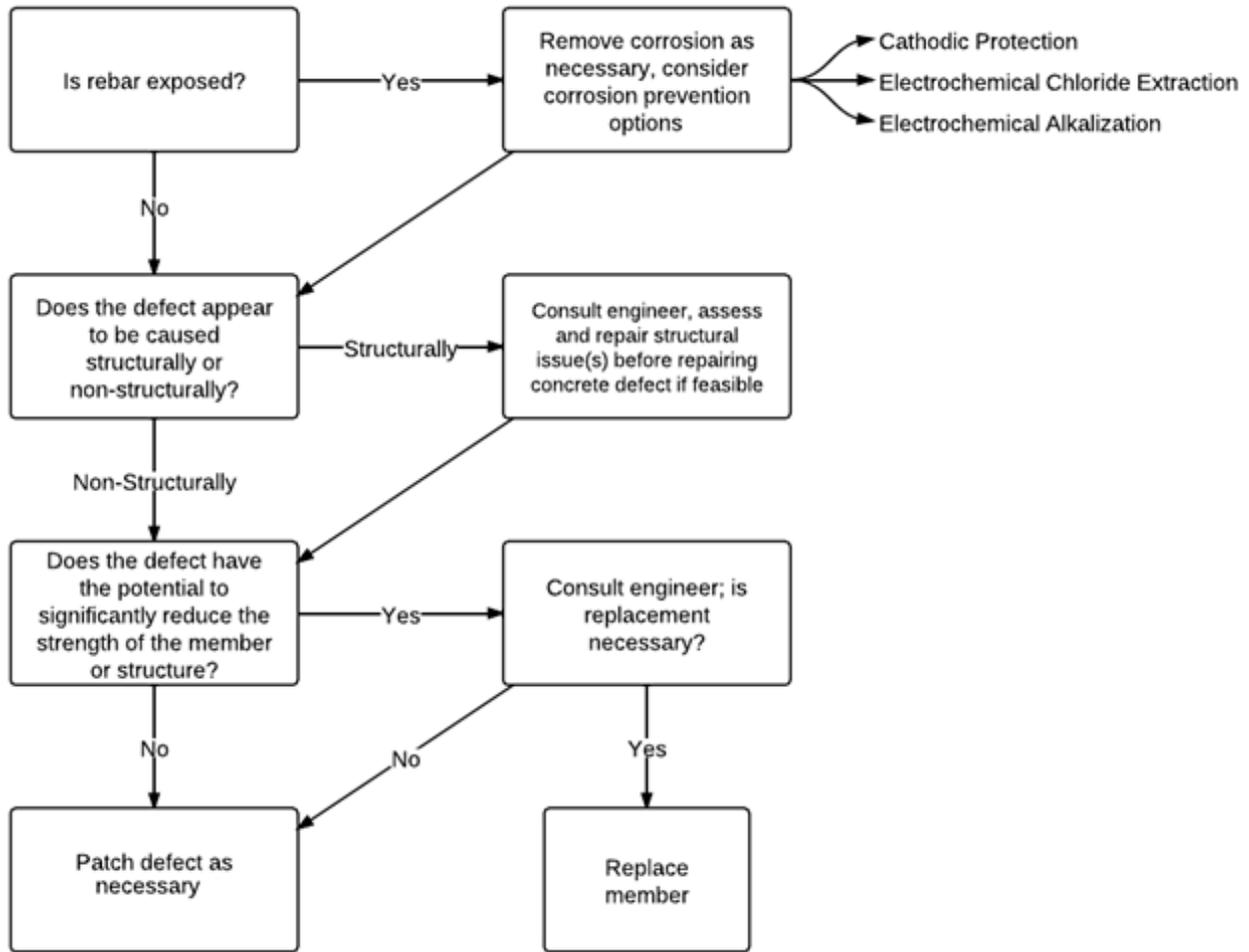
Figure 7-1. Flowchart for Spalling, Scaling, Delamination, Pop-outs, and Reinforcing Steel Corrosion in Concrete Elements.

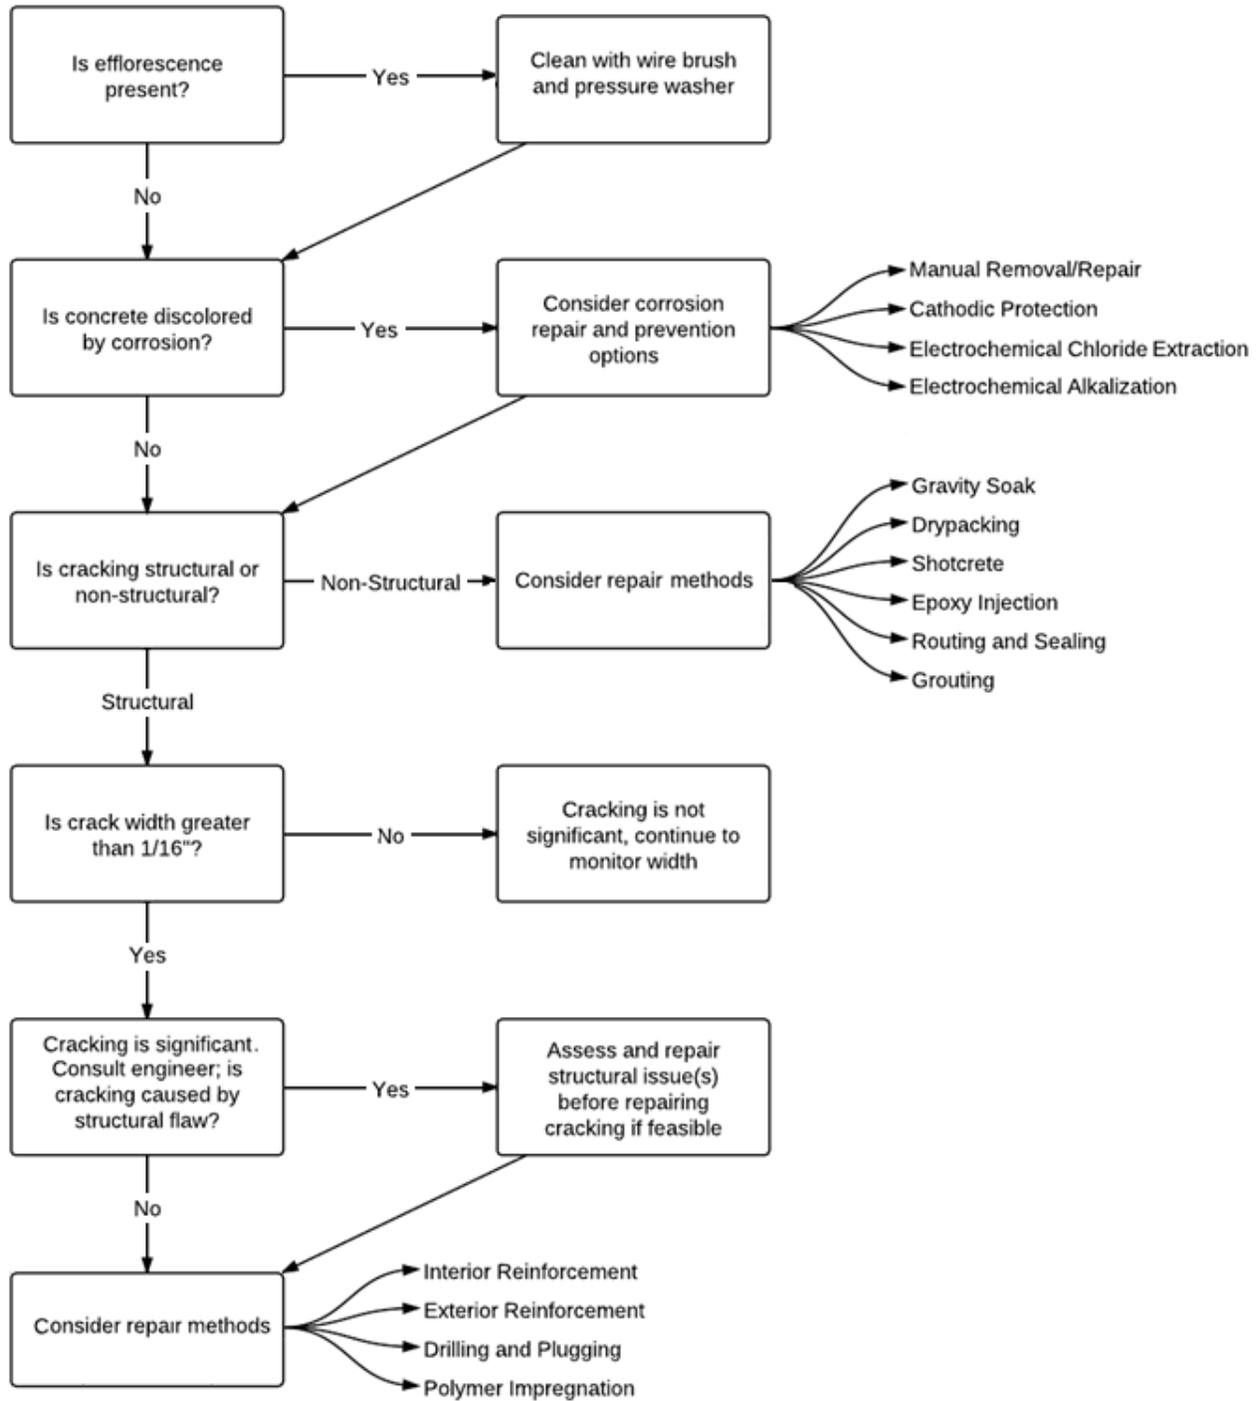
Figure 7-2. Flowchart for Cracking, Efflorescence, and Discoloration in Concrete Elements.

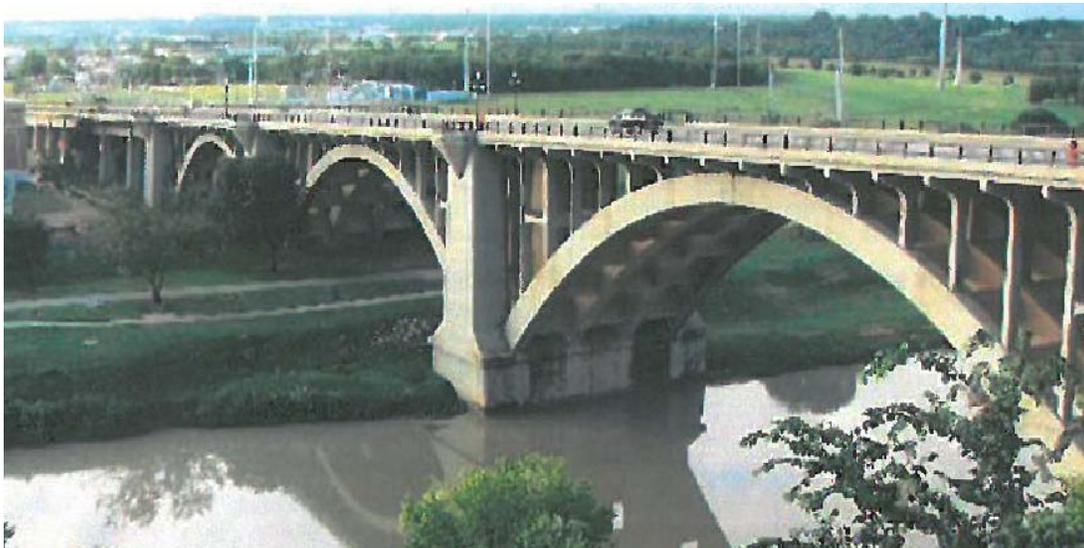
Figure 7-3. BU 287P (N. Main Street) over Clear Fork Trinity River (TxDOT 2012a).

This section contains examples of preservation plans for two bridges. The first carries BU 287P (North Main Street) over the Clear Fork of the Trinity River (Figure 7-3). This bridge has an open-spandrel concrete arch superstructure and is listed on the NRHP. The second is a steel truss bridge that also features steel girder and concrete girder spans, carrying West Lancaster Avenue over the Clear Fork of the Trinity River (Figure 7-4).

The Current Condition and Recommended Actions sections of the example preservation plans list actions that should be considered based on the inspection results. In some cases, defects may exist that are essentially beyond repair, such as misaligned arch posts in the superstructure of the concrete arch bridge. Mitigating this problem would require major rehabilitation and replacement of members, which would not be practical on a bridge its age. The Regular-Interval Maintenance sections recommend actions discussed in Section 6.3 that are applicable to the bridges of concern. In the Condition-Based Actions sections, the tables and figures from this chapter are listed as references for determining actions based on element condition states.

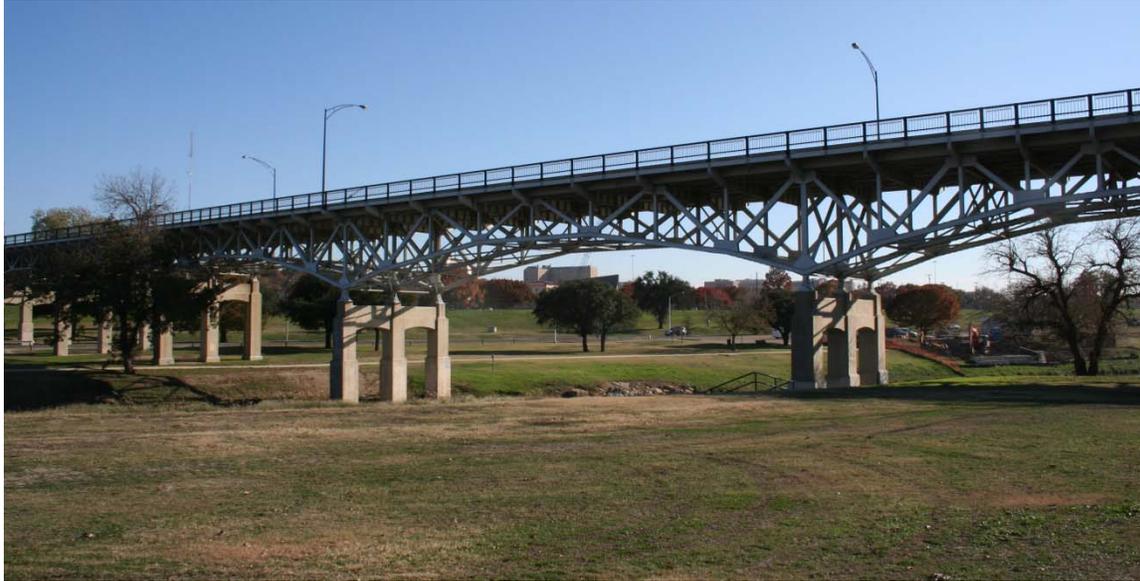
Figure 7-4. W. Lancaster Avenue over Clear Fork Trinity River.

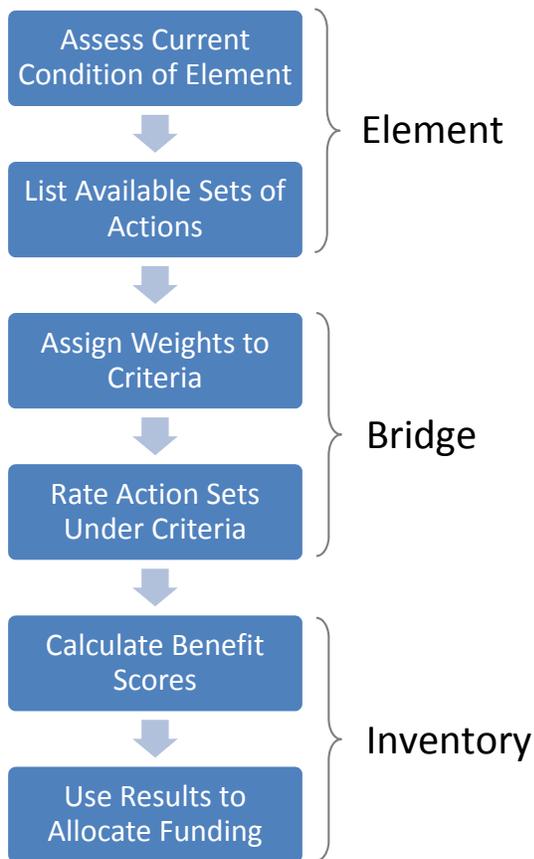
Figure 8-1. Flowchart Depicting the Resource Allocation Framework.

Section 8.5. The first method maximizes total benefit within the inventory, while the second maximizes benefit-to-cost ratio. It is recommended that the highest-ranked actions be performed first, but exceptions exist. Section 8.8 presents an example illustrating the use of the framework.

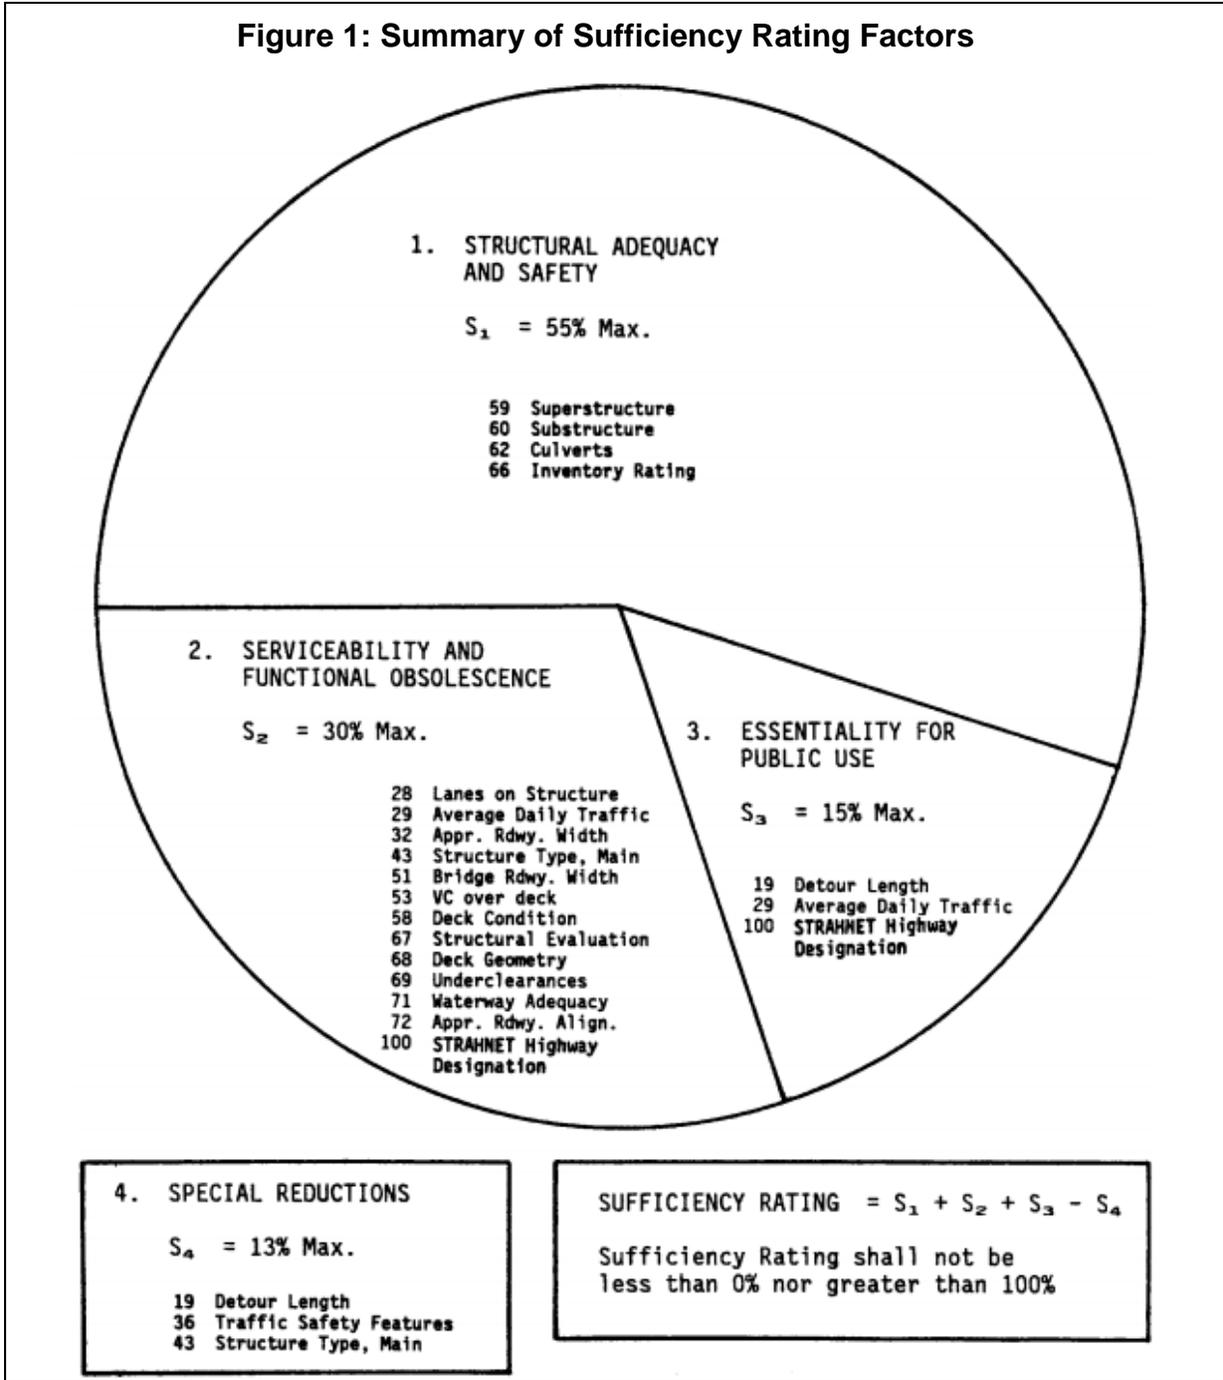
Figure 1: Summary of Sufficiency Rating Factors

Figure A-1. Calculation of FHWA Sufficiency Rating (FHWA 1995).

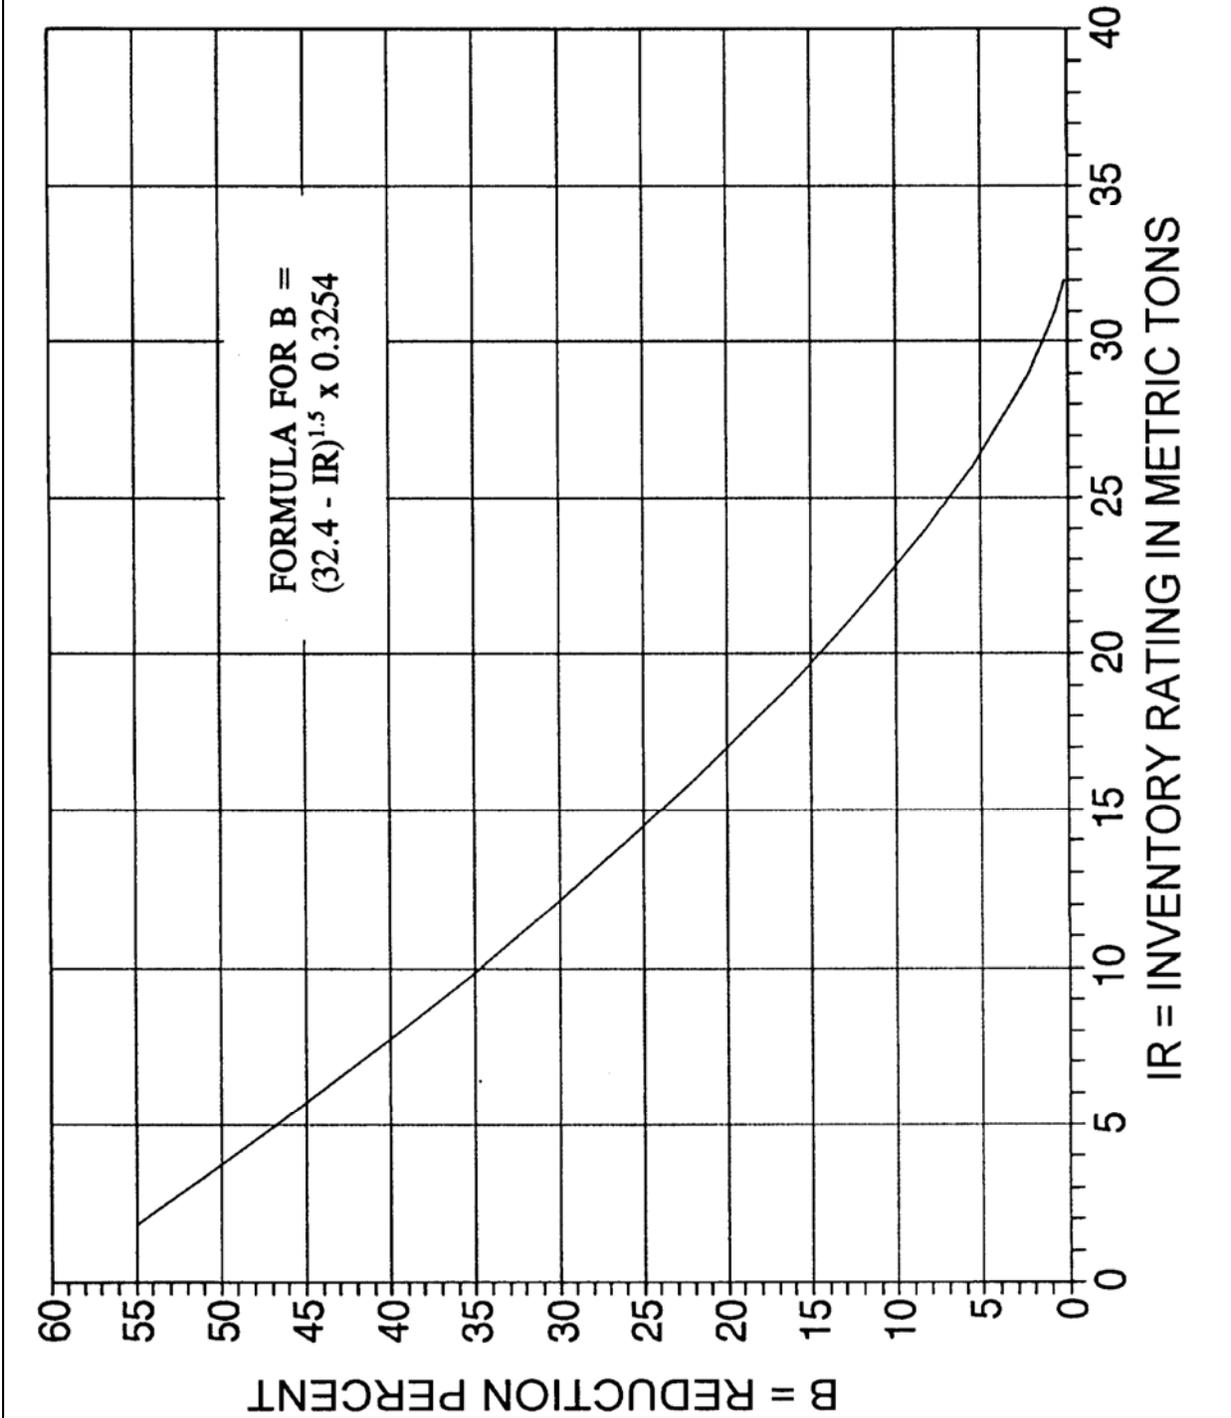
Figure 2: Reduction for Load Capacity

Figure A-1. Calculation of FHWA Sufficiency Rating (FHWA 1995; continued).

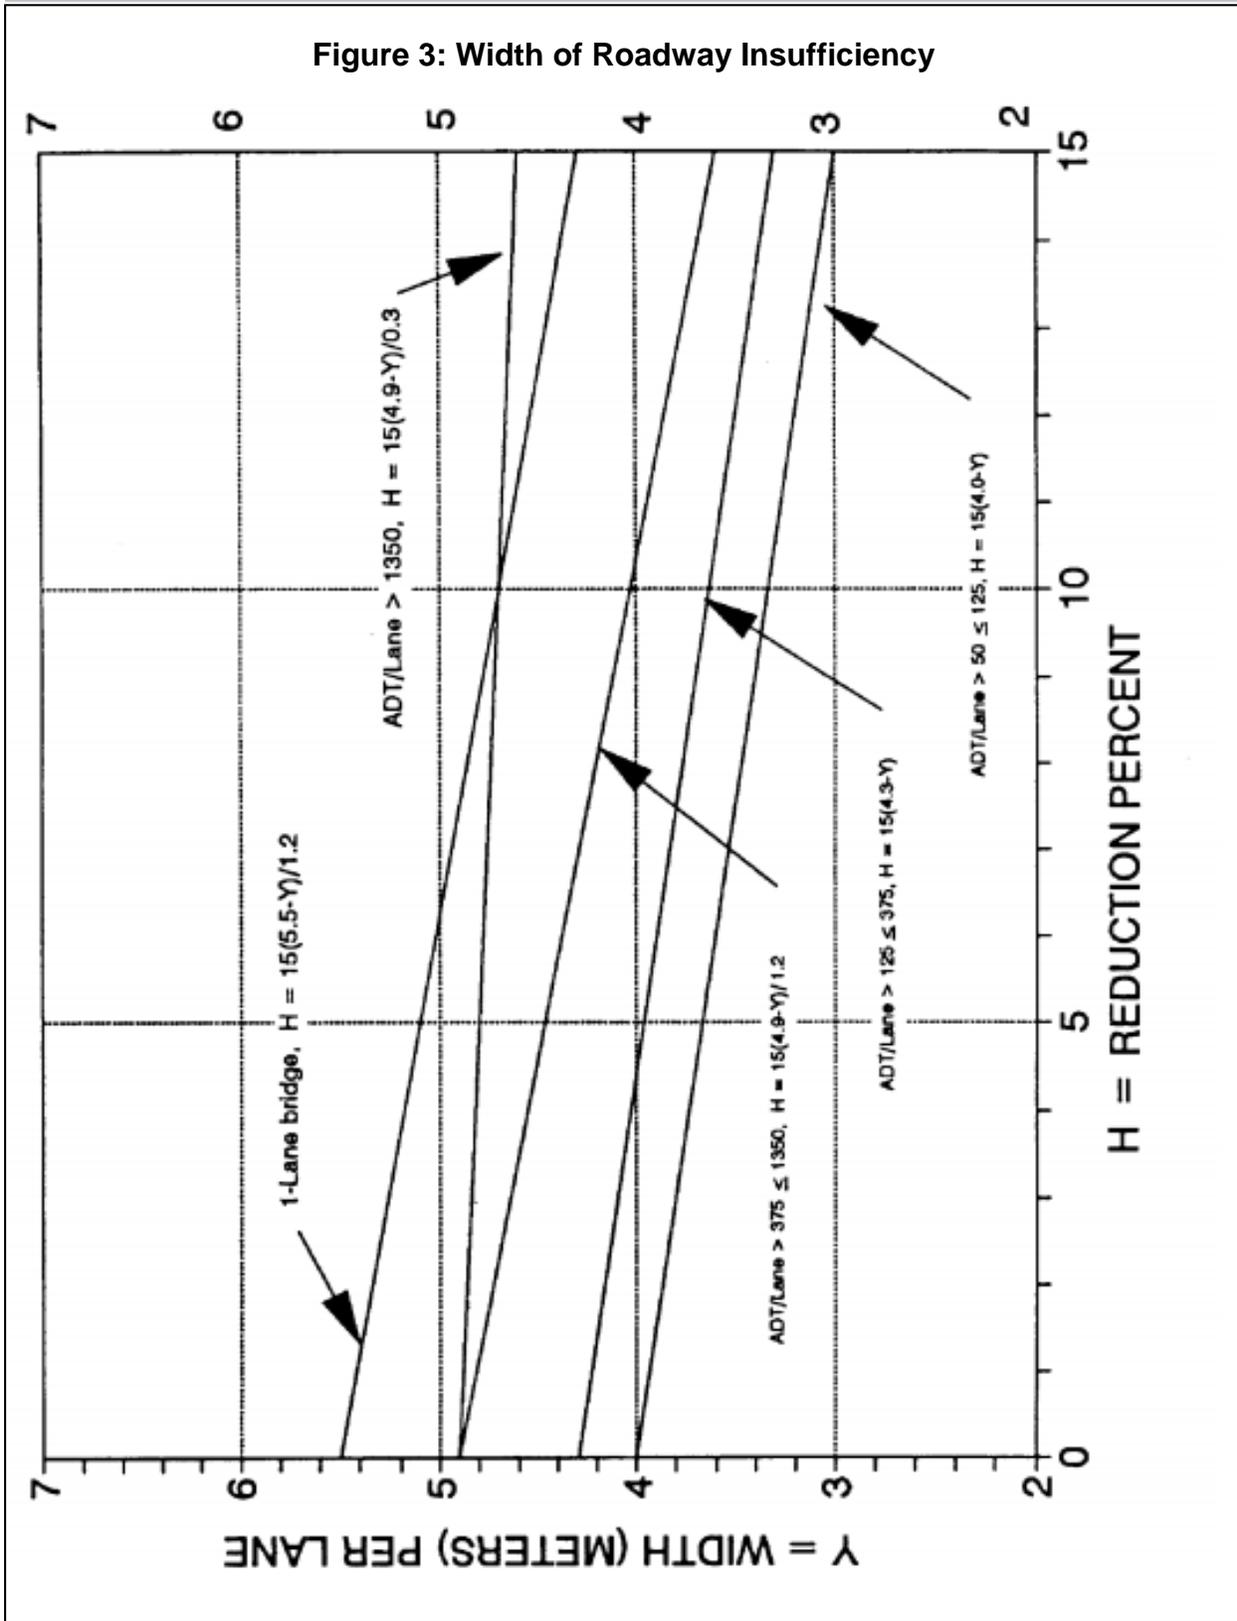
Figure 3: Width of Roadway Insufficiency

Figure A-1. Calculation of FHWA Sufficiency Rating (FHWA 1995; continued).

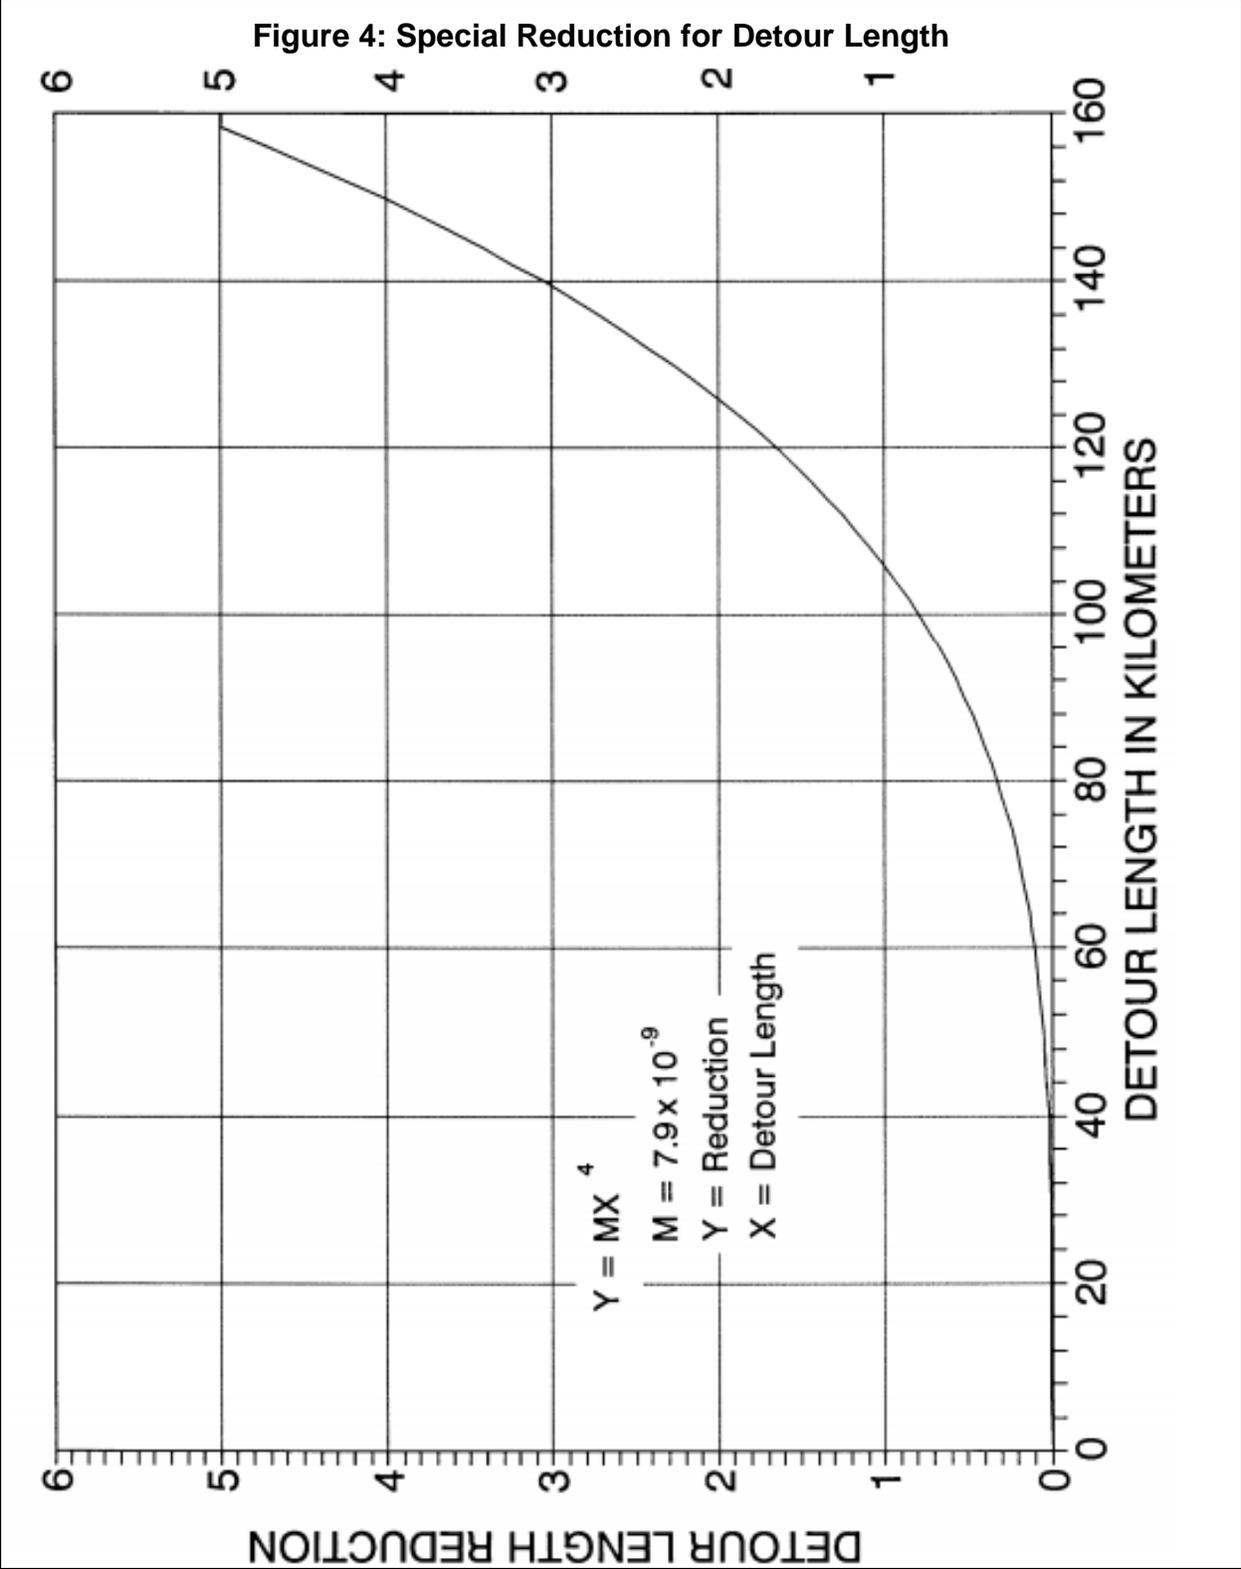
Figure A-1. Calculation of FHWA Sufficiency Rating (FHWA 1995; continued).

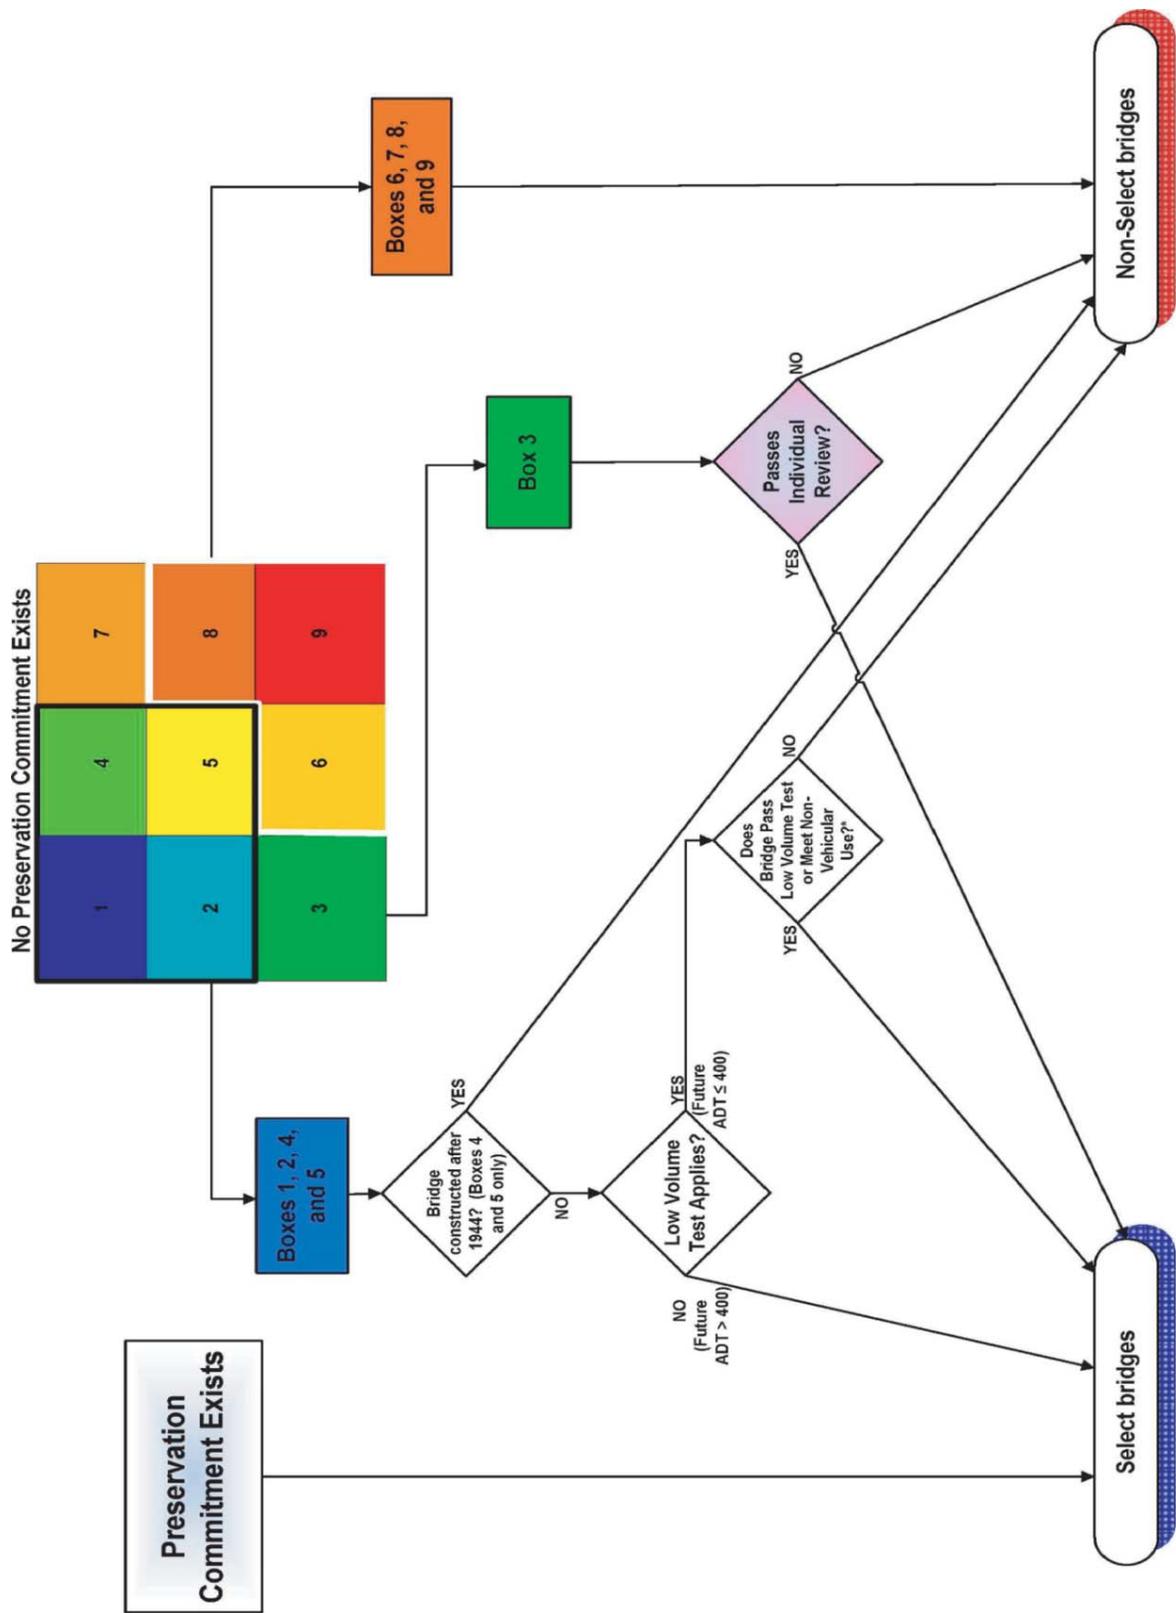
Figure D-1. Flowchart for Indiana Prioritization Process (Rathke et al. 2010).

length. Bridges in Boxes 6, 7, 8, and 9 were automatically determined non-select. A flowchart depicting the selection process can be found in Appendix D.

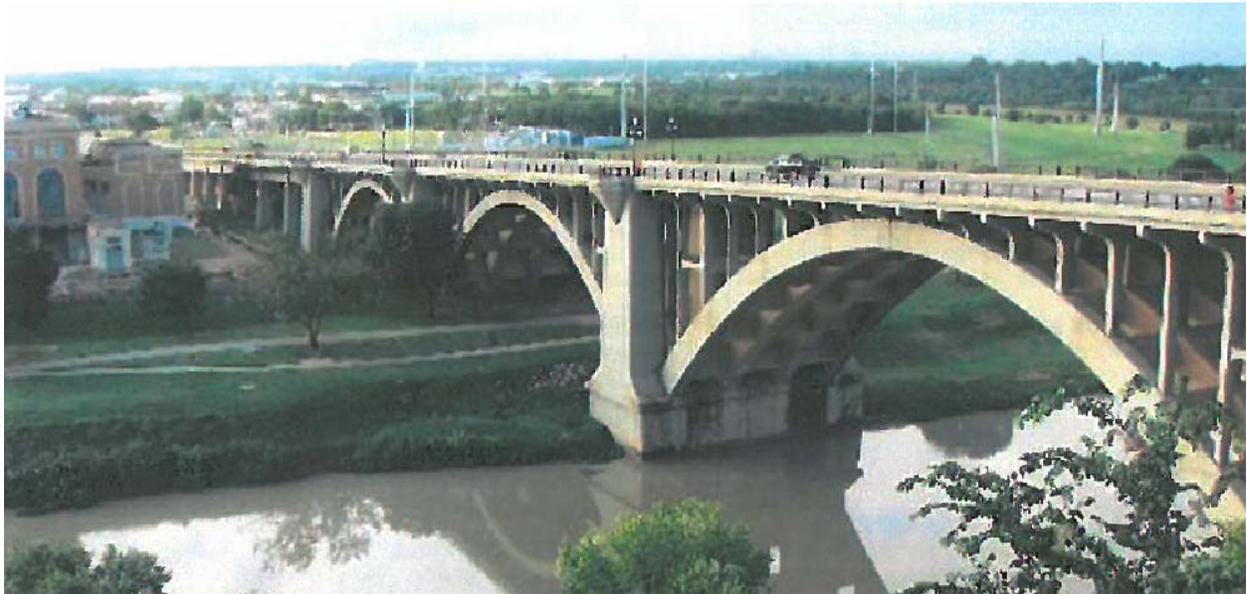
Figure F-1. BU 287P (N. Main Street) over Clear Fork Trinity River (TxDOT 2012a).

The bridge carrying Business Route 287P, also known as North Main Street, over the Clear Fork of the Trinity River is the only bridge in Tarrant County listed on the National Register of Historic Places. This bridge, also known as the Paddock Viaduct, was built in 1914 and was recently rehabilitated. It is a concrete open-spandrel arch bridge, a member type of great historical significance. The structure is 1319 ft long with a maximum span length of 225 ft and a total of 16 spans. The bridge experiences an annual average daily traffic of 13,500 vehicles.

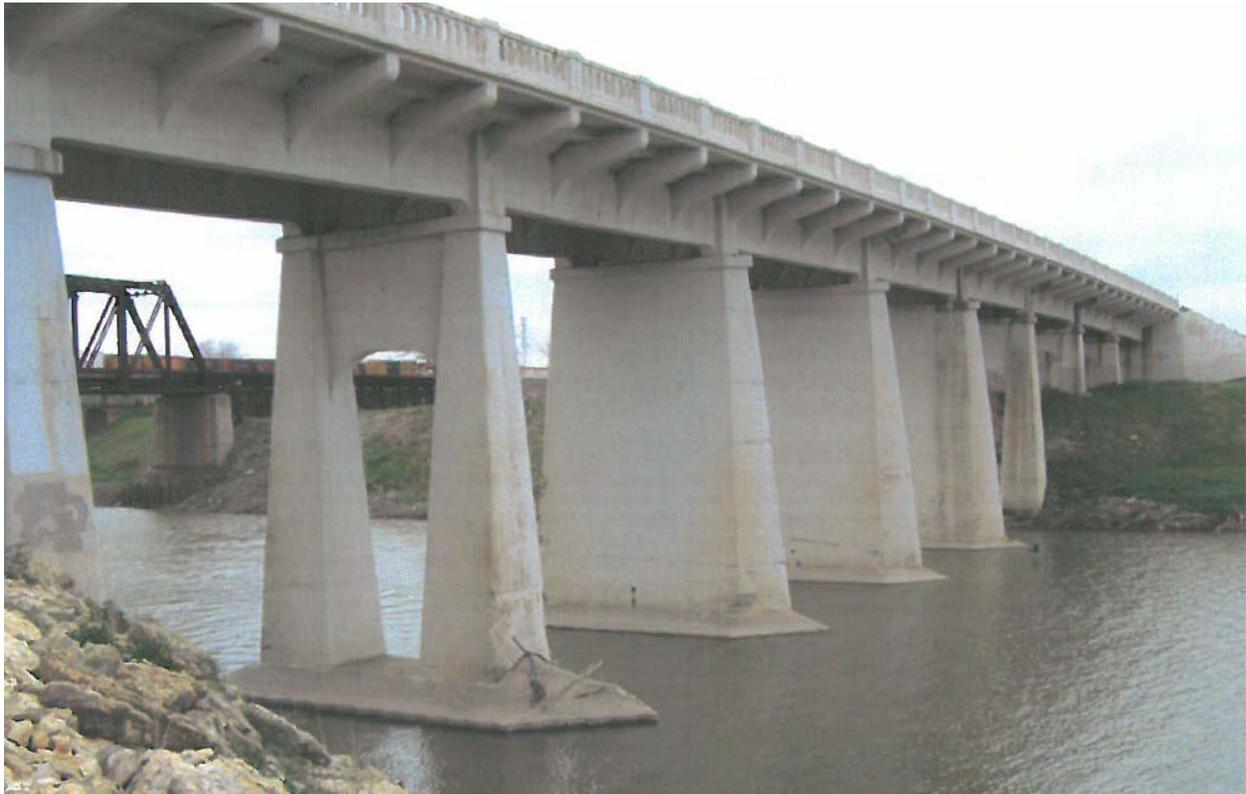
Figure F-2. Samuels Avenue over West Fork Trinity River (TxDOT 2012a).

The bridge carrying Samuels Avenue over the West Fork of the Trinity River was built in 1914. It has a continuous concrete tee-beam superstructure and Type H rails, which add to its historical significance. The structure is 450 ft long with a maximum span length of 50 ft and a total of nine spans. The bridge experiences an annual average daily traffic of 3990 vehicles.

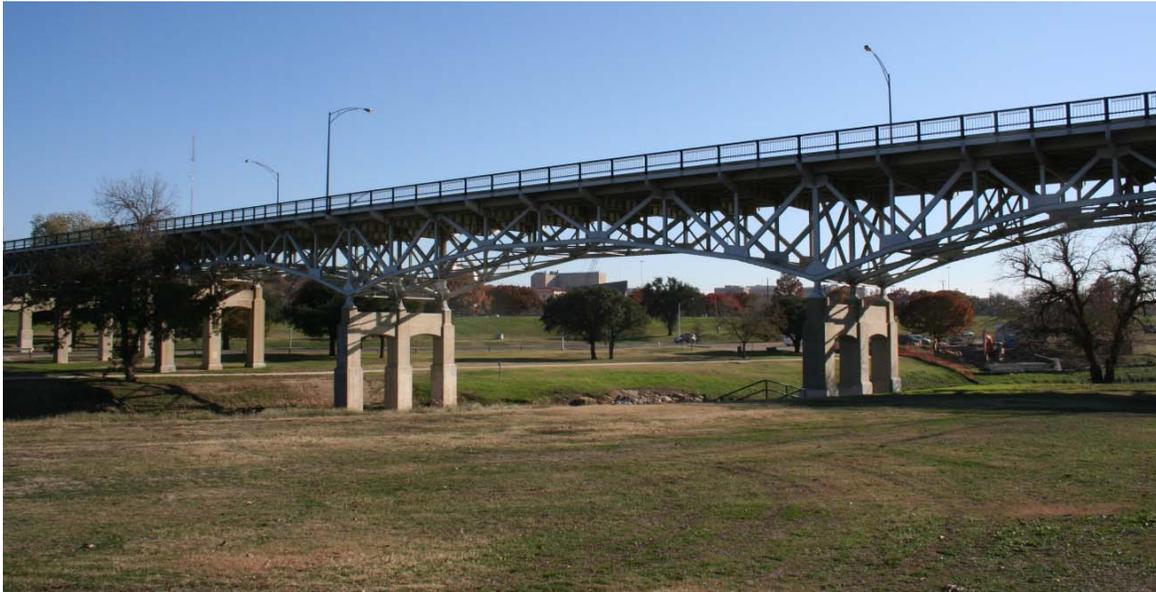
Figure F-3. W. Lancaster Avenue over Clear Fork Trinity River/Forest Park.

The bridge carrying West Lancaster Avenue over the Clear Fork of the Trinity River and Forest Park was built in 1938. It has a continuous steel truss superstructure and specially designed rails, which add to its historical significance. The structure is 2976 ft long with a maximum span length of 133 ft and a total of 46 spans. The bridge experiences an annual average daily traffic of 12,850 vehicles.

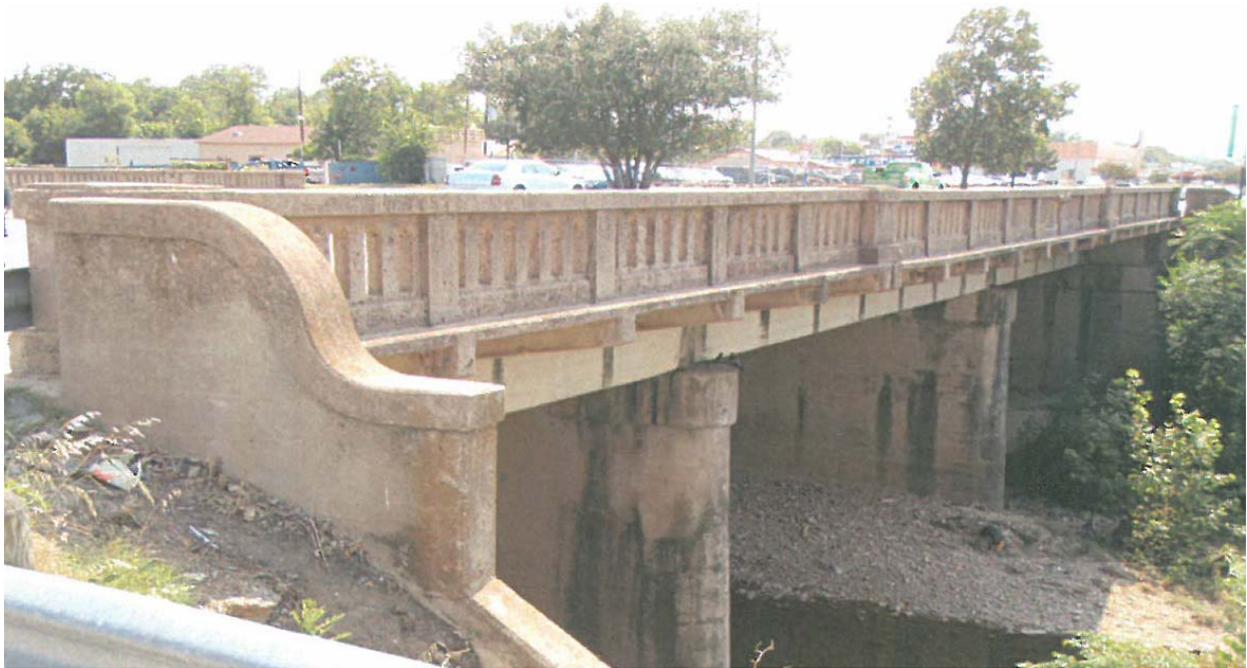
Figure F-4. SH 180 WB over Sycamore Creek (TxDOT 2012a).

The bridge carrying State Highway 180 Westbound over Sycamore Creek was built in 1928. It has a continuous concrete tee beam superstructure and Type H rails, which add to its historical significance. The structure is 122 ft long with a maximum span length of 50 ft and a total of three spans. The bridge experiences an annual average daily traffic of 7050 vehicles.

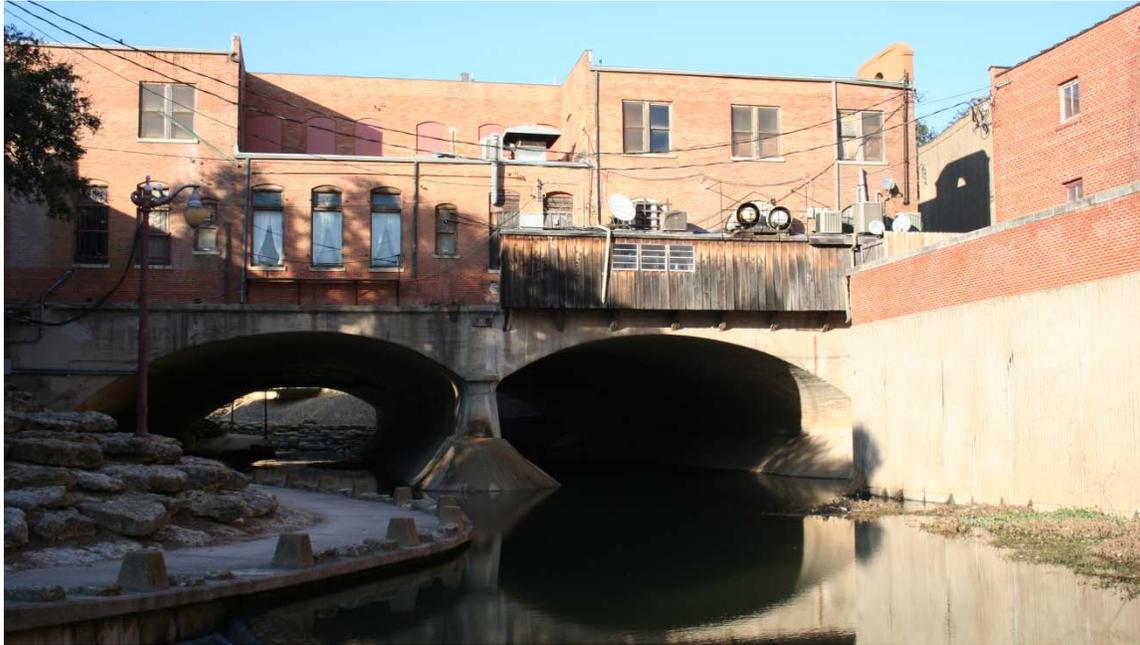
Figure F-5. E. Exchange Avenue over Marine Creek.

The bridge carrying East Exchange Avenue over Marine Creek was built in 1930. It has a concrete arch superstructure and supports buildings on East Exchange Avenue, adding to its historical and engineering significance. The structure is 83 ft long with a maximum span length of 43 ft and a total of two spans. The bridge experiences an annual average daily traffic of 1420 vehicles.
