A Framework for Historic Bridge Preservation in Tarrant County

Technical Report 409139-1

TEXAS A&M TRANSPORTATION INSTITUTE
COLLEGE STATION, TEXAS

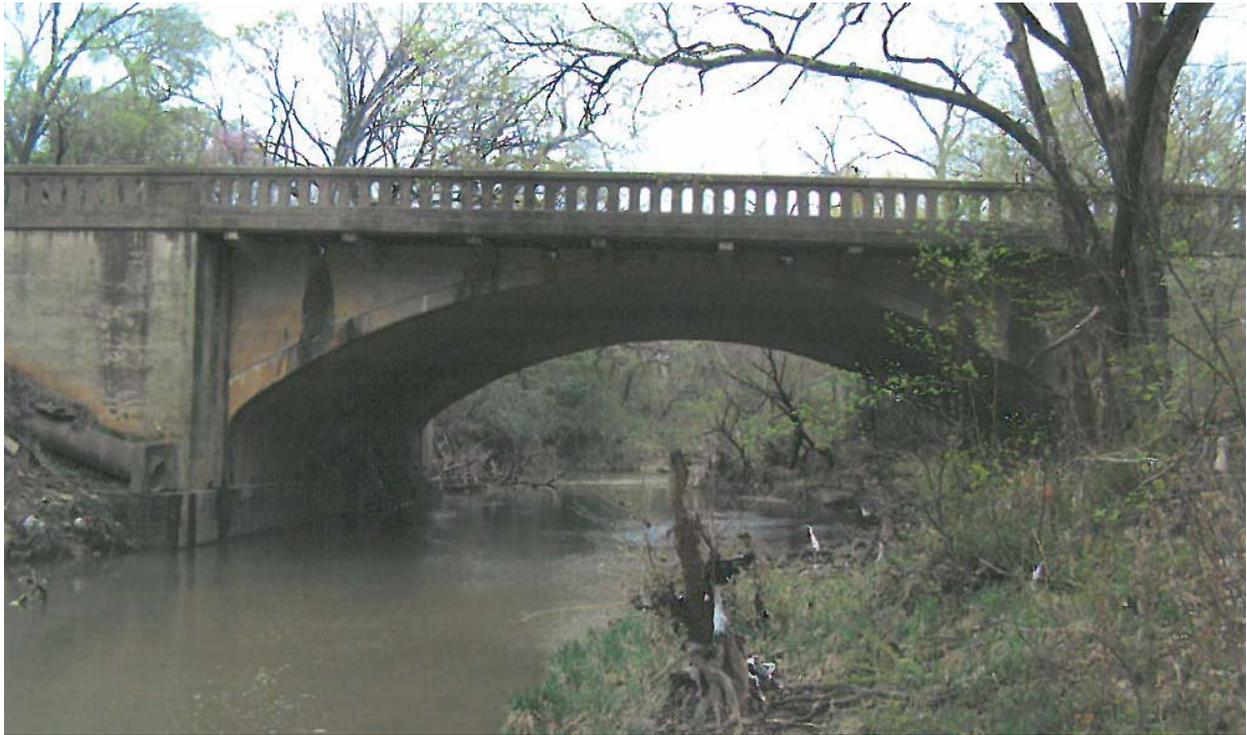
Figure F-6. E. Vickery Boulevard over Sycamore Creek (TxDOT 2012a).

The bridge carrying East Vickery Boulevard over Sycamore Creek was built in 1930. It has a closed-spandrel concrete arch superstructure and Type H rails, which add to its historical significance. The structure is 116 ft long and has one span with a length of 60 ft. The bridge experiences an annual average daily traffic of 4350 vehicles.

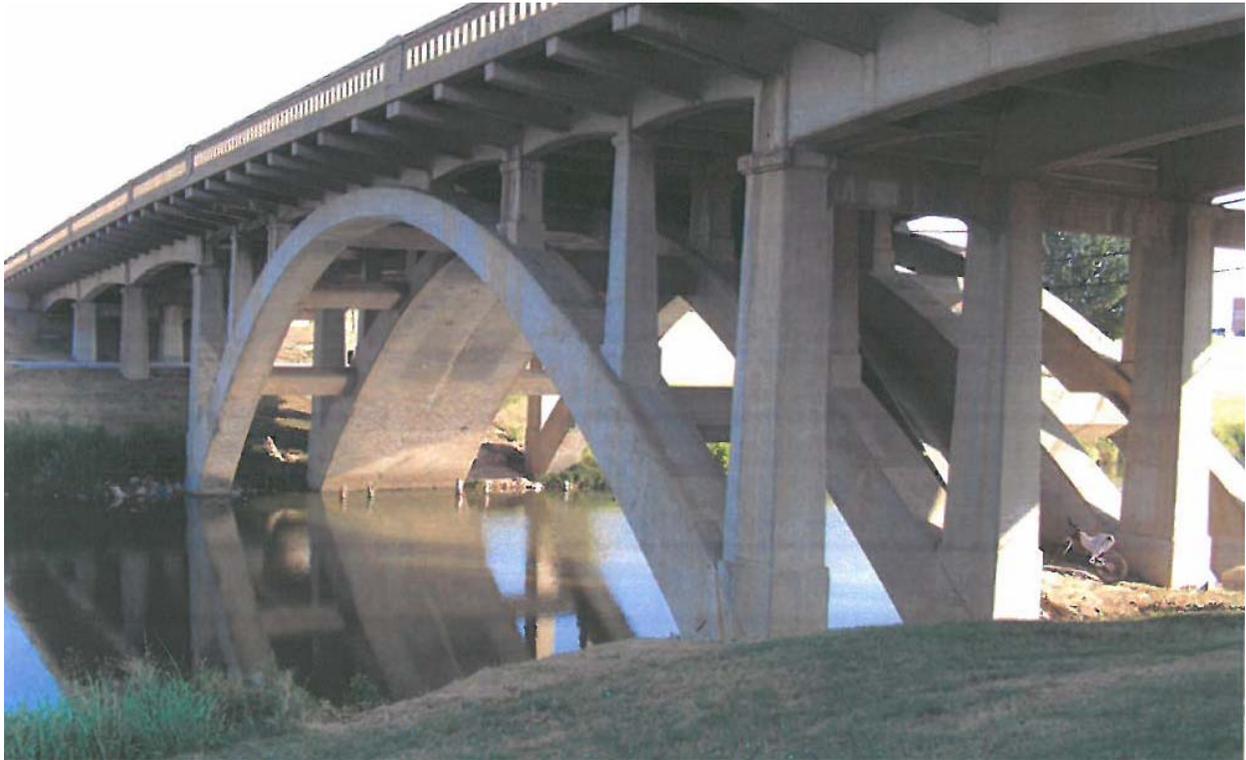
Figure F-7. SH 199 (Henderson Street) over Clear Fork Trinity River (TxDOT 2012a).

The bridge carrying State Highway 199, also known as Henderson Street, over the Clear Fork of the Trinity River was built in 1930. It has an open-spandrel concrete arch superstructure and Type H rails, which add to its historical significance. The structure is 796 ft long with a maximum span length of 124 ft and a total of 15 spans. The bridge experiences an annual average daily traffic of 29,000 vehicles.

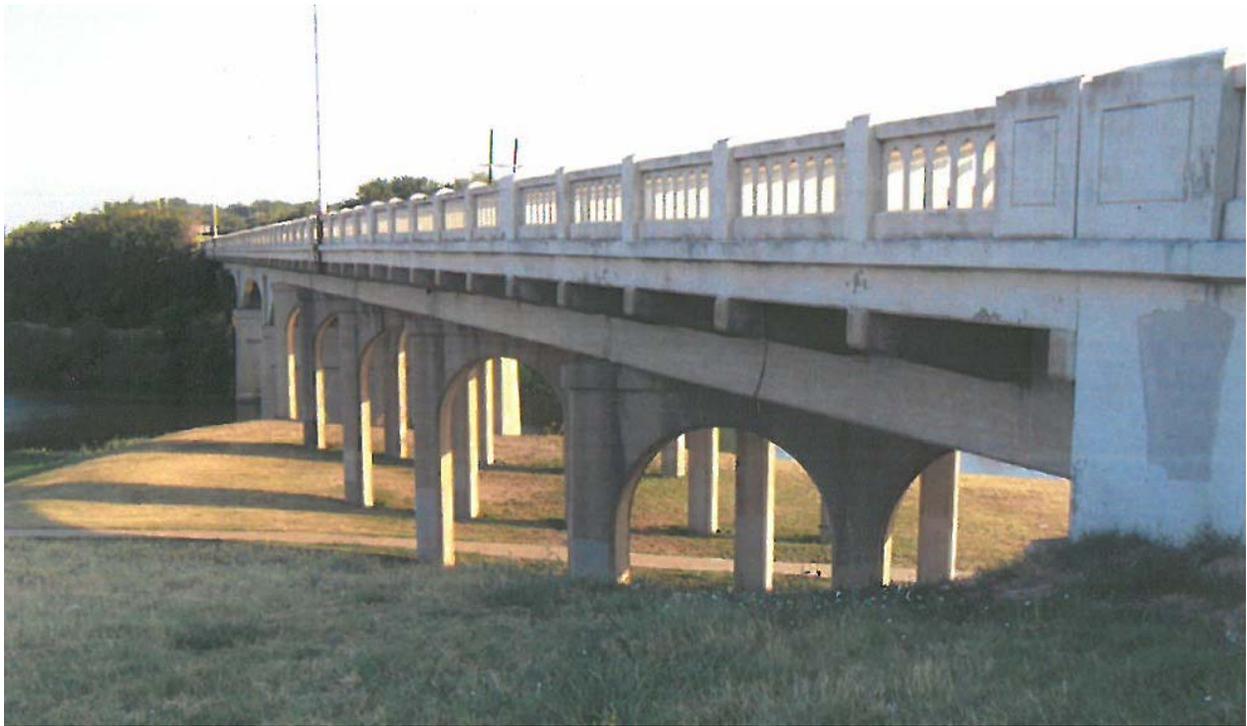
Figure F-8. SH 199 (Henderson Street) over West Fork Trinity River (TxDOT 2012a).

The bridge carrying State Highway 199, also known as Henderson Street, over the West Fork of the Trinity River was built in 1931. It has a variable-depth concrete tee beam superstructure and specially designed rails, which add to its historical significance. The structure is 486 ft long with a maximum span length of 164 ft and a total of 10 spans. The bridge experiences an annual average daily traffic of 29,000 vehicles.

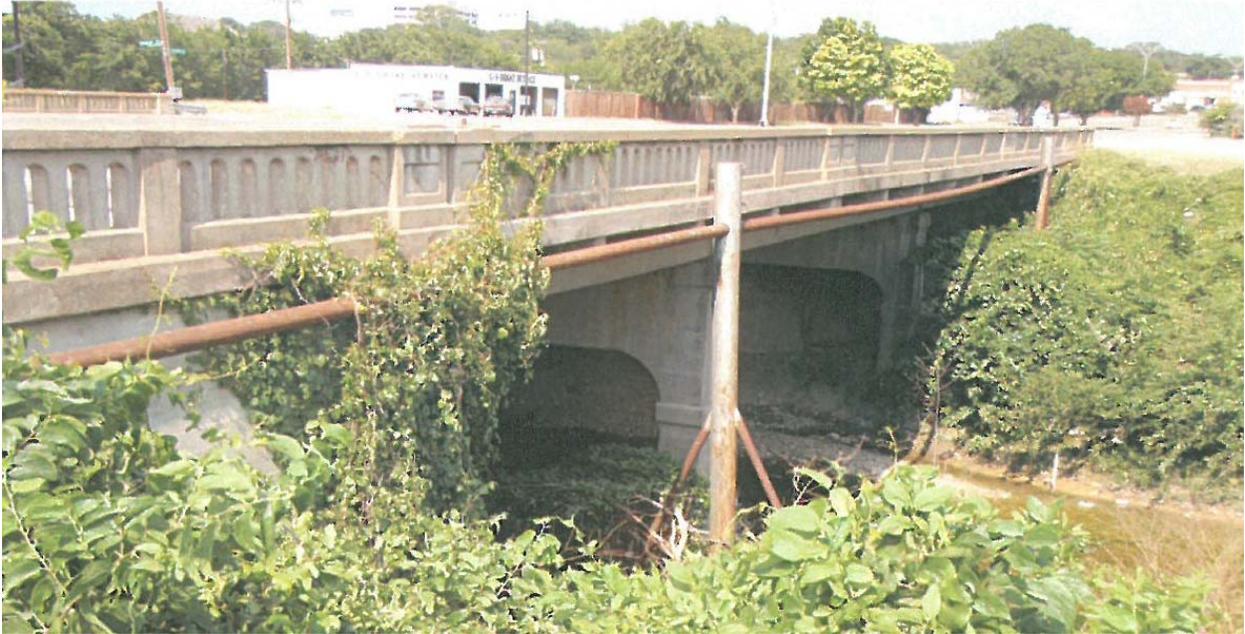
Figure F-9. SH 180 EB over Sycamore Creek (TxDOT 2012a).

The bridge carrying State Highway 180 Eastbound over Sycamore Creek was built in 1938. It has a concrete tee-beam superstructure and Type H rails, which add to its historical significance. The structure is 125 ft long with a maximum span length of 50 ft and a total of three spans. The bridge experiences an annual average daily traffic of 7050 vehicles.

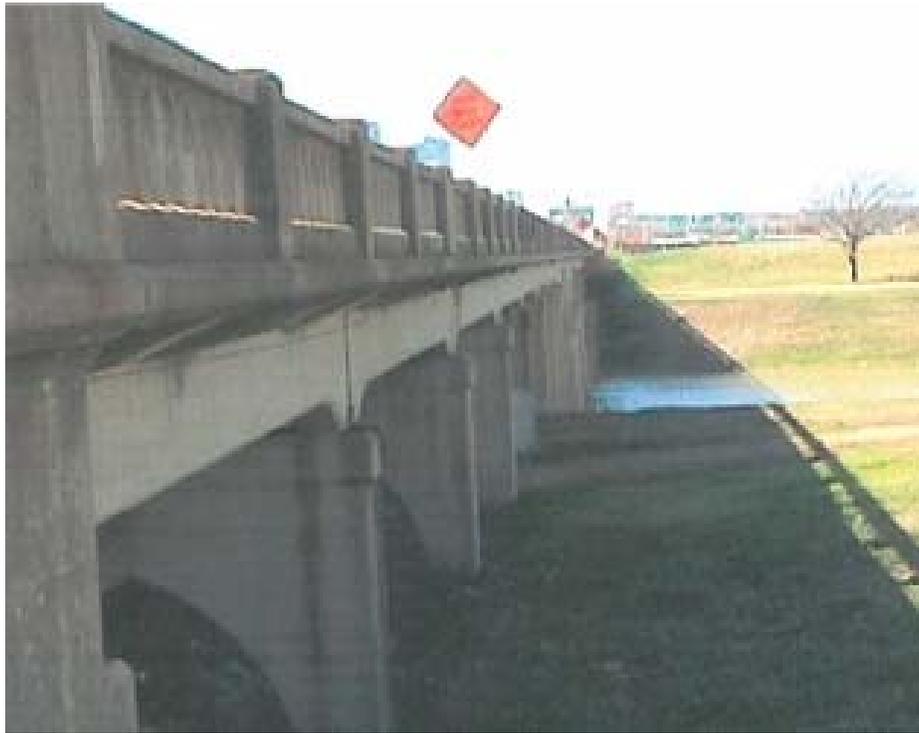
F.10 US 377 (E. BELKNAP STREET) OVER CLEAR FORK TRINITY RIVER

Figure F-10. US 377 (E. Belknap Street) over Clear Fork Trinity River (TxDOT 2012a).

The bridge carrying US 377, also known as East Belknap Street, over the Clear Fork of the Trinity River was built in 1932. It has a variable-depth concrete tee-beam superstructure and specially designed rails, which add to its historical significance. The structure is 717 ft long with a maximum span length of 164 ft and a total of 16 spans. The bridge experiences an annual average daily traffic of 6200 vehicles.

The bridge currently has a sufficiency rating of 56.5 and a historical significance of 2, as listed in the National Bridge Inventory. This places it in the portion of the matrix considered first priority. The structure was included on the list of 24 recommended bridges by TxDOT and ranked as the #6 highest-priority bridge in Tarrant County for maintenance and preservation by Historic Fort Worth, Inc. Receiving a score of 87 using the quantitative rating system, the bridge ties for tenth in Tarrant County. The bridge is shown in Figure F-10, and Table F-10 summarizes the main features, placement in the selection matrix, and quantitative rating of the bridge.

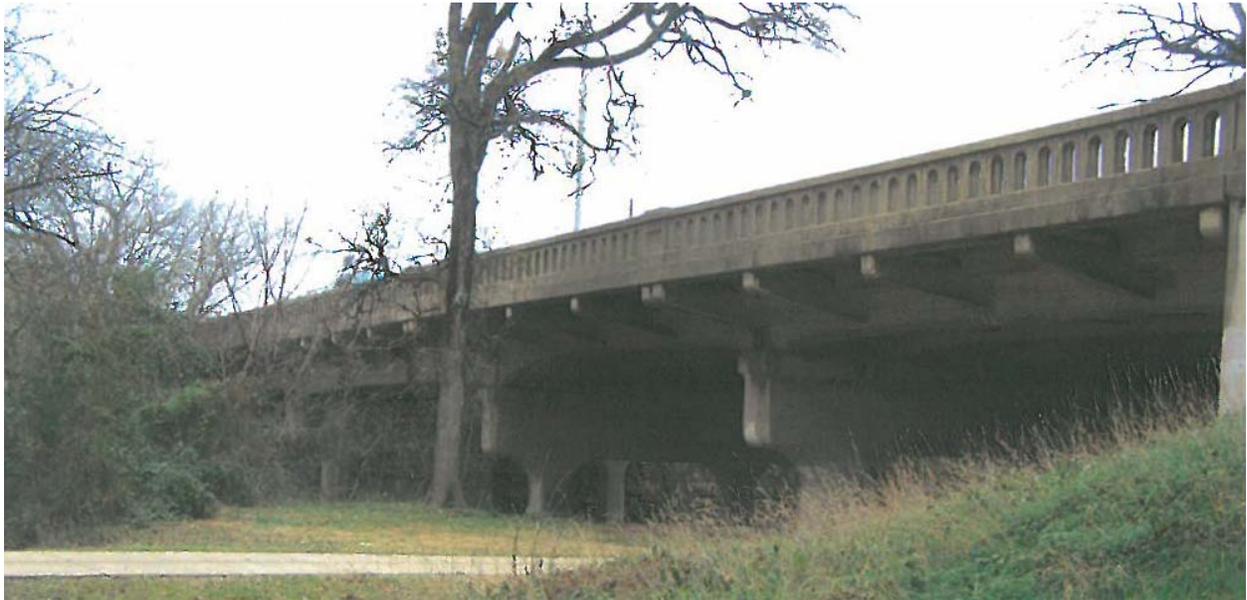
F.11 E. ROSEDALE STREET OVER SYCAMORE CREEK

Figure F-11. E. Rosedale Street over Sycamore Creek (TxDOT 2012a).

The bridge carrying East Rosedale Street over Sycamore Creek was built in 1936. It has a variable-depth concrete tee-beam superstructure and Type H rails, which add to its historical significance. The structure is 181 ft long with a maximum span length of 60 ft and a total of four spans. The bridge experiences an annual average daily traffic of 9310 vehicles.

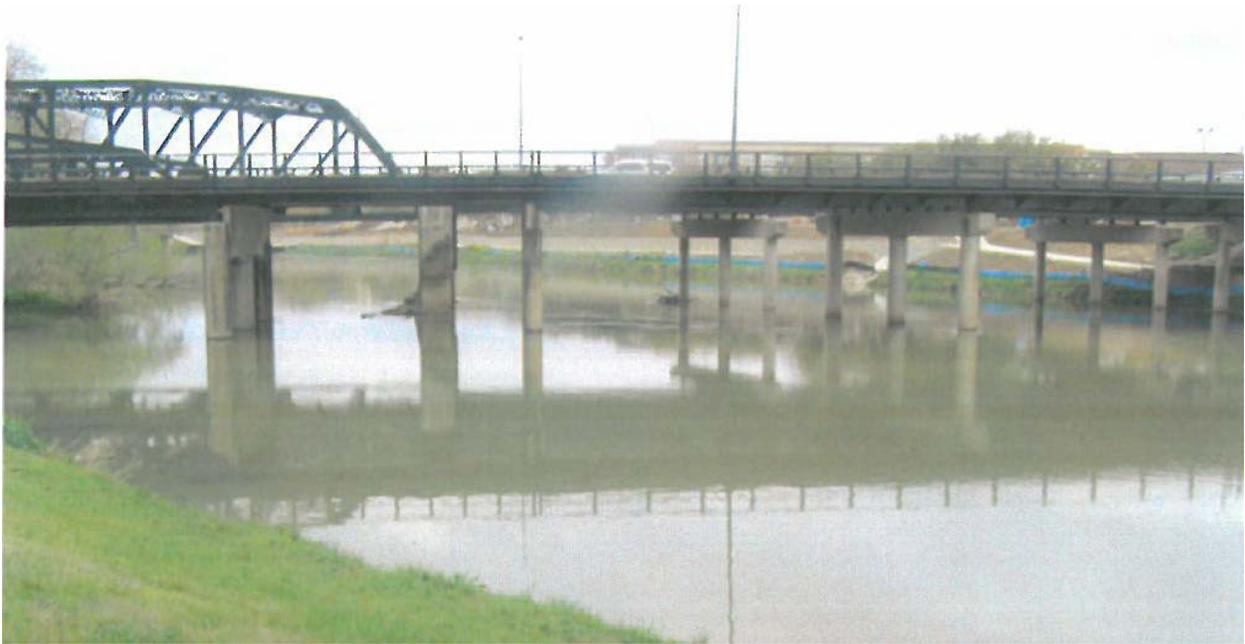
F.12 S. UNIVERSITY DRIVE SB OVER CLEAR FORK TRINITY RIVER

Figure F-12. S. University Drive SB over Clear Fork Trinity River (TxDOT 2012a).

The bridge carrying South University Drive Southbound over the Clear Fork of the Trinity River was built in 1936. It has a camelback through truss and steel I-beam superstructure and specially designed rails, which add to its historical significance. The structure is 340 ft long with a maximum span length of 140 ft and a total of four spans. The bridge experiences an annual average daily traffic of 17,330 vehicles.

The bridge currently has a sufficiency rating of 45 (recently upgraded from 37.8 after a repair that included replacing rivets with bolts) and a historical significance of 2, as listed in the National Bridge Inventory. This places it in the portion of the matrix considered second priority. The structure was included on the list of 24 recommended bridges by TxDOT and ranked as the #3 highest-priority bridge in Tarrant County for maintenance and preservation by Historic Fort Worth, Inc. Receiving a score of 87 using the quantitative rating system, the bridge ties for tenth in Tarrant County. The bridge is shown in Figure F-12, and Table F-12 summarizes the main features, placement in the selection matrix, and quantitative rating of the bridge.

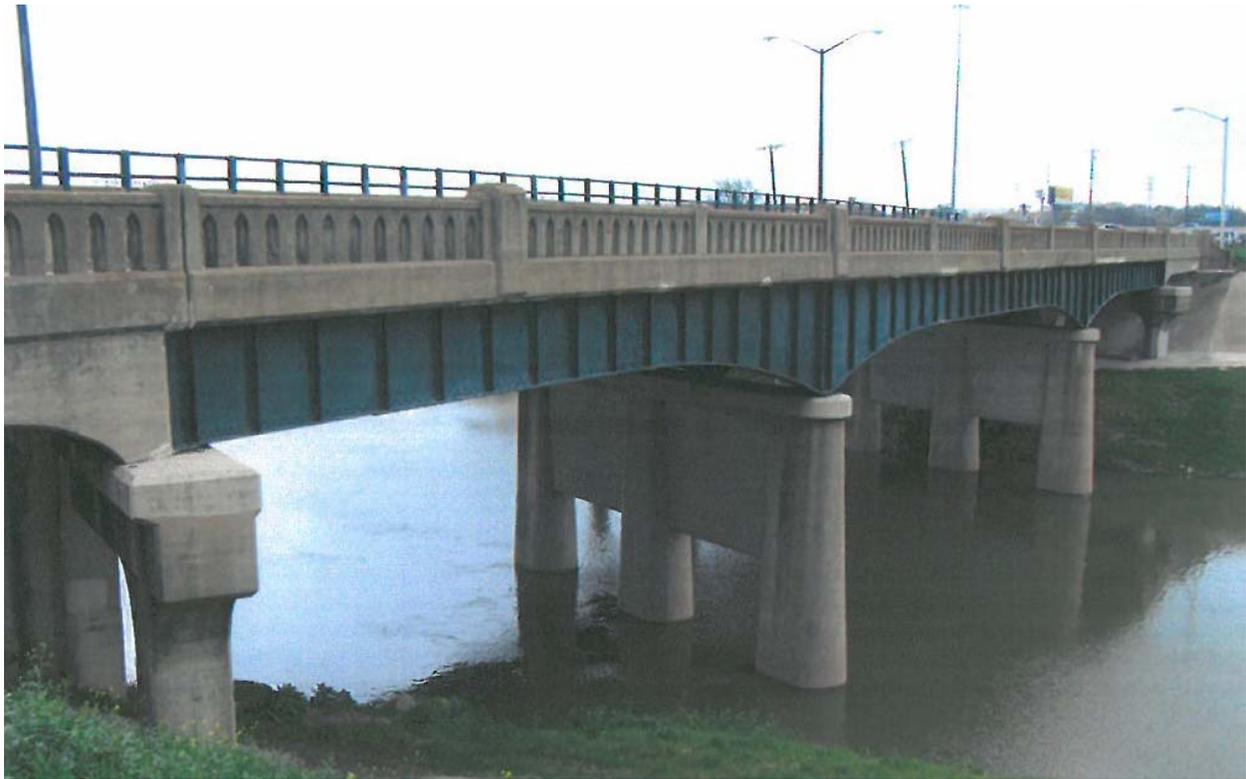
F.13 RIVERSIDE DRIVE SB OVER WEST FORK TRINITY RIVER

Figure F-13. Riverside Drive SB over West Fork Trinity River (TxDOT 2012a).

The bridge carrying Riverside Drive Southbound over the West Fork of the Trinity River was built in 1931. It has a variable-depth steel plate girder superstructure and specially designed rails, which add to its historical significance. The structure is 292 ft long with a maximum span length of 96 ft and a total of five spans. The bridge experiences an annual average daily traffic of 20,290 vehicles.

The bridge currently has a sufficiency rating of 53.4 and a historical significance of 2, as listed in the National Bridge Inventory. This places it in the portion of the matrix considered first priority. The structure was included on the list of 24 recommended bridges by TxDOT and ranked as the #8 highest-priority bridge in Tarrant County for maintenance and preservation by Historic Fort Worth, Inc. Receiving a score of 87 using the quantitative rating system, the bridge ties for tenth in Tarrant County. The bridge is shown in Figure F-13, and Table F-13 summarizes the main features, placement in the selection matrix, and quantitative rating of the bridge.

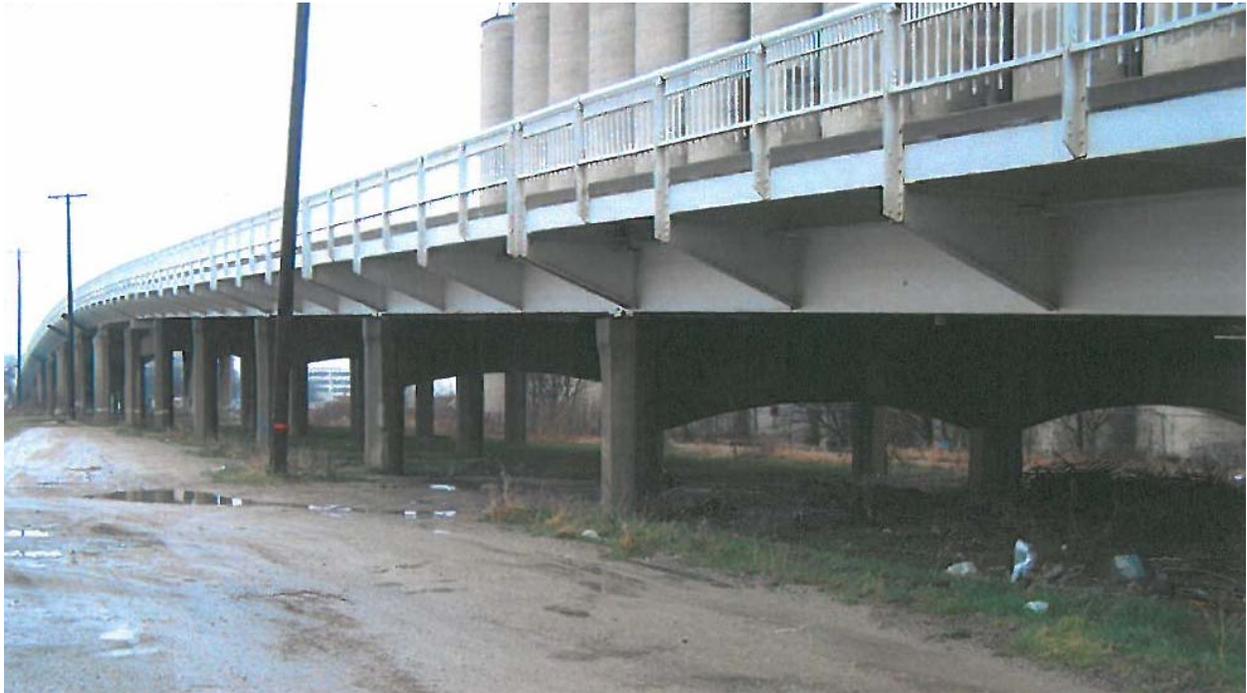
F.14 SOUTH MAIN STREET OVER BN & SF RAILROAD

Figure F-14. South Main Street over BN & SF Railroad (TxDOT 2012a).

The bridge carrying South Main Street over the BN & SF Railroad was built in 1937. It has a steel plate girder superstructure and specially designed rails, which add to its historical significance. The structure is 892 ft long with a maximum span length of 82 ft and a total of 16 spans. The bridge experiences an annual average daily traffic of 2260 vehicles.

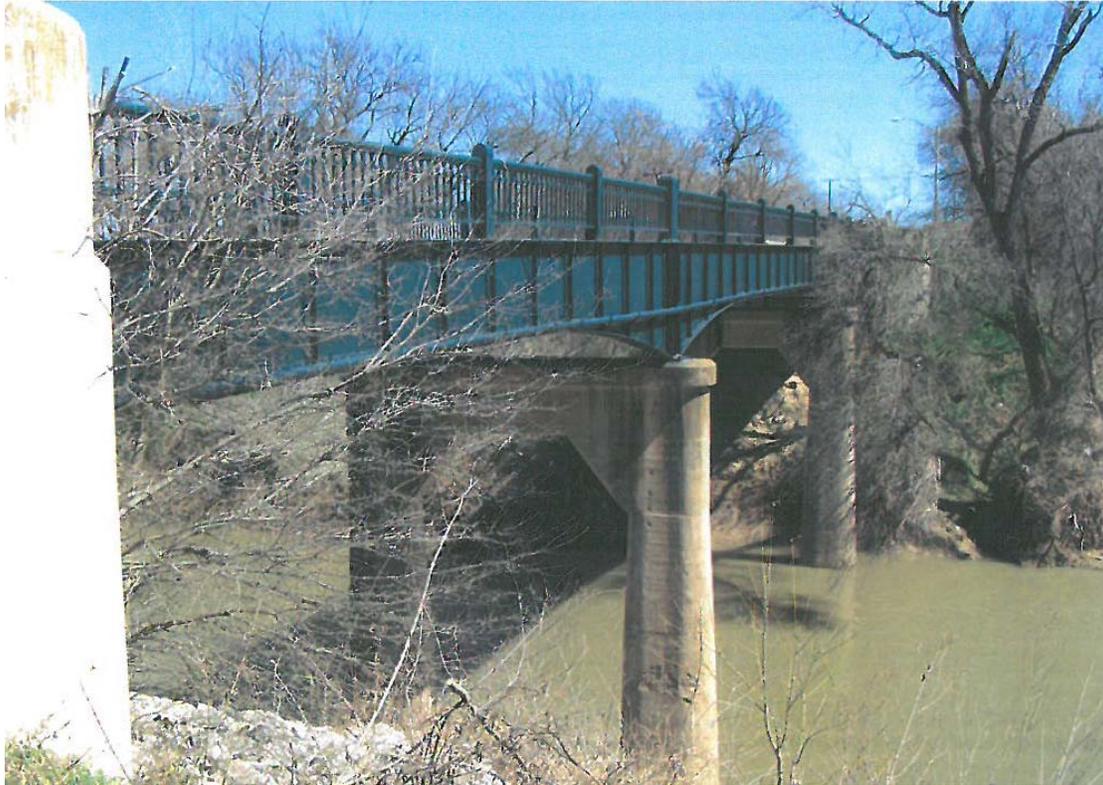
F.15 E. 1ST STREET OVER WEST FORK TRINITY RIVER

Figure F-15. E. 1st Street over West Fork Trinity River (TxDOT 2012a).

The bridge carrying East 1st Street over the West Fork of the Trinity River was built in 1936. It has a variable-depth steel plate girder superstructure and specially designed rails, which add to its historical significance. The structure is 202 ft long with a maximum span length of 80 ft and a total of three spans. The bridge experiences an annual average daily traffic of 3680 vehicles.

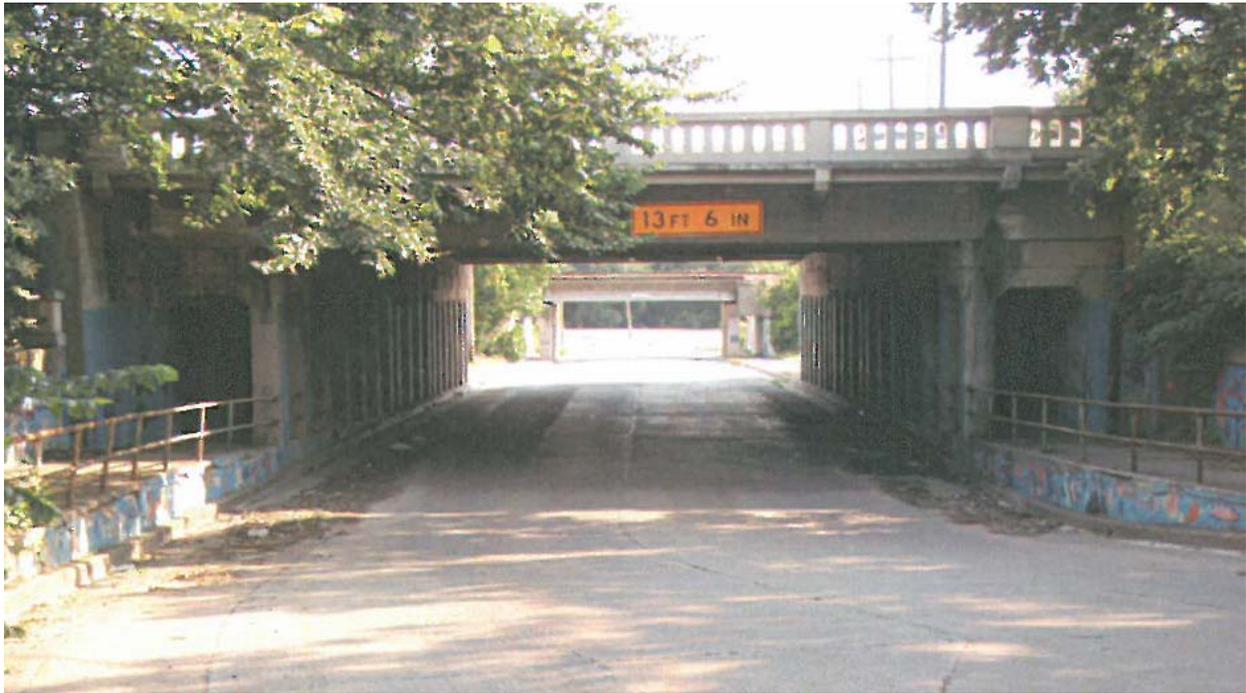
F.16 SH 180 WB OVER CONNER AVENUE

Figure F-16. SH 180 WB over Conner Avenue (TxDOT 2012a).

The bridge carrying State Highway 180 Westbound over Conner Avenue was built in 1928. It has a concrete tee-beam superstructure and Type H rails, which add to its historical significance. The structure consists of one span of 44 ft and experiences an annual average daily traffic of 7050 vehicles.

The bridge currently has a sufficiency rating of 68.5 and a historical significance of 4, as listed in the National Bridge Inventory. This places it in the portion of the matrix considered third priority; however, it was recommended for further consideration by TxDOT personnel despite its low placement. The structure ranks 16th in Tarrant County with a score of 84 using the quantitative rating system. The bridge is shown in Figure F-16, and Table F-16 summarizes the main features, placement in the selection matrix, and quantitative rating of the bridge.

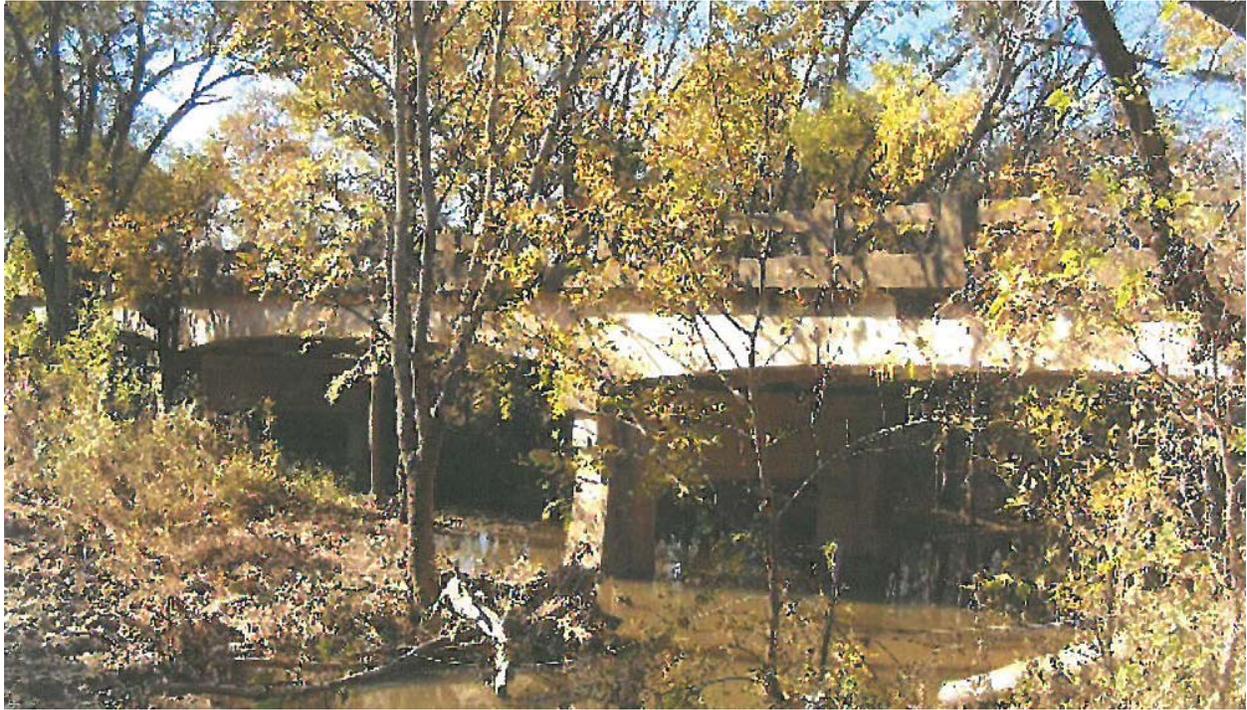
F.17 OLD DENTON ROAD OVER HENRIETTA CREEK

Figure F-17. Old Denton Road over Henrietta Creek (TxDOT 2012a).

The bridge carrying Old Denton Road over Henrietta Creek was built in 1939. It has a variable-depth concrete tee-beam superstructure and Type K rails, which add to its historical significance. The structure is 150 ft long with a maximum span length of 60 ft and a total of three spans. The bridge experiences an annual average daily traffic of 240 vehicles.

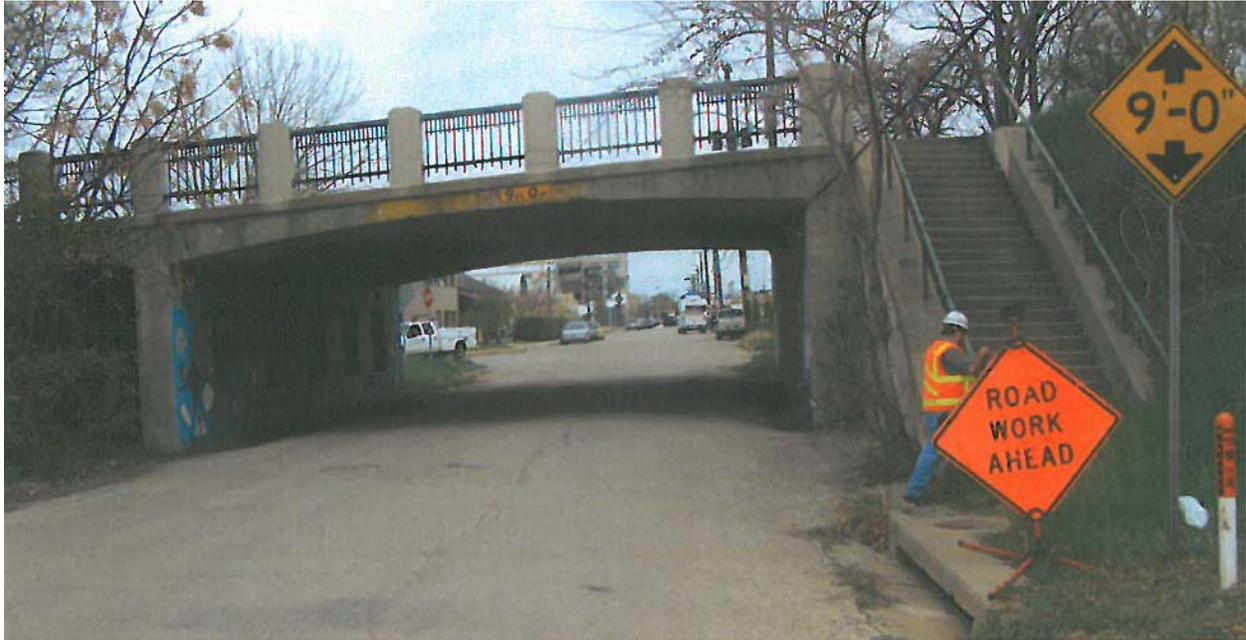
F.18 W. LANCASTER AVENUE OVER FOCH STREET

Figure F-18. W. Lancaster Avenue over Foch Street (TxDOT 2012a).

The bridge carrying West Lancaster Avenue over Foch Street was built in 1938. It has a concrete slab superstructure and specially designed rails, which add to its historical significance. The structure is 48 ft long with a maximum span length of 35 ft and a total of two spans. The bridge experiences an annual average daily traffic of 6910 vehicles.

The bridge currently has a sufficiency rating of 43.5 and a historical significance of 4, as listed in the National Bridge Inventory. This places it in the portion of the matrix considered third priority; however, it was recommended for further consideration by TxDOT personnel despite its low placement. The structure ranks 18th in Tarrant County with a score of 83 using the quantitative rating system. The bridge is shown in Figure F-18, and Table F-18 summarizes the main features, placement in the selection matrix, and quantitative rating of the bridge.

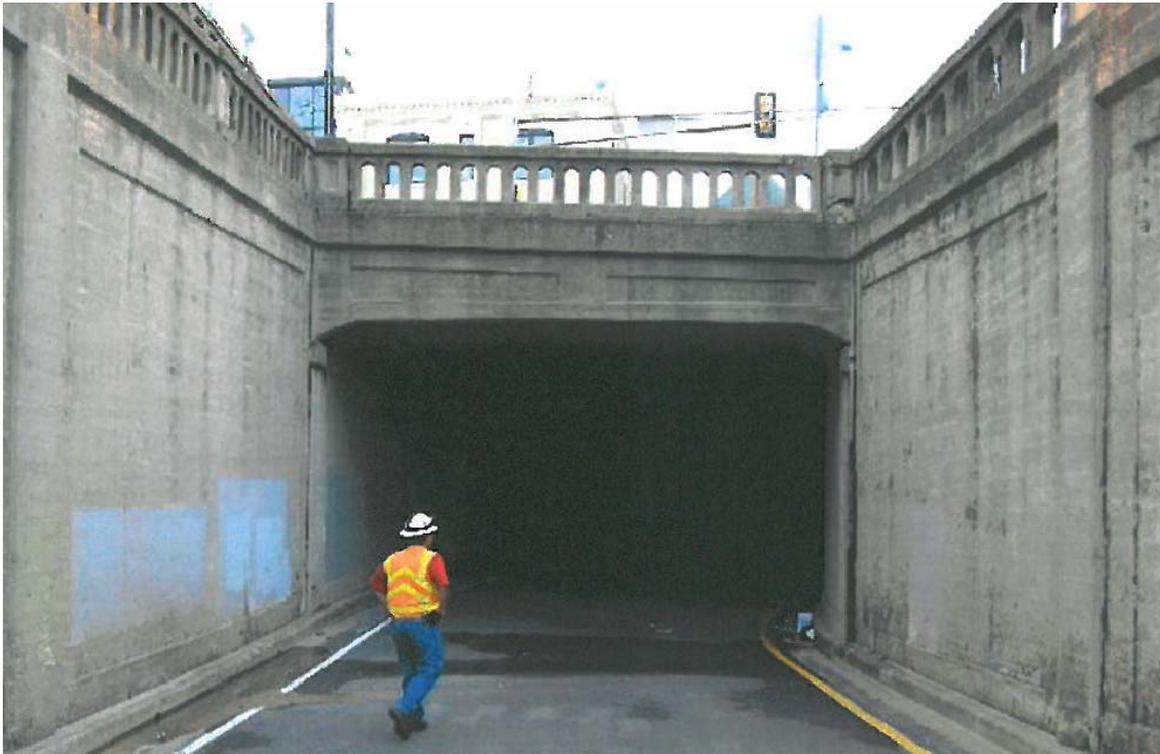
F.19 JENNINGS AVENUE (MH 48) OVER W. VICKERY BOULEVARD

Figure F-19. Jennings Avenue (MH 48) over W. Vickery Boulevard (TxDOT 2012a).

The bridge carrying Jennings Avenue over West Vickery Boulevard was built in 1930. It has a concrete rigid frame superstructure and specially designed rails, adding to its historical and engineering significance. The structure consists of one span of 40 ft and experiences an annual average daily traffic of 22,040 vehicles.

The bridge currently has a sufficiency rating of 85.1 and a historical significance of 4, as listed in the National Bridge Inventory. However, the bridge possesses uniqueness that makes it potentially eligible for a historical significance rating of 2, placing it in the portion of the matrix considered first priority. The structure was included on the list of 24 recommended bridges by TxDOT and ranked as the #5 highest-priority bridge in Tarrant County for maintenance and preservation by Historic Fort Worth, Inc. Receiving a score of 77 using the quantitative rating system, the bridge ties for 20th in Tarrant County. The bridge is shown in Figure F-19, and Table F-19 summarizes the main features, placement in the selection matrix, and quantitative rating of the bridge.

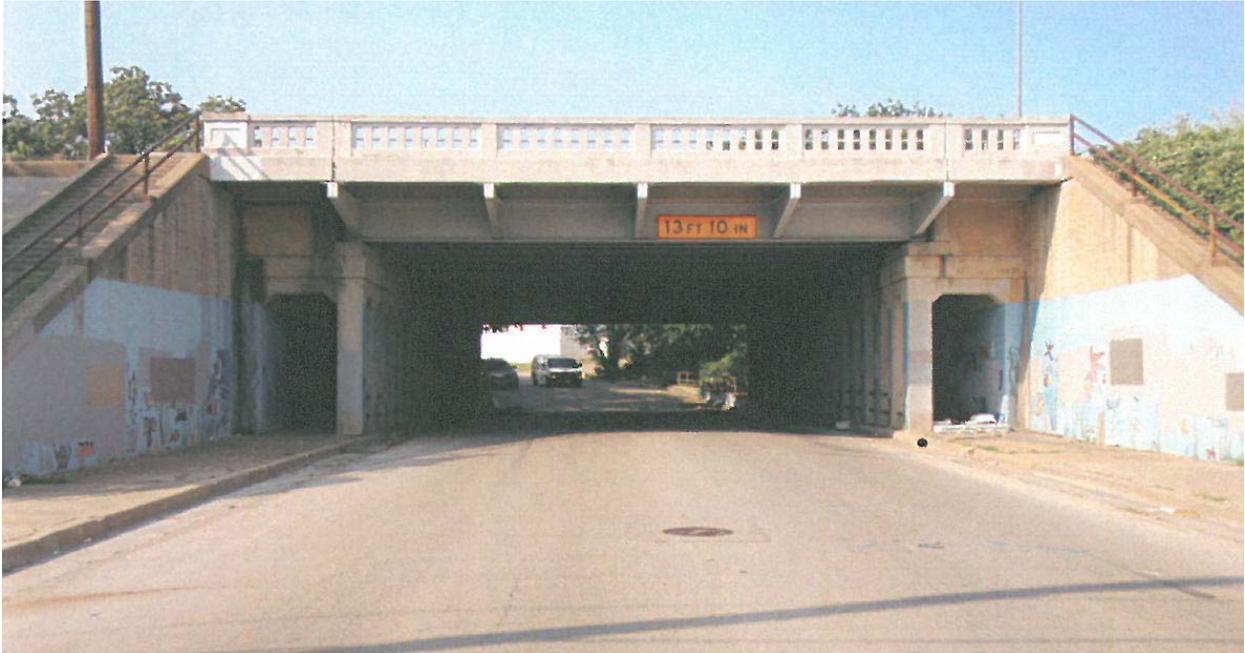
F.20 SH 180 EB OVER CONNER AVENUE

Figure F-20. SH 180 EB over Conner Avenue (TxDOT 2012a).

The bridge carrying State Highway 180 Eastbound over Conner Avenue was built in 1932. It has a steel I-beam superstructure and Type H rails, which add to its historical significance. The structure consists of one span of 38 ft and experiences an annual average daily traffic of 7050 vehicles.

The bridge currently has a sufficiency rating of 74.1 and a historical significance of 4, as listed in the National Bridge Inventory. This places it in the portion of the matrix considered third priority; however, it was recommended for further consideration by TxDOT personnel despite its low placement. The structure ties for 20th in Tarrant County with a score of 69 using the quantitative rating system. The bridge is shown in Figure F-20, and Table F-20 summarizes the main features, placement in the selection matrix, and quantitative rating of the bridge.

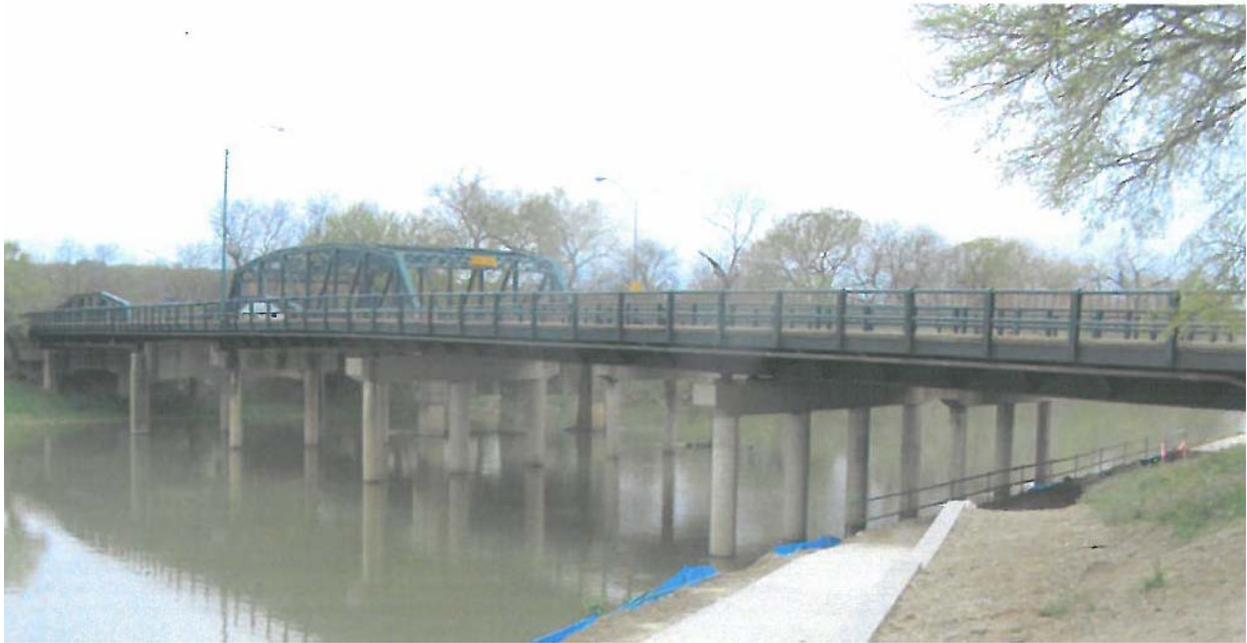
F.21 S. UNIVERSITY DRIVE NB OVER CLEAR FORK TRINITY RIVER

Figure F-21. S. University Drive NB over Clear Fork Trinity River (TxDOT 2012a).

The bridge carrying North University Drive Southbound over the Clear Fork of the Trinity River was built in 1951. It has a camelback through truss and steel I-beam superstructure and specially designed rails, which add to its historical significance. The structure is 362 ft long with a maximum span length of 86 ft and a total of six spans. The bridge experiences an annual average daily traffic of 17,330 vehicles.

The bridge currently has a sufficiency rating of 71.4 and a historical significance of 3, as listed in the National Bridge Inventory. This places it in the portion of the matrix considered second priority. The structure was included on the list of 24 recommended bridges by TxDOT and ranked as the #3 highest-priority bridge in Tarrant County for maintenance and preservation by Historic Fort Worth, Inc. Receiving a score of 69 using the quantitative rating system, the bridge ties for 20th in Tarrant County. The bridge is shown in Figure F-21, and Table F-21 summarizes the main features, placement in the selection matrix, and quantitative rating of the bridge.

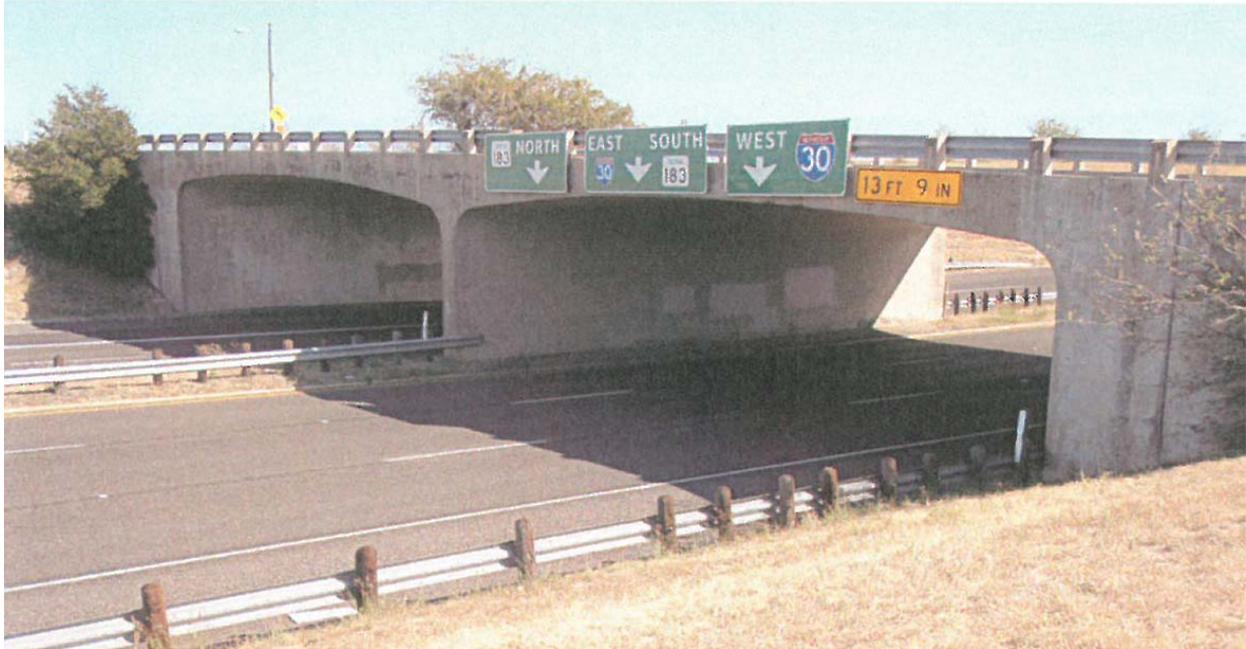
F.22 WHITE SETTLEMENT ROAD OVER SPUR 341

Figure F-22. White Settlement Road over Spur 341 (TxDOT 2012a).

The bridge carrying White Settlement Road over Spur 341 was built in 1953. It has a concrete rigid frame superstructure and a maximum span length of 56 ft, adding to its historical and engineering significance. The structure is 112 ft long and consists of two spans. The bridge experiences an annual average daily traffic of 16,710 vehicles.

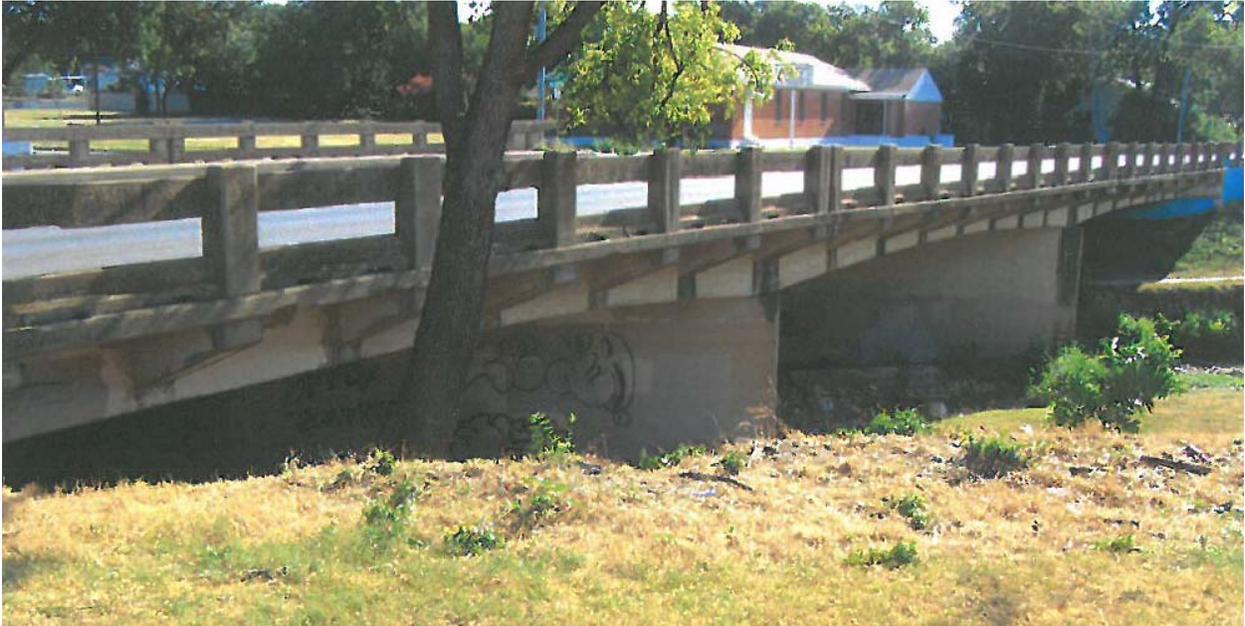
F.23 SH 183 OVER MARINE CREEK

Figure F-23. SH 183 over Marine Creek (TxDOT 2012a).

The bridge carrying State Highway 183 over Marine Creek was built in 1943. It has a variable-depth concrete slab superstructure and Type K rails, which add to its historical significance. The structure is 169 ft long with a maximum span length of 65 ft and a total of three spans. The bridge experiences an annual average daily traffic of 16,900 vehicles.

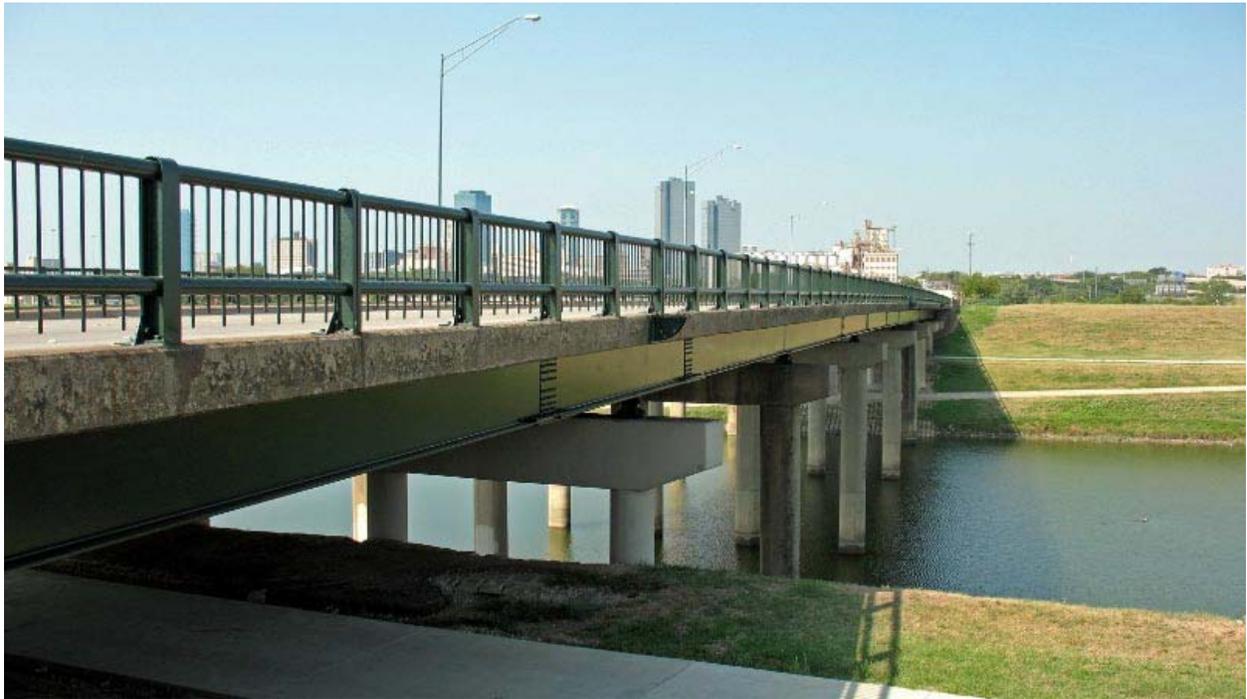
F.24 E. 4TH STREET OVER WEST FORK TRINITY RIVER

Figure F-24. E. 4th Street over West Fork Trinity River (photo courtesy of Cecil Smith).

The bridge carrying East 4th Street over the West Fork of the Trinity River was built in 1951. It is located at the site of the first Fort Worth bridge to cross the Trinity River. It has a steel plate girder superstructure and specially designed rails, which add to its historical significance. The structure is 521 ft long with a maximum span length of 65 ft and a total of 10 spans. The bridge experiences an annual average daily traffic of 3100 vehicles.

The bridge currently has a sufficiency rating of 54.8 and a historical significance of 4, as listed in the National Bridge Inventory. This places it in the portion of the matrix considered third priority; however, it was recommended for further consideration by Cecil Smith of Historic Fort Worth, Inc. due to its historical significance. The structure was also ranked as the #2 highest-priority bridge in Tarrant County for maintenance and preservation by Historic Fort Worth, Inc. Receiving a score of 67 using the quantitative rating system, the bridge ranks 24th in Tarrant County. The bridge is shown in Figure F-24, and Table F-24 summarizes the main features, placement in the selection matrix, and quantitative rating of the bridge.

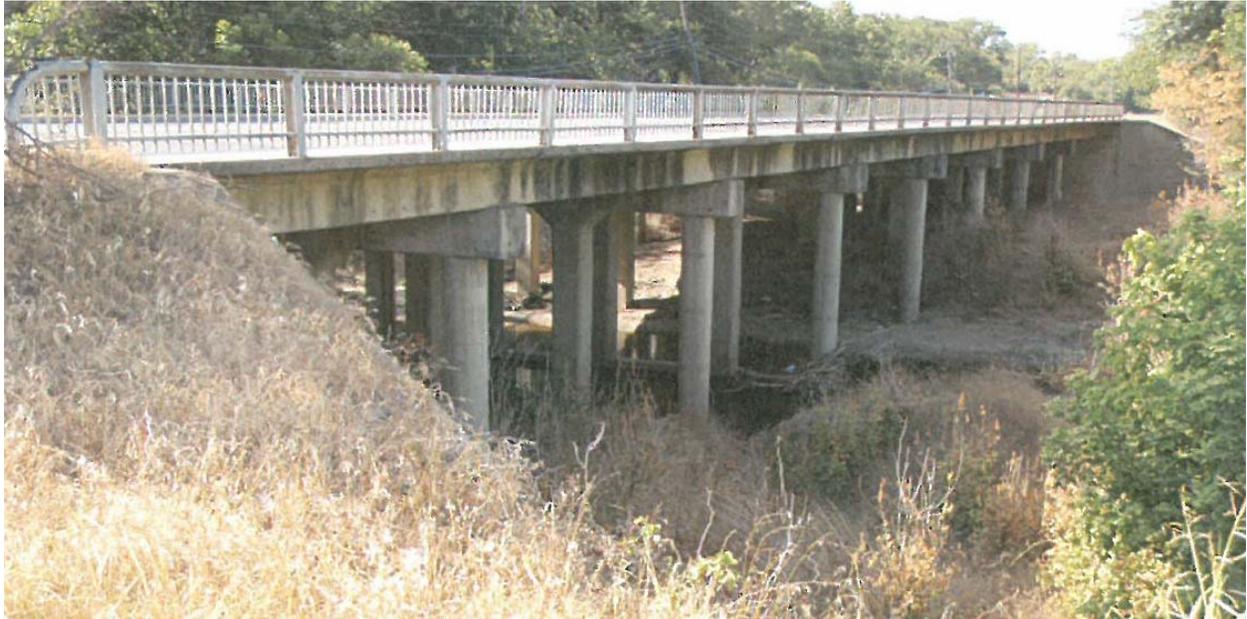
Figure F-25. BUS 287 (LP 496) over Sycamore Creek (TxDOT 2012).

The bridge carrying Business Route 287, also known as Loop 496, over Sycamore Creek was built in 1931. It has a concrete tee beam superstructure and specially designed rails, which add to its historical significance. The structure is 228 ft long with a maximum span length of 28 ft and a total of eight spans. The bridge experiences an annual average daily traffic of 9900 vehicles.

The bridge currently has a sufficiency rating of 67.6 and a historical significance of 4, as listed in the National Bridge Inventory. This places it in the portion of the matrix considered third priority; however, it was recommended for further consideration by TxDOT personnel despite its low placement. The structure ranks 25th in Tarrant County with a score of 65 using the quantitative rating system. The bridge is shown in Figure F-25, and Table F-25 summarizes the main features, placement in the selection matrix, and quantitative rating of the bridge.

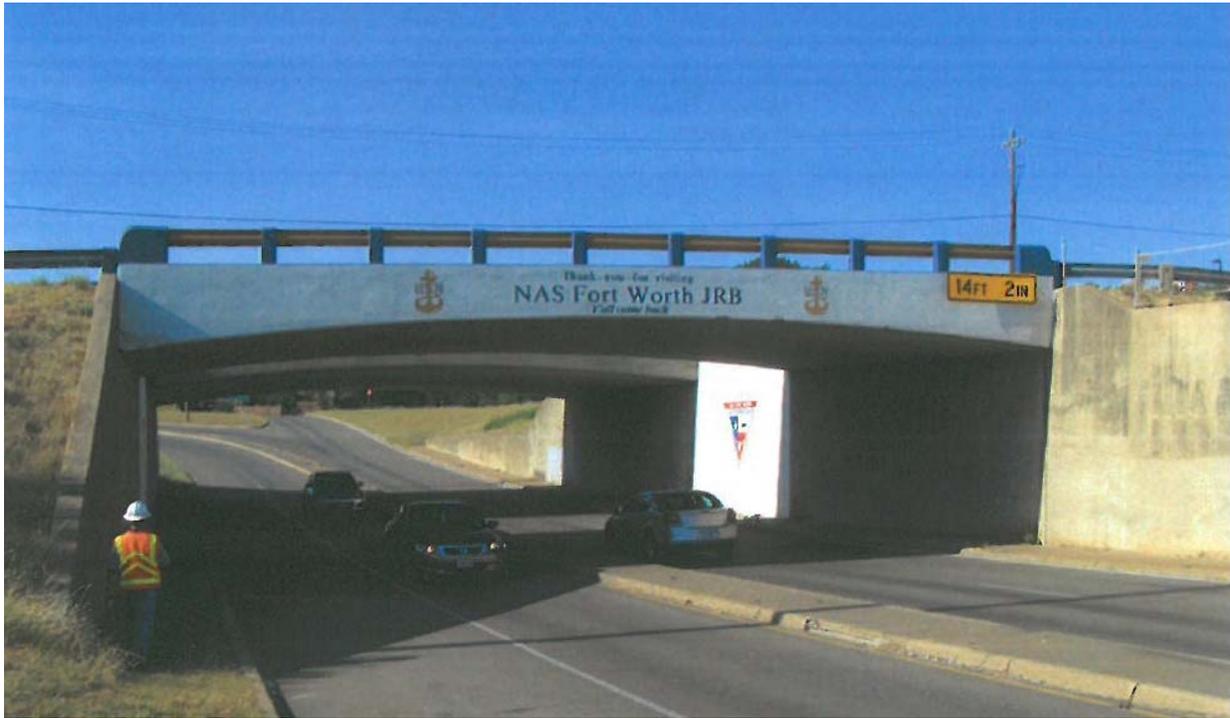
Figure F-26. SH 183 WB over Pumphrey Drive (TxDOT 2012a).

The bridge carrying State Highway 183 Westbound over Pumphrey Drive was built in 1954. It has a concrete rigid frame superstructure and a span length of 66 ft, adding to its historical and engineering significance. The structure consists of one span and experiences an annual average daily traffic of 13,500 vehicles.
