A Framework for Historic Bridge Preservation in Tarrant County

Technical Report 409139-1

TEXAS A&M TRANSPORTATION INSTITUTE
COLLEGE STATION, TEXAS

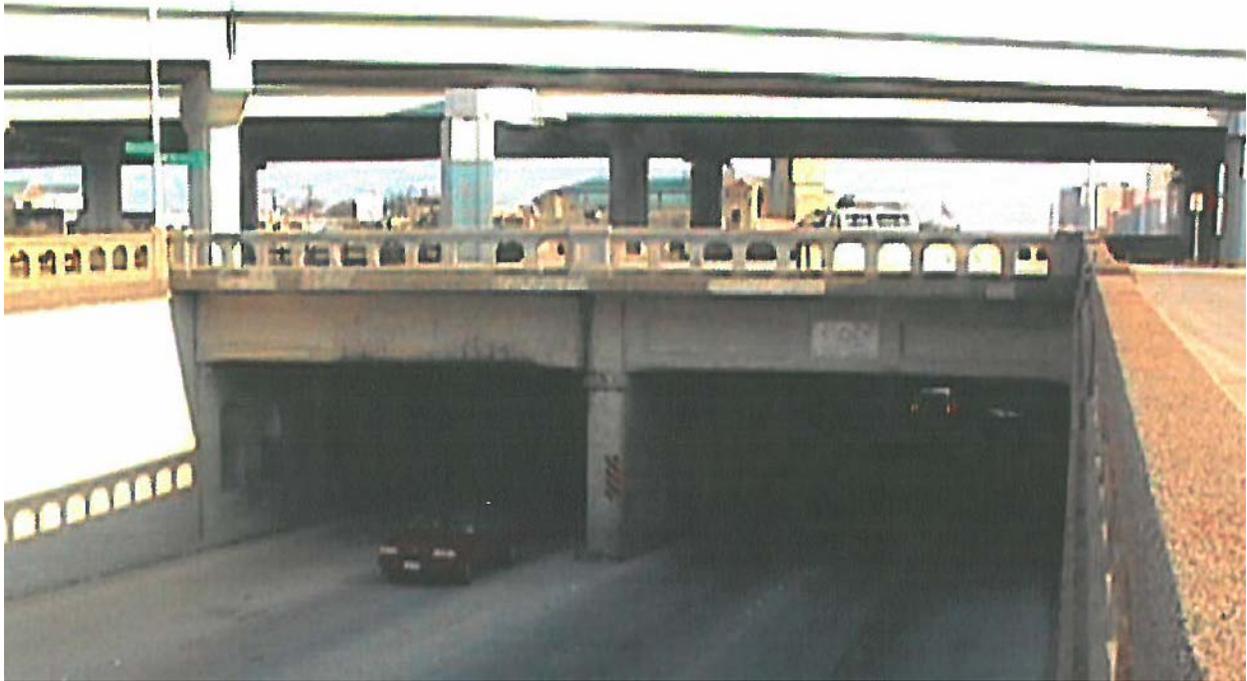
Figure F-27. W. Vickery Boulevard over Henderson Street (TxDOT 2012a).

The bridge carrying West Vickery Boulevard over Henderson Street was built in 1930. It has a concrete flat slab superstructure and a main span length of 23 ft, adding to its historical and engineering significance. The structure is 63 ft long and consists of four spans. The bridge has been closed to traffic due to its deteriorated condition.

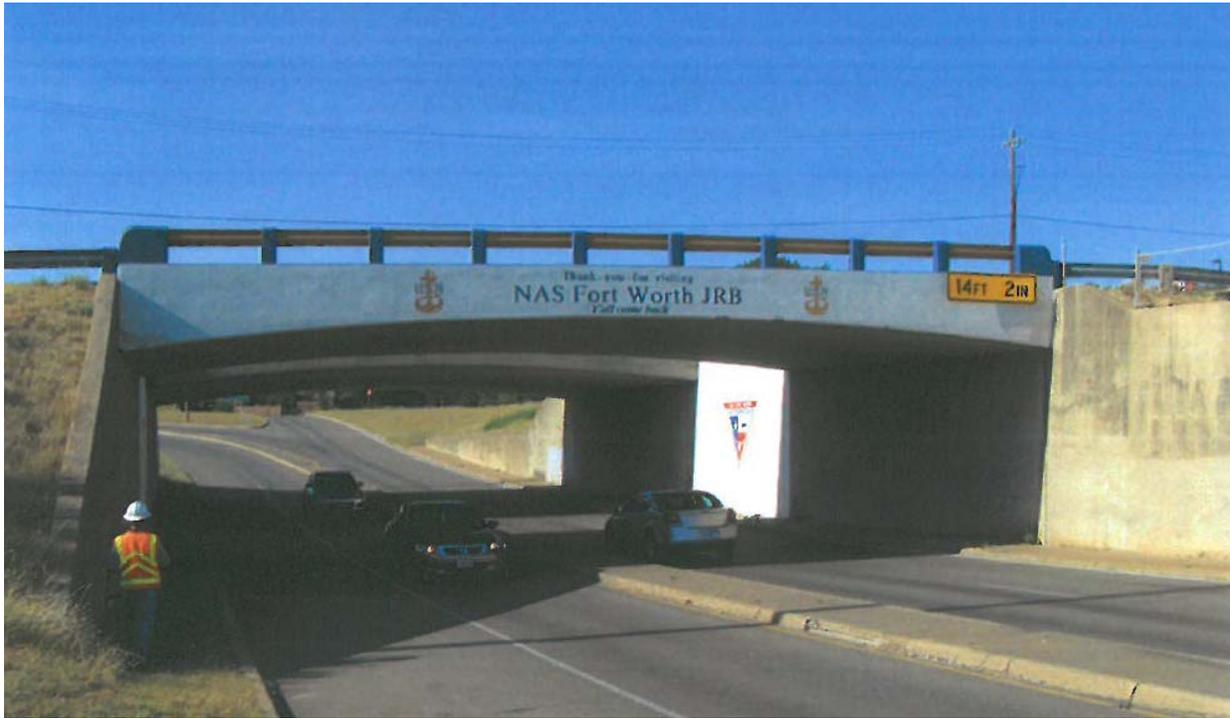
Figure F-28. SH 183 EB over Pumphrey Drive (TxDOT 2012a).

The bridge carrying State Highway 183 Eastbound over Pumphrey Drive was built in 1954. It has a concrete rigid frame superstructure and a span length of 66 ft, adding to its historical and engineering significance. The structure consists of one span and experiences an annual average daily traffic of 13,000 vehicles.

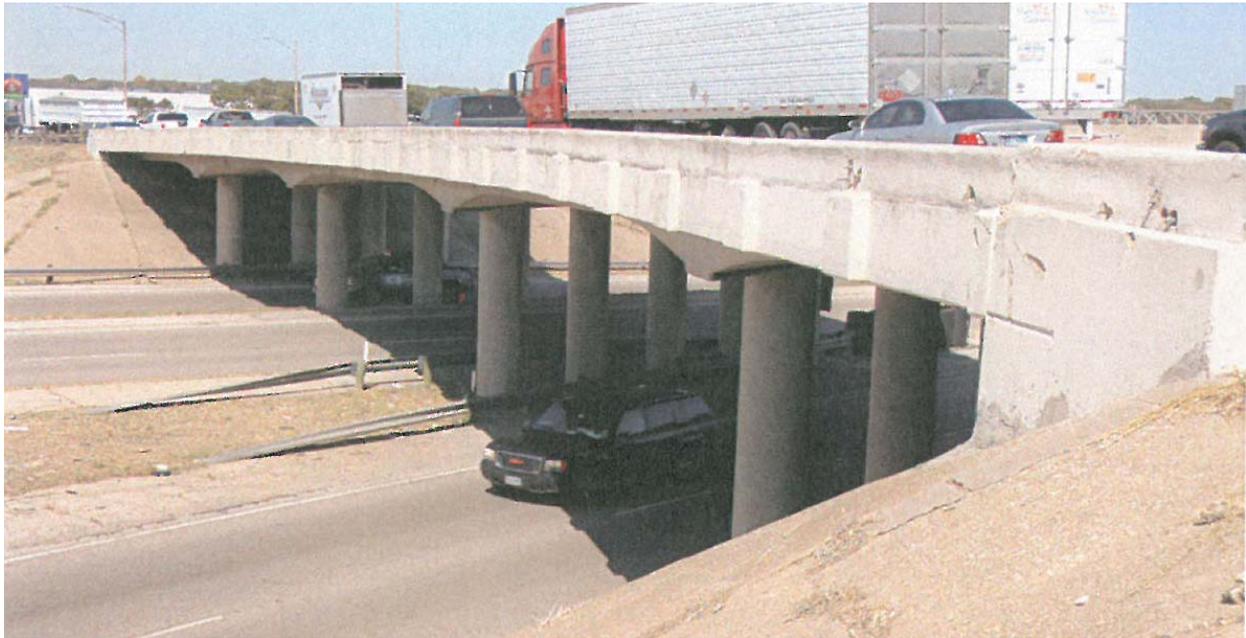
Figure F-29. IH 35W NB over US 377 WB (SH 121 WB; TxDOT 2012a).

The bridge carrying Northbound IH 35 West over US 377 and State Highway 121 Westbound was built in 1961. It has a variable-depth concrete slab superstructure and a main span length of 55 ft, adding to its historical and engineering significance. The structure is 249 ft long and consists of five spans. The bridge experiences an annual average daily traffic of 69,820 vehicles.

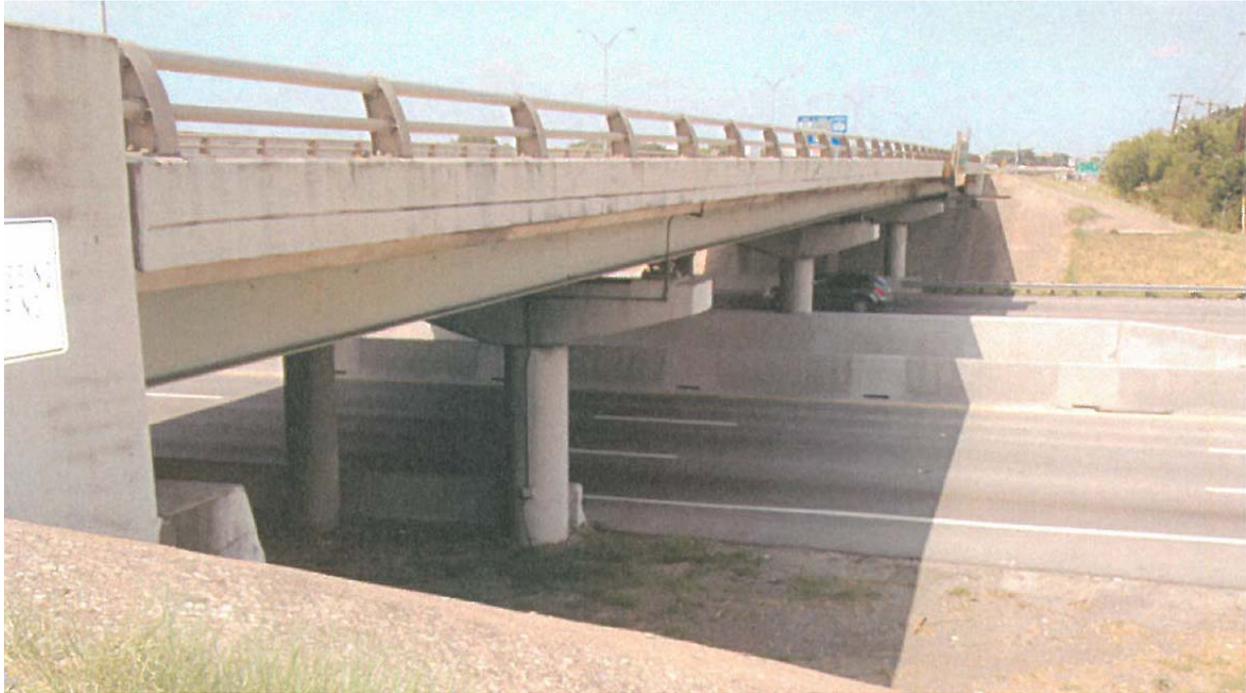
Figure F-30. SH 360 NB Frontage (Watson Street) over IH 30 (TxDOT 2012a).

The bridge carrying State Highway 360 Northbound Frontage, also known as Watson Street, over IH 30 was built in 1956. It has a steel I-beam superstructure and a main span length of 80 ft, adding to its historical and engineering significance. The structure is 244 ft long and consists of four spans. The bridge experiences an annual average daily traffic of 108,680 vehicles.

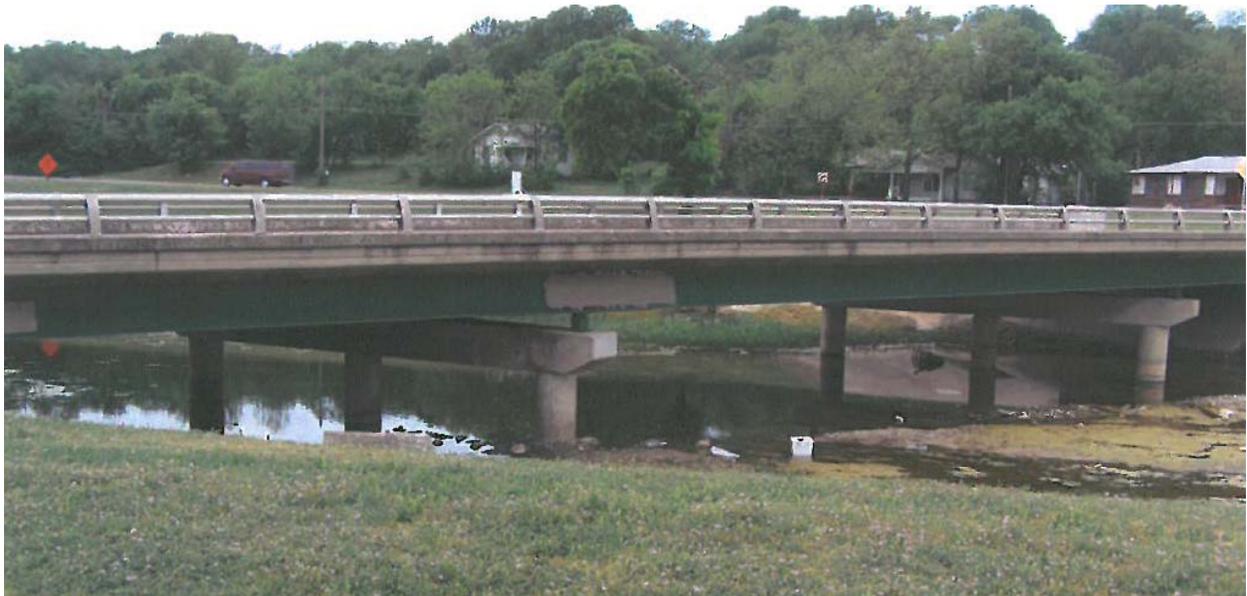
Figure F-31. NW 30th Street over Marine Creek (TxDOT 2012a).

The bridge carrying Northwest 30th Street over Marine Creek was built in 1964. It has a steel I-beam superstructure and a main span length of 67 ft, adding to its historical and engineering significance. The structure is 170 ft long and consists of three spans. The bridge experiences an annual average daily traffic of 5510 vehicles.

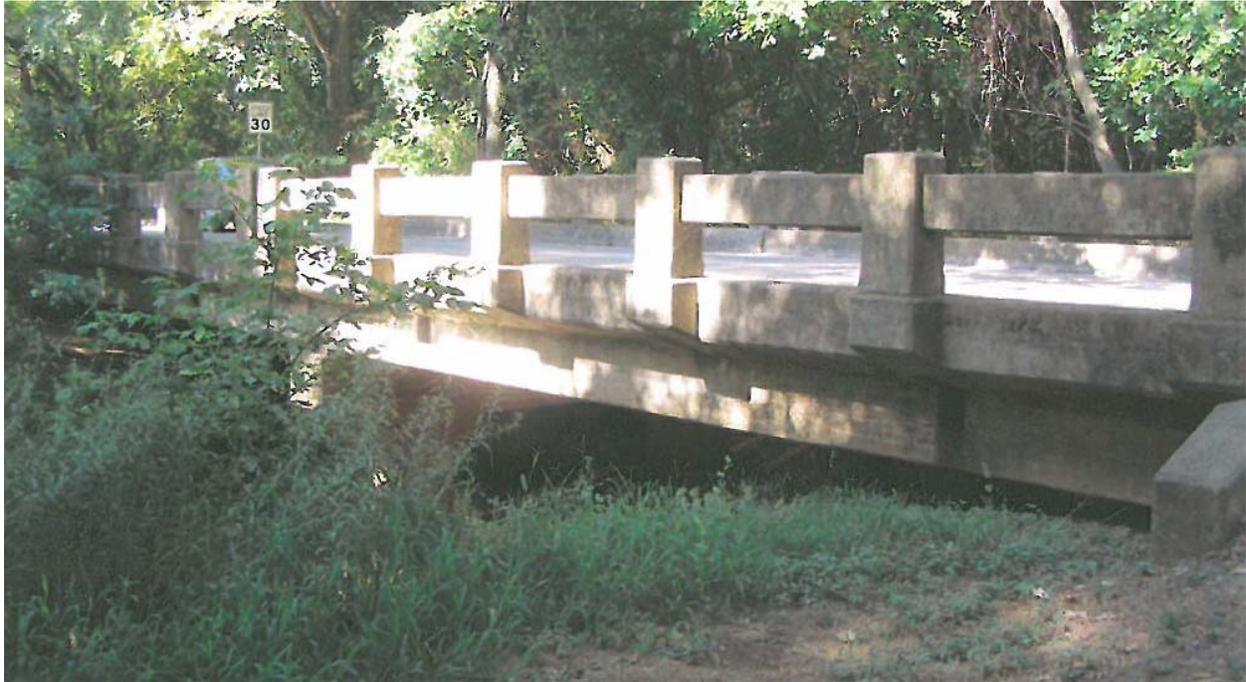
Figure F-32. Bedford Road over Tributary to Mountain Creek (TxDOT 2012a).

The bridge carrying Bedford Road over a tributary to Mountain Creek was built in 1939. It has a concrete tee-beam superstructure and Type K rails, which add to its historical significance. The structure is 70 ft long with a maximum span length of 34 ft and a total of two spans. The bridge experiences an annual average daily traffic of 5450 vehicles.

The bridge currently has a sufficiency rating of 68.6 and a historical significance of 4, as listed in the National Bridge Inventory. This places it in the portion of the matrix considered third priority; however, it was recommended for further consideration by TxDOT personnel despite its low placement. The structure ranks 32nd in Tarrant County with a score of 55 using the quantitative rating system. The bridge is shown in Figure F-32, and Table F-32 summarizes the main features, placement in the selection matrix, and quantitative rating of the bridge.

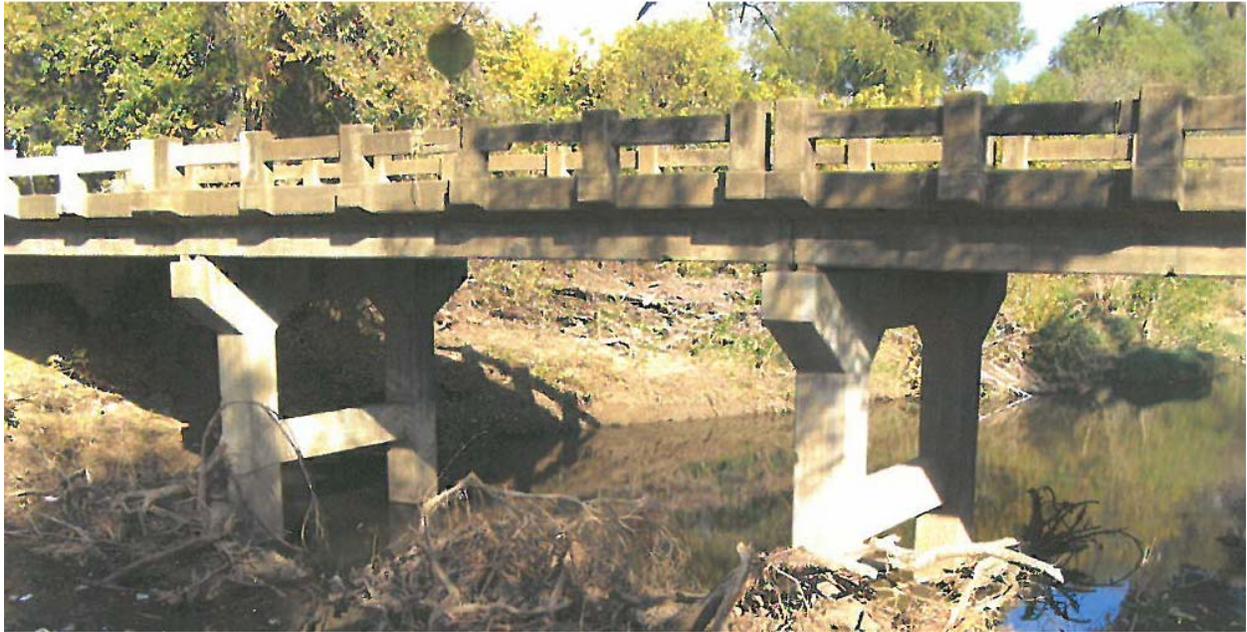
Figure F-33. Burlleson-Retta Road over Village Creek (TxDOT 2012a).

The bridge carrying Burlleson-Retta Road over Village Creek was built in 1939. It has a concrete tee-beam superstructure and Type K rails, which add to its historical significance. The structure is 105 ft long with a maximum span length of 35 ft and a total of three spans. The bridge experiences an annual average daily traffic of 3960 vehicles.

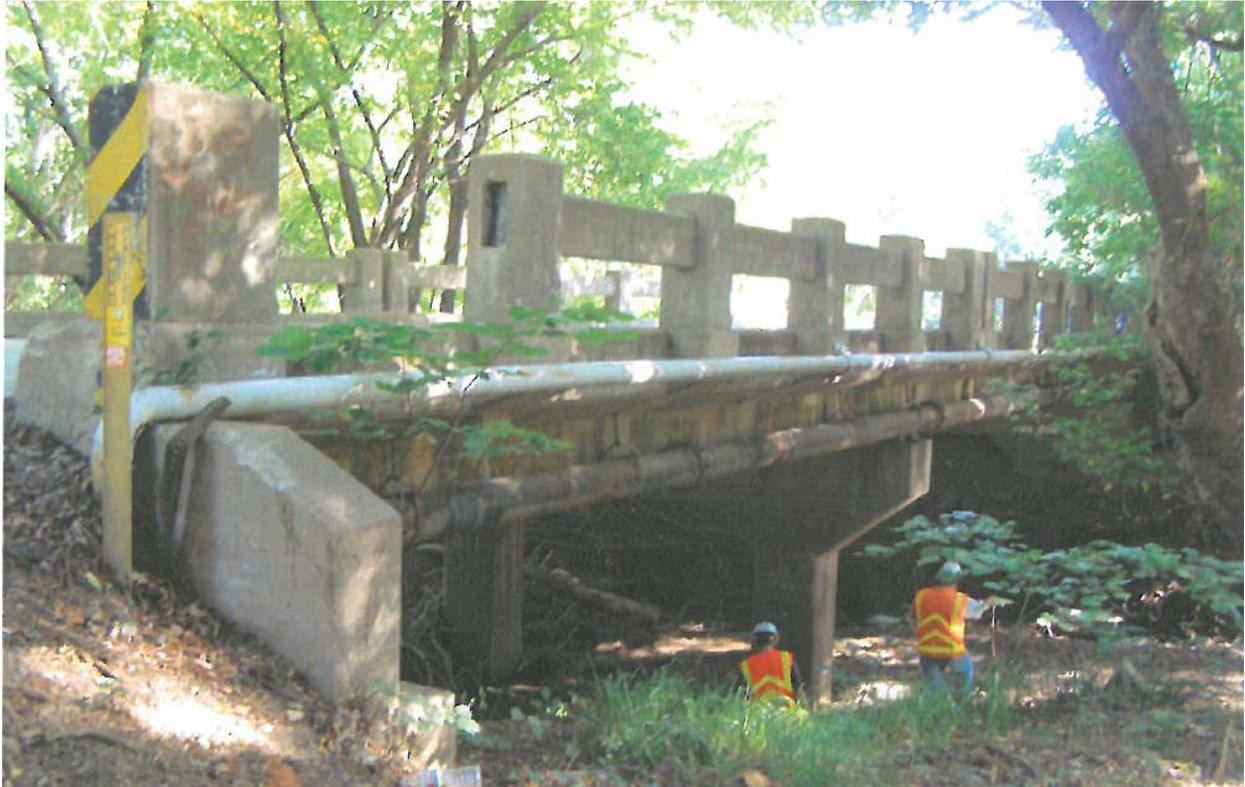
Figure F-34. Jackson Drive over Little Bear Creek (TxDOT 2012a).

The bridge carrying Jackson Drive over Little Bear Creek was built in 1949. It has a concrete tee-beam superstructure and Type K rails, which add to its historical significance. The structure is 70 ft long with a maximum span length of 35 ft and a total of two spans. The bridge experiences an annual average daily traffic of 3650 vehicles.

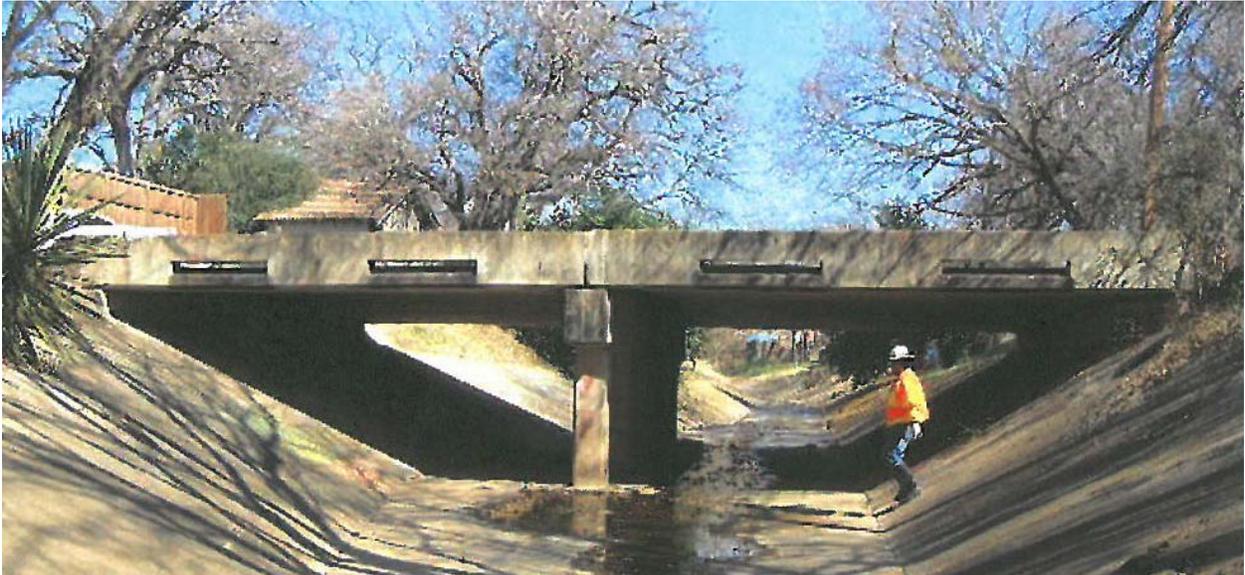
Figure F-35. Marlene Drive over Tributary to West Fork Trinity River (TxDOT 2012a).

The bridge carrying Marlene Drive over a tributary to the West Fork of the Trinity River was built in 1949. It has a concrete flat slab superstructure and a main span length of 25 ft, adding to its historical and engineering significance. The structure is 50 ft long and consists of two spans. The bridge experiences an annual average daily traffic of 1650 vehicles.

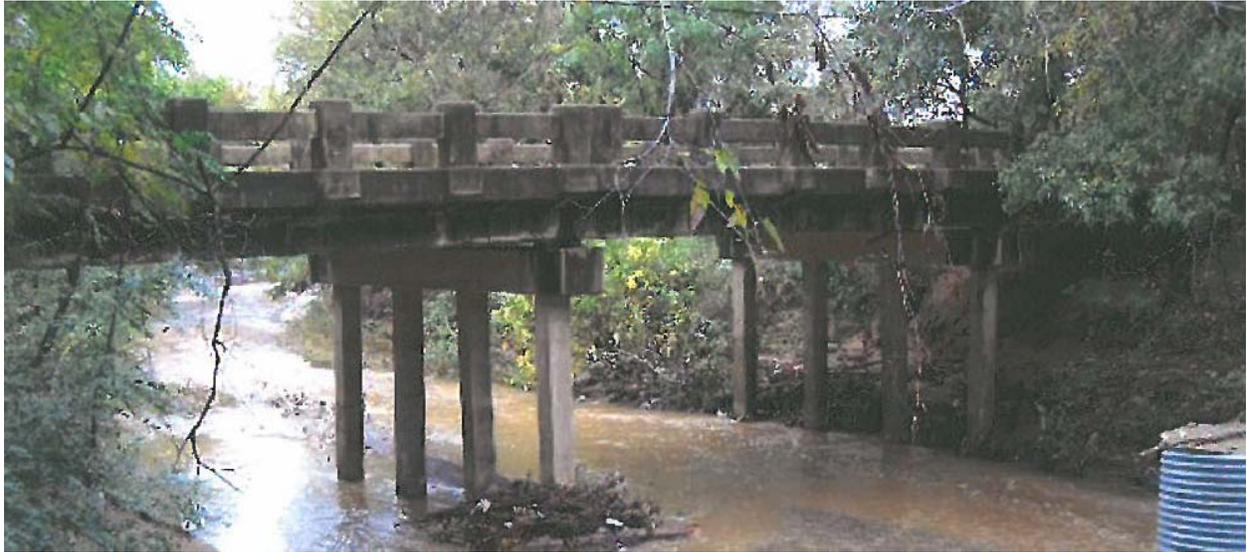
Figure F-36. Mayfield Road over Kee Branch (TxDOT 2012a).

The bridge carrying Mayfield Road over Kee Branch was built in 1940. It has a concrete tee-beam superstructure and Type K rails, which add to its historical significance. The structure is 88 ft long with a maximum span length of 30 ft and a total of three spans. The bridge experiences an annual average daily traffic of 2390 vehicles.

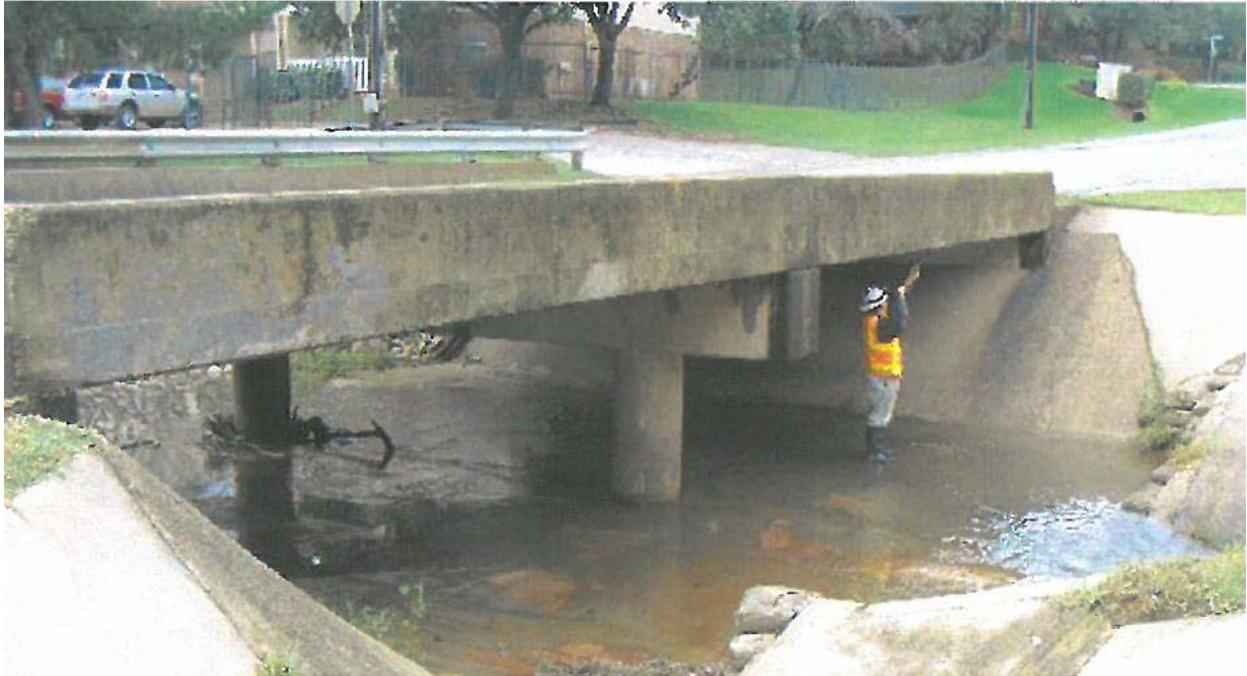
Figure F-37. Burney Road over Tributary to Trinity River (TxDOT 2012a).

The bridge carrying Burney Road over a tributary to the Trinity River was built in 1964. It has a concrete flat slab superstructure and a main span length of 25 ft, adding to its historical and engineering significance. The structure is 50 ft long and consists of two spans. The bridge experiences an annual average daily traffic of 2960 vehicles.

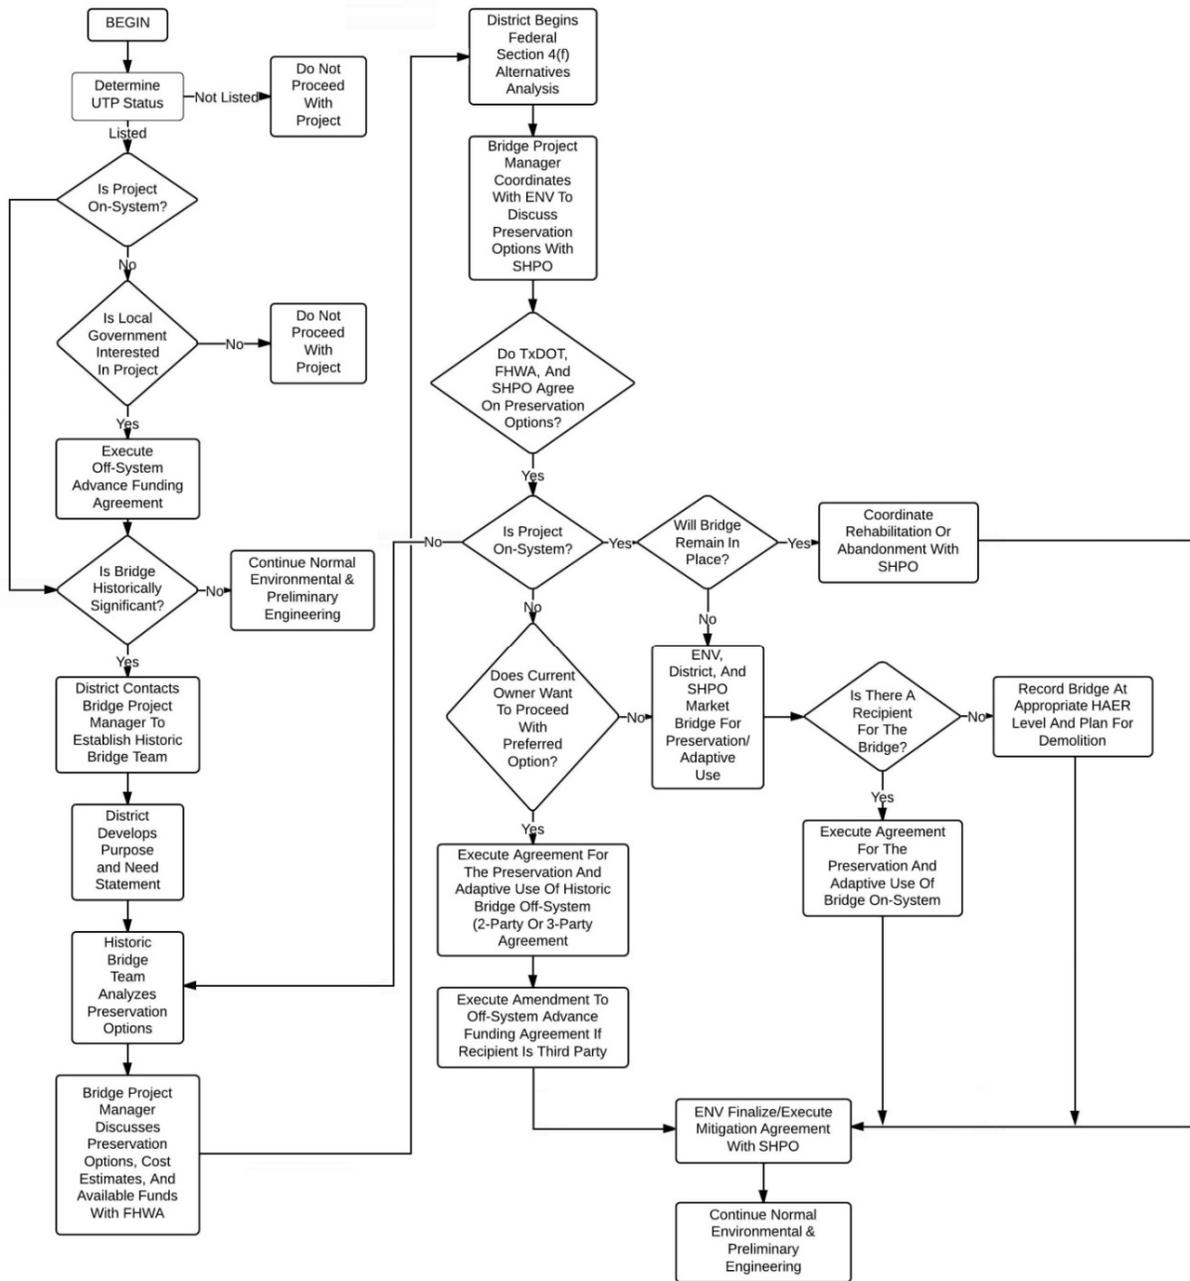
Figure G-1. Flowchart for Projects Involving Historically Significant Bridges (adapted from TxDOT 2010)
