1. Report No. FHWA/TX-03/4126-1		2. Government Accession No.		3. Recipient's Catalog No.	
4. Title and Subtitle USING INFRARED IMAGING AND GROUND-PENETRATING RADAR TO DETECT SEGREGATION IN HOT-MIX OVERLAYS				5. Report Date May 2002 Resubmitted: September 2002

14. Sponsoring Agency Code	
15. Supplementary Notes Research performed in cooperation with the Texas Department of Transportation and the U.S. Department of Transportation. Research Project Title: Development of Infrared Photography and GPR Procedures for Identifying Mixture Segregation

**USING INFRARED IMAGING AND GROUND-PENETRATING RADAR
TO DETECT SEGREGATION IN HOT-MIX OVERLAYS**

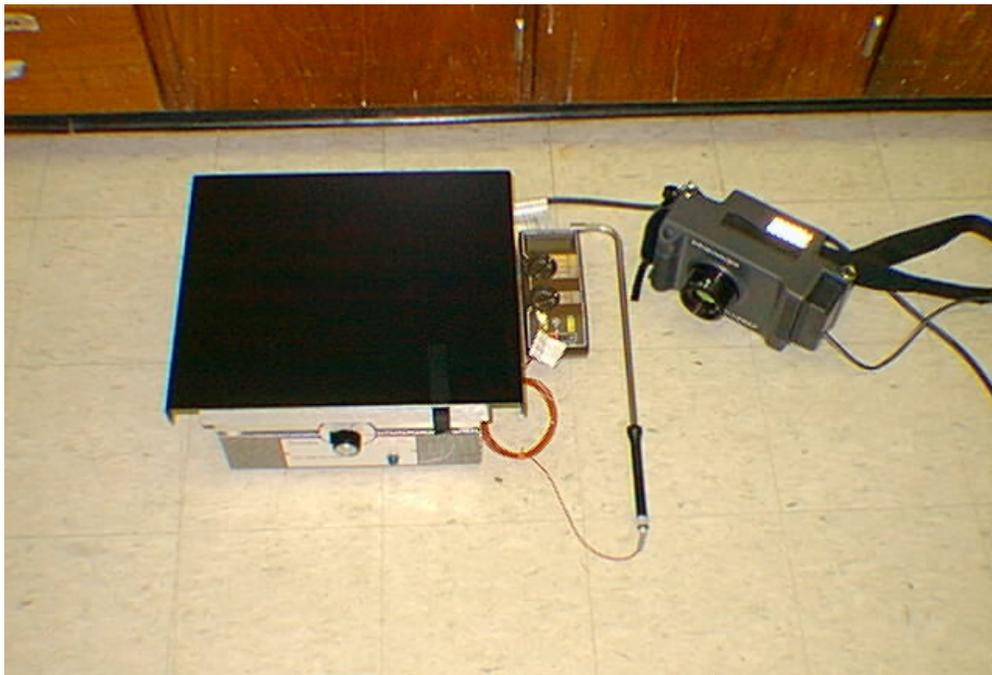
Figure 7. Equipment for Lab Verification of Infrared Equipment.

Before using the infrared imaging equipment in the field, researchers performed a laboratory check of the equipment using an aluminum hotplate, an aluminum plate painted black to go on top of the hot plate and represent HMA, a calibrated surface thermocouple, and the infrared camera. [Figure 7](#) shows the equipment used.

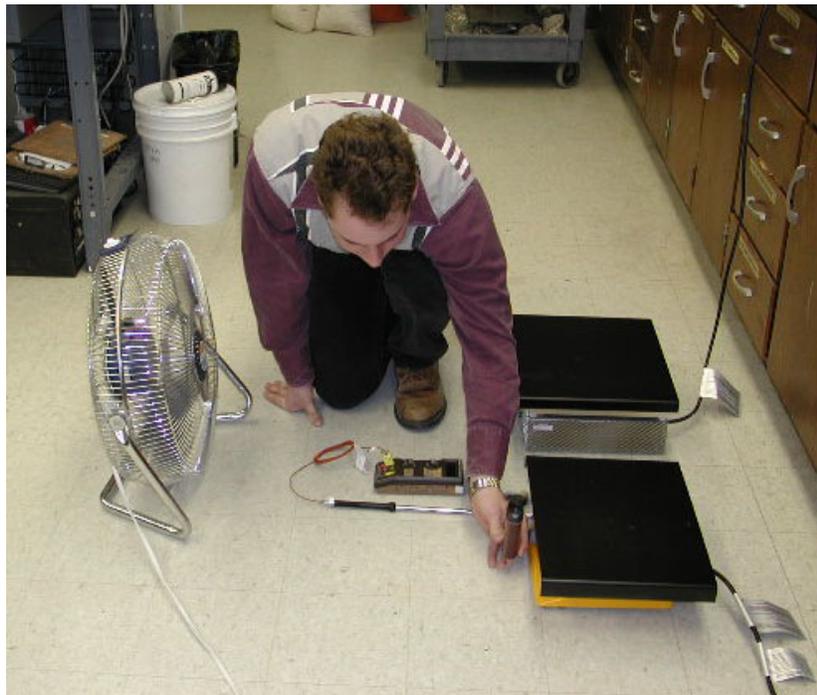
Figure 19. Setup and Wind Speed Being Measured for Lab Testing with Wind.

For the laboratory testing with wind effects, two hot plates were set at different temperatures and placed side by side. With no wind, one plate was set to have a surface temperature of approximately 315 °F. The other plate had a surface temperature around 280 °F. A camera height of 6 feet was used, and the images presented below are from a 60° angle. At this angle, camera temperatures were within the camera's accuracy range and usually varied from thermocouple temperatures by no more than 2 °F. At a 45° angle and less, the camera temperatures typically were not accurate for reasons previously presented. Figure 19 shows the basic setup and the wind speed being measured over one of the hot plates. It was not possible to get uniform wind speed over both of the plates; the wind speed actually varied even as the anemometer was moved across each plate. For this reason, the wind speed was determined by holding the anemometer in the center of each plate, which is where temperature measurements were taken with the thermocouple for comparison with the infrared camera.

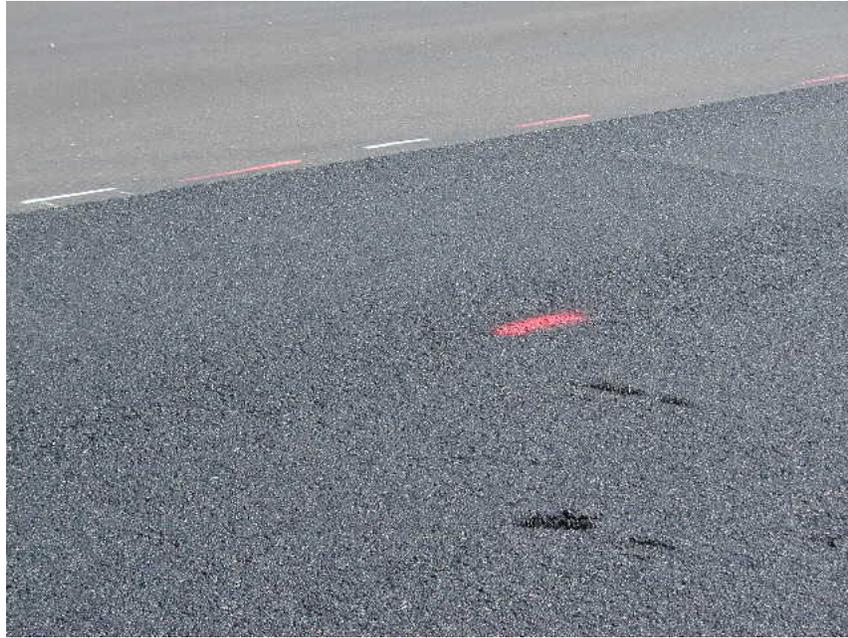
Figure 53. Close-up of Cold Streak Shown in [Figure 52](#).

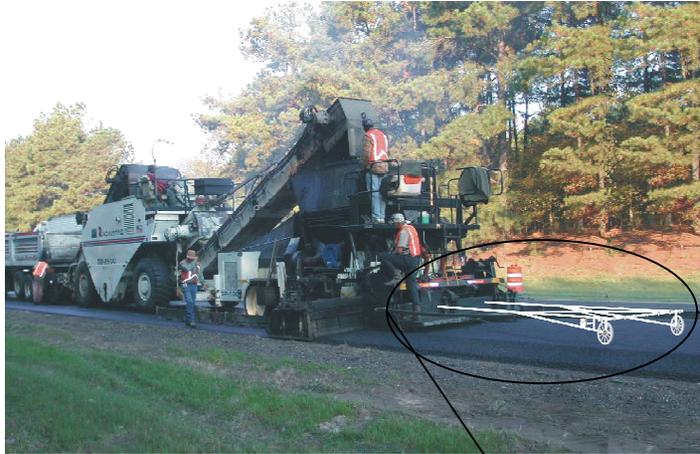
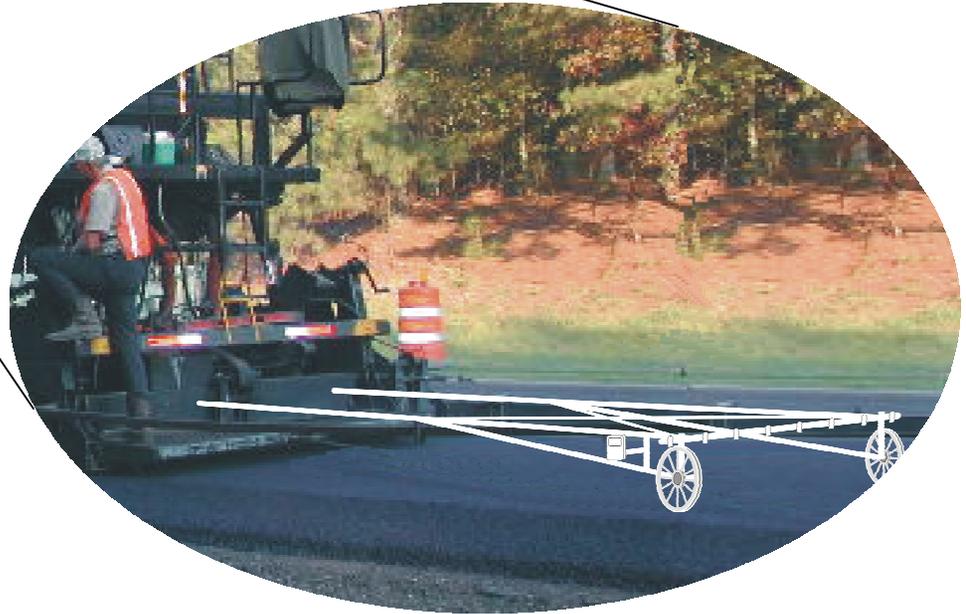
Figure 80. Concept Infrared Sensor Bar for Quality Control.

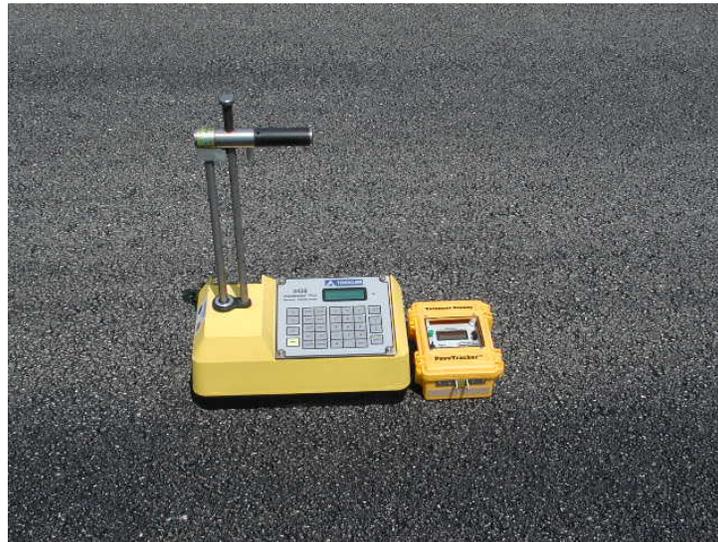
Figure F1. Nuclear Gauge (left) vs. Pavetracker (right).
