# WORKSHOP INSTRUCTOR GUIDEBOOK

WORKSHOP ON  
IMPLEMENTING ULTRA  
THIN SLURRY SURFACINGS  
ON TXDOT ROADWAYS

Texas A&M Transportation  
Institute

Published: October 2020

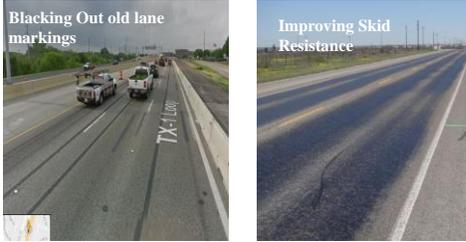
Blacking Out old lane markings

Improving Skid Resistance

The Austin District’s primary interest was to use the UT slurry seal to black out pavement markings for rehab projects. Some districts were also interested in looking at the treatment to improve friction.

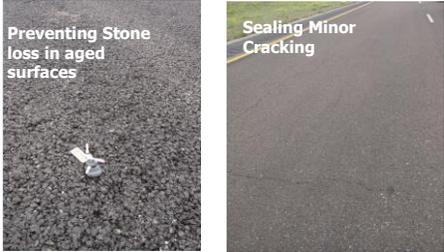
Preventing Stone loss in aged surfaces

Sealing Minor Cracking

Another potential application was to seal the pavement. This includes cracks in older hot mix pavements or even to seal old PFC pavements which have reached the end of their life and need to be removed or overlaid. Also, there was interest to see if the UT slurry could retard raveling in old PFCs.

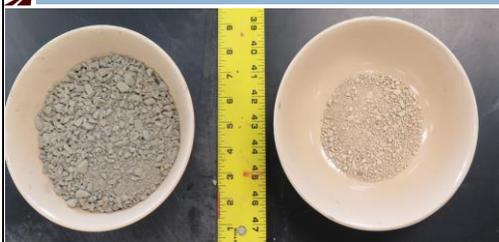
Slide 16

Relative difference in amount of aggregate per sq.yd

**Microsurfacing      UT Slurry Seal**

Researchers compared the quantity of aggregate in microsurfacing vs that in the UT slurry.

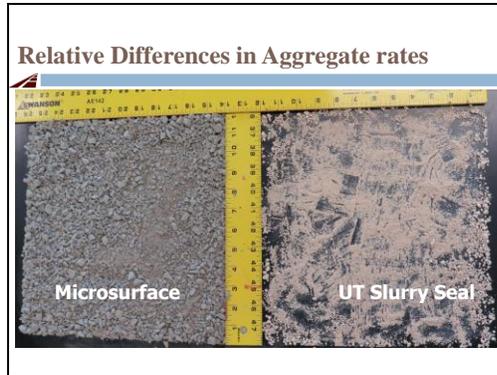
Slide 15

Here is another representation of the quantity and size of aggregate in the microsurfacing compared with that of the UT seal.

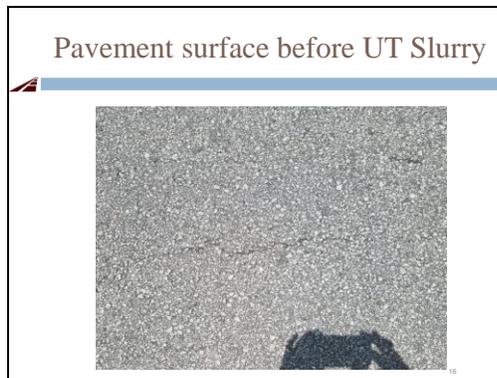
This photo shows a HMAC pavement in Beaumont prior to application of the UT slurry seal (in 2017).

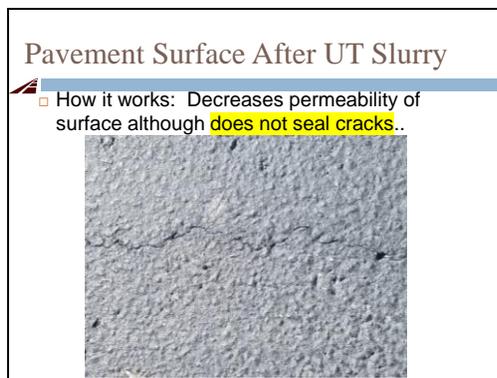
Slide 17

Here is the same crack after application of the UT slurry. While the slurry does seem to seal the overall surface and decrease permeability, it clearly does not seal cracks.

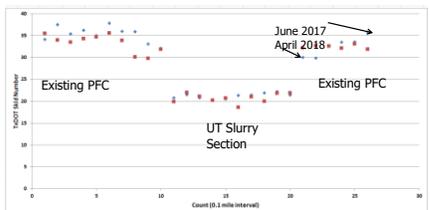
- Skid reduction on UT slurry sections

The slide contains a scatter plot showing skid reduction on UT slurry sections. The y-axis is labeled 'Skid Number' and ranges from 0 to 45. The x-axis is labeled 'Count (0.1 mile interval)' and ranges from 0 to 30. The plot shows two data series: 'Existing PFC' (red dots) and 'UT Slurry Section' (blue dots). The 'Existing PFC' data points are clustered between 20 and 35, while the 'UT Slurry Section' data points are clustered between 10 and 20. Two arrows point to the 'Existing PFC' data points, labeled 'June 2017' and 'April 2018', indicating a decrease in skid number over time.

Skid testing was performed on the UT slurry and the untreated sections at either end. The UT slurry caused a significant reduction in skid which remained the case even one year later.

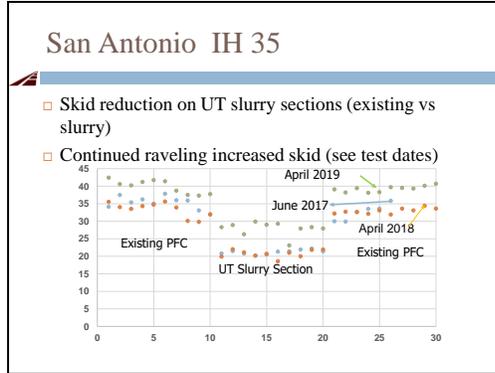
Slide 33

A final skid test was performed after another year and the UT slurry had improved skid but so had the sections had either end. The increase is exhibited to increased raveling in all of the sections which likely resulted in an increase in friction.

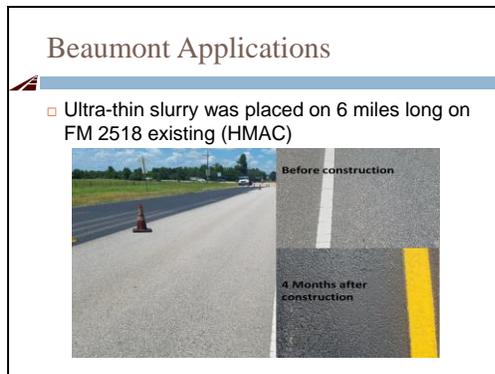
Slide 35

In Beaumont, the UT slurry was placed on 6 miles of FM 2518 existing hot mix. Two layers of about 0.15 gsy were applied. A minimum of about one hour was needed to adequately cure the surface before allowing traffic. Shaded areas required more time to cure. The second pass was made the following day. Four months after construction the surfacing still looked good.

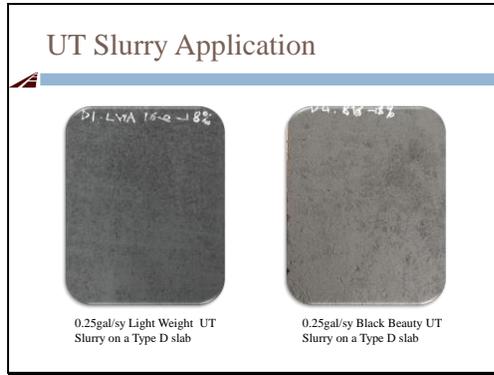
Slide 48

These are photos showing the increase in texture achieved with the lightweight aggregate versus the conventional black beauty aggregate.

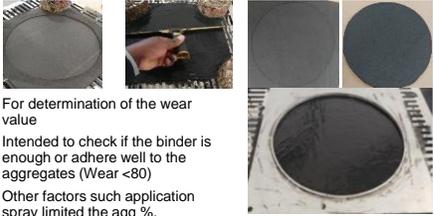
Thin sample preparation

- For determination of the wear value
- Intended to check if the binder is enough or adhere well to the aggregates (Wear <80)
- Other factors such application spray limited the agg %.

A procedure was developed for fabricating samples in the wet track abrasion. The conventional method as used for microsurfacing created a problem. It forced the black beauty aggregate down into the sample and did not represent field conditions.

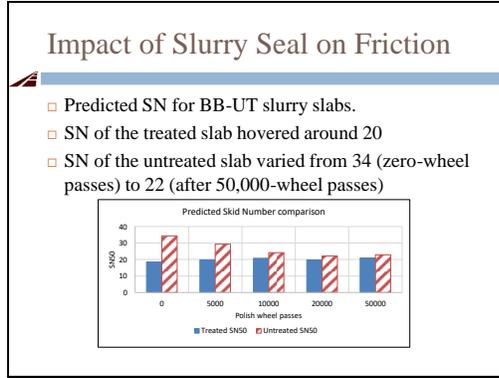
Slide 56

This slide shows the predicted SN vs the polish wheel passes for both treated and untreated slabs. The predicted SNs of the treated slab hovered around 20 for wheel pass levels evaluated, whereas the skid numbers of the untreated slab varied from 34 to 22 (after 50,000 wheel passes). In general, the UT slurry as currently formulated with BB aggregates reduced the SN of the HMA slabs.

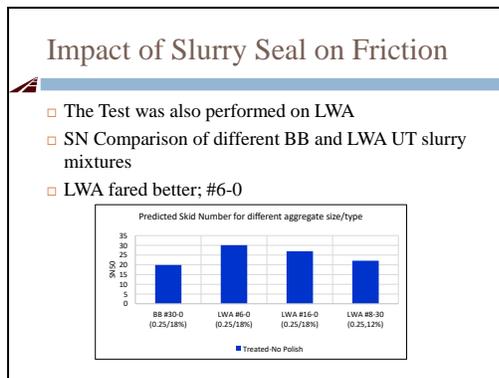
Slide 57

This figure shows the comparison of different UT slurry mixtures based on different aggregate type and size. The LWA #6-0 (0.25/18%) showed the best performance and the BB (#30-0) was the poorest.

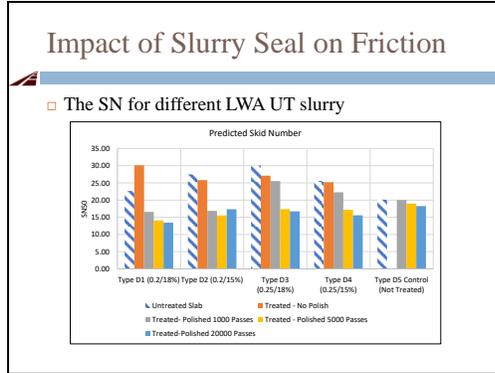
Slide 59

This figure shows the general skid test results. However to identify the best slab treatment, normalization of the data was needed because the slabs initial surface conditions slightly differed.

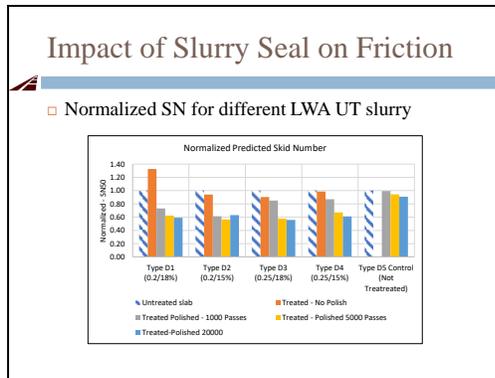
Slide 60

This shows the normalized data whereby D4 performed slightly better than the other treated slabs as it offered a steady and slower rate of skid loss. Nevertheless, it was outperformed by the type D5, the new untreated slab.

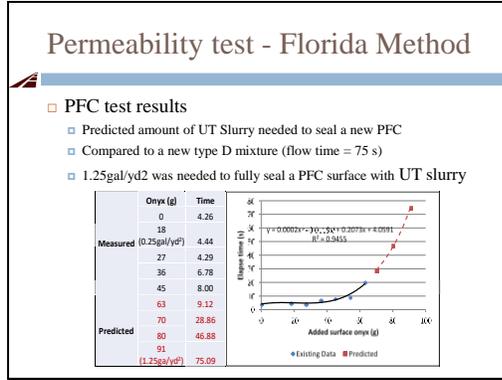
Slide 68

The improvement values show that the PFC molds were not complete sealed for all levels of the added slurry. Therefore, the researchers used a statistical model to predict the amount of slurry needed to seal a new PFC mold to a level equivalent to a new dense HMA mix.

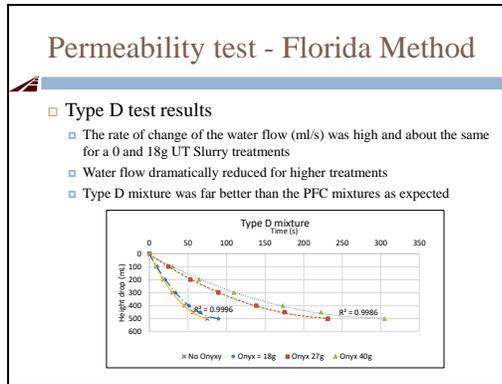
Slide 69

As was for the PFC molds this figure shows the time elapsed for the water to flow through the Type D molded specimen with different amounts of the slurry treatment. The rate of change of the water flow (mL/s) was higher for a 0 and 18 g UT slurry treatment and dramatically reduced for treatments above 27 g as shown.

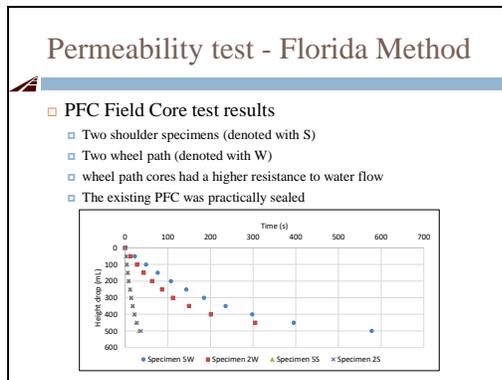
Slide 70

This figure shows lab permeability flow time for the FM 3959 field cores. Four field core specimens were tested, two from the shoulder and the other two from the wheel path (w). The results show that the specimens cored from the wheel path had a higher resistance to water flow than the shoulder cores. The permeability properties of the assessed HMA mixtures improved with the use of UT slurry treatment

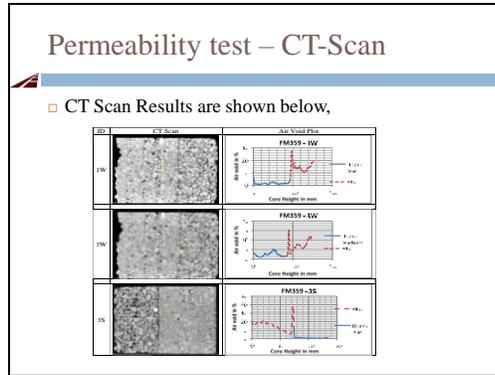
Slide 74

On the other hand, the CT scan showed that the air void is higher at the top half inch of the PFC and reduced towards the center where the air void detected was below 10%. Note that there is a spike at the middle of the air void plot which represents the joint between the pavement bottom dense layer and the surface PFC.

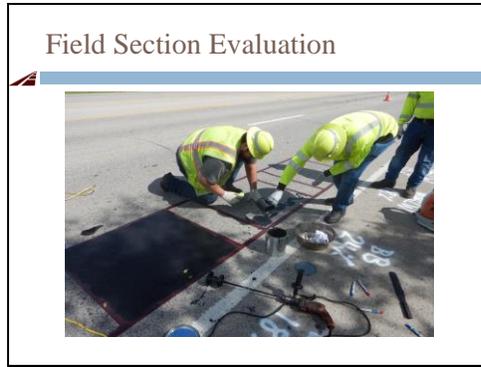
Slide 80

Two layers of the UT mixtures were applied on square sections of 3 ft x 3 ft. The mixture was applied manually and spread very fast before it dried up. Each patch was divided into small 4 equal bays to apply the material. After about two hours of total curing, the DFT and CTM tests were performed.

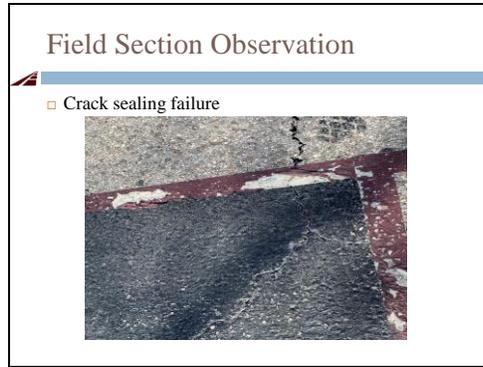
Slide 83

After 3 months of service, it is obvious the cracks were not sealed by the UT slurry.
