TECHNICAL MEMORANDUM 605-4

TESTING PROGRAM

SAFETY PROVISIONS FOR SUPPORT STRUCTURES

ON OVERHEAD SIGN BRIDGES

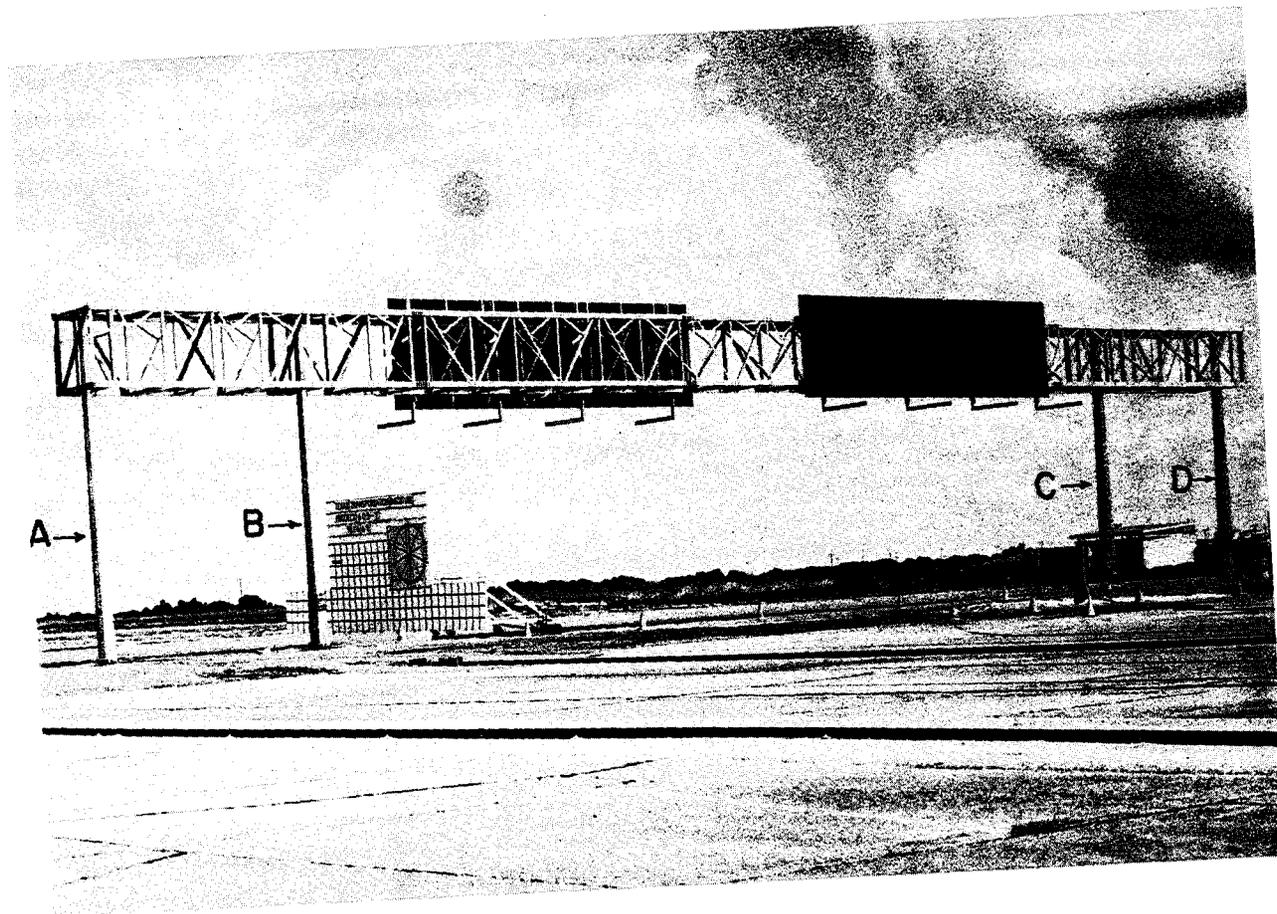
Figure 1, Prototype Overhead Sign Bridge
Supports are designated A, B, C and D.

Following the erection of the Overhead Sign Bridge, which was completed on September 8, 1969, an experimental program was begun which included both static load testing and dynamic vehicle crash tests. The purpose of the testing program was the experimental evaluation of the various factors which influence the forces acting on impacting vehicles and the reaction of the Overhead Sign Bridge to the loads imposed during collision events. Figure 1 shows the completed structure and gives a letter designation (A through D) to each support.

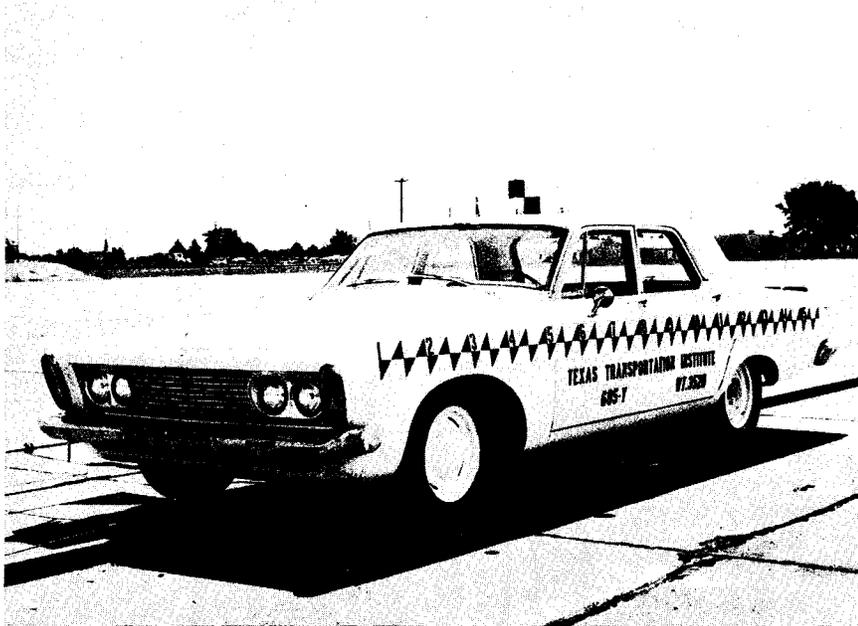
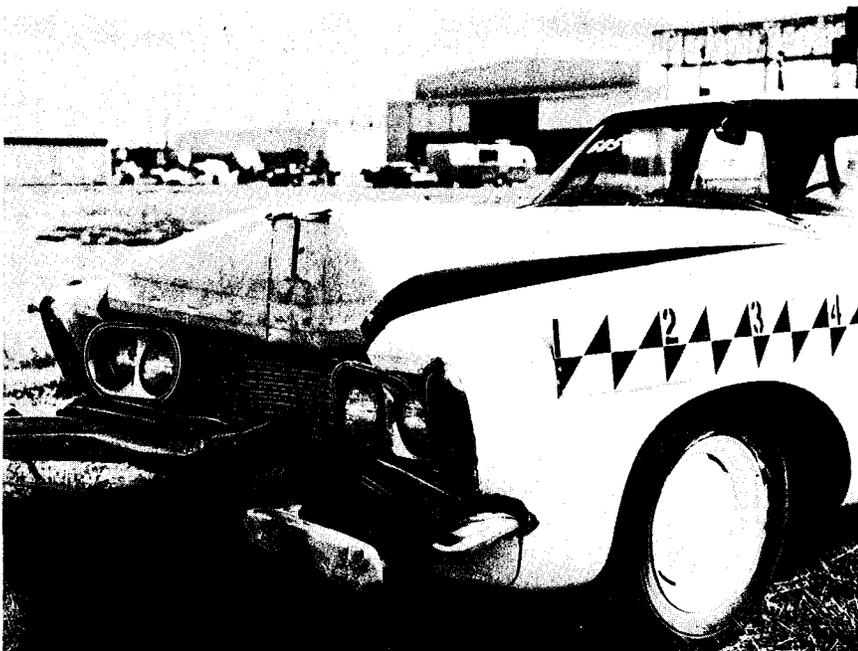
Figure 2, Vehicle Before Test 605-Y.

Figure 3, Vehicle After Test 605-Y.

The system functioned as designed, and the results checked with the mathematical simulation* very closely. The support rotated up and away from the vehicle through an angular displacement of 55°. The vehicle passed underneath after sustaining only minor damage. Figures 2 through 5 show selected photographs of the vehicle and OSB before and after the test. Based on this test, the functioning of the "break-away" components was verified and the reliability of the simulation was indicated.

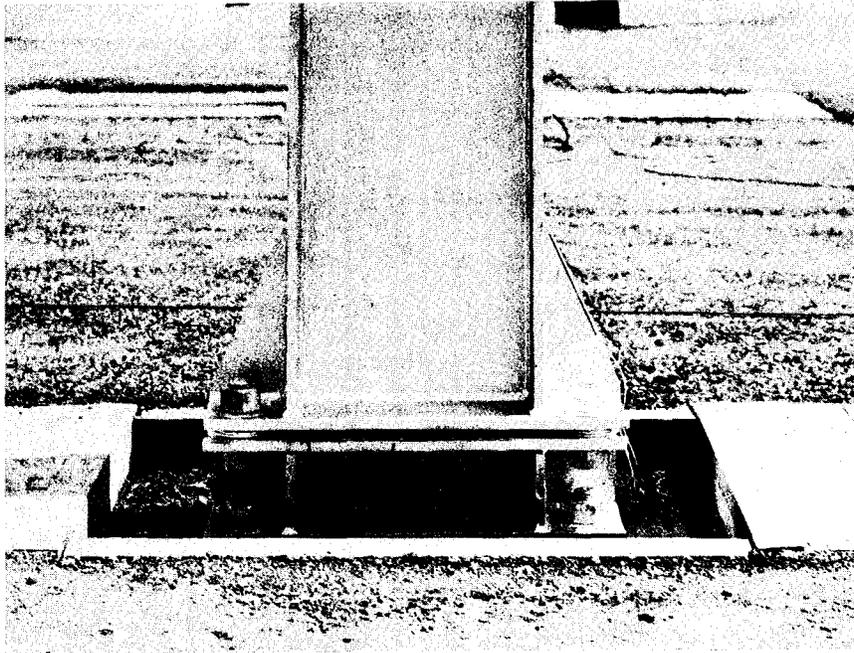
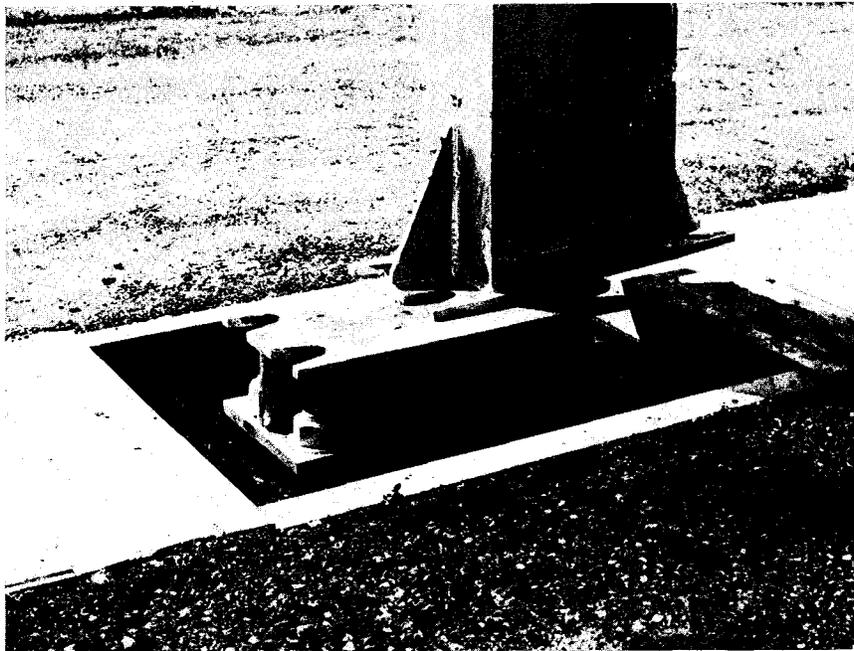
Figure 4, Support Base Before Test 605-Y.

Figure 5, Support Base After Test 605-Y.

As a preliminary check of the "break-away" capabilities of the Overhead Sign Bridge (OSB) before beginning the evaluation and development (regular) series, a 1963 Plymouth traveling 20 mph was directed head-on into Support A, the outside left support. The details of test conditions and results are given in Tables 2 and 3. This test was conducted primarily to confirm estimated fracture strength of the upper bolted connection, and secondarily to observe the overall system. Lower bolt torque was 100 ft-lbs and no bolt keeper plate was installed at the break-away base. Upper bolts, at the connection to the upper chord, were finger-tight.

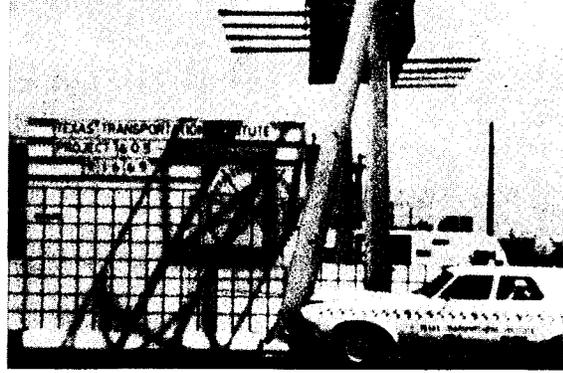
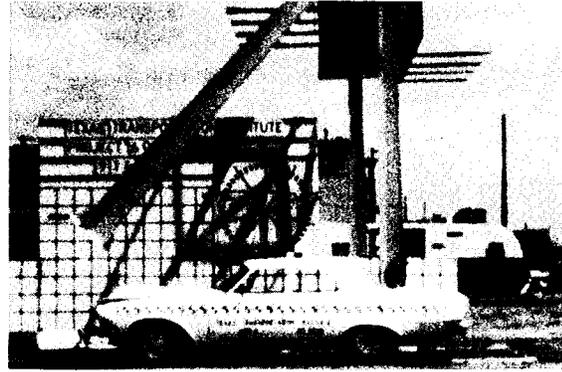
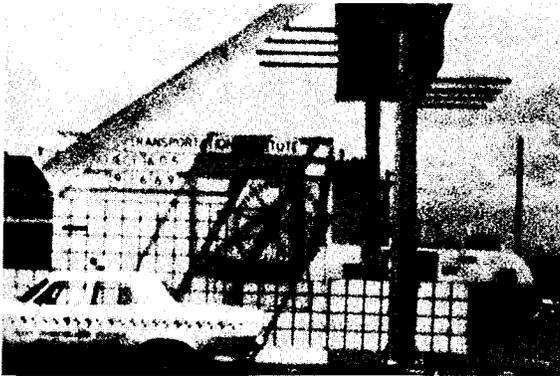
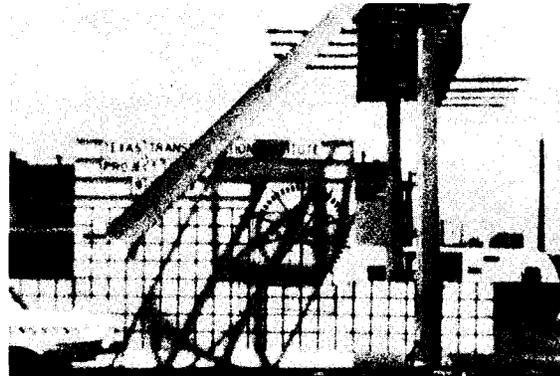
Figure 6, Sequential Photographs of Test 605-Y.

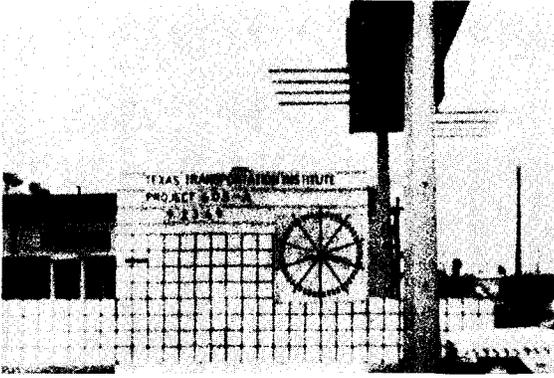
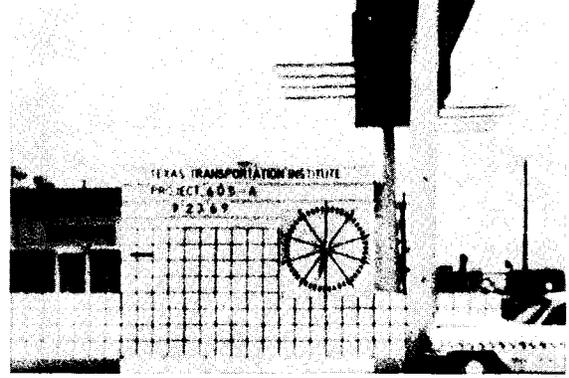
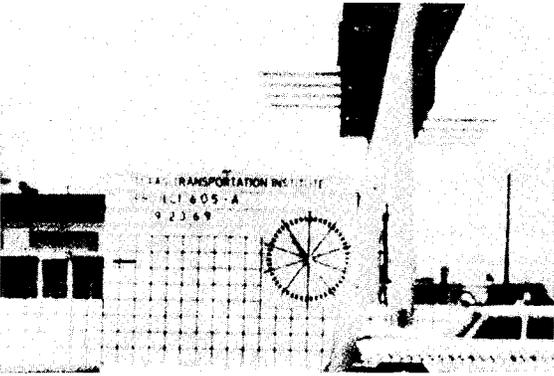
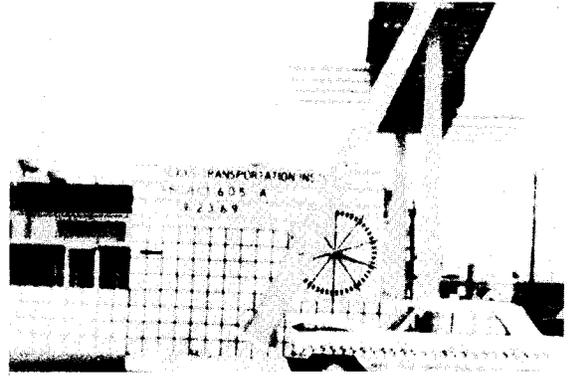
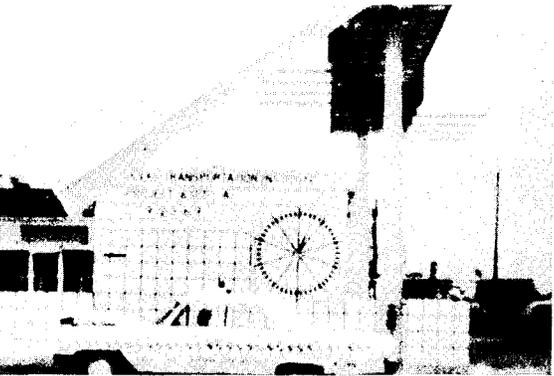
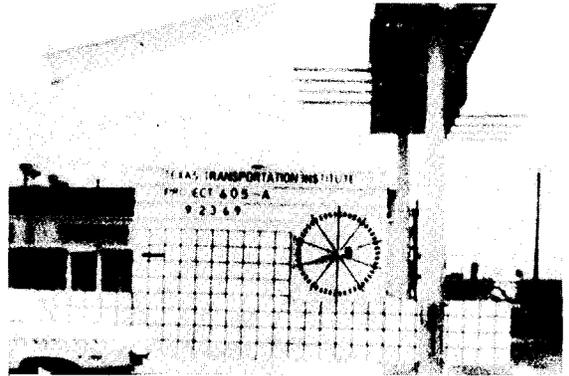
Figure 7, Sequential Photographs of Test 605-A.

The reaction of the support was again as predicted by the mathematical simulation. The support rotated through 83° (observed), allowing the vehicle to pass underneath. Damage to the vehicle was similar to that of Test 605-Y. Figure 7 shows sequential photographs of the interaction of vehicle and OSB during the test. Figures 8 and 9 show the vehicle before and after the test. A comparison of test results of 605-Y and 605-A, presented in Table 3, indicates that average deceleration increased 11 percent and maximum deceleration increased about 47 percent. The change in velocity was less than in the preliminary 20 mph test (605-Y).

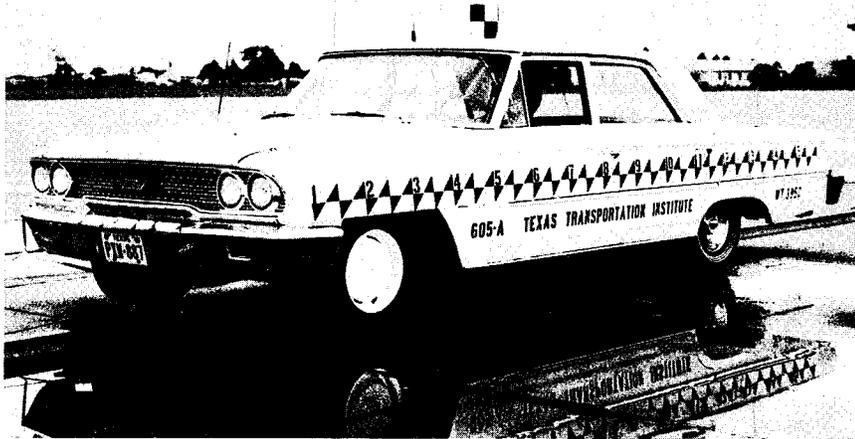
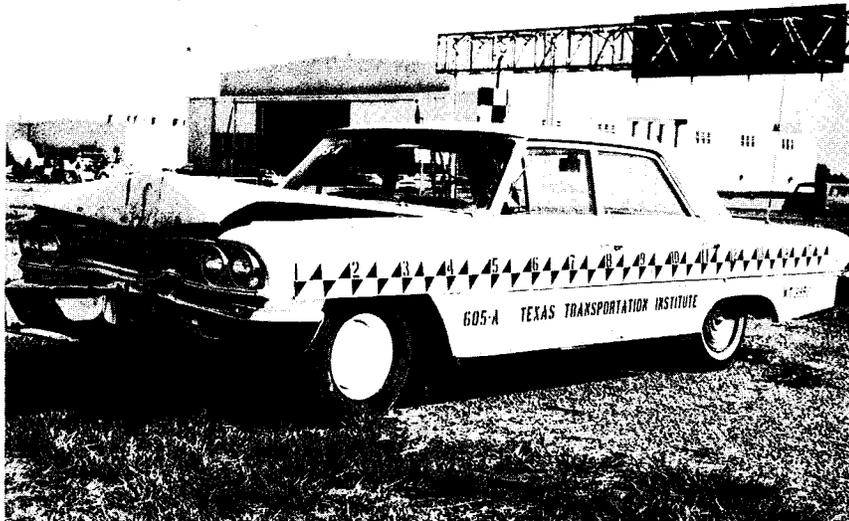
Figure 8, Vehicle Before Test 605-A.

Figure 9, Vehicle After Test 605-A.

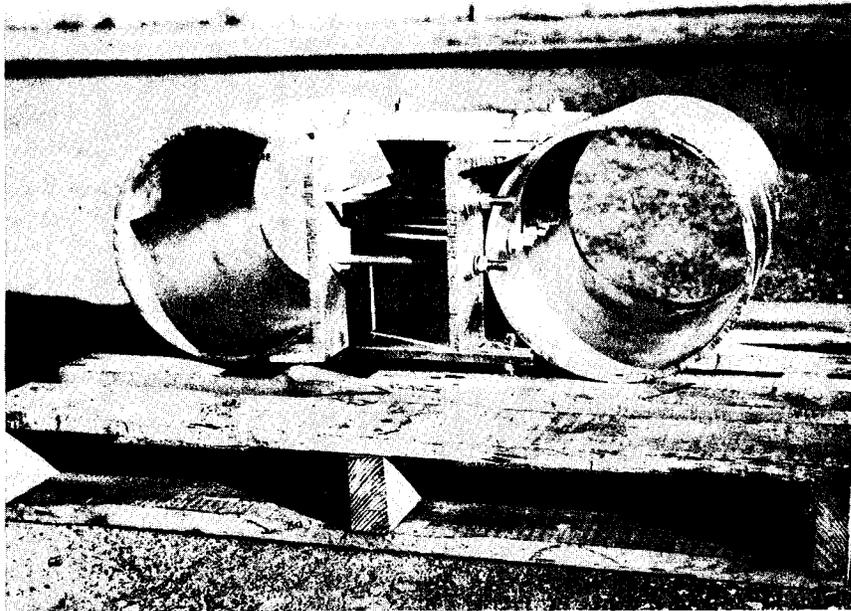
Figure 10, Energy Absorbers
(Steel tubing: $\frac{3}{8}$ in. wall thickness,
12 in. diameter, 17 inches long).

In evaluating the break-away features of the Overhead Sign Bridge and the functioning of the bridge structure, two distinct areas of interaction are apparent. One, the interaction of the vehicle with the support; and two, the interaction of the rotating OSB support with the lower chord members of the truss. The first two tests showed that the interaction of the vehicle with the support leg could be predicted with reasonable accuracy by use of the computer simulation. A matter of major concern then became the interaction of the rotating support with the truss. For vehicle velocities greater than 25 mph, the computer simulation predicted that the support would possess a significant amount of kinetic energy when it impacted the lower chords of the truss. The protection of the lower chord members by distributing the impact force, as well as the dissipation of this excess energy, was carefully considered. To provide the required distribution and dissipation, a steel tube energy absorber was designed which could be placed to protect the lower chord members of the truss. Static laboratory and field tests were run to verify the function of these energy absorbers before crash tests were conducted. A closeup of this energy absorber before it was placed on the truss is shown in Figure 10. The energy absorbers installed on the truss are shown in Figures 11 and 12. Selection of the channel sections was made (1) to provide adequate load distribution to the truss, and (2) to provide a flat bearing surface for the cylindrical tubes during impact loading. The design of the connection provided both conditions, as can be seen in Figure 13. No damage to the lower chord occurred and the energy absorbers were crushed against the channel sections.

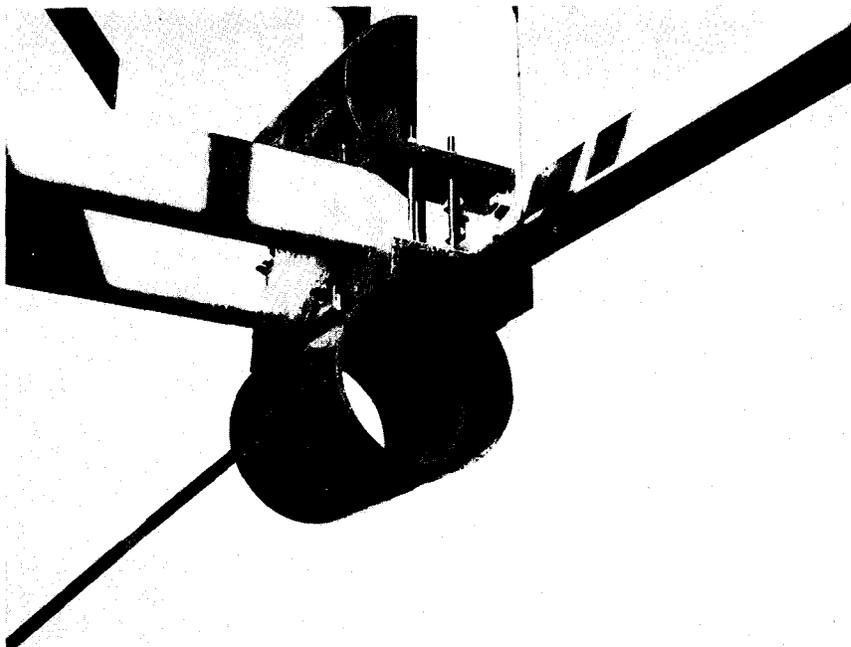
Figure 11, Energy Absorber
Bolted in place on
Lower Truss Chord at Support A.

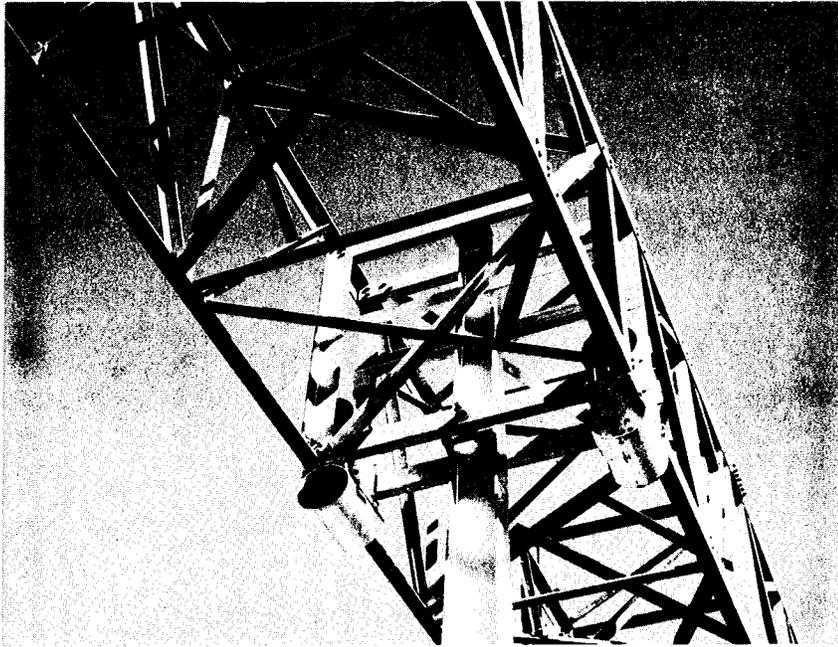
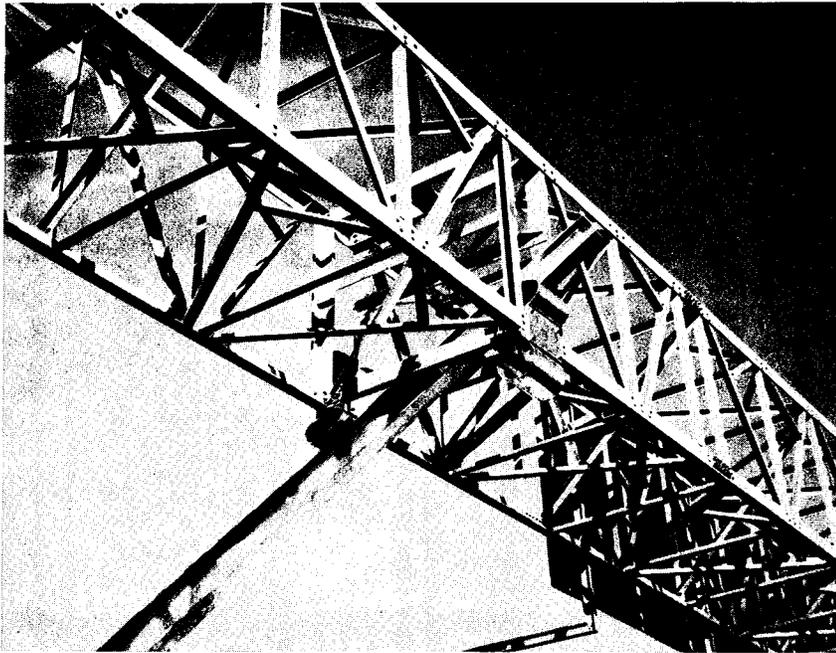
Figure 12, Energy Absorbers at Support B Before Test 605-B.

Figure 13, Energy Absorbers at Support B After Test 605-B.

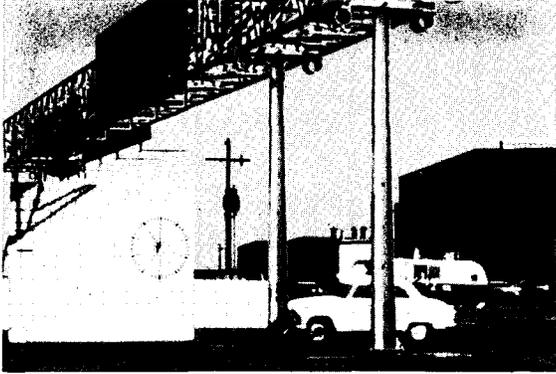
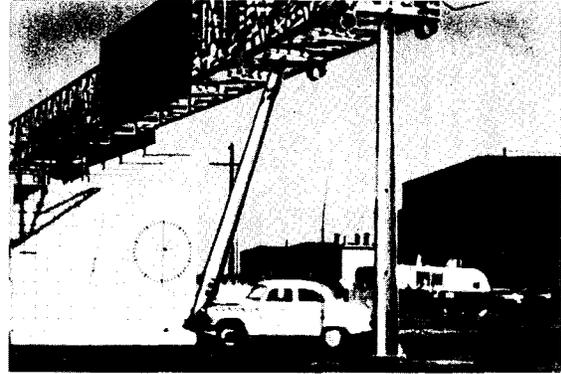
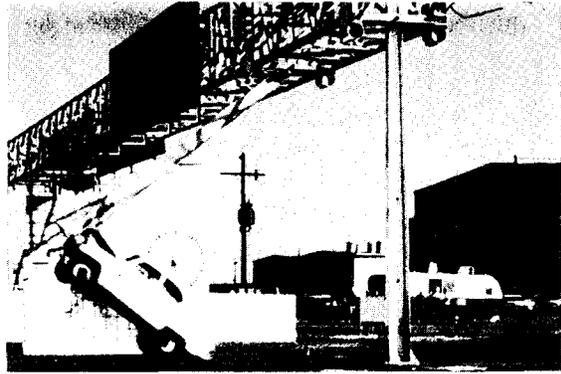
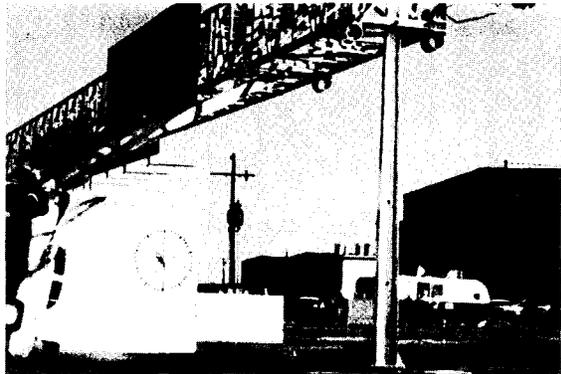
Figure 14, Sequential Photographs of Test 605-B.

A very unexpected condition occurred during Test 605-B: The vehicle remained in intimate contact with the support after initial contact. This interaction of vehicle and support is shown by the sequence photographs of Figure 14. The front of the vehicle was deformed significantly by the impact with the support, remained in contact with the support, and was lifted at the front end by the support, finally wedging itself between the ground and support in a vertical position. The major reason for this behavior is believed to be that the front of the Simca is relatively soft compared to the larger automobiles tested. This front end "deformability" allowed the post to penetrate 21 inches in toward the motor while bending the frame's front cross member. The bending of this cross member forced the two longitudinal members to come together, thus clamping the support in the pincer-type action of the vehicle's front structure. This pincer action prevented the support from springing away from the vehicle after the "break-away" connections at the bottom and top sheared. As the support rotated, while maintaining contact with the Simca, the elevation of the support base plate increased. The slotted projections of this base plate (see Figure 5) acted as a fork which caught the front end of the Simca and raised it to the maximum elevation shown at $t = 0.781$ seconds in Figure 14.

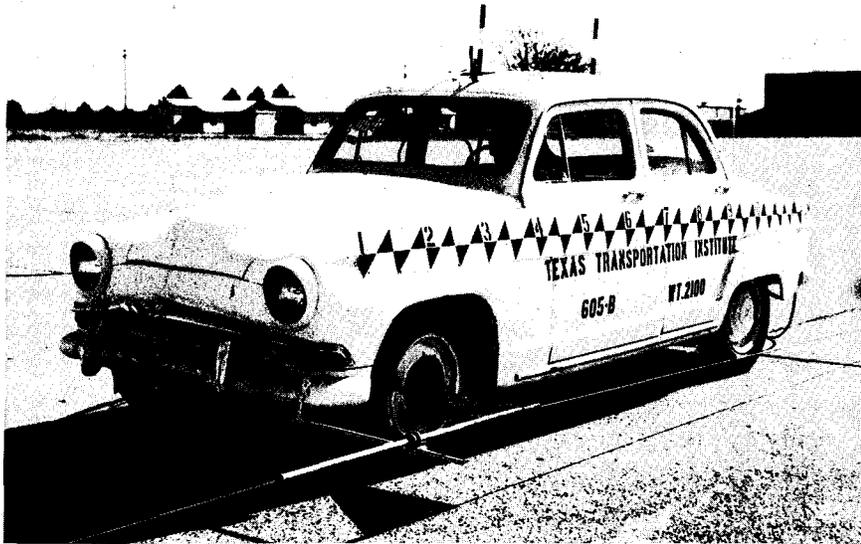
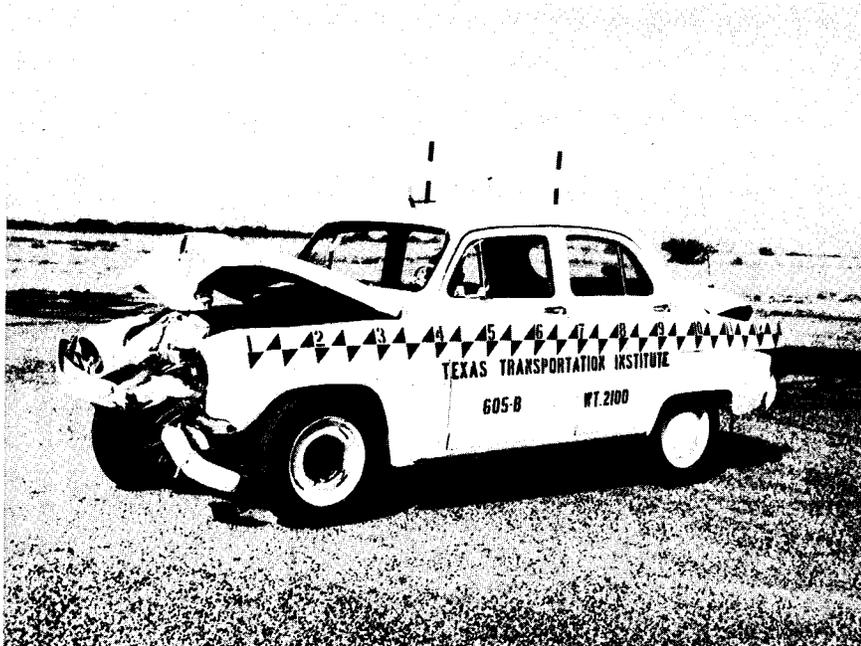
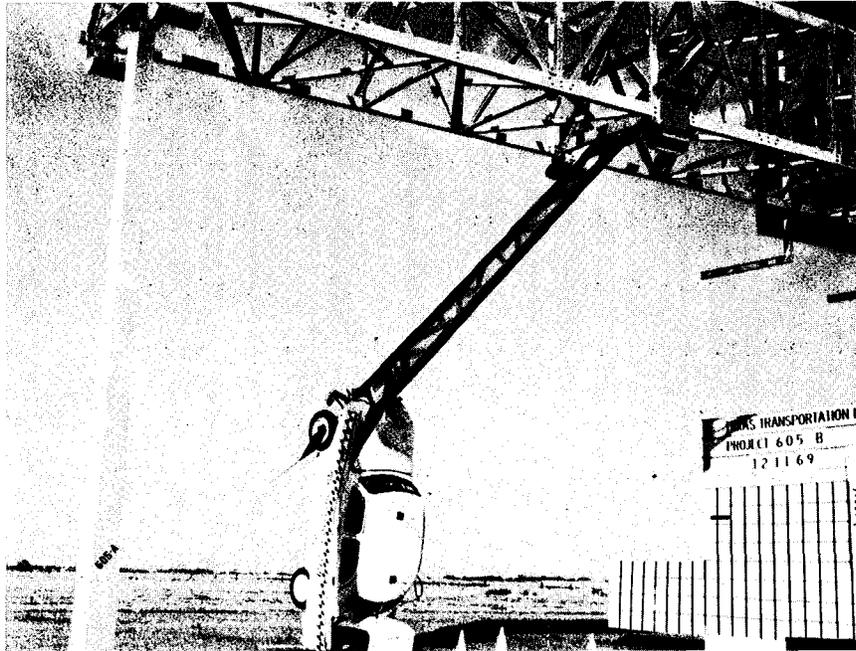
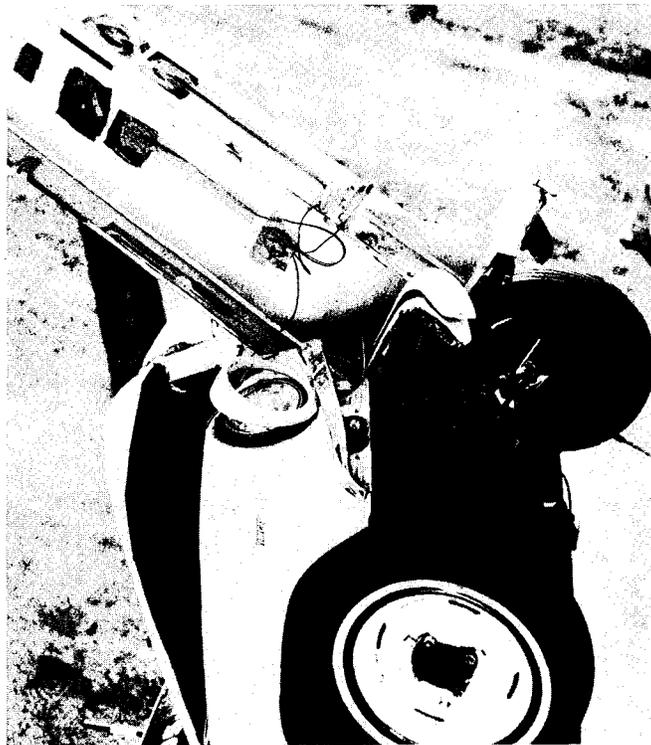
Figure 15, Vehicle Before Test 605-B.

Figure 16, Vehicle After Test 605-B.

Figure 17, Impact Area After Test 605-B.

Figure 18, Vehicle Damage, Test 605-B.

Even though the interaction of vehicle and post after the initial shearing of the lower support was rather unexpected, the damage to the vehicle was not more than had been expected and the decelerations that the vehicle experienced were not excessive. The average deceleration (from accelerometer traces) during the period necessary to activate the break-away component of the support was 9.6 g's over 0.068 seconds, producing a change in velocity of 21.5 feet per second or 14.6 miles per hour. The maximum deceleration was rather high, 22.4 g's.

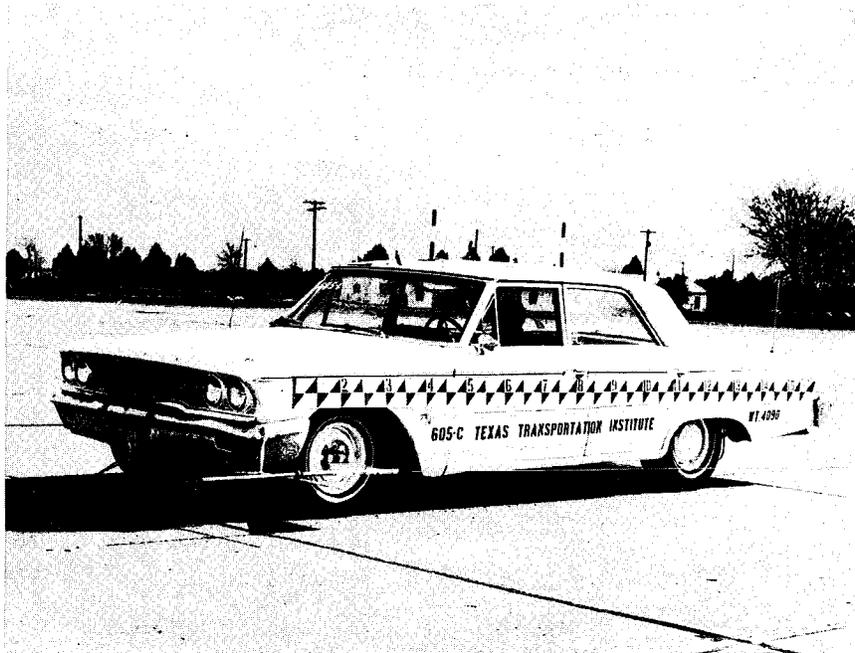
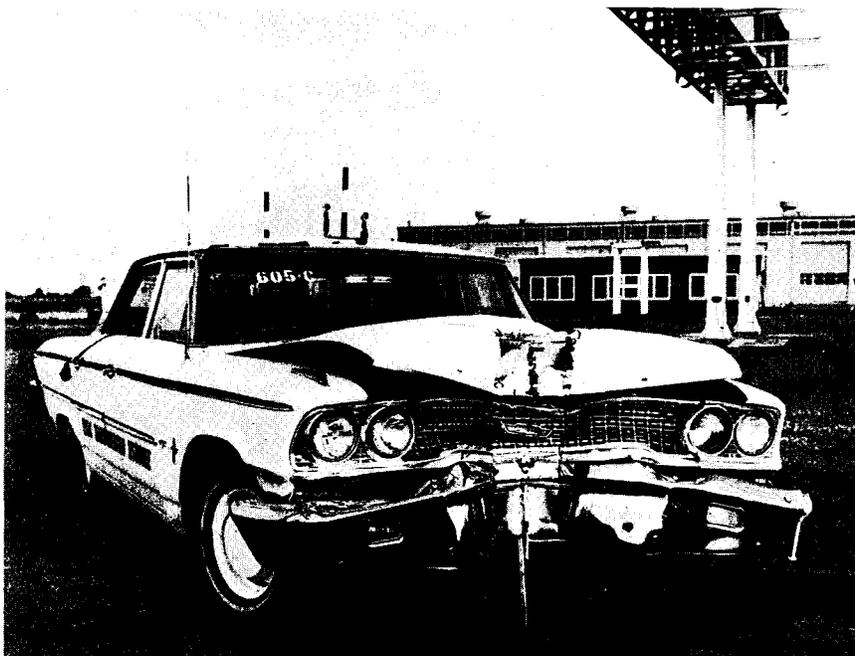
Figure 19, Vehicle Before Test 605-C.

Figure 20, Vehicle After Test 605-C.

In an effort to provide a more critical test of the energy absorption capabilities of the Overhead Sign Bridge and to determine the interaction of a medium-sized vehicle at moderate speed, Test 605-C was performed. The 4090 lb 1963 Ford impacted Support B head-on at a velocity of 47 mph. The interaction of vehicle with post was as expected and a nominal vehicle damage is shown by Figure 20. The average deceleration during contact with the support was 6.7 g's and the peak deceleration was 19.1 g's.

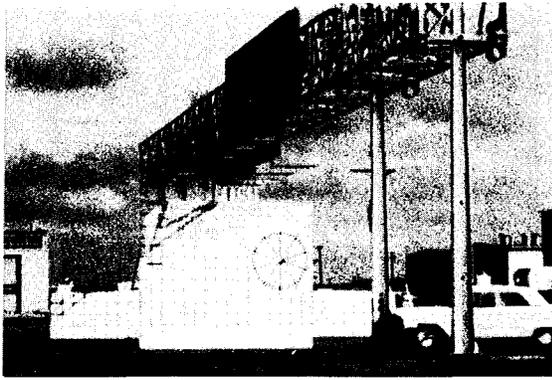
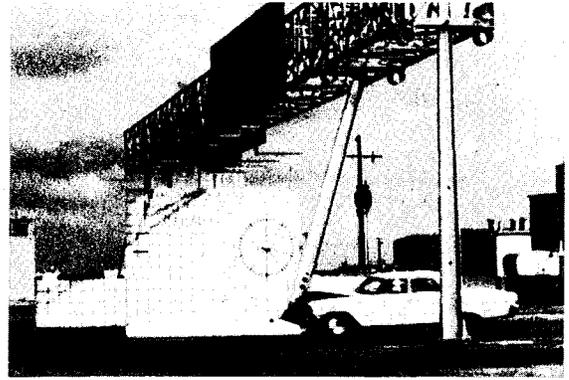
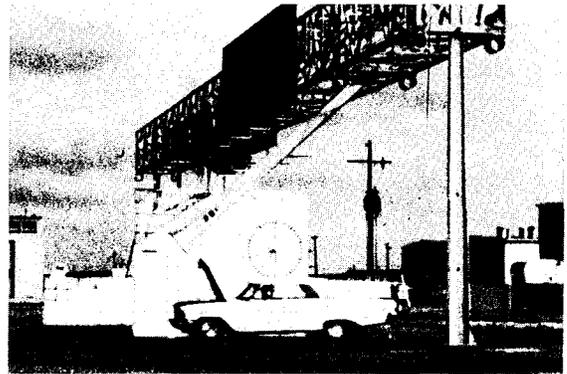
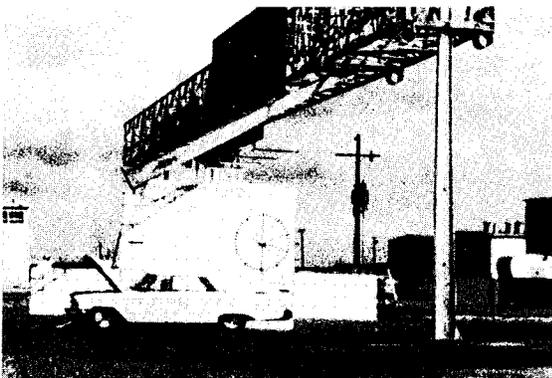
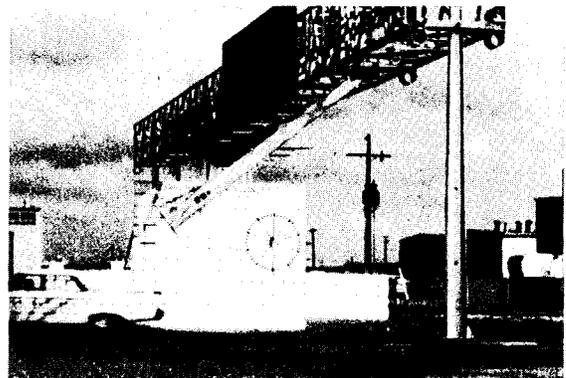
Figure 21, Sequential Photographs of Test 605-C.

The break-away devices at the bottom and top of Support B functioned as predicted, allowing the support to rotate up and away from the vehicle. During the time from initial vehicle contact until the upper bolts sheared, the truss rotation was only approximately 1° . This was somewhat surprising since the previous 3 tests had shown truss rotations from 2° to 3° during this time. The vehicle passed under the support with a clearance of approximately 5.8 ft. After swinging through an angle of 50.5° , the support made contact with the energy absorbers and proceeded to crush them until the total support rotation had increased to 62.5° . During the crushing of the energy absorbers, the rotation of the truss was less than 1° .

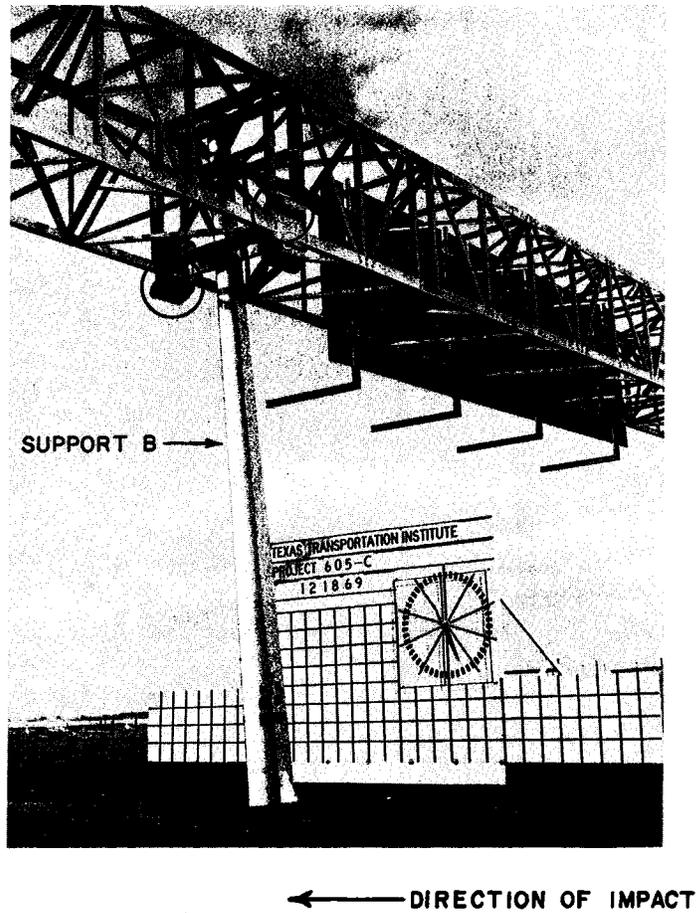
Figure 22, Impact Area After Test 605-C.
Note crushed energy absorbers,
(circled above),

Using photographic analysis, the angular velocity of the support was estimated to be 2.72 radians per second when contact was made with the energy absorbers. Using elementary equations of physics, the energy dissipated by the energy absorbers was calculated to be 23 Kip-Ft. Based on the static load analysis of Appendix B, it was estimated that the Overhead Sign Bridge could absorb 145 Kip-Ft of energy. Our estimates of support energy when contact is made between support and truss appear to be somewhat high. The 60-mph test of a 5000 lb vehicle which will take place in February 1970 should provide a critical test of the OSB's capacity for absorbing energy.

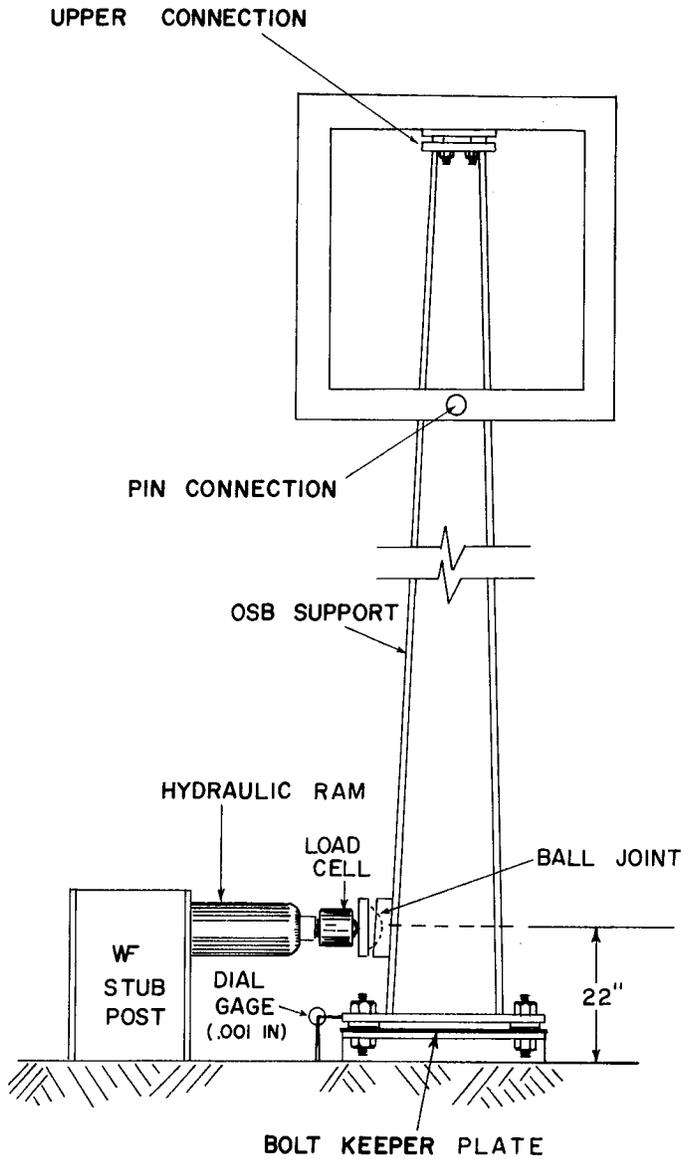
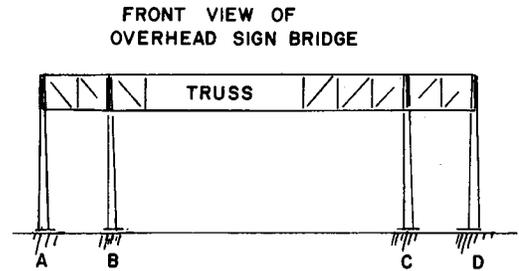
To perform this test, a hydraulic ram was placed so that a load could be applied to Support D at the same point and in the same direction as the load applied by a vehicle impacting head-on. The test layout is shown in Figure 23. A gradually increasing load was applied to exterior Support D until the base slipped free; subsequently the four bolts at the upper connection were fractured.

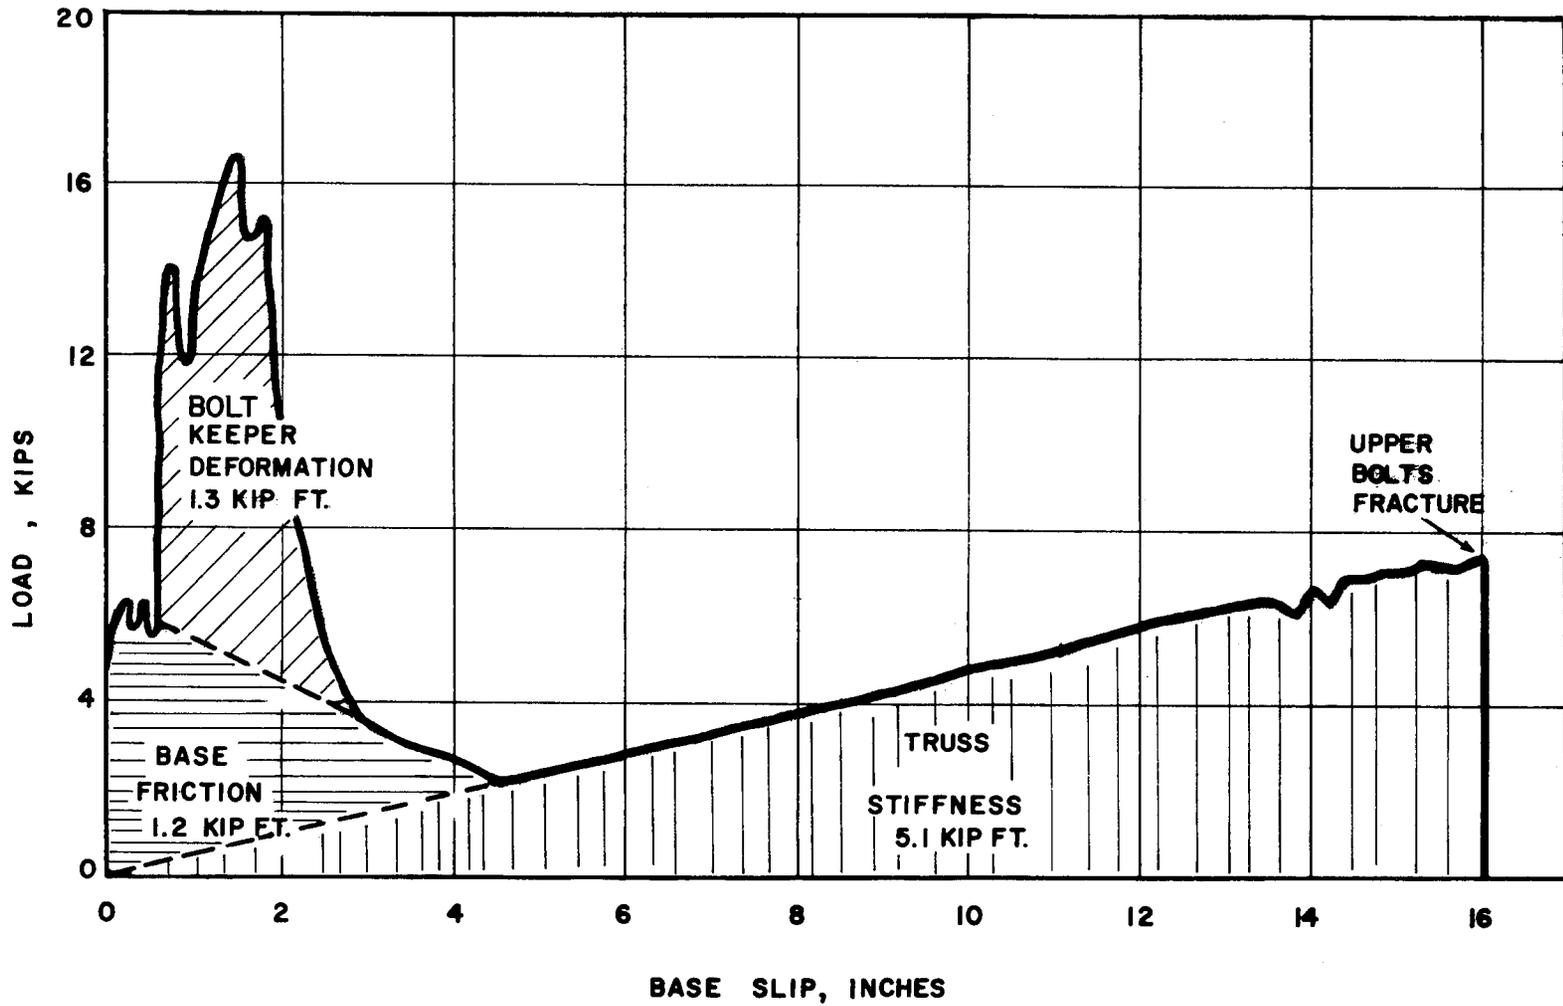
The relationship observed between load and slip (base movement in the direction of the applied load) is shown in Figure 24. Initial slip of the base began at an applied load of slightly over 4,000 pounds. As the lower connection bolts came in contact with the 20 gage steel keeper plate, the load necessary to continue the slipping increased to a maximum of 17,000 pounds and then decreased abruptly as the bolts tore free of the keeper. After a slip of 4.5 inches, the support was completely free of the base plate. The load dropped to 2,000 pounds at this point and then increased gradually to 7,100 pounds when the upper connection bolts fractured. The dotted lines dividing the area under the curve in Figure 24 show a hypothesis concerning the energy attributed to each of the factors resisting base movement. The area designated as truss stiffness would include both truss flexural and torsional stiffness. The test indicated that both lower and upper

FIGURE 24, LOAD - SLIP CURVE, TEST 605-SI.

Each component of this system contributed to the load-slip characteristics shown in Figure 24. Estimates of the load required to overcome base friction, tear the keeper plate and fracture the upper connection bolts were made prior to conducting this test. The total force required to actuate the break-away system was higher than the estimates. As a result of this test, the load-slip characteristics of each component of the total system were more clearly defined.

A comparison of force variation as a function of lower connection slip between static load test 605-S1 and the force versus slip variation determined by the "summation-of-effects" from the LC test series is given in Figure 38. The peak transverse force predicted by the "sum-of-effects" method is approximately 20 percent lower than the maximum force observed in the S1 test. The two methods compare very well in predicting the amount of energy necessary to slip the lower end of the support free. The energy determined from the load-slip curves from Test 605-S1 was 2.54 kip-ft and the energy given by the "sum-of-effects" method was 2.36 kip-ft. The largest discrepancy between the two curves is in the region between 2.5 and 3 inches of base slip. One reason for this may be the slight difference in the way the upper plate moves with respect to the lower plate in Test S1 and in the LC test series. In the S1 test, the upper plate was moving in an arc of very slight curvature and the load was applied approximately 22 inches above the ground, while in the LC test series, the upper plate moved in a straight path and the load was applied directly to the upper plate. Another possible discrepancy is due to the fact that the axial load for the S1 test was assumed to be 8 kips. This assumption could be considerably in error.

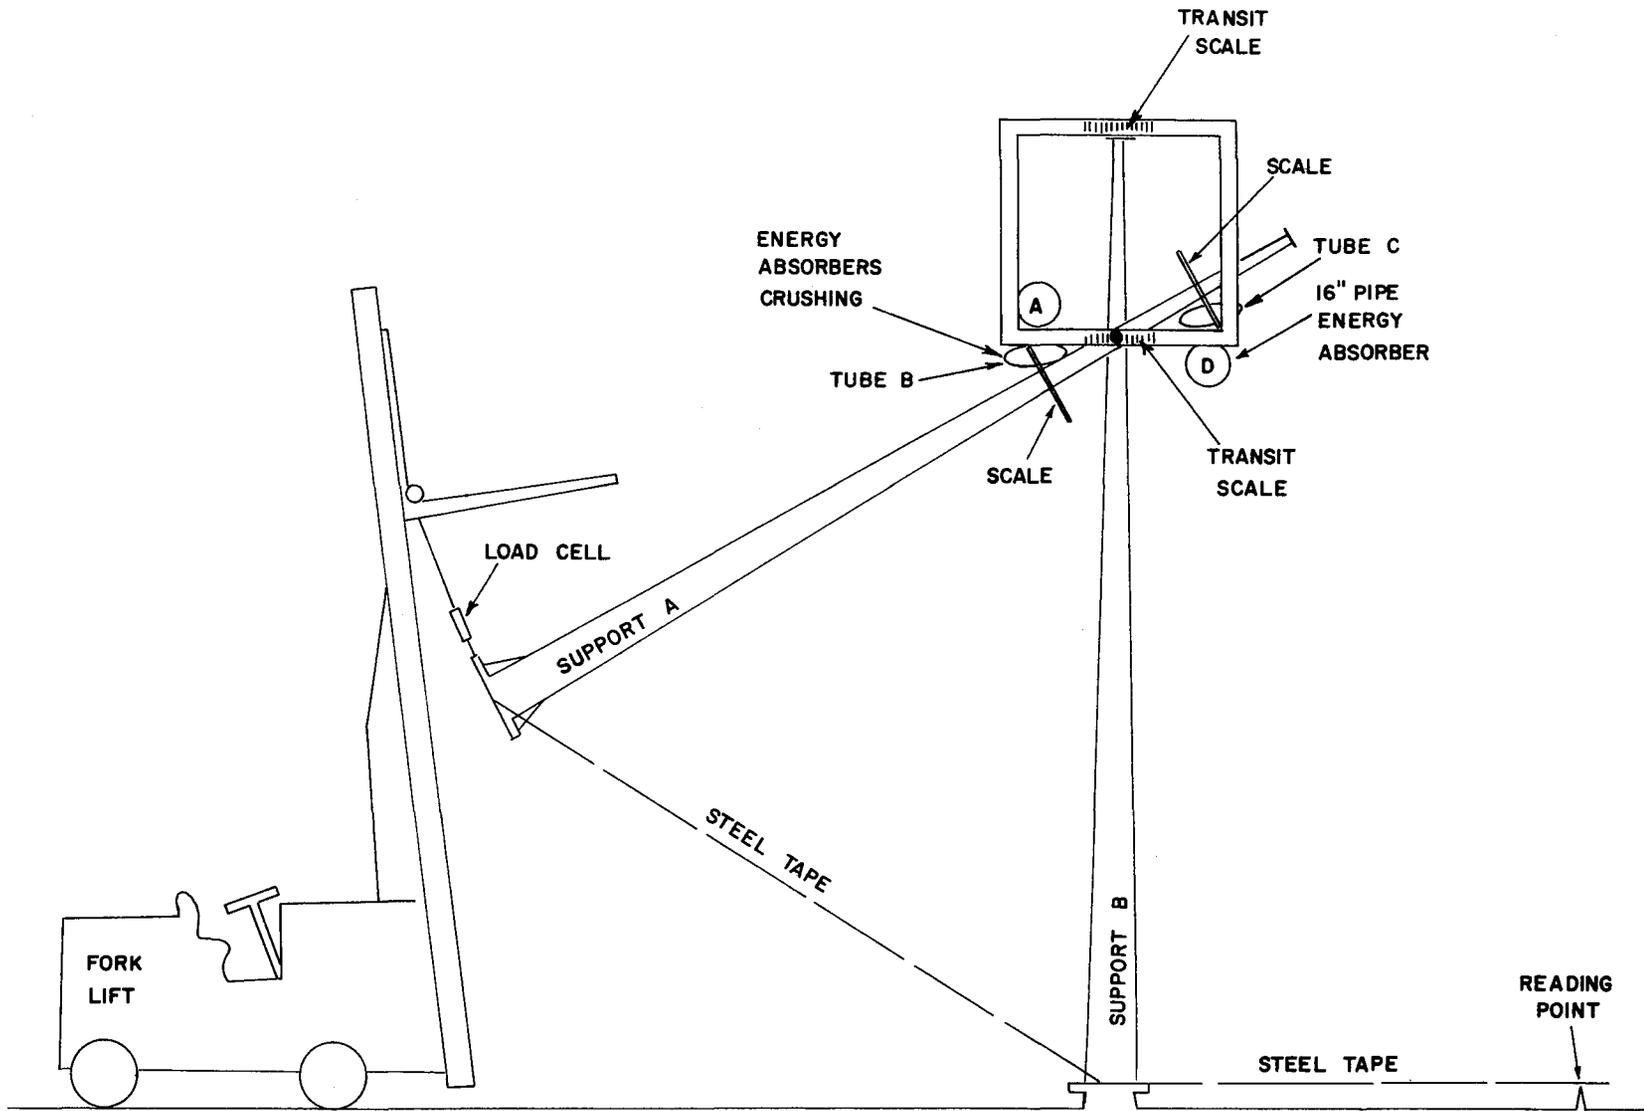
FIGURE 25, LAYOUT OF TEST 605-S2.

A layout of Test 605-S2 is given by Figure 25. Support A was detached at the base and rotated until contact was made with the tubes B and C. By attaching Support A to a fork lift, a load was applied which produced a rotation of Support A, crushing energy absorbers B and C and producing a torsional rotation of the truss elements. This load on Support A was increased progressively until the energy absorbers were completely crushed, and until the upper connection bolts at Support B failed. At this time, the load dropped off to 130 kip-ft and the rotation of Support A was again continued until the applied torque was equal to 190 kip-ft. The test was discontinued when the fork lift capacity (for vertical height) had been reached.
