TECHNICAL MEMORANDUM 605-4

TESTING PROGRAM

SAFETY PROVISIONS FOR SUPPORT STRUCTURES

ON OVERHEAD SIGN BRIDGES

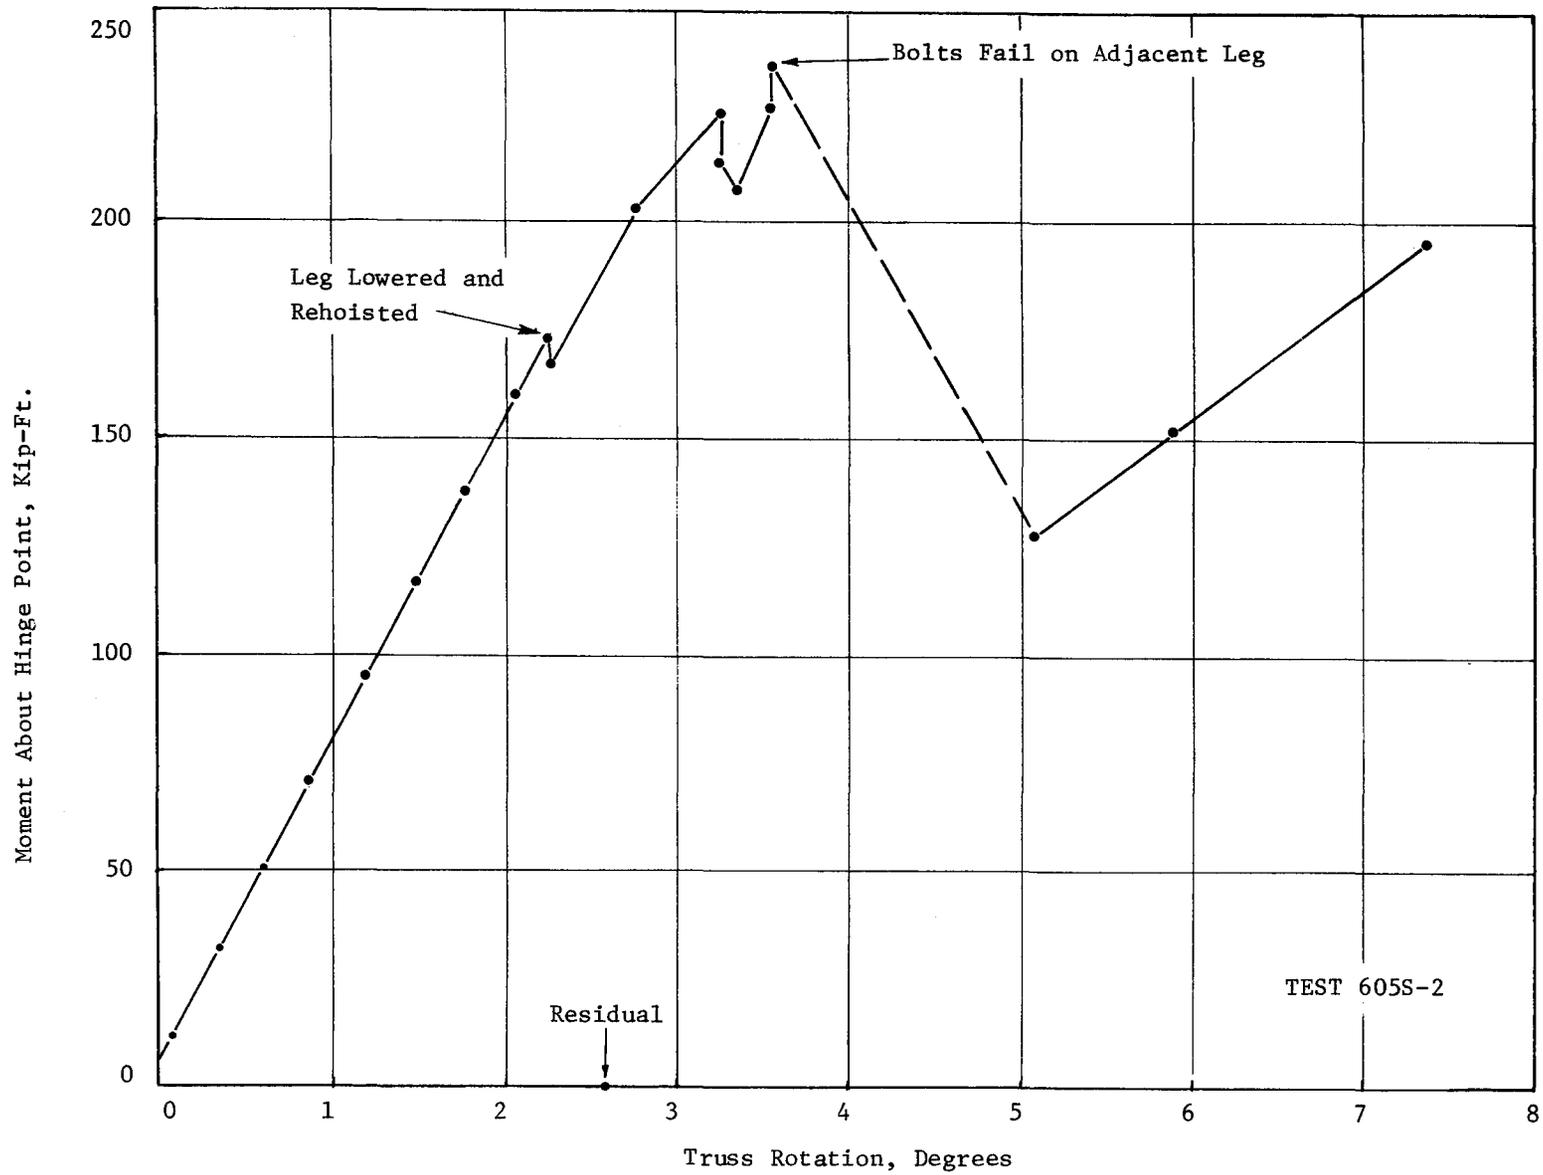
The computed moments versus truss rotation are plotted in Figure 26. A detailed analysis of the data in this test is given in Appendix B. The

Figure 26, Applied Moment Versus Truss Rotation.

results of the analysis indicate the following: the torsional stiffness of a 20-foot segment of the OSB truss is 79 kip-ft per degree rotation. The resistance of a single support before failure of the upper bolt connection was previously found by conventional analytical methods to be 750 kip-ft per degree. Based on the results of this test, the torsional stiffness coefficient of Support B after failure of the upper connection bolts was found to be 24 kip-ft per degree. Based on these stiffness coefficients, and the empirically determined moment necessary to produce failure of upper connection bolts at any support (230 kip-ft), a torque versus truss rotation curve was constructed for an applied torque at Support A up the point where the bolts at the upper connection of Support C fail. This curve is shown in Figure 27, and indicates that the OSB may absorb 145 kip-ft of energy before the failure of all upper connection bolts takes place. This calculation assumes that no inelastic action takes place within the Overhead Sign Bridge and is based on the extrapolation of a very limited amount of data. Therefore, the actual magnitude of the energy found is subject to considerable question. The indications are, however, that the truss may be able to absorb at least the 80 kip-ft of energy predicted for the impact of a 5,000 pound vehicle traveling 60 mph. Test 605-S2 indicated that vehicle crash testing may be conducted at higher speeds without severe damage to the OSB.

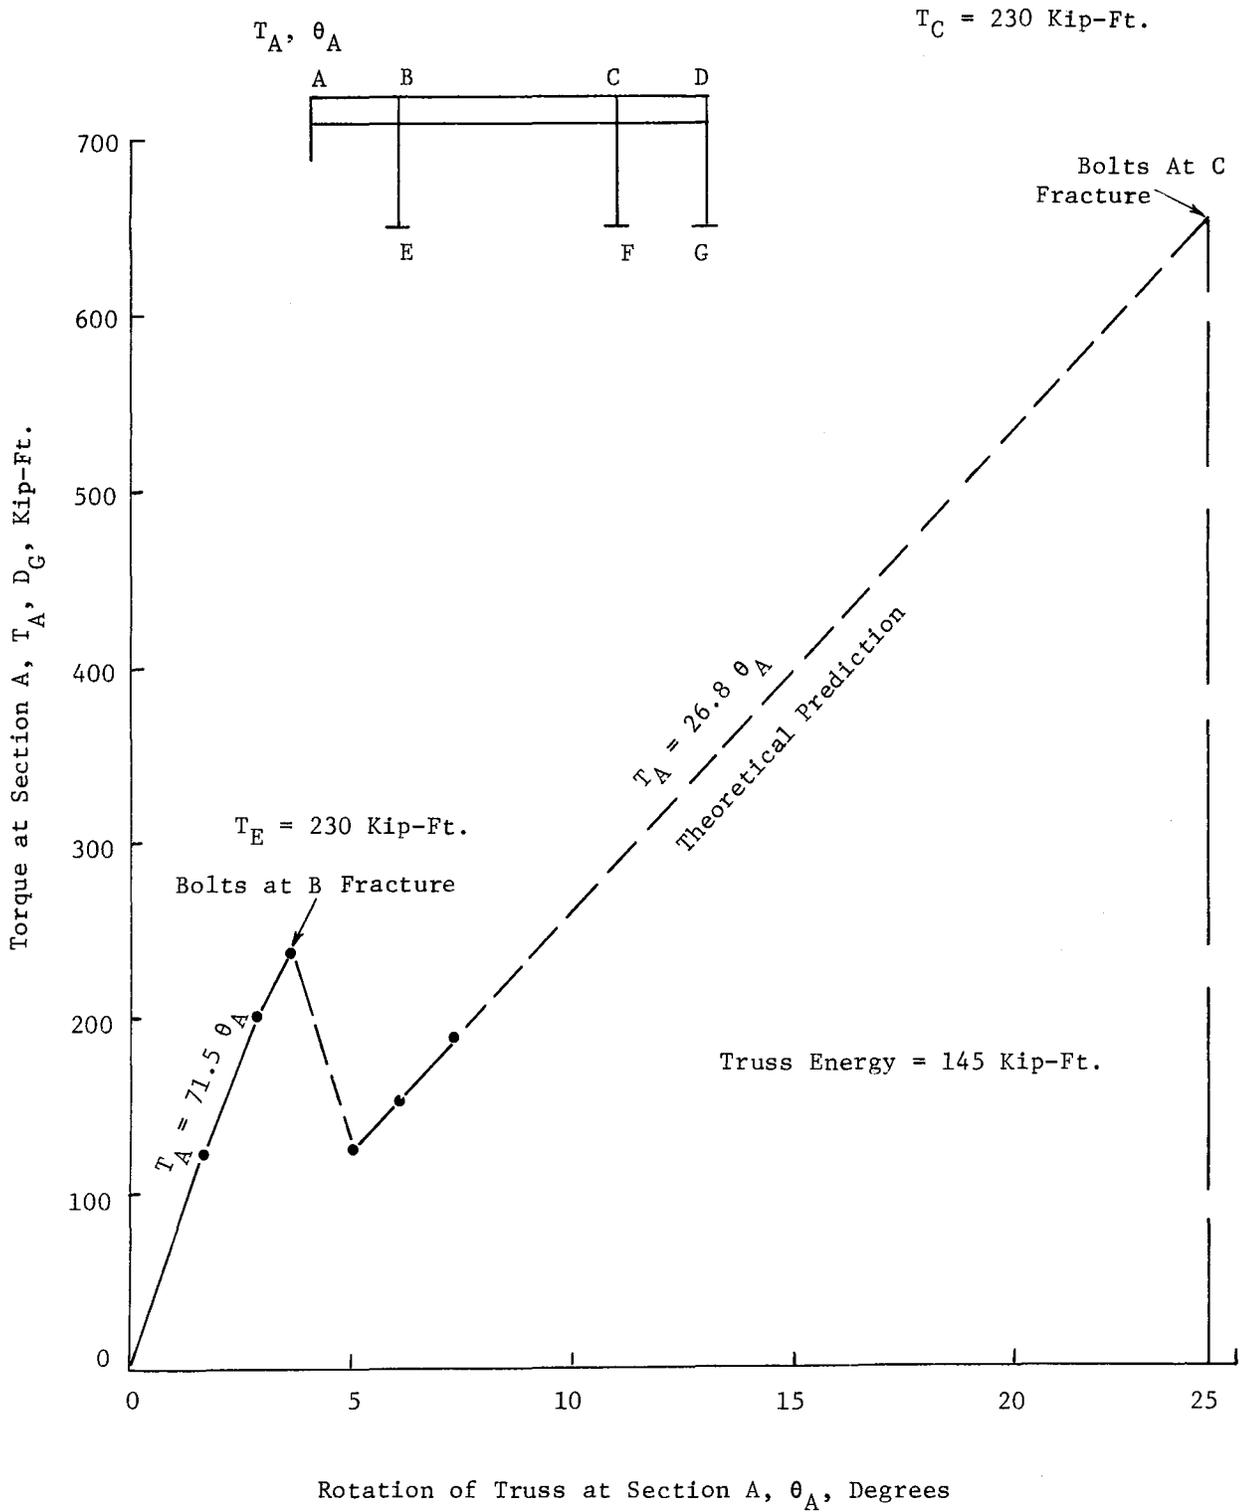
Rotation of Truss at Section A, θ_A , Degrees

Figure 27, Torque-Rotation Relationship.

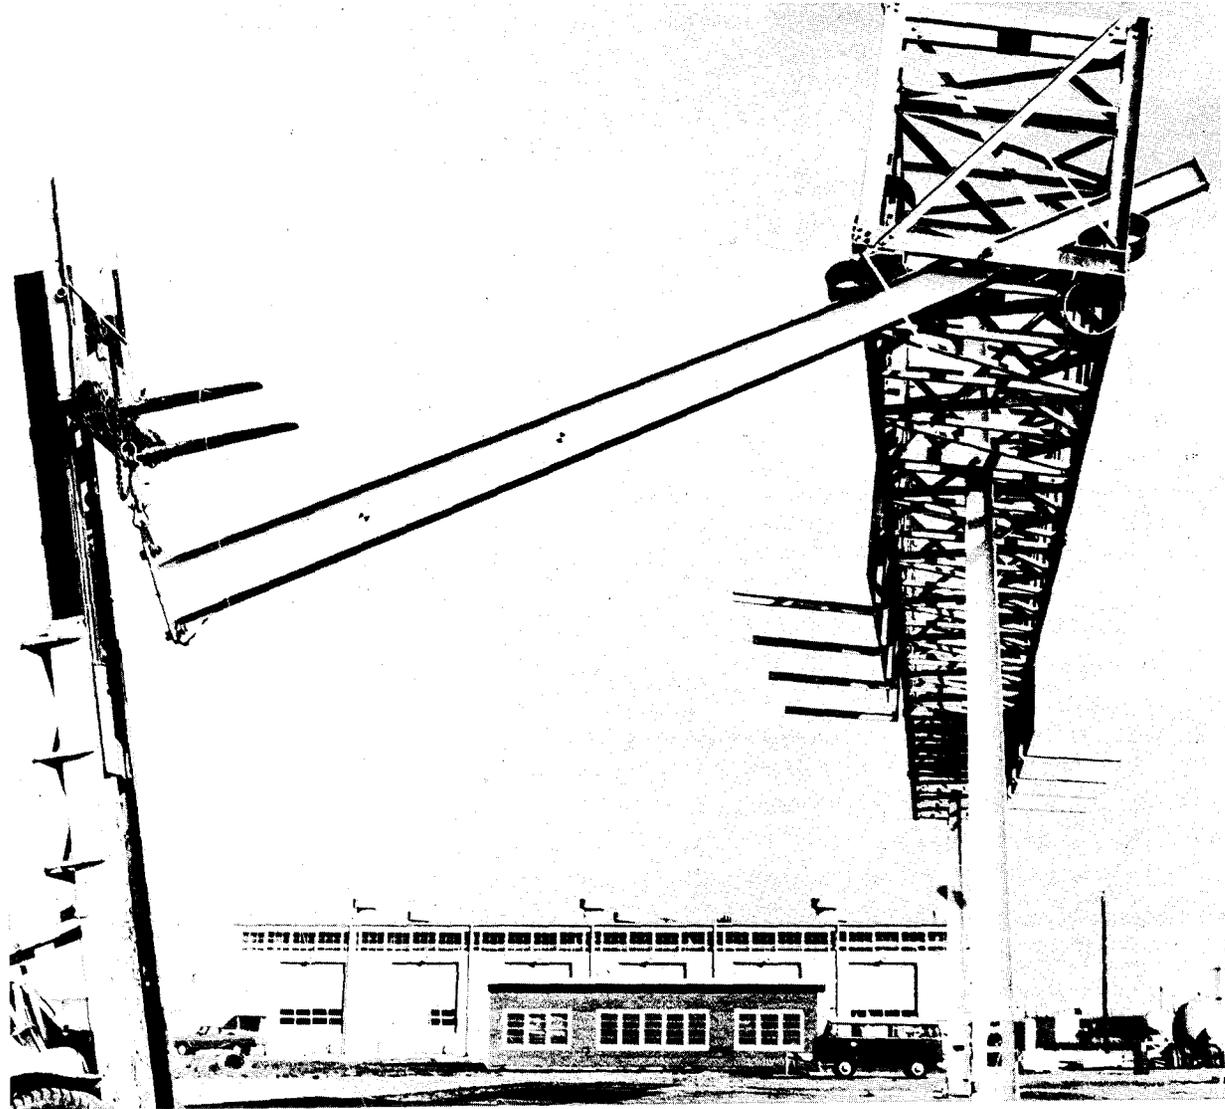
Figure 28 illustrates the OSB behavior at 190 kip-ft static moment and a rotation of 7.4°.

Figure 28, Dead Load Test of Prototype Structure.

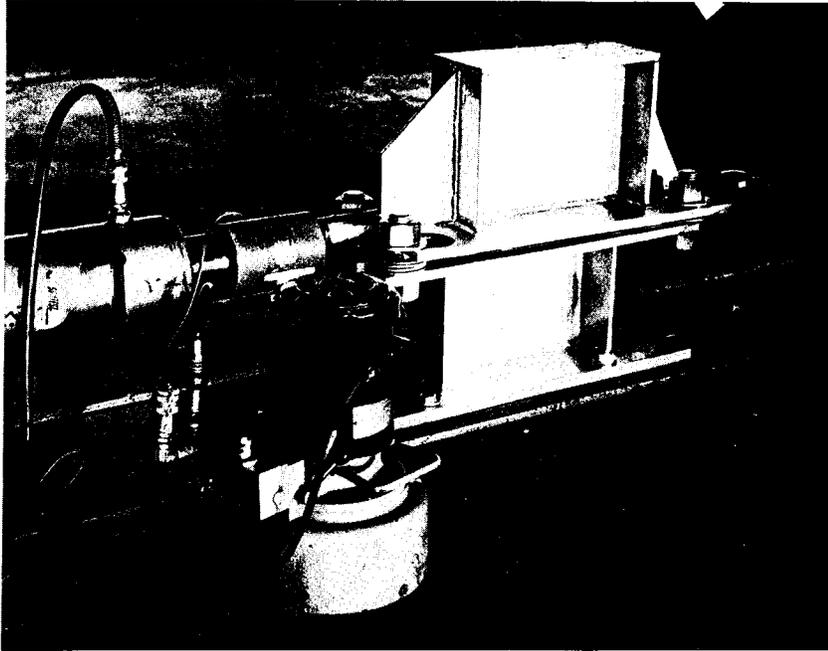
Figure 29, Test Apparatus.

(Note three washers between base plates.)

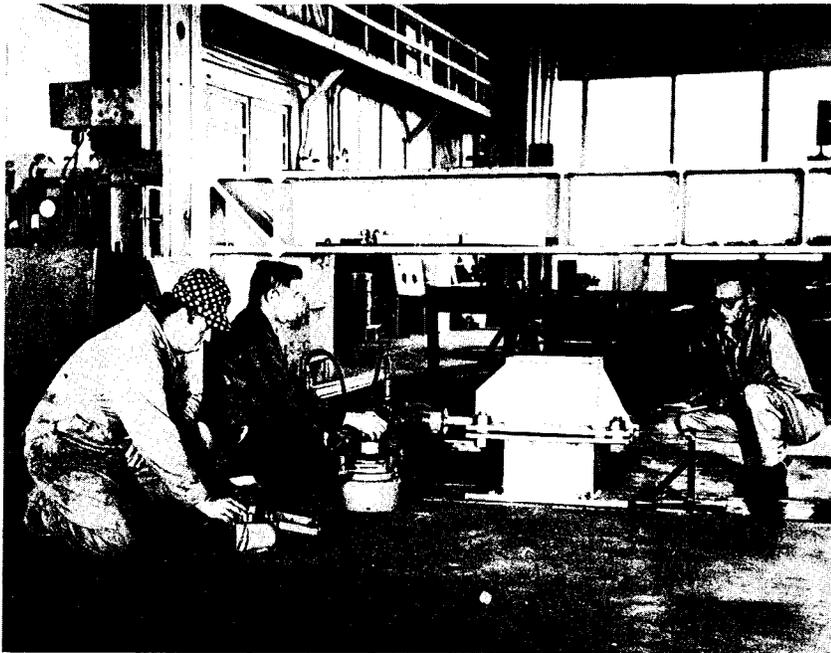
Figure 30, Test 605 LC-9 in Progress.

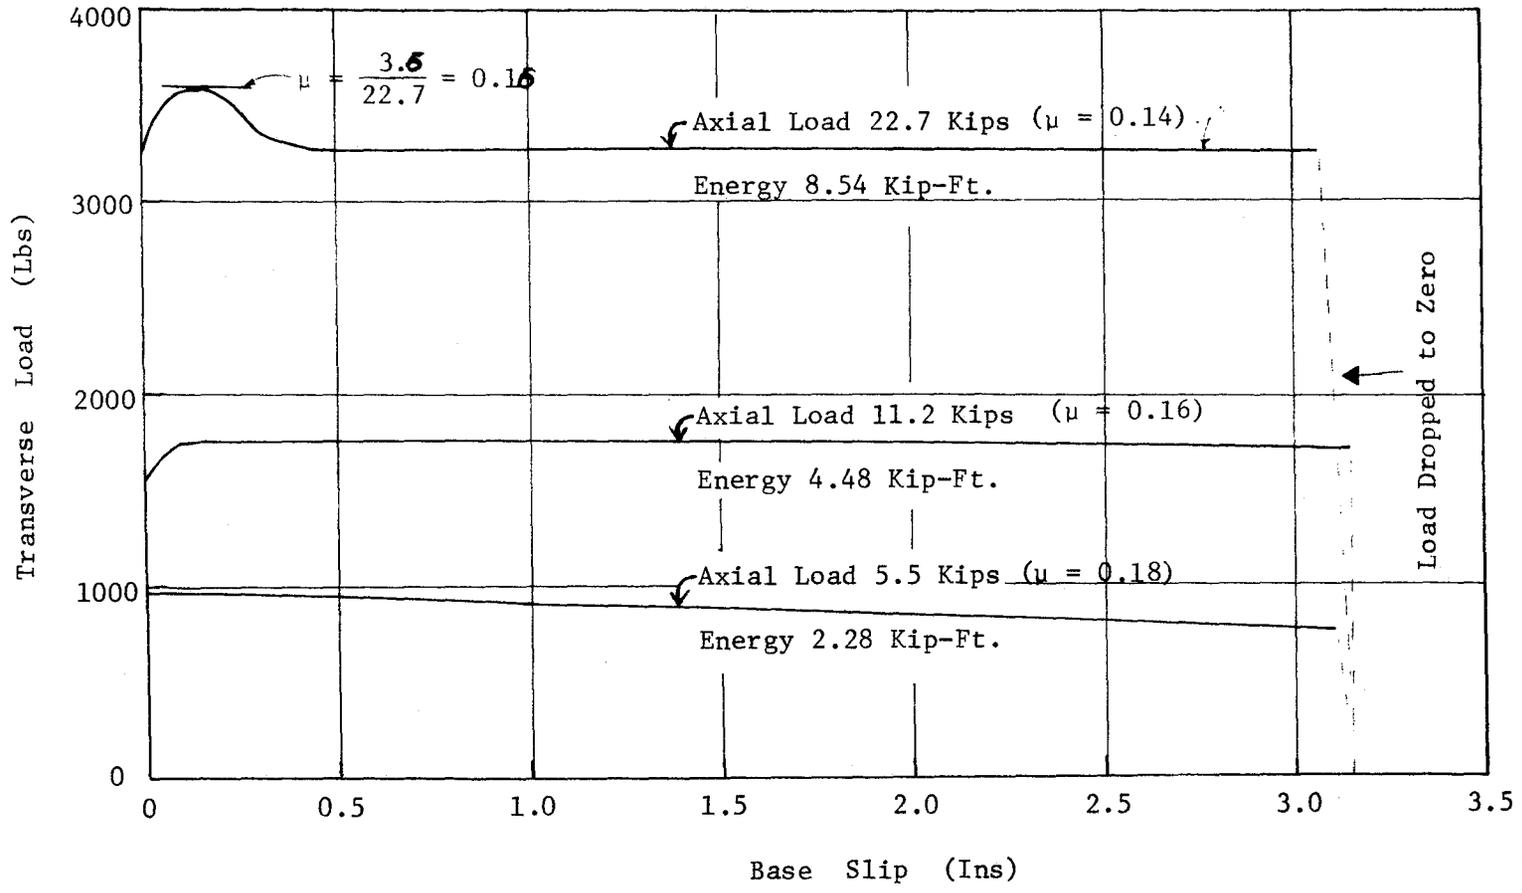
The effect of axial load on load-slip characteristics is shown in Figure 32. This series of tests was conducted without a bolt keeper plate, and the bolt torque was zero (bolts were in place and nuts were hand tightened). The ratio of the load required to cause initial slip to initial axial load provides an estimate of the effective coefficient of friction. In this series of tests, the effective coefficient of friction varied between 0.14 and 0.18.

Figure 32, Load-Slip Curves, Tests 605 LC - 1 through 3.

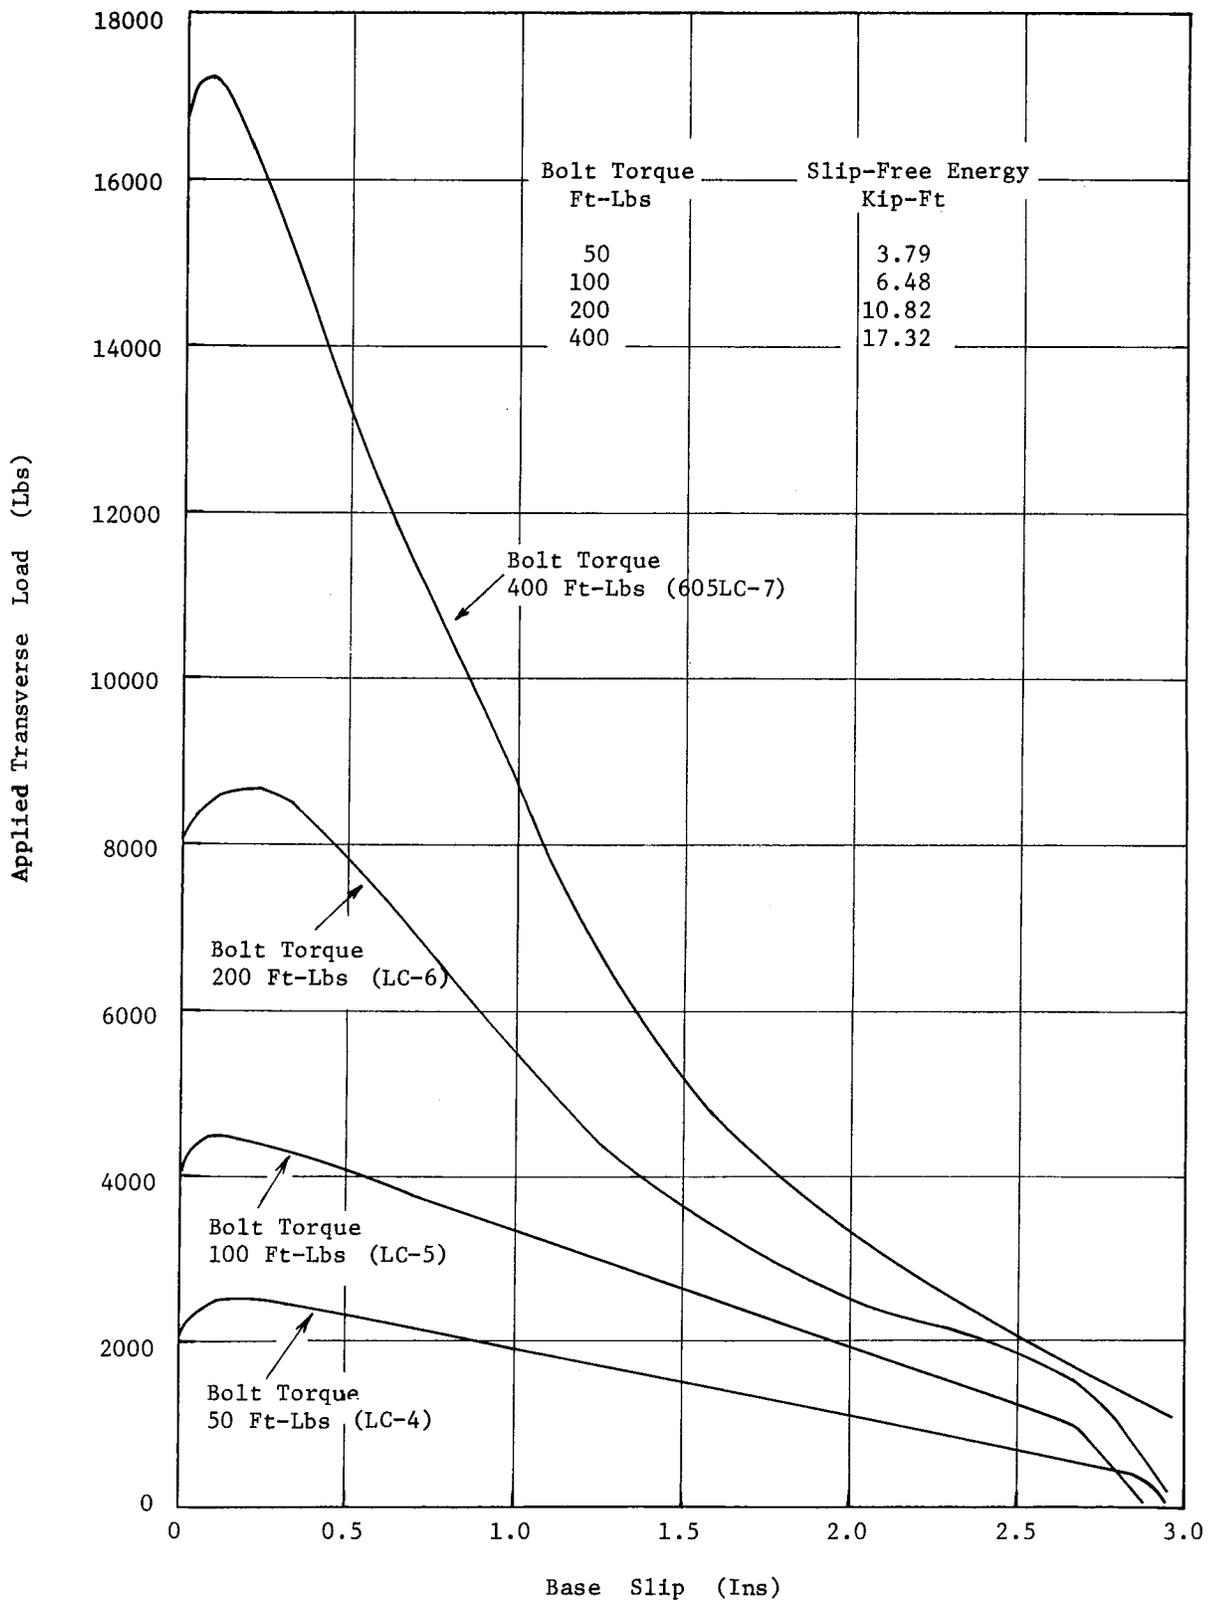
Figure 33, Load-Slip Curves, Tests 605 LC - 4 Through 7.

The effect of bolt torque on the transverse load required to produce slip of the break-away base was investigated, with the results shown in Figure 33. In this series of tests, the axial load was removed, as was the bolt keeper plate. The 1-3/4 inch diameter base bolts were tightened to the specified torque using a torque wrench. The base plates were separated by three washers on each bolt. This tightening procedure corresponded to that employed in tightening the base bolts on the prototype structure.

It is interesting to note that the value at which initial slip occurred is almost directly proportional to the bolt torque in the range tested. The 400 ft-lb torque curve has the largest deviation and is still within 5 percent of being directly proportional. The peak load occurs at a slip of 0.1 inch to 0.2 inches in each test, and the total slip at which the applied transverse load became zero is in each case approximately 3 inches.

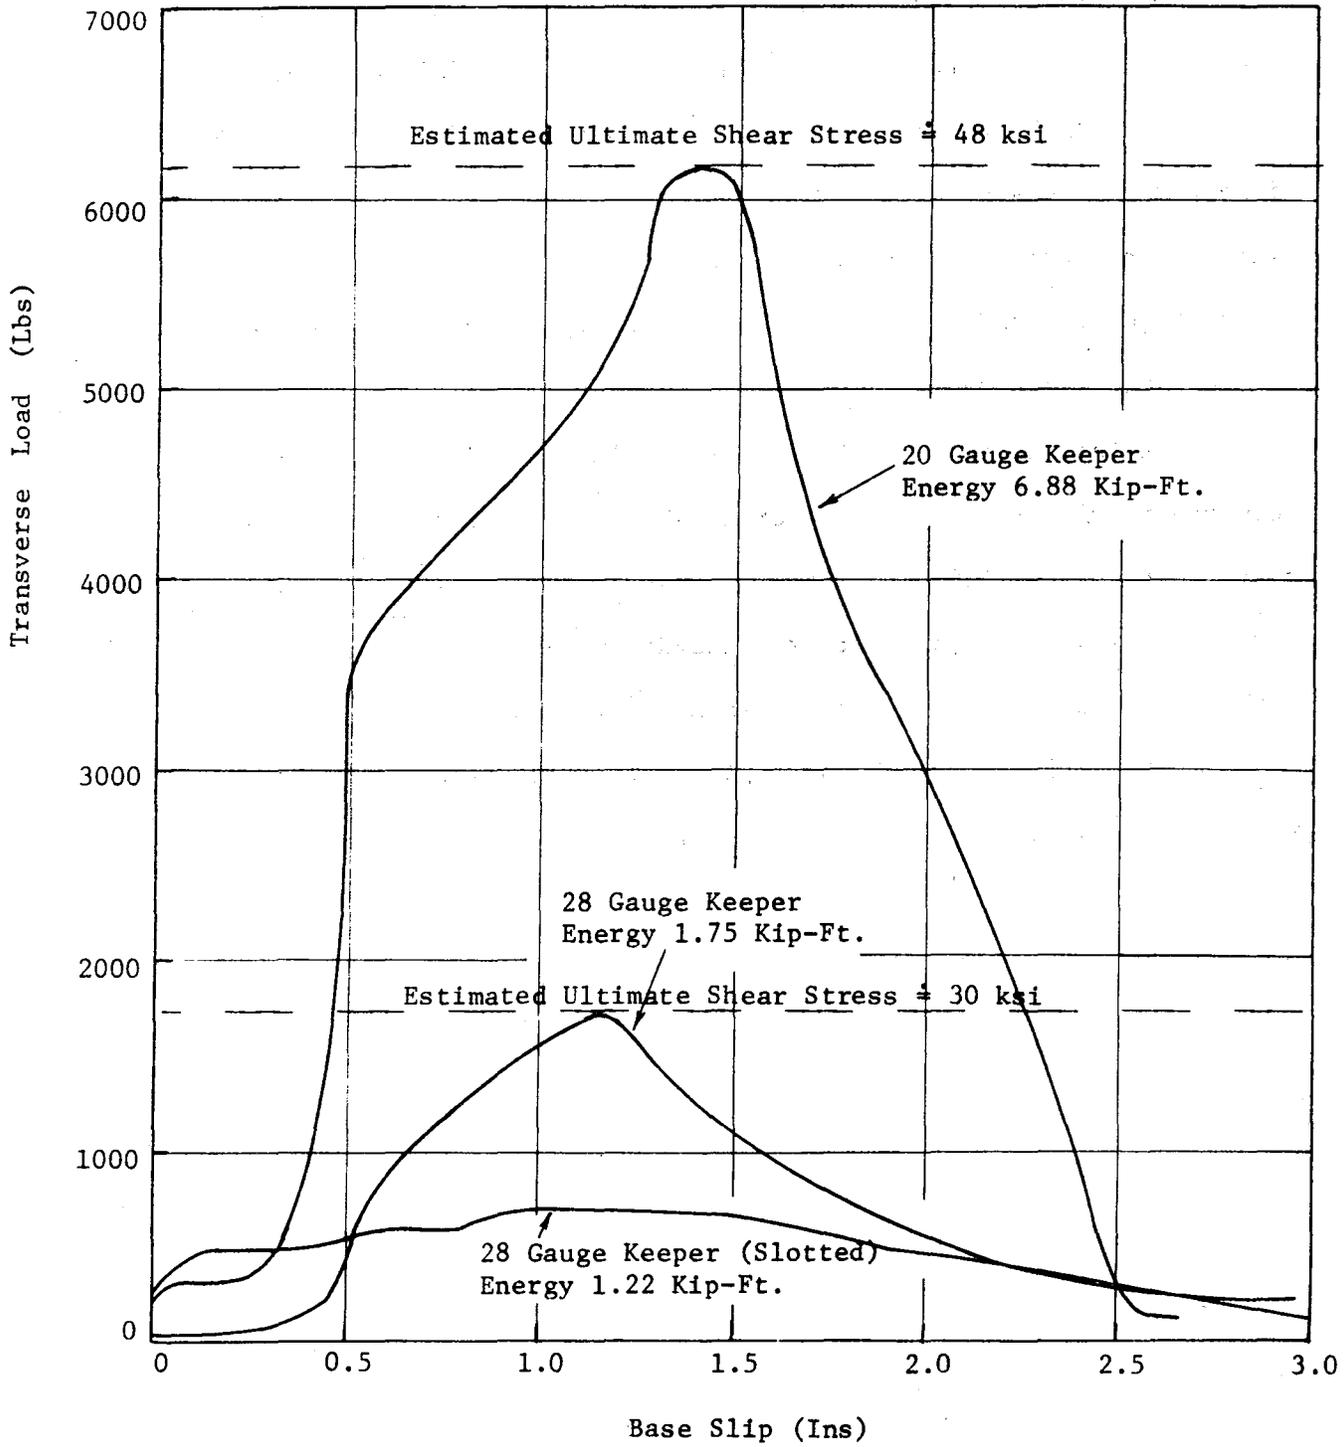
Figure 34, Load-Slip Curves, Tests 605 LC - 8 Through 10.

Finally, the strength of the keeper plate was investigated, with the results shown in Figure 34. In this series of tests, the bolts were hand tightened in place, and no axial load was applied. An estimate of the fracture strength of a keeper plate (assuming direct shear) is shown on the plot of Figure 34. These values, based on the greatly simplified failure mode, appear reasonable. They are based on a nominal 2-inch diameter hole (+ 1/8 inch tolerance). The effective width at tear out, as seen in Figure 39, was actually significantly greater. Also, it is apparent that the mode of failure of the sheet metal was not simple shearing, but was combined with bearing deformation of the metal keeper plate.

The slotted keeper plate was tested to determine the effect of weakening the shear strength of the bolt keeper plate. Such slotting is not believed necessary since the energy required to fracture the 28-gage keeper plate is quite low.

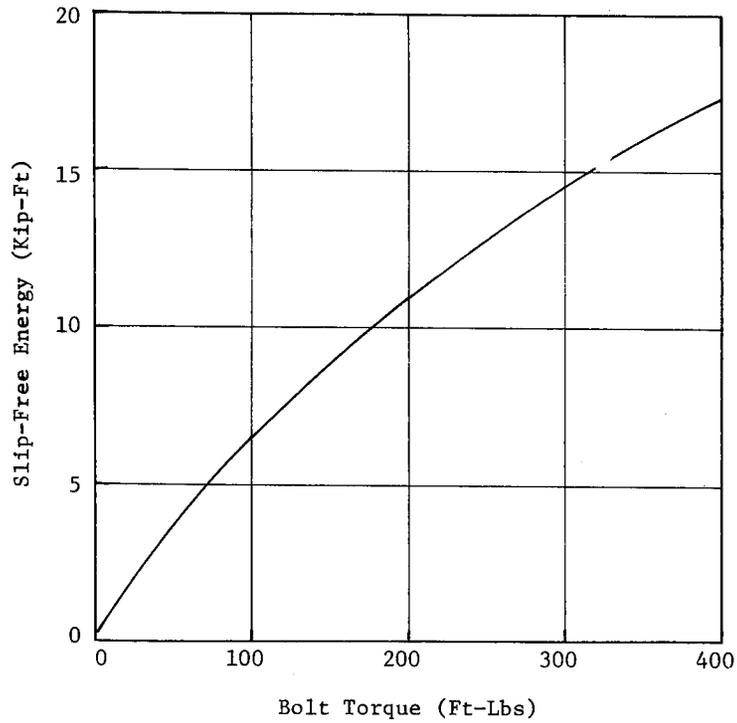
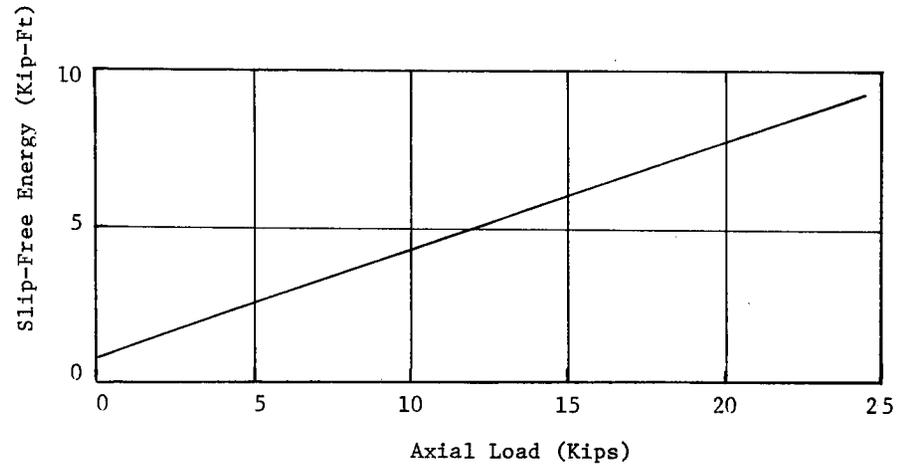
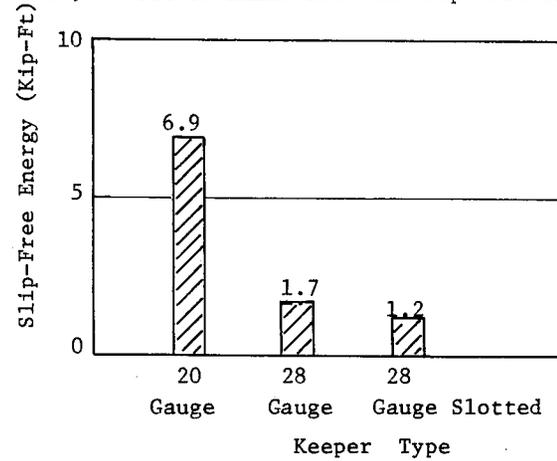
A more convenient form of the data obtained is given by Figures 35, 36, and 37 which show slip-free energy as a function of bolt-torque, axial load, and keeper configuration respectively. The energy necessary to activate a given lower connection under any combination of the three variables should then be found by a simple summation of the individual effects. The energy levels determined by this series of static tests are probably not quantitatively equal to the energy levels that would be found by dynamic tests. It is believed, however, that the relative importance and influence of each parameter are indicated by the static tests.

Figure 35, Effect of Bolt Torque on Slip-Free Energy.

Figure 36, Effect of Axial Load on Slip-Free Energy.

Figure 37, Effect of Keeper Type on Slip-Free Energy.

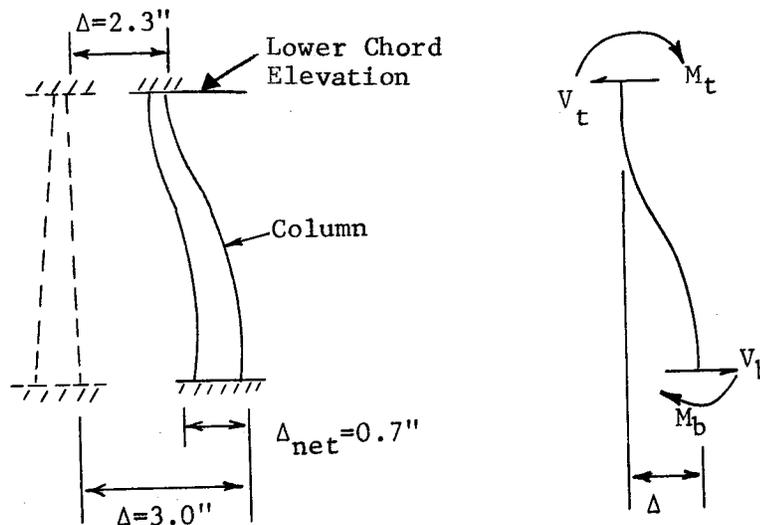
It should be recalled that the support column is connected to the lower chord by a 1-7/16 inch diameter stainless steel pin, which can transmit a horizontal shear force to the truss through the pinned connection, and that a bending moment in the column also exists at this location. Data from Test 605-S1 indicated that the truss, at the column under load, translated in the direction of load without significant rotation up to the point when the base slipped free. At the point when the base slip was 3 inches, the truss had translated 2.3 inches. This suggests that the portion of resistance to base slip due to the rigidity of the truss can be calculated using the following simplified model:

Analysis of this model by slope-deflection technique results in a transverse force at the base, V_b , of 8,000 pounds for a base slip of 3 inches. This force is assumed to vary linearly from zero to zero

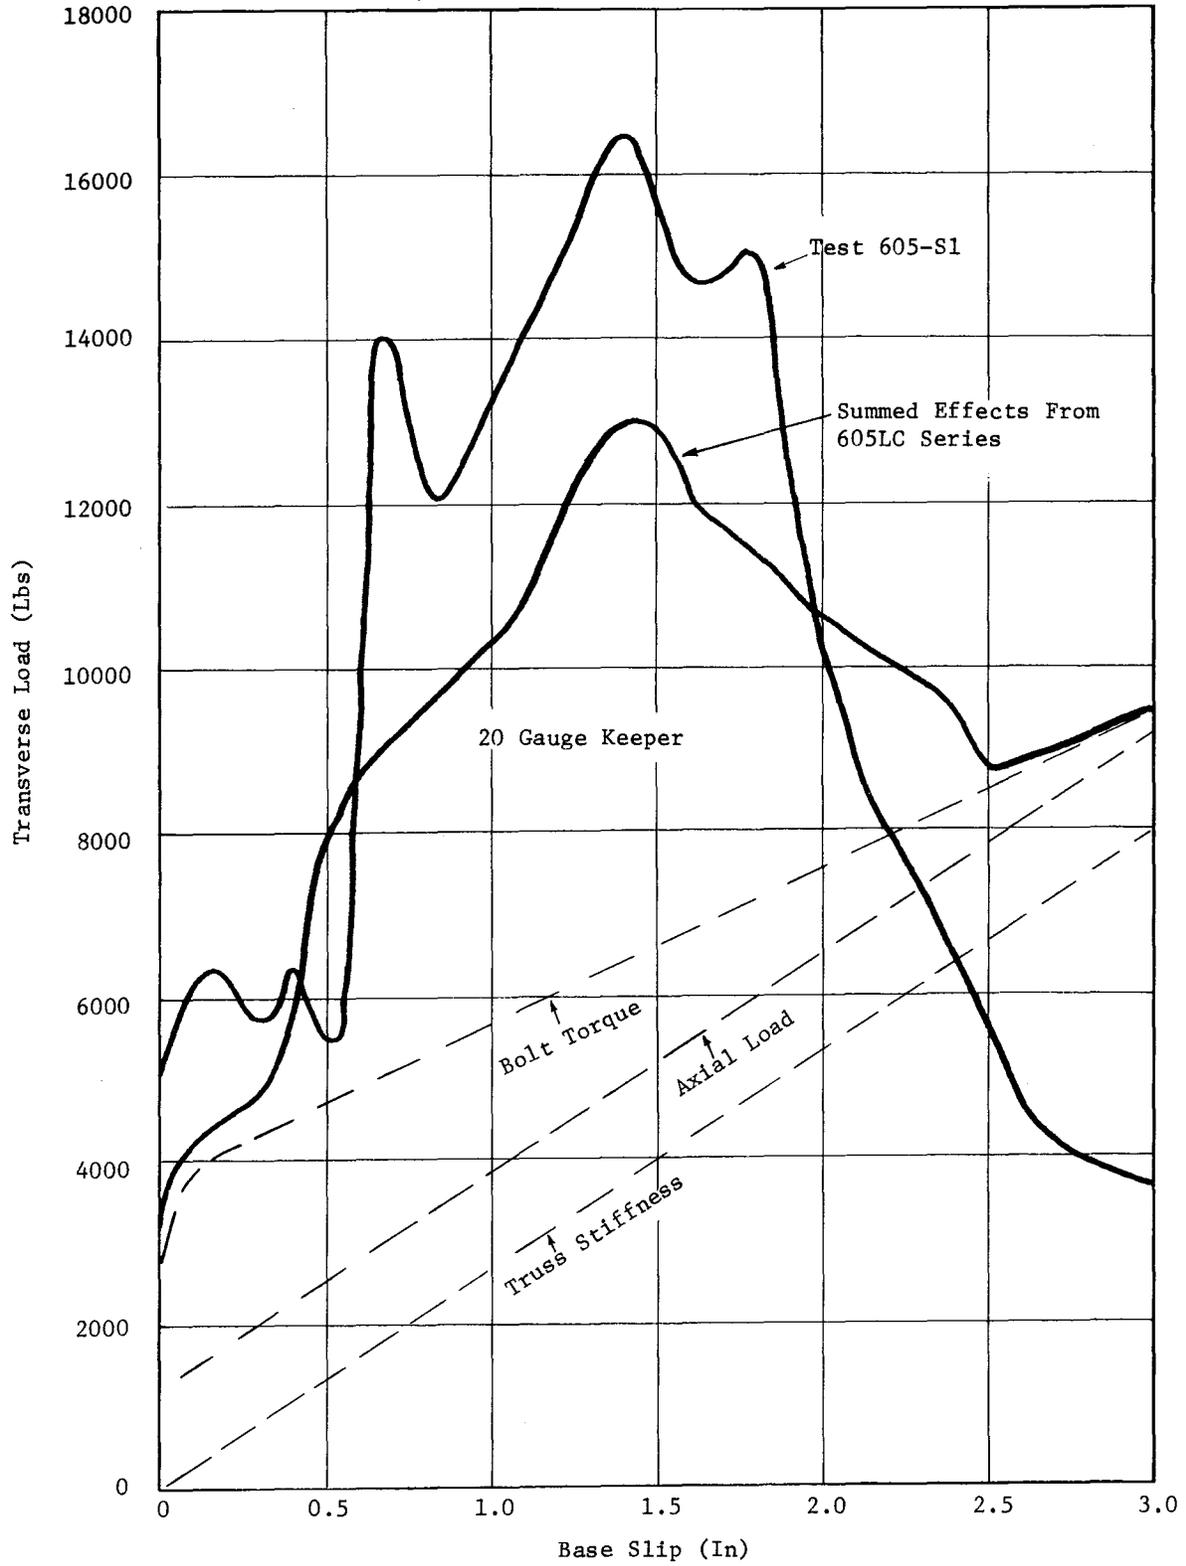
A comparison of force variation as a function of lower connection slip between static load test 605-S1 and the force versus slip variation determined by the "summation-of-effects" from the LC test series is given in Figure 38. The peak transverse force predicted by the "sum-of-effects" method is approximately 20 percent lower than the maximum force observed in the S1 test. The two methods compare very well in predicting the amount of energy necessary to slip the lower end of the support free. The energy determined from the load-slip curves from Test 605-S1 was 2.54 kip-ft and the energy given by the "sum-of-effects" method was 2.36 kip-ft. The largest discrepancy between the two curves is in the region between 2.5 and 3 inches of base slip. One reason for this may be the slight difference in the way the upper plate moves with respect to the lower plate in Test S1 and in the LC test series. In the S1 test, the upper plate was moving in an arc of very slight curvature and the load was applied approximately 22 inches above the ground, while in the LC test series, the upper plate moved in a straight path and the load was applied directly to the upper plate. Another possible discrepancy is due to the fact that the axial load for the S1 test was assumed to be 8 kips. This assumption could be considerably in error.

Figure 38, Comparison of Load-Slip Curves for Tests 605-S1 and 605 LC Series.

In view of these possible variances between the full-scale static load tests on the OSB and the LC test series, the comparison shown in Figure 38 is remarkable. The information obtained from these static tests indicated that the base resistances employed as input to mathematical simulation were reasonable. Thus, the investigators were

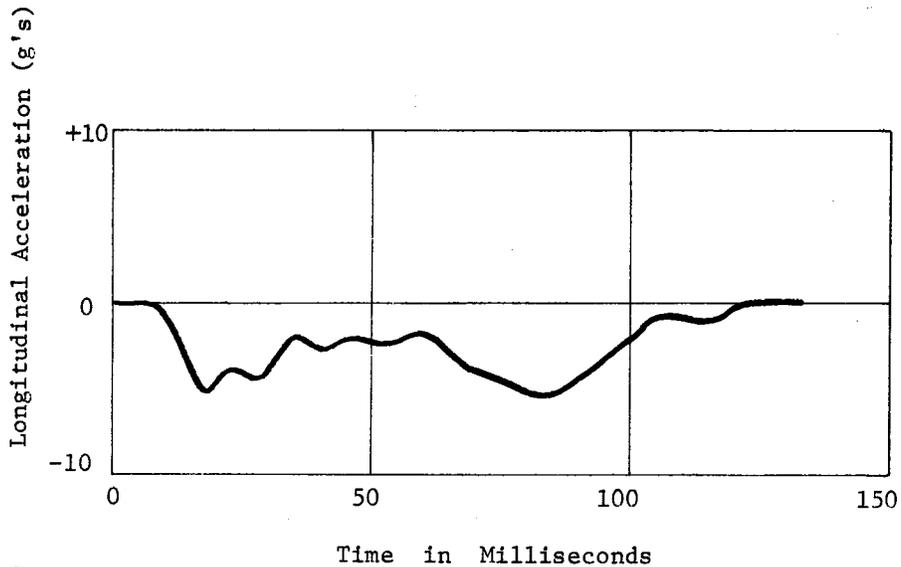
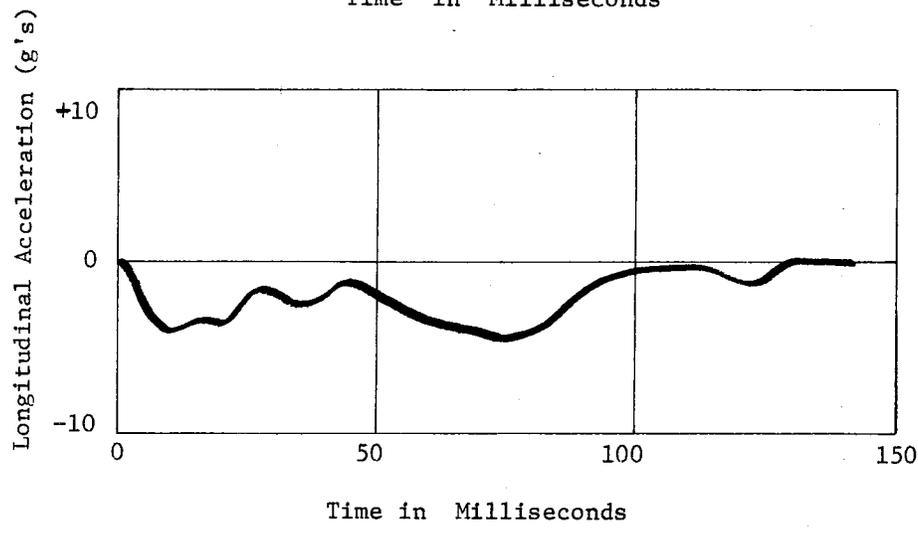
TEST 605-Y

Figure A1, Longitudinal Accelerometer Data

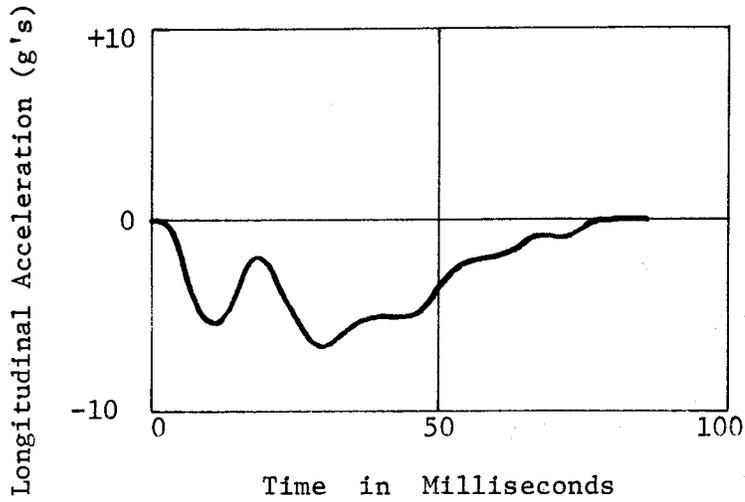
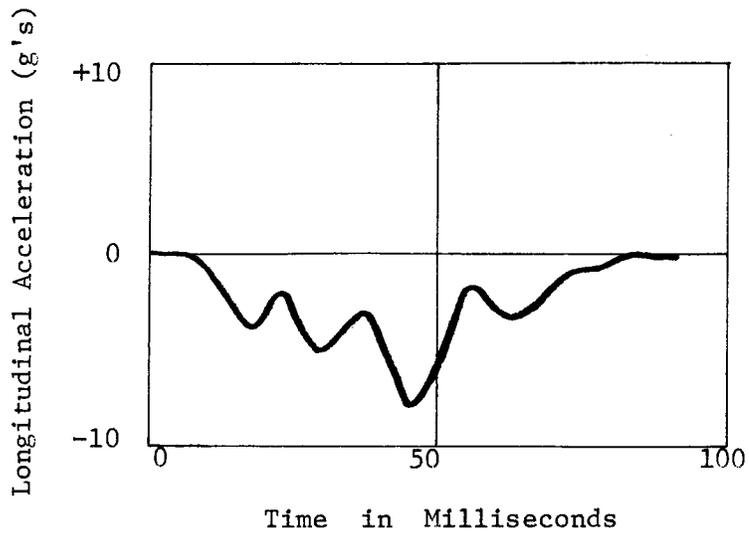
TEST 605-A

Figure A2, Longitudinal Accelerometer Data

Statham 11081 (left)
80 HZ Filter
Average = 10.1 g's
Peak = 23.4 g's
 $\Delta t = 67.6$ msec

Statham 12186 (right)
80 HZ Filter
Average = 9.2 g's
Peak = 21.5 g's
 $\Delta t = 68.1$ msec

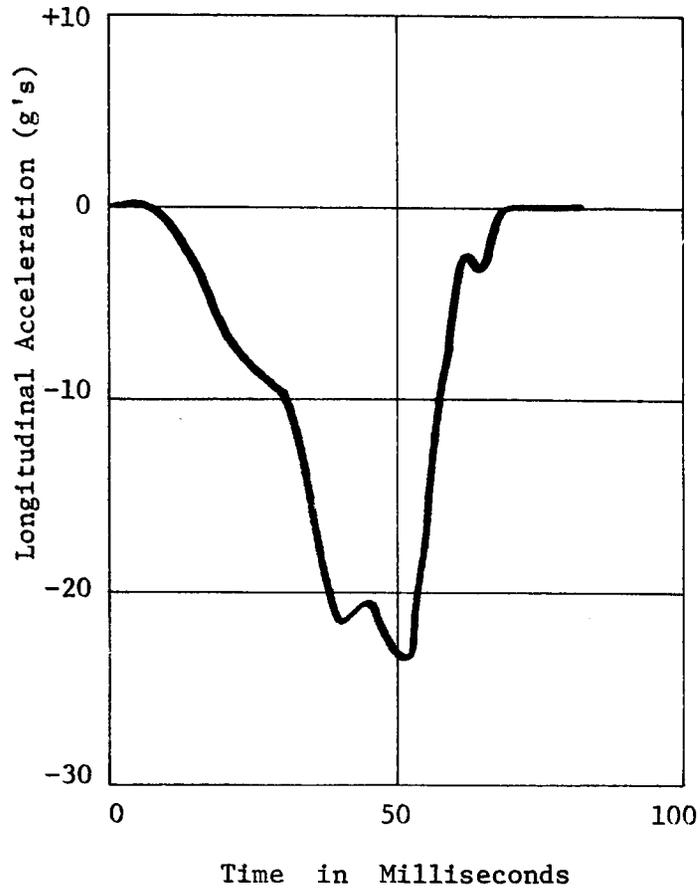
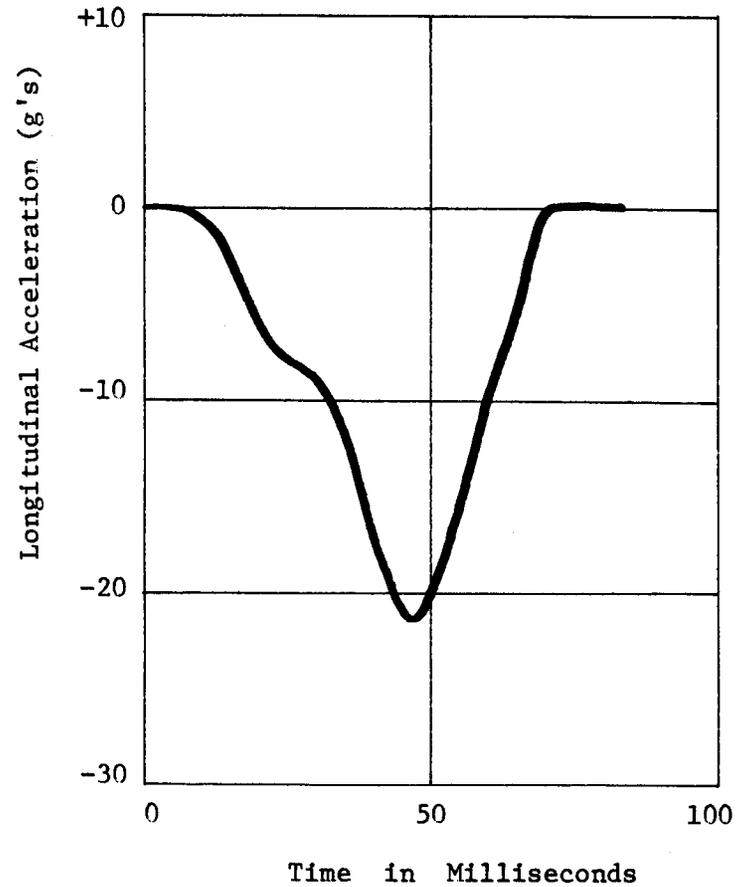
Figure A3, Longitudinal Accelerometer Data

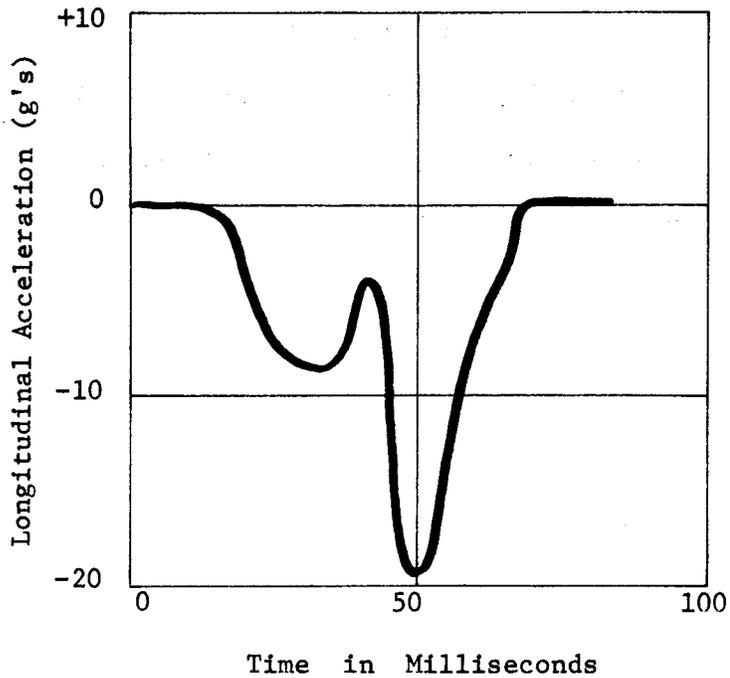
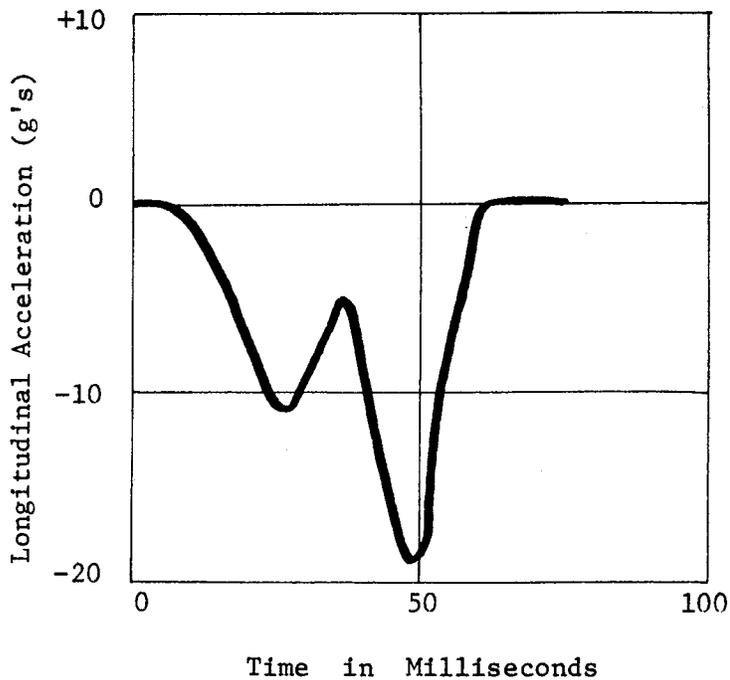
TEST 605-C

Figure A4, Longitudinal Accelerometer Data

Preliminary observations indicate that there may be a correlation between some events observed in the high-speed films (such as pole-base and top breakaway) and the peaks on the accelerometer traces. A further investigation is being conducted.

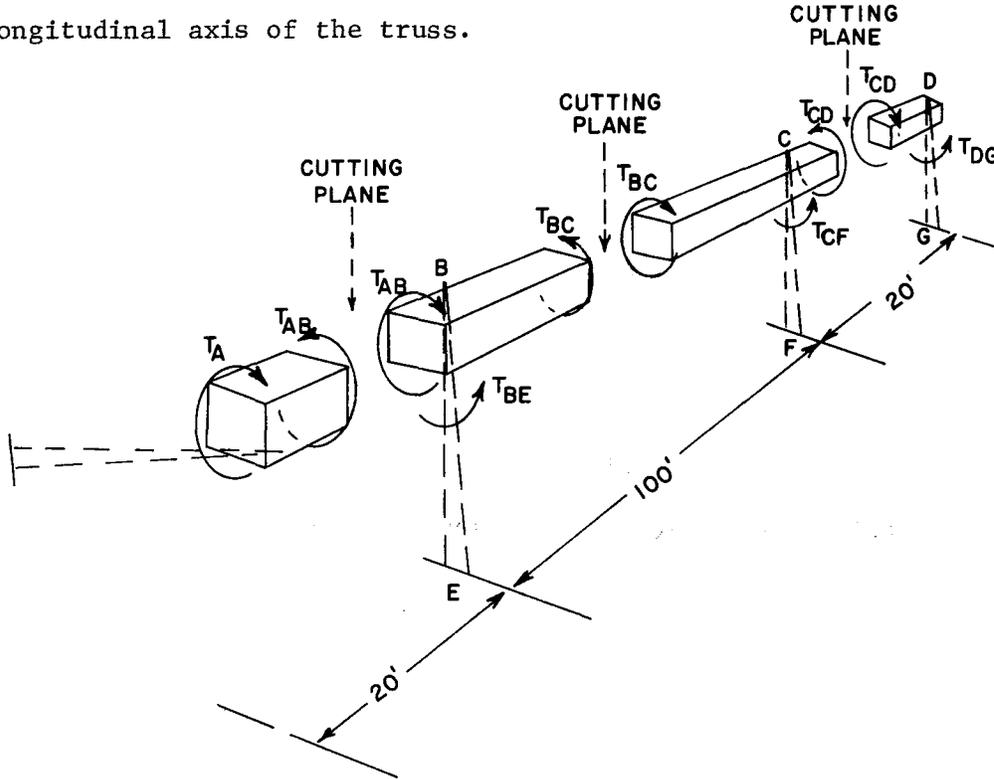
The overhead sign bridge can be simulated as shown in Figure B1. The assumption is made that the support at point A has been broken free at the base and is applying a torque (T_A) at point A. All torques shown in Figure B1 are in planes perpendicular to the longitudinal axis of the truss.

Figure B1, Torsional Loads on OSB Truss.

T_A is the externally applied torque at point A. T_{AB} , T_{BC} and T_{CD} are the torques within the truss between points AB, BC and CD, respectively. T_{BE} , T_{CF} and T_{DG} are the resisting torques applied by the OSB supports at points B, C and D, respectively. By taking a summation of torques about the axis of the truss for the free bodies indicated in Figure B1, the following equations may be written.

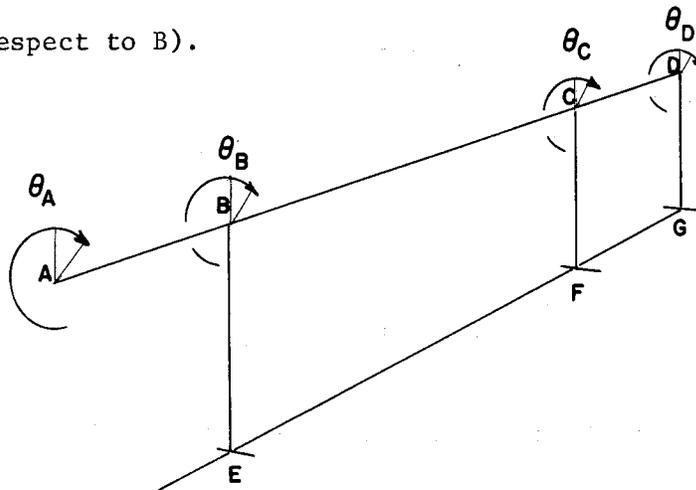
Using a line diagram representation of the OSB in Figure B2, the rotations (θ 's) of various planes in the truss may be defined. A rotation, with a single subscript (e.g. θ_A) defines the total rotation of the truss at point A with respect to its position under no load. A rotation with a double subscript (e.g. θ_{AB}) defines the rotation of the truss at point A with respect to the position of the truss at point B (i.e., relative rotation of A with respect to B).

Figure B2, Torsional Displacements of OSB Truss.

Using the displacement diagram shown in Figure B2, the following compatibility equations can be written.

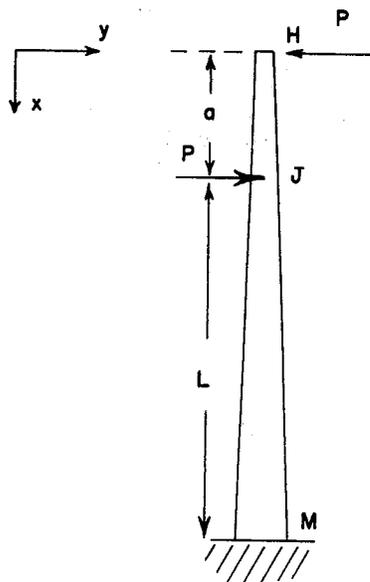
Moment of Inertia, I_x , Variable
