TECHNICAL MEMORANDUM 605-4

TESTING PROGRAM

SAFETY PROVISIONS FOR SUPPORT STRUCTURES

ON OVERHEAD SIGN BRIDGES

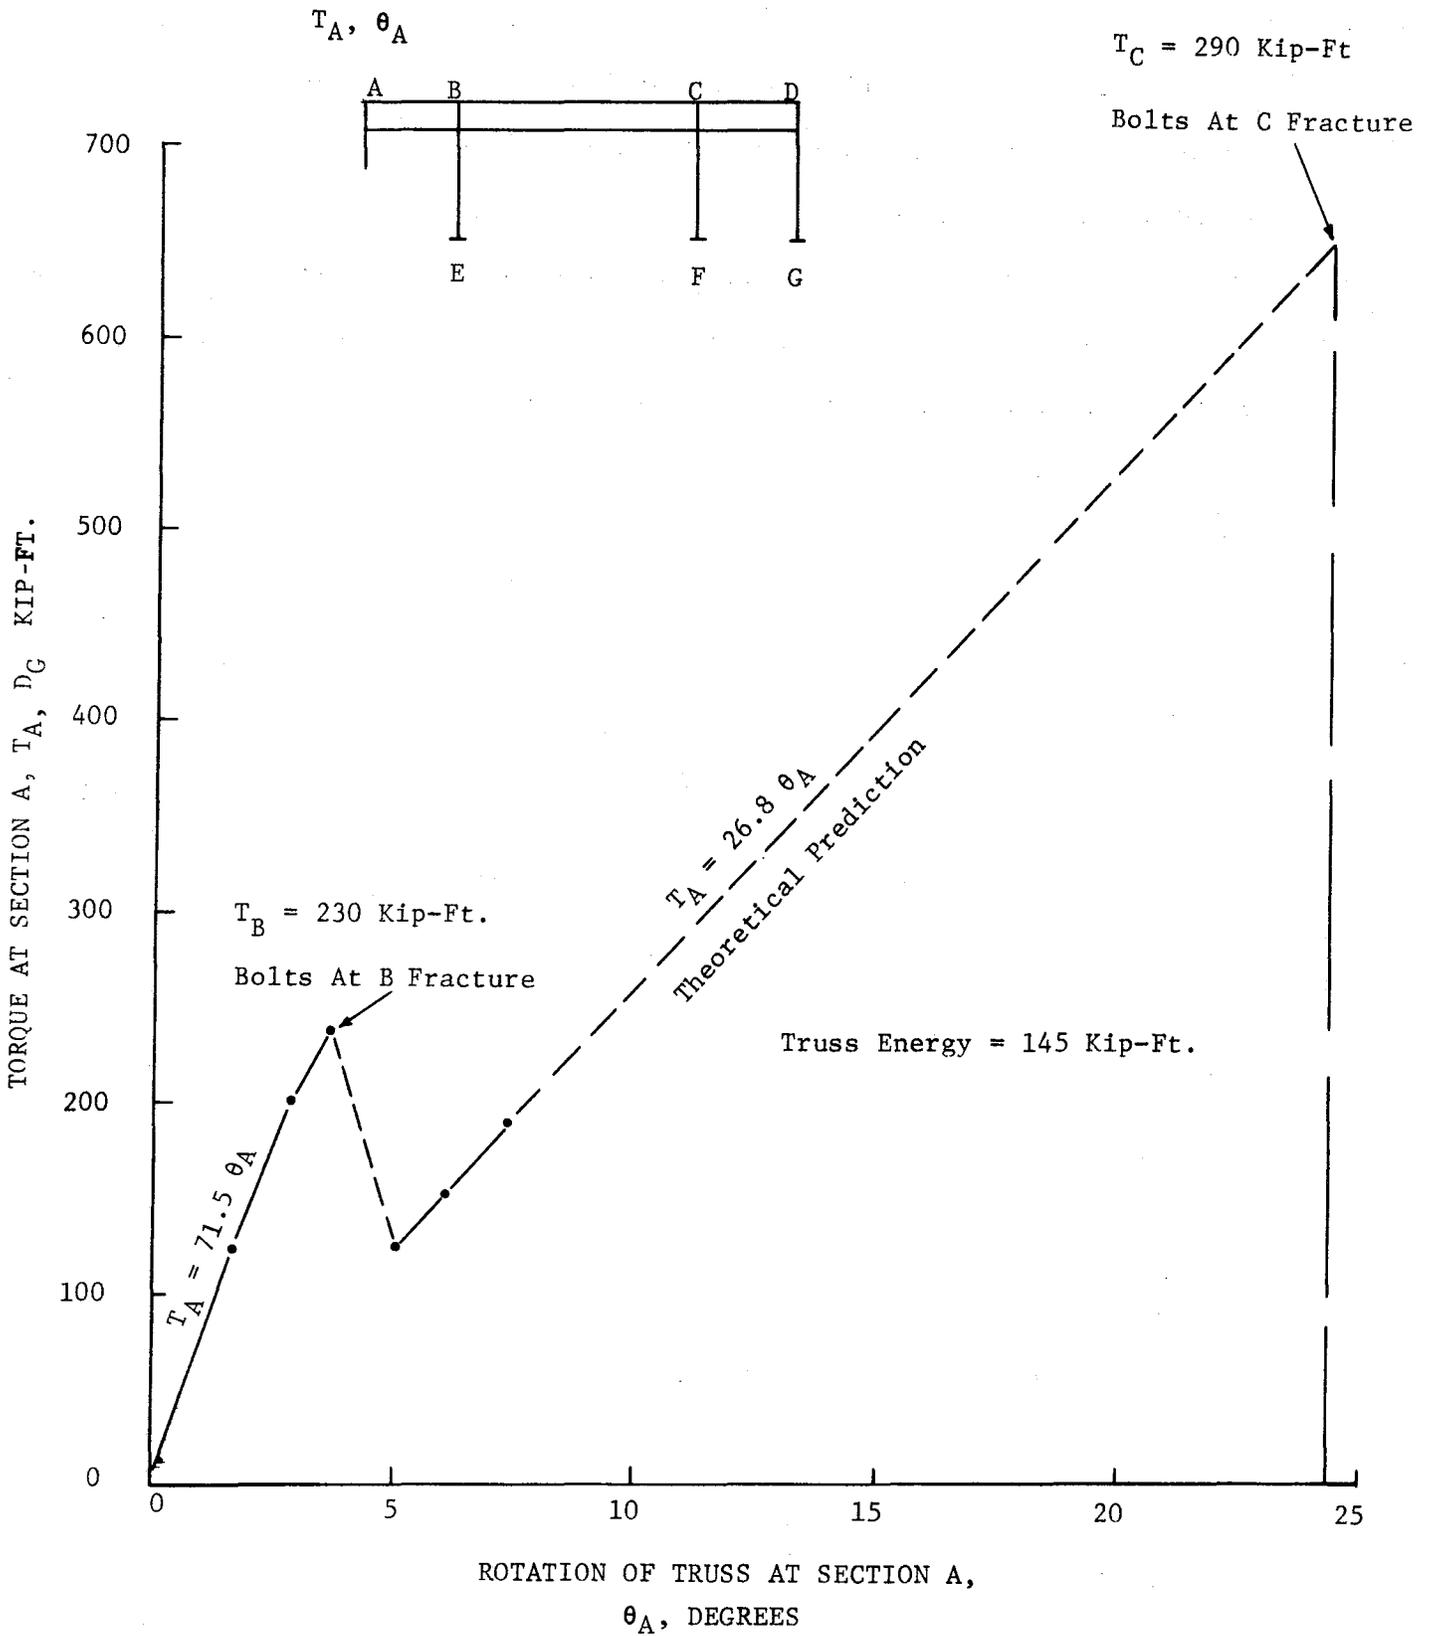
With these corresponding values of T_A and θ_A , the torque-rotation relationship of the OSB can be plotted up to failure of the upper connection bolts at Support C. This is done in Figure B4. The area under this curve, with the abscissa expressed in radians is the amount of energy the truss can absorb. This was found to be

Figure B4, Torque-Rotation Relationship.

145 kip-ft (up to connection failure at Support C). This analysis precludes any inelastic action within the truss and is tenuously based on the extrapolation of a very limited amount of data beyond the point of Support B upper connection failure. It is felt to be indicative that the OSB will probably be able to accommodate the 80 kip-ft of energy imparted by Support A during a 5000-pound -- 60 mph collision.
