TECHNICAL MEMORANDUM 605-6

SUPPLEMENTARY STUDIES

SAFETY PROVISIONS FOR SUPPORT STRUCTURES
ON OVERHEAD SIGN BRIDGES

MARCH 1971

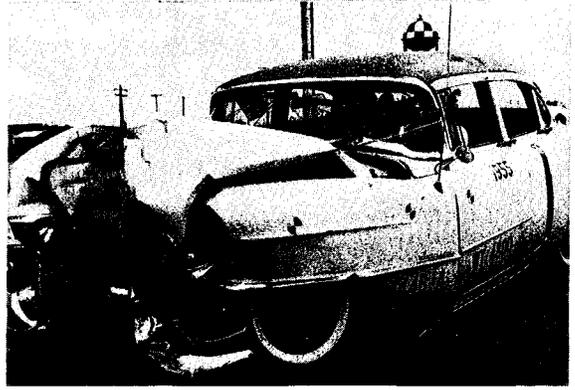
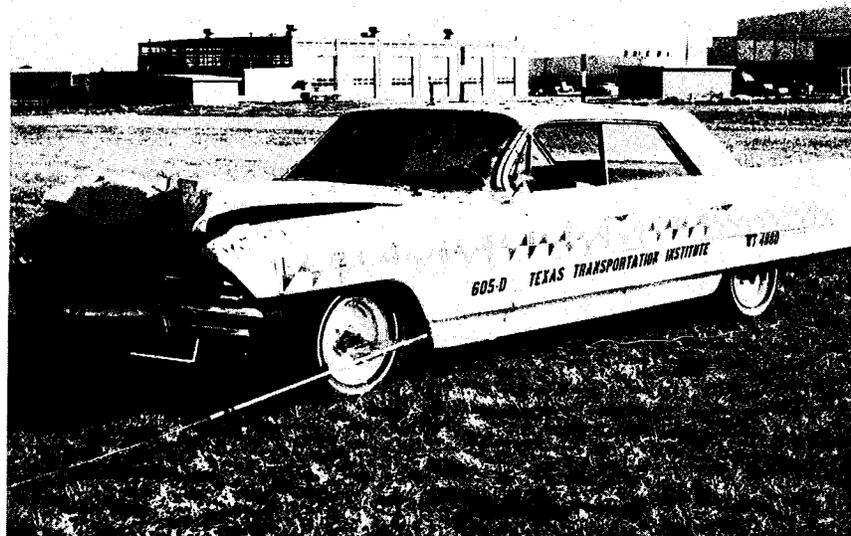
FIGURE 2. COMPARISON OF VEHICLE DAMAGE

a) 1954 Cadillac, weighing 4,800 lbs., after collision with fixed post at 44.1 mph (10)

b) View showing damage to 1954 Cadillac, maximum post penetration was 4.50 feet (10)

c) 1962 Cadillac weighing 4,880 lbs., following 54.0 mph collision with prototype breakaway support, maximum post penetration was 1.50 feet, vehicle was driven to garage (8)

Initial findings indicated the feasibility of the application of the breakaway concept to supports for overhead sign bridges (8). Further, they showed that for a given vehicle weight and impact speed, deceleration forces and vehicular damage increase as base plate and upper plate connection strengths increase. And moreover, vehicle damage resulting from a collision with a breakaway overhead sign bridge support is minor when compared with a similar fixed barrier collision (see Figure 2).

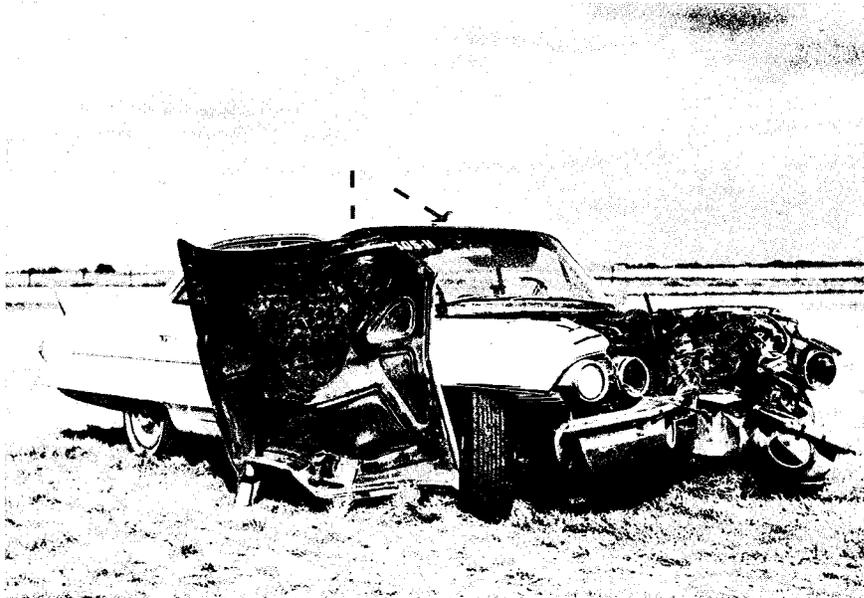
FIGURE 11. Crash vehicle after Test H

Damage to the vehicle is shown in Figure 11. The automobile was slowed 11.5 mph by the force of the collision. The average and peak decelerations are shown in Table 10. The high-speed film data from Test H is given in Table 12.

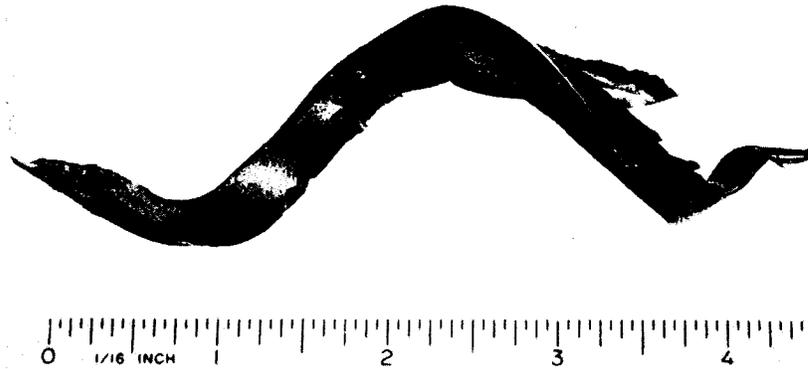
FIGURE 15. Splinter from Guide Angle

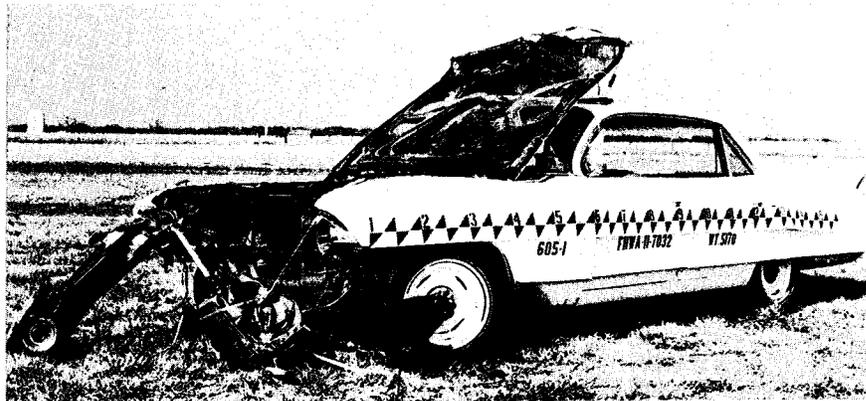
FIGURE 16. Damaged Vehicle, Test I

Vehicle damage is shown in Figure 16 in which it can be seen that the major damage was to the bumper and grill of the car.
