1. Report No. FHWA/TX-12/9-1001-2		2. Government Accession No.		3. Recipient's Catalog No.	
4. Title and Subtitle EVALUATION OF TRAFFIC CONTROL DEVICES, YEAR 3				5. Report Date Published: March 2012

EVALUATION OF TRAFFIC CONTROL DEVICES, YEAR 3

Report 9-1001-2

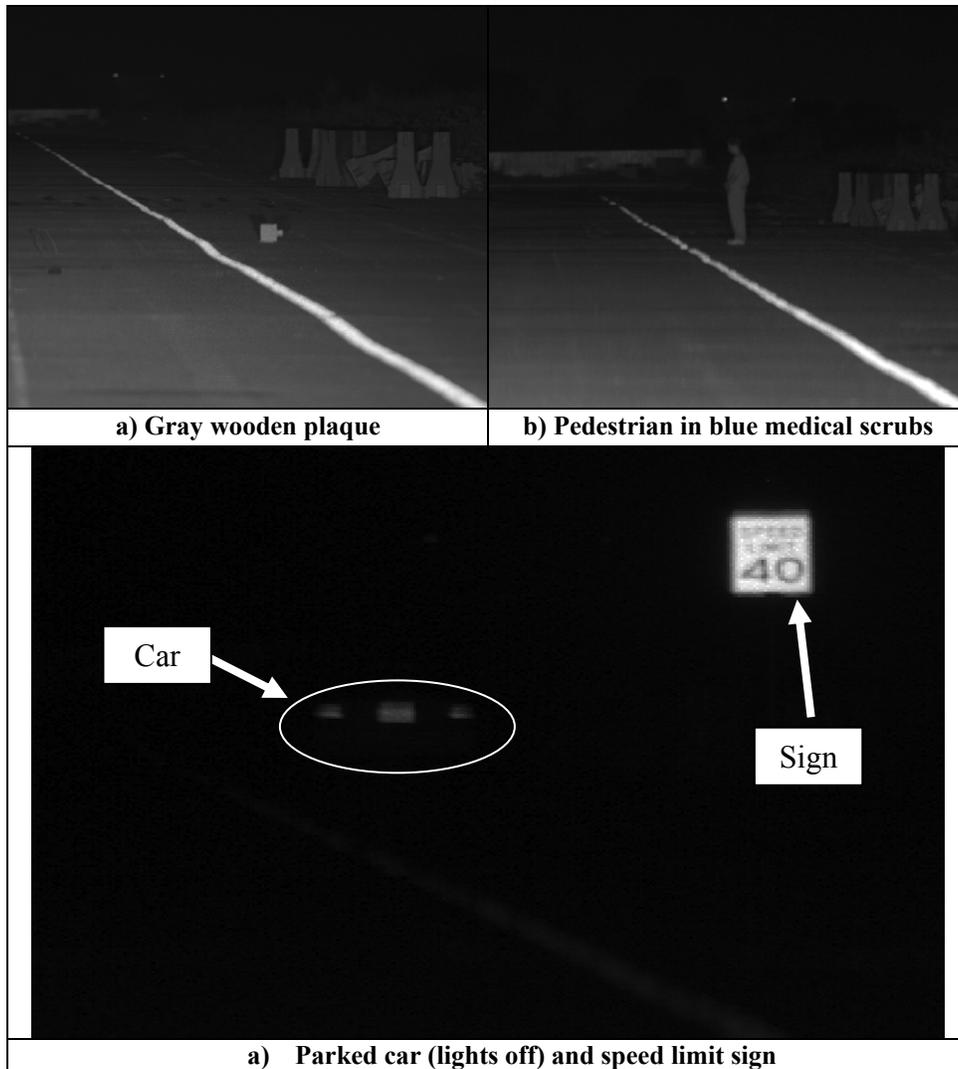
Figure 1. Nighttime Images from Dynamic Luminance Camera.

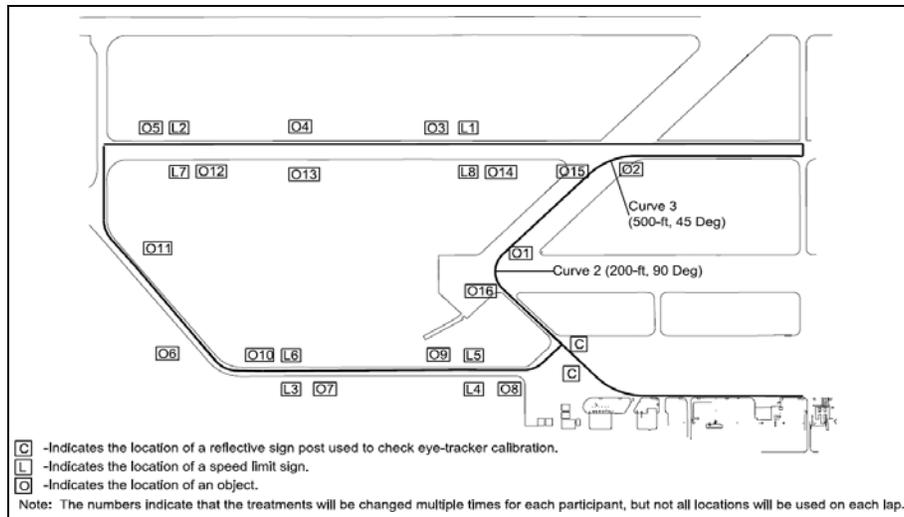
Figure 2. TTI Study Course Layout.

Study objects placed in conjunction with a sign were always located 200 ft downstream of the sign. This distance was fixed for the entire study. We determined that each participant needed to complete at least five laps to allow for randomization of the treatments, including null cases where neither signs nor objects were located at one or more of the locations specified in [Figure 2](#). Data were collected in both directions along the course to further reduce the likelihood of heuristic responses; however, direction was not considered a factor in this study. Based on previous studies, researchers made the assumption that direction along the tangent segments of the study course would not impact the results.

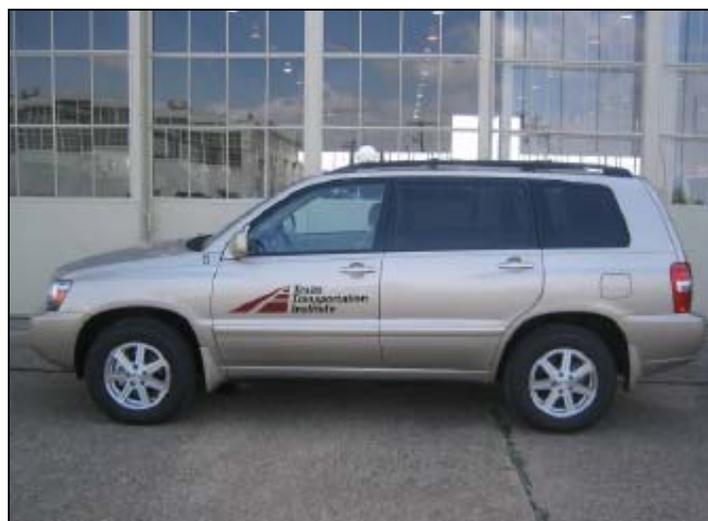
Figure 3. TTI Instrumented Vehicle.

Researchers installed several pieces of state-of-the-art equipment in the TTI Highlander instrumented vehicle (see [Figure 3](#)). The heart of the equipment was a data acquisition system (DAS) consisting of a small-profile computer using an Intel Core 2 Quad Q9500 2.83 GHz processor with 4 GB of DDR2 RAM and two 1 TB internal hard drives. While there was ample internal memory storage, the DAS transferred the data directly to a 1 TB external hard drive using an eSATA connection. The external hard drive enhanced the portability of the data, which amounted to approximately 100 GB for each participant.

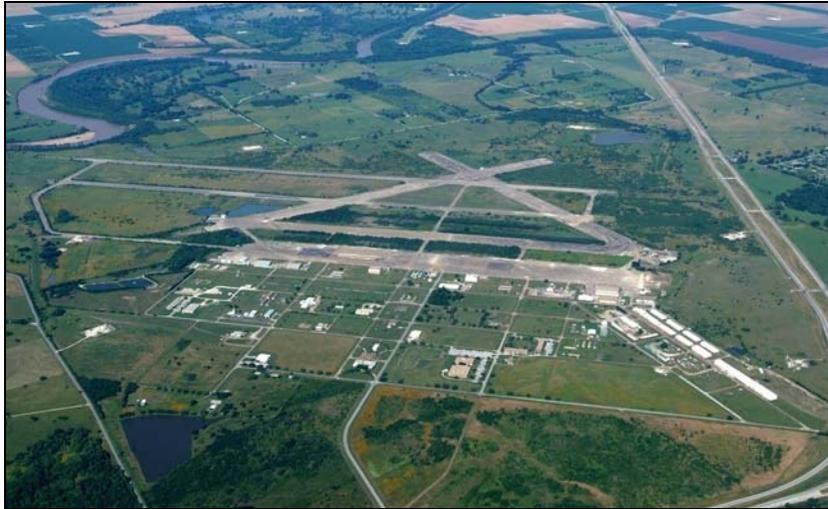
Figure 4. Riverside Campus Test Facility.

Participants drove through a closed-course route at the Texas A&M University Riverside Campus (see Figure 4) at night. The participants were met at the entrance to the Riverside

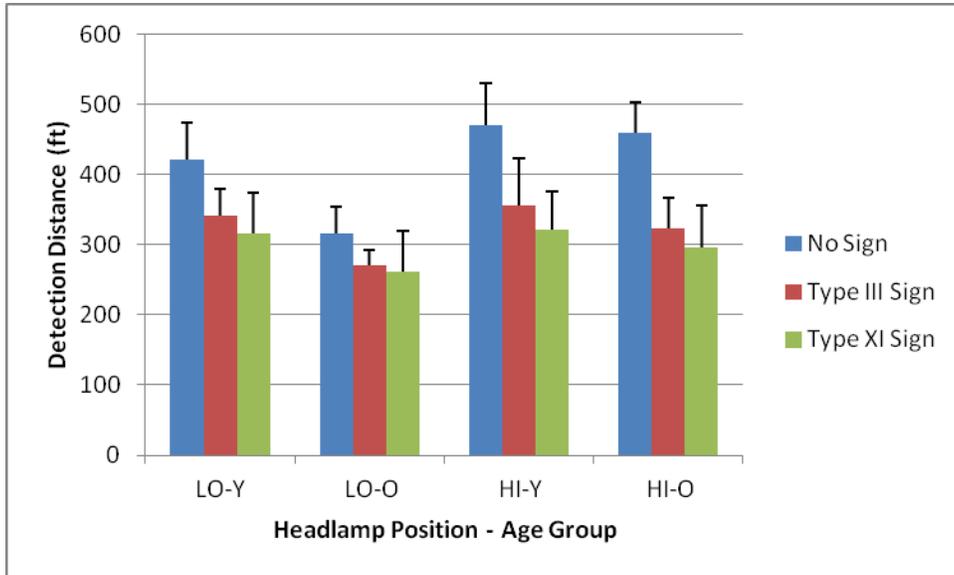
The average detection distances for the detection targets are shown in [Figure 5](#) through [Figure 7](#). The x-axis includes four sets of data. LO represents the vehicle low-beam headlamp pattern, while HI represents the vehicle high-beam headlamp pattern. Y represents the young participant age group, and O represents the older participant age group. The T-bars represent one standard deviation.

Figure 5. Detection Distances for Small Square Target.

For the small square target, the main effects of age group, lighting level, and sign condition are all significant, but no interaction term is significant (factors marked with * are significant with a p-value < 0.05). With respect to the objective of this study, the sign condition factor is fundamental. Here sign condition (i.e., no sign, ASTM D4956 Type III sign, or ASTM D4956 Type XI sign) was significant. The average detection distance with no sign in advance of

the small square target was almost 420 ft. When a sign was placed 200 ft in advance of the small square target, the detection distance decreased significantly to about 310 ft. There was not a statistical difference concerning the detection distances associated with the different types of retroreflective sign materials. Sign luminance profiles for the two different types of retroreflective sign materials and two different levels of headlamp illumination are shown in Figure 8.

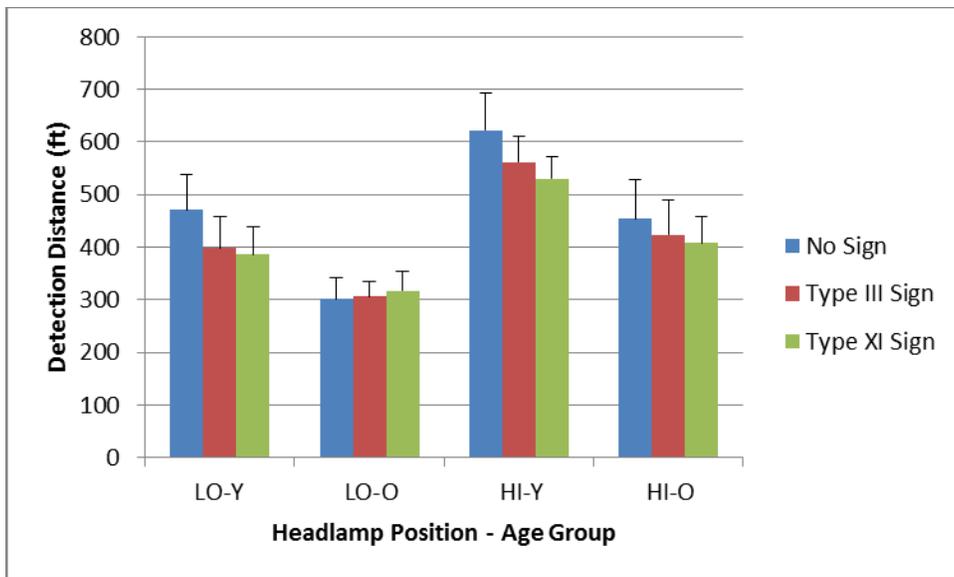
Figure 6. Detection Distances for the Pedestrian.

Unlike before, the sign condition factor is not significant for the pedestrian. However, both the age group and lighting level factors were significant (factors marked with * are significant with a p-value < 0.05).

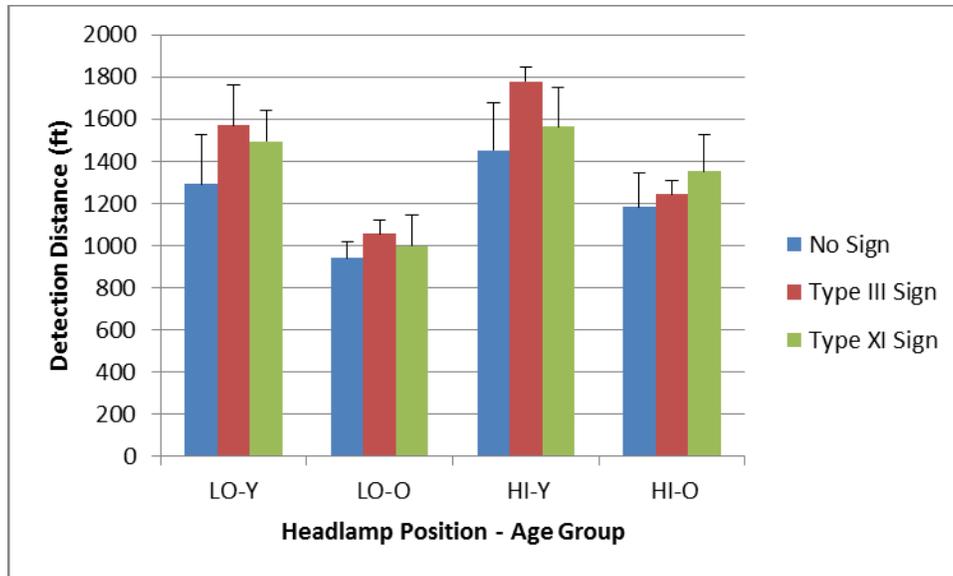
Figure 7. Detection Distances for the Vehicle.

For the vehicle target, the main effects of age group, lighting level, and sign condition are all significant, but no interaction term is significant (factors marked with * are significant with a p-value < 0.05). Interestingly, when the a sign was placed 200 ft in front of the parked vehicle, the participants were able to detect the vehicle significantly further than without the sign (about 1220 ft without a sign, 1420 ft with the ASTM D4956 Type III sign, and 1350 ft with the ASTM D4956 Type XI sign).

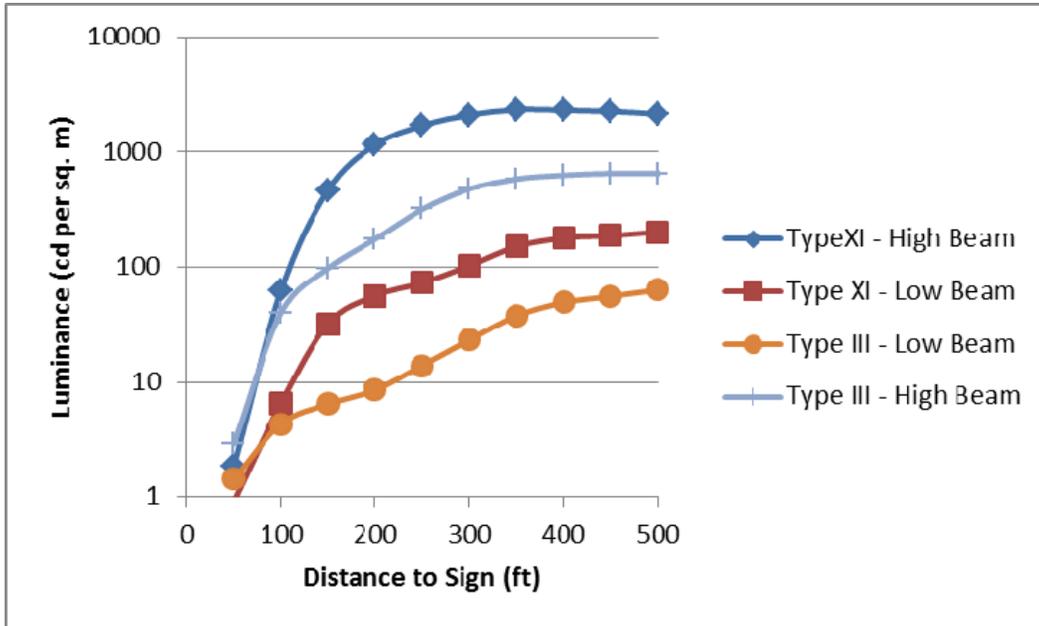
Figure 8. Sign Luminance Profiles.

A follow-up study is recommended that will include different objects (a deer rather than the parked vehicle) and various distances between the objects and the sign. An inspection of the luminance curves shown in [Figure 8](#) and the average detection distances reveals that objects closer to the sign would be even harder to detect than those placed 200 ft downstream of the sign. In addition, the research team proposes that follow-up research consider different pavement types. This study was conducted on concrete pavement, which provides different contrast ratios than asphalt or seal-coat pavements, which are much more common in Texas.

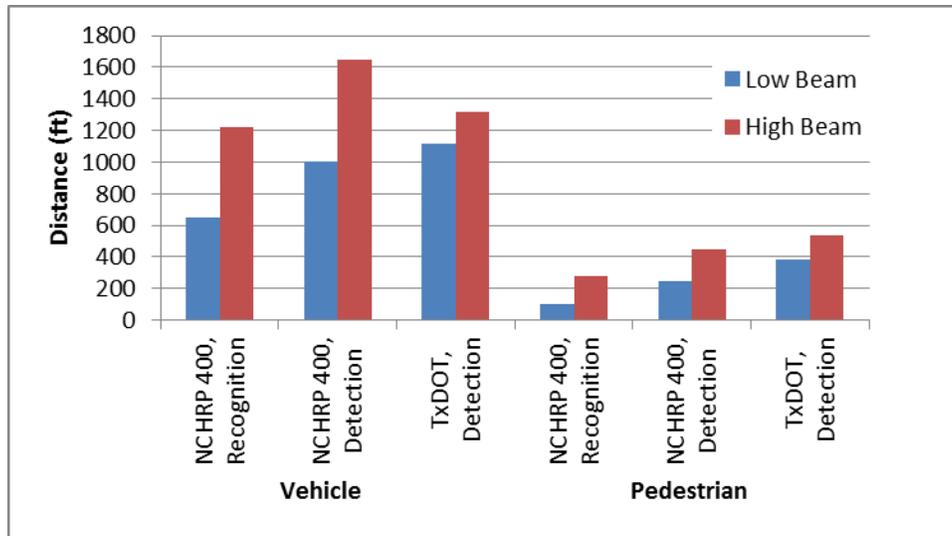
In National Cooperative Highway Research Program (NCHRP) Report 400, similar research findings are published for nighttime detection distances. With low-beam headlamp illumination the researchers found that the rear of a vehicle was detected at a range of 550 to 725 ft and then recognized between 725 and 1000 ft. For high-beam illumination, the recognition distances started at about 1100 ft and the detection distances extended to almost 1800 ft. For their pedestrian, who was dressed in dark clothing, recognition under low-beam headlamp illumination was about 100 ft and the detection distance was about 225 ft. Under high-beam headlamp illumination, the recognition distance was about 300 ft and the detection distance maxed out at almost 500 ft. A comparison of the detection distance data is shown in [Figure 9](#) (using the data without signs present).

Figure 9. Comparison of Detection Distance Data.

The vehicle detection results look quite similar, whereas the pedestrian detection distances from the report described herein are slightly longer than those found in NCHRP Report 400. There are two likely causes. One is that the description of the pedestrian used for the NCHRP Report 400 work described dark clothing, while we used blue medical scrubs in this study, which are not as dark. Another reason could be the evolution of headlamp technologies. More likely, the longer detection distances found here are based on a combination of the clothing used in each study and the difference in headlamp flux and patterns.

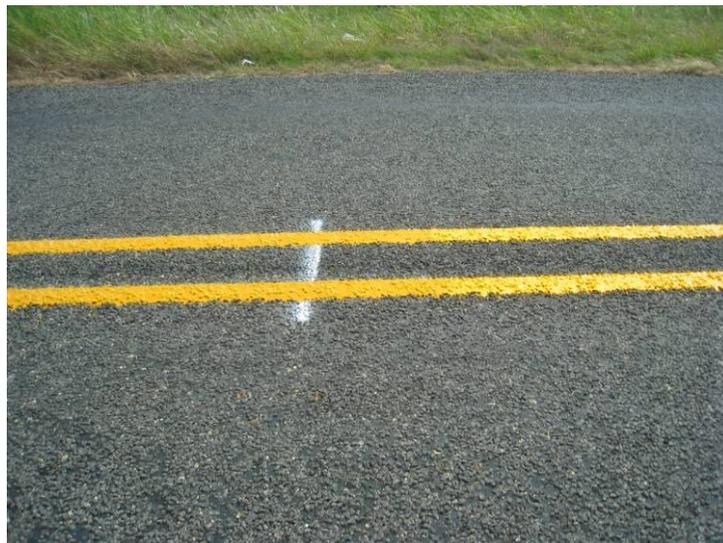
Figure 10. FM 1680 Road Surface with Marking.

Test deck 4 was installed in June 2010 on FM 1680 near Moulton, Texas. The road surface was a new seal coat surface treatment with approximately 400 ADT. This section compared two lead-free materials to an adjacent leaded material. Each of the three materials was spray applied for approximately 4 miles. The markings were applied at approximately 100 mil thick and had a double drop of Type II and III beads each applied at approximately 12 lb/100 ft². [Figure 10](#) shows a typical section of the roadway with the marking applied. Only centerline markings and RRPMS are applied to this road.

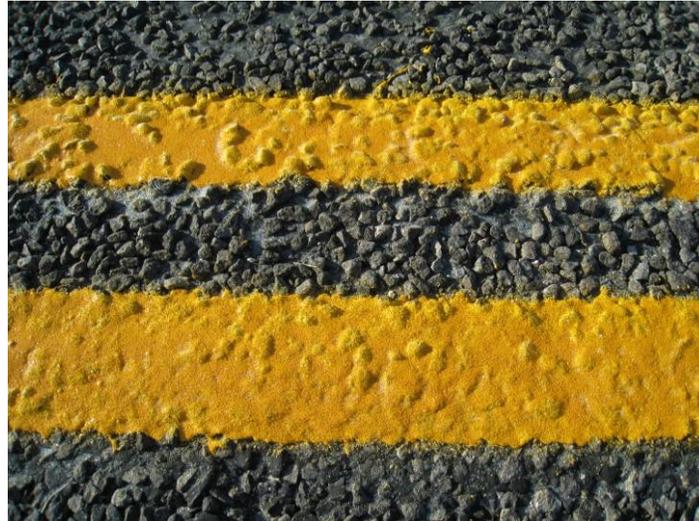
Figure 11. SH 85 Road Surface with Marking.

Test deck 5 was installed in September 2010 on SH 85 near Dilley, Texas. The road surface was a new seal coat surface treatment with approximately 1700 ADT. Three different marking materials were applied; each test section is approximately 4 miles long. The markings were applied at approximately 100 mil thick and had a double drop of Type II and III beads, each

applied at approximately 12 lb/100 ft². [Figure 11](#) shows a close-up of the roadway with the marking applied. Both centerline and edgeline markings as well as RRPMS are applied to this road.

The fourth and fifth test decks are part of a new evaluation that TxDOT is conducting to determine if the new lead-free thermoplastic specification can work on a typical seal coat road surface when properly installed. These test decks had close supervision by TxDOT and TTI during their installation. The thickness of the marking, bead drop rates, and bead embedment were all monitored.

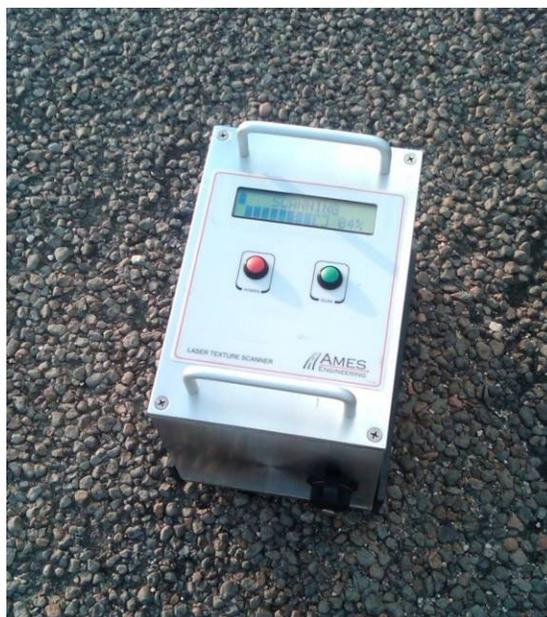
Figure 12. Laser Texture Scanner Taking a Reading.

The ETD calculated by measuring the MPD with a laser device has been found to closely relate to the mean texture depth (MTD) values measured using ASTM E965 (12). ASTM E965 is often referred to as the “sand patch method.”

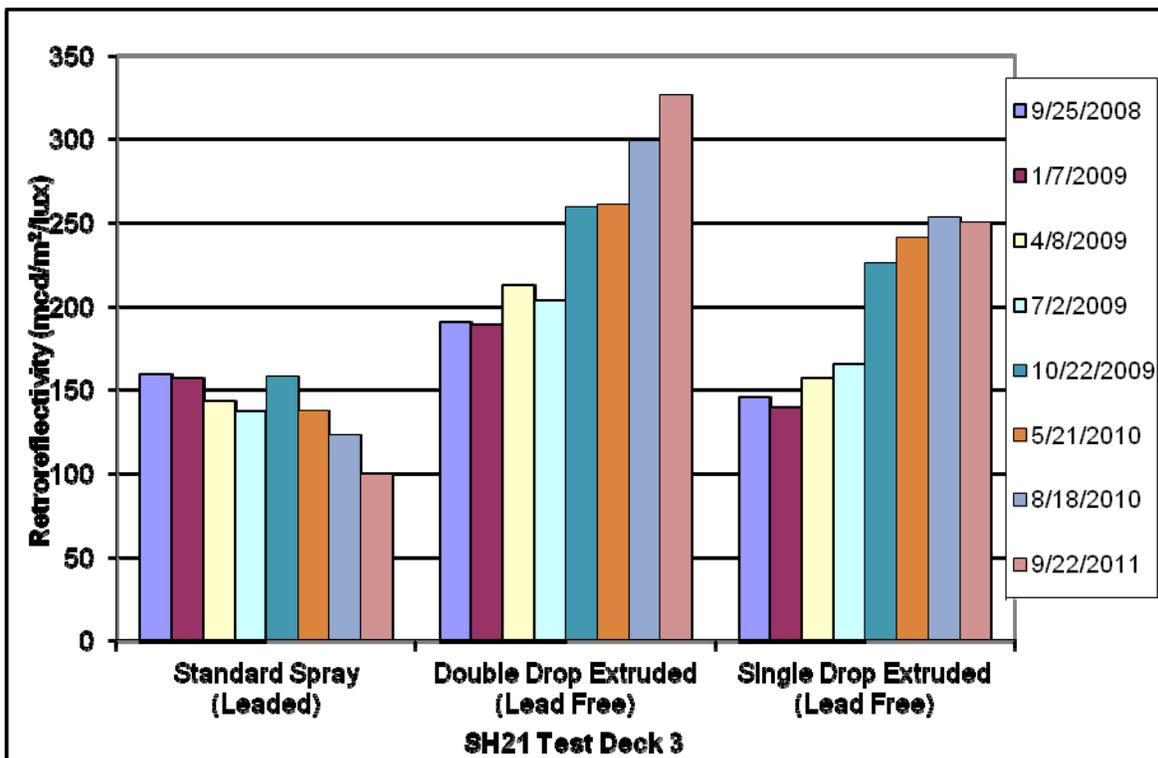
As seen in Figure 13, the retroreflectivity at each location varied somewhat as the markings aged. The extruded lead-free pavement markings on deck 3 generally increased in retroreflectivity as they aged. This is interesting in that the single-drop extruded marking was slightly below the minimum retroreflectivity level initially, but 1, 2, and 3 years later it was above the minimum level. The leaded sprayed thermoplastic generally decreased in retroreflectivity over the 3-year study period.

Figure 13. Average Retroreflectivity Test Deck 3.

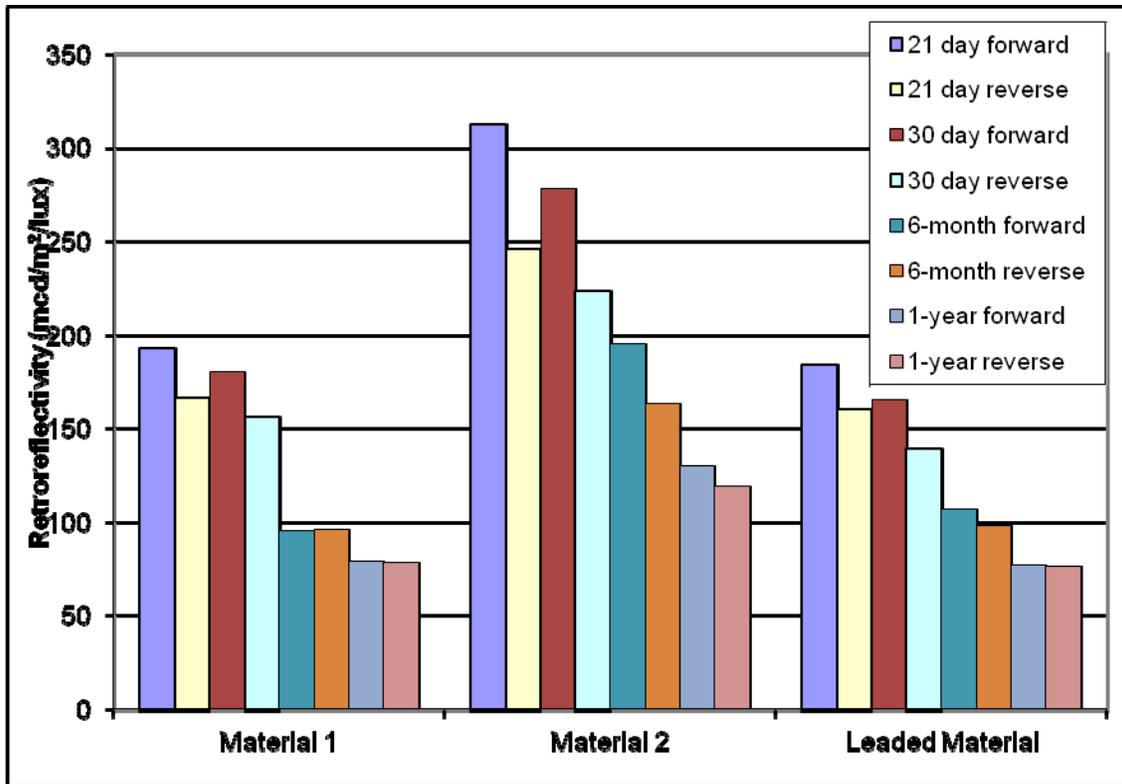
Four sets of data were collected at the FM 1680 site over the 1-year study period (see Figure 14). The first set of data was collected 21 days after the markings were installed, slightly after the 3 to 10 day window specified in SS 8251. As can be seen in Figure 14, when measured in the direction of application (forward), both lead-free materials 1 and 2 as well as the leaded material met the SS 8251 minimum retroreflectivity level of 175 mcd/m²/lux for yellow pavement markings when measured any time after 3 days but not later than 10 days after application. In the reverse direction the leaded material and lead-free material 1 were slightly

Figure 14. Average Retroreflectivity Test Deck 4.

[Table 6](#) expands on the data displayed in [Figure 14](#) by providing the values displayed in the chart and also providing the percentage of segments passing the indicated threshold levels. The threshold levels selected were 175 mcd/m²/lux, which is the minimum install level required by TxDOT and 100 mcd/m²/lux. SS 8251 requires a 175 mcd/m²/lux average retroreflectivity level and that a maximum of 30 percent of segments per mile not pass the threshold level. The data in [Table 6](#) indicate that even though some of the sets of readings may have averaged more than 175 mcd/m²/lux, the number of segments falling below this level often exceeded 30 percent.

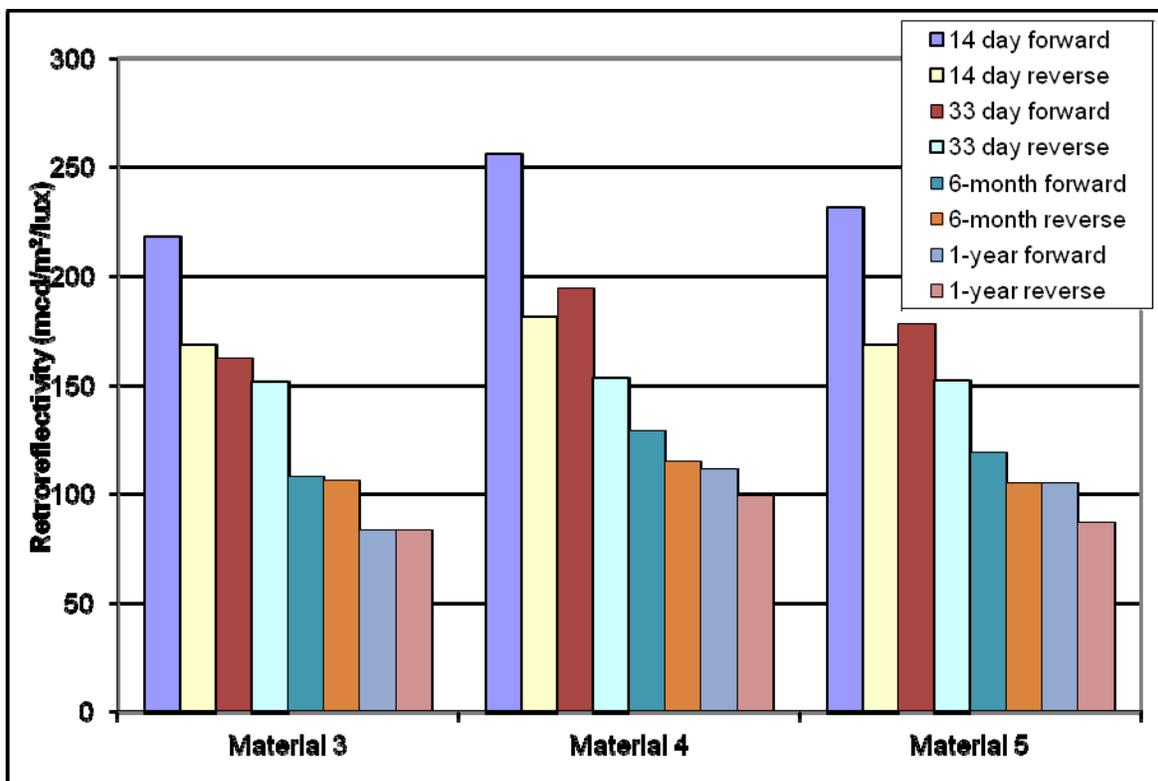
Table 7 expands on the data displayed in Figure 15 by providing the values displayed in the chart and also providing the percentage of segments passing the indicated threshold levels. The threshold levels selected were 175 mcd/m²/lux, which is the minimum install level required by TxDOT, and 100 mcd/m²/lux. SS 8251 requires a 175 mcd/m²/lux average retroreflectivity level and that a maximum of 30 percent of segments per mile not pass the threshold level. The data in Table 7 indicate that even though some of the sets of readings may have averaged more than 175 mcd/m²/lux, the number of segments falling below this level often exceeded 30 percent.

Figure 15. Average Retroreflectivity Test Deck 5.

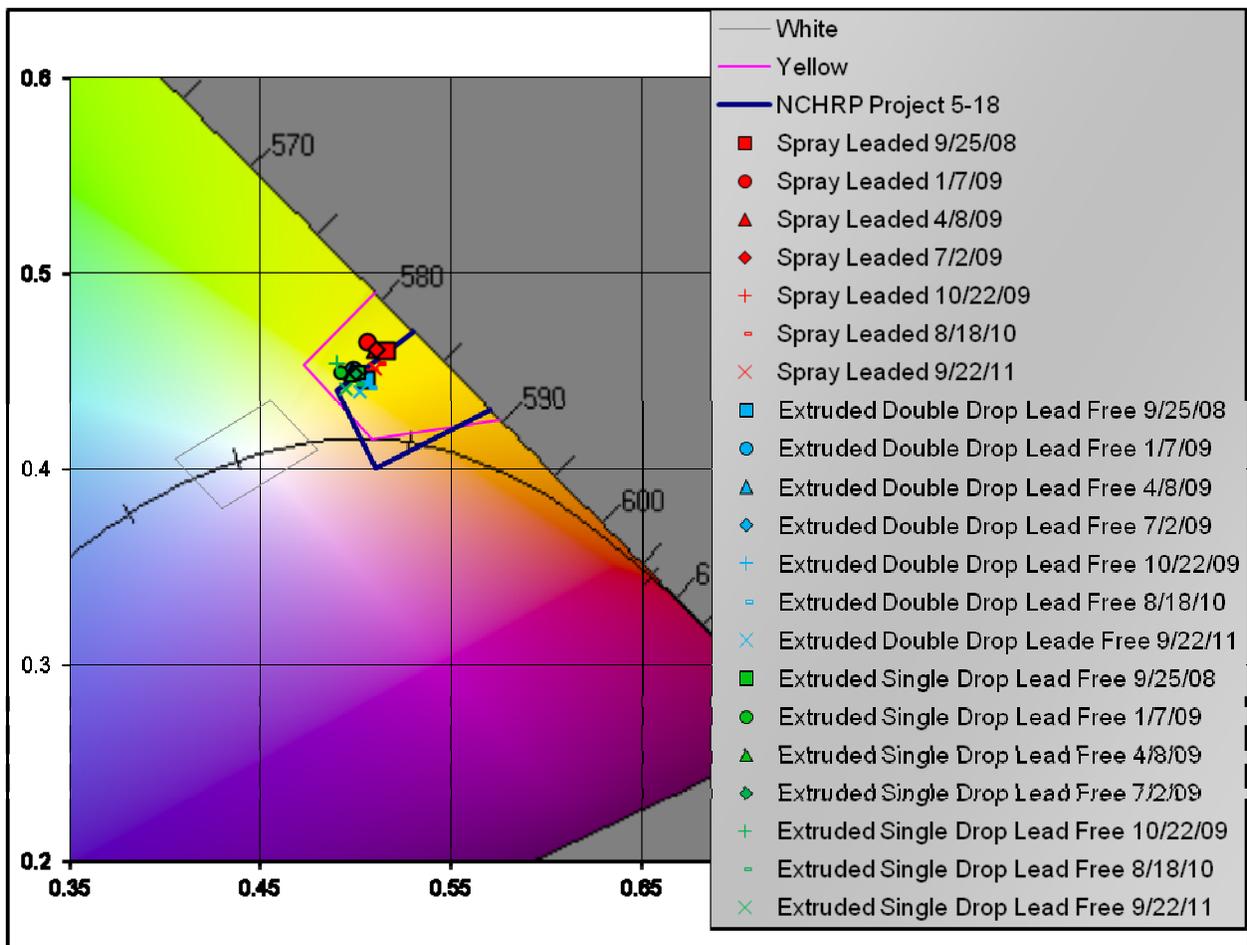
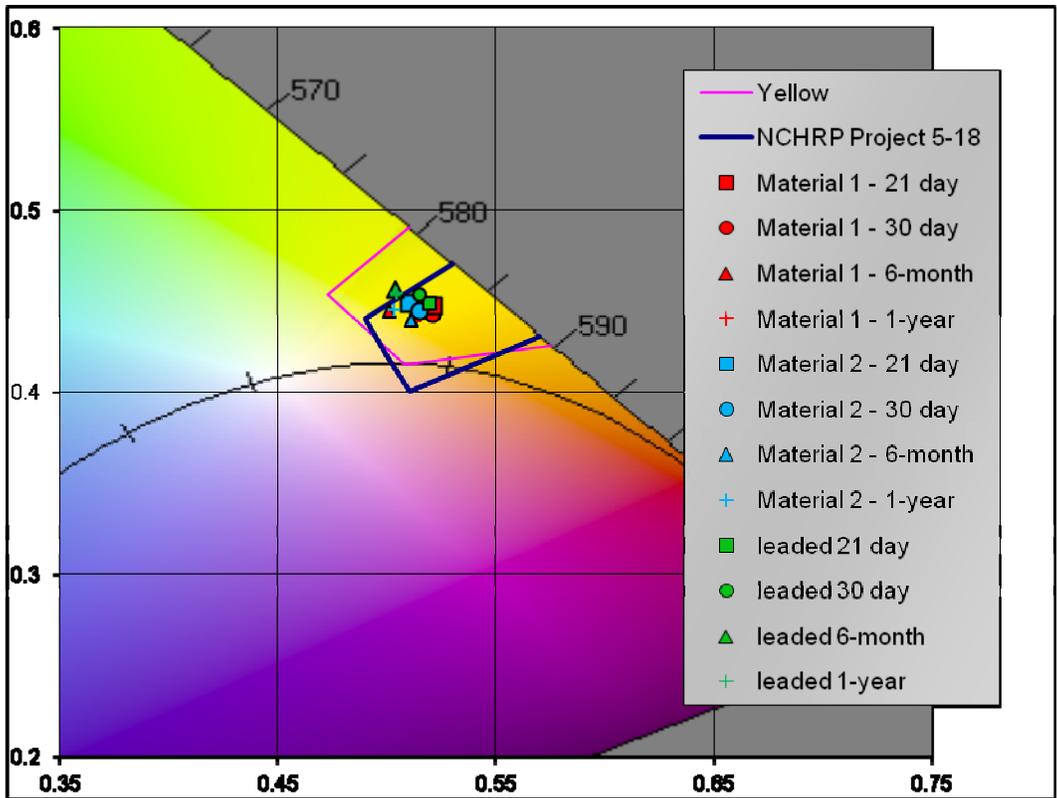
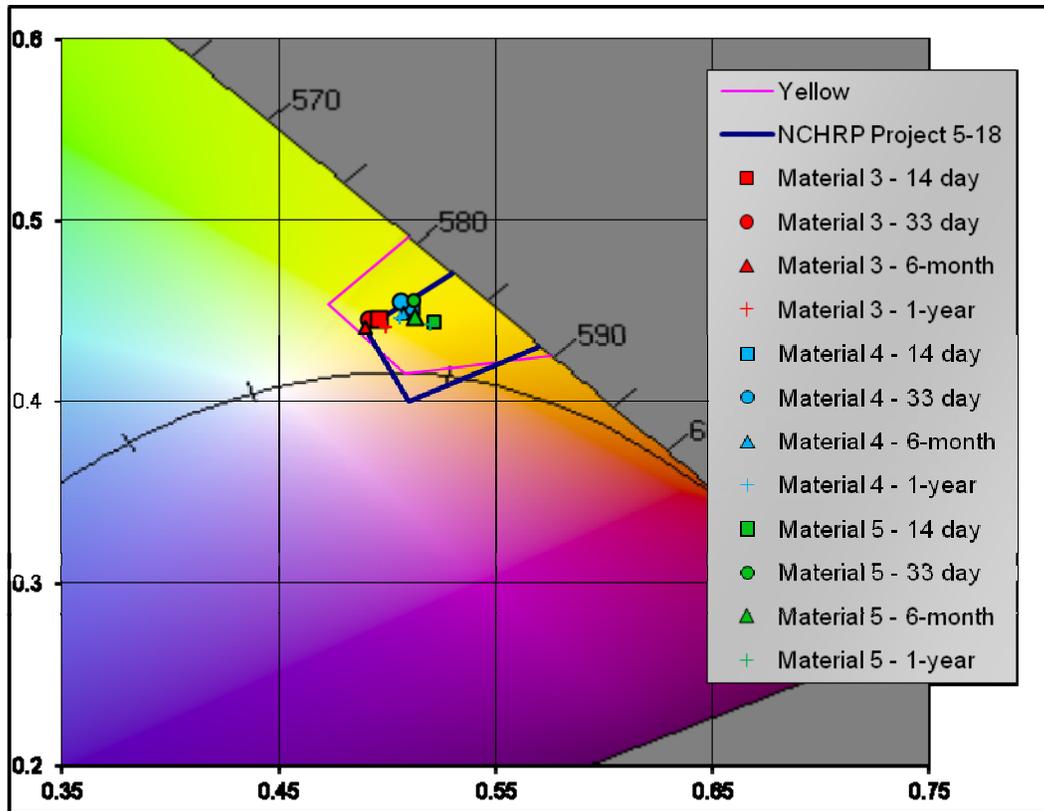
The average 30 m color values from each data collection period were plotted against the x-y points defining the color box from the FHWA final rule on marking color. This color box is based on illuminant A and a viewing geometry that is the same as the 30 m retroreflectivity geometry. The NCHRP recommended color box, which is also the 30 m color box for TxDOT, is also illustrated to show the difference. [Figure 16](#), [Figure 17](#), and [Figure 18](#) illustrate the plot of the average color points for the color measurements at each test deck. All of the average

measurements from each data collection period on both the leaded and lead-free materials are within the FHWA yellow color box. Test deck 3 resulted in measurements that were on the edge or just outside of the NCHRP color box. The measurements from test decks 4 and 5 were typically within the NCHRP color box. It appears that as the markings age, both leaded and lead-free trend toward the white area of the color chart. The leaded marking at test deck 3 was more saturated in color initially and over time than were the lead-free markings on the same deck. The leaded and lead-free materials on decks 4 and 5 were similar in color, other than material 3, which was slightly less saturated.

Figure 16. Average 30 m Night Color Test Deck 3.

Figure 17. Average 30 m Night Color Test Deck 4.

Figure 18. Average 30 m Night Color Test Deck 5.

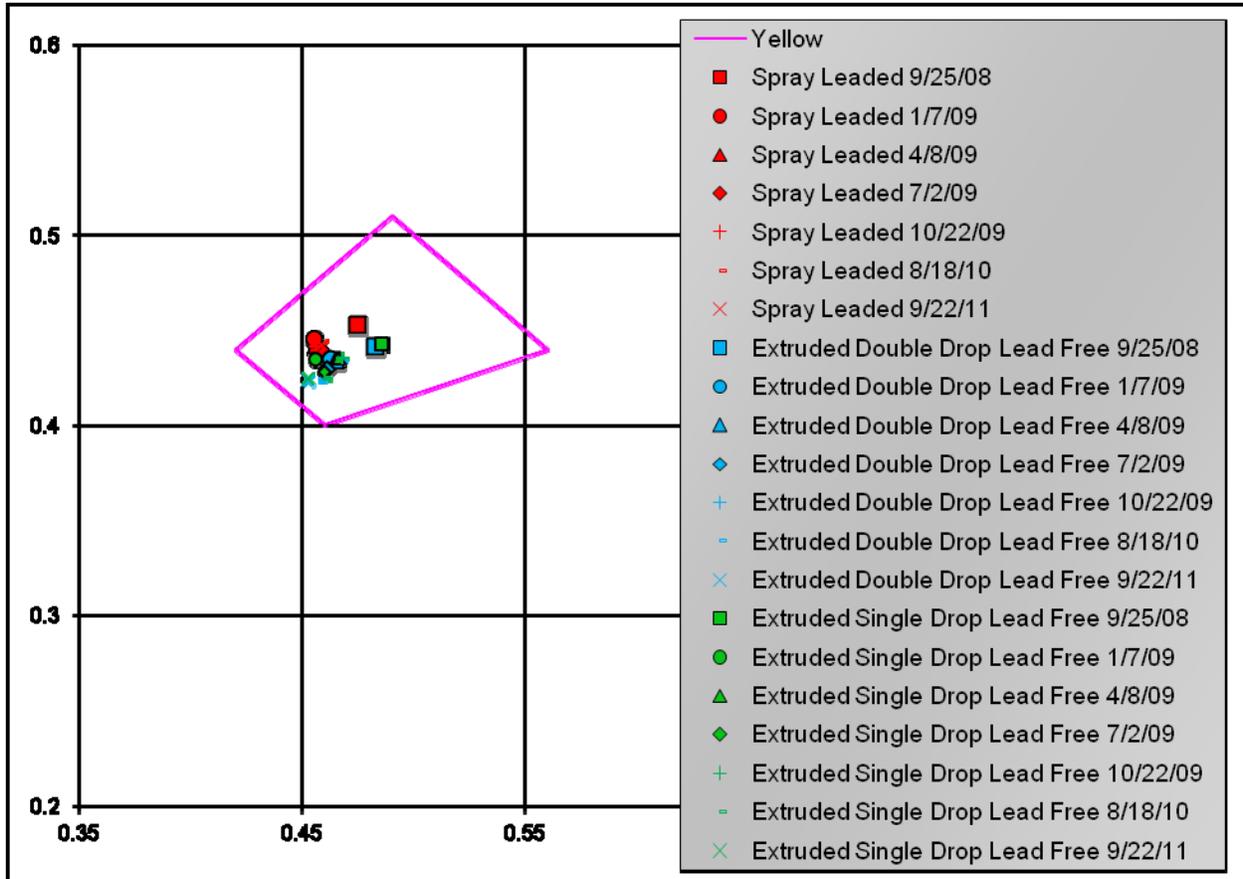
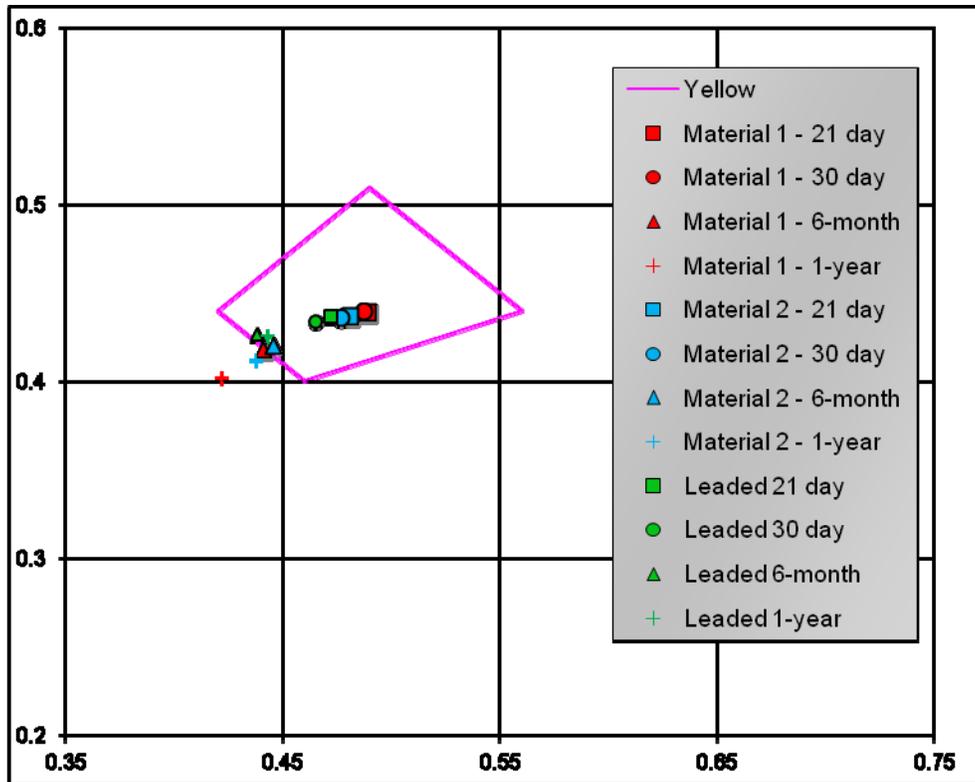
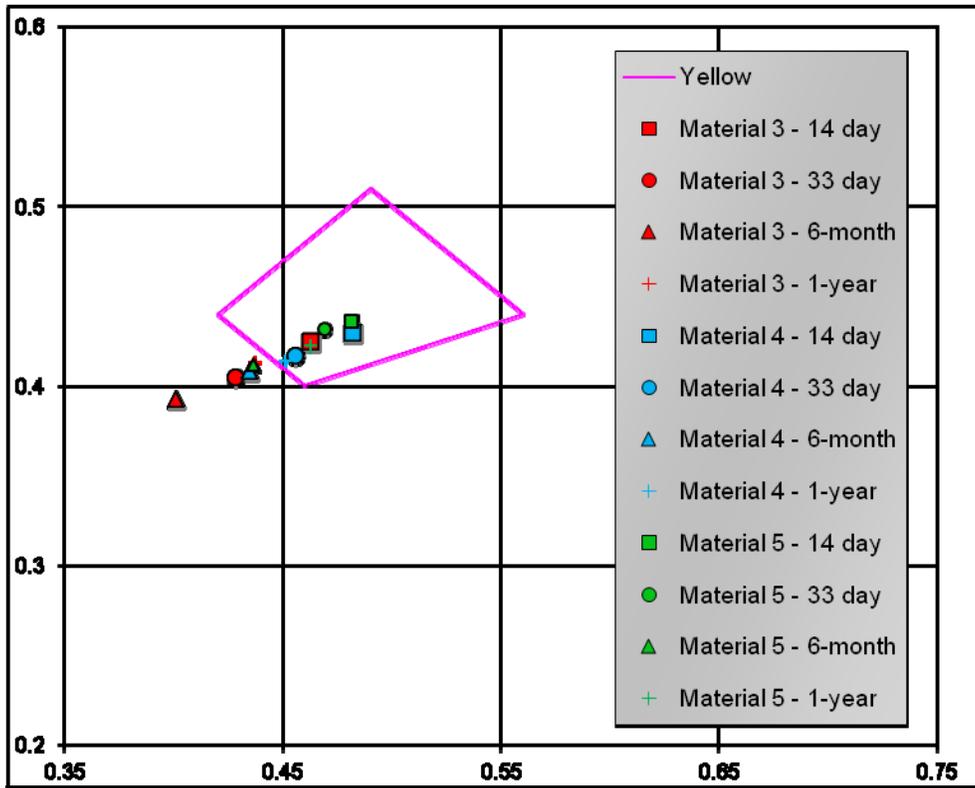
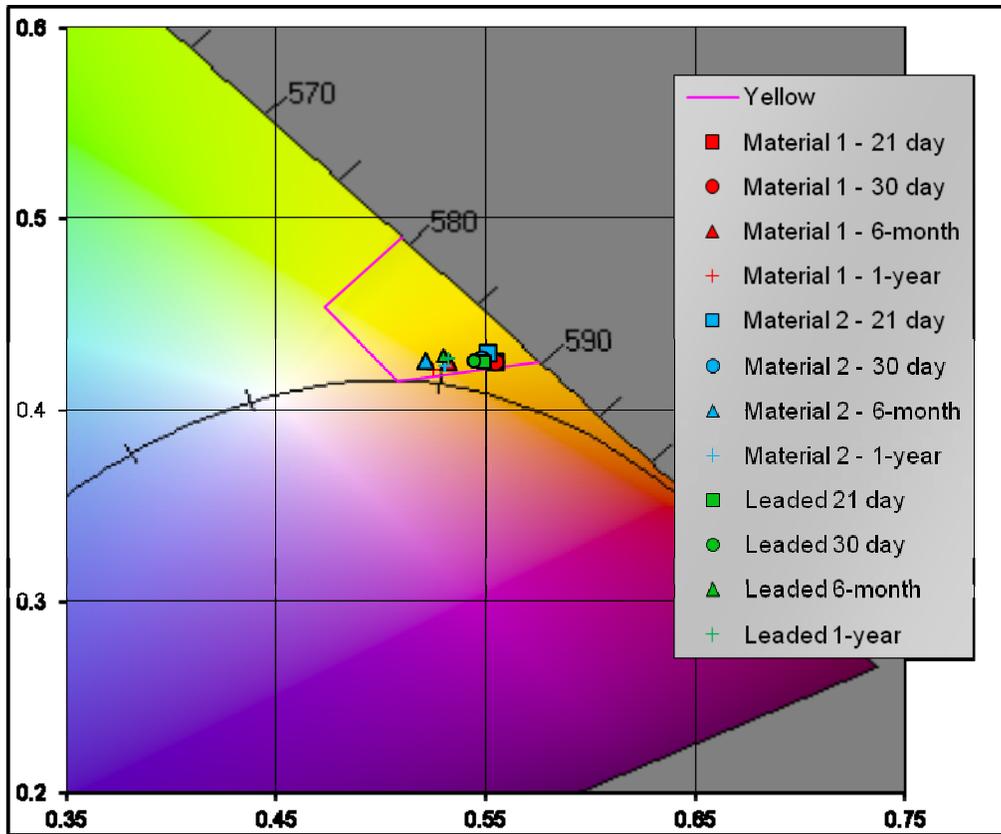
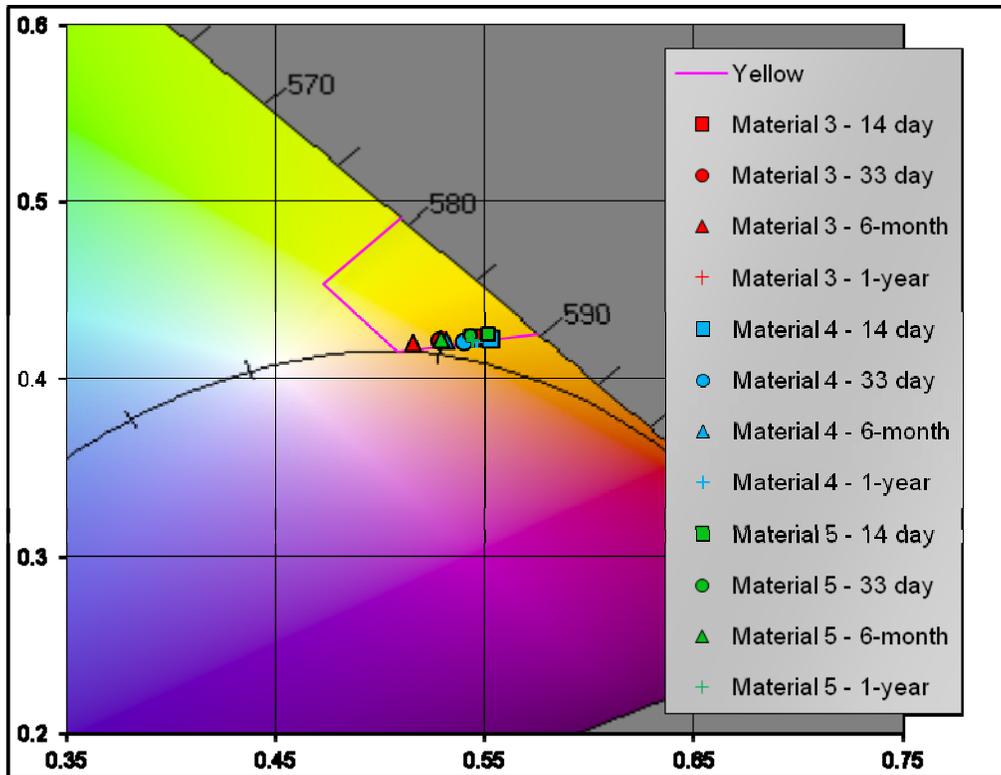
The researchers also measured the color of the yellow thermoplastic marking materials containing beads and no beads using illuminants A and D65 with a 2° standard observer at a 45° illumination geometry and a 0° observation geometry. The color measurements on the beaded and nonbeaded sections were pooled after little difference was found between the two measurement sets. Figure 19, Figure 20, and Figure 21 display the average color values for illuminant D65 for the three test decks. Figure 22 and Figure 23 display the average color values for illuminant A for test decks 4 and 5. All points were plotted with the appropriate day or night color boxes.

All of the initial measurements were within the appropriate color boxes. In the daytime color measurements using illuminant D65, some average measurements from decks 4 and 5 fall outside of the color box requirements, trending toward white. In the nighttime color measurements using illuminant A, the average measurements from decks 4 and 5 were consistently below the bottom of the box for each of the measurement periods.

Figure 19. Average Daytime Color (D65) with 2° Standard Observer Test Deck 3.

Figure 20. Average Daytime Color (D65) with 2° Standard Observer Test Deck 4.

Figure 21. Average Daytime Color (D65) with 2° Standard Observer Test Deck 5.

Figure 22. Average Nighttime Color (A) with 2° Standard Observer Test Deck 4.

Figure 23. Average Nighttime Color (A) with 2° Standard Observer Test Deck 5.

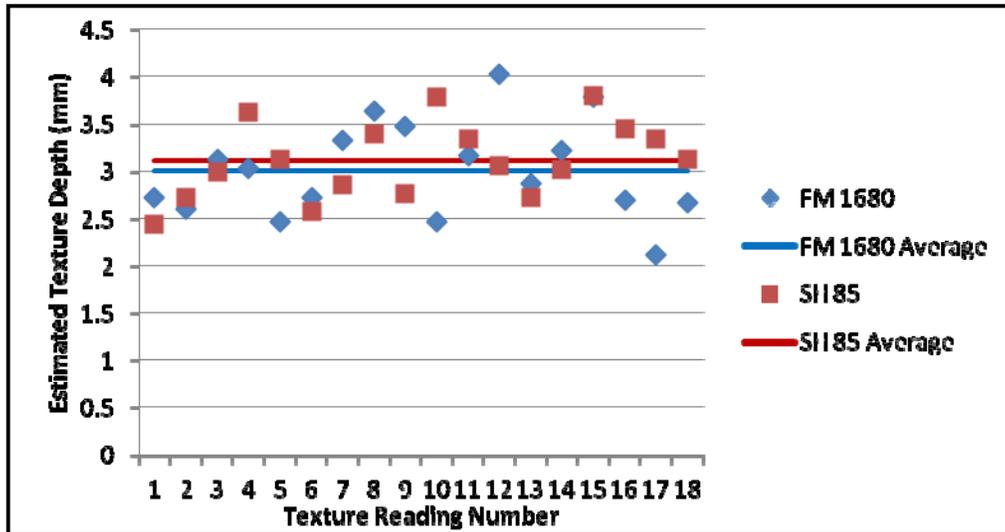
In total, 18 measurements of each test deck were taken. Table 8 presents the average and standard deviations of these readings for each test deck. Figure 24 presents the 18 individual readings from each test deck as well as the average reading. The average estimated texture depths of each test deck were very near each other and were found to not be significantly different using a student's t-test.

Figure 24. Estimated Texture Depth Readings of Test Decks 4 and 5.

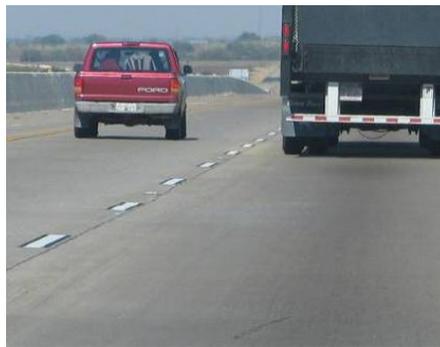
Figure 25. Contrast Marking Example.

Contrast markings are used to improve the visibility of a white pavement marking by applying a contrasting black marking surrounding or near the white marking. In this study researchers evaluated the potential benefits of different sizes of contrast markings where the contrasting black is applied to the left and right sides of a white skip marking (Figure 25).

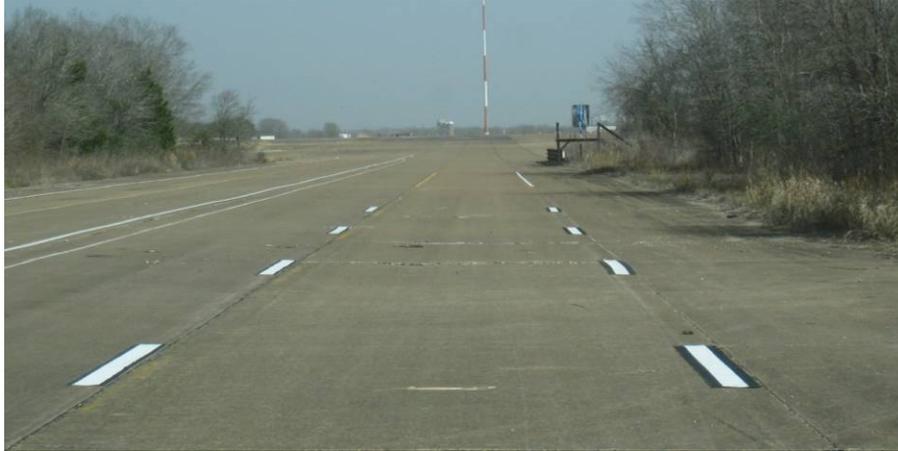
Figure 26. Setup Example.

The expert panel met at Texas A&M University Riverside Campus to view the treatments in this study. For this activity, a TTI researcher rode with two expert panel members from TxDOT in each test vehicle. Each vehicle drove past six setup locations. Each setup location had contrast markings on both the left- and right-hand sides of the vehicle as it passed (Figure 26).

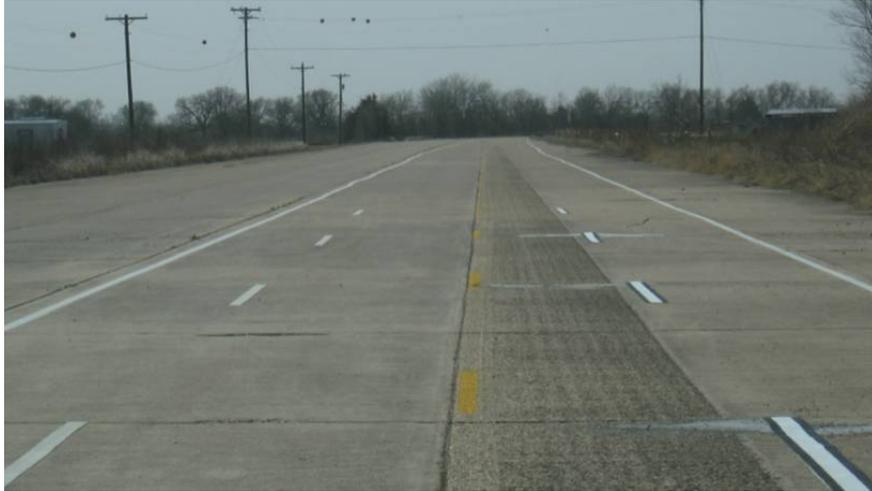
- 4-inch white line alone.
- 4-inch white line with 2 inches of black on each side.

Figure 28. Setup 1.

The significant contrast of a treatment with and without contrast highlights the visibility of the contrast markings. Panel members noted that without the black contrast the white marking looked dull. All of the members agreed that the 4-inch white line with 2 inches of black per side stood out well as a lane-dividing pavement marking. With the black borders the white portion of the strip actually looked wider compared to the noncontrast marking, even though the two white portions are the same size.

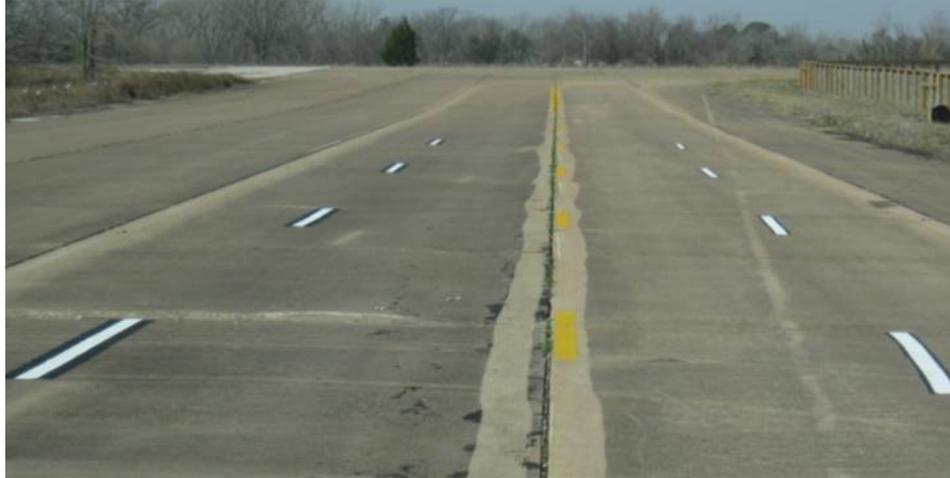
- 4-inch white line with 3 inches of black per side (left).
- 4-inch white line with 1 inch of black per side (right).

Figure 29. Setup 3.

The panel came quickly to a consensus that the left marking with 3-inch black contrast was too much black contrast material for the pavement marking. Additionally, the panel agreed that the right marking with only 1 inch of black contrast material on each side of the white marking did not provide enough contrast. One panelist disagreed with this assessment of having too little black material, believing that the 1-inch black stripe provided contrast without being a distracting element of the pavement marking. However, none of the participants believed these were the most desirable of the markings viewed for lane-dividing contrast pavement markings.
