1. Report No. FHWA/TX-12/9-1001-2		2. Government Accession No.		3. Recipient's Catalog No.	
4. Title and Subtitle EVALUATION OF TRAFFIC CONTROL DEVICES, YEAR 3				5. Report Date Published: March 2012

EVALUATION OF TRAFFIC CONTROL DEVICES, YEAR 3

Report 9-1001-2

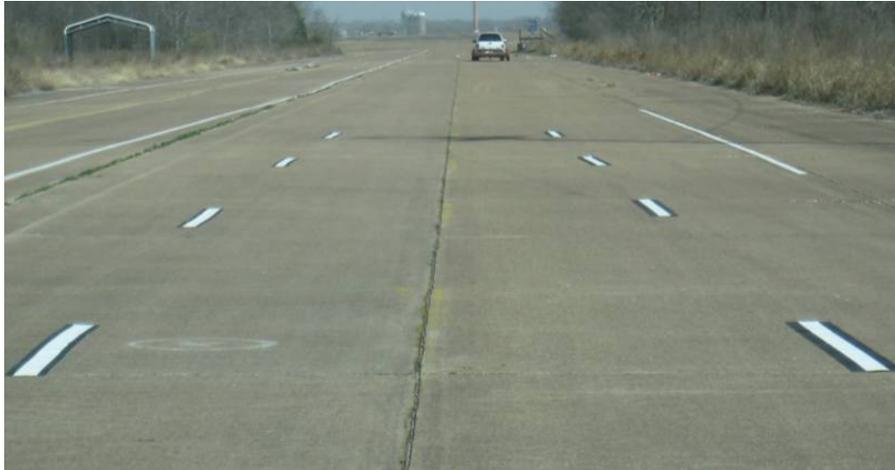
Figure 30. Setup 5.

The two markings evaluated at setup 5 (shown in [Figure 30](#)) were:

- 4-inch white line with 1.5 inches of black per side (left).
- 4-inch white line with 2.5 inches of black per side (right).

The panel did not come to a simple consensus in this situation as to which of the markings was preferable for use. Some panelists believed that the 2.5 inches of black contrast was too much, and others believed that this amount of black helped the marking to stand out more on the road surface and thereby was preferable. The same was true for the 1.5-inch contrast marking, which got comments of too little contrast and that it was desirable as it looked bright even with less contrasting marking needed.

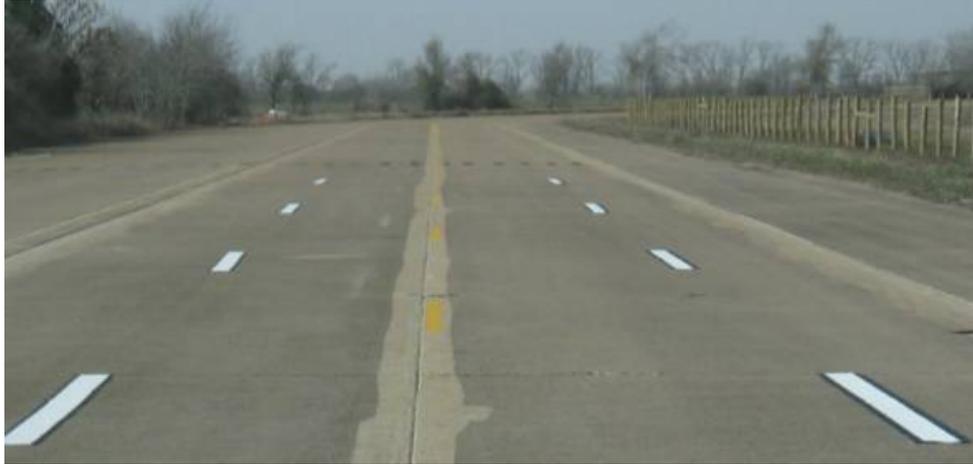
- 6-inch white line with 2 inches of black per side (right).
- 6-inch white line with 1 inch of black per side (left).

Figure 31. Setup 2.

Panelists felt the 6-inch white marking with 1-inch of black contrast was too thin to adequately provide the contrast desired for lane-dividing applications and almost went unnoticed compared to the white. It was stated that if there was no more black contrast than this it was not worth having a contrast marking as compared to a typical white stripe.

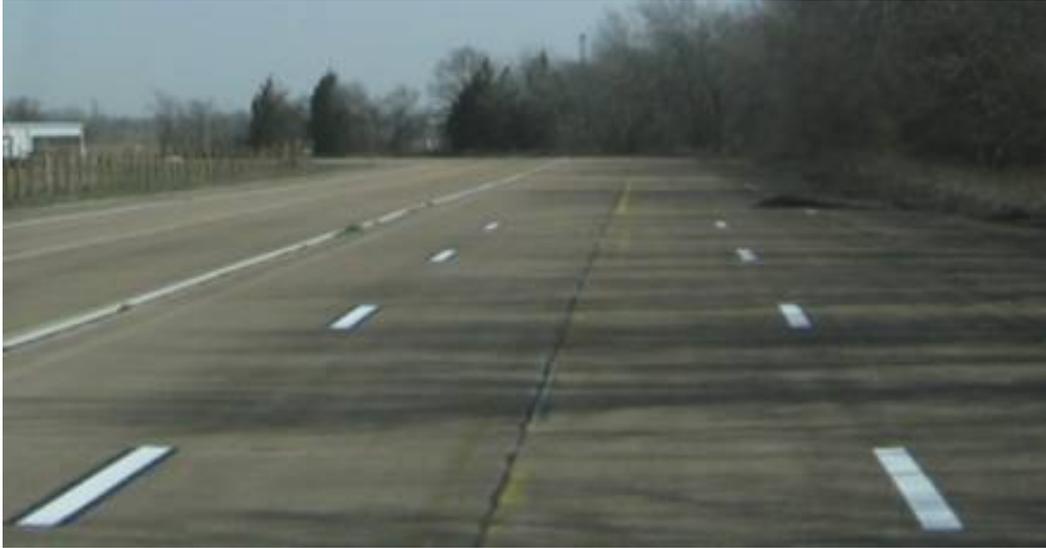
- 6-inch white line alone.
- 6-inch white line with 2.5 inches of black per side.

Figure 32. Setup 4.

Due to the location and shadows of this setup, it was believed that both markings were very good and panelists noted that 6-inch white stripes are typically easier to see even without contrast as compared to the narrower 4-inch white stripes. However, panelists believed that in a situation with new concrete (i.e., the typical situation for contrast markings) that the marking with 2.5 inches of black contrasting material would be more visible.

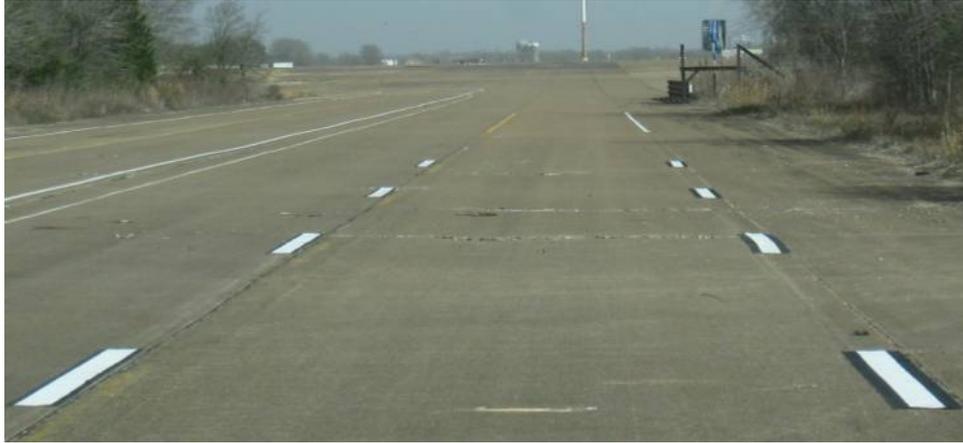
Figure 33. Setup 6.

The two markings evaluated at setup 6 (shown in [Figure 33](#)) were:

- 6-inch white line with 1.5 inches of black per side (left).
- 6-inch white line with 3 inches of black per side (right).

The panel agreed that both treatments were adequately visible and provided contrast for the white marking but that the 3-inch contrasting black material was better than the 1.5-inch contrast, which was believed to be too narrow to appear adequately proportioned. This being stated, many of the panel members believed that although the 3-inch black did provide the contrast desired, it was too much black material and therefore was not appropriate for application as a lane-dividing pavement marking. Overall, panelists did not believe that either of these markings were appropriate with regard to proportionality for use.

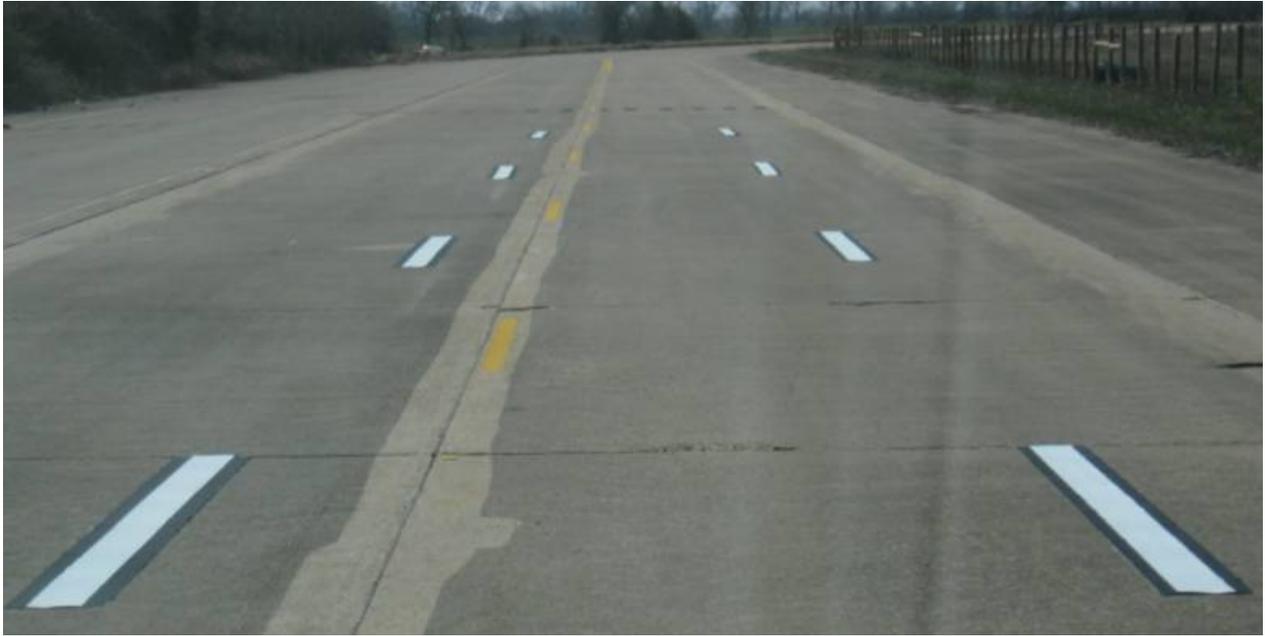
After the initial drive-through and discussion of the contrast markings, panel members desired to see one final setup to provide a visual comparison of the 6-inch white markings with 2 and 2.5 inches of black contrasting material on each side. These were selected as the most appropriate markings from the treatments evaluated with the 6-inch white stripe; however, there was much debate among the panelists that made it necessary to see the markings in a closer side-by-side comparison to make a final decision on which they believed was the better proportionally. This setup is shown in [Figure 34](#), with 2.5 inches of contrast on the left and 2 inches of contrast on the right.

Figure 34. Setup 7.

Upon viewing these two markings at a single location, it was stated that there was very little difference between the two and that it was hard to determine which marking dimension was which. Panel members believed that this being the case, the marking that was the easiest to apply or was more cost-effective should be used; however, after some discussion it was decided that there was probably not much difference in the cost savings factor between these two markings.

With regard to proportionality of the different markings and the appropriateness for use, the decisions were still split between these two markings and were discussed heavily. Finally, the panel decided that the 2-inch contrast material would be the recommended marking to use for lane dividing since there was no reason to use the larger dimensioned marking if there was not a marked difference between these two options.

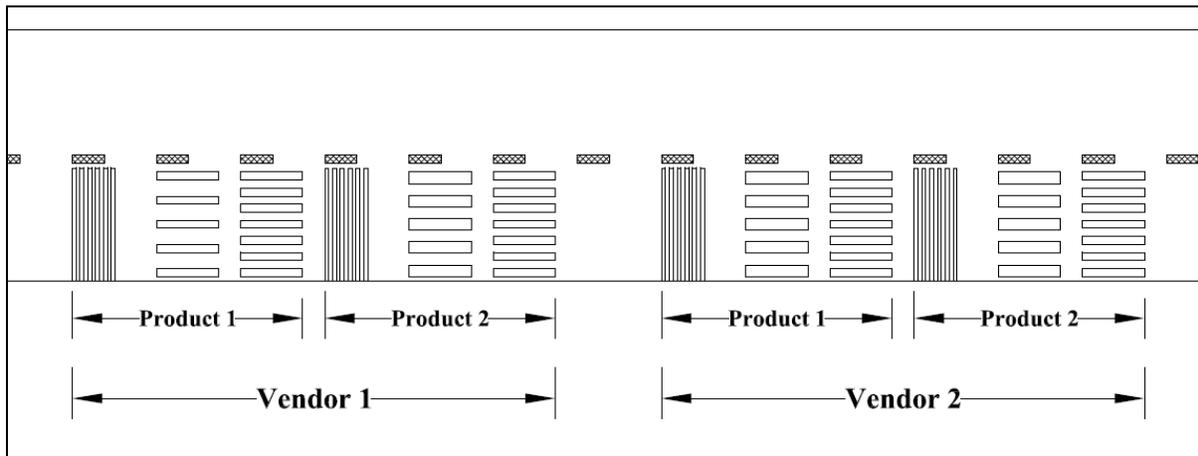
- Longitudinal lines are installed in two patterns of five and seven lines equally spaced across the lane, as shown in [Figure 35](#).
- The length of the longitudinal lines is 20 ft with a gap of 20 ft between the two sets.
- Longitudinal lines are either applied by truck or handcart on all decks for each marking system.

Figure 35. Test Deck Configuration.

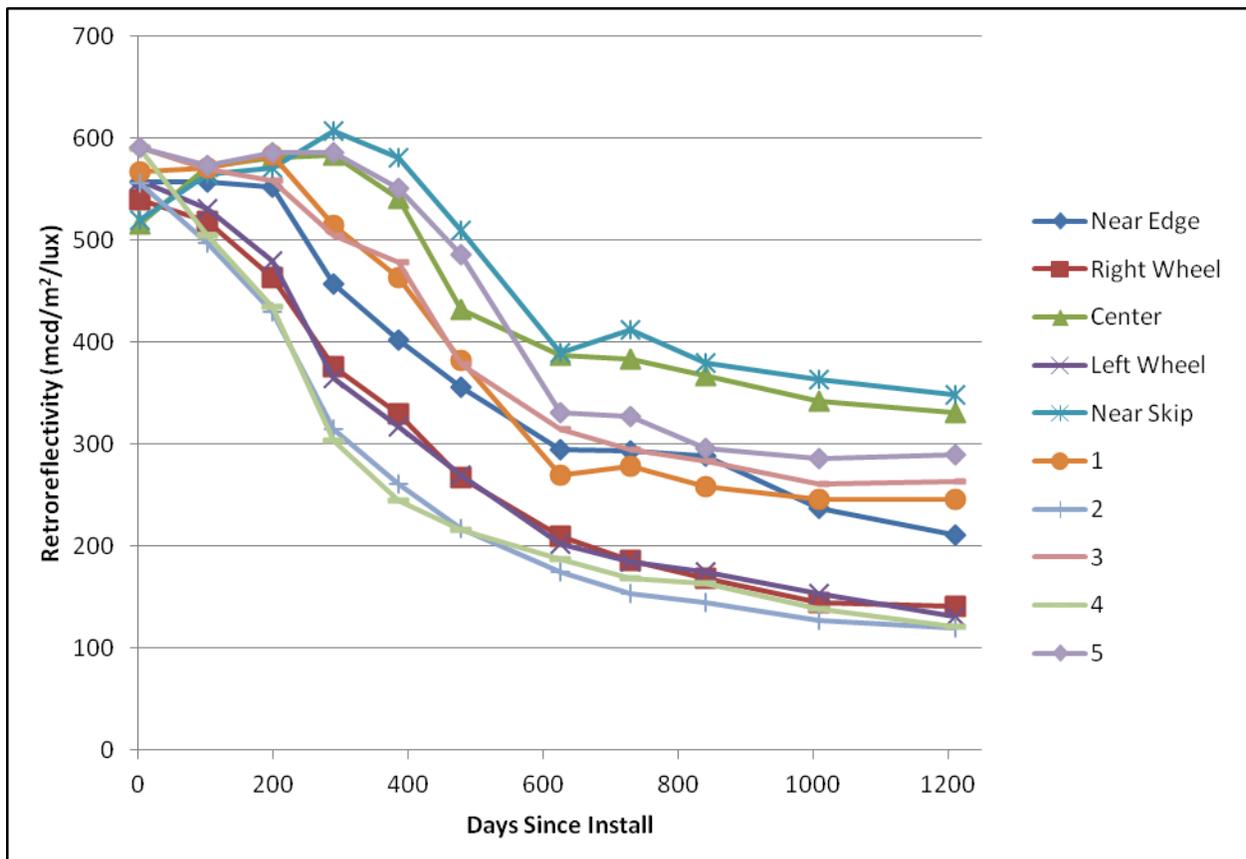
Figure 36 illustrates the average retroreflectivity data of each measurement location for all 10 markings on the deck. Visual inspection of the curves shown in Figure 36 indicates that the measurement points near the wheel path have lower retroreflectivity values than the other measurement areas regardless of being in the transverse or longitudinal sections. The measurement points of the transverse lines have a similar performance trend with the corresponding points of the five-line section over time. These results are unchanged from the original report, other than the additional degradation of the markings.

Figure 36. Summary of Retroreflectivity in Beaumont.

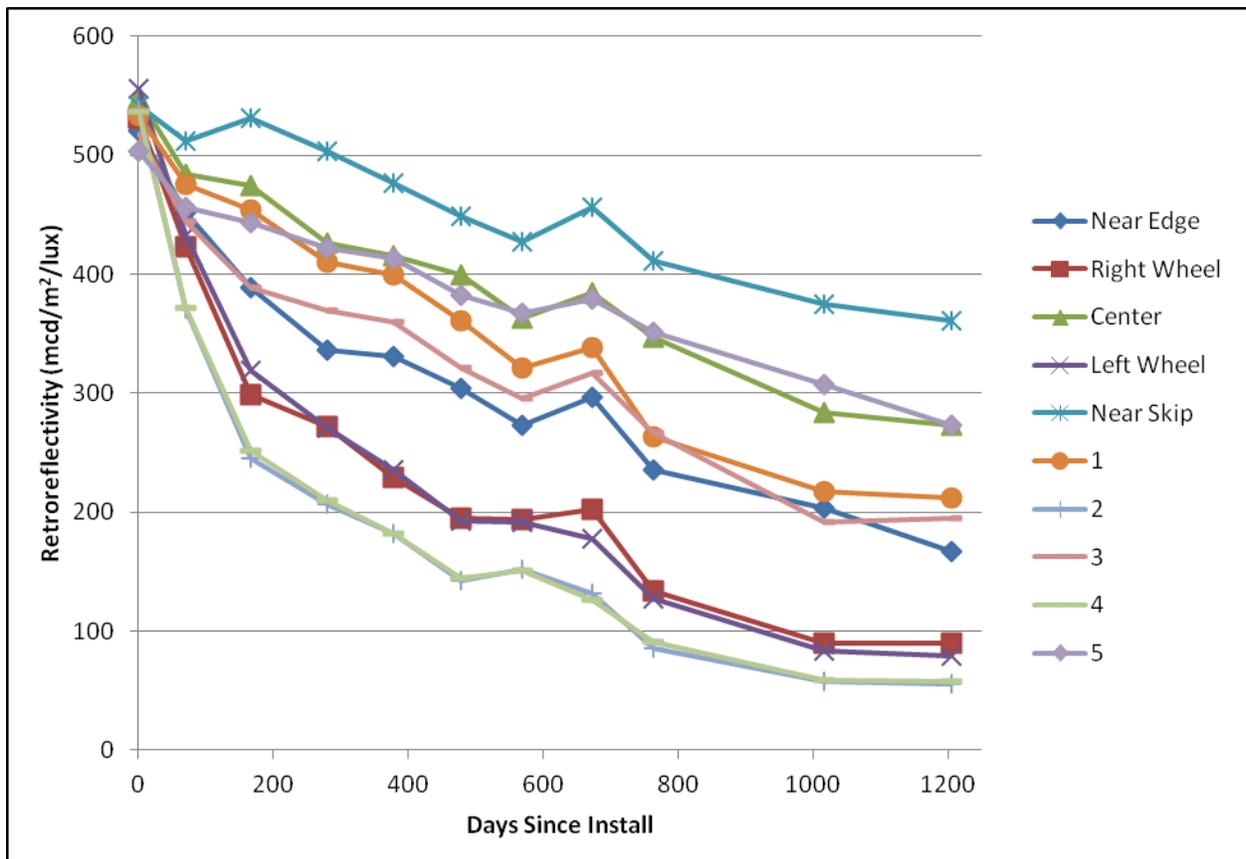
Figure 37 illustrates the average retroreflectivity values of each measurement location for all 15 markings on the deck. Visual inspection of the curves indicates that the measurement points near the wheel path have lower retroreflectivity values than the other measurement areas regardless of being in the transverse or longitudinal sections. The measurement points of the transverse lines have a similar performance trend with the corresponding points of the longitudinal lines over time. The average rate of decay at the Lubbock deck is higher than that of the Beaumont deck. The difference in decay rate between the two decks is likely due to a combination of factors, such as the types of pavement marking used, traffic conditions, and vehicle speeds. These results are unchanged from the original report, other than the additional degradation of the markings.

Figure 37. Summary of Retroreflectivity in Lubbock.

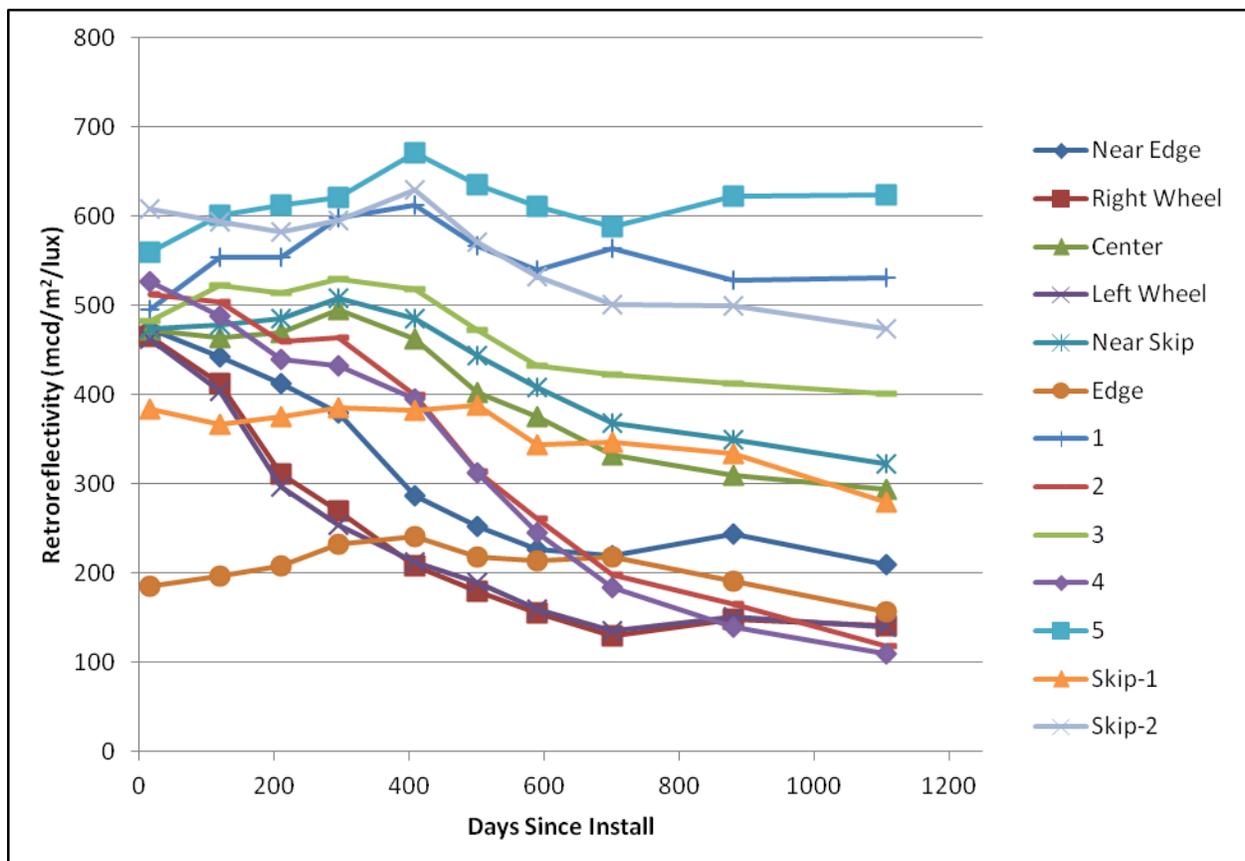
Figure 38 illustrates the average retroreflectivity data of each measurement location for all eight sections on the deck. In general the longitudinal markings edge, near edge, near skip, and skip line markings had relatively flat trend curves over the evaluation period. All transverse line measurements and the longitudinal lines in the wheel paths and center all exhibited a greater level of degradation. Similar to the other two test decks, the measurement points of the transverse lines have a similar performance trend with the corresponding points of five and seven longitudinal lines. These results are unchanged from the original report, other than the additional degradation of the markings.

Figure 38. Summary of Retroreflectivity in Bryan.

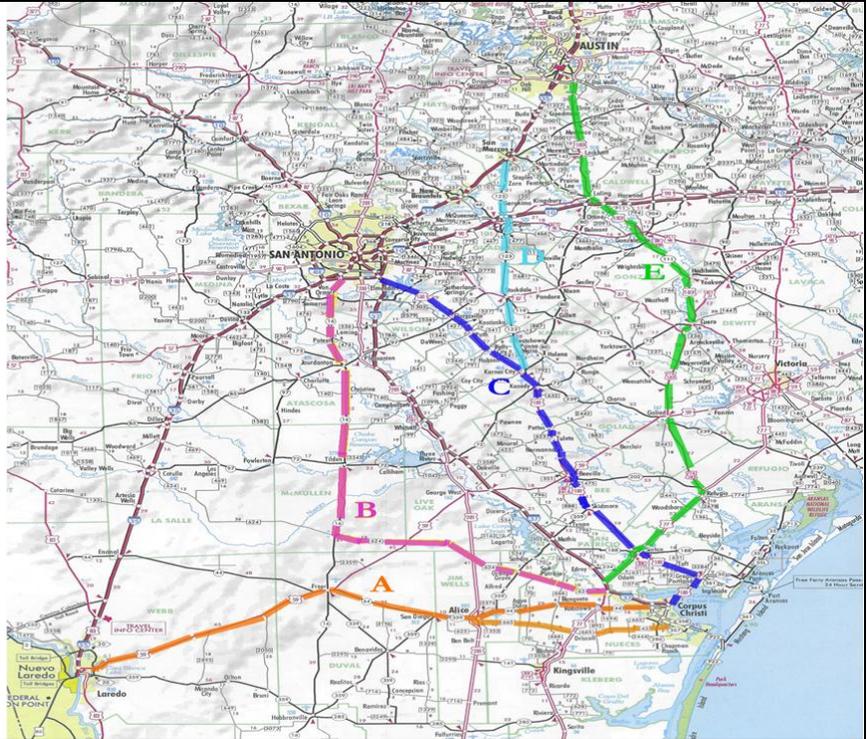
- I-37 to San Antonio**
- A - SH 44 to US 59 to Laredo**
- B - FM 624 to SH 16 to San Antonio**
- C - US 181/SH 89 to San Antonio**
- D - SH 123 to IH 35 to Austin**
- E - US 77 to US 183 to Austin**

Figure 39. Evacuation Routes from Corpus Christi District.

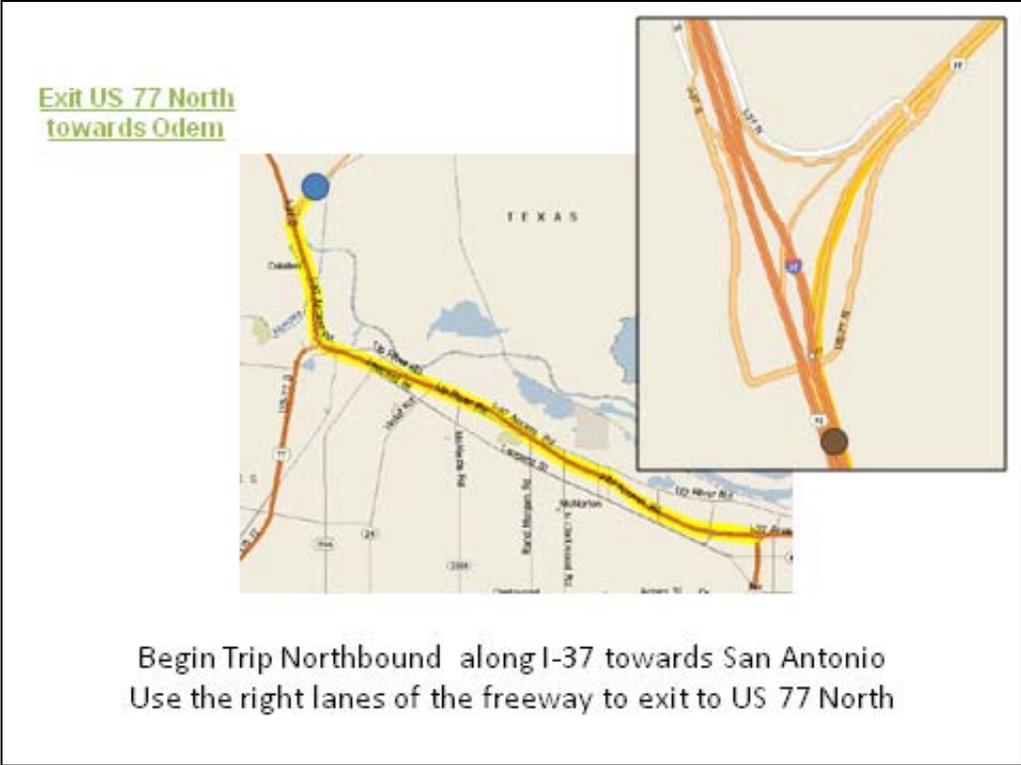
Figure 42. Example of Inset Map to Provide Turning Directions.

trip providing a general overview of the complete route. In some cases, route-specific information has been provided to encourage motorists to take nonconventional routing to avoid roadways that are expected to be congested with the evacuating traffic. For example (Figure 41), to reduce the demand on I-37, traffic using US 181 to San Antonio is encouraged to use the Harbor Bridge toward Portland to begin the evacuation trip. In Figure 42, the animation map inset map provides turning directions for traffic from I-37 to US 77 to begin the trip to US 183 toward Austin.

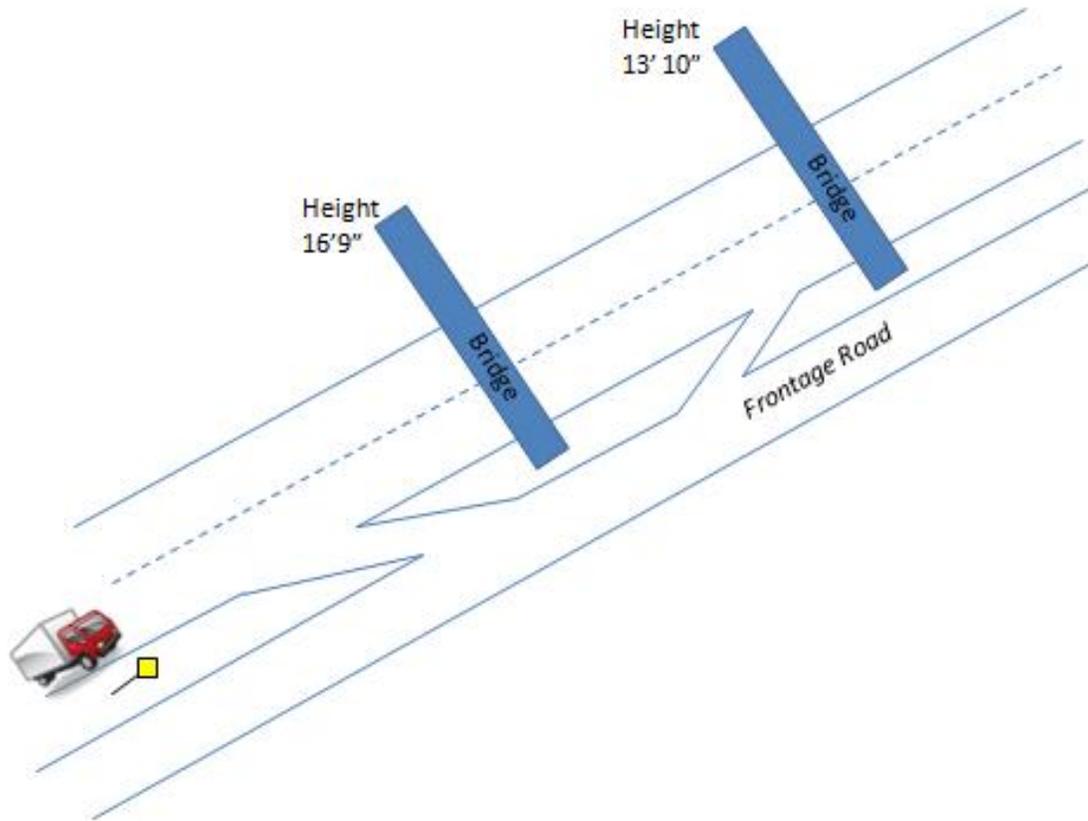
TxDOT personnel identified the concern that sometimes a bridge clearance sign is needed to identify a bridge that is currently not visible to a driver due to distance and is also beyond another bridge of higher height that is within the view of the driver. The reason for needing to identify this distant bridge at the earlier point is that it is the last exit before vehicles will encounter this height restriction. [Figure 43](#) shows an illustration of this situation.

Figure 43. Situation Illustration.

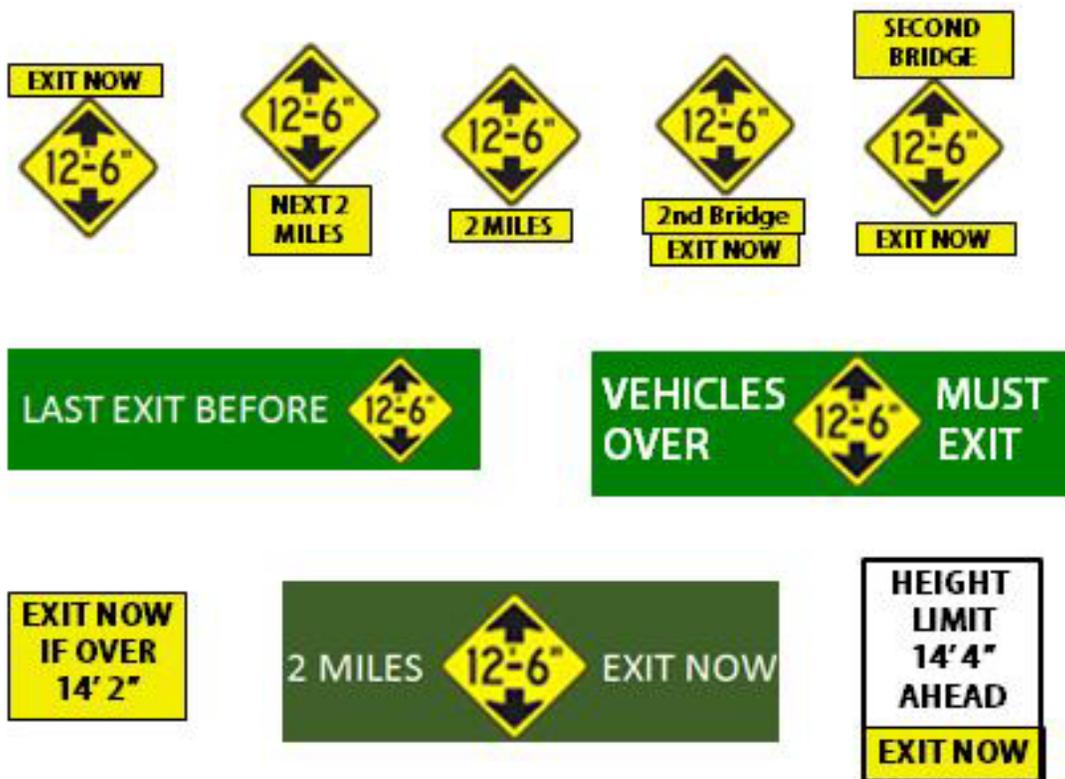
Although researchers believed that all three of these information elements were important to drivers, there was also discussion that not all of the element may be needed to convey the critical point to a driver. To illustrate this point, Figure 44 shows the information combinations created within sign designs for use on the highway. Note that in some cases a distance is used on the sign without an action (exit now) and vice versa. Researchers believed that it may be possible for drivers to infer the need to exit without both of these information elements. However, in all signing alternatives researchers felt that the height information was not mandatory to ensure correct audience for the action.

Figure 44. Expert Panel Sign Alternatives.

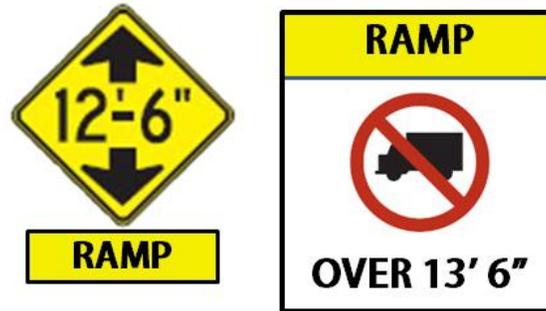
Figure 45. Entrance Ramp Sign Alternatives.

With respect to the concern of vehicles not using a specific entrance ramp to enter or re-enter the highway, researchers developed two signing alternatives. The primary information difference for this signing as compared to typical bridge height signing was that the sign needed

to be understood to only apply to the ramp and not to the frontage road. Figure 45 shows the two sign alternatives that were developed for this application.

Once this collection of signs had been identified, researchers narrowed the group of alternatives for evaluation in a human factors study based on the fact that multiple designs provided the exact same information and the comprehension evaluation would not benefit multiple signs with the exact same information. Figure 46 shows the group of six signs that will be evaluated for highway use during the human factors study. Both of the ramp sign designs will also be evaluated.

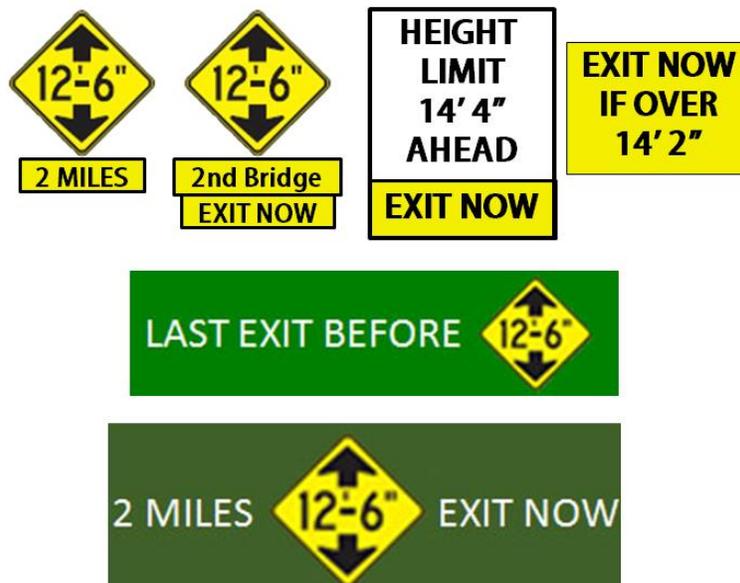
Figure 46. Signs for Survey Evaluation.
