**VOLUME V: APPENDIX D -  
CRASH TESTING AND EVALUATION OF A  
WASHINGTON, DC, PL-1 BRIDGE RAIL**

**Research Study No. RF 471470  
Contract No. DTFH61-89-C-00089**

"Testing of State Roadside Safety Systems"

**Texas Transportation Institute**  
THE TEXAS A & M UNIVERSITY SYSTEM  
COLLEGE STATION, TEXAS

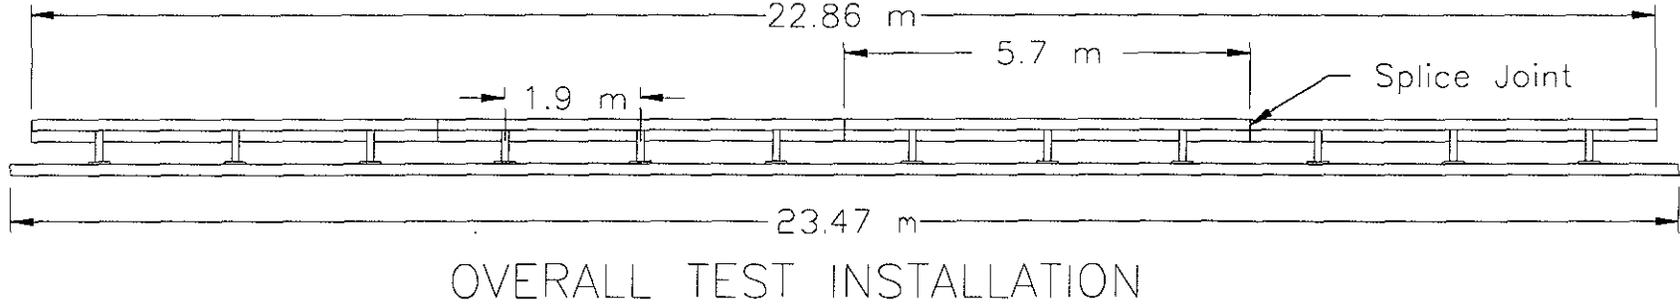
Figure 1. Washington, DC, historic bridge rail overall test installation.

The overall test installation consisted of a 23.5-m- (77-ft-) long simulated bridge deck and a 22.9-m- (75-ft-) long bridge railing, as shown in figure 1. The simulated bridge deck was attached to an existing simulated bridge deck foundation and cantilevered out for a length of 1.02 m (40 in). It should be noted that the bridge railing is typically used with a sidewalk behind the railing for pedestrian traffic. However, for the purpose of evaluating the impact performance of the bridge railing, the pedestrian sidewalk was not deemed necessary and thus was not included in the test installation. Details of the steel reinforcement are shown in figure 2. The bridge railing sat on top of a 15.2-cm- (6-in-) high curb with cutouts for anchoring the base plates of the metal bridge railing posts.

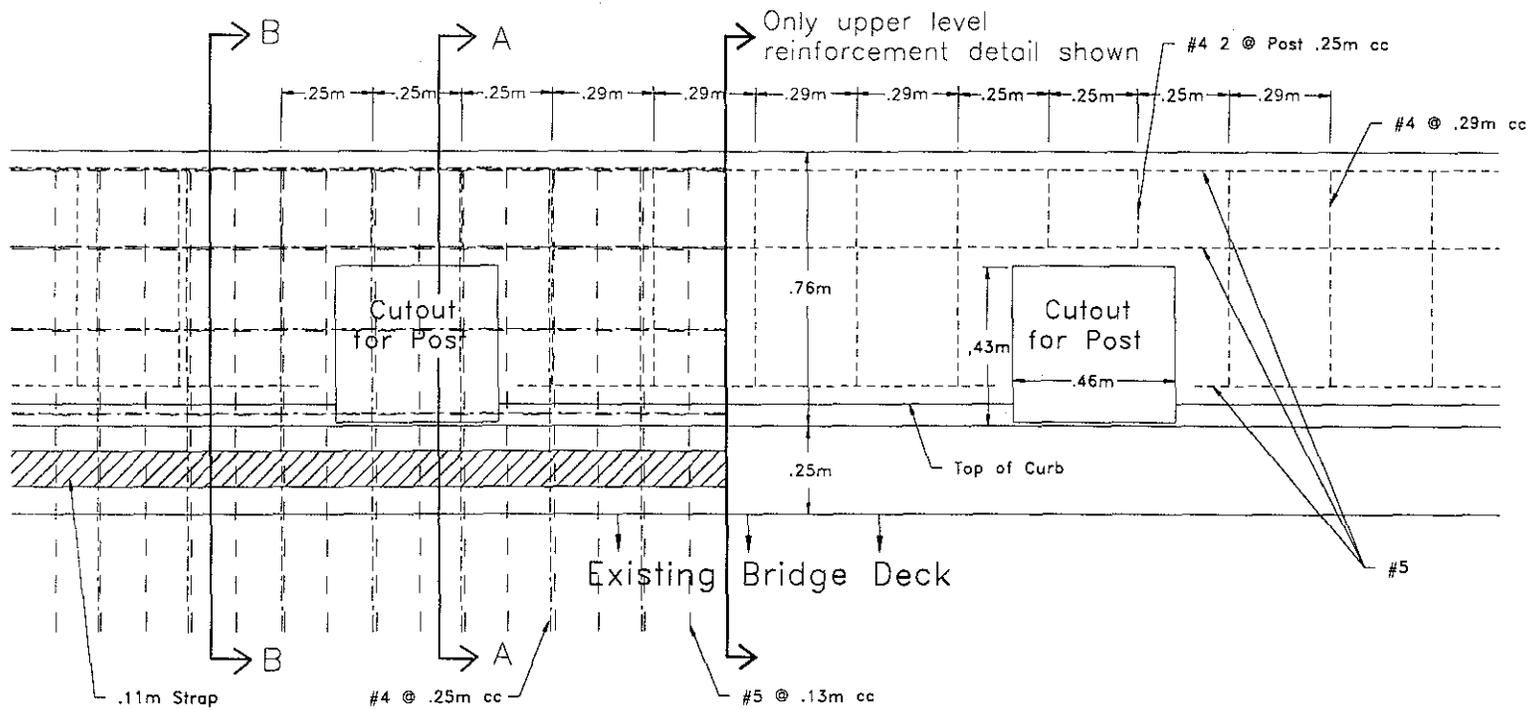
Figure 2. Steel reinforcement details for Washington, DC, historic bridge rail.

PLAN VIEW OF REINFORCEMENT DETAILS

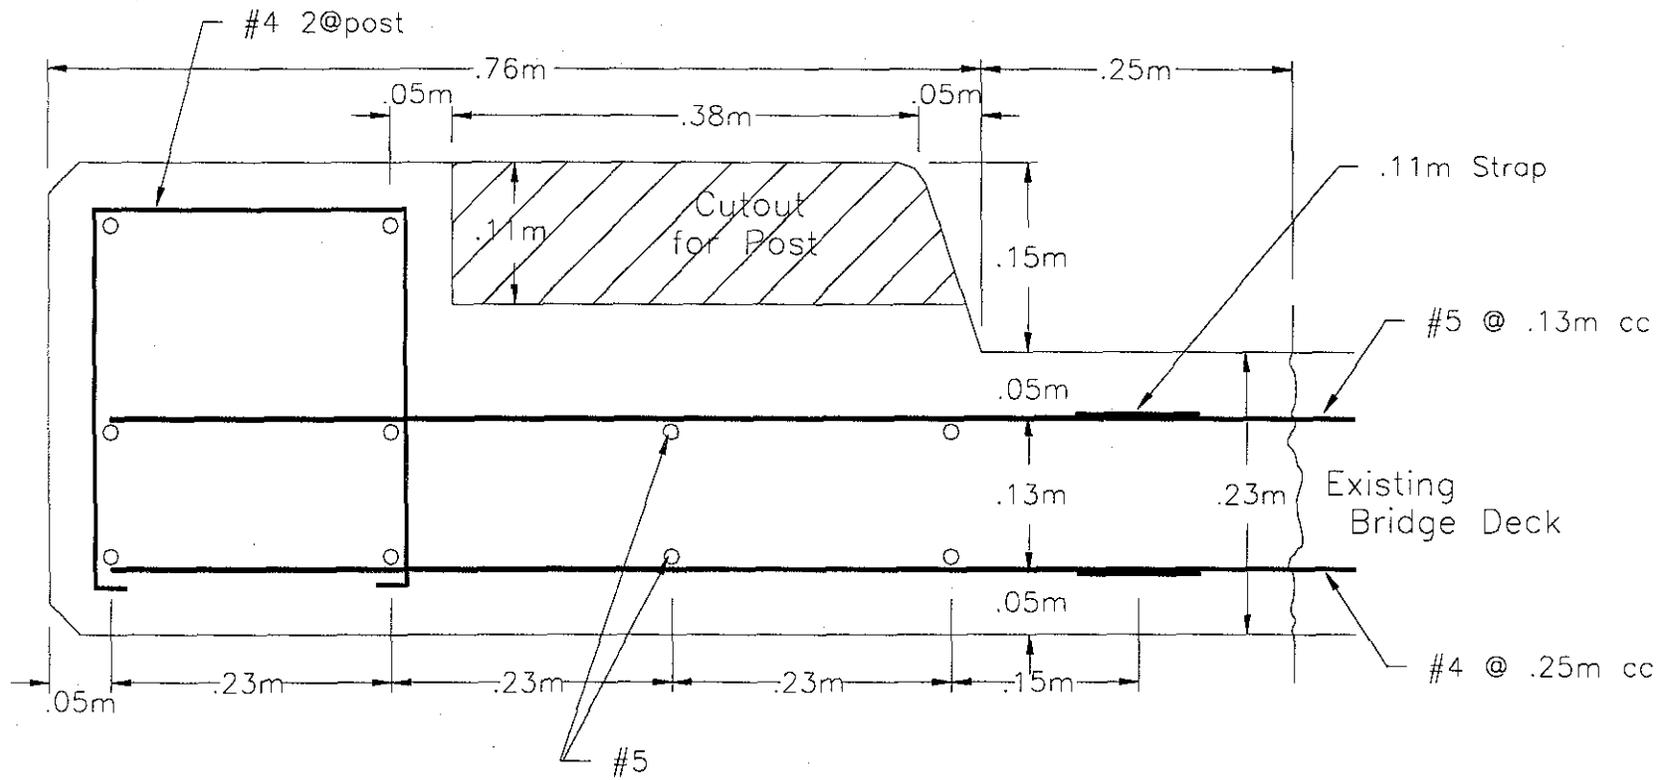
Figure 2. Steel reinforcement details for Washington, DC, historic bridge rail (continued).

### SECTION A-A

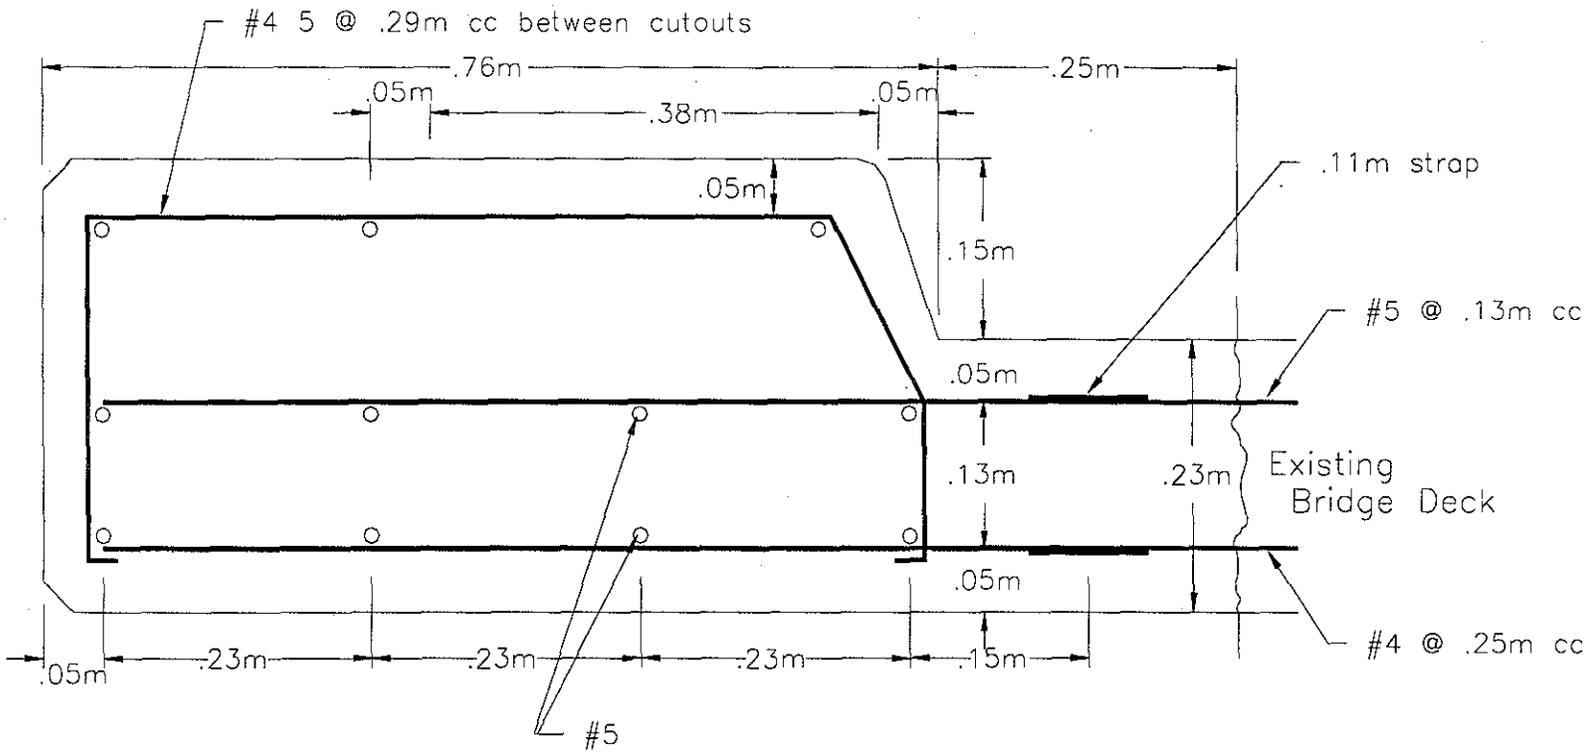
Figure 2. Steel reinforcement details for Washington, DC, historic bridge rail (continued).

### SECTION B-B

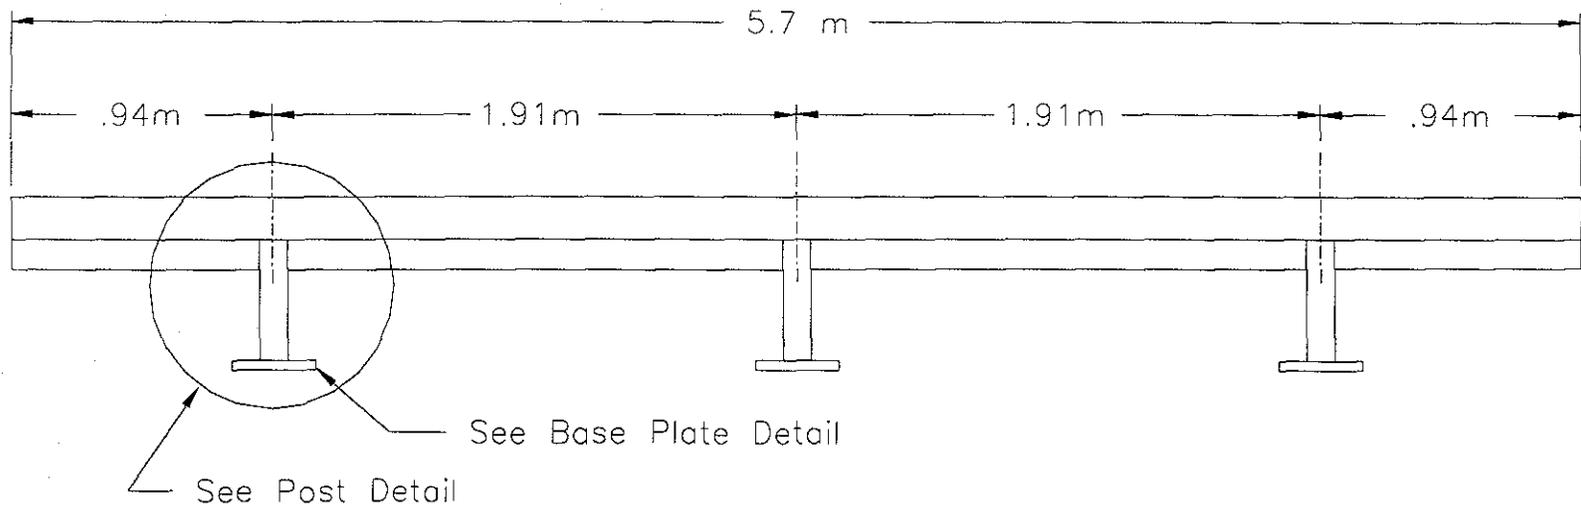
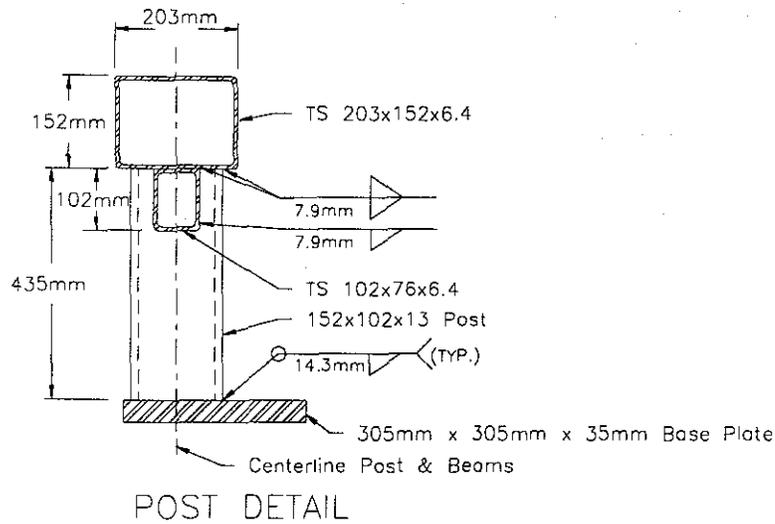
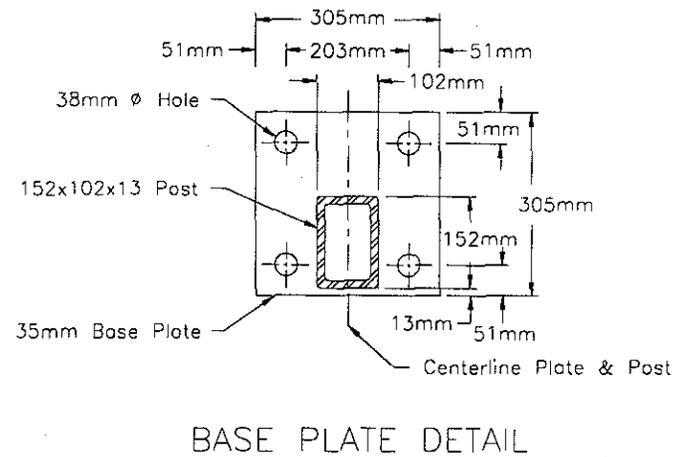
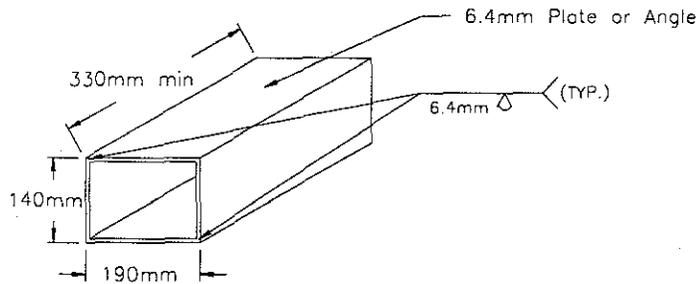
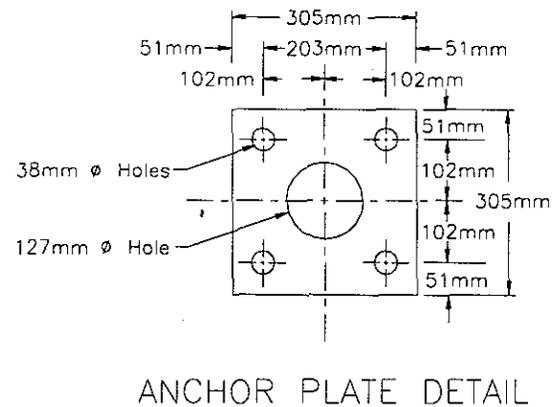
Figure 3. Details of metal bridge railing for Washington, DC, historic bridge rail.

Each railing post was welded to a 305-mm  $\times$  305-mm  $\times$  25.4-mm (12-in  $\times$  12-in  $\times$  1-in) base plate and attached to the simulated bridge deck using four 32-mm- (1-1/4-in-) diameter high-strength bolts that were built into the bridge deck with an anchor plate. Grout pads, approximately 25.4-mm (1-in) thick, were used under the base plates to level the bridge railing and to adjust the height of the bridge railing to 686 mm (27 in). The cutouts were then backfilled with concrete after installation of the metal bridge railing. Photographs of the completed test installation are shown in figure 4.

TYPICAL RAIL SECTION

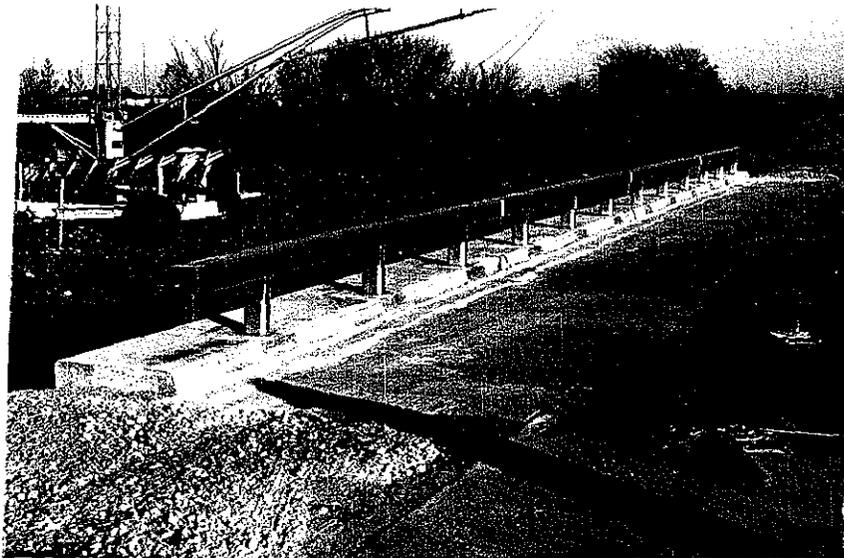
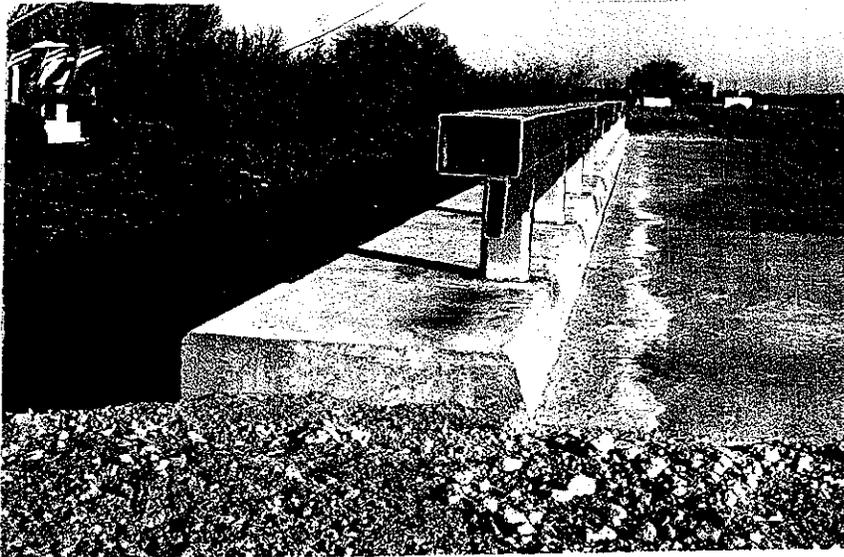
Figure 5. Washington, DC, historic bridge rail before testing (overall view).

These box beams were welded to the bottom of the TS 203-mm × 152-mm × 6.4-mm (8-in × 6-in × 1/4-in) box beam and to the sides of the posts. This modification would reduce the height of the opening beneath the beam element and thus reduce the potential of the bumper and the front wheel of the vehicle to underride the beam element and snag on the posts. The modified bridge rail design was then crash tested in the next two crash tests (test nos. 471470-8 and 471470-9). Photographs of the modified test installation are shown in figures 5 and 6.

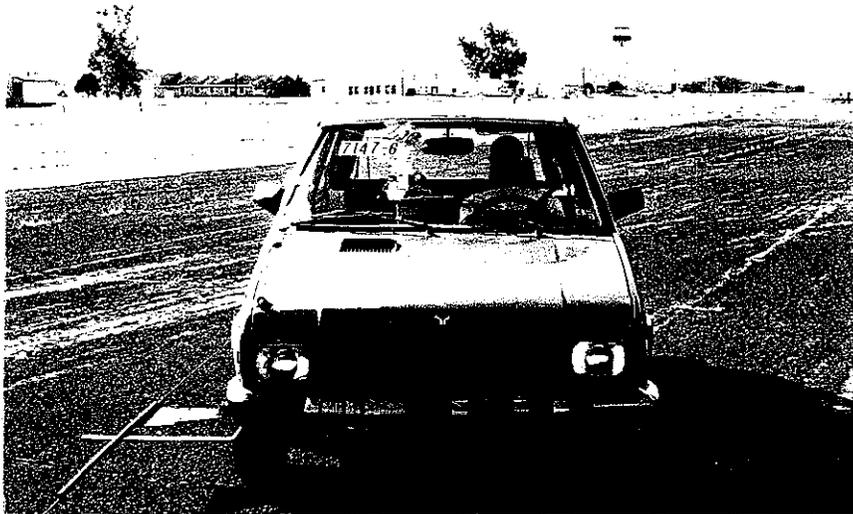
Figure 7. Vehicle prior to test 7147-6.

A 1987 Yugo GV, shown in figures 7 and 8, was used for this crash test on the original bridge railing design. Test inertia weight of the vehicle was 817 kg (1800 lb) and its gross static weight was 894 kg (1970 lb). The height to the lower edge of the vehicle bumper was 343 mm (13.5 in) and it was 470 mm (18.5 in) to the upper edge of the bumper. Additional dimensions and information on the vehicle are given in figure 9. The vehicle was directed into the bridge railing using the cable reverse tow and guidance system, and was released to be free-wheeling and unrestrained just prior to impact.

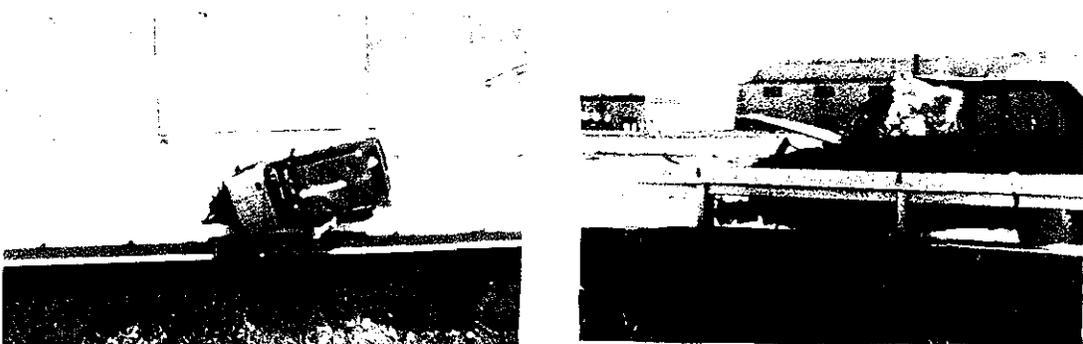
Figure 10. Sequential photographs for test 7147-6 (overhead and behind the rail views).

The vehicle impacted the bridge railing midspan between posts 3 and 4, or approximately 5.72 m (18 ft 9 in) downstream from the upstream end of the bridge railing, at a speed of 82.4 km/h (51.2 mi/h) and at an angle of 20.1 degrees. As the vehicle bumper contacted the bridge rail, the left front tire contacted the curb at the same time. At 0.028 s after initial impact, the left front tire appeared to partially air out. At 0.030 s after initial impact, the vehicle bumper hit post 4 and the vehicle began to redirect. The left front tire of the vehicle mounted the curb at 0.033 s and contacted post 4 at 0.053 s, at which time the roof of the vehicle began to buckle. Tire marks indicated that the left front tire folded and went underneath the box beam and overlapped post 4 by a distance of 254 mm (10 in). At 0.059 s, the tires began to pull to the left. The front bumper began to come apart at approximately 0.072 s and was extending out behind the rail at 0.080 s. There was sudden left steer input again at 0.087 s. The front bumper of the vehicle contacted post 5 at 0.134 s. At

After the vehicle exited from the bridge rail, the bumper struck post 6 at 0.282 s and cleared the rail at 0.292 s. The left front tire dropped off the curb at 0.377 s. Because of the damage sustained by the left front tire and the orientation of the front tires, the vehicle turned back toward the bridge rail after exiting the bridge rail from the initial impact and impacted the bridge rail again near post 8 and rode along the bridge rail until the end of the bridge rail. The brakes were applied after the vehicle cleared the test installation, and the vehicle came to rest 32.0 m (105 ft) downstream from and 7.6 m (25 ft) behind the point of initial impact. Sequential photographs of the test sequence are presented in figures 10 and 11.

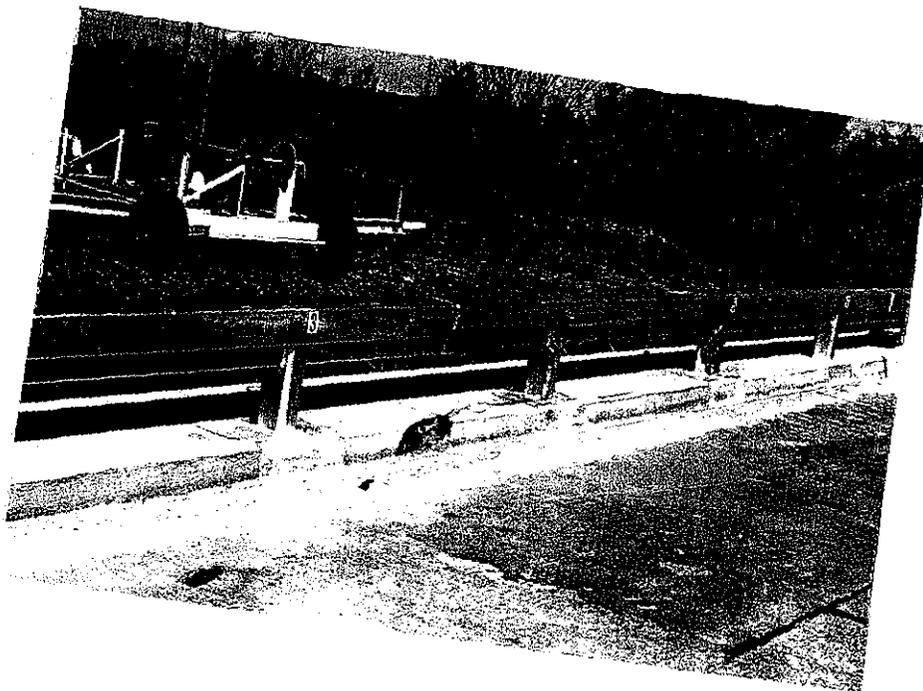
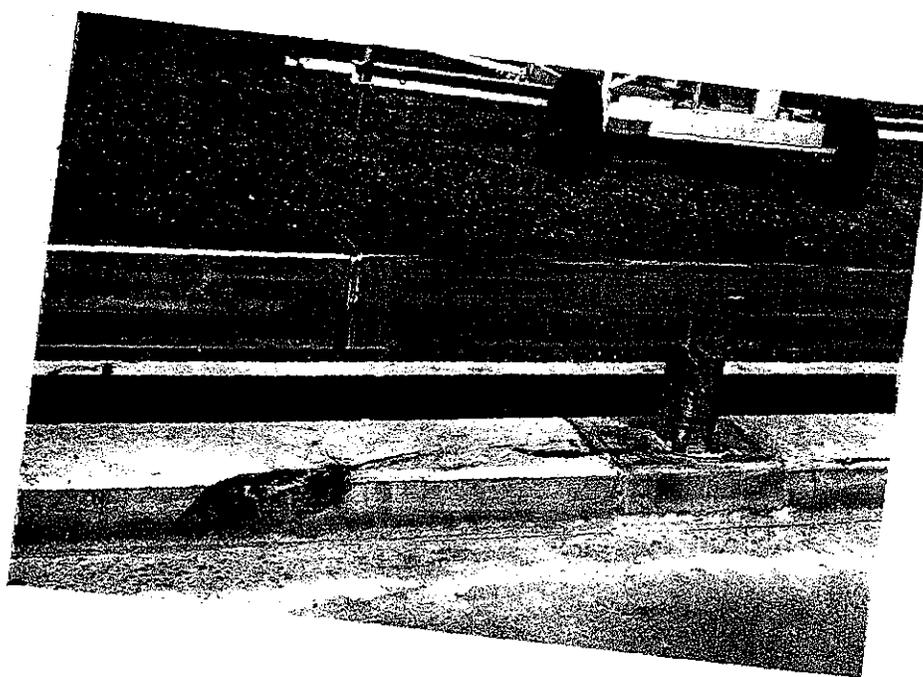
Figure 12. Washington, DC, historic bridge rail after test 7147-6.

The bridge rail system received minimal damage, as shown in figure 12. There was no permanent deformation of the bridge railing. The total length of-contact for the initial impact was 4.0 m (13.0 ft). Tire marks extended 254 mm (10.0 in) under the rail element at post 4.

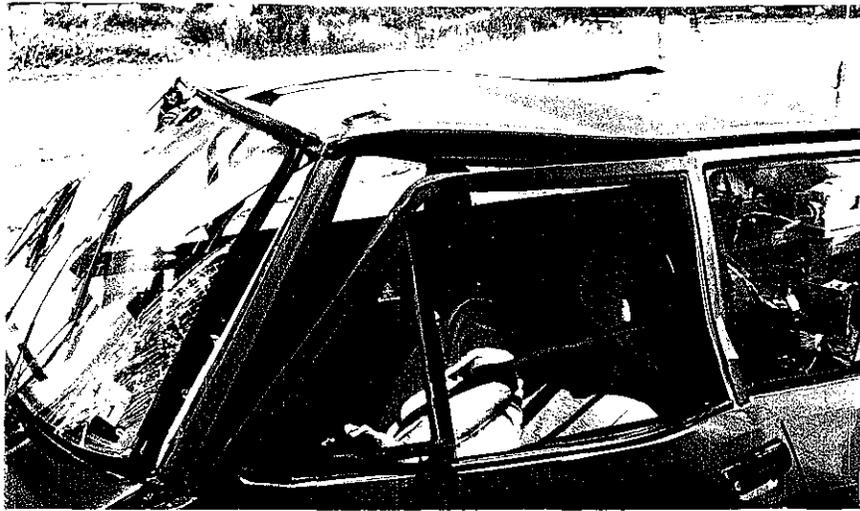
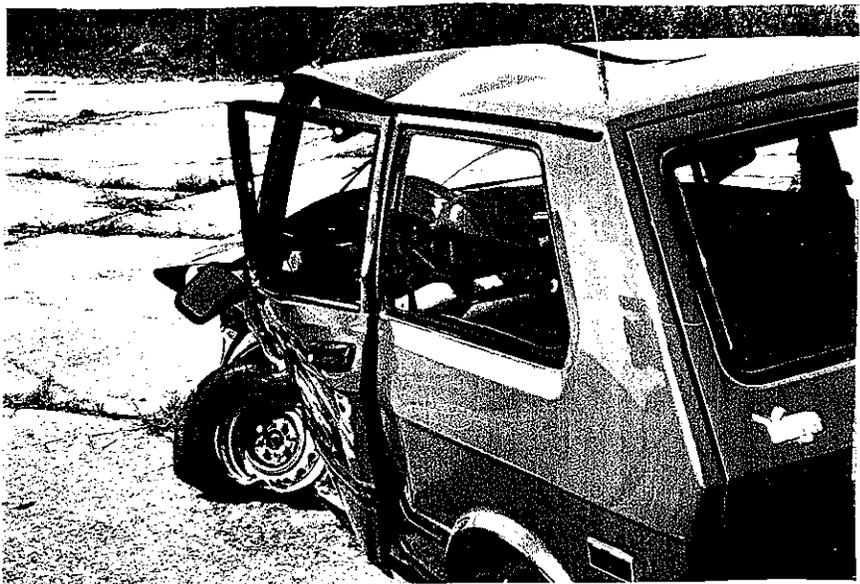
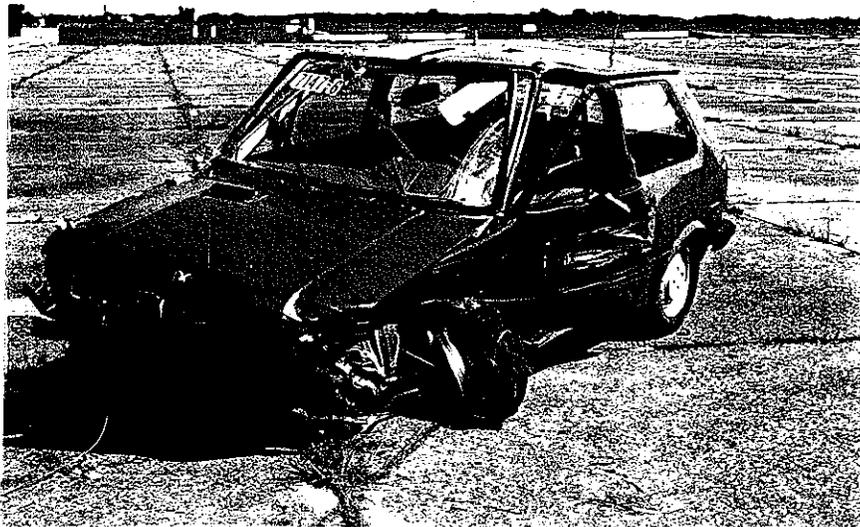
Figure 13. Vehicle after test 7147-6.

The vehicle (shown in figure 13) sustained extensive damage. The sway bar, left strut, and inner C.V. joint was damaged. The windshield was broken, and the roof, floor pan and instrument panel were bent. There was damage to the front bumper, hood, grill, radiator, left front quarter panel, left rear door and glass, left rear quarter panel, and the rear bumper. The firewall and floor pan were pushed into the steering column and clutch pedal for a maximum intrusion into the occupant compartment of 356 mm (14.0 in). The wheelbase on the right side was shortened from 2.1 m (84.0 in) to 1.7 m (66.5 in). The left front tire and rim were damaged from contact with the posts and the rear tire and rim were damaged in later contact with the curb. Maximum crush to the vehicle was 254 mm (10.0 in) at the left front corner at bumper height.

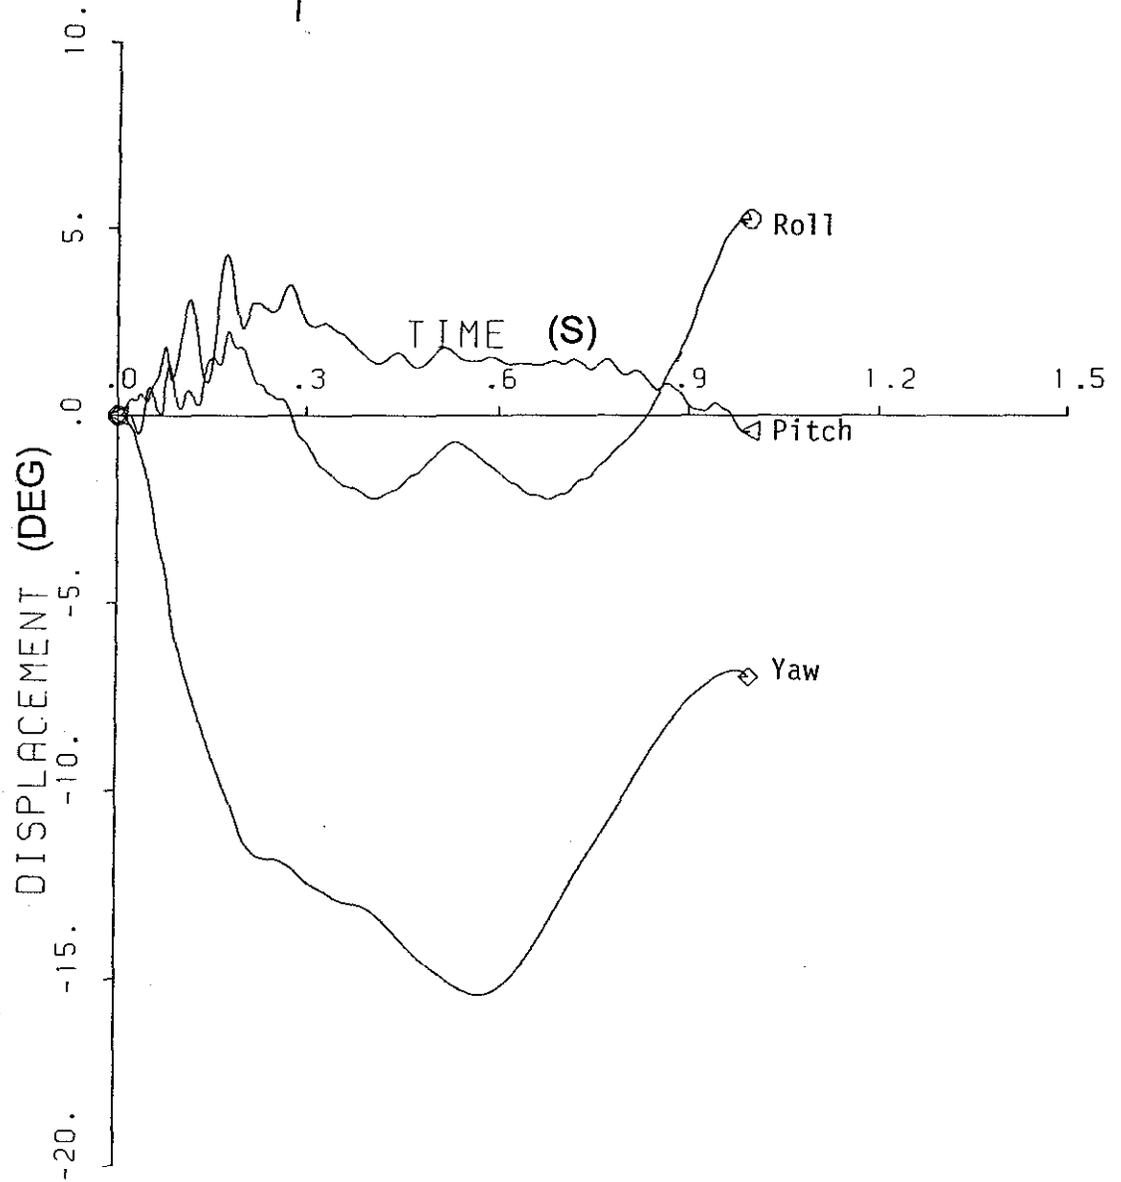
Figure 15. Vehicle angular displacement for test 7147-6.

Axes are vehicle fixed.  
Sequence for determining  
orientation is:

1. Yaw
2. Pitch
3. Roll

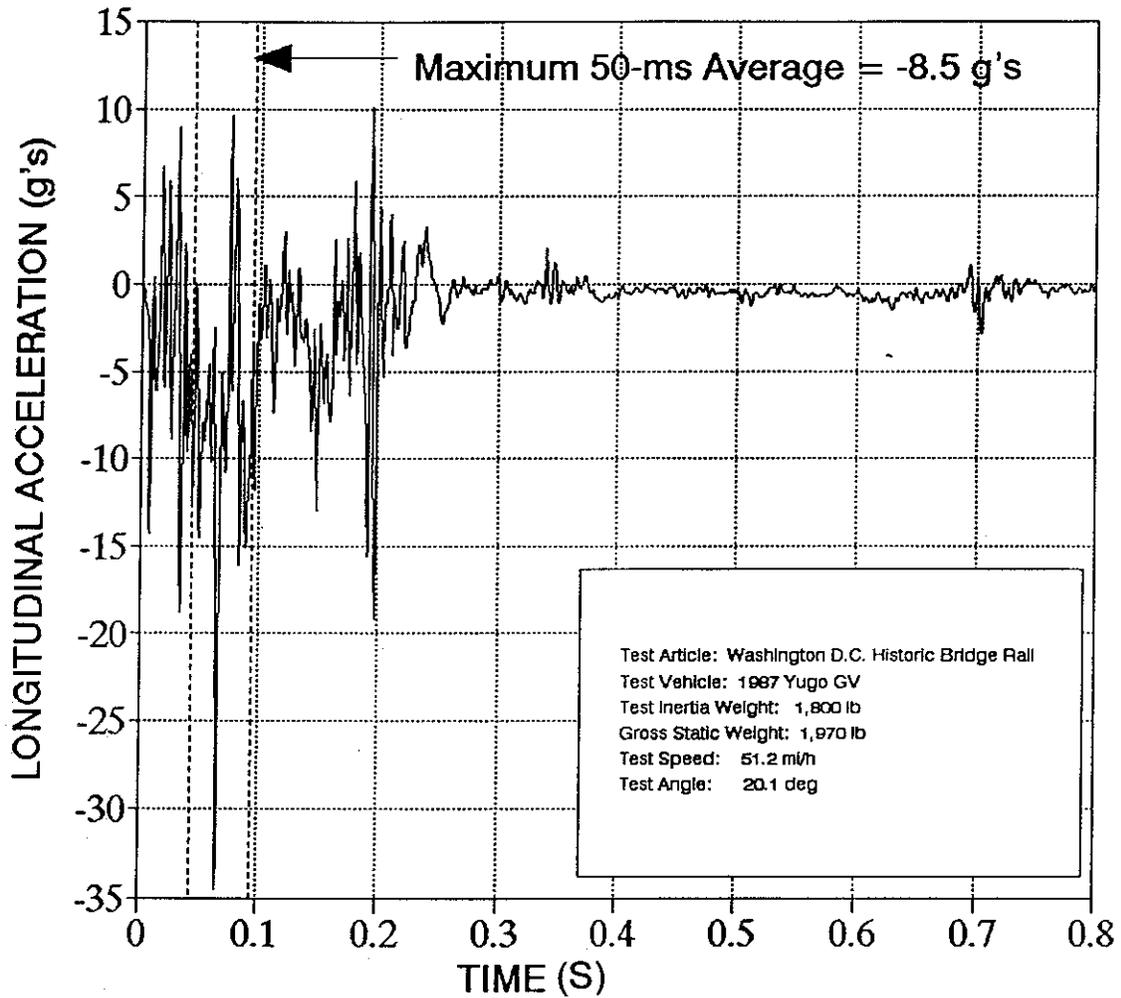
Figure 16. Vehicle longitudinal accelerometer trace for test 7147-6.

## Class 180 Filter - At center of gravity

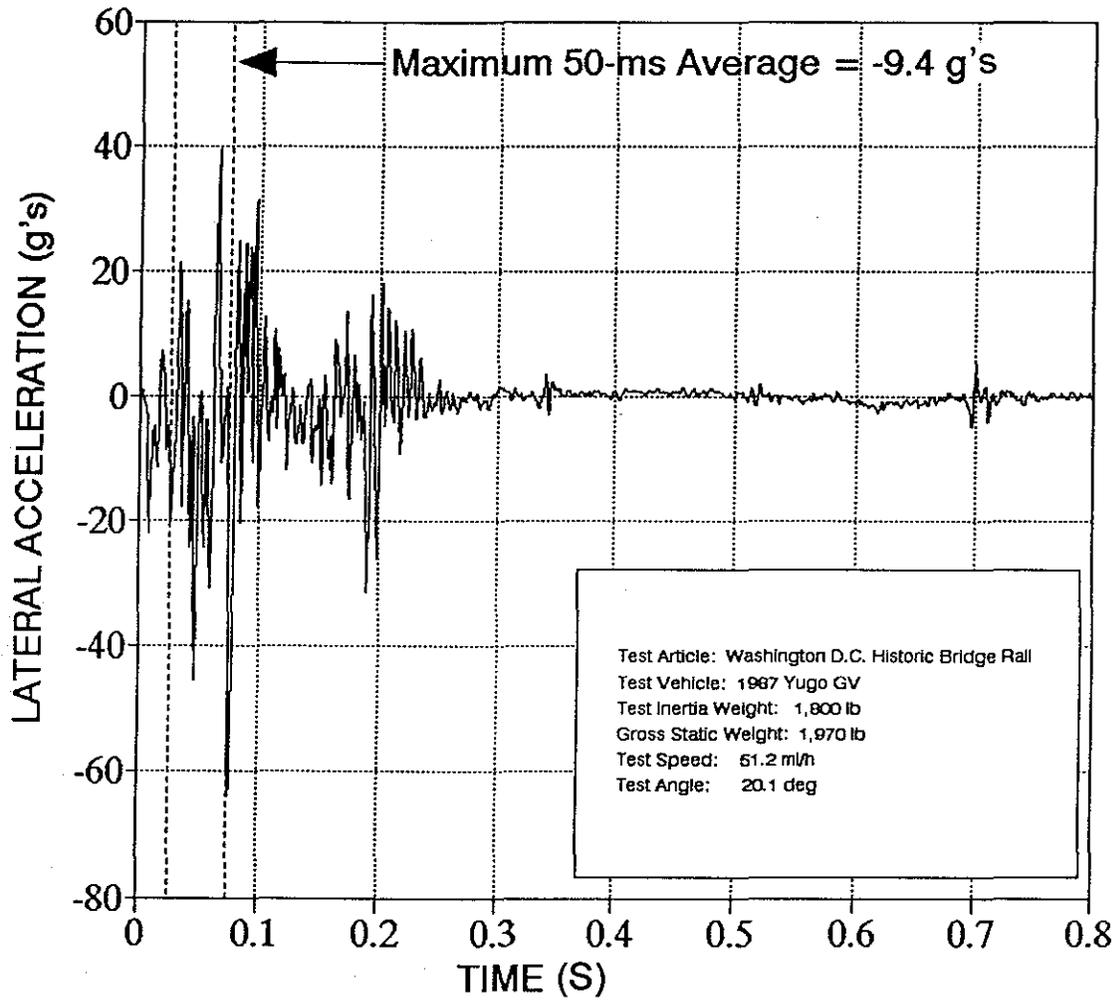
Figure 17. Vehicle lateral accelerometer trace for test 7147-6.

## Class 180 Filter - At center of gravity

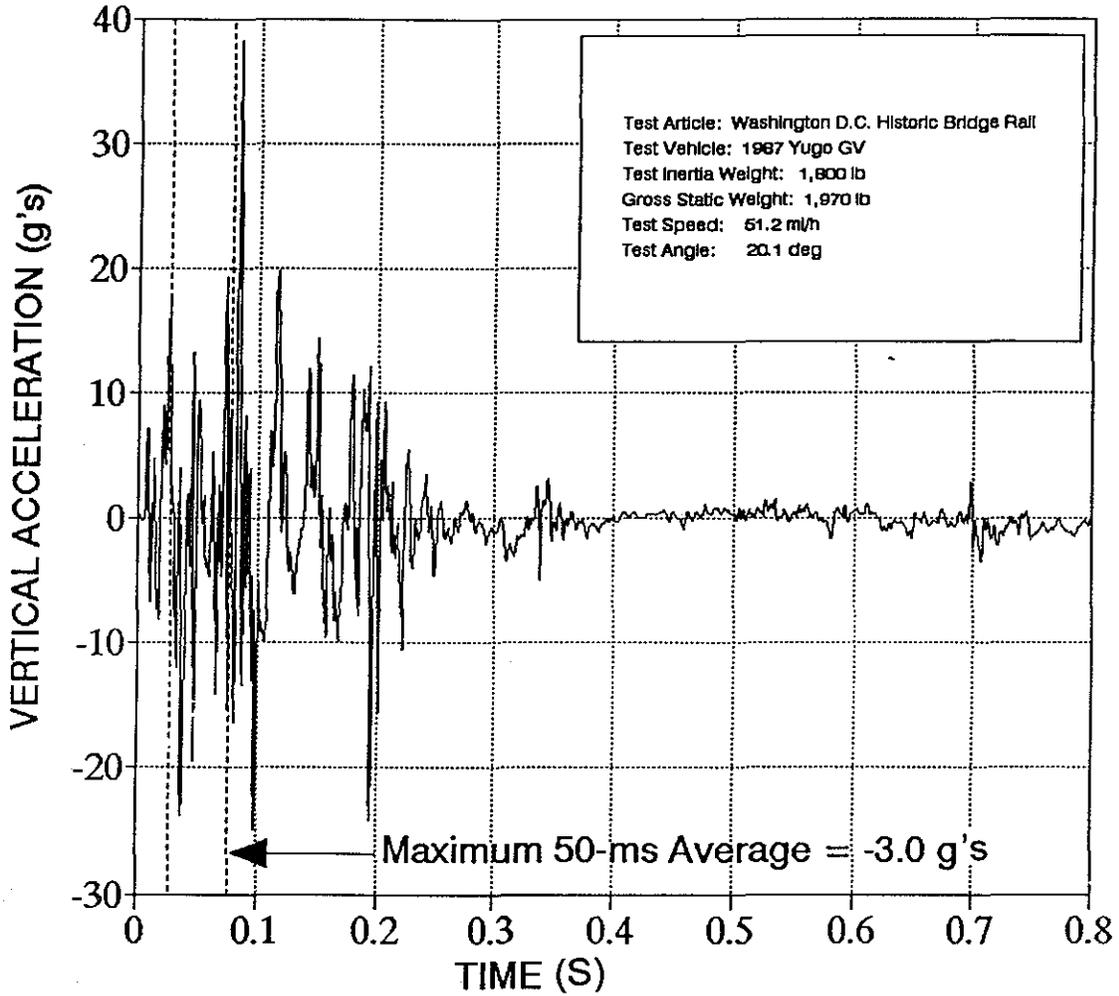
Figure 18. Vehicle vertical accelerometer trace for test 7147-6.

## Class 180 Filter - At center of gravity

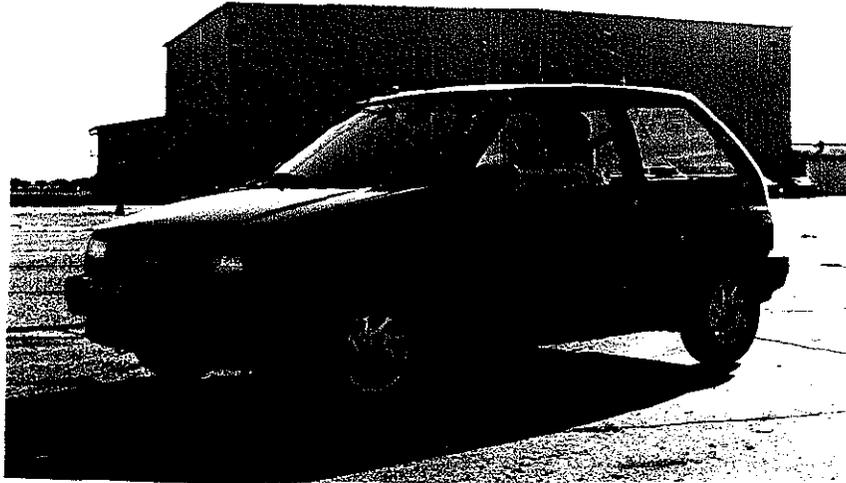
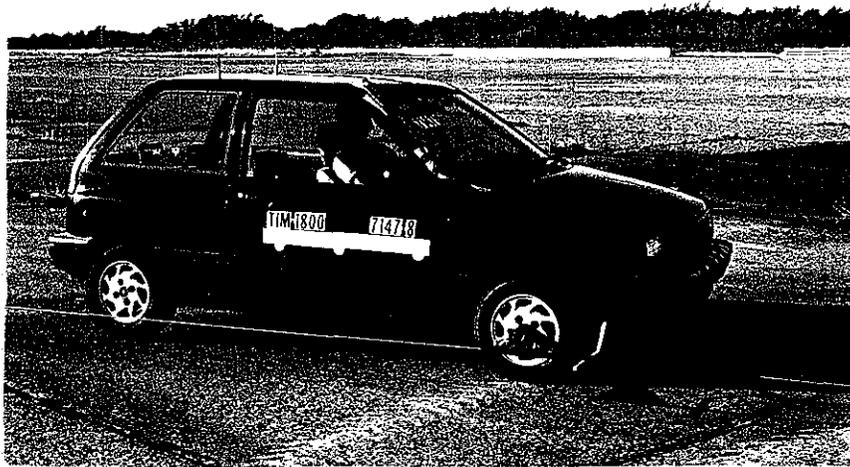
Figure 19. Vehicle before test 7147-8.

A 1988 Ford Festiva, shown in figures 19 and 20, was used for this crash test with the modified bridge railing design. Test inertia weight of the vehicle was 817 kg (1800 lb) and its gross static weight was 892 kg (1965 lb). The height to the lower edge of the vehicle bumper was 349 mm (13.75 in) and it was 502 mm (19.75 in) to the upper edge of the bumper. Additional dimensions and information on the vehicle are given in figure 21. The vehicle was directed into the bridge railing using the cable reverse tow and guidance system, and was released to be free-wheeling and unrestrained just prior to impact.

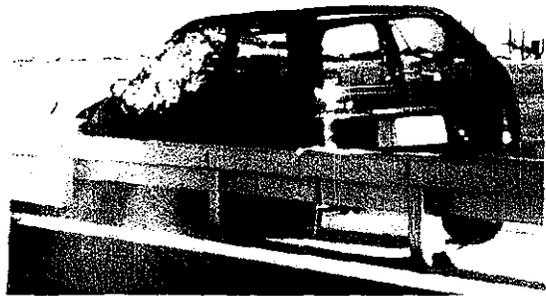
Figure 22. Sequential photographs for test 7147-8 (overhead and behind the rail views) (continued).

The vehicle impacted the bridge railing midspan between posts 3 and 4, or approximately 5.72 m (18 ft 9 in) downstream from the upstream end of the bridge railing, at a speed of 80.0 km/h (49.7 mi/h) and at an angle of 21.5 degrees. As the vehicle bumper contacted the bridge rail, the left front tire contacted the curb at the same time. The front of the vehicle began to shift to the right at 0.017 s after initial impact, and at 0.019 s the left front tire aired out. At 0.028 s after initial impact, the vehicle began to redirect. The left front tire of the vehicle mounted the curb at 0.043 s and contacted post 4 at 0.077 s. Tire marks indicated that the left front tire went underneath the box beam a distance of 64 mm (2.5 in) just before impacting post 4. At 0.152 s, the vehicle was traveling parallel to the bridge rail system at a speed of 65.3 km/h (40.6 mi/h) and the rear of the vehicle contacted the rail at 0.160 s. The vehicle exited the bridge rail at 0.239 s, traveling at a speed of 64.5 km/h (40.1 mi/h), with an exit angle of 3.5 degrees. The brakes were applied after the vehicle cleared the test installation, and the vehicle came to rest 59 m (195 ft) downstream from and 29 m (95 ft) forward of the point of initial impact. Sequential photographs of the test sequence are presented in figures 22 and 23.

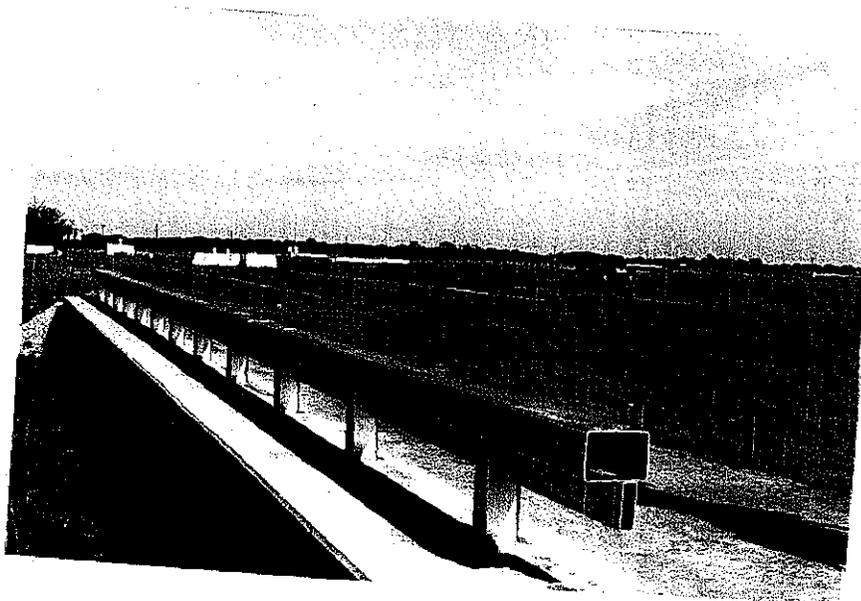
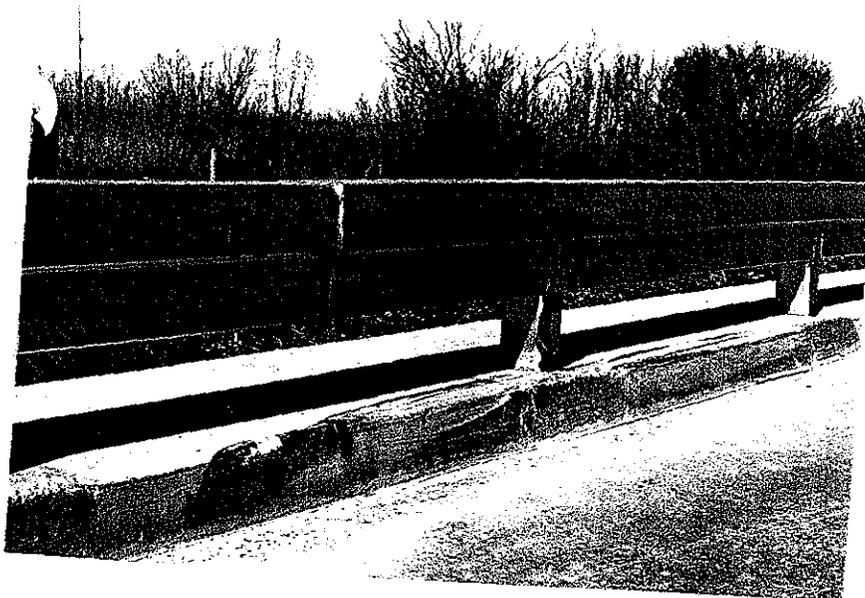
Figure 24. Test site and bridge rail after 7147-8.

The bridge railing received minimal damage, as shown in figure 24. There was no permanent deformation of the bridge railing. The total length of contact with the rail was 2.5 m (8.3 ft). Tire marks extended 64 mm (2.5 in) under the rail element just before post 4.

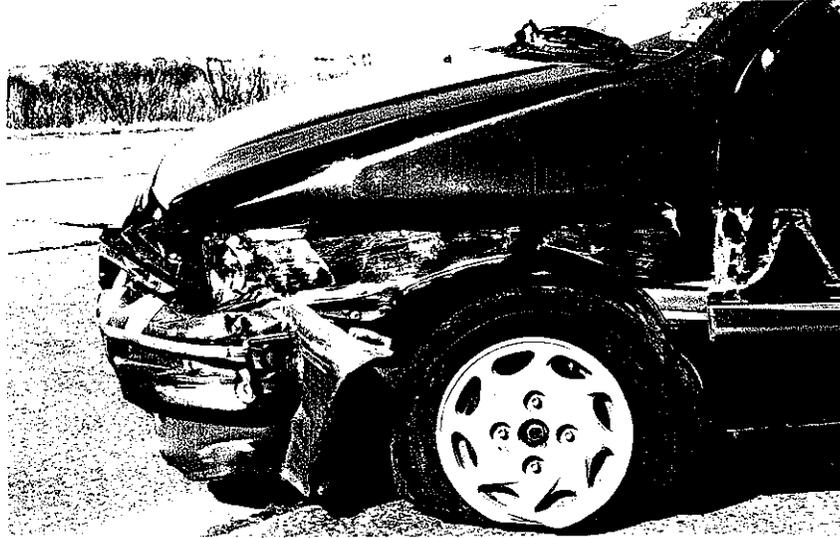
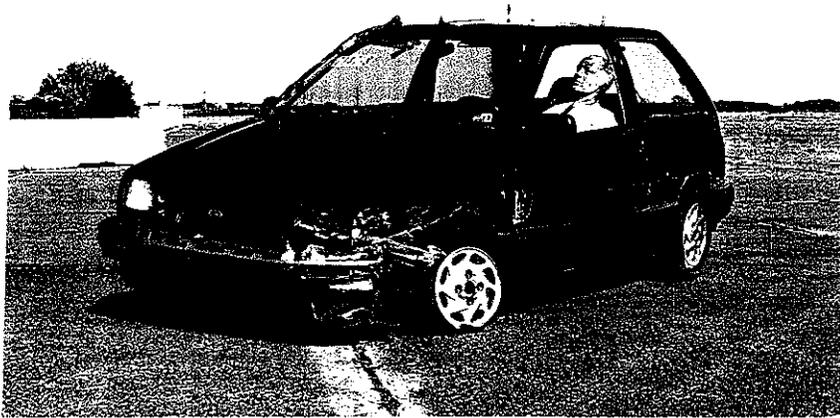
Figure 25. Vehicle after test 7147-8.

The vehicle (shown in figure 25) received moderate damage. The left strut and C.V. joint were damaged. The driver's window was broken and there was damage to the front bumper, hood, grill, radiator, left front quarter panel, left door, left rear quarter panel, and the

rear bumper. The wheelbase on the left side was shortened from 2.3 m (90.25 in) to 2.2 m (87.0 in). The left front tire and rim were damaged from contact with the curb and post 4. Maximum crush to the vehicle was 216 mm (8.5 in) at the left front corner at bumper height.

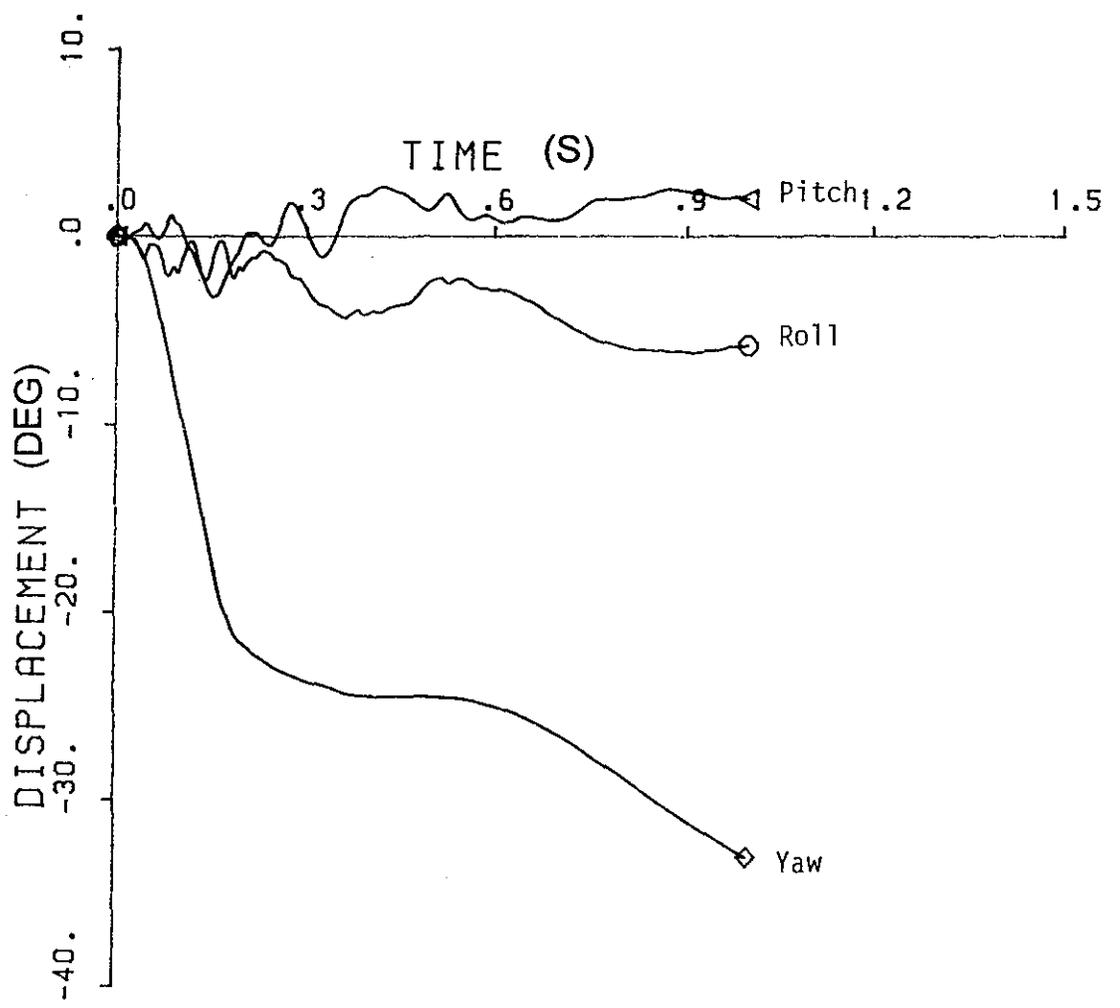
Figure 27 . Vehicle angular displacements for test 7147-8.

Axes are vehicle fixed.  
 Sequence for determining orientation is:

1. Yaw
2. Pitch
3. Roll

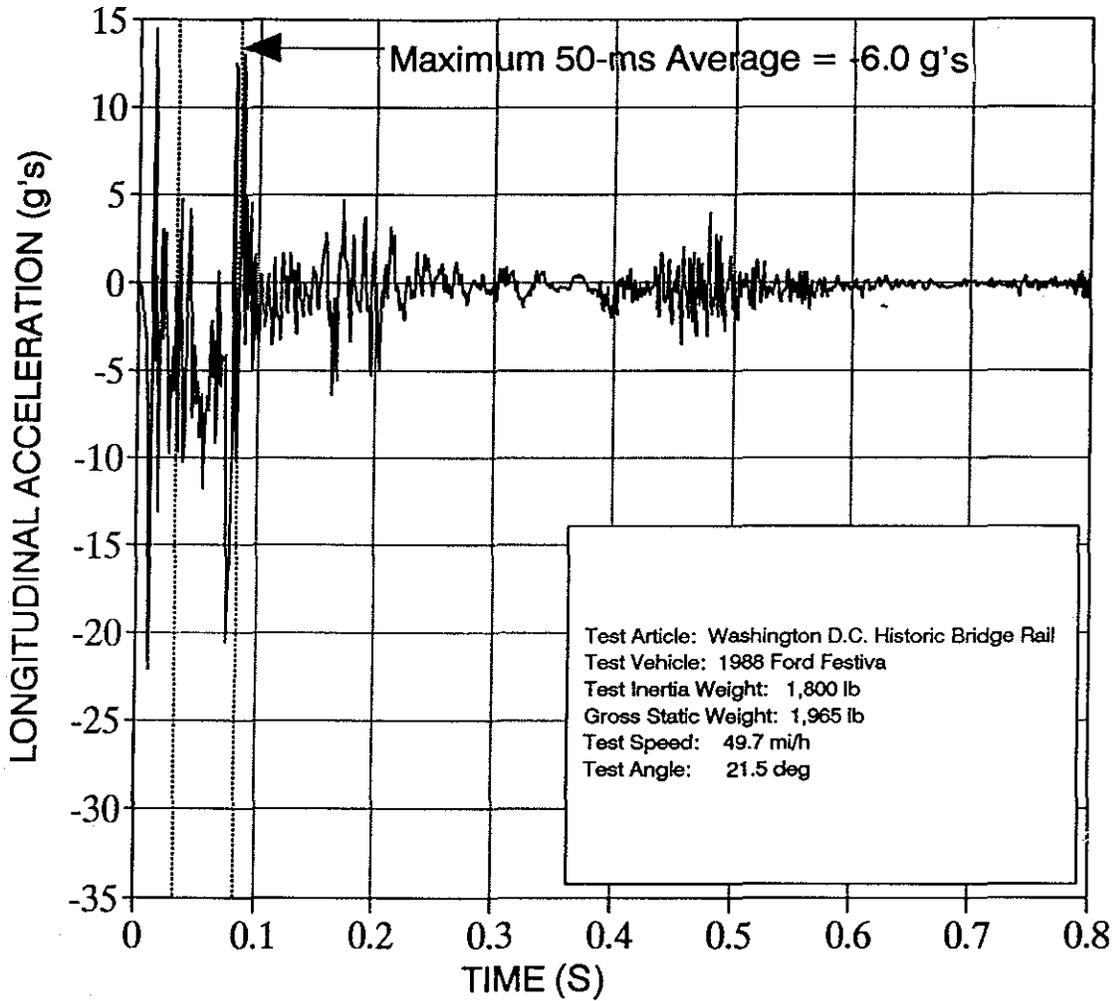
Figure 28. Vehicle longitudinal accelerometer trace for test 7147-8.

## Class 180 Filter - At center of gravity
