**VOLUME V: APPENDIX D -  
CRASH TESTING AND EVALUATION OF A  
WASHINGTON, DC, PL-1 BRIDGE RAIL**

**Research Study No. RF 471470  
Contract No. DTFH61-89-C-00089**

"Testing of State Roadside Safety Systems"

**Texas Transportation Institute**  
THE TEXAS A & M UNIVERSITY SYSTEM  
COLLEGE STATION, TEXAS

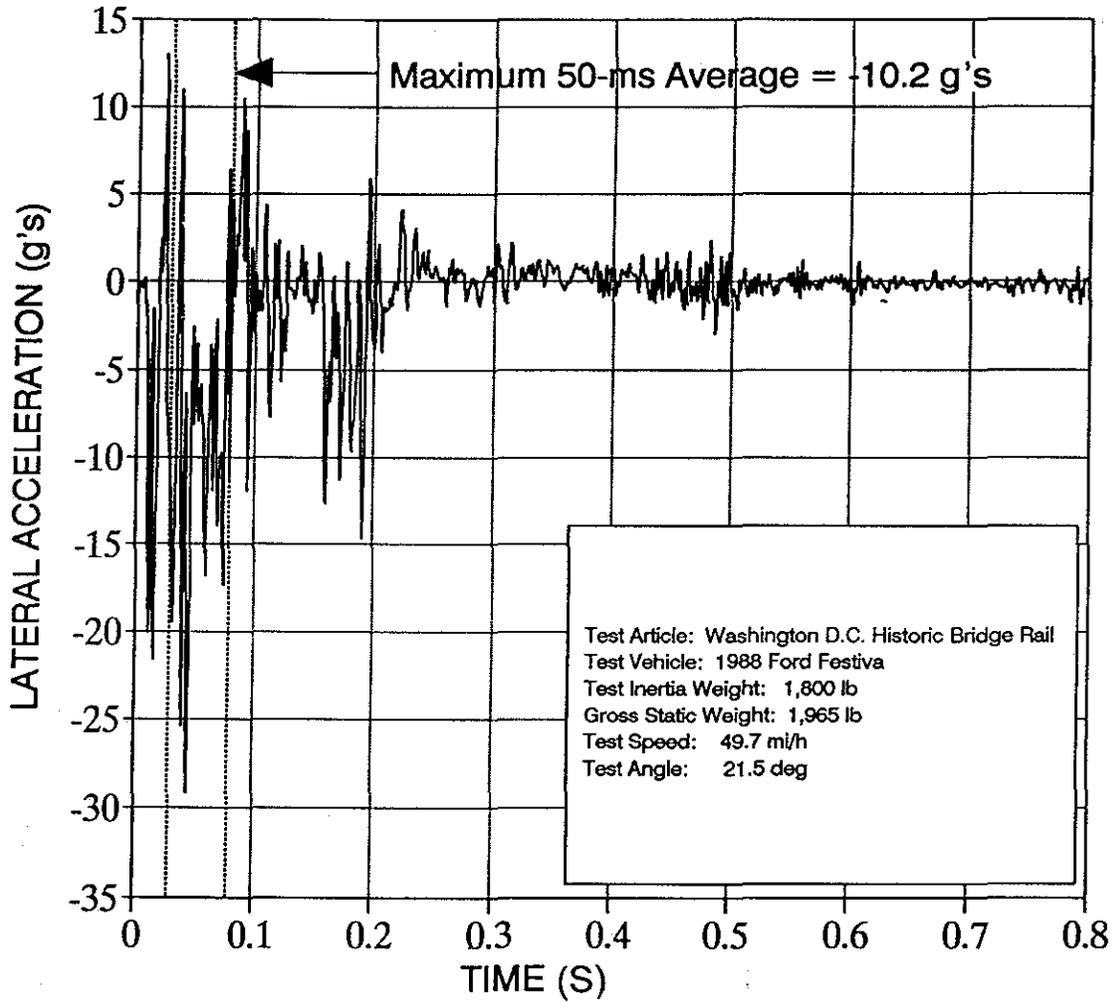
Figure 29. Vehicle lateral accelerometer trace for test 7147-8.

## Class 180 Filter - At center of gravity

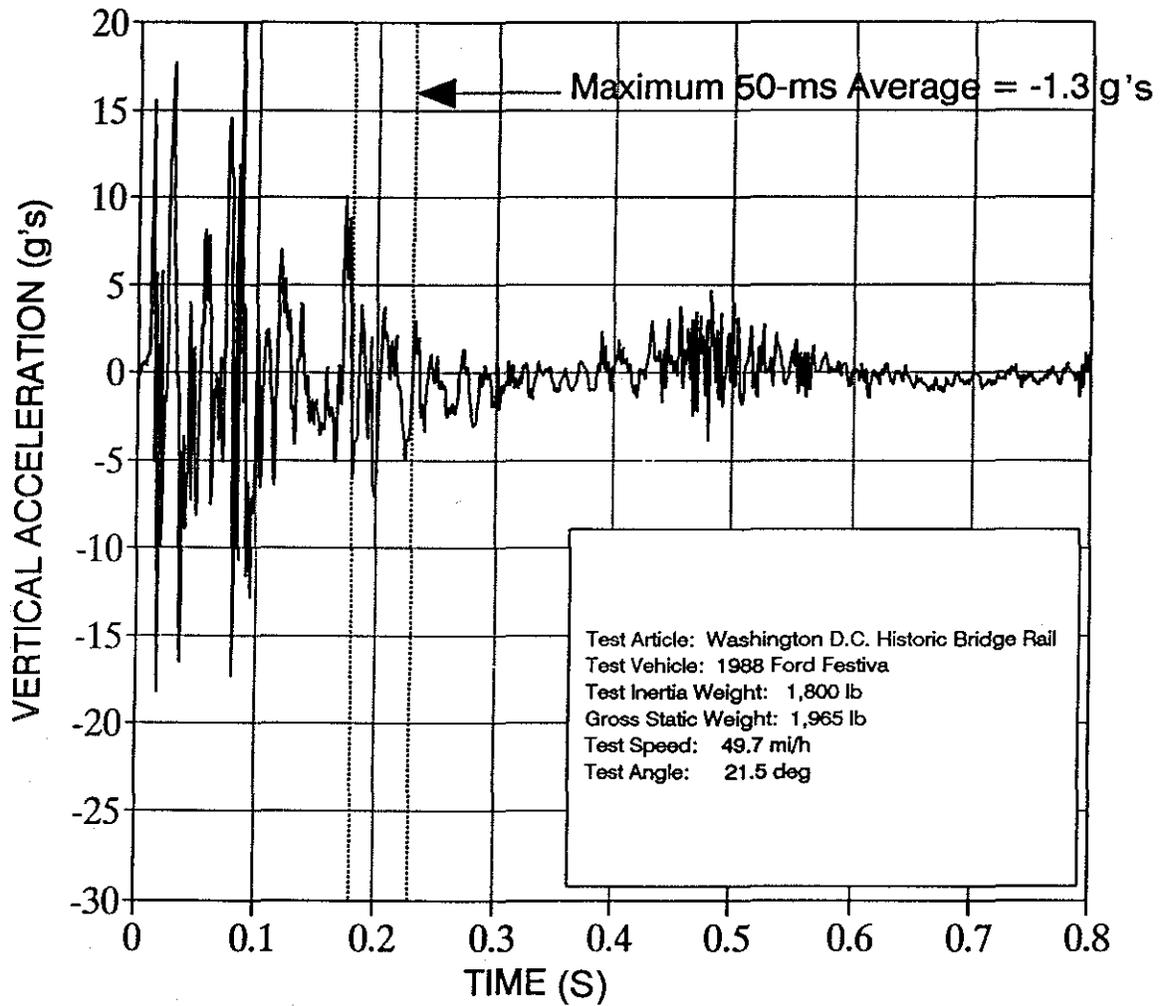
Figure 30. Vehicle vertical accelerometer trace for test 7147-8.

## Class 180 Filter - At center of gravity

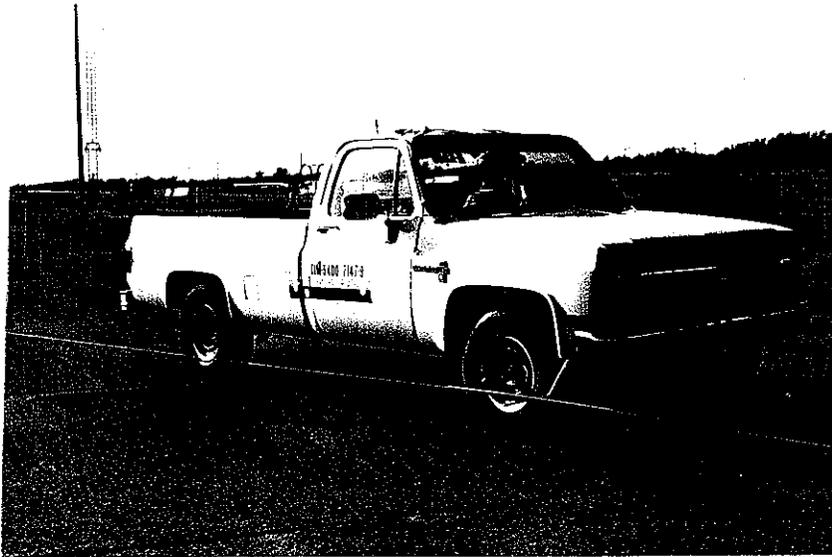
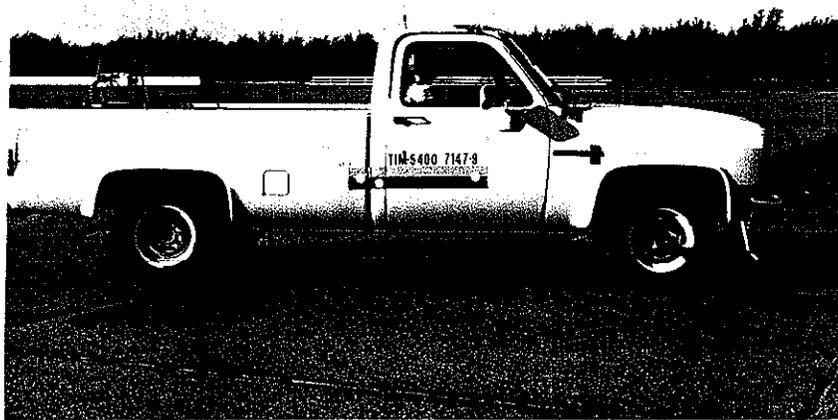
Figure 31. Vehicle before test 7147-9.

A 1986 Chevrolet pickup, shown in figures 31 and 32, was used for the second crash test on the modified bridge rail design. Test inertia weight of the vehicle was 2452 kg (5400 lb) and its gross static weight was 2527 kg (5565 lb). The height to the lower edge of the vehicle bumper was 451 mm (17.75 in) and it was 679 mm (26.75 in) to the upper edge of the bumper. Additional dimensions and information on the vehicle are given in figure 33. The vehicle was directed into the bridge railing using the cable reverse tow and guidance system, and was released to be free-wheeling and unrestrained just prior to impact.

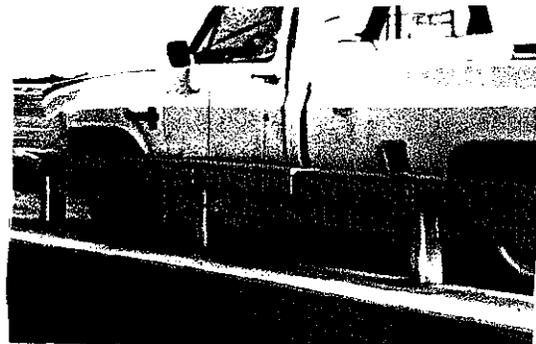
Figure 34. Sequential photographs for test 7147-9 (overhead and behind the rail views).

downstream from and 9 m (30 ft) forward of the point of initial impact. Sequential photographs of the test sequence are presented in figures 34 and 35.

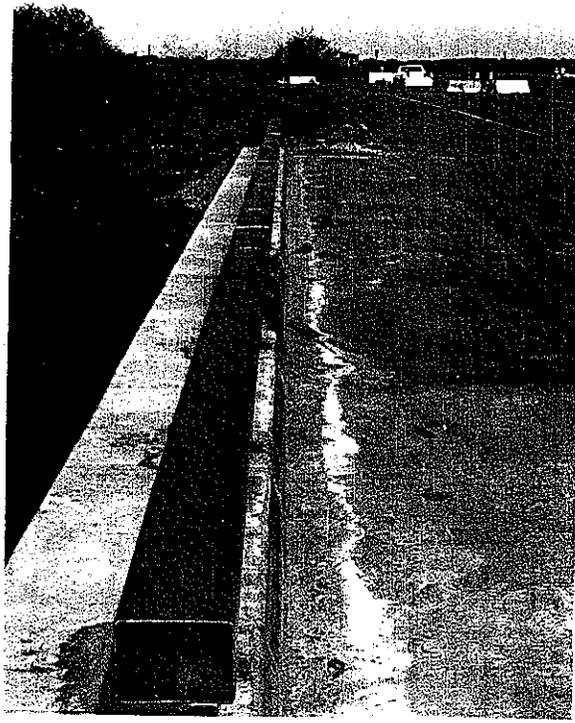
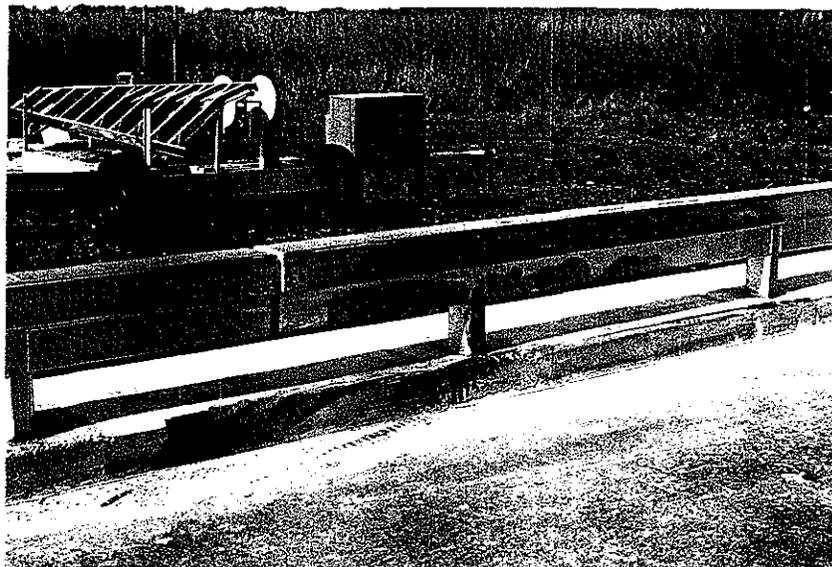
Figure 36. Washington, DC, bridge rail after test 7147-9.

The bridge railing received minimal damage, as shown in figure 36. There was no permanent deformation of the bridge railing. The total length of contact with the rail was 3.9 m (12.9 ft). Tire marks indicated that the tire did not go under the rail element.

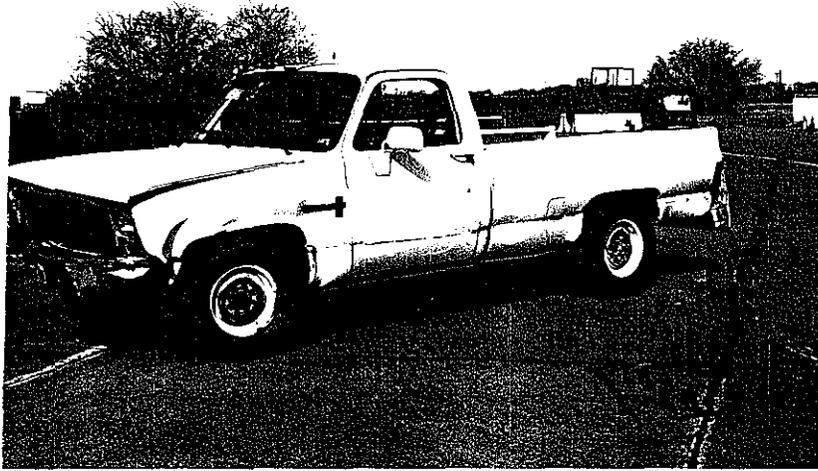
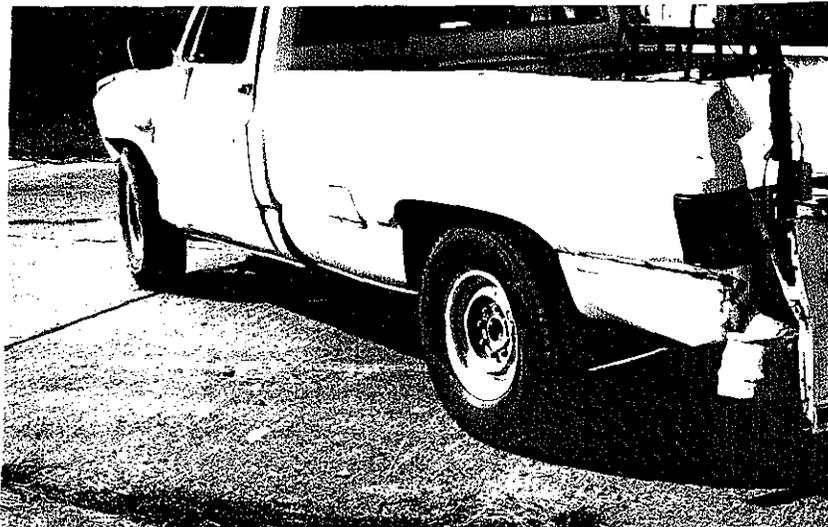
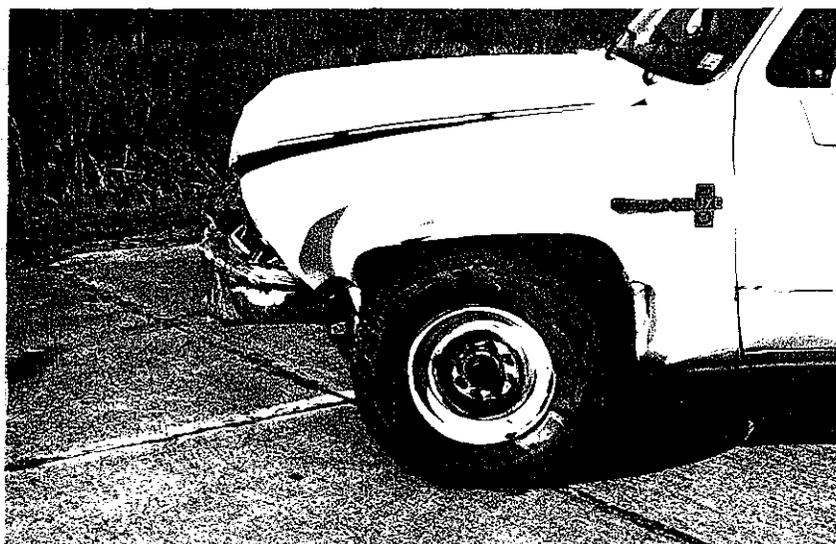
Figure 37. Vehicle after test 7147-9.

The vehicle (shown in figure 37) received moderate damage. The driver's window was broken and there was damage to the front bumper, hood, grill, left front quarter panel, left door, left rear quarter panel, and the rear bumper. The left front and rear rims were damaged from contact with the curb and rail element. Maximum crush to the vehicle was 254 mm (10.0 in) at the left front corner at bumper height.

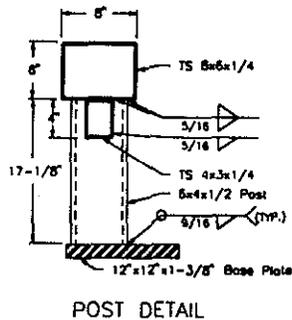
Figure 38. Summary of results for test 7147-9.

Test No. ....	7147-9
Date .....	12/16/91
Test Installation .....	Washington, DC, Historic Bridge Rail
Installation Length .....	23 m (75 ft)
Max. Dynamic Deflection .....	Nil
Max. Perm. Deformation .....	None
Test Vehicle .....	1986 Chevrolet Pickup
Vehicle Weight	
Test Inertia .....	2352 kg (5400 lb)
Gross Static .....	2527 kg (5565 lb)
Vehicle Damage Classification	
TAD .....	11FL2 & 11LD3
CDC .....	11FLEK2 & 11LDEW2
Maximum Vehicle Crush .....	254 mm (10.0 in)

Impact Speed .....	76.7 km/h (47.7mi/h)
Impact Angle .....	20.6 deg
Speed at Parallel .....	71.4 km/h (44.4 mi/h)
Exit Speed .....	70.3 km/h (43.7 mi/h)
Exit Trajectory .....	5.4 deg
Vehicle Accelerations (Max. 0.050-s avg)	
Longitudinal .....	-3.6 g's
Lateral .....	-8.7 g's
Occupant Impact Velocity at true c.g.	
Longitudinal .....	2.7 m/s (8.9 ft/s)
Lateral .....	4.8 m/s (15.6 ft/s)
Occupant Ridedown Accelerations	
Longitudinal .....	-2.2 g's
Lateral .....	-14.1 g's

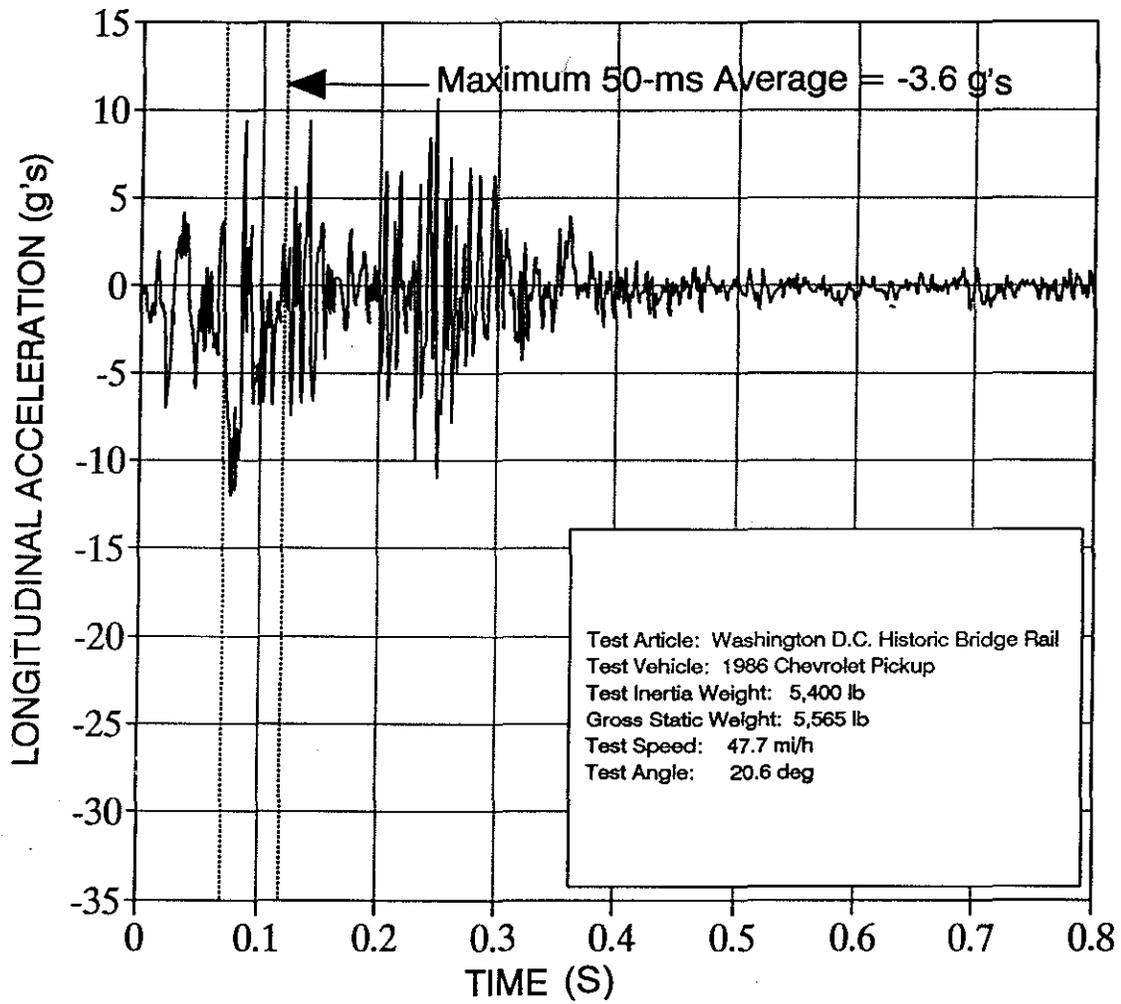
Figure 40. Vehicle longitudinal accelerometer trace for test 7147-9.

## Class 180 Filter - At center of gravity

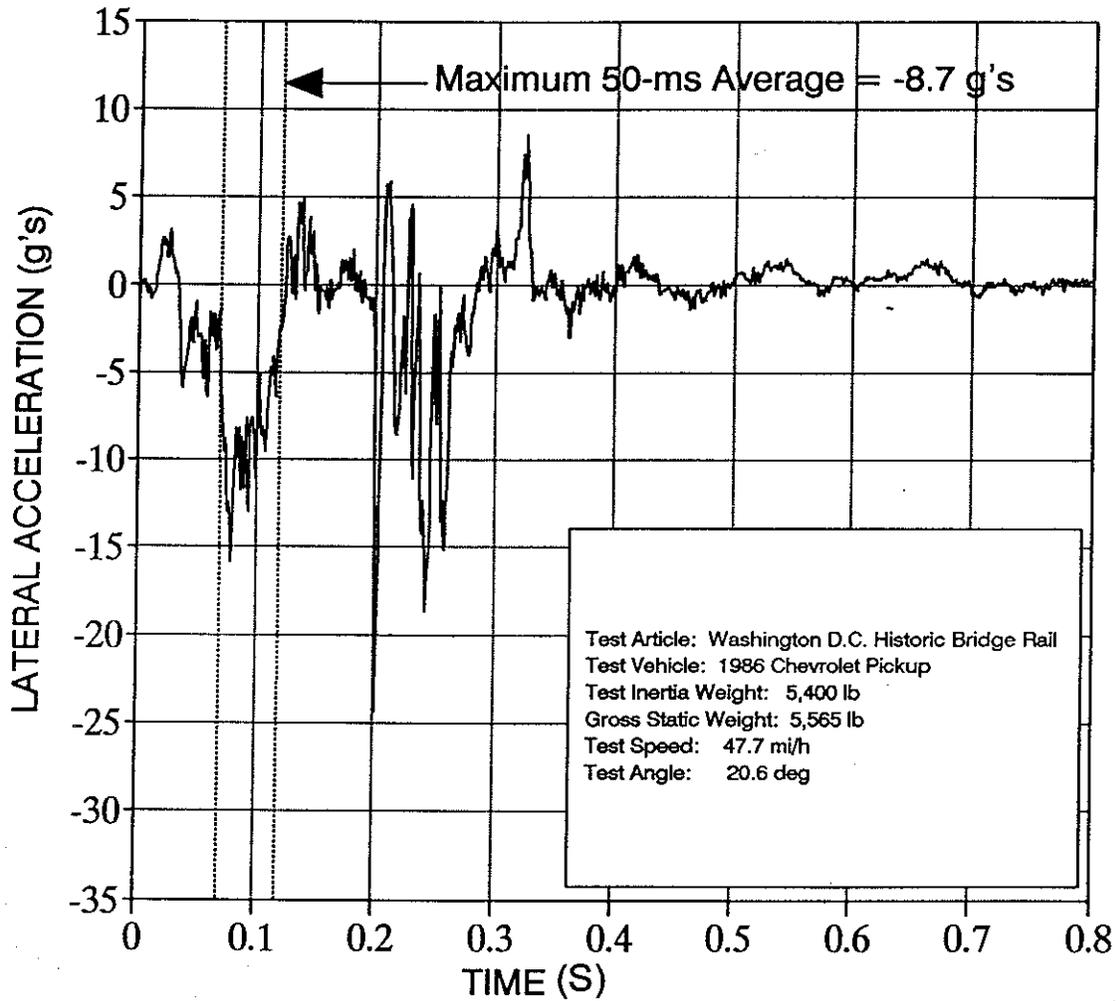
Figure 41. Vehicle lateral accelerometer trace for test 7147-9.

## Class 180 Filter - At center of gravity

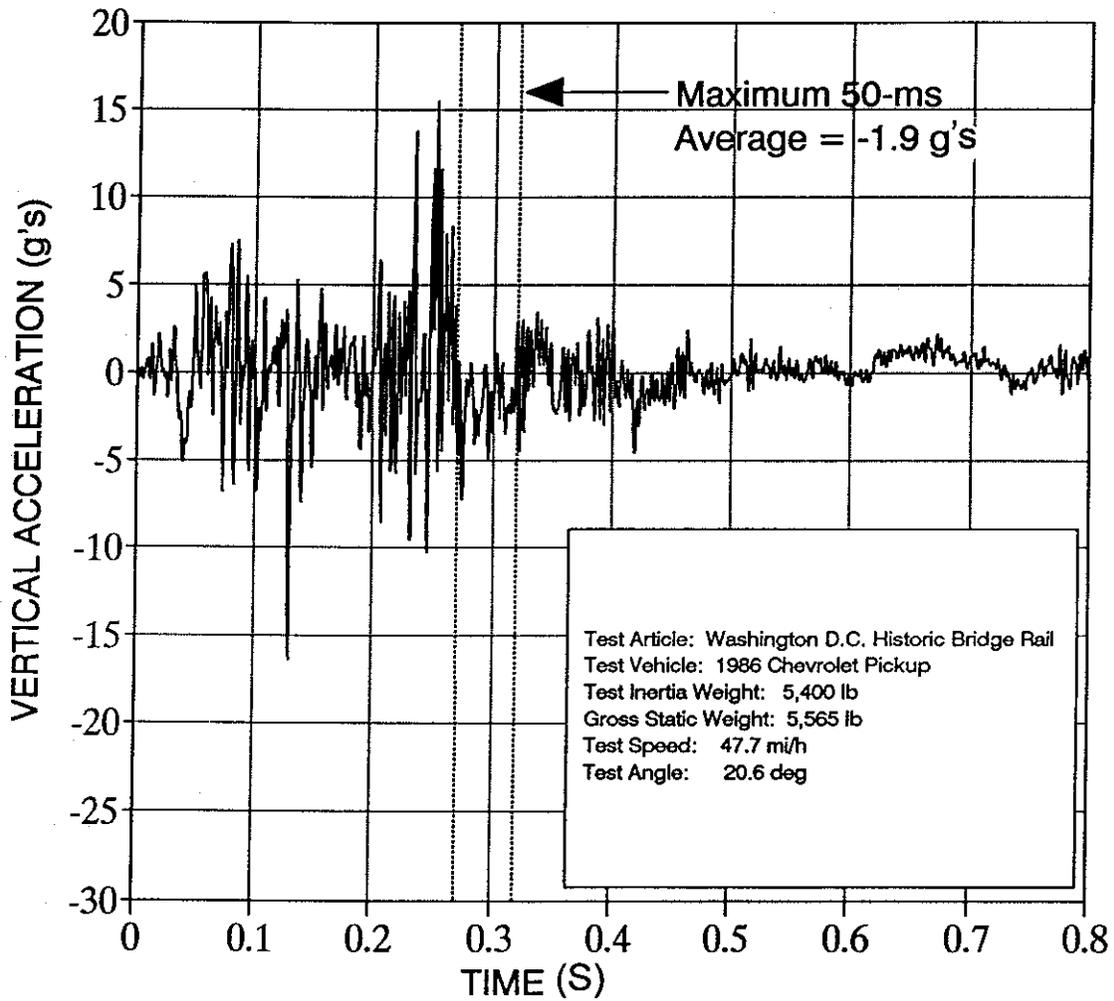
Figure 42. Vehicle vertical accelerometer trace for test 7147-9.

## Class 180 Filter - At center of gravity
