# Evaluation of TxDOT Variable Speed Limit Pilot Projects

## FINAL REPORT

JUNE 2015

TEXAS A&M TRANSPORTATION INSTITUTE  
The Texas A&M University System  
College Station, TX 77843-3135

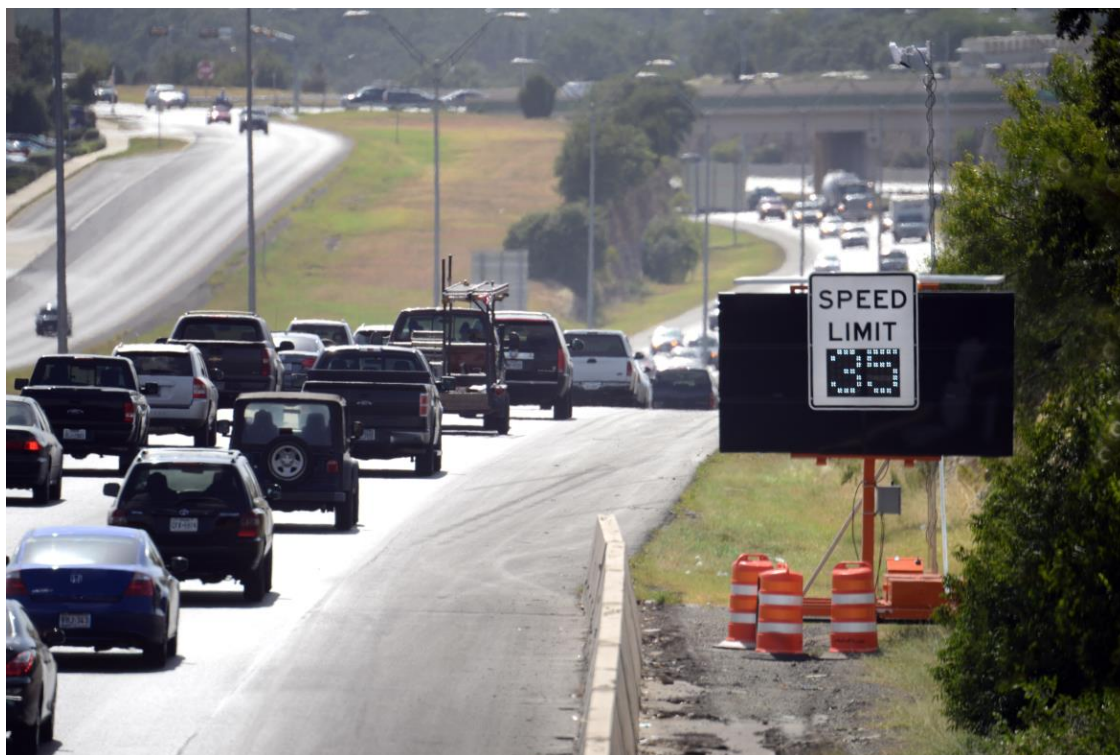
**Figure ES-1. VSL Sign Installation, San Antonio District.**

A photo of the installation on SL 1604 in San Antonio is shown in Figure ES-1. Those in Temple and Ranger Hill, Eastland County were similar in design and layout.

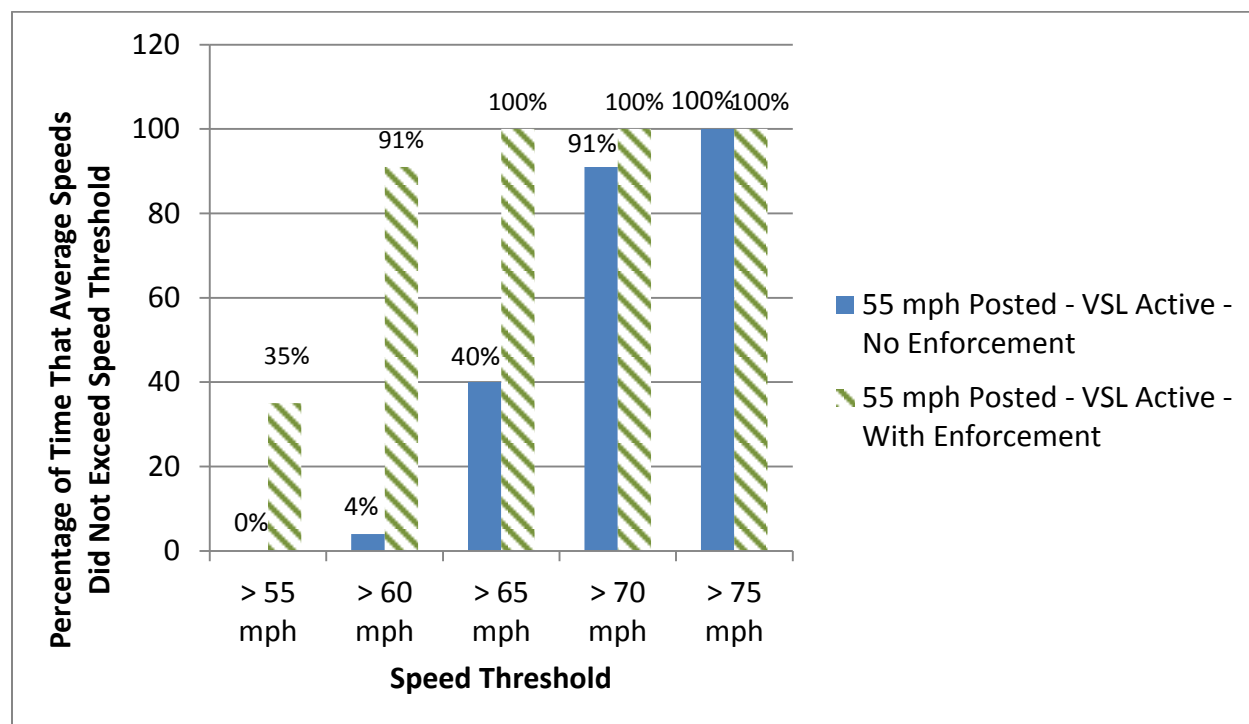
**Figure ES-6. Impacts of VSL on Average Speeds, With and Without Enforcement.**

analysis of violation data, presented in Figure ES-6, indicate that the VSL system alone without enforcement had an impact on the percentage of time that average speeds exceed specific speed thresholds, more at higher speeds than at lower speeds. When a patrol officer was present, the impact increased, most likely because motorists perceived a need to slow down, albeit to avoid the penalty of receiving a speeding ticket. Thus, VSL compliance increases in the presence of law enforcement.

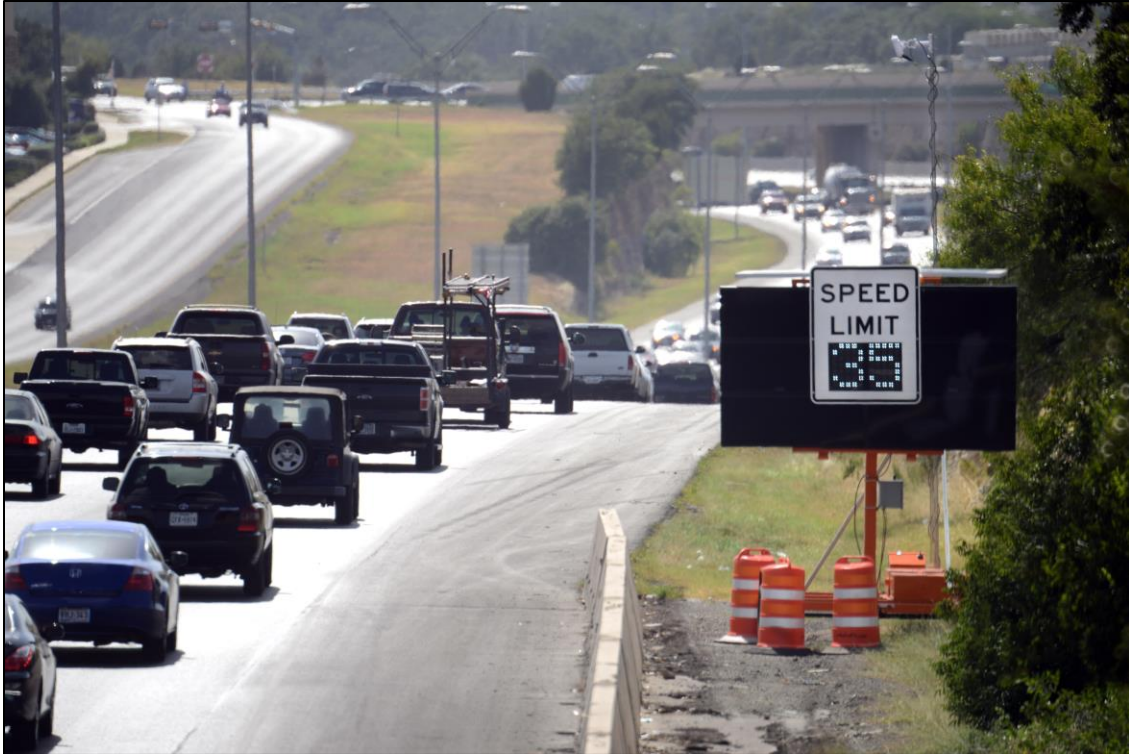
**Figure 1. VSL Sign Installation, San Antonio.**

The following figures and tables provide detailed deployment design and locations for the various portable changeable message signs (PCMSs) allocated for each VSL pilot study location. Figure 1, Figure 2, and Figure 3 show the VSL signs installed in San Antonio, Temple, and Ranger Hill, Eastland County, respectively. Each sign consisted of a solar-powered PCMS equipped with a cellular modem, a road condition sensor, a roadway visibility sensor (Ranger Hill, Eastland County only), and a vehicle detection system and was installed with a minimum of four safety drums for protection, per the *Manual on Uniform Traffic Control Devices* (MUTCD). Additional information on the field equipment is included in Appendix D.

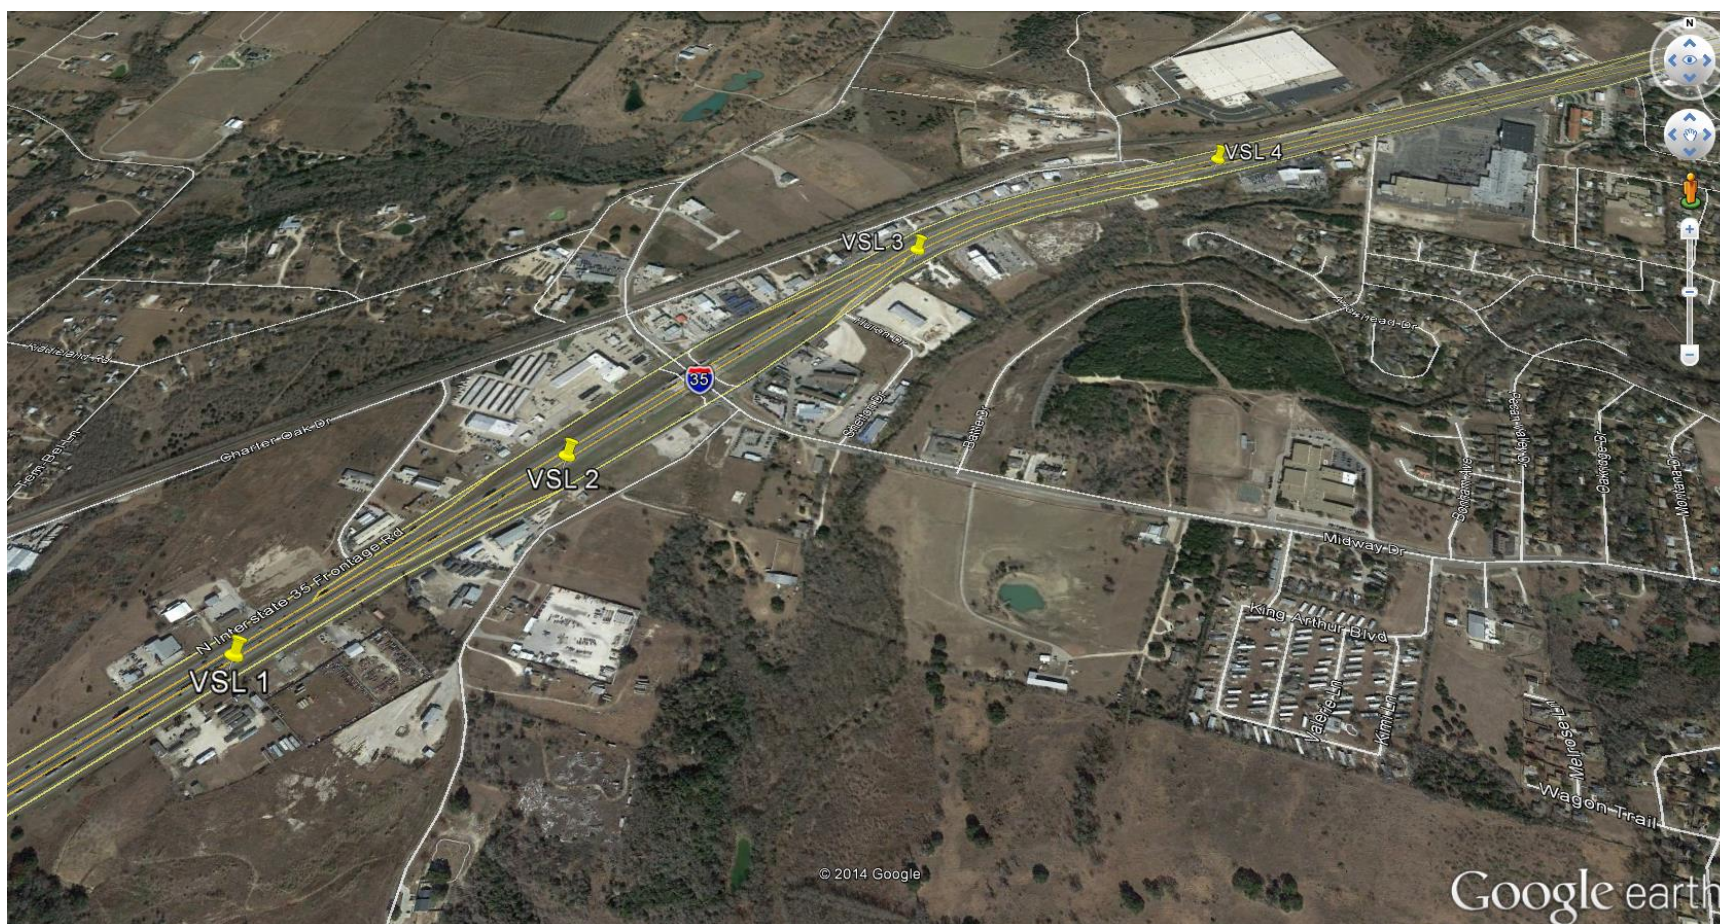
**Figure 5. Sign Locations, NB IH-35 VSL Site, Temple.**

Table 3 provides a list of the individual sign locations along with their description for the Temple deployment. Figure 5 shows the sign locations along NB IH-35 in Temple.

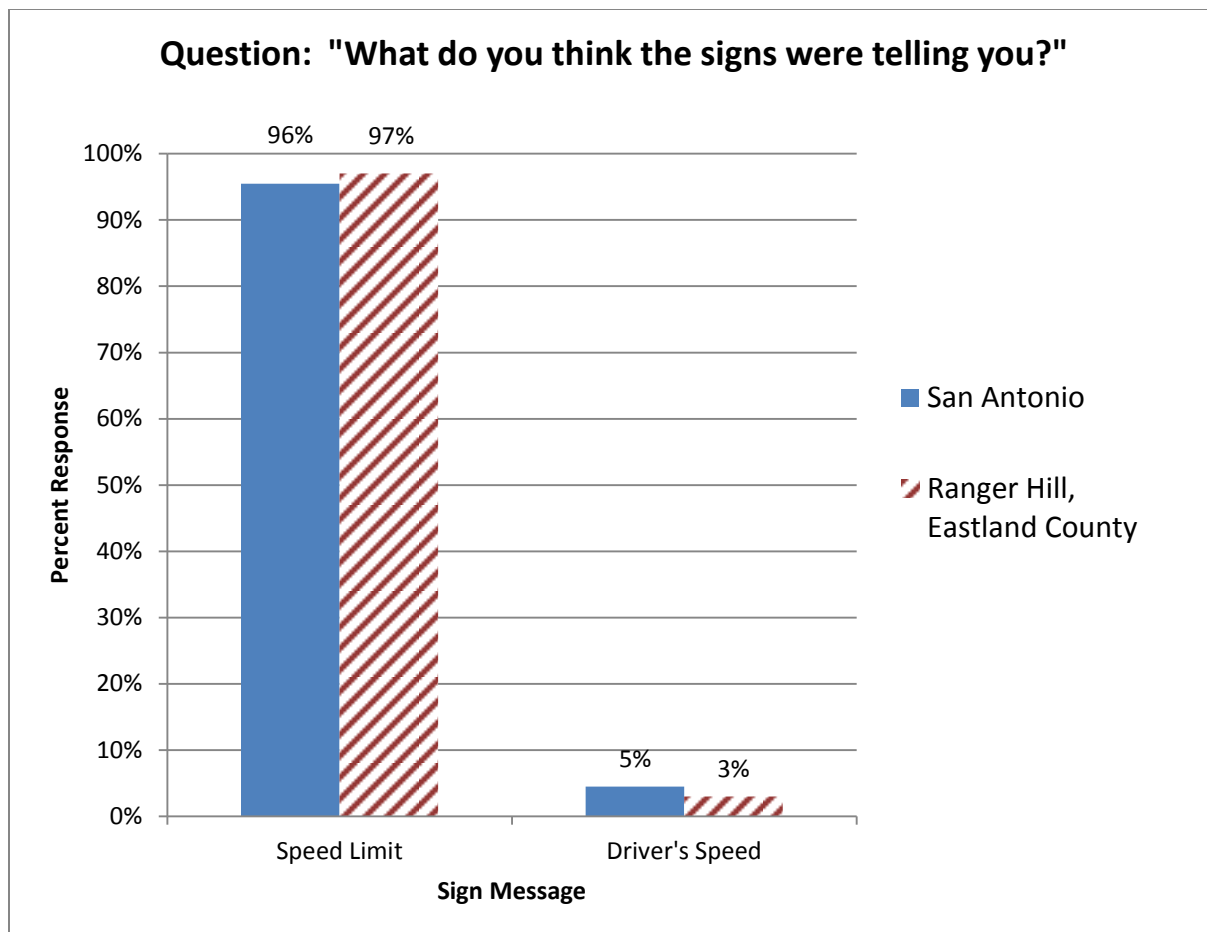
**Figure 19. Users' Perceptions of VSL Message.**

As noted previously, Figure 19 shows that the majority of respondents understood that the signs display a legal, enforceable speed limit VSL sign was displaying a speed limit.

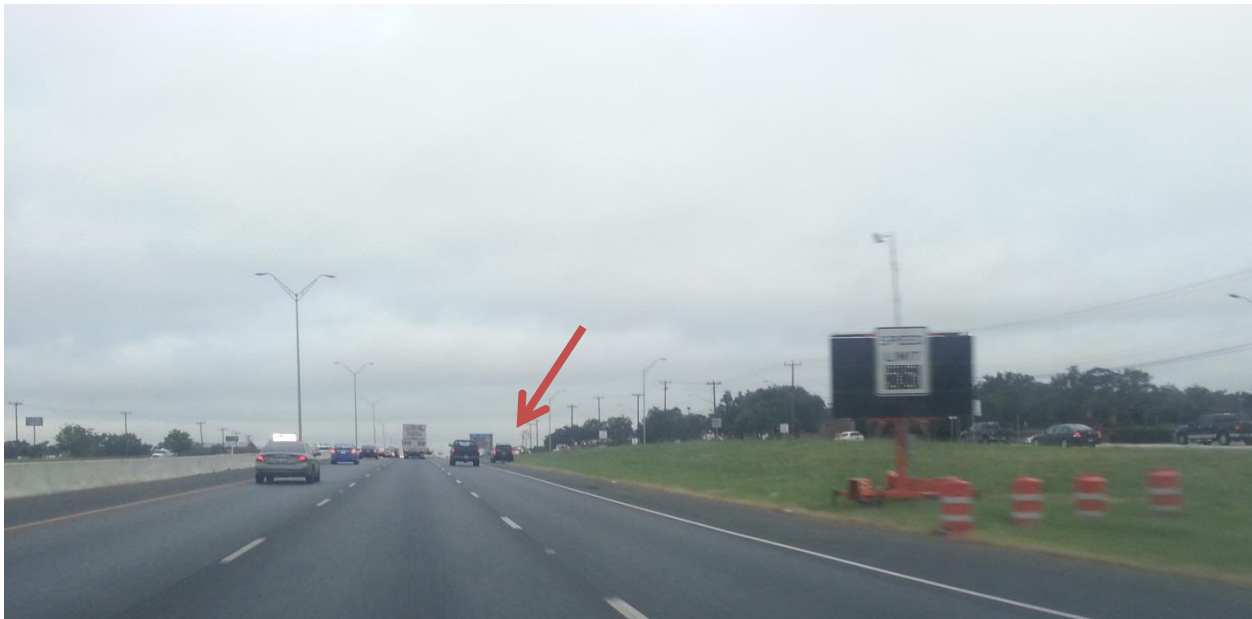
**Figure H-30. Patrol Car Stationed Near VSL#1 in San Antonio.**

On September 30 and October 1, 2014, a patrol car was positioned near VSL#1 during the a.m. and p.m. peak periods. At this location, the VSL routinely displayed lowered speed limits during peak periods. Figure H-30 shows the patrol car position and the VSL displaying 55 mph during relatively light traffic conditions. For comparison, the project team used data collected on September 23, 24, and October 7 with the reduced speed limit of 55 mph without the officer present. Control data were collected at the advance warning PCMS while it was displaying “Reduced Speed Ahead” and while the VSL#1 display was 55 mph. Table H-20 shows a summary of these occurrences used for the enforcement study.

San Antonio data revealed that congestion at downstream VSLs (such as #5 and #6) often triggered the system to deploy speed limits of 55 or 60 mph farther upstream. In the upstream area, motorists often could not physically see any apparent need to reduce their speed, despite the “Reduced Speed Ahead” display on the advance warning PCMS and a reduced speed limit on VSL#1.
