## **EVALUATION OF ALLOWABLE TAPER RATES OF FREESTANDING SINGLE-SLOPE CONCRETE BARRIERS**

Texas Department of Transportation  
<https://tti.tamu.edu/documents/0-7086-R2.pdf>

1. Report No. FHWA/TX-23/0-7086-R2		2. Government Accession No.		3. Recipient's Catalog No.	
4. Title and Subtitle EVALUATION OF ALLOWABLE TAPER RATES OF FREESTANDING SINGLE-SLOPE CONCRETE BARRIERS				5. Report Date Published: August 2023

6. Performing Organization Code	
7. Author(s) Roger P. Bligh, Sofokli Cakalli, Nauman M. Sheikh, William J. L. Schroeder, and Darrell L. Kuhn				8. Performing Organization Report No. Report 440862-03 3-4

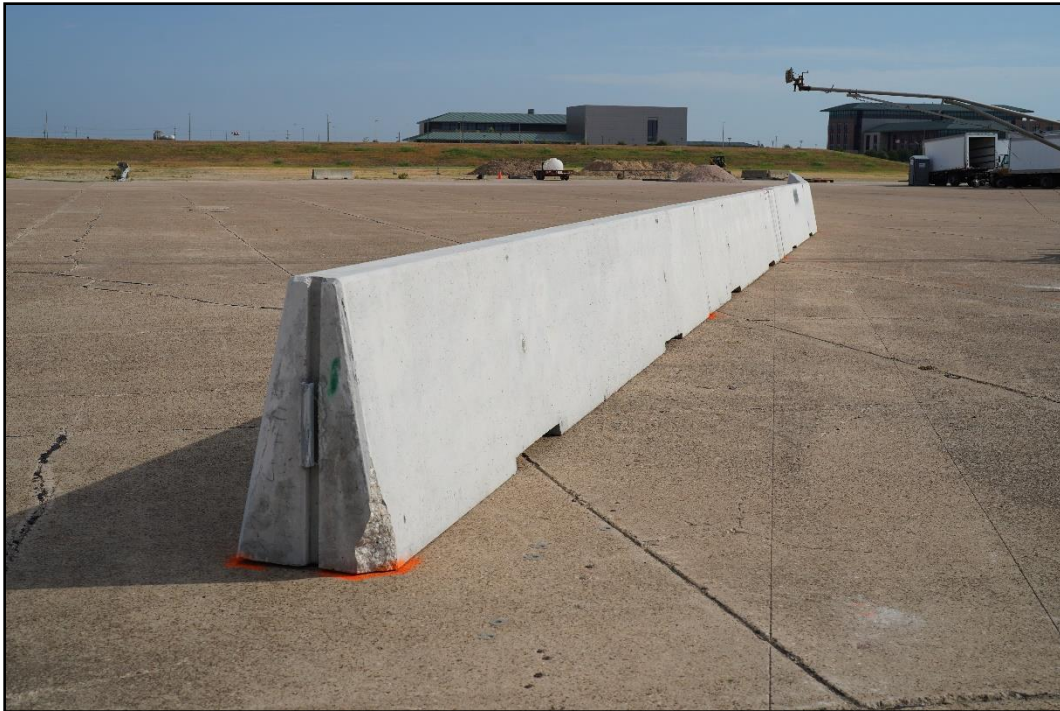
**Figure 3.2. Flared Single-Slope Portable Concrete Barriers Prior to Testing.**

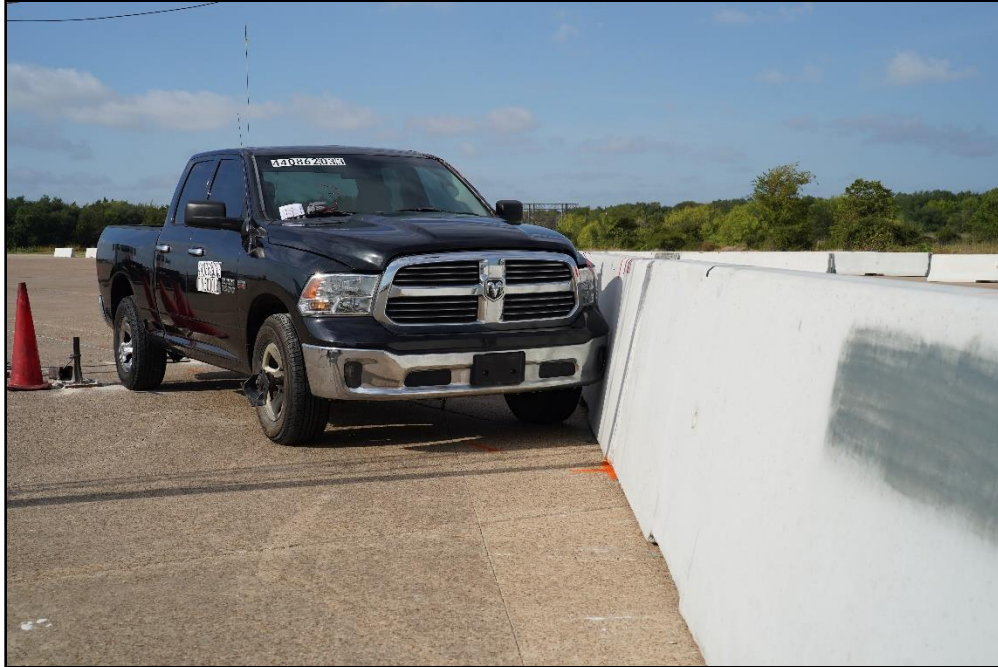
**Figure 6.1. Flared Single-Slope Portable Concrete Barriers/Test Vehicle Geometries for Test 440862-03-3.**

See Table 6.1 for details on the *MASH* impact conditions and Table 6.2 for the exit parameters of Test 440862-03-3. Figure 6.1 and Figure 6.2 depict the target impact setup.

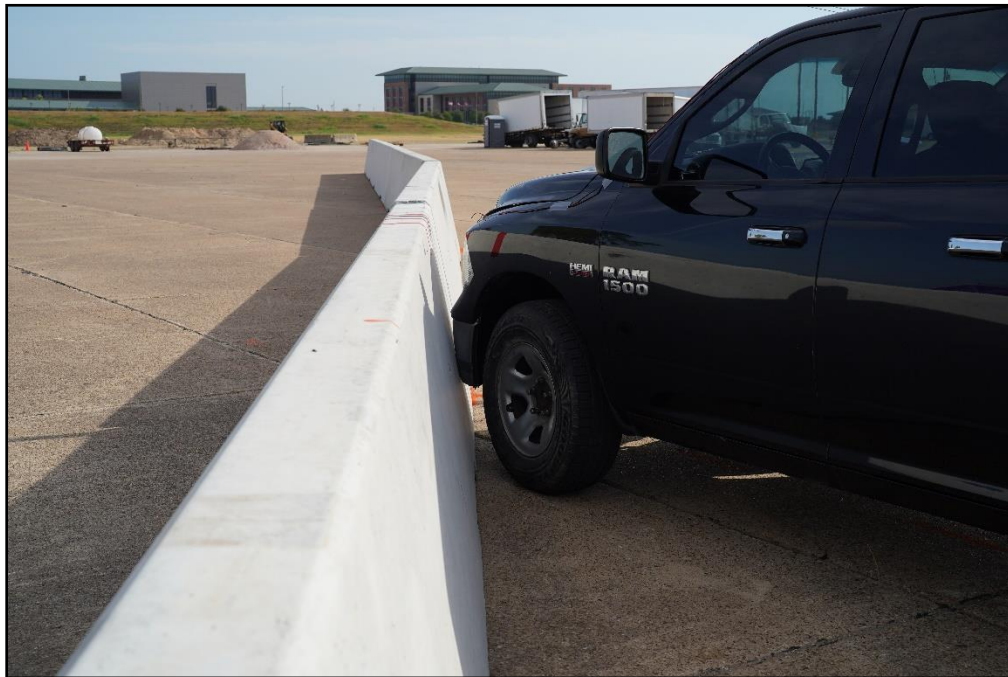
**Figure 6.2. Flared Single-Slope Portable Concrete Barriers/Test Vehicle Impact Location for Test 440862-03-3.**

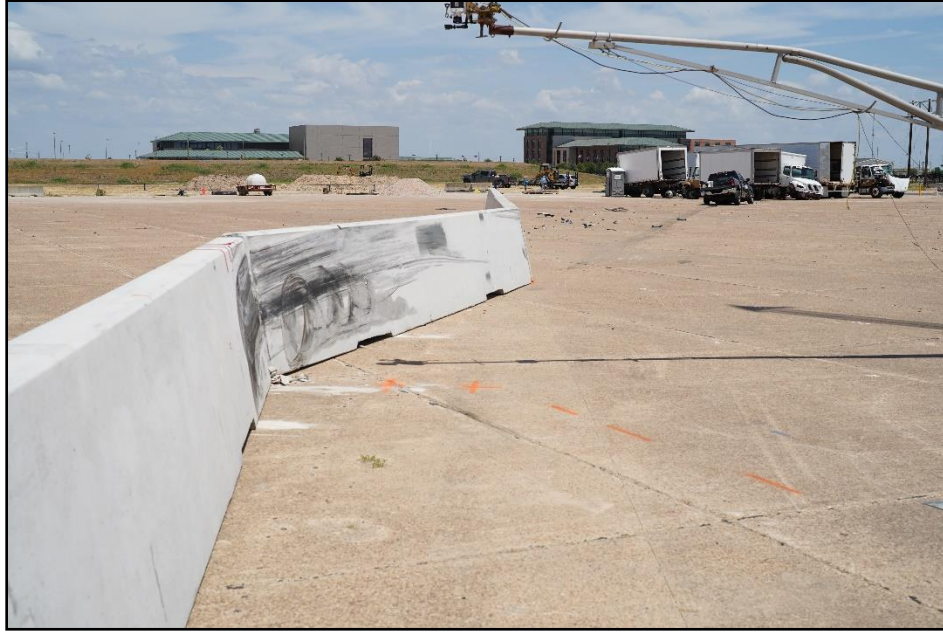
There was concrete scuffing and spalling at impact. There was concrete spalling at the joint between barriers 2 and 3, with exposed rebar on barrier 2. There were cracks in barriers 2 and 3. The concrete was also spalled on the field side at the joint between barriers 3 and 4.

**Figure 6.5. Flared Single-Slope Portable Concrete Barriers after Test 440862-03-3.**

Table 6.6 and Table 6.7 describe the damage to the flared single-slope PCBs. Figure 6.5 and Figure 6.6 show the damage to the flared single-slope PCBs.

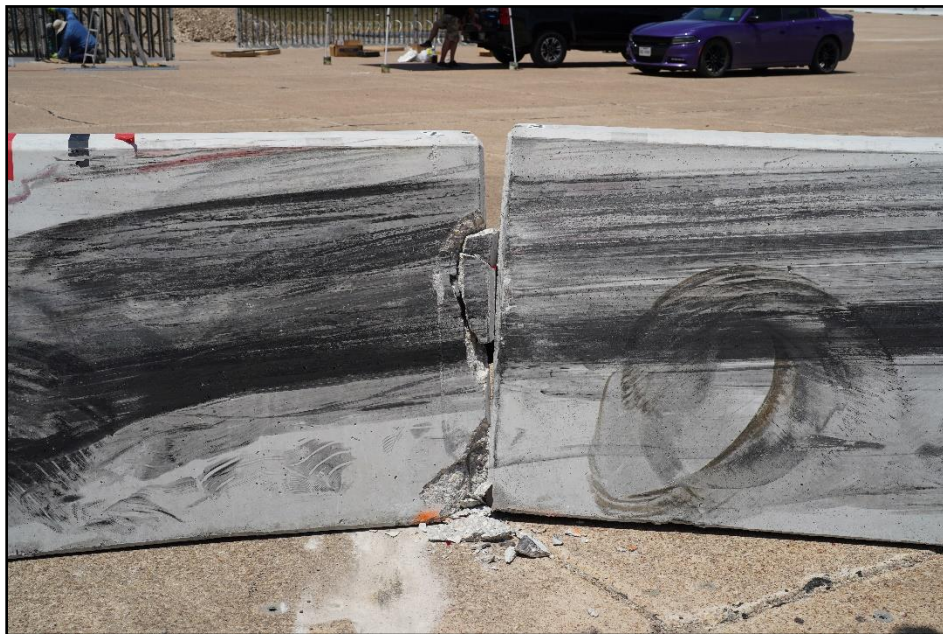
**Figure 6.6. Flared Single-Slope Portable Concrete Barriers after Test at Impact Location, Test 440862-03-3.**

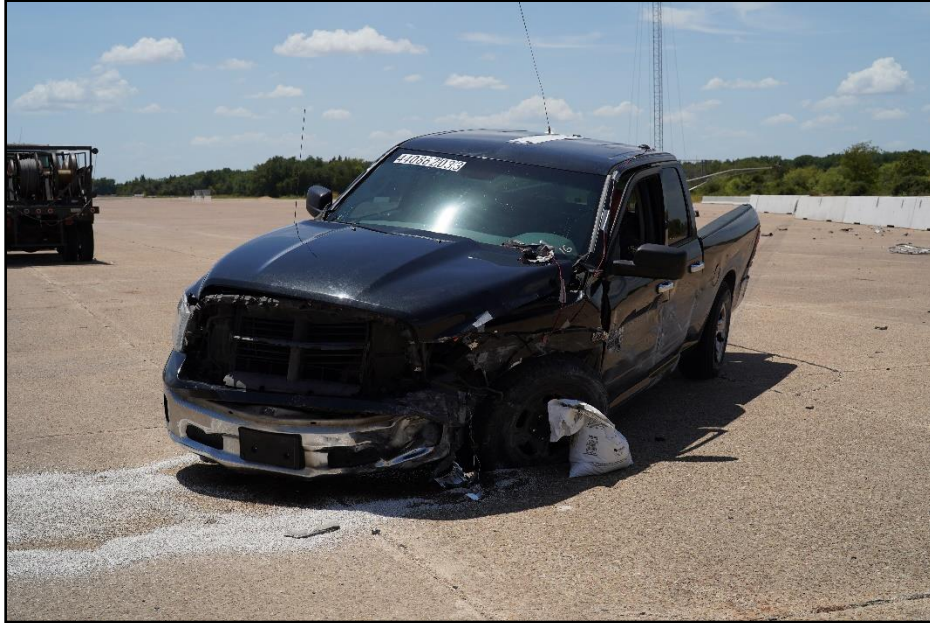
**Figure 6.7. Impact Side of Test Vehicle after Test 440862-03-3.**

Side Windows	The left side window shattered due to deformation of the door.
Maximum Exterior Deformation	9 inches in the front plane at the left front corner at bumper height.
VDS	11LFQ4
CDC	11FLEW5
Fuel Tank Damage	None
Description of Damage to Vehicle:	The front bumper, hood, grill, left headlight, left front quarter fender, left front tire and rim, windshield, left front door and glass, floor pan, left rear door, left rear cab corner, left rear quarter fender, left rear rim, left taillight, and rear bumper were damaged. The windshield had some cracking (caused by flexing of the body), and the left front door had a 2.5-inch gap at the top of the door.

Figure 6.7 and Figure 6.8 show the damage sustained by the vehicle. Figure 6.9 and Figure 6.10 show the interior of the test vehicle. Table 6.8 and Table 6.9 provide details on the occupant compartment deformation and exterior vehicle damage. Figures B.2 and B.3 in Appendix B.1 provide exterior crush and occupant compartment measurements.

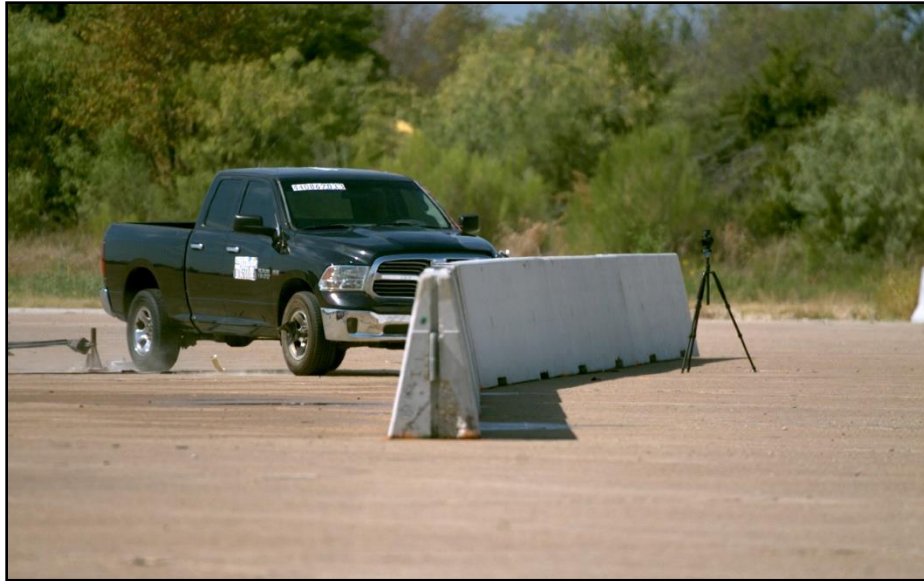
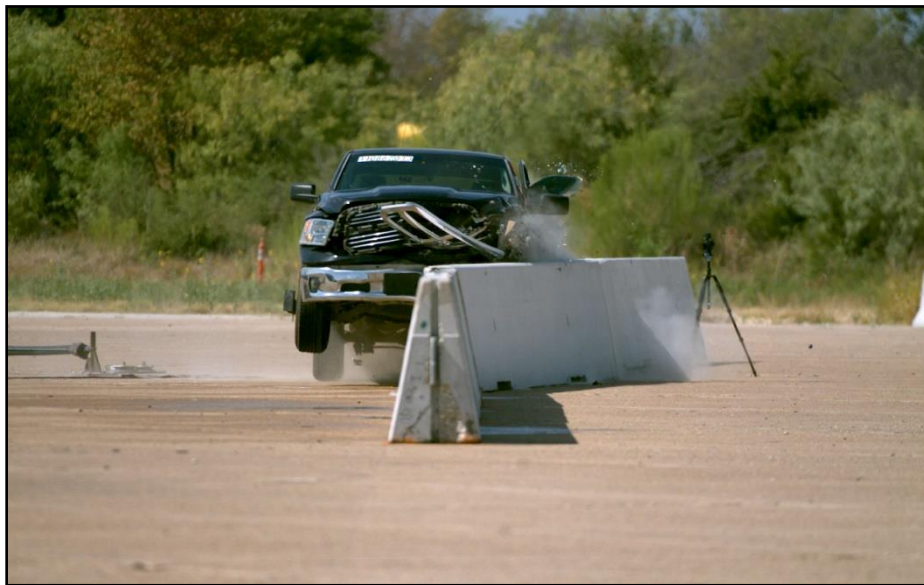
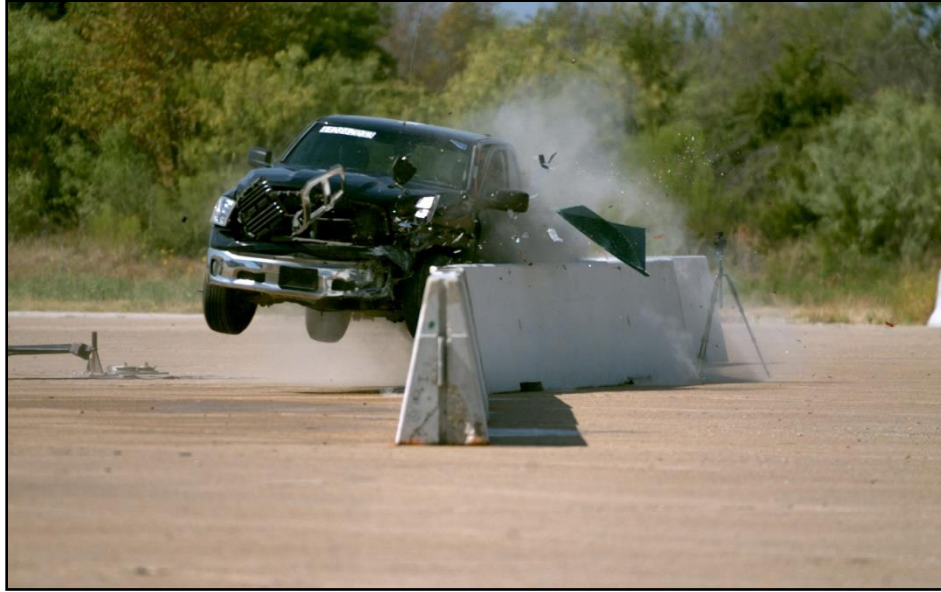
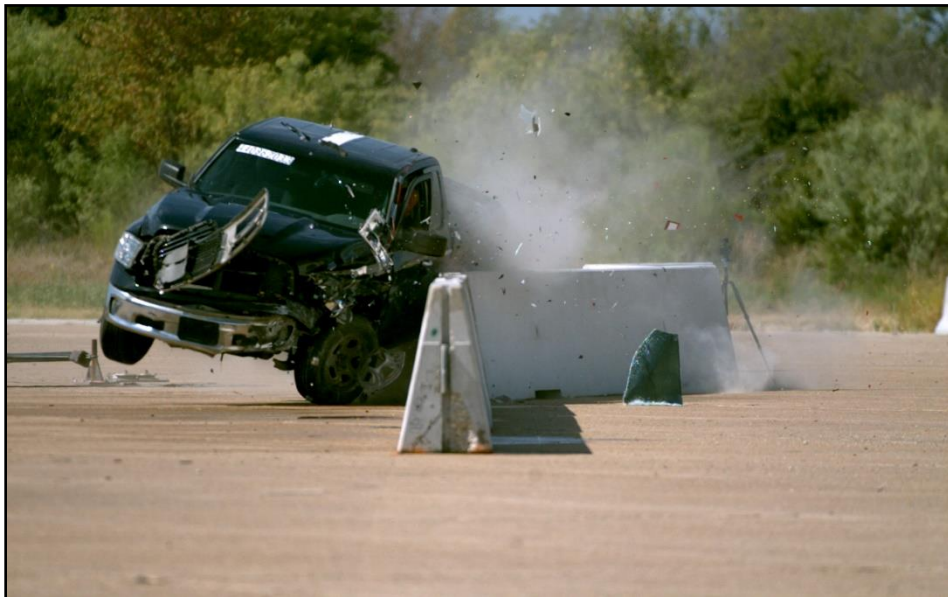
**Figure 6.12. Summary of Results for Test 440862-03-3, Sequential Test Pictures.**

Figure 6.11, Table 6.11, and Table 6.12 summarize the results of *MASH* Test 440862-03-3. Figure 6.12 shows the sequential photographs from the crash test. Figure 6.13 shows the summary drawing for the crash test.

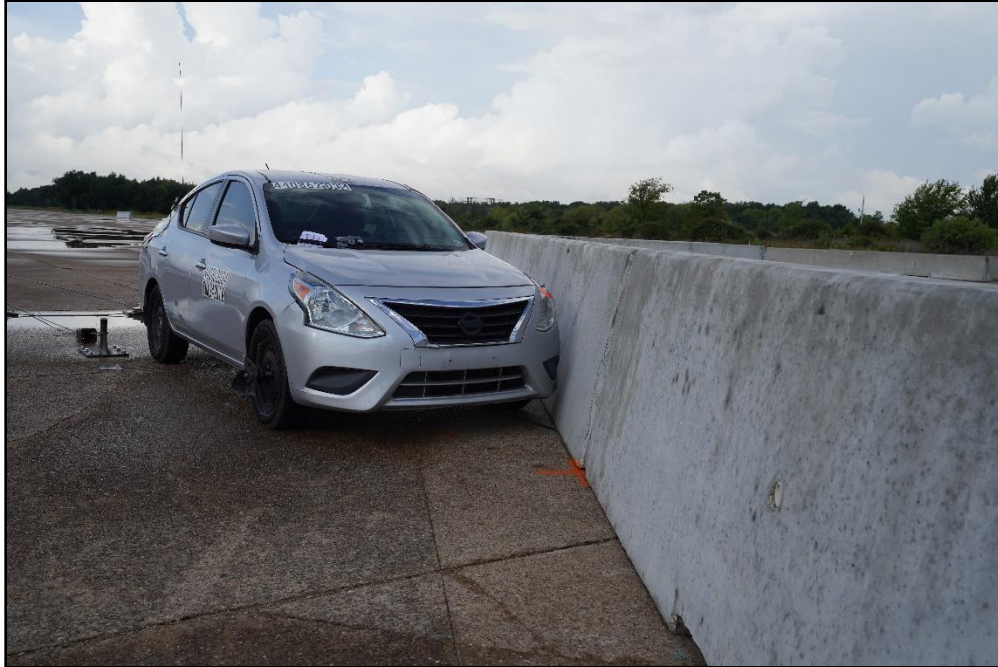
**Figure 7.1. Flared Single-Slope Portable Concrete Barriers/Test Vehicle Geometries for Test 440862-03-4.**

See Table 7.1 for details on the *MASH* impact conditions and Table 7.2 for the exit parameters for Test 440862-03-4. Figure 7.1 and Figure 7.2 depict the target impact setup.

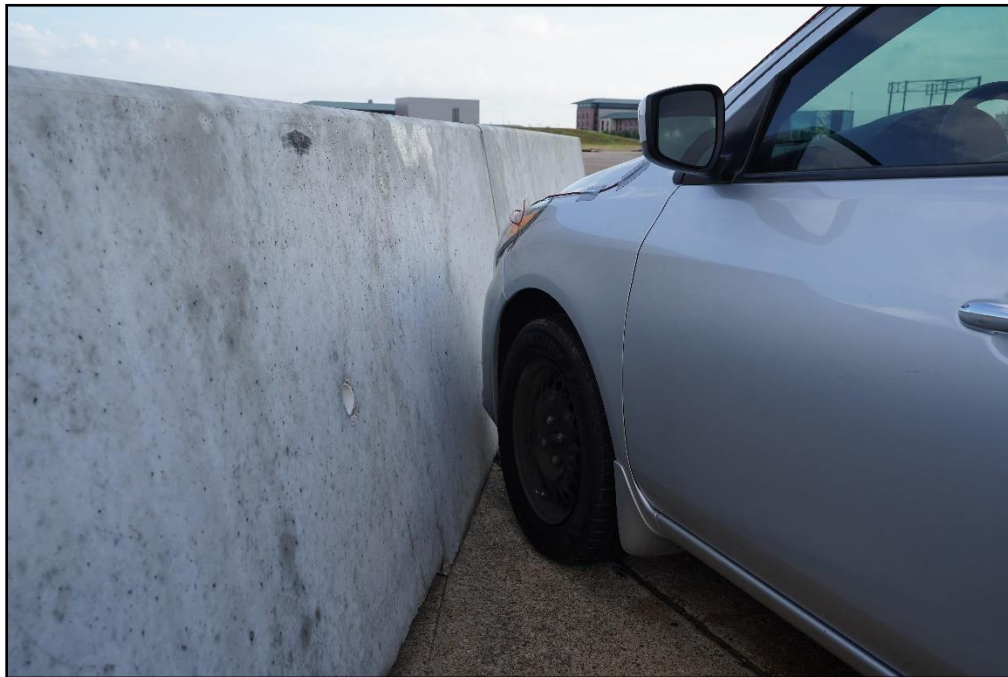
**Figure 7.2. Flared Single-Slope Portable Concrete Barriers/Test Vehicle Impact Location for Test 440862-03-4.**

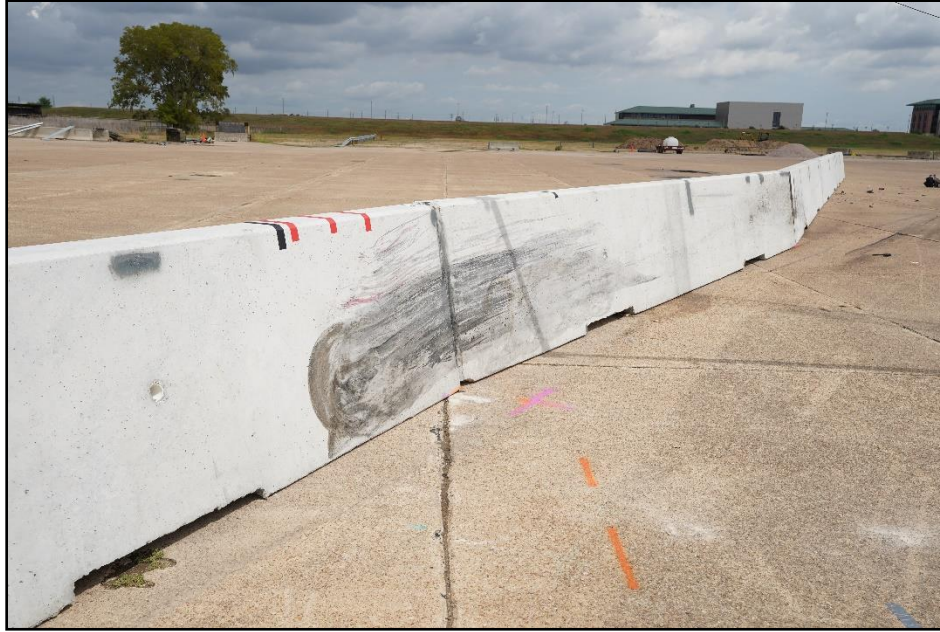
**Figure 7.5. Flared Single-Slope Portable Concrete Barriers after Test at Impact Location, Test 440862-03-4.**

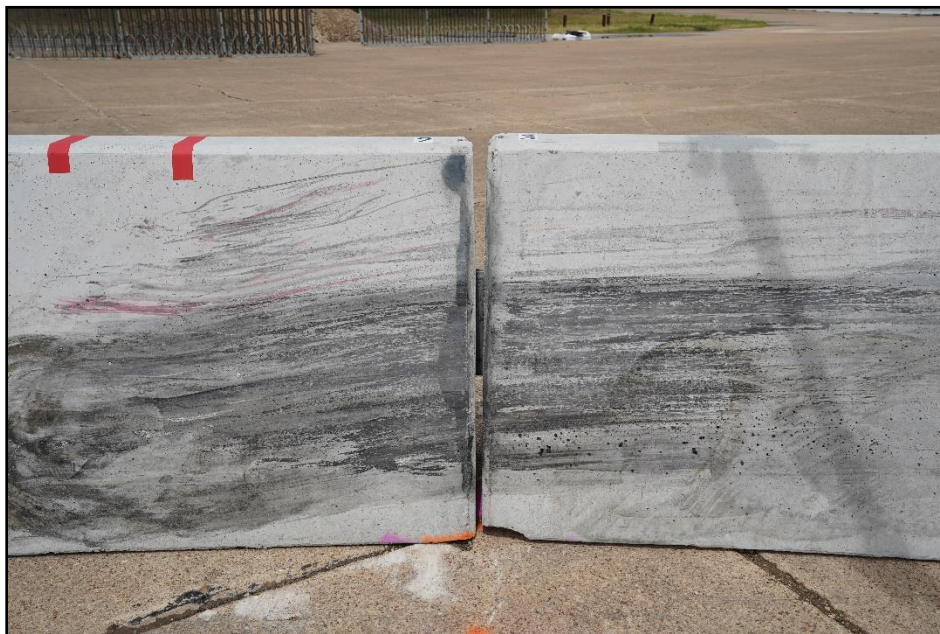
**Figure 7.6. Flared Single-Slope Portable Concrete Barriers after Test at the Joint of Barriers 2 and 3, Test 440862-03-4.**

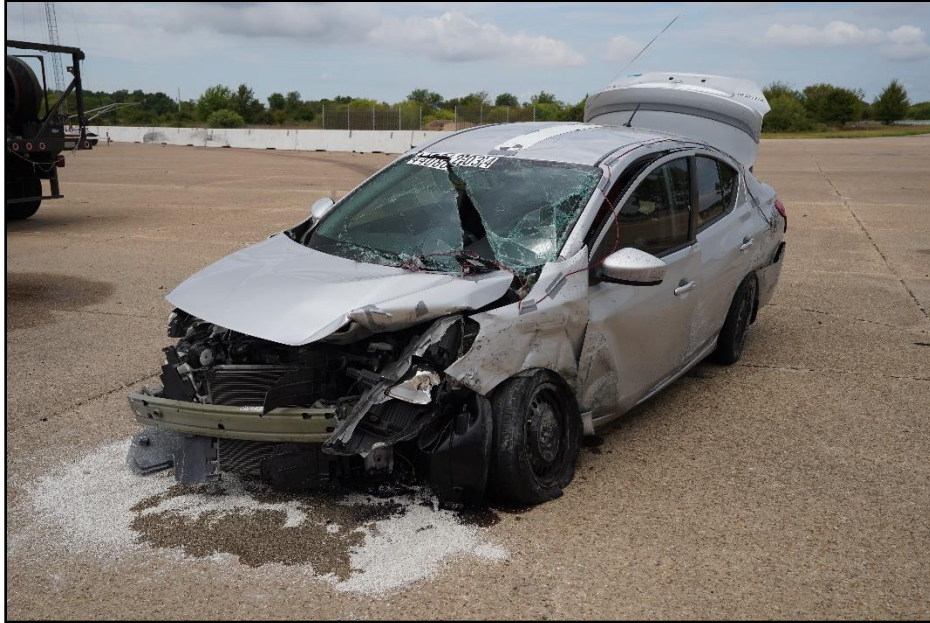
**Figure 7.7. Impact Side of Test Vehicle after Test 440862-03-4.**

Figure 7.7 and Figure 7.8 show the damage sustained by the vehicle. Figure 7.9 and Figure 7.10 show the interior of the test vehicle. Table 7.8 and Table 7.9 provide details on the occupant compartment deformation and exterior vehicle damage. Figures C.2 and C.3 in Appendix C.1 provide exterior crush and occupant compartment measurements.

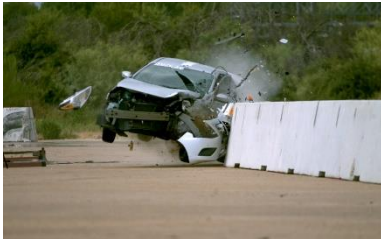
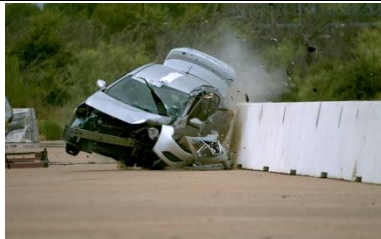
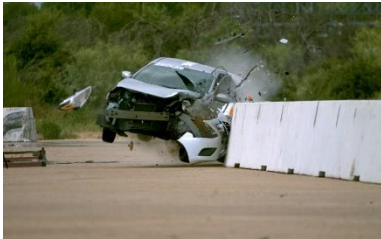
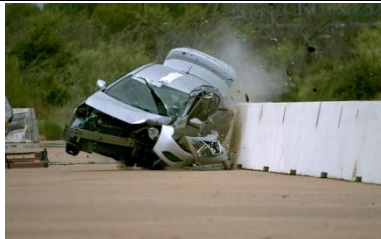
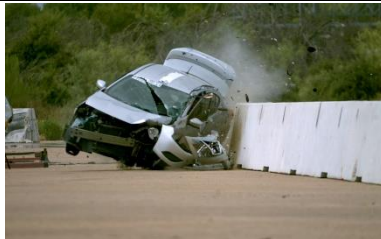
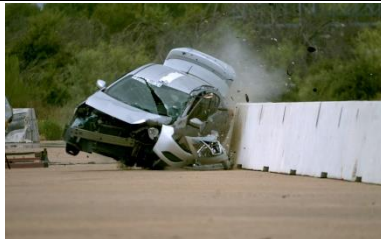
Impact Speed (mi/h)		61.6					
	Impact Angle (deg)		25.7					
	Impact Location		44.8 inches upstream of the center of the joint between barriers 2 and 3					
	Impact Severity (kip-ft)		58.3

<b>TEST ARTICLE DEFLECTIONS</b>							
	Dynamic (inches)		17.8					
	Permanent (inches)		17.0					
	Working Width/Height (inches)		41.8/1

**Figure 7.11. Summary of Results for MASH Test 3-10 on Flared Single-Slope Portable Concrete Barriers.**

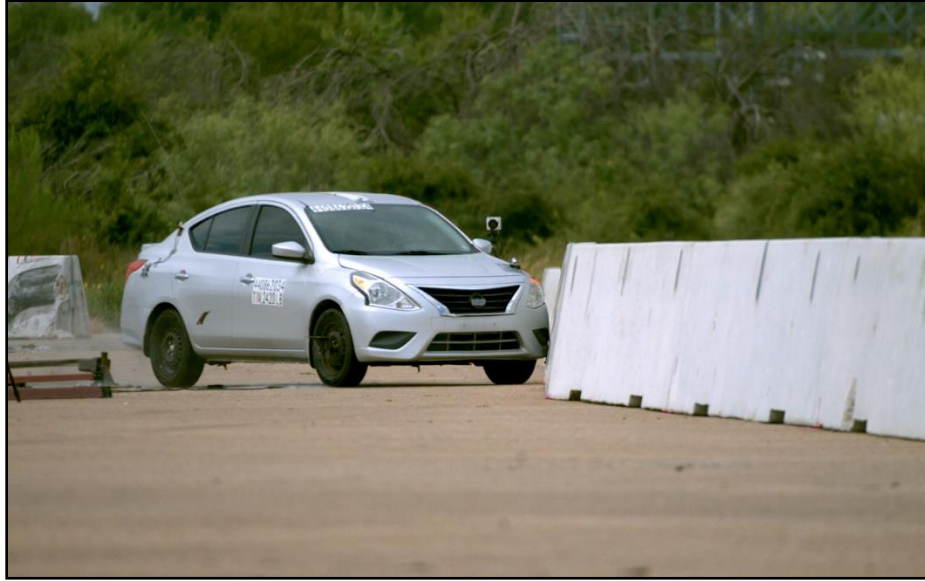
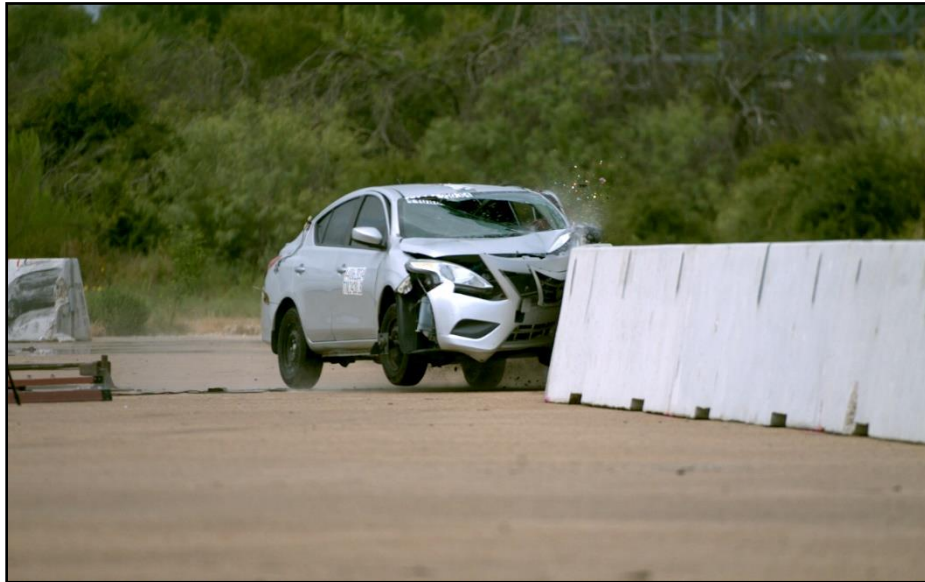
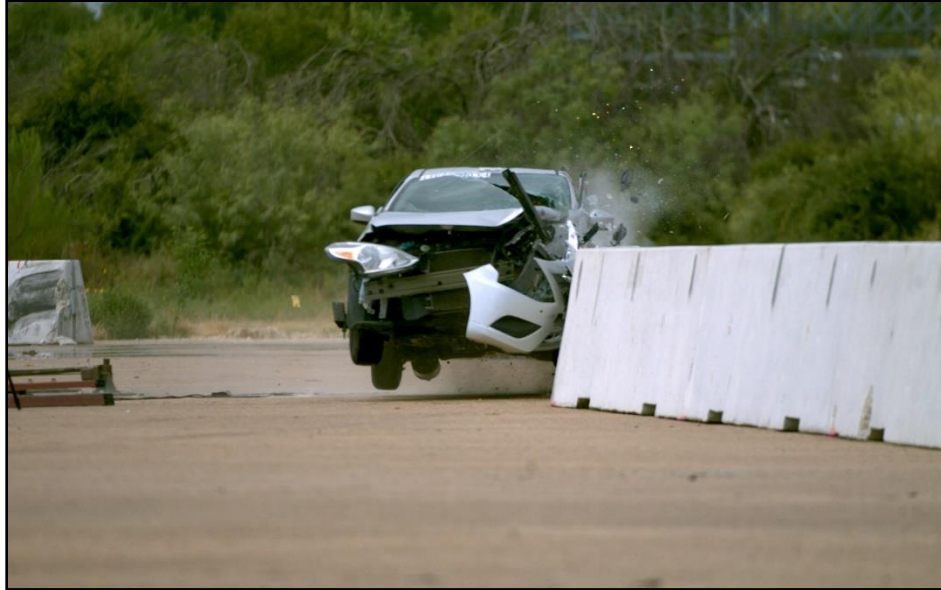
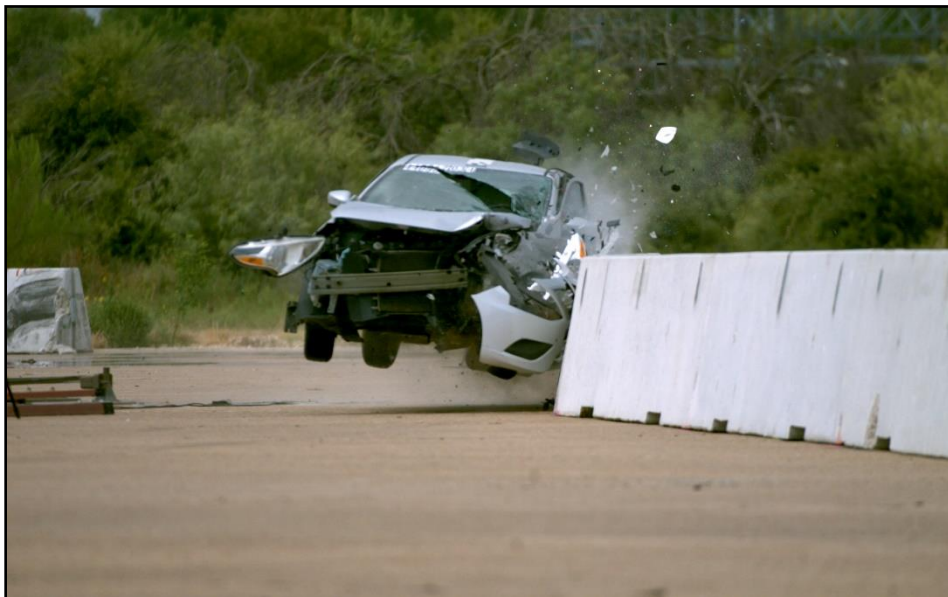
**Figure 7.12. Summary of Results for Test 440862-03-4, Sequential Test Pictures.**
