Statewide Implementation of the Surface Performance Graded (SPG) Specification for Chip Seal Binders in Service: Implementation Report

Implementation Report 5-6616-01-R1

TEXAS A&M TRANSPORTATION INSTITUTE
COLLEGE STATION, TEXAS

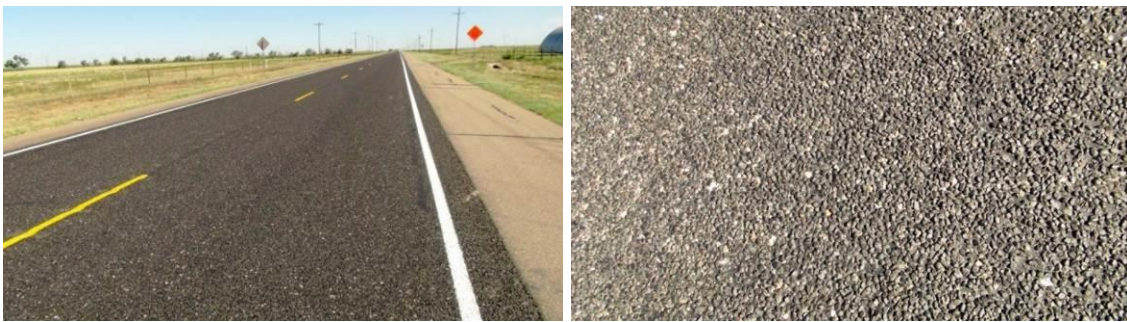
Figure 10. Example of Adequate Performance on 16-AMA-1 after the First Winter.

An example of adequate field performance is shown in Figure 10 for 16-AMA-1 after the first winter in service. This section is located on US83 in Ochiltree County in the AMA district. The SPG climatic requirement in that county is 64-25, and the binder specified for construction was a SPG 64-25. The binder used for construction was graded as a SPG 64-34 with the continuous phase angle meeting the SPG requirement of less than 80° . The 2016 AADT was approximately 3500 on this section with 28 percent trucks. This HS exhibited adequate performance in terms of aggregate loss ($\text{SCI}_{\text{AL}} = 100$) and bleeding ($\text{SCI}_{\text{BL}} = 96$) as shown Figure 10.

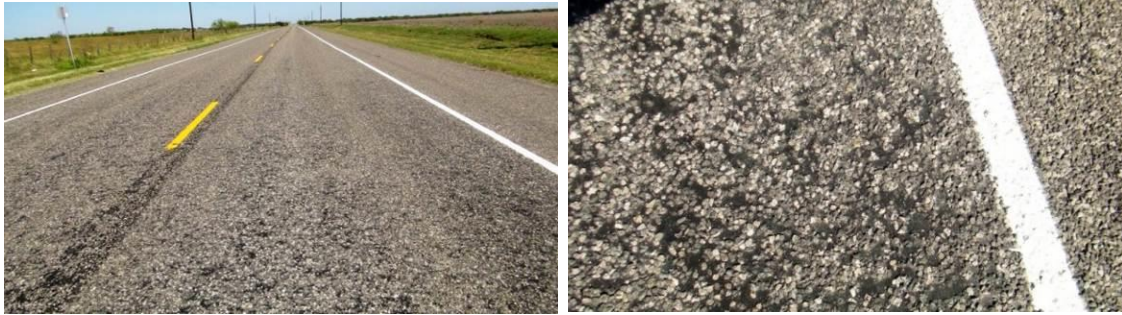
Figure 11. Example of Inadequate Performance on 16-CRP-2 after the First Winter.

Figure 11 shows an example of inadequate performance for 16-CRP-2 after the first winter. This section is located on FM0665 in Nueces County in the CRP district. The SPG climatic requirement in that location is 67-13, and the binder specified for construction was a SPG 70-19. The binder used for construction was graded as a SPG 73-22, but the continuous phase angle failed to meet the SPG requirement of less than 80° . The 2016 AADT on this section was recorded at approximately 3500 with 8 percent trucks. The inadequate performance in terms of aggregate loss ($\text{SCI}_{\text{AL}} = 57$) is reflected in Figure 11.

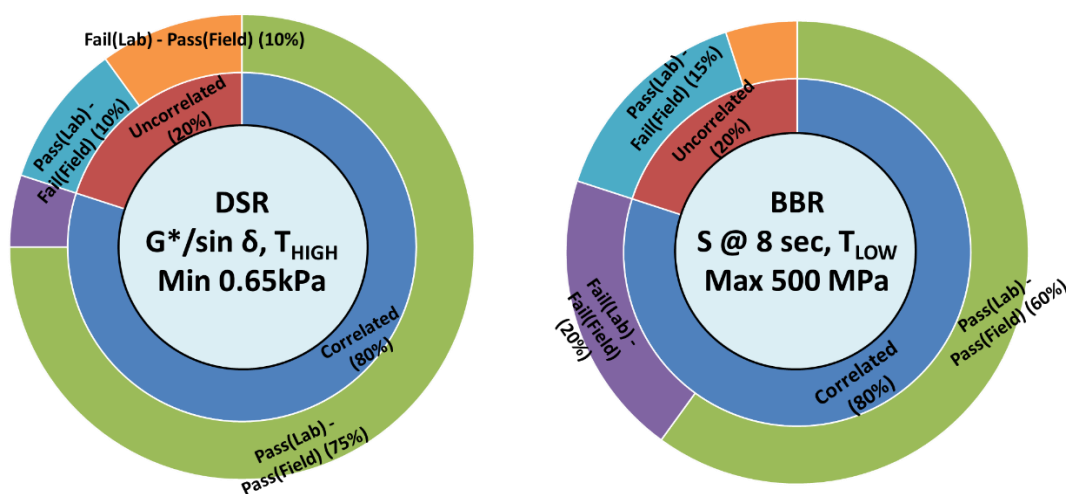
Figure 13. Special Provision (2016, 2017) Laboratory vs. Field Correlation.

Table 21 also indicates that 10 HSs included in the comparison and 16-PHR-1 produced failing field performance results ($\text{Fail}_{\text{Field}}$) based on inadequate resistance to bleeding ($\text{SCI}_{\text{BL}} < 70$) [16-ABL-1, 16-AUS-3, 16-PAR-1, and 16-PHR-1] or aggregate loss ($\text{SCI}_{\text{AL}} < 70$) [16-AUS-1, 16-BWD-1, 16-CRP-1, 16-CRP-2, 16-PAR-3, 17-AMA-1, and 17-AMA-2]. As shown in

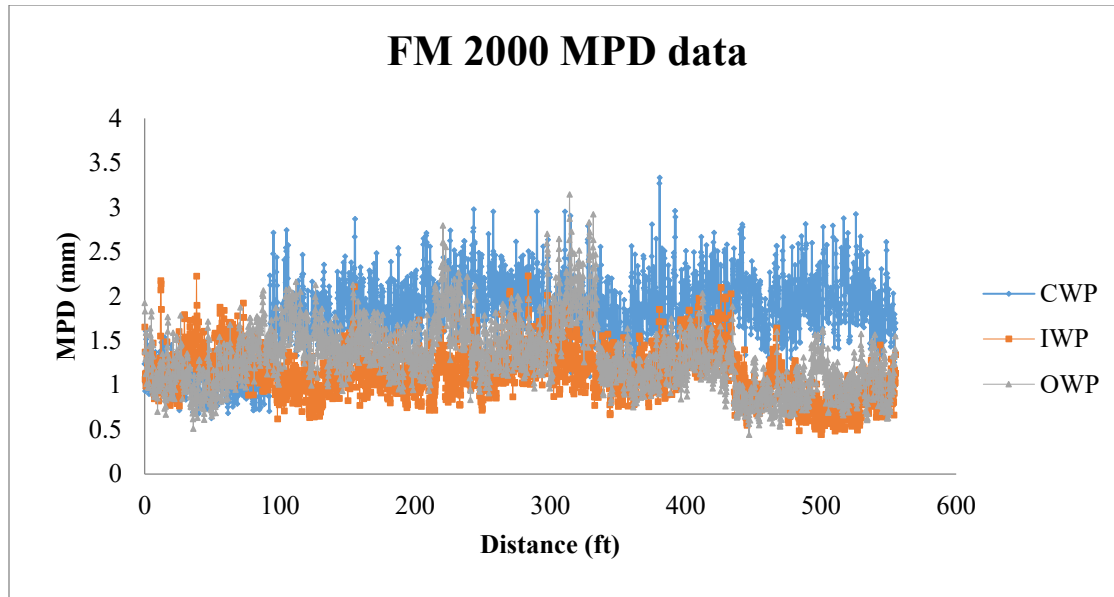
Figure 16. MPD Data for Different Locations on FM 2000 in the K1 Lane.

The aggregates used in the FM 2000 and FM 0487 field sections were both Grade 4, which according to TxDOT specifications has 95–100 percent passing the #4 (4.75 mm) sieve (2). This aggregate size was selected as representative to compare against the MPD peaks. The ED was then calculated (using MATLAB) by subtracting the representative aggregate size (4.75 mm) from the peak points, and then dividing by the predominant aggregate size.

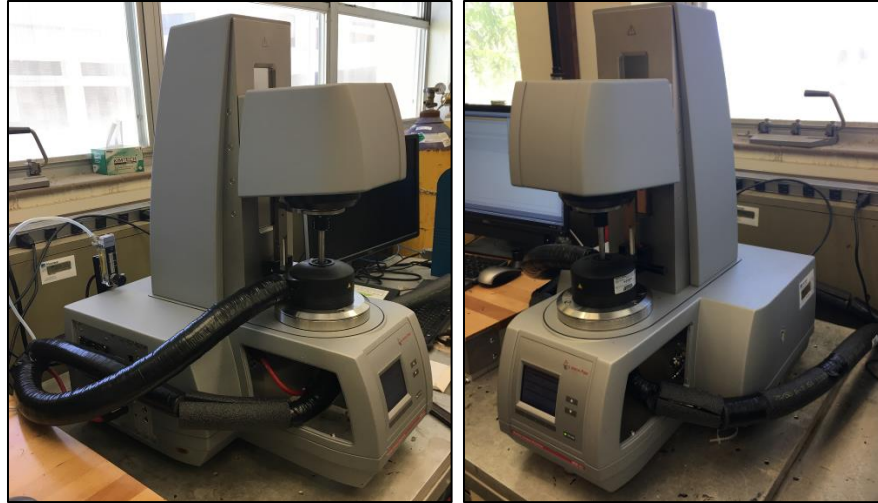
Figure 34. Anton Paar MCR 302.

Additional considerations and calibration procedures are required when conducting 4-mm DSR low temperature measurements as reported in previous literature (43, 46, 49). The technique is an ongoing topic of discussion among researchers, and experimental difficulties continue to arise as more researchers pursue implementation of the method using different equipment configurations as compared to that at WRI and MTE where the original methods and correlations were developed. In this study, an Anton Paar Modular Compact Rheometer (MCR) 302 with H-PTD 200 Peltier hood and plate configuration, as shown in Figure 34, was used to perform the 4-mm DSR testing. The pipelines connecting the counter cooling system to the Peltier were insulated to provide more stable counter cooling. The selected Peltier plate/hood configuration includes top and bottom active heating and cooling plus air circulation, and it is capable of maintaining stable temperatures from –40 to 200°C provided that the appropriate counter cooling is supplied to the Peltier.

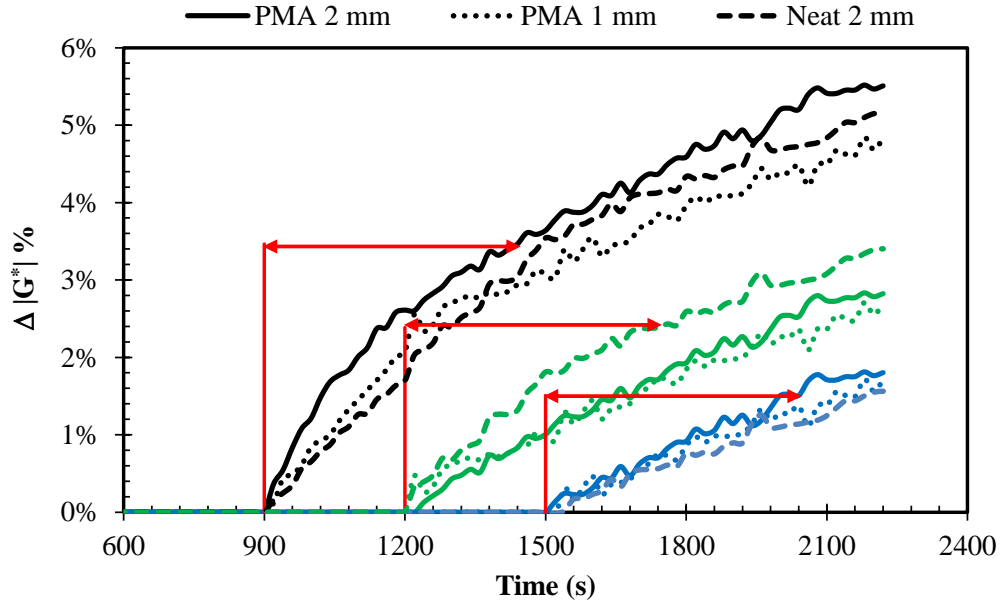
b) $\Delta|G^*|$: Temperature Equilibrium versus Physical Hardening
Figure 36. Selection of Equilibrium Time for Initial Temperature Step 0 to -31°C .

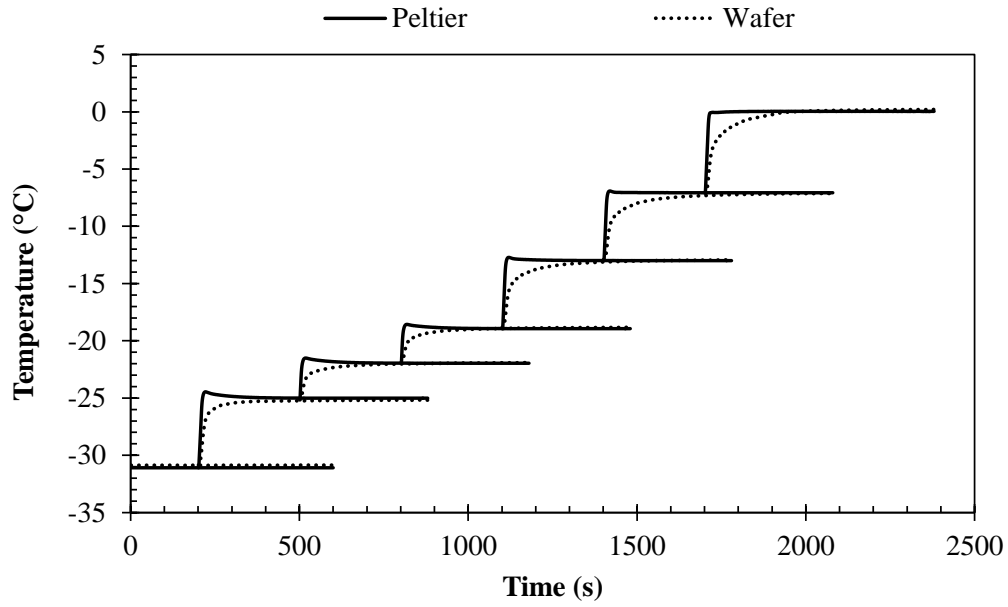
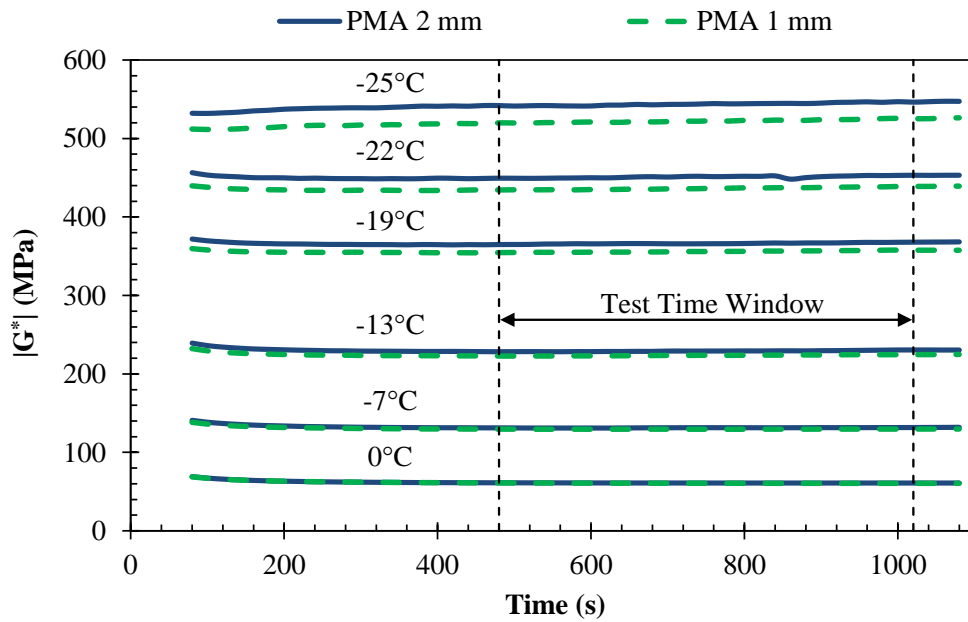
a) Temperature Peltier and Wafer during Subsequent Temperature Steps

b) $|G^*|$ and Test Time Window
