TECHNICAL MEMORANDUM

**LOW-COST SAFETY SOLUTIONS, PAVEMENT
PRESERVATION AND MAINTENANCE
PRACTICES FOR RURAL HIGHWAYS**

TxDOT Project 9-1529 – Task 1.6

**INNOVATIVE LOW-COST SAFETY SOLUTIONS FOR RURAL
HIGHWAYS**

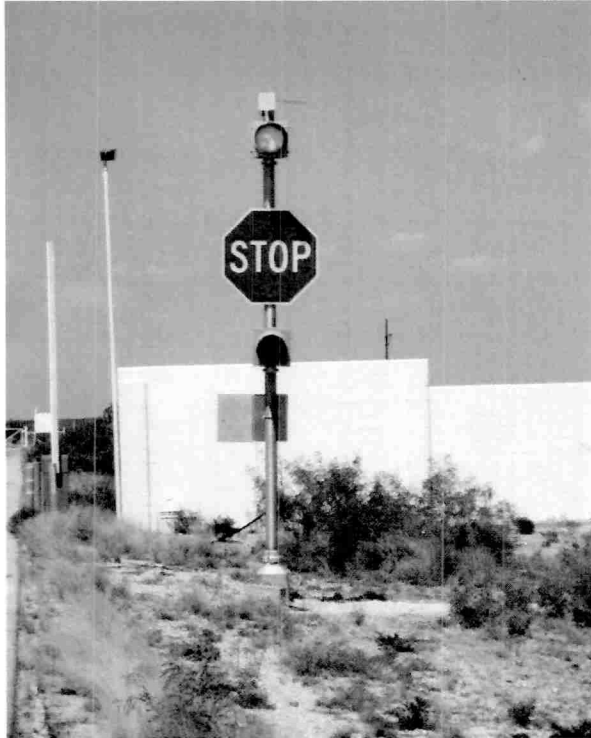
Figure 3. STOP Sign Installed at Pecos Test Track.

TTI researchers worked with TxDOT Odessa district to install two roadside flashing beacon assemblies (RFBA). A STOP sign (R1-1) with red DC flashing beacons and a STOP Ahead sign (W3-1) with yellow DC flashing beacons were installed at the locations identified in Figure 1. Flasher cabinets fabricated by TTI researchers, Sensys access points, and repeaters were installed on the sign posts by TxDOT technicians. The two RFBA are illustrated in Figure 3 and Figure 4. One Sensys repeater was installed in the RFBA assembly for the STOP Ahead Sign and the second one was installed on a temporary pole. Sensys sensors were placed on the pavement and vehicles driven over them. This facilitated exhibiting the functionality of the treatment and allowed TTI/TxDOT further use of the sensors in project. Solar panels were not installed as these signs were installed for a demonstration only. 12 volt batteries were used by TTI researchers to power the flasher cabinets and the beacons.

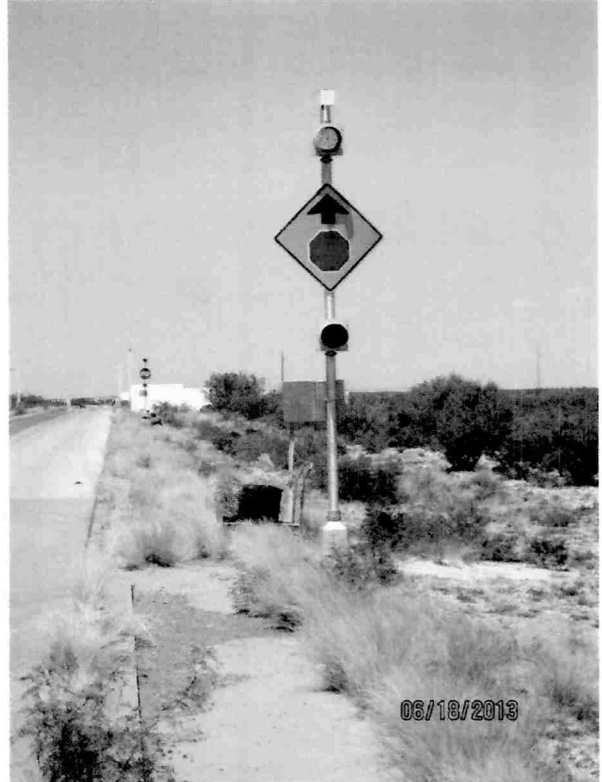
Figure 4. STOP Ahead Sign Installed at Pecos Test Track

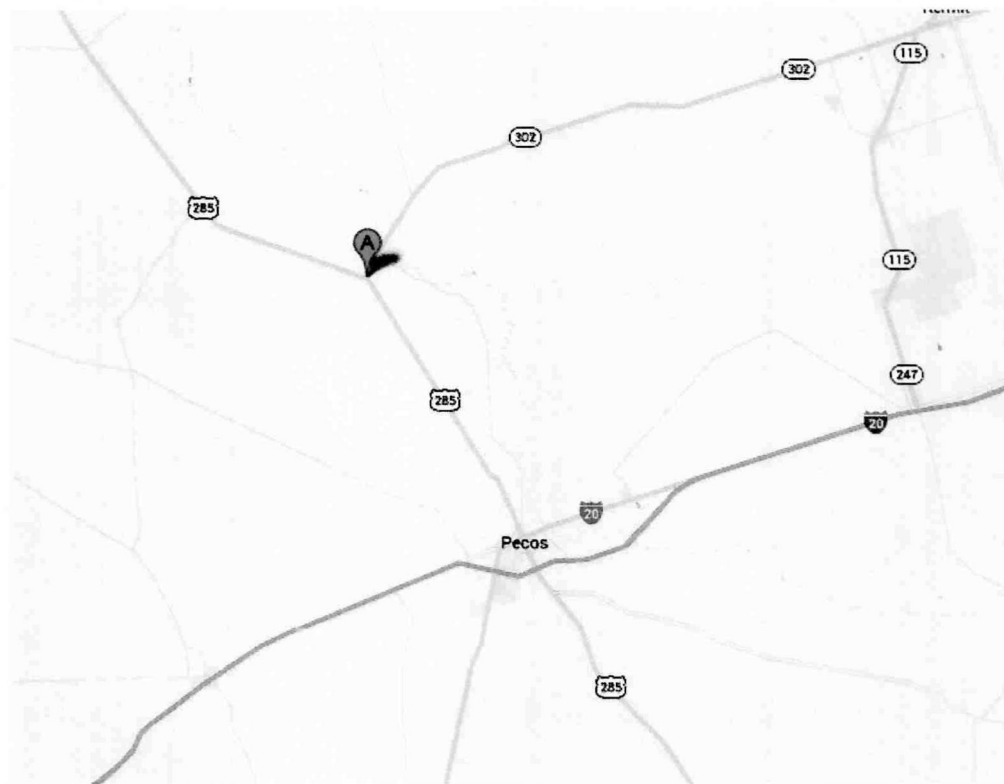
After a thorough review TxDOT engineers in Odessa district selected the intersection of US 285 and SH 302 in Odessa district. This intersection is located about 20 miles north of I20 in Pecos as illustrated in Figure 5.

Figure 5. Installation Site Near Pecos .

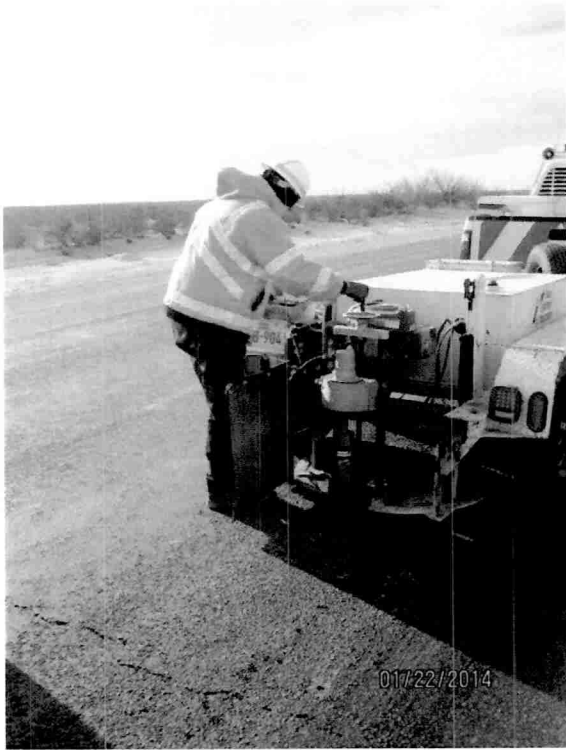
Figure 7. Core Machine preparing the Pavement to Install the Sensors.

The system consisted of two sub-systems. The first sub-system consisted of active beacons on stop ahead sign. This sub-system consisted of a wireless sensor (VSN240-F) installed at a distance of approximately 600 feet upstream of the stop ahead sign. A long life repeater (RP240-BH-LL) was installed on the back side of the sign post for JCT 285 which was located at a distance of 1700 feet from the stop bar. An Access Point (AP240) was installed on the pole on which solar panel and the cabinet with the batteries was installed near the stop ahead sign. The flasher cabinet was then installed on the same pole. Figures 7 to 10 illustrate the system being installed.

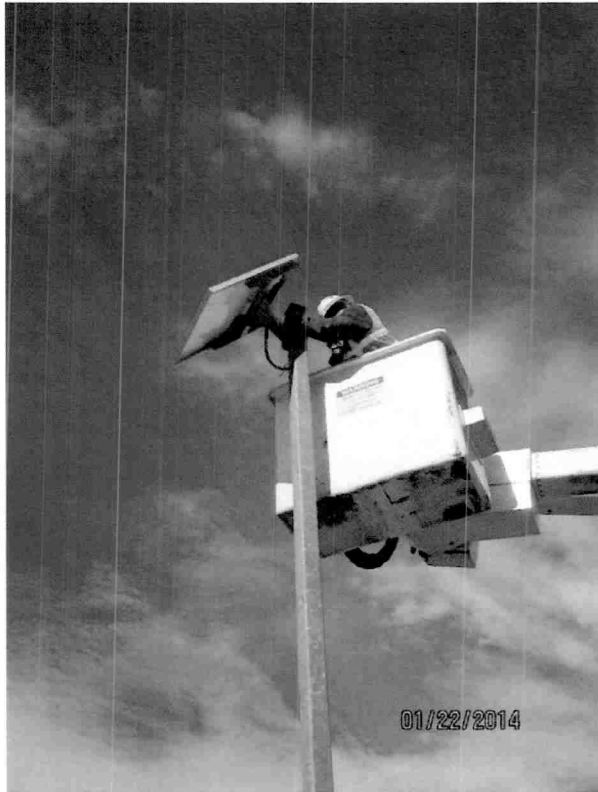
Figure 9. Access Point Installation on the Solar Panel Pole.

The second sub-system consisted of active beacons on the stop sign. This sub-system consisted of a wireless sensor (VSN240-F) installed about 50 feet upstream of the stop ahead sign and a long life repeater (RP240-BH-LL) installed on the pole with the solar panel near the stop ahead sign. The sub-system also had two additional wireless sensors at the stop bar (VSN240-T) and an Access Point (AP240) installed on the pole with the solar panel near the stop sign.

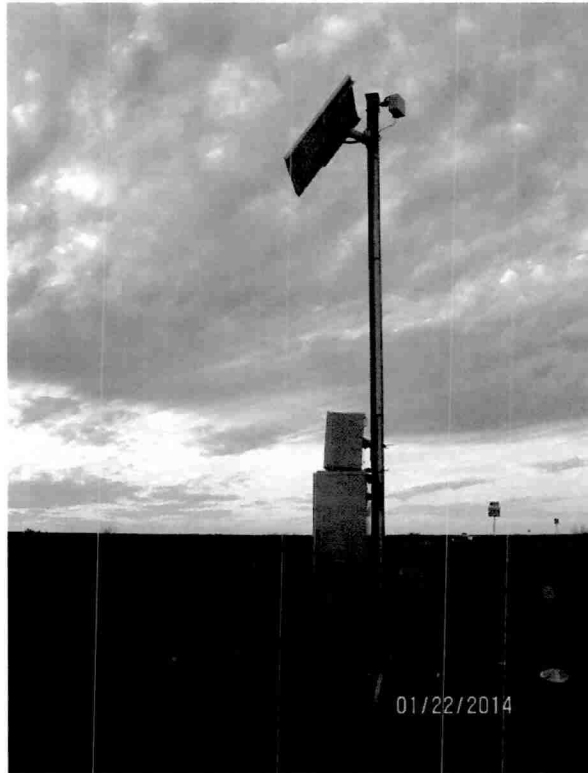
Figure 10. Flasher Cabinet Installed on the Solar Panel Pole.
