Paper No. 961276

WYOMING ROAD CLOSURE GATE

THE 75th ANNUAL MEETING
TRANSPORTATION RESEARCH BOARD
WASHINGTON, D.C.

TEXAS TRANSPORTATION INSTITUTE
THE TEXAS A&M UNIVERSITY SYSTEM
COLLEGE STATION, TEXAS

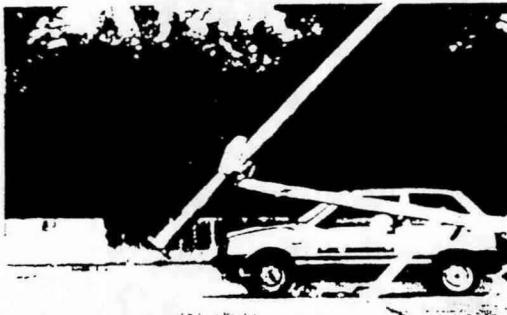
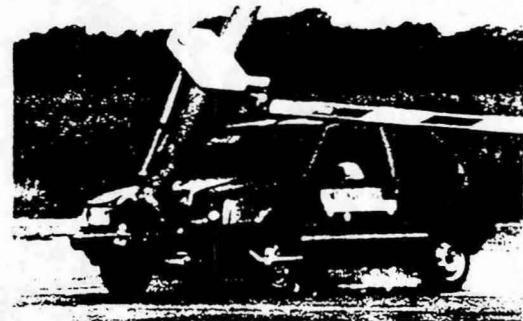
FIGURE 7. Sequential photographs of first low-speed crash test.

Upon impact, the slip base activated as designed and the support pole structure rotated free of the slip-base assembly. As the vehicle continued traveling forward, the support pole structure rotated past the horizontal position and impacted the rear of the roof of the vehicle, breaking the glass in the rear hatchback and damaging the roof severely. The vehicle lost contact with the road closure gate traveling at 28.2 km/h (17.5 mi/h). Sequential photographs of the test are shown in Figure 7.

The occupant risk factors were well within the limits set forth in NCHRP Report 350 as summarized in Table 1. However, this test was considered a failure due to intrusion into the occupant compartment resulting from the secondary impact of the separated support pole structure with the roof of the test vehicle. Analysis of the high-speed film indicated that the separated support pole structure had an angular velocity of approximately 180 deg/sec and was rotating about a point approximately 610 mm (2 ft) above the roof of the test vehicle. In comparison, a review of high-speed film from successful crash tests with slip-base luminaire supports indicated a much smaller angular velocity and higher point of rotation for the separated support pole structure.

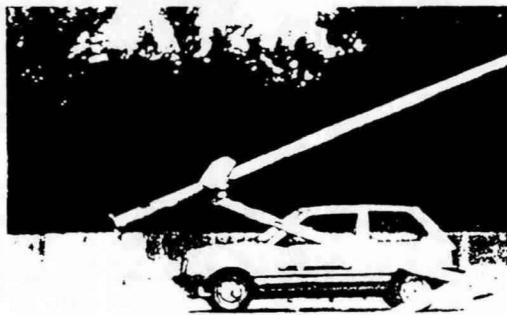
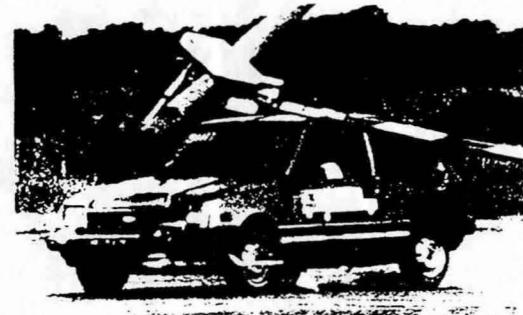
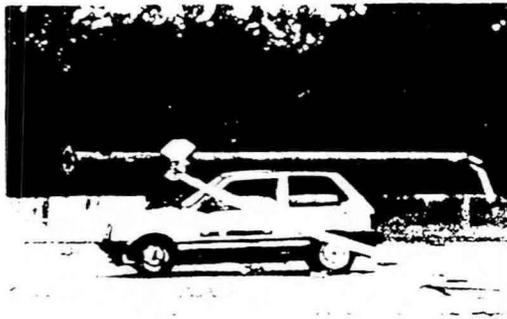
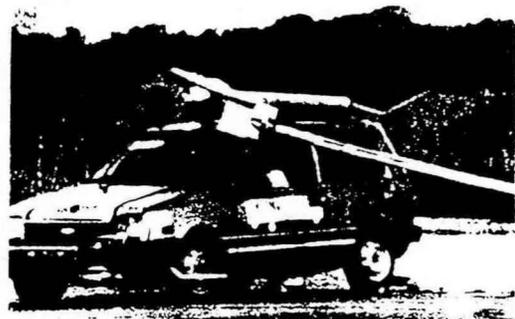
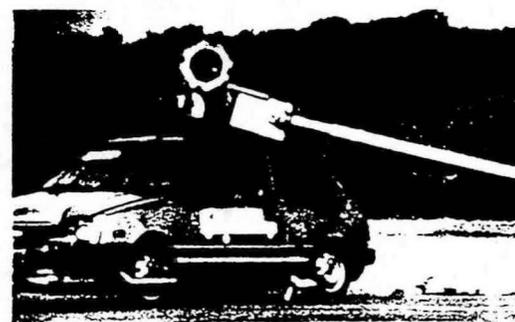
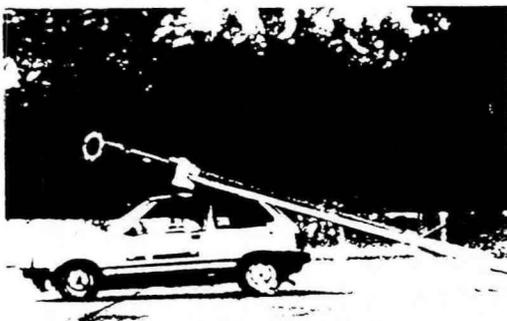
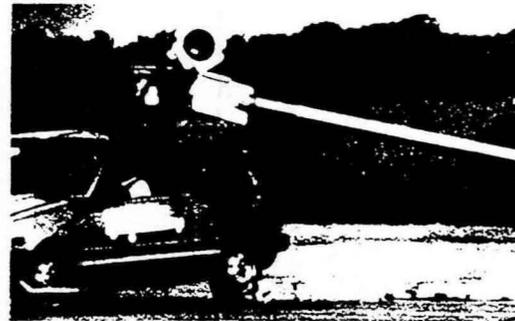
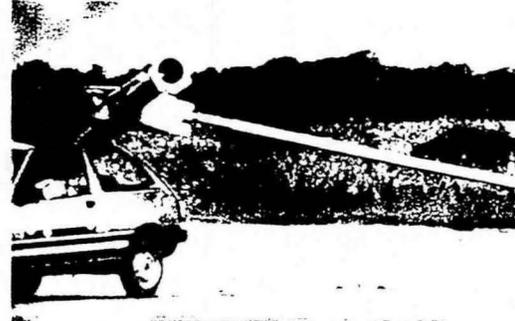
FIGURE 7. Sequential photographs of first low-speed crash test (continued).

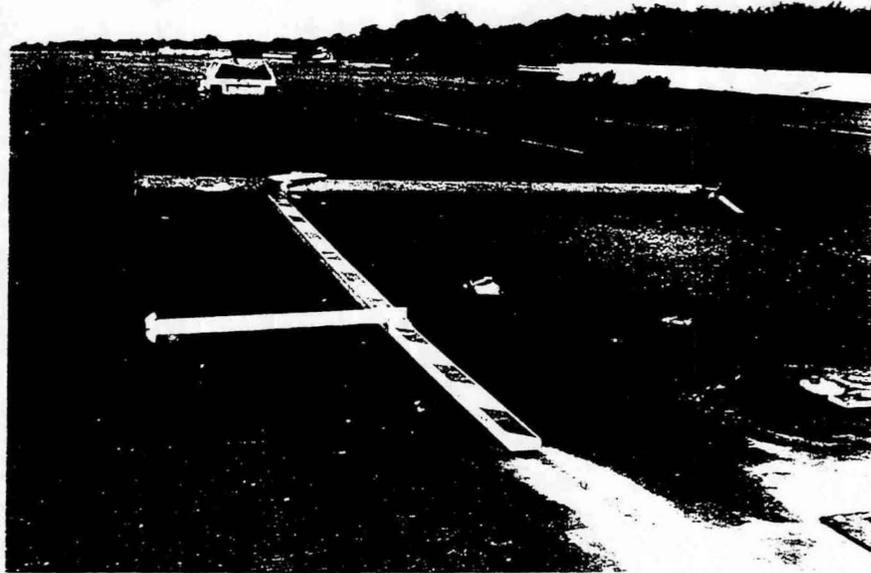
FIGURE 8. Damage sustained by test installation in first low-speed crash test.

Damage to the road closure gate was minimal. The cast aluminum housing of the electric motor was fractured during the test and would require repair or replacement prior to reinstalling the road closure gate. Although the front of the test vehicle sustained only minor damage, the roof of the vehicle was severely crushed. The maximum recorded roof deformation was 160 mm (6.3 in) across the passenger compartment area and around the head of the anthropomorphic dummy which was positioned in the driver's seat. Damage to the test installation and test vehicle is shown in Figures 8 and 9, respectively.

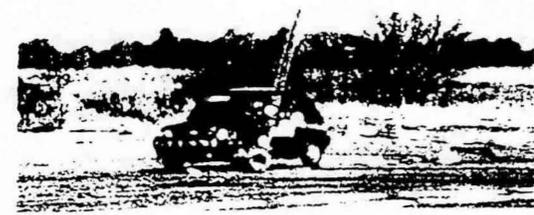
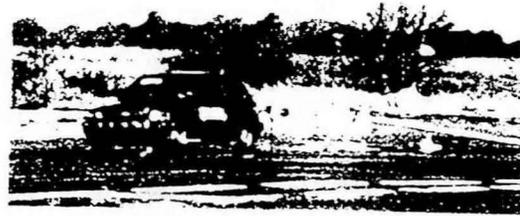
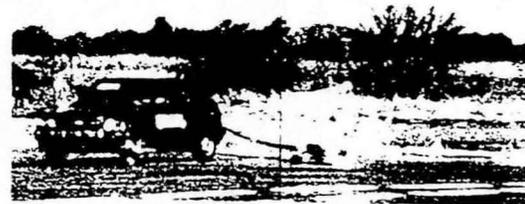
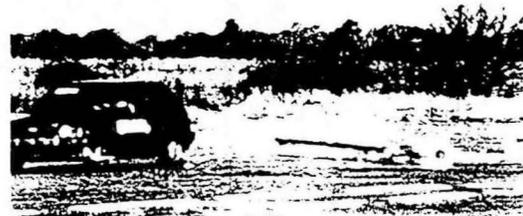
FIGURE 10. Sequential photographs of second low-speed crash test.

FIGURE 10. Sequential photographs of second low-speed crash test (continued).

The low-speed crash test was repeated with the taller, modified support structure. Photographs of the test installation are shown in Figure 2. The vehicle impacted the modified road closure gate head-on at a speed of 31.8 km/h (19.7 mi/h) with the left front quarter point of the vehicle aligned with the centerline of the support pole. Upon impact, the road closure gate released from the slip base as designed and achieved an angular velocity of approximately 73 deg/sec. As the vehicle continued traveling forward, the support pole structure briefly contacted the left rear corner of the roof of the vehicle. The vehicle lost contact with the road closure gate traveling at 20.8 km/h (12.9 mi/h). Sequential photographs of the test are shown in Figure 10.

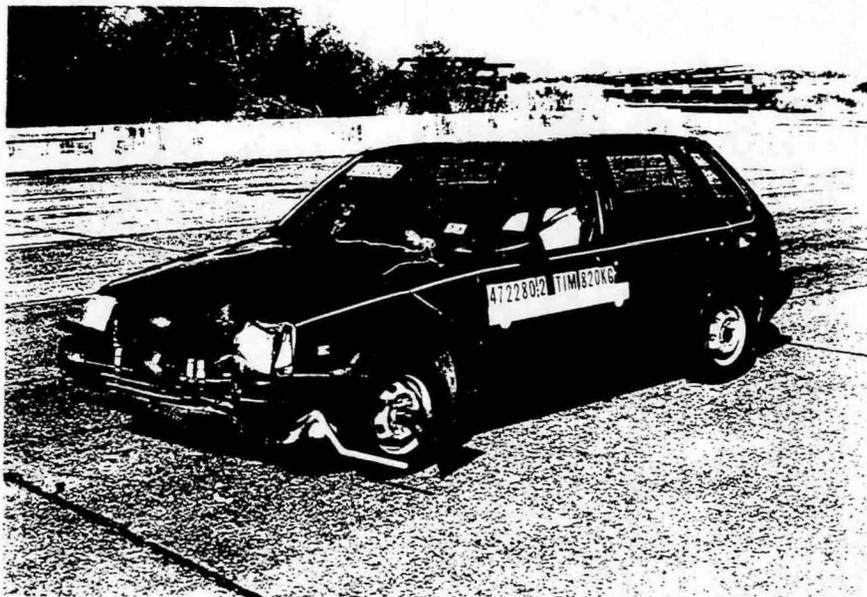
FIGURE 11. Damage sustained by test installation and vehicle in second low-speed crash test.

Damage to the road closure gate installation was relatively minor. The electric motor housing was again fractured and would require repair or replacement prior to reinstallation. Additionally, the luminaire was broken and would require replacement. The left front of the vehicle sustained light damage as did the left rear of the roof. The roof was deformed downward 10 mm (0.4 in) at the left rear corner, and there was no apparent intrusion into the passenger compartment area. Post-impact damage sustained by the vehicle and road closure gate is shown in Figure 11.

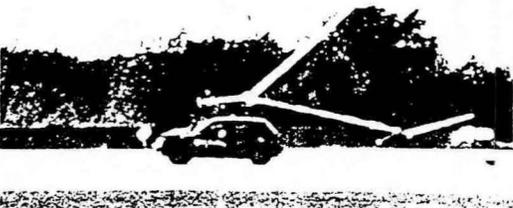
FIGURE 12. Sequential photographs of high-speed crash test.

The vehicle used in the low-speed crash test was reused for this crash test. The vehicle impacted the road closure gate at an impact speed of 104.0 km/h (64.6 mi/h) with the right front quarter point of the vehicle aligned with the centerline of the support pole structure. Upon impact, the slip base activated as designed, allowing the support pole structure to rotate freely above the vehicle. The support pole eventually came to rest on the ground without contacting the vehicle. Sequential photographs of the test are shown in Figure 12.

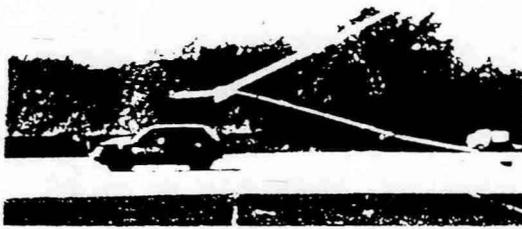
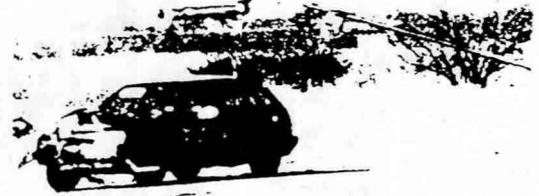
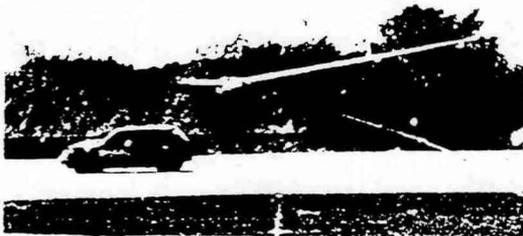
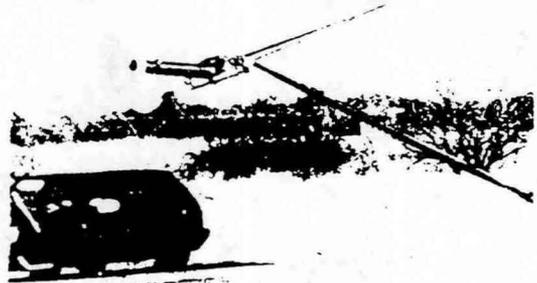
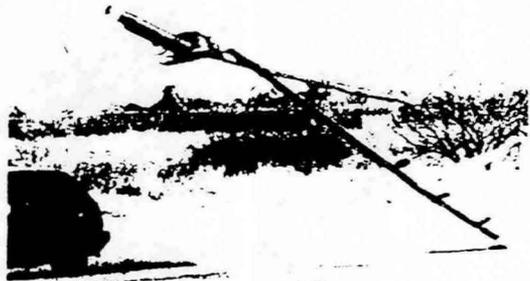
FIGURE 12. Sequential photographs of high-speed crash test (continued).

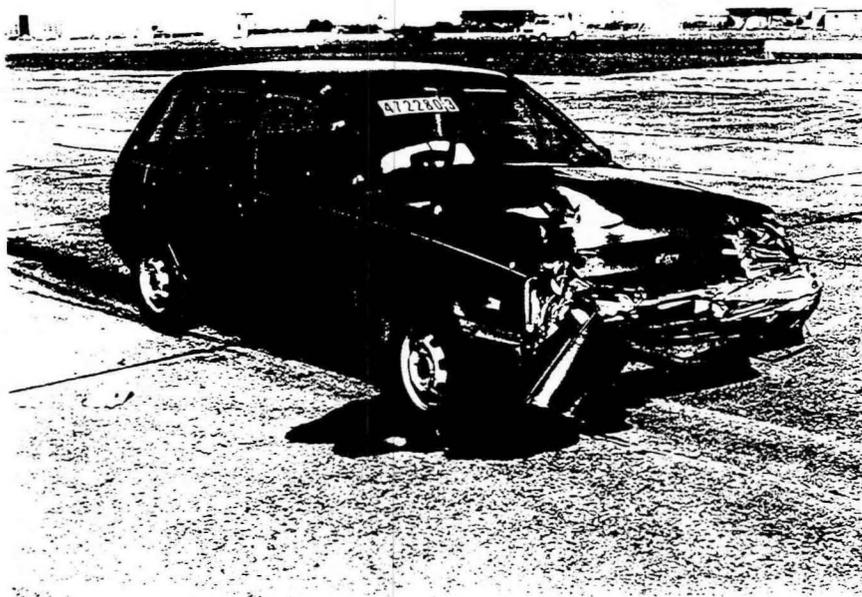
FIGURE 13. Damage sustained by test installation and vehicle in high-speed crash test.

Photographs of the test installation and vehicle after the test are shown in Figure 13. The road closure gate received extensive damage and the entire installation would need to be replaced. The vehicle sustained moderate damage to the right front. Maximum crush at the right quarter point of the bumper was 180 mm (7.1 in).

As summarized in Table 1, all occupant risk factors were well within the acceptable limits set forth in NCHRP Report 350. A small hole, measuring 10 mm (0.4 in) x 20 mm (0.8 in), was punched in the passenger side floor pan and the oil pan was also punctured. Upon further investigation, it appears that one of the slip bolts was first caught between the permanent lower slip base assembly and the undercarriage of the vehicle and then between the concrete pavement and the undercarriage of the vehicle, resulting in the damage. This behavior was indicated by gouge marks present on the top surface of the spacer plate of the permanent lower slip base assembly and on the concrete pavement.
