CLOSED COURSE PERFORMANCE TESTING OF THE AWARE INTRUSION ALARM SYSTEM

Prepared for Oldcastle Materials, Inc.
Round Rock, TX 78681

April 12, 2017

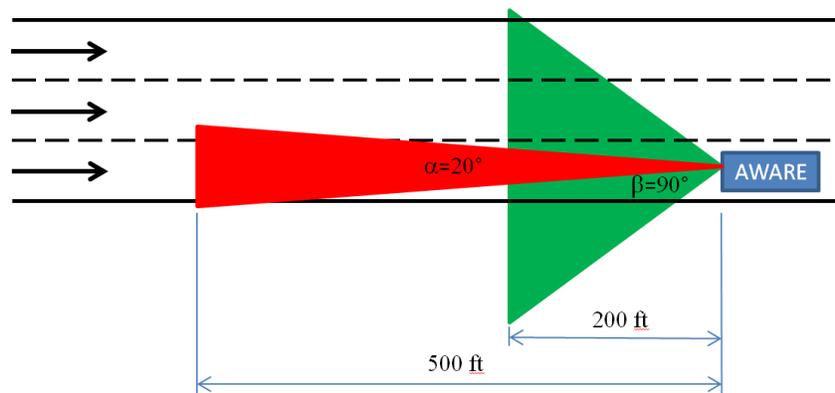
Figure 1. Threat Detection Regions.

The long-range region (shown in red) extends approximately 500 ft upstream of the alarm system. The width of the region expands 10 degrees on either side of the centerline (for a total detection angle $\alpha = 20$ degrees). The short-range region (shown in green) extends approximately 200 ft upstream of the alarm system and expands 45 degrees on either side of the centerline (for a total detection angle $\beta = 90$ degrees).

Oldcastle Materials and ARTIS, LLC have joined forces to develop an innovative work zone intrusion detection and alarm system. This system has been named AWARE, for Advance Warning And Risk Evasion. Unlike previous intrusion alarm systems that rely on the detection of vehicles crossing a predetermined perimeter (typically identified with pneumatic tubes or infrared beams), this new system utilizes a target threat detection and tracking methodology to logically assess approaching vehicle speed, location, and possible trajectory. When the AWARE system is deployed in a roadway environment (i.e., a work zone), threats are detected in two flat, fan-shaped regions, as shown in Figure 1.

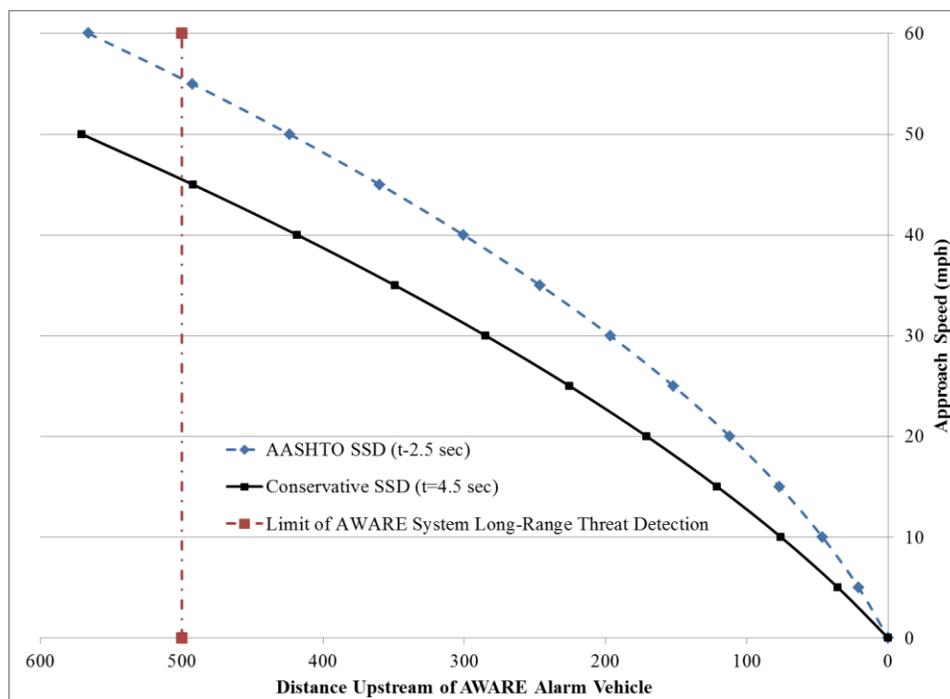
The AWARE system also relies on an alternate (more conservative) calculation of SSD assuming that $t=4.5$ seconds to activate some of its alerts and alarms. By substituting this in the equation in lieu of 2.5 seconds, the outcome is longer SSD values. For example, for a vehicle approaching at a speed of 45 mph, the conservative calculated SSD would be 492 ft; for a vehicle approaching at 60 mph, the conservative SSD would be 742 ft. As shown in Figure 2, the conservative SSD is longer than the long-range threat detection capabilities of the AWARE system once approach speeds exceed 45 mph, and the AASHTO SSD is longer than the long-range region once approach speeds exceed 55 mph. This means that the detection range of the system governs activation of its alarms and alerts for system testing purposes.

Figure 2. Conservative and AASHTO SSD values used by AWARE.

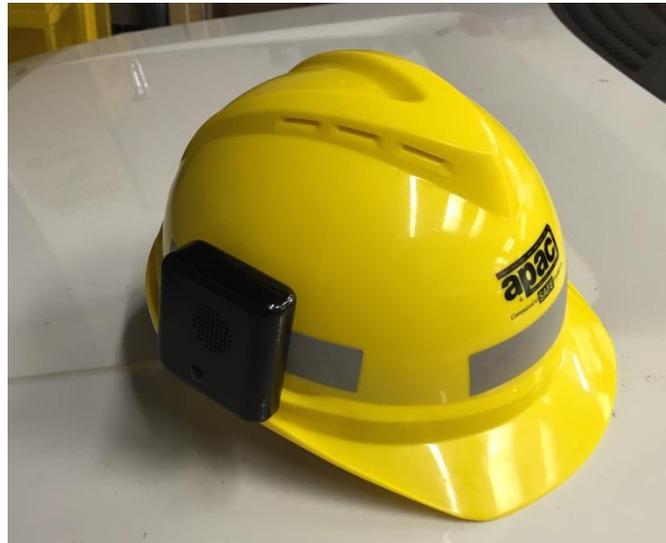
The AWARE system also includes personal body alarms called Worktrax. These devices, which can be worn by workers as part of their personal protective equipment (PPE), are linked to the main AWARE alert system and produce both vibratory (tactile) and audible alerts when the main alarm system is triggered if the worker is positioned within the potential trajectory of the intrusion threat vehicle. A hardhat-mounted Worktrax device is shown in Figure 3.

Figure 3. Worktrax Personal Alarm Mounted on Hardhat.

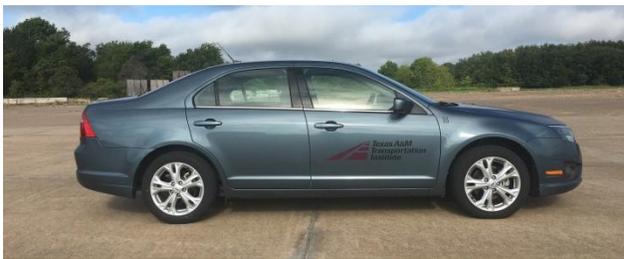
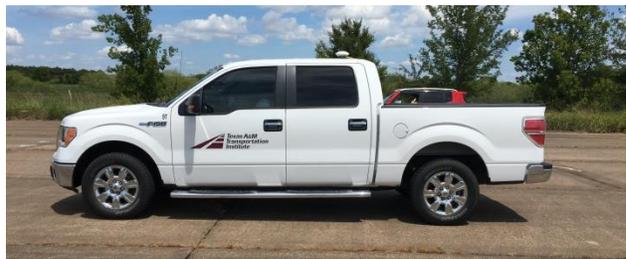
During testing, the researchers used two different approach vehicles (shown in Figure 4). This allowed the researchers to verify that the AWARE system could detect vehicles of different sizes. The passenger car was a 2012 Ford Fusion and the pickup truck was a 2011 Ford F-150.

Figure 4. Approach Vehicles Used in Tangent Alignment Testing.

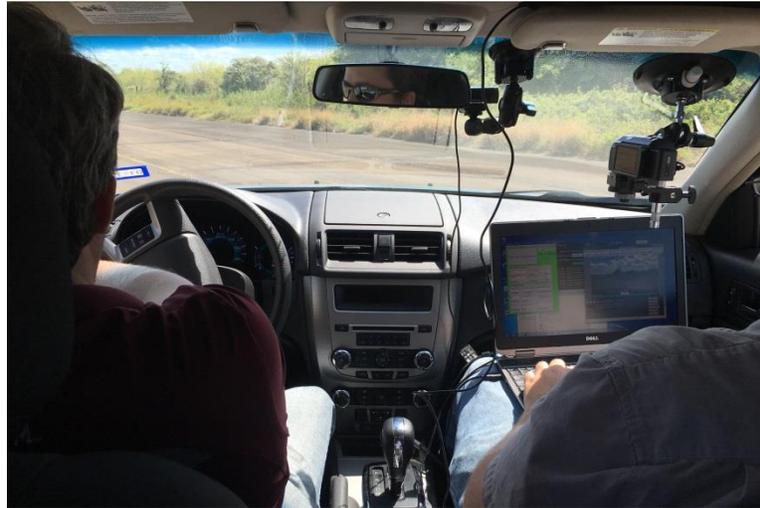
A dash-mounted video camera was also linked to the in-vehicle laptop for continuous capture of the forward scene view from the approach vehicle. As a backup, a separate time-synced video camera also independently recorded the forward scene data. The cameras and laptop are shown in Figure 5.

Figure 5. Approach Vehicle Data Collection Equipment.

The approach vehicles were instrumented with a Trimble GPS system using Real Time Kinematic (RTK) satellite navigation to continuously track approach vehicle position via corrected GPS data. The RTK base station was located approximately 3,200 ft (less than 1 km)

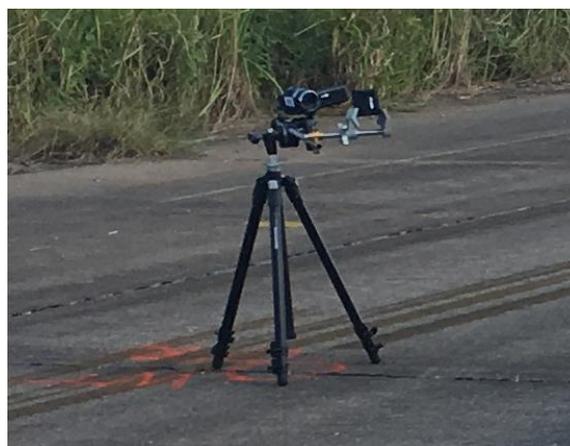
During portions of the testing, Worktrax devices were also evaluated for proper response when the main alarm was triggered. The researchers used tripod-mounted video cameras to record the Worktrax responses (i.e., alarm sound and vibration) using time-synchronized videos which could then be matched to the time stamps of the in-vehicle data. A typical test setup is shown in Figure 6.

Figure 6. Worktrax Alarm Monitoring During Testing.

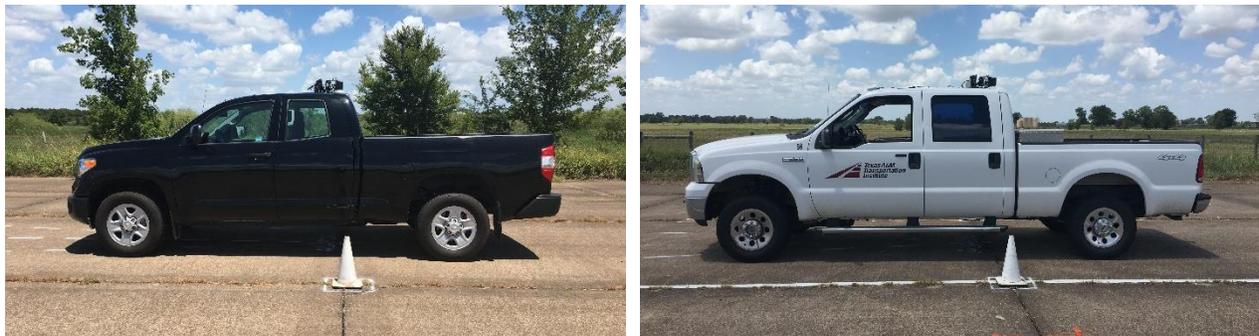
For these tests, the AWARE systems were mounted on two different host vehicles, as shown in Figure 7. The black truck was parked facing northbound, while the white truck was parked facing southbound on the opposite side of the test track. This allowed the researchers to obtain two approach runs during a single lap of the test track.

Figure 7. AWARE Vehicles Used in Tangent Alignment Testing.

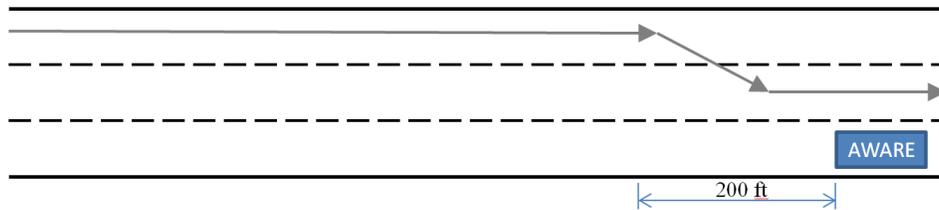
In Trajectory A, TTI staff drove the instrumented vehicle towards the AWARE system beginning two lanes left of the lane in which the AWARE vehicle was located. Once the instrumented vehicle was within 200 ft of the AWARE vehicle (i.e., within the short-range detection region of

the system), the TTI driver made an abrupt lane change into the lane adjacent to the AWARE vehicle, and then continued past the AWARE vehicle in that adjacent lane. This approach path is shown in Figure 8. The expectation was that the alarm system would not produce an alert (i.e., would not activate the lights, audible alarm, or Worktrax).

Figure 8. Approach Path for Trajectory A of Tangent Alignment Testing.

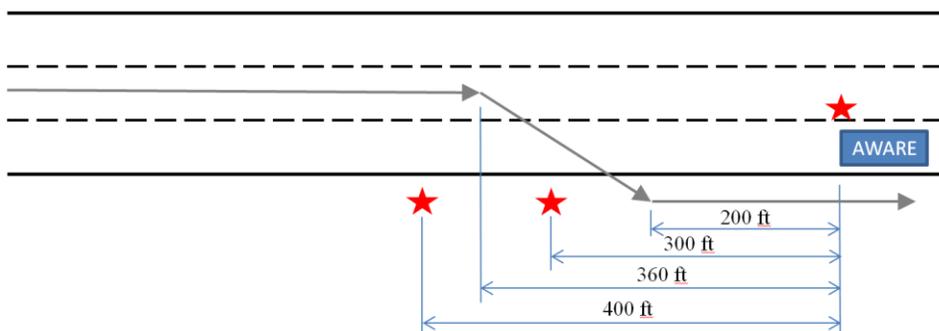
In Trajectory C, the instrumented vehicle began in the left lane adjacent to the lane in which the AWARE vehicle was located. At a location between 360 ft and 200 ft upstream of the AWARE vehicle, the instrumented vehicle crossed over into the lane adjacent to the AWARE vehicle on the right side. This approach path is shown in Figure 10. The red stars indicate the Worktrax locations for this series of tests. The expectation was that this trajectory would produce an alert which would trigger the lights and audible alarm. The Worktrax devices would activate only if the threat was detected upstream of the Worktrax locations (i.e., the devices located at 0 ft and potentially 300 ft upstream).

Figure 10. Approach Path for Trajectory C of Tangent Alignment Testing.

In Trajectory C testing, the Worktrax device located adjacent to the AWARE vehicle was expected to activate, but the Worktrax device located at 300 ft and 400 ft upstream of the vehicle were not expected to activate. As stated previously, the trajectory vehicle entered the protected lane between 360 ft and 200 ft from the AWARE system vehicle (typically around or closer than 300 ft) and therefore did not activate the upstream devices. Of 144 potential Worktrax device responses, 15 could not be accurately ascertained due to TTI equipment failure. However, all of the remaining responses were correct.

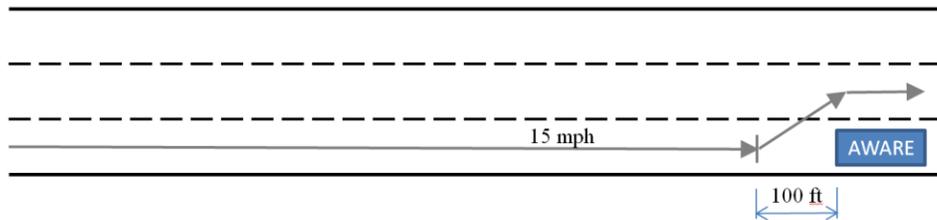
In Trajectory D, the instrumented vehicle began in the same lane in which the AWARE vehicle was located and traveled towards the system at a speed of 15 mph. Within 100 ft of the AWARE vehicle, the instrumented vehicle came to a full stop, and then passed the AWARE vehicle on the left at a speed no greater than 15 mph, similar to how a construction vehicle might enter and pass by a work crew. This approach path is shown in Figure 11. For this trajectory, the expectation was that the alarm system would not produce an alert. Once proper system response was verified using the instrumented passenger car, the sponsor agreed that the pickup truck need not be also tested under this trajectory.

Figure 11. Approach Path for Trajectory D of Tangent Alignment Testing.

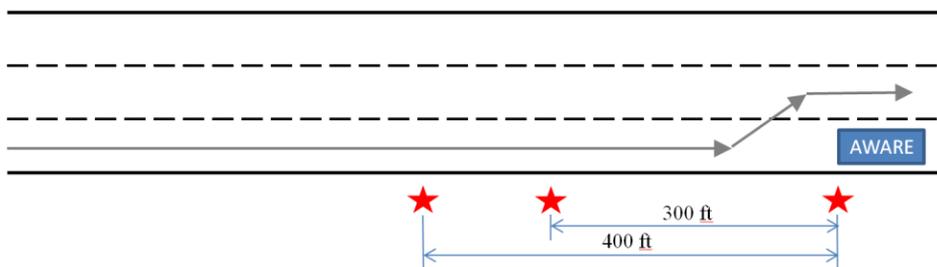
In Trajectory E, the instrumented vehicle penetrated the SSD threshold for a prescribed approach speed. In the northbound direction, the approach speed was 45 mph, yielding an AASHTO SSD limit of 360 ft and a conservative SSD of 492 ft. In the southbound direction, the approach speed was 60 mph, yielding an AASHTO SSD limit of 566 ft and a conservative SSD of 742 ft. This approach path is shown in Figure 12. Again, the red stars indicate the Worktrax locations for this series of tests. The expectation was that this trajectory would produce an alert which would trigger the lights, audible alarm, and Worktrax components of the system. For both approach speeds, the lights and Worktrax devices should be activated upon penetration of the long-range threat detection region since the conservative SSD in both cases was equal to or greater than the 500 ft long-range threat detection region.

Figure 12. Approach Path for Trajectory E of Tangent Alignment Testing.

In Trajectory E testing, the approach vehicle made a direct penetration of the SSD in the lane where the AWARE vehicle was parked. Due to road noise inside the instrumented vehicle at higher speeds coupled with being at a further distance from the alarm than in Trajectory C, the time at which the audible alarm was activated could not be determined for all test runs. Therefore, the researchers focused solely on the activation of the flashing lights and the Worktrax devices for analysis of Trajectory E data.

At 45 mph, the range of flashing light activation distance was 382 ft to 522 ft. Statistically, there was no difference in activation distances between the car and the truck. Overall, the average activation distance was 478.8 ft. Considering that the data collection methods may have introduced some lag time due to laptop recording speed, etc., the researchers concluded that the AWARE system met the performance requirements of a 500 ft detection range for Trajectory E at 45 mph.

At 60 mph, the range of flashing light activation distance was 388 ft to 554 ft. Statistically, there was no difference in activation distances between the car and the truck. Overall, the average activation distance was 477.9 ft, essentially equal to that observed for the 45 mph tests. Once again, this demonstrates the verification of the 500 ft detection range of the system.

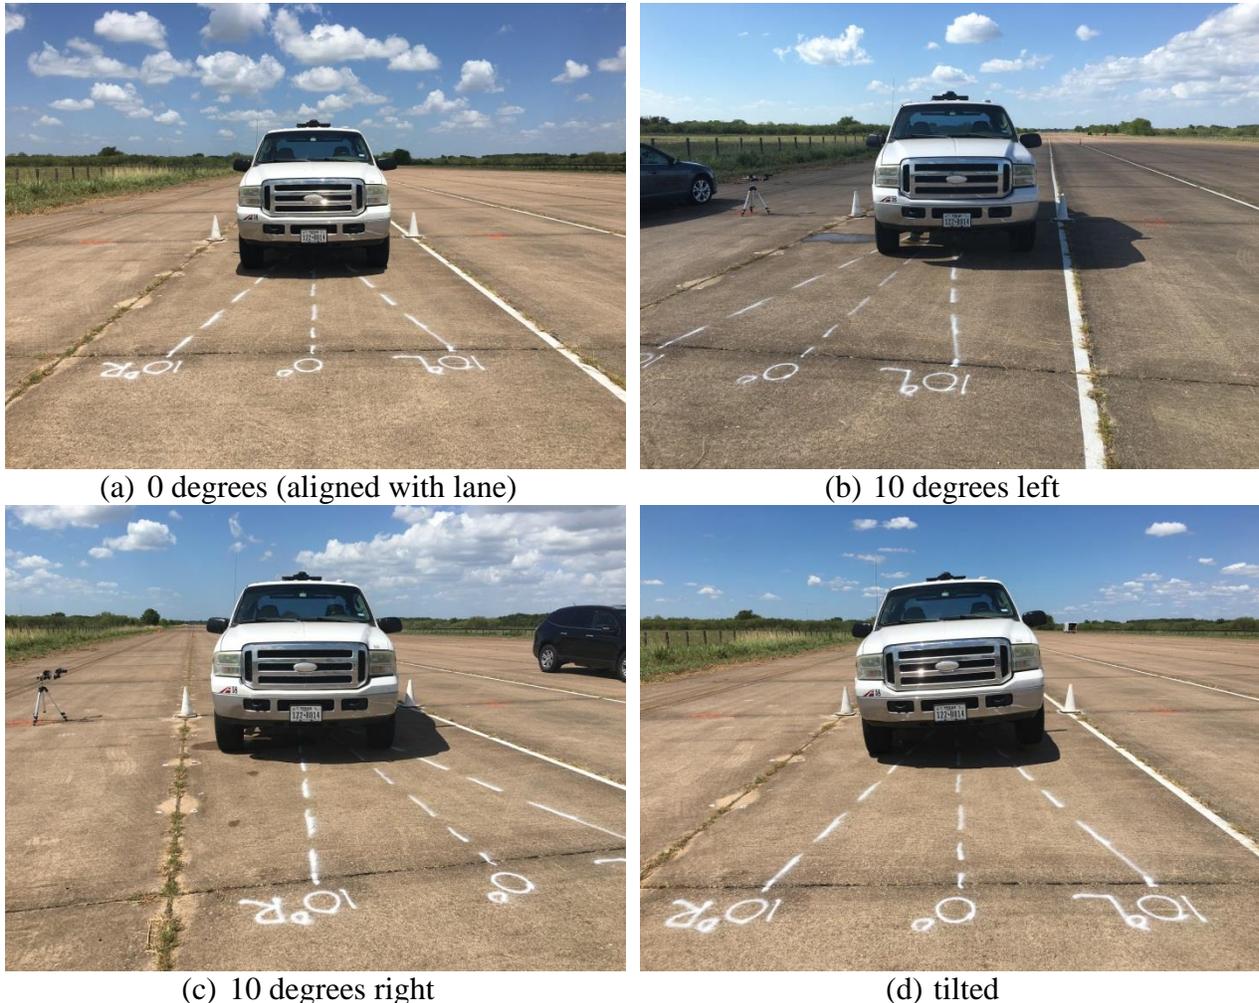
Next, TTI staff evaluated the ability of the AWARE system to operate in slightly skewed deployments. This was intended to simulate a condition where the AWARE vehicle may not be perfectly aligned during deployment in a real work zone. These data were collected with the AWARE vehicle alignment skewed approximately 10 degrees left and 10 degrees right from

parallel to the travel lane. In addition, data were collected with the AWARE vehicle aligned parallel with the lanes, but with the left tires lifted approximately four inches to simulate the AWARE vehicle parked on a paved shoulder (at approximately six degrees of tilt). The normal and skewed AWARE vehicle alignments are shown in Figure 13.

Figure 13. AWARE Vehicle Alignments Used in Tangent Alignment Testing.

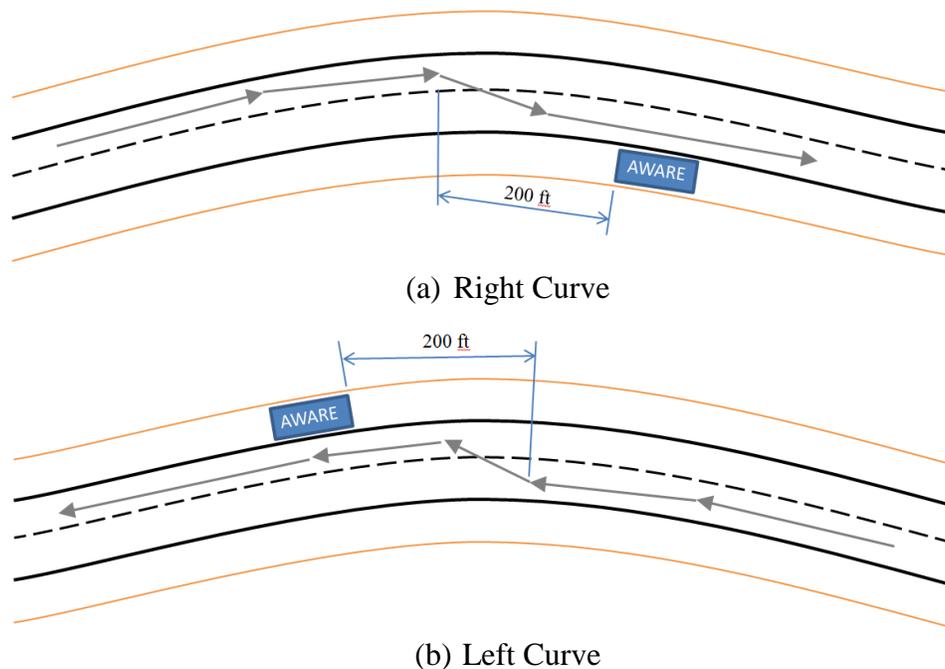
With the AWARE vehicle in position, TTI researchers drove the instrumented vehicle along a designated path at 40 mph according to four trajectories (A, B, C, and E). Figure 14 through Figure 17 show the trajectories used for the right and left curve alignment testing. A total of 48 runs were made during the curved alignment testing. Although the distances shown in the Figures indicate straight line chord distances, they were in fact measured along the curve during these tests.

Figure 14. Approach Path for Trajectory A of Curve Alignment Testing.

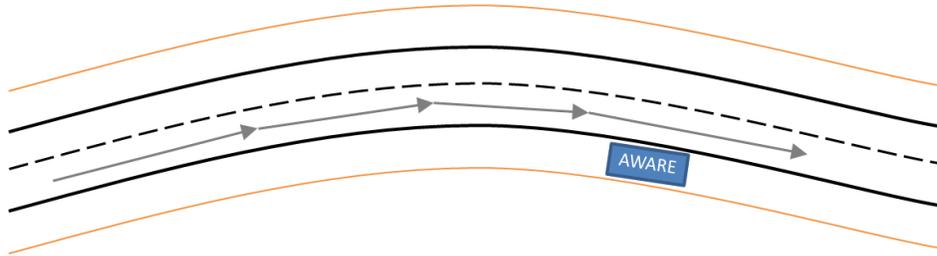
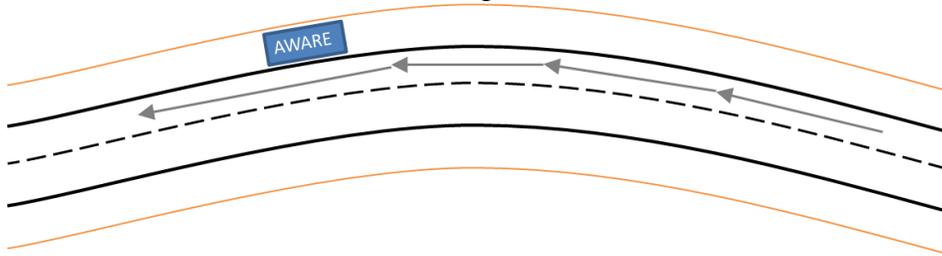
Figure 15. Approach Path for Trajectory B of Curve Alignment Testing.

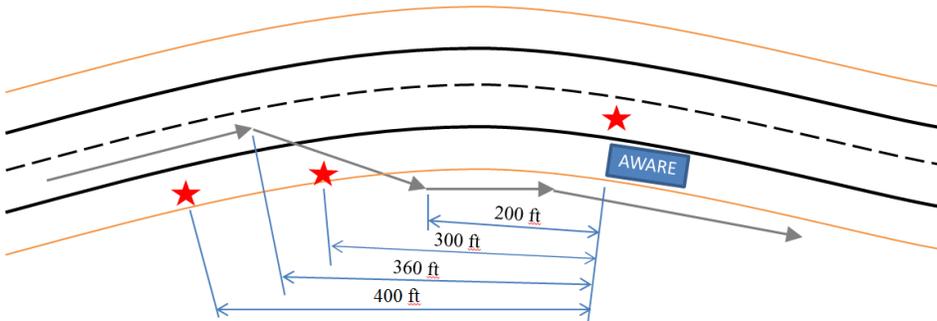
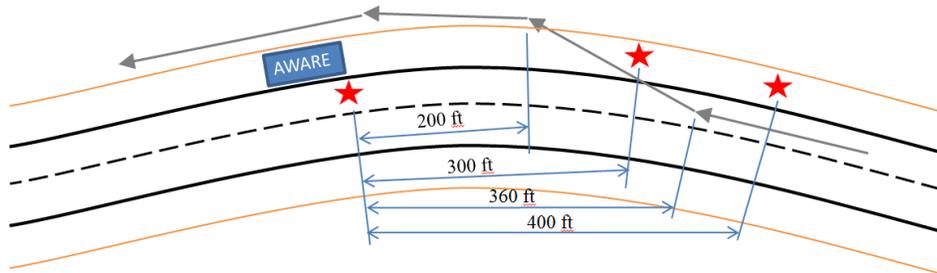
Figure 16. Approach Path for Trajectory C of Curve Alignment Testing.

In Trajectory C testing, the approach vehicle made a crossover maneuver and the AWARE system responded with both flashing light and sound activation as expected. The Worktrax device located adjacent to the AWARE vehicle was expected to activate, and did so in all 12 runs for this trajectory. The Worktrax devices located at 300 ft and 400 ft should not have activated since the crossover maneuver did not occur until the trajectory vehicle was within 300 ft of the AWARE vehicle. At these locations, the proper response (no alert) was documented during all 12 runs. Thus, all responses were correct.

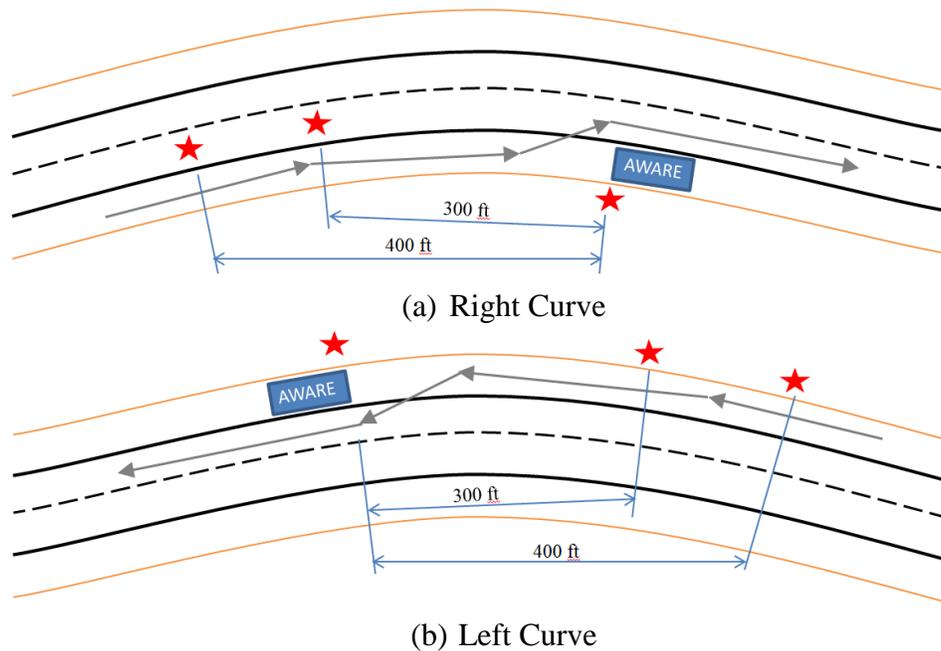
Figure 17. Approach Path for Trajectory E of Curve Alignment Testing.

In Trajectory E testing, the approach vehicle made a direct penetration of the conservative SSD in the lane where the AWARE vehicle was parked. As before, the researchers focused solely on the activation of the flashing lights for analysis of Trajectory E data. At 40 mph, the range of flashing light activation distance was 265 ft to 424 ft, measured along the curve trajectory. Figure 24 shows the results of the curved alignment testing.

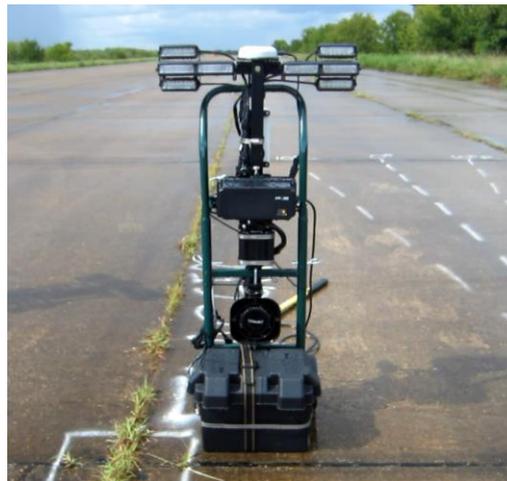
For the flagging operation, a single AWARE system was mounted on a hand truck to replicate a freestanding alarm system, or “flagger cart” that is under development. This system is shown in Figure 18. The cart was positioned approximately two feet from the travel lane used for the instrumented vehicle approaches (to simulate where a flagger would stand). The researchers used a sledge hammer to apply dead weight to the flagger cart foot pedal. When the pedal was pressed, the cart was operating in SLOW PADDLE mode. This simulated a flagger holding the pedal down and allowing vehicles to pass by. When the sledge hammer was removed, the cart was operating in STOP PADDLE mode. This simulated a flagger holding traffic and not allowing vehicles to pass by.

Figure 18. AWARE System Used in Flagging Operation.

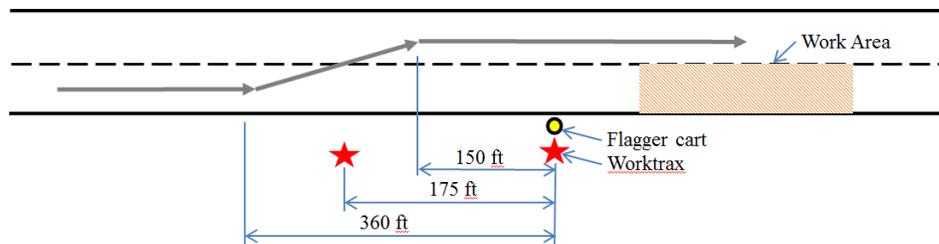
In testing of Trajectories F and G, TTI staff drove the instrumented vehicle towards the flagger cart in the approach lane at 45 mph. Once the instrumented vehicle was within 360 ft of the flagger cart, the TTI driver made a lane change into the adjacent (left) lane and completed that maneuver before reaching a point 150 ft upstream of the flagger cart. The driver then continued past the flagger cart in that adjacent lane at 45 mph. This approach path is shown in Figure 19.

Figure 19. Approach Path for Trajectories F and G of Flagging Operation Testing.

The flagger cart was operating in SLOW PADDLE mode during Trajectory F. This simulated a flagger waving a car around into the open lane, so the alarm system was not expected to produce an alert. During Trajectory G, the flagger cart was operating in STOP PADDLE mode. This was to simulate a vehicle disregarding the flagger instruction and the alarm system was expected to produce an alert and trigger the Worktrax as well.

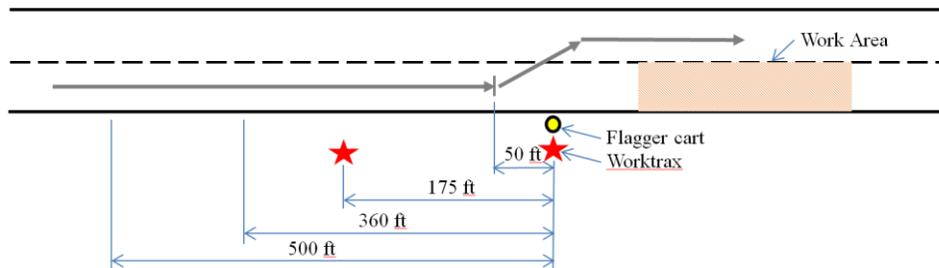
In testing of Trajectory H, TTI staff drove the instrumented vehicle (starting at 45 mph and decelerating to a stop) according to the approach path shown in Figure 20.

Figure 20. Approach Path for Trajectory H of Flagging Operation Testing.

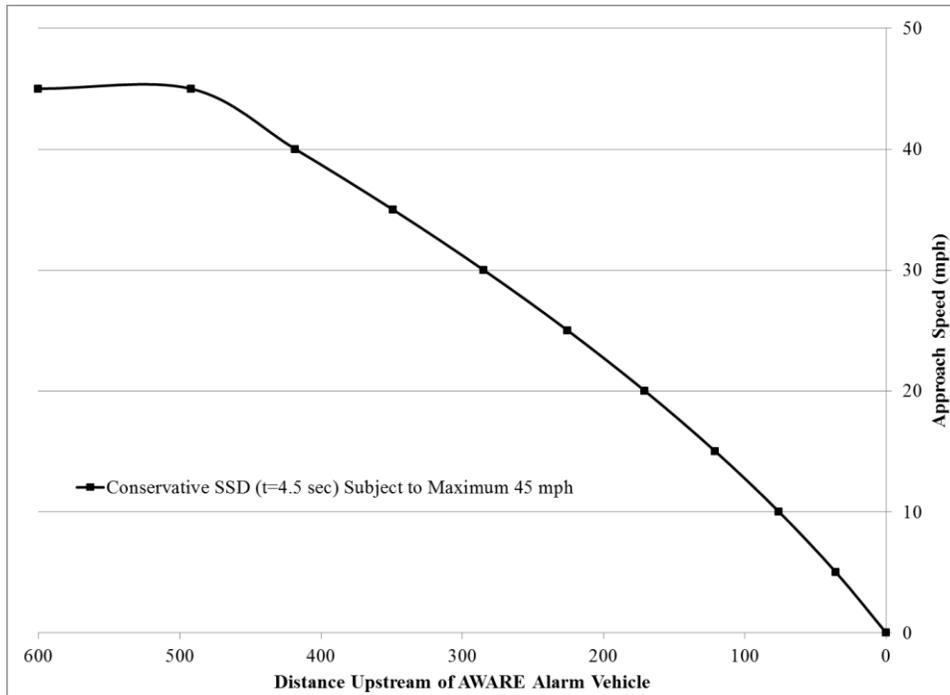
Testing of Trajectory H was intended to demonstrate that the AWARE system would not respond to vehicles traveling just under the conservative SSD threshold while the flagger cart is in STOP PADDLE mode. This trajectory test would require that the driver of the instrumented vehicle continuously maintain a vehicle speed below the conservative SSD (i.e., less than 45 mph at the 500 ft mark, less than 30 mph at the 300 ft mark, etc.). This proved to be challenging in the field, so the researchers performed six runs using this trajectory, some of which exceeded the threshold and some which did not (these are described in greater detail in the Results section). The target approach speeds for the instrumented vehicle during testing of Trajectory H are shown in Figure 21.

Figure 21. Target Approach Speeds for Trajectory H of Flagging Operation Testing.

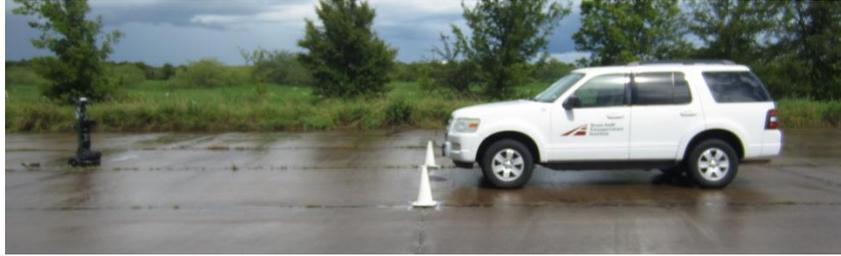
In testing of Trajectories I and J, the flagger cart was operating in STOP PADDLE mode. A TTI fleet vehicle was parked in the approach lane approximately 20 ft upstream of the flagger cart. This was intended to simulate a condition where a queue of waiting traffic would potentially block detection of a vehicle jumping the queue and proceeding into the work zone (i.e., ignoring the STOP PADDLE instructions). This setup is shown in Figure 22.

Figure 22. Simulation of Queued Traffic in Trajectory I and J Testing.

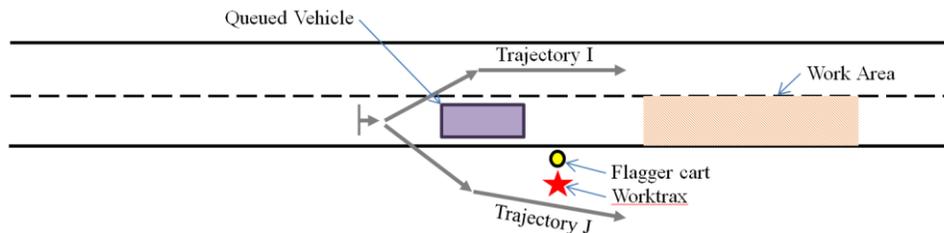
TTI staff began the tests with the instrumented vehicle stopped in the approach lane just behind the queued vehicle. For Trajectory I, the driver accelerated and passed the queued vehicle on the left. For Trajectory J, the driver accelerated and passed the queued vehicle on the right. These trajectories are shown in Figure 23. In both cases, the alarm system was expected to produce an alert which would trigger the lights, audible alarm, and Worktrax components of the system.

Figure 23. Approach Path for Trajectories I and J of Flagging Operation Testing.

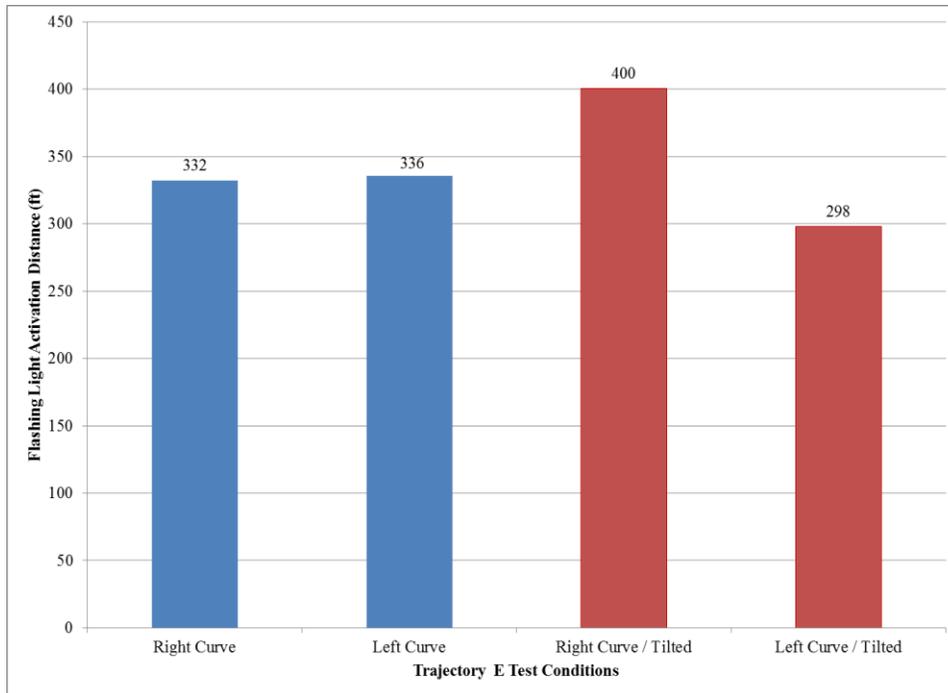
Figure 24. Curved Alignment Trajectory E Testing Results.

It appears that the direction of the curve had no impact on the AWARE system’s ability to detect the passenger car (as shown by the blue bars). Note that the conservative SSD for 40 mph is 418 ft and the AASHTO SSD is 301 ft. Thus, the system did activate prior to the AASHTO SSD value but after the conservative SSD value, on average, when the AWARE system vehicles were level. Interestingly, when the AWARE system vehicle was tilted, there was a noticeable difference in the activation distances. With the AWARE system vehicle tilted, the activation distance in the right curve is substantially longer than in the left curve. This is likely due to the small passenger car approaching the AWARE system underneath the fan-shaped threat detection region in the left curve and proceeding much closer to the AWARE system before it is detected. Conversely, on the right curve, the tilted AWARE system detection area appeared to activate at a distance closer to the conservative SSD than the AASHTO SSD value. Nonetheless, the AWARE system did detect the instrumented vehicle and produce an alert prior to the instrumented vehicle reaching the AASHTO SSD in all cases.

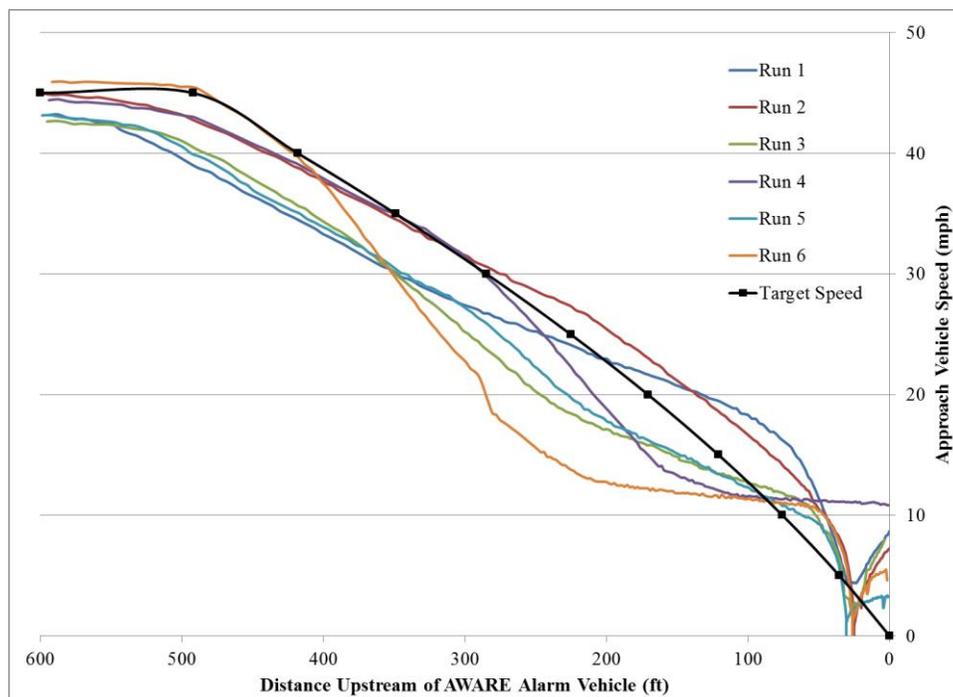
The analysis of Trajectory H test results was more complex. During three of the six test runs, the AWARE system lights activated, but the audible alarm did not. Further analysis of the data revealed that the instrumented vehicle speed equaled or exceeded the conservative SSD threshold at some distance upstream of the cart for some of the runs, but not others. Figure 25 illustrates those trajectories. The conservative SSD values were matched or exceeded by the instrumented vehicle at some point during test runs 2, 4, and 6. Conversely, the trajectories for runs 1, 3, and 5 remained below the conservative SSD line until speeds were below 25 mph and so correctly did not activate. Therefore, the AWARE system responded appropriately in all six test runs of Trajectory H.

Figure 25. Test Runs versus Conservative SSD Threshold for Trajectory H.
