**FIELD TESTS USING GEOSYNTHETICS IN FLEXIBLE AND RIGID
PAVEMENTS TO REDUCE REFLECTION CRACKING**

Report 0-1777-2

Project 0-1777

Project Title: Field Synthesis of Geotextiles in Flexible and Rigid Pavement Rehabilitation
Strategies Including Cost Consideration

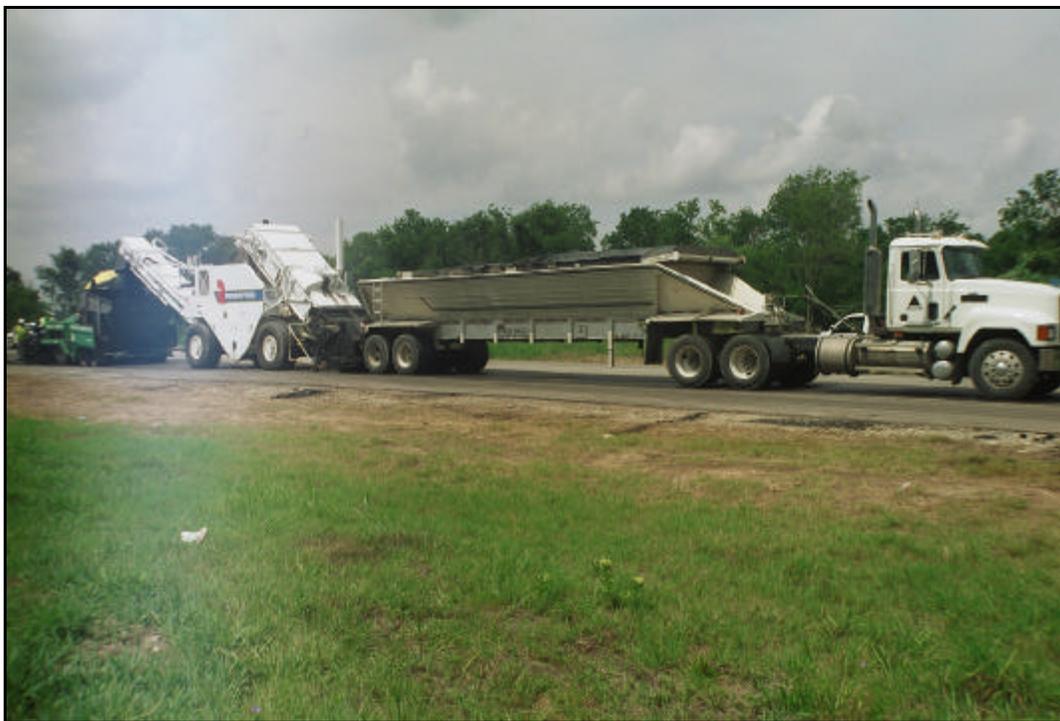
Figure 7. View of Paving Train at Bus 6 in Marlin, Texas.

For overlay placement, the contractor used a Roadtech[®] material transfer device (MTD) and live-bottom trucks (Figure 7). The haul trucks deposited the HMA into the hopper of the MTD, which, in turn, deposited the remixed HMA into the paving machine. All geosynthetic products were placed in strips over all longitudinal (centerline and both edges) and transverse joints (Figure 8). The level-up surface was tacked using AC-20 prior to application of the geosynthetics by a distributor truck using a 5-foot (approximate) spray bar. Generally, no tack was placed on the pavement surface areas between the strips of geosynthetic products. Quite often, the contractor spread loose HMA on the geosynthetic products to reduce the tendency of construction equipment tires to stick and pull them up. Placement of each geosynthetic product is described in the following paragraphs.

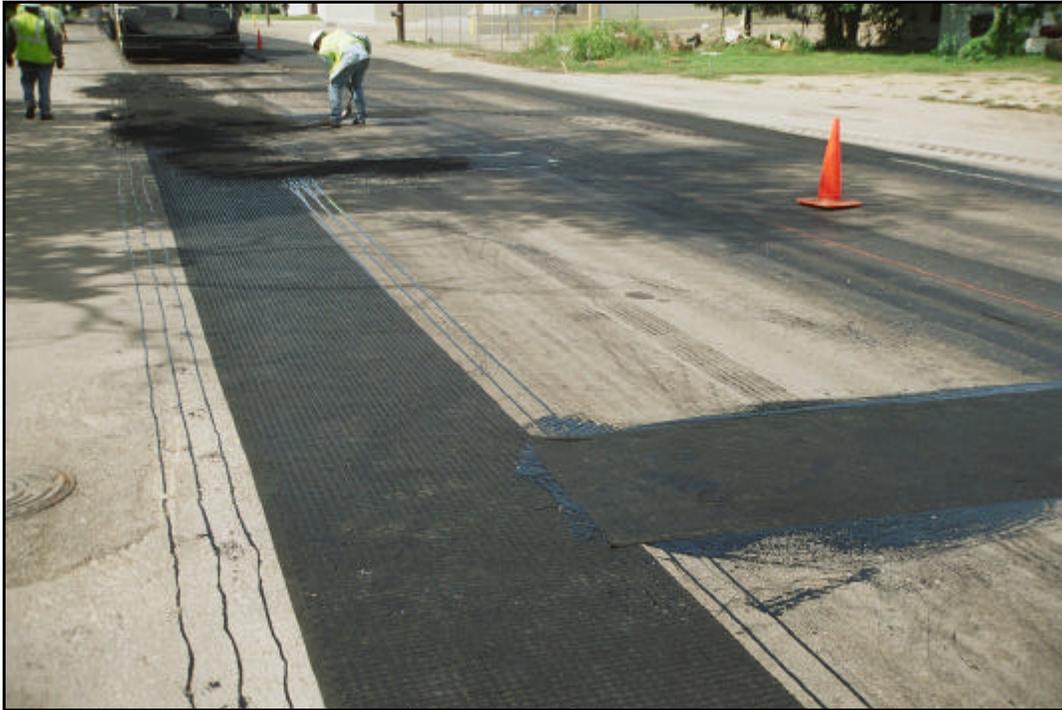
Figure 8. Marlin Project showing Geosynthetic Strips with No Tack between Them and Application of Loose HMA to Reduce Sticking to Construction Equipment Tires.

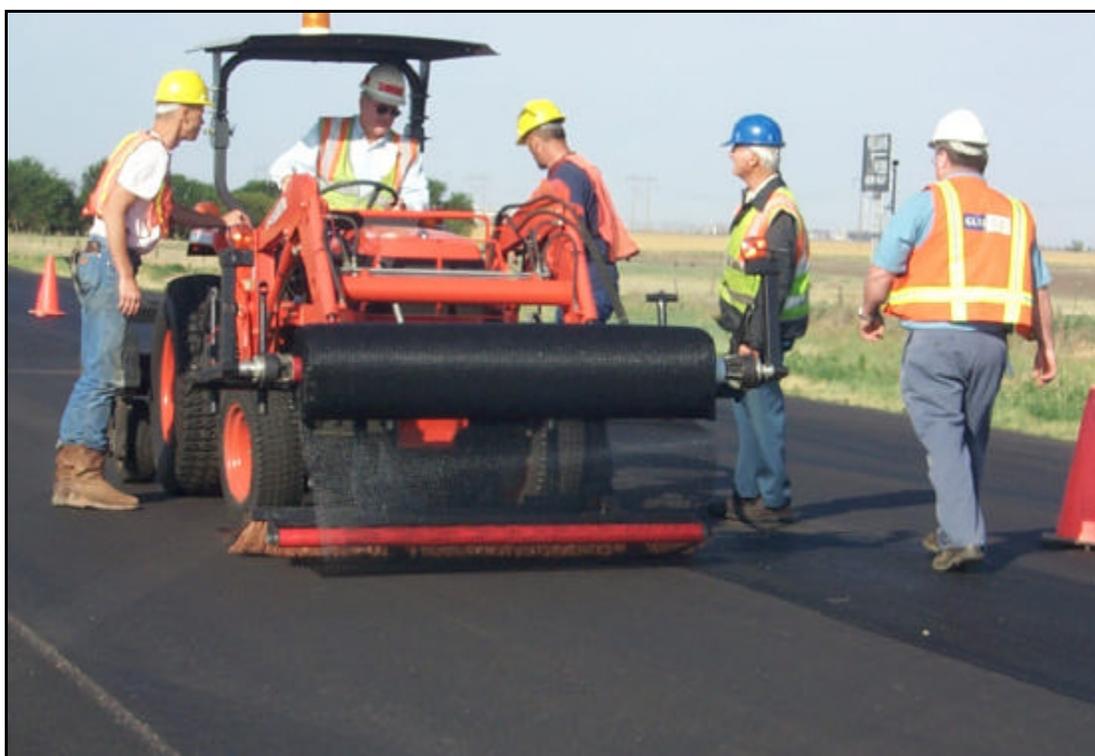
Figure 14. Placement of GlasGrid Product.

the small modified tractor was relatively easy and quick. It took 30 to 40 minutes to place this 500-foot section. [Figure 14](#) illustrates placement of the GlasGrid product.

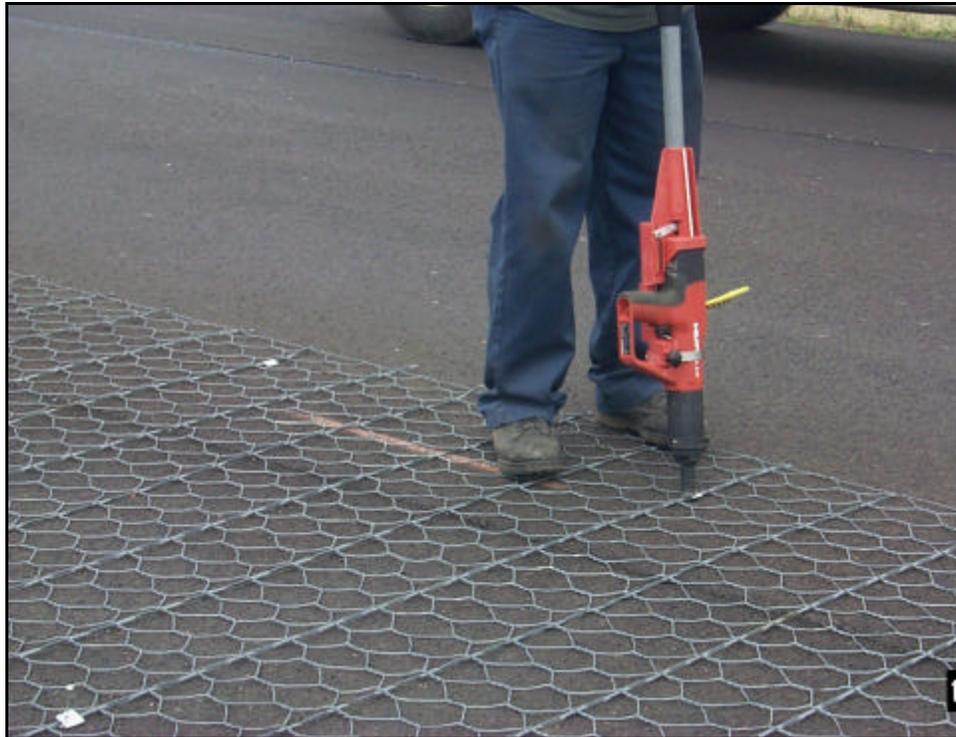
Figure 15. Anchoring Pavetrac Wire Mesh to Leveling Course Using Special Nail Gun.

the bulges. Every 25 feet along the length, they cut the outside thick wire to relieve longitudinal tension and allow the mesh to lie flat on the pavement. Further, the mesh was anchored to the pavement using nails 25 feet apart in the longitudinal direction and 4 feet apart in the lateral direction. The whole procedure required about one hour. Tack coat was applied at a rate of 0.1 gallons/yd². Application of tack was not uniform; that is, it was heavy at the center and light on both sides. [Figure 15](#) illustrates anchoring of the wire mesh.

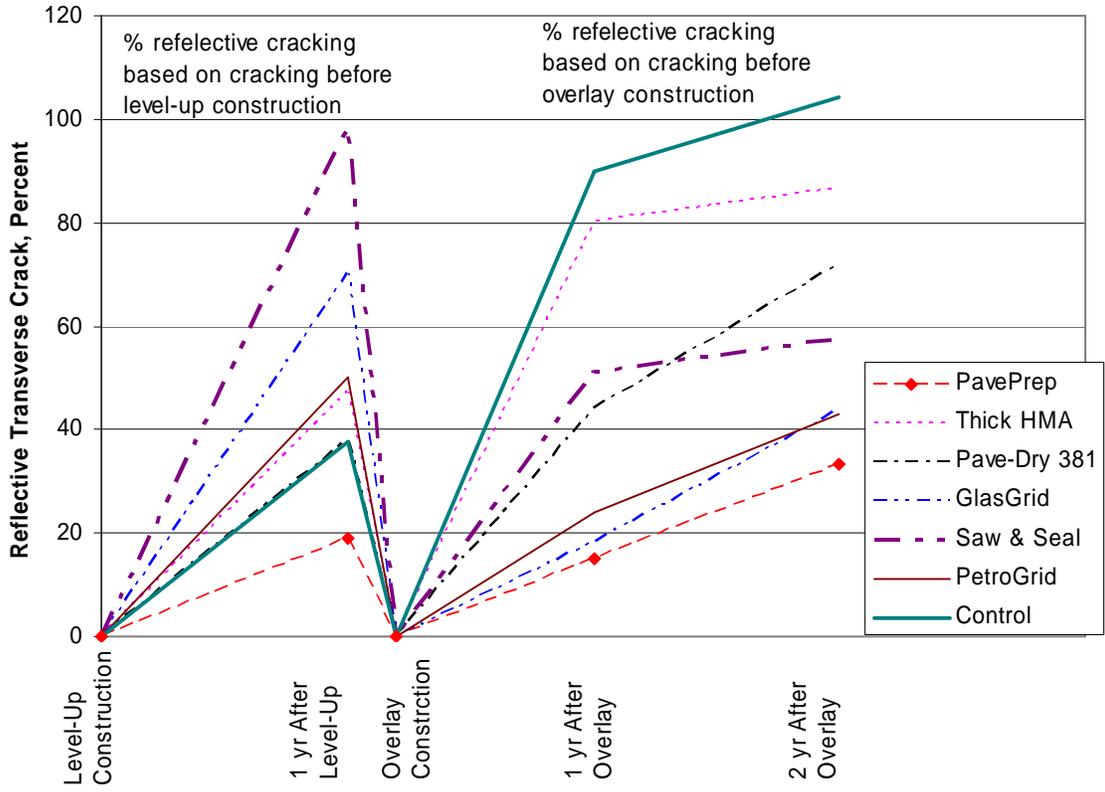
Figure B1. Waco District Reflective (Transverse) Cracking vs. Time — Based on Cracking Measured on Leveling Course Before Overlay.

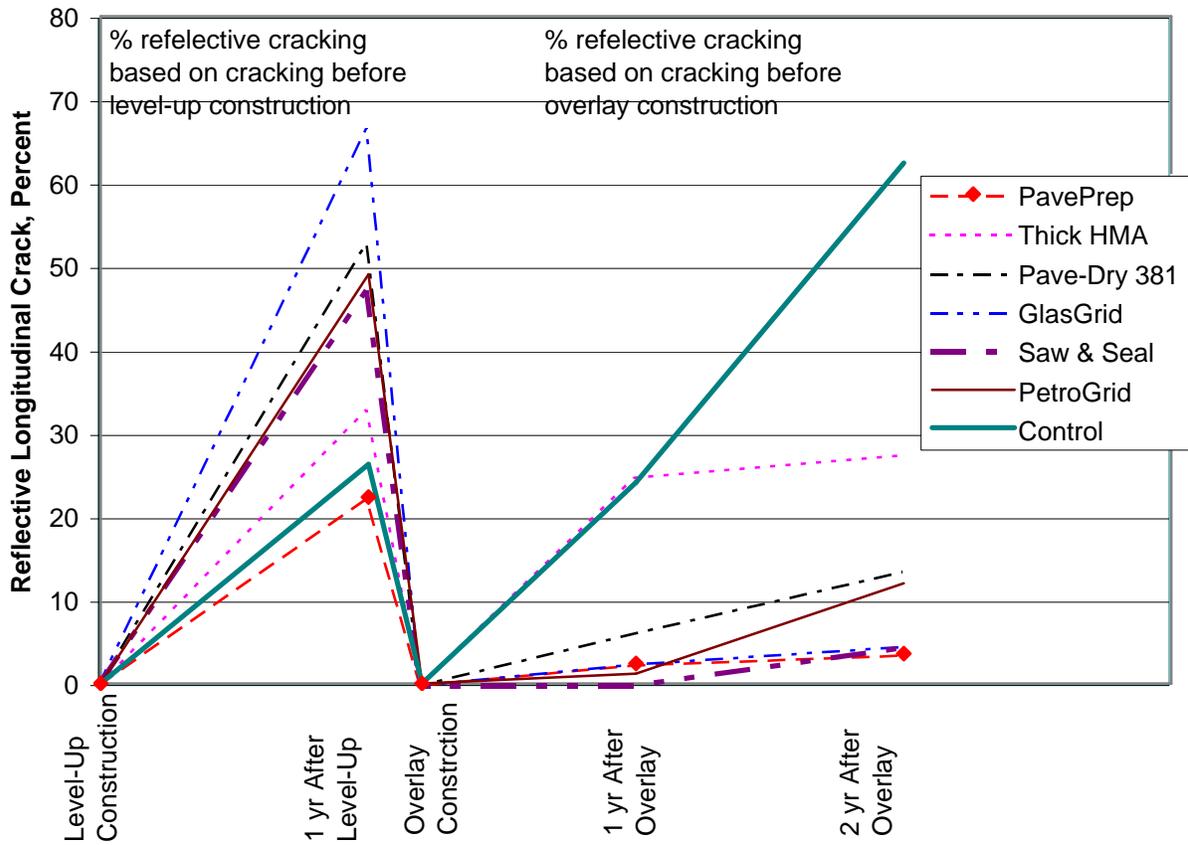
Figure B2. Waco District Reflective (Longitudinal) Cracking vs. Time — Based on Cracking Measured on Leveling Course Before Overlay.

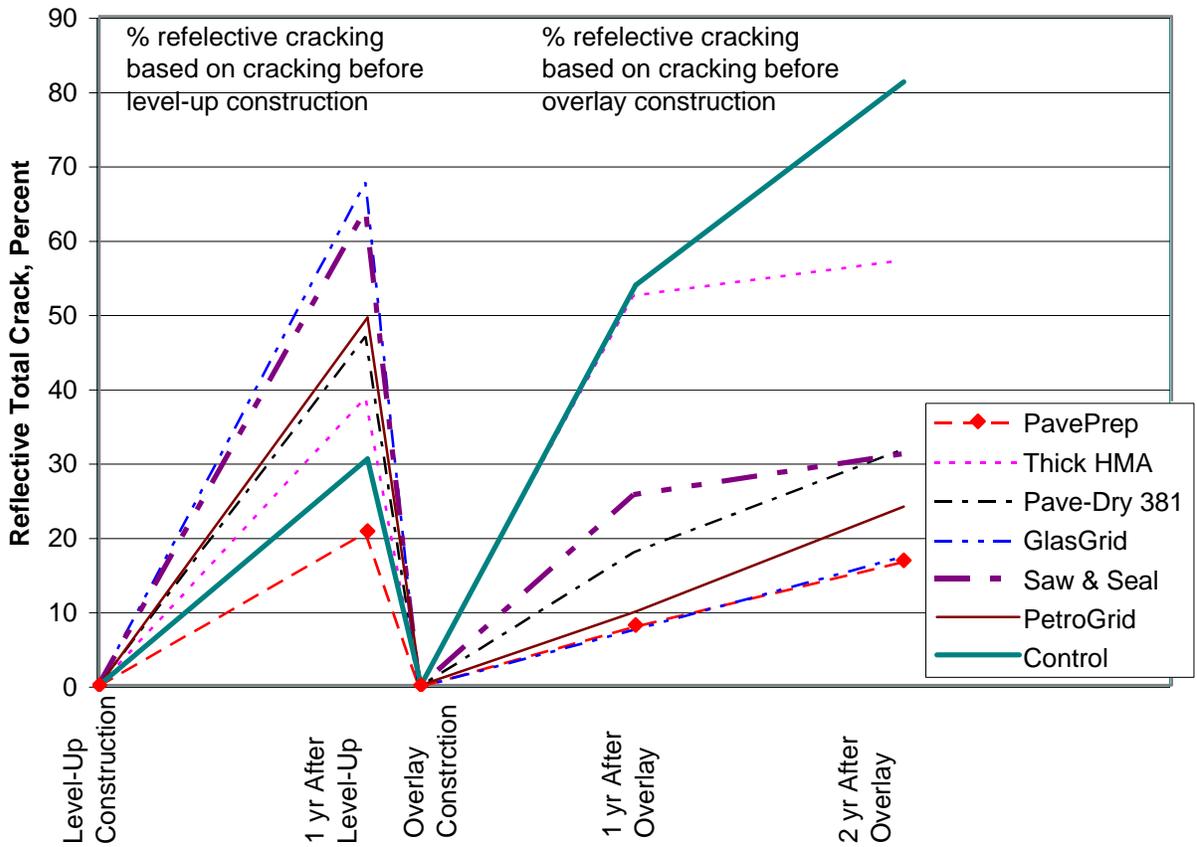
Figure B3. Waco District Reflective (Total) Cracking vs. Time — Based on Cracking Measured on Leveling Course Before Overlay.
