1. Report No. FHWA/TX-10/0-5270-1	2. Government Accession No.	3. Recipient's Catalog No.
4. Title and Subtitle <b>SEAL COAT DAMAGE EVALUATION DUE TO SUPERHEAVY LOAD MOVES BASED ON A MECHANISTIC-EMPIRICAL APPROACH</b>		5. Report Date December 2009 Published: March 2010

11. Contract or Grant No. <b>Project 0-5270</b>
12. Sponsoring Agency Name and Address Texas Department of Transportation Research and Technology Implementation Office P.O. Box 5080 Austin, Texas 78763-5080	13. Type of Report and Period Covered <b>Technical Report:</b> September 2007–August 2009

**SEAL COAT DAMAGE EVALUATION DUE TO SUPERHEAVY  
LOAD MOVES BASED ON A MECHANISTIC-EMPIRICAL  
APPROACH**

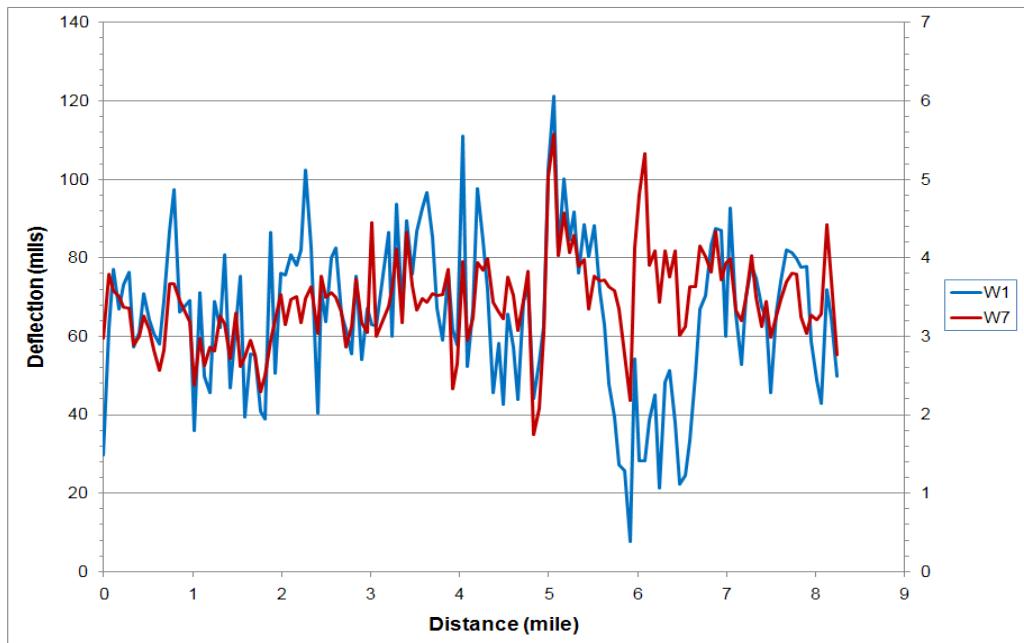
**Figure 3. Normalized FWD Deflection on FM 796.**

With regard to structural failure, a severe damage was recently reported from the Corpus Christi District in 2004. The SHL type was a hydrotreater reactor having 1,978 kips of GVW with 21-ft width and height and 117-ft length. The maximum tire load was 12,500 lb and most of tires weighed 6,250 lb. The move originated from Aransas Pass, Texas, on January 12, 2004, and was completed at Three Rivers on February 26, which was around 150 mile of travel. Along the route, around 7 mileage of FM 796 at the San Patricio County, which classified with load zoned road, was found to be the weakest section. The TxDOT engineers evaluated the route and found that the route was structurally inadequate to sustain such loads. Since there was no alternative route available, the move was allowed under agreement that the carrier should be responsible for whatever damage occurred. The route was generally composed of 2-in of asphalt concrete with multiple chip seals, 8-in of flexible base, and subgrade. The lane width was about 20-ft wide. Considering the width of SHL, the outer wheels appeared to travel either very close to the edge that has no shoulder or outside the edge of pavement. Figure 3 shows the variation of normalized deflection at the center of loading (W1) and 72-in from the load (W7) the FWD test results. The W1 ranged from 7.7 to 121.3 mils with an

overall average value of 65.4 mils, while W7 ranged from 1.7 to 5.6 mils with average value of 3.4 mils.

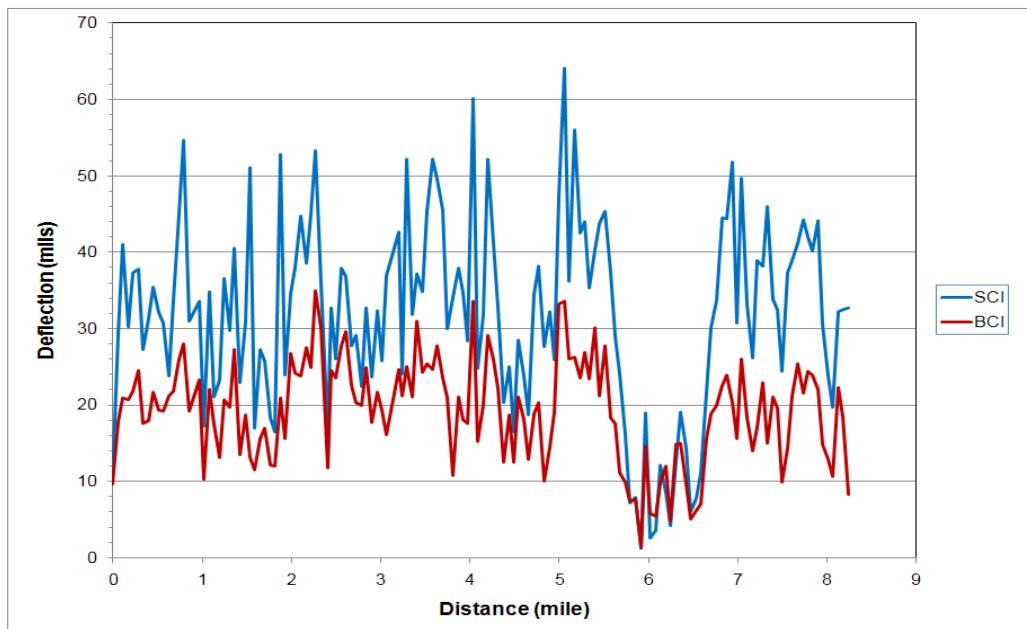
**Figure 4. SCI and BCI on FM 796.**

Researchers calculated the surface curvature index (SCI) and base curvature index (BCI) to evaluate structural condition along the route. The SCI is the difference between W1 and W2 (8-in from the load) and BCI is computed by subtracting W3 (16-in from the load) from W2. Figure 4 shows the distribution of two indices along the route. The Project 5-1712 conducted training classes on selecting rehabilitation options for flexible pavements along with CDs. (16). Researchers employed this tool to interpret structural condition and found that the route is fallen into very poor condition with respect to SCI and BCI since most of values were above 20 and 10 with a given surface layer thickness, respectively.

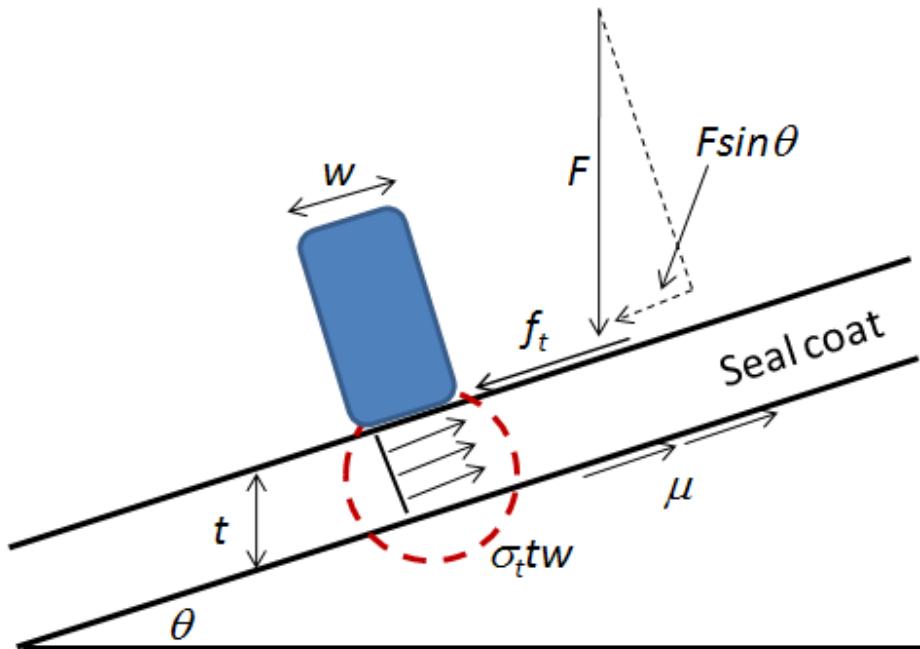
Figure 10. Free Body Diagram of Seal Coat Damage.

Considering representative phenomenon of peeling seal coats along the sloped pavement, researchers conceptualized the seal coat failure mode through a free body diagram as shown in Figure 10. From this diagram, it is feasible to estimate resistance force terms induced within the seal coats and fracture force components generated from wheel load as a function of different slope level, friction condition, and tire width.

From the diagram, the Equation (3) can be considered based on the equilibrium force relationship. In the equation, the positive force term is applied along with the slope angle ( $\theta$ ).

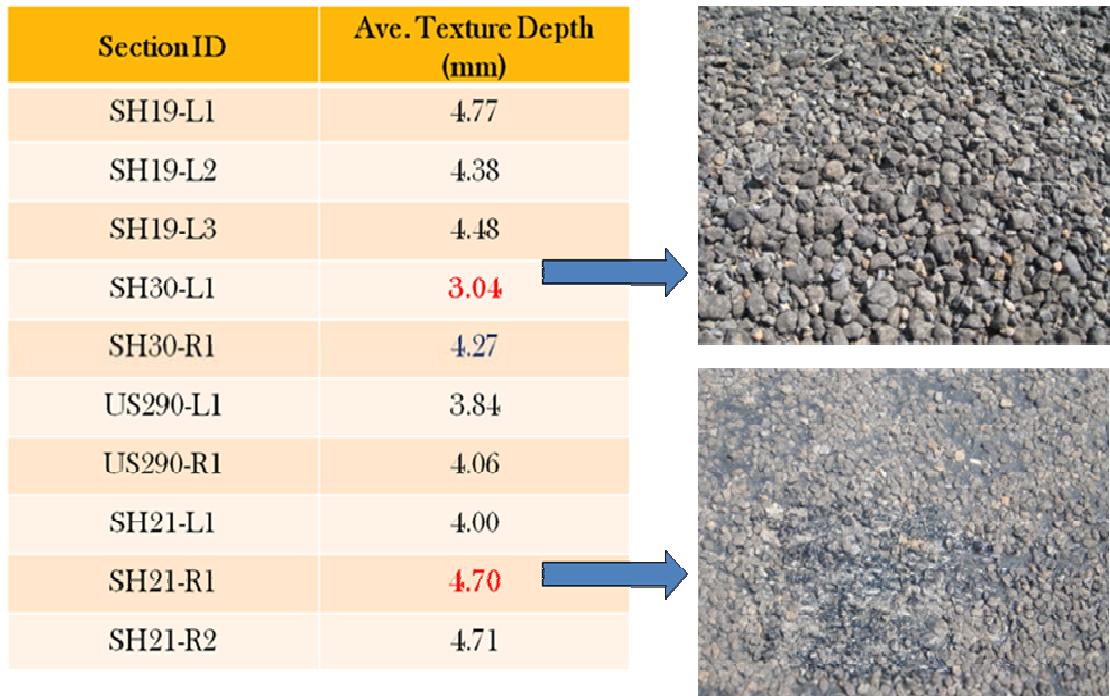
**Figure 33. Texture Depth Measured in FY08 Testing.**

where  $T$  = texture depth,  $V$  = volume of sand, and  $D$  = average diameter. Figure 33 shows the measured texture depth of test sections. The texture depth of test sections typically ranged over 4 mm. Lower texture depth indicates that the surface is smoother because of larger diameter of sanded area representing more voids filled with aggregates. Contrary to this, higher texture depth is likely to provide more chances for binders to

expose to environmental conditions. The damage rate in SH30-L1 location was not as severe as observed in other sections.

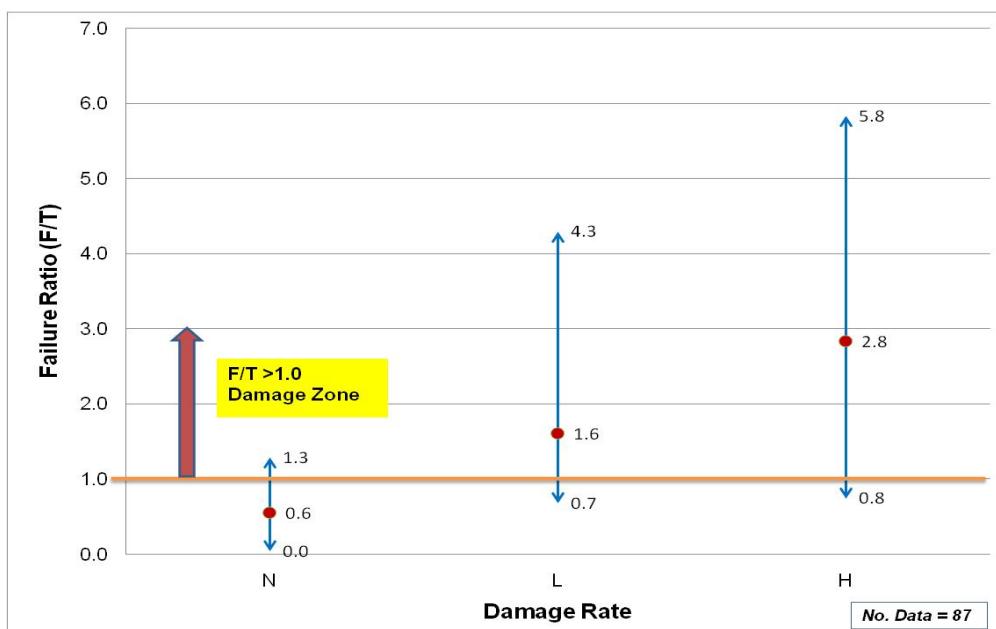
**Figure 34. Relationship between Failure Ratio (F/T) and Damage Rate.**

Figure 34 shows the range of failure ratio determined for each observed damage rate. Upper and lower arrow indicates corresponds to maximum and minimum values, and dots are averaged ones. Researchers believe that the proposed mechanistic approach realistically captures seal coat damage potential by exhibiting the trend that a higher failure ratio corresponds to a severe damage rate even though a wide range of variance in failure ratio was detected.

Researchers calculated failure ratio with given information on measured wheel load, slope, temperature, and material properties to relate with observed damage rate. From this, first set of calibration was achieved shown in Table 14 and Figure 34.

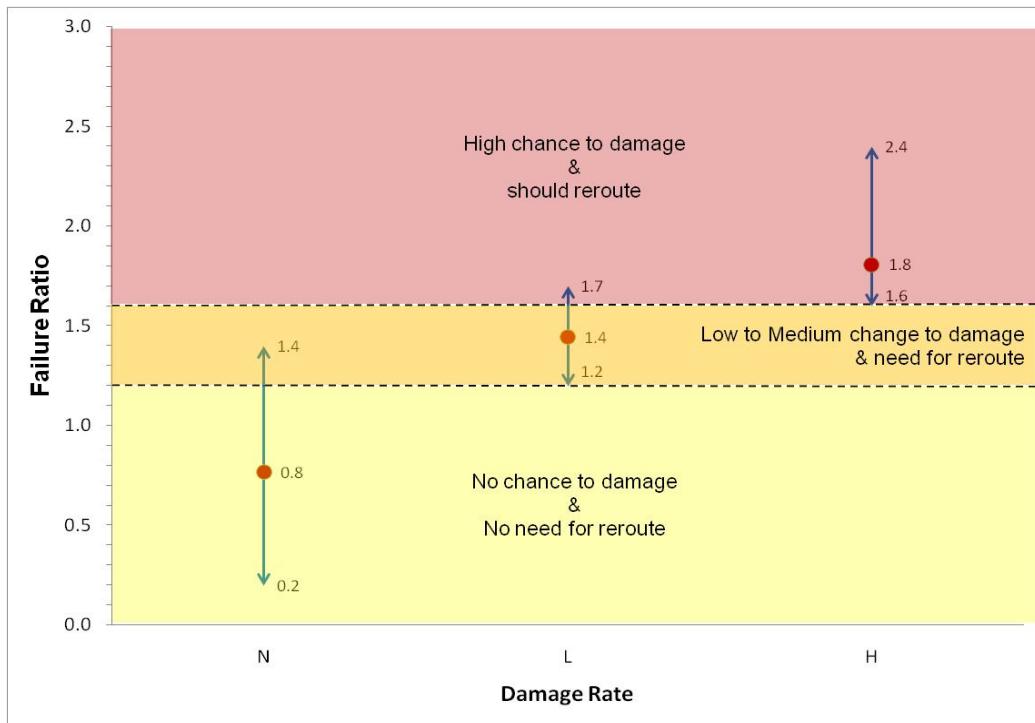
**Figure 40. Failure Ratio versus Damage Rate from FY09 Field Tests.**

Figure 40 shows that the relationship between failure ratio and damage rate observed from the field testing. It was observed that the recalibrated mechanistic model fairly captures the variation of damage rate across sections tested. Researchers categorized three zones based on the results. Theoretically, the failure ratio greater than one means the seal coat damages occur. However researchers recommend that a failure ratio up to 1.2 appears to be safe for routing SHL moves based on field validations. Therefore, rerouting may not be an option in such cases. When the failure ratio is distributed between 1.2 and 1.6, low to medium levels of damages are likely to occur, thus rerouting would be an option as long as alternative routes are available. Rerouting or rescheduling of SHL moves should be considered when the failure ratio is greater than 1.6. During the field validations, researchers noted that following findings as well.

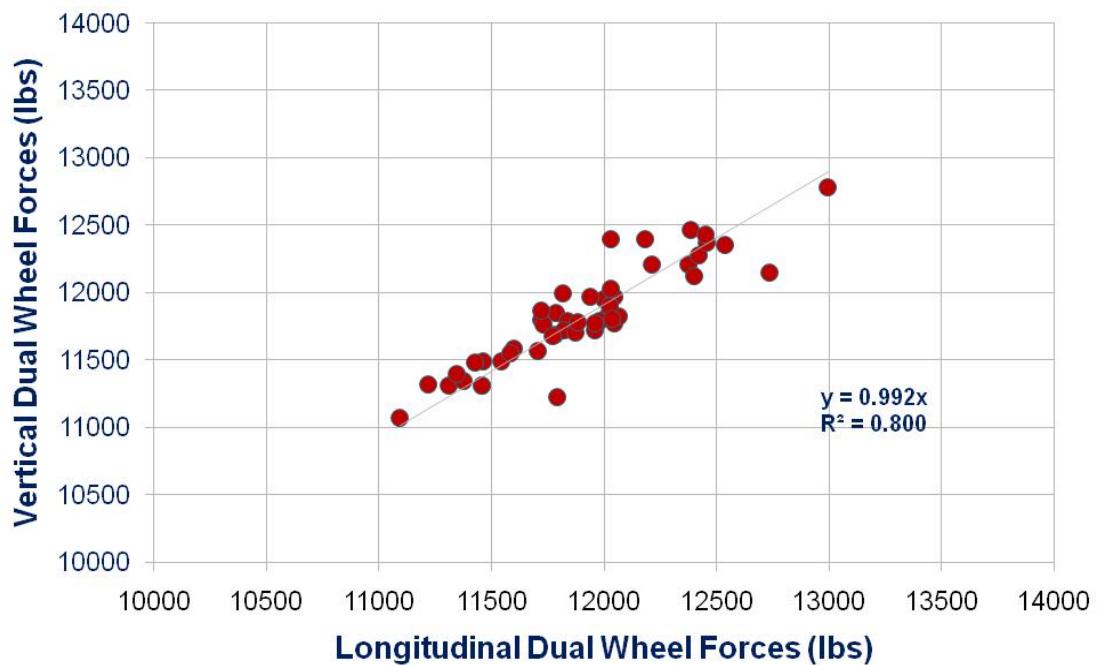
**Figure 41. Relationship between Vertical and Longitudinal Wheel Forces.**

Figure 41 compares two forces. The  $F_x$  was overall slightly larger than  $F_z$  by a factor of 1.008 because the test truck was operated along the slope. Researchers incorporated this finding into the proposed model by setting the traction force  $f_t$  multiplied by a factor of 1.008 to the maximum tire load ( $F$ ) denoted in equation (3).
