| 1. Report No. FHWA/TX-11/0-6589-1 | 2. Government Accession No. | 3. Recipient's Catalog No. | |
| 4. Title and Subtitle PAVEMENT REPAIR STRATEGIES FOR SELECTED DISTRESSES IN FM ROADWAYS | | 5. Report Date Published: June 2012 | |

Project Title: Pavement Repair Strategies for 2R and Routine Maintenance (RMC) Projects

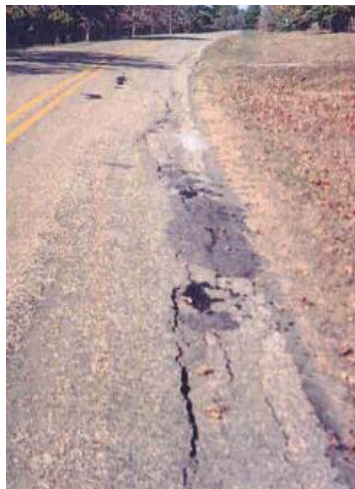
Figure 2.1. Longitudinal cracking and failure (Sebesta 2005).

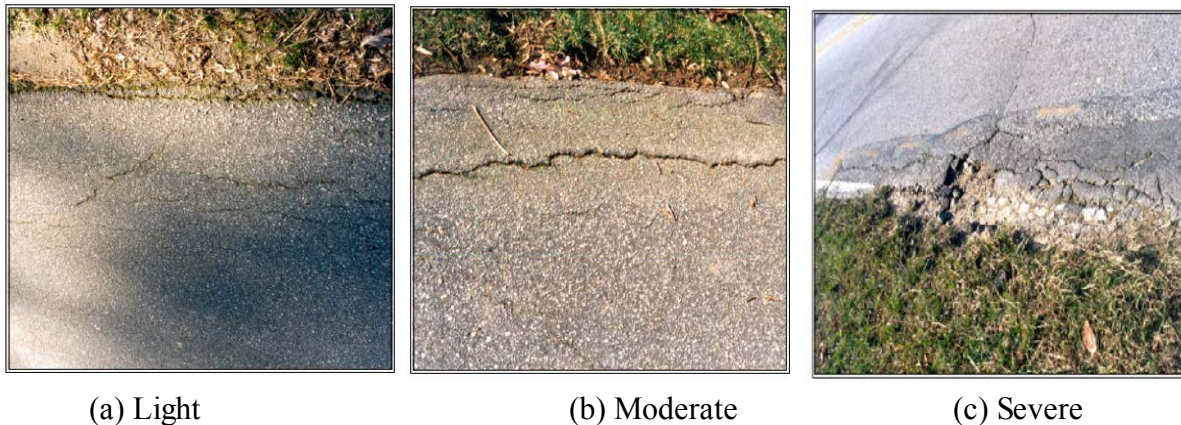
Narrow Low volume roads, that lack lateral shoulder support, are experienced longitudinal cracking combined with rutting along the edge of the pavement. This type of narrow pavement constitute to significant. These types of distresses are referred to edge failure. Edge failures on narrow roads occur within 1–2 ft of the pavement edge in the form of longitudinal, fatigue and alligator cracking, rutting or a combination of these distresses. These failures can propagate toward the travel lane in the form of transverse cracks. Although these cracks are formed within a finite distance from the edge, they often propagate along the wheel paths and allow intrusion of moisture in the subgrade and base materials. Example of edge failures severity is shown in Figure 2.1 (Sebesta 2005).

Figure 2.2. Edge Failure with Low, Medium, and High Severity (*Distress Survey Manual*).

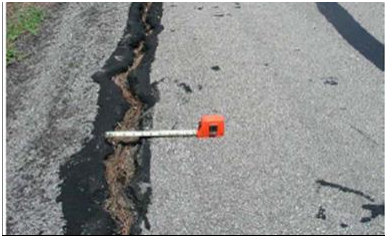
Other forms of failures in narrow roads are edge break and drop-offs (Figure 2.3). Edge breaks generally occur where the edge of the bituminous surfaces are fretted or broken; while edge drop-offs happen where the elevation of pavement shoulders has eroded and settled several inches lower than the pavement. The possible causes of edge breaks include: insufficient pavement width; alignment that encourages drivers to travel on the pavement edge; lack of lateral support; and loss of adhesion in the base material.

(a) Edge breaks due to loss of adhesion

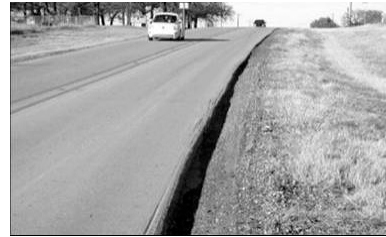
The causes of edge drop-offs include erosion caused by wind, rain or other environmental conditions. Lawson and Hossain (2004) conducted a study to investigate the causes of edge drop-off in Texas. They found that certain types of construction procedures often cause significant edge drop-off problems. They also remarked that edge drop-off occurs mainly in East Texas as a result of buildup of soil along the pavement edges. This problem occurs during the service life of pavement as vegetation adjacent to the pavement starts to encroach onto the pavement and cause a higher edge elevation than the pavement surface. As mentioned (Lawson

(b) Edge drop-off due to erosion

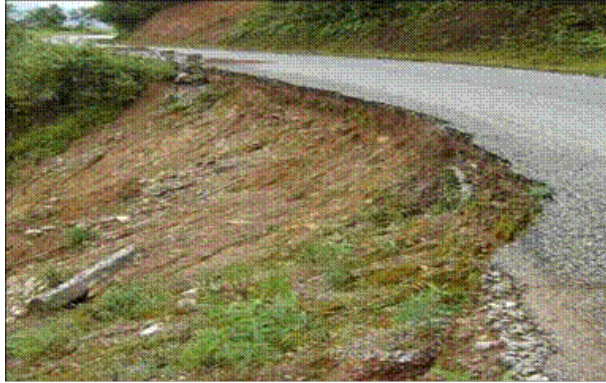
Hearn et al. (2008) (Figures 2.4) correlates edge failure of roads ground movements at the edge of roads combined with existence higher wet season groundwater and water content in soils. Weathered rock masses at exposed steep roadside cuts also accelerate the ground movements at edges. These conditions are more common in roads at higher elevations. In addition, Heath et al. (1990) summarized the causes of edge slope instability, such as exceptional storms, seismic activity, erosion or the disturbances of materials due to road construction, and weak cohesive soils due to rapid weathering.

Figure 2.4. Edge Failure due to Slope Instability (Hearn et al. 2008).

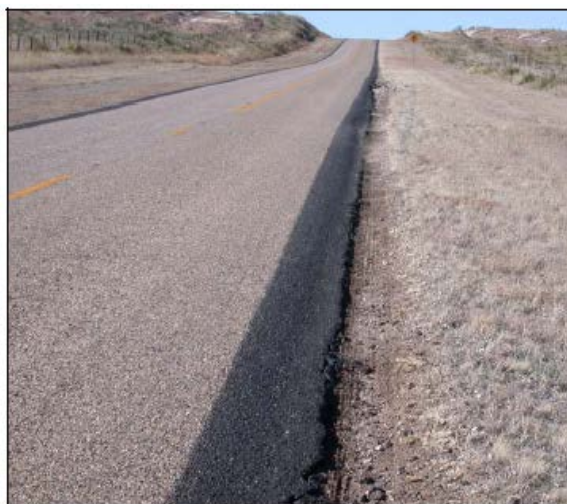
The research focused on best practices strategy to define and implement best practices for repair and stabilization of pavement naturally-occurring edge drop-offs on low-volume roads. Edge drop-off as defined in this project is the difference in vertical elevation between the paved surface and unpaved shoulder surface adjacent to it. This type of distresses has maintenance, safety and liability issues for TxDOT. This distress is affected by the narrow road width and absence of shoulders, traffic volume and type, and adverse environmental conditions (Figure 2.8).

Figure 2.8. Pavement edge drop-off.

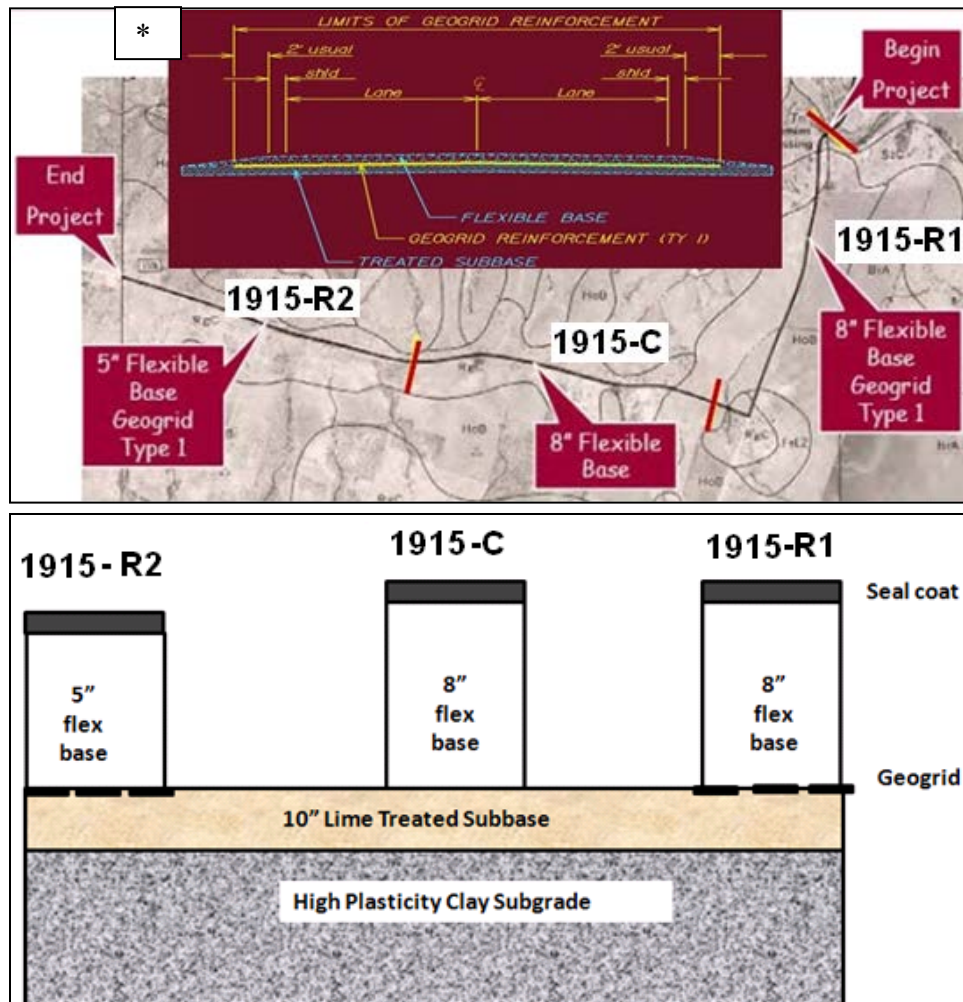
Figure 4.1. FM 1915 Test Sections Layout and Layers Thicknesses. (*Schematic courtesy of Darlene Goehl, P.E.).

The GPR data on sections 1915-R1 and 1915-C (Figure 4.1) showed higher variability in reflections compared to 1915-R2. With respect to layer thickness analysis, researchers estimated 1 in. of surface layer, 7 to 8 in. of base, and 8 to 10 in. of subbase layer from the GPR and the coring measurements. Details of field visual survey (Tables C-1 to C-3) along with captured GPR images (Figures C-1 to C-3) can be found in Appendix C. The results indicated that the control section (1915-C) exhibited more deteriorated areas with a higher number of distresses observed. However, geogrid reinforced section 1915-R1 also revealed severe longitudinal cracking. Section 1915-R2 was found to perform the best, as indicated by the shortest length of longitudinal cracking measured.

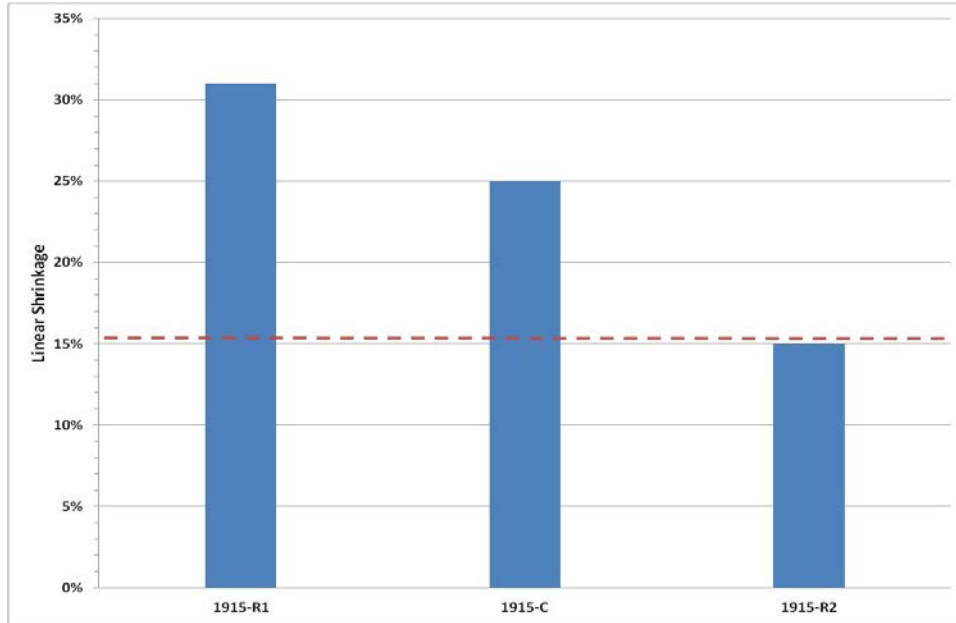
Figures 4.3 and 4.4 indicated that the subgrade of sections 1915-R1 and 1915-C was more prone to shrink in higher extent than that in section 1915-R2. This seems to be consistent with GPR data interpretation, FWD and DCP data analysis, and field visual survey. Considering the severe shrinkage potential of 1915-R1 soils, geogrid reinforcement alleviates soil movement to some extent, where a relatively lesser extent of damage was observed compared to control section. Swelling test protocol states that the lime treatment should reduce 3-D swell to 7 percent or less. From this perspective, the soils in sections 1915-R1 and 1915-C are required to be stabilized to prevent further damage.

Figure 4.3. Shrinkage Test Results of FM 1915 Subgrade.

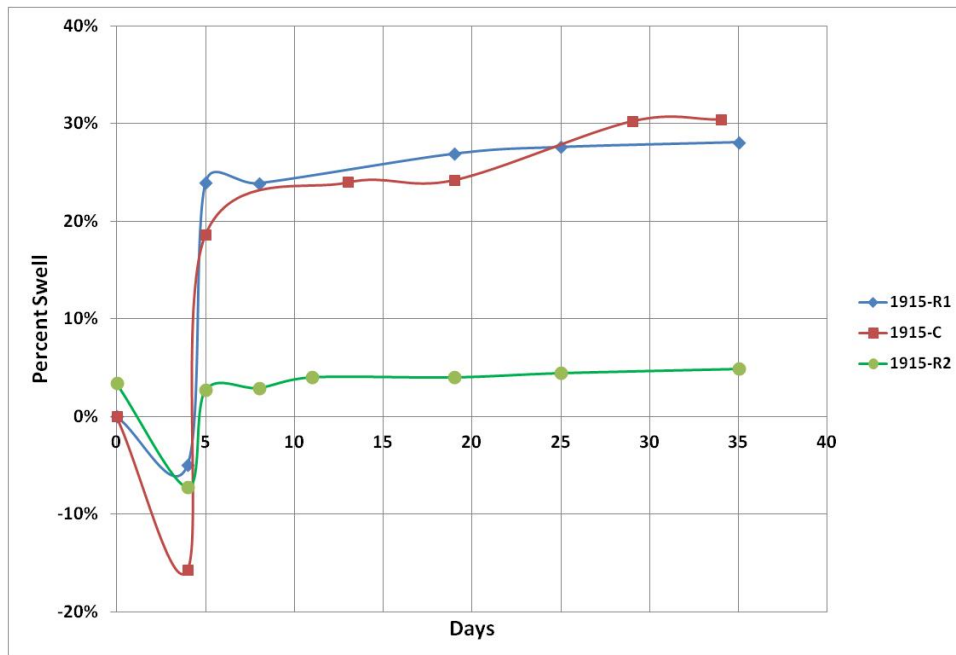
Figure 4.4. Variation of Percent Swell versus Time of FM 1915 Subgrade.

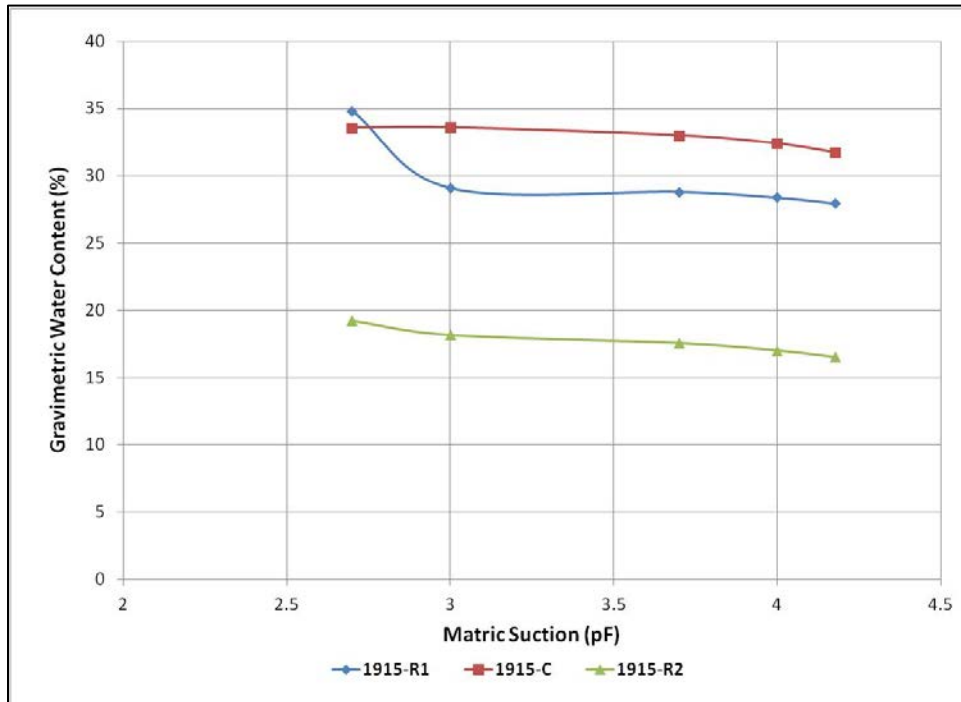
The sulfate content was measured through a colorimeter following the Tex-145-E procedure. Chen et al. (2009) employed this test to identify cause of soil heaving. The test results showed that the sulfate content was not significant for all the tested soils. The pressure plate test (Figure 4.5) revealed that the variation of moisture content was not sensitive to the change of matric suction. This suggests that the soils tend to have a high capability of retaining water and a higher possibility to yield larger movement in case the soil encounters considerable amount of rainfall.

Figure 4.5. Soil Water Characteristic Curves of FM 1915 Subgrade.

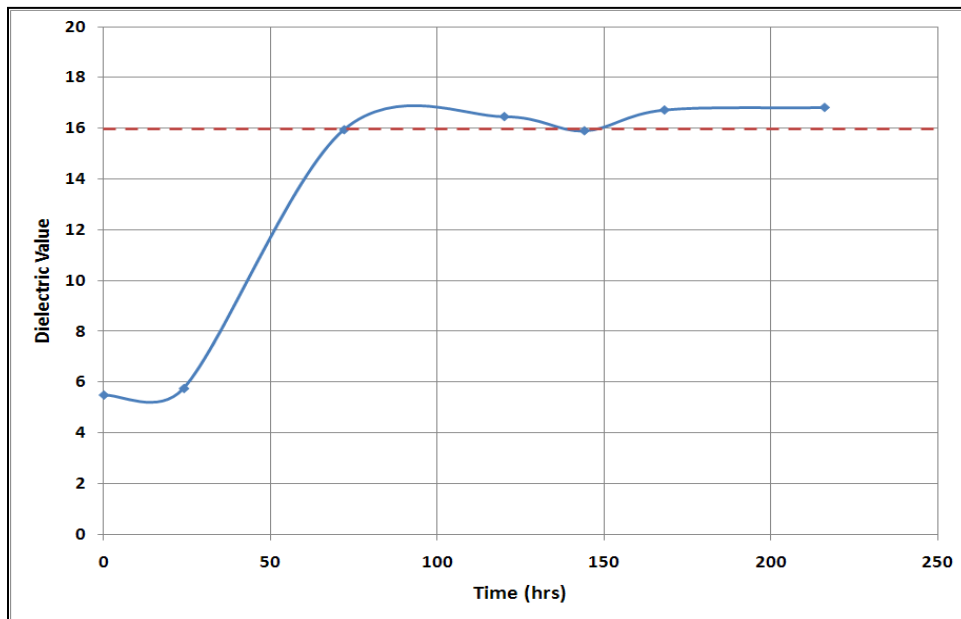
The tube suction test on the base material revealed a dielectric value (DV) slightly over 16 after 72 hrs. of soaking as shown in Figure 4.6. This figure indicated that the base material can be classified as high moisture susceptible material according to the tentative guideline provided by Barbu and Scullion (2006).

Figure 4.6. Tube Suction Test Results of FM 1915 Base.

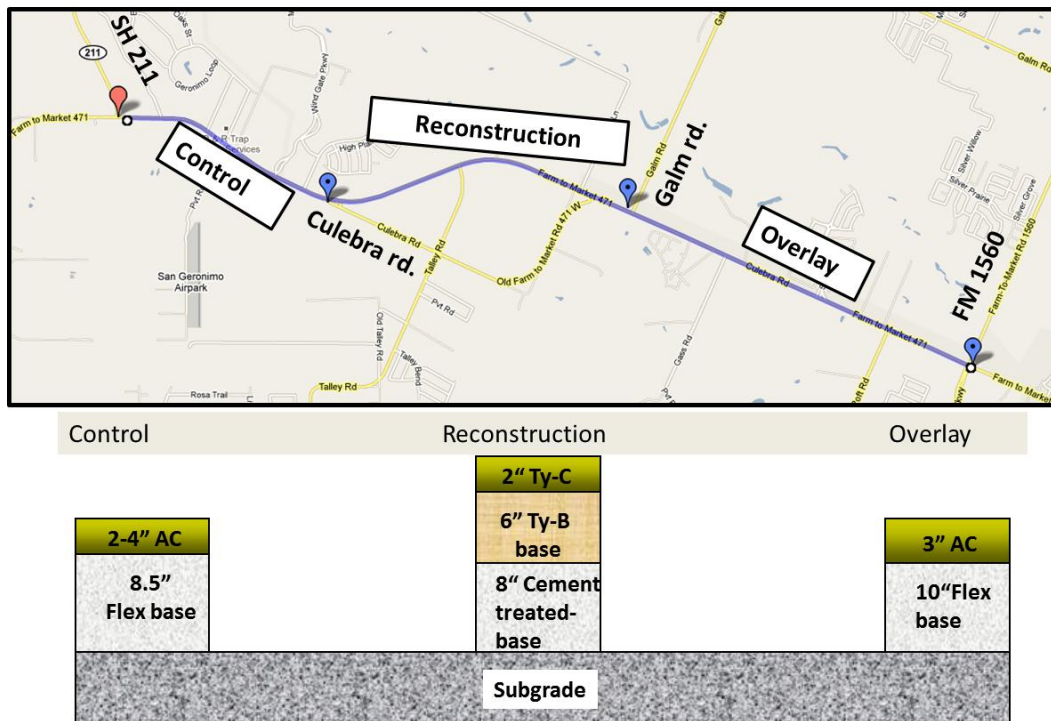
Limited field survey was conducted to check the performance of the section after 3 years of construction. There was no sign of longitudinal cracks at the reconstructed and overlay section

(shown in Figure 4.11) while cracks (sealed) and rutting was noticed in the control section particularly along the wheel paths.

Figure 4.10. Selected Sections of FM 471.

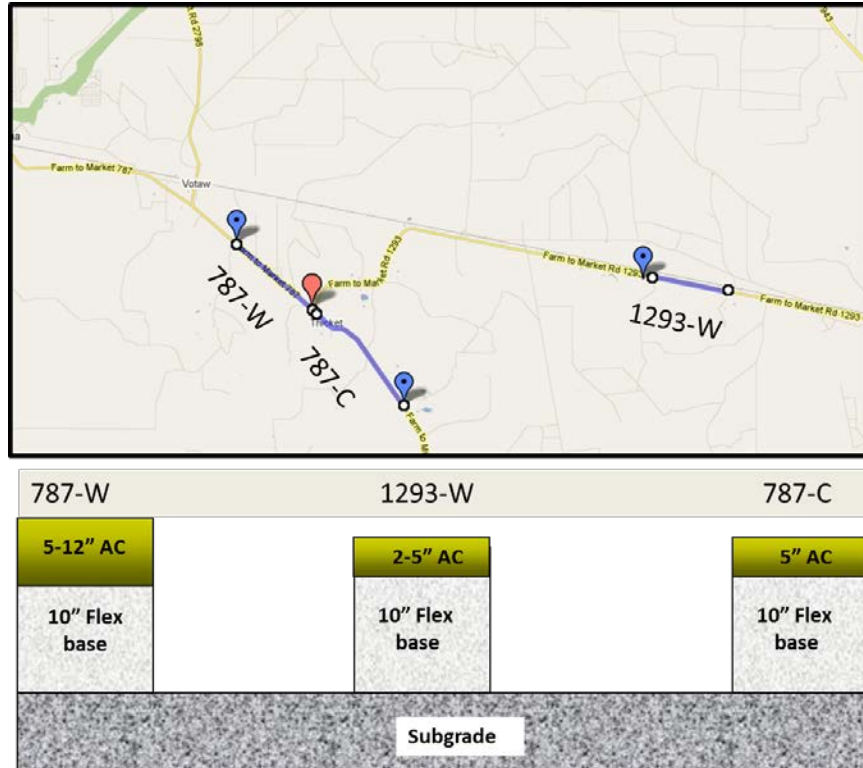
Visual survey indicated that the control section (787-C) experienced shallow rutting and fatigue cracking at the wheel path. The widened section (1283-W) experienced surface cracking that is attributed to segregation of the 1.5" overlay (Figure 4.16). No evidence of cracking in the 787-W section.

Figure 4.15. Test Sites Layout in Beaumont District.

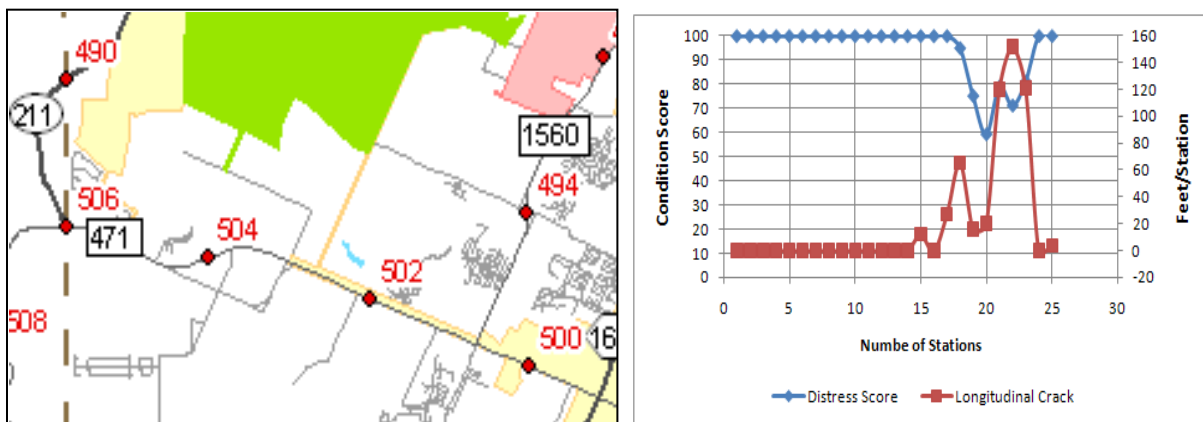
An attempt to verify the sites performance with PMIS data of year 2010 is shown in Figures 4.17 to 4.20. The plots showed condition score and longitudinal crack data against the test segment. PMIS data was extracted based on the reference marker taken from the TxDOT statewide map system. The longitudinal crack here was shown in the average length in feet. The correlation between condition score and longitudinal crack seems reasonable. Also, the condition scores are in agreement with the visual inspection of the surface conditions. Figure 4.17 indicated the significant drop in condition score and increase in the longitudinal cracking in the control section (station 20-25). The effectiveness of the cement-treated base and overlay can also be noted (station 0-17). Figure 4.18 indicated the performance of the geogrid section (station zero) compared to the control (station 7-12). Figures 4.19-4.20 indicated the best performance among all sites in this study. Figure 4.21 indicated the effectiveness of the cement-treated base reconstruction section (station 0-6) versus the control lime-treated section (station 12-16).

Figure 4.17. Plot of PMIS Data of FM 471.

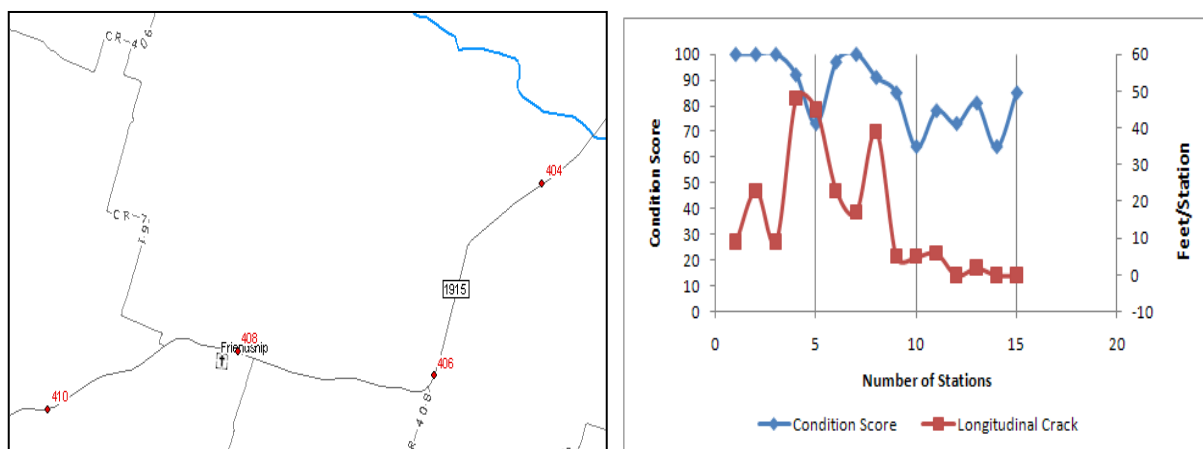
Figure 4.18. Plot of PMIS Data of FM 1915.

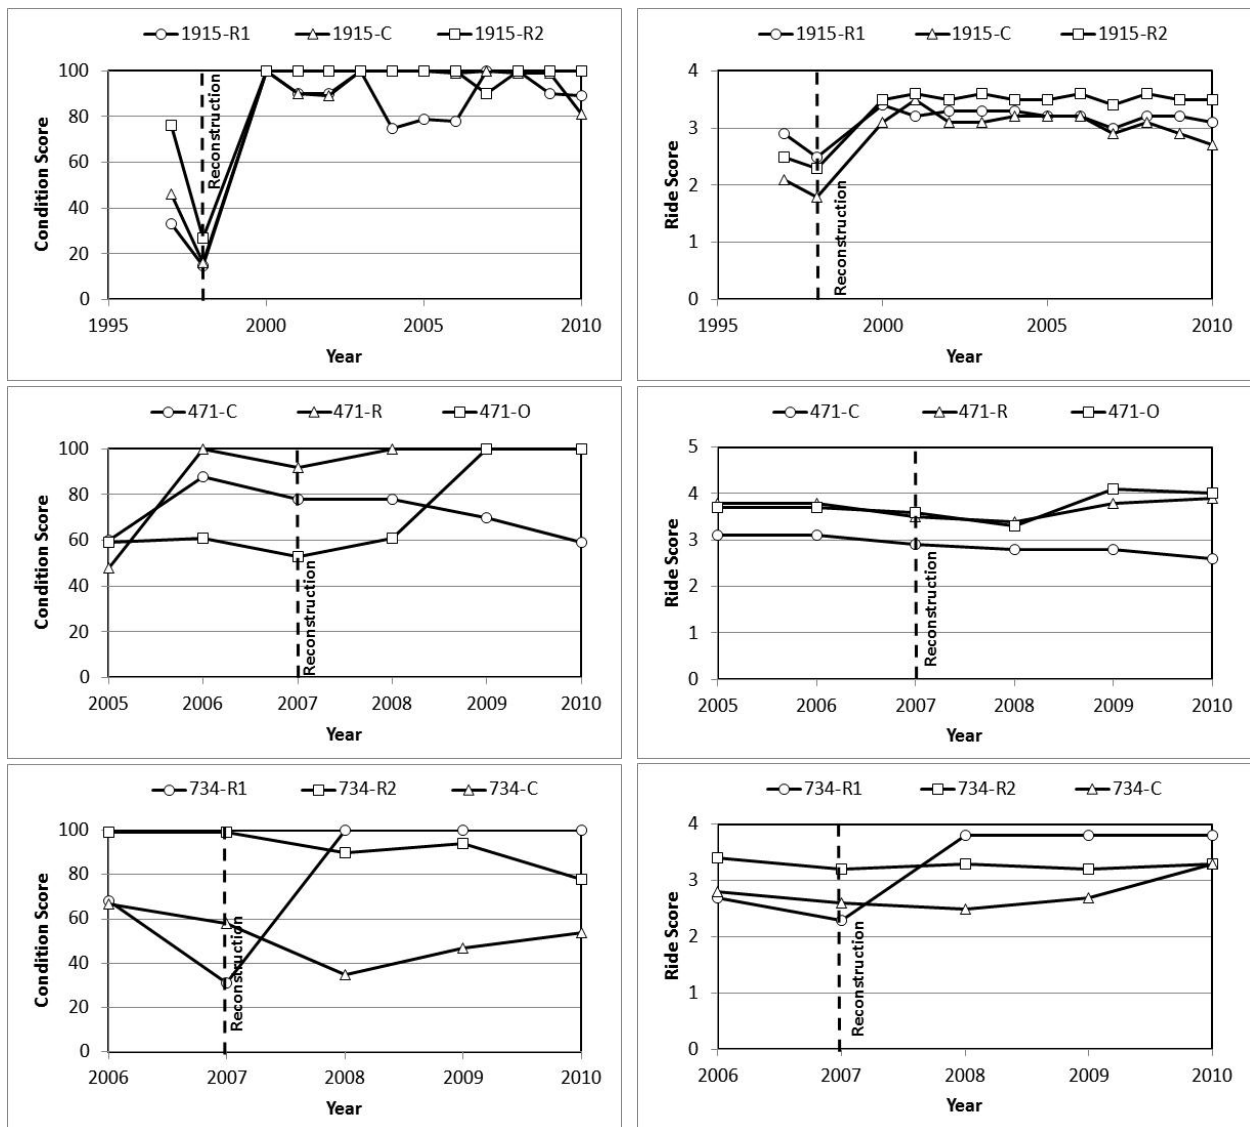
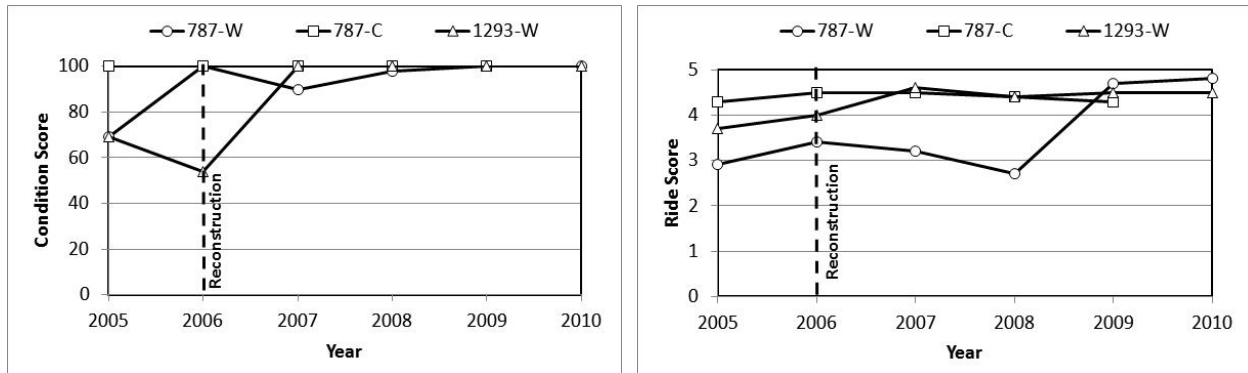
Figure 4.22. The Condition Scores and Ride Scores Before and After the Reconstruction.

Figure 4.22 suggest that the condition score and ride scores have significantly increased after the repair was taken place at each site. With regard to the expansive soil sites the treatment of cement-treated base, lime treated subgrade with geogrid and overlay were considered in this study. One can notice the effectiveness of the cement-treated base (471-R and FM 734-R2). Although this treatment was showing higher scores against the expansive soil conditions and the heavy traffic, it is a very costly repair. Geogrid at base-subgrade interface was also an effective treatment against expansive soil. Geogrid effectiveness is increased when combined with lime treated subgrade (734-R1). This repair is also costly but with less degree than in cement treatment base. On other hand, the overlay has also shown acceptable performance (471-O) and could be considered one of less costly treatments. With regard to the edge failure, only one site was investigated. It seems that incorporating the lateral support with overlay increases the performance scores of the pavement (787-W and 1293-W).
