VEHICLE CRASH TEST AND EVALUATION OF
MEDIAN BARRIERS FOR
TEXAS HIGHWAYS

Research Report Number 146-4
Studies of Field Adaptation of Impact Attenuation Systems

September 1972
Texas Transportation Institute
Texas A&M University
College Station, Texas

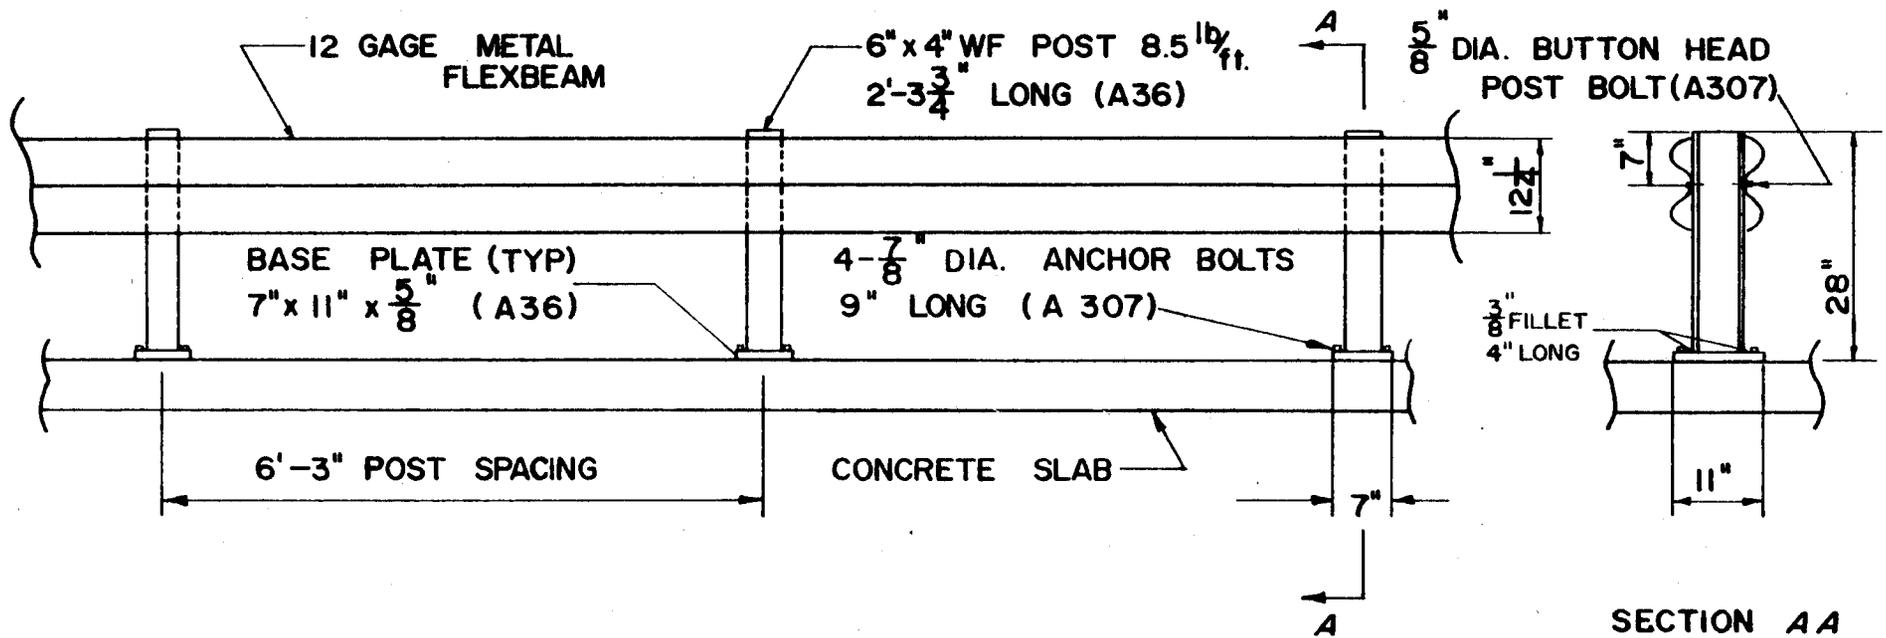
FIGURE 3. TEXAS HIGHWAY DEPT. METAL BEAM GUARD FENCE (BARRIER)
MBGF (B) - 69A

The metal beam guard fence or barrier, designated as MBGF(B)-69A, consists of two standard 12-gage steel W-shaped rail members mounted back-to-back on each side of a 6 WF 8.5 support post as shown in Figure 3. The posts are spaced on 6 ft.-3 in. centers, and the height above the roadway to the top of the rail member is 27 in.

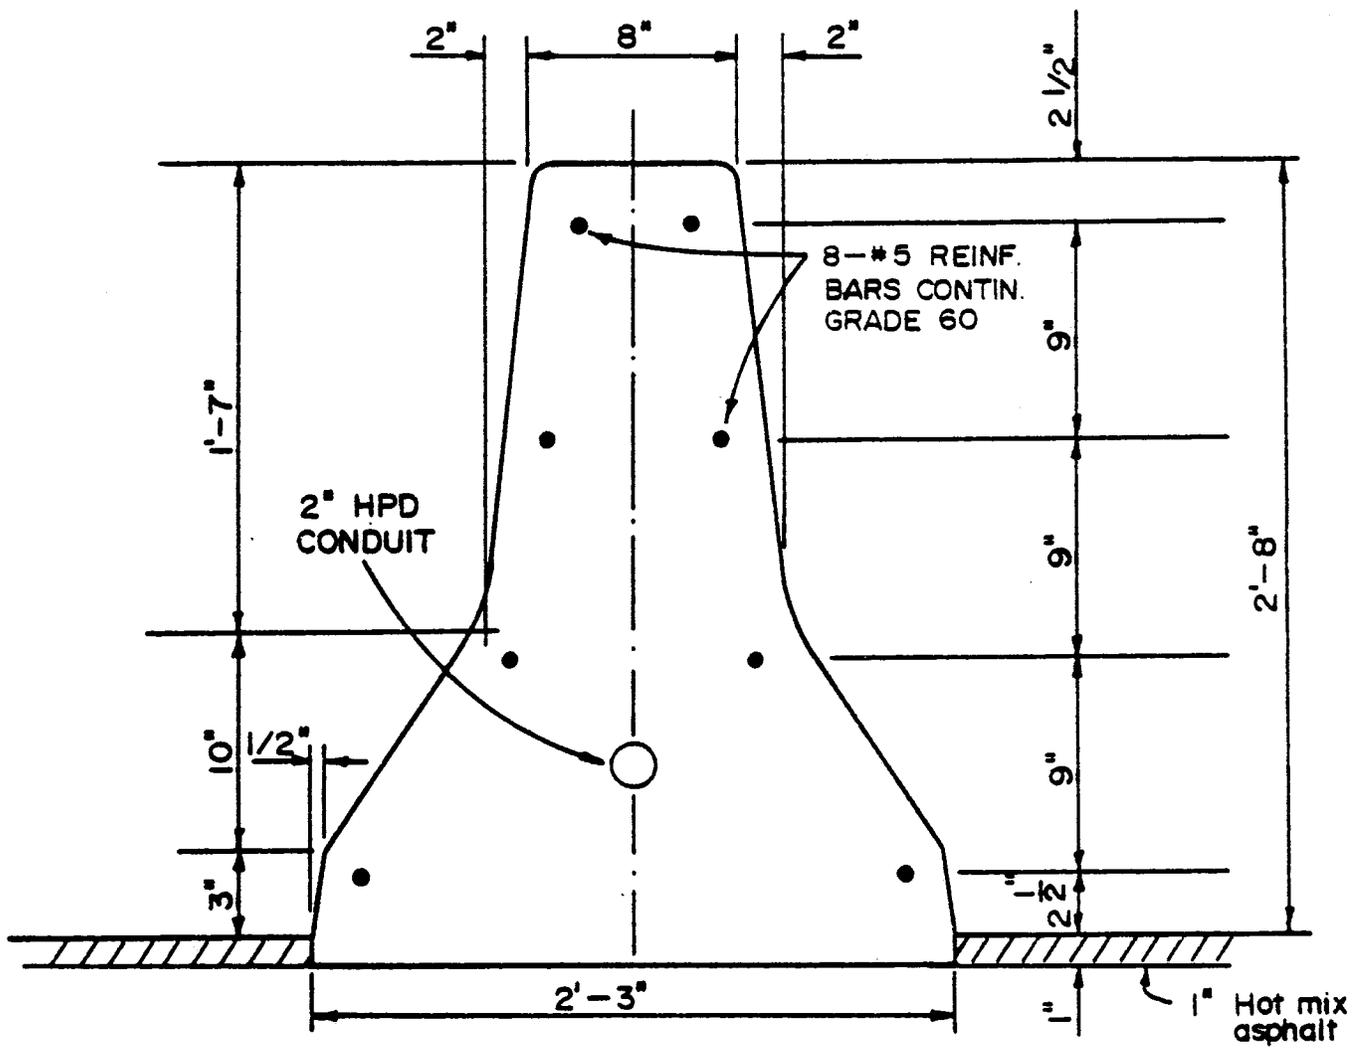
FIGURE 4. TEXAS HIGHWAY DEPT. CONCRETE
 MEDIAN BARRIER (CMB 70)

cross sectional view of Figure 4. The CMB barrier tested had: a weight of about 507 lb./ft.; a height of 32 in. above the roadway; a lower 10-in. high inclined surface of about 55 degrees; an upper 19-in. high inclined surface of about 84 degrees; a base width of 27 in.; and a top width of 8 in.

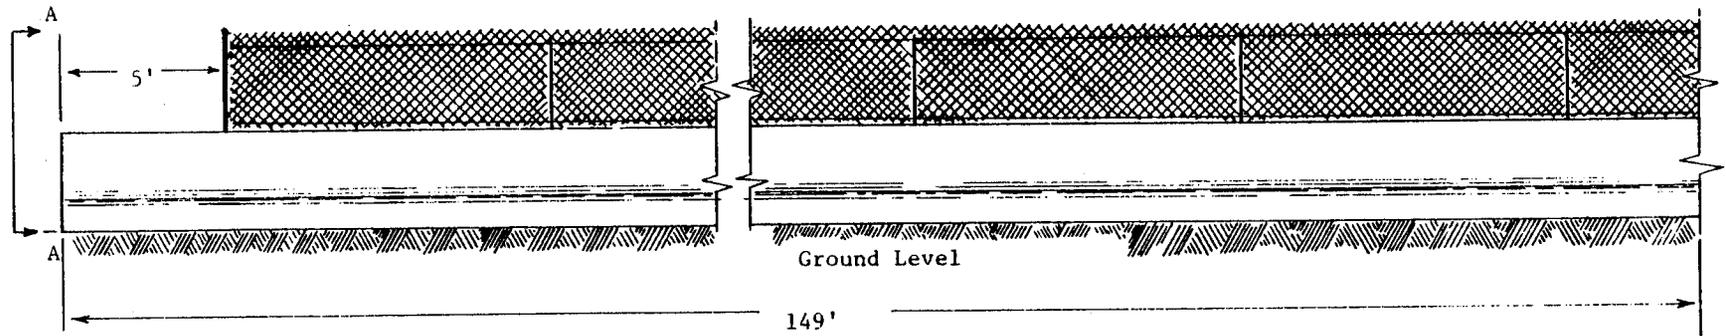
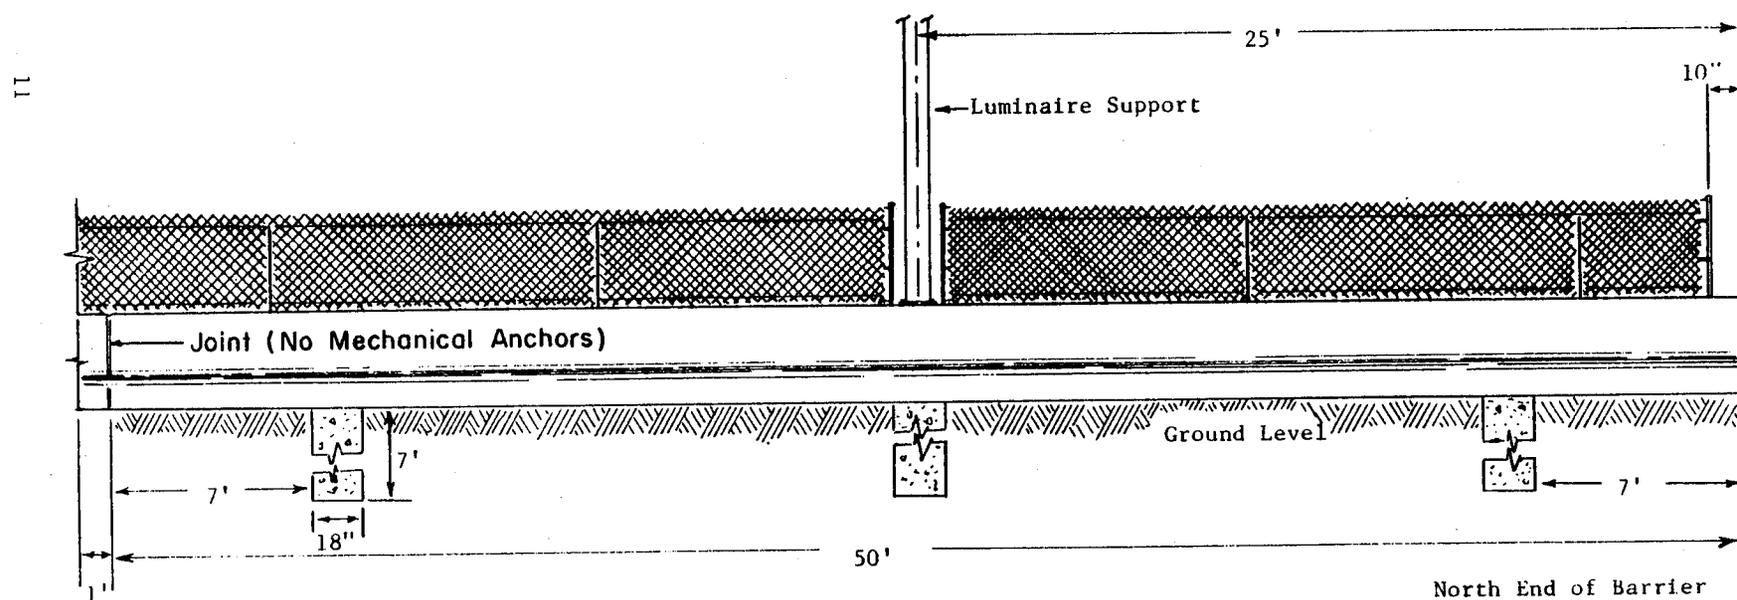
FIGURE 5. CONCRETE MEDIAN BARRIER (CMB 70)

The Texas CMB barrier is similar to the New Jersey Median Barrier (2) except that #5 longitudinal reinforcing steel is used in the Texas barrier whereas none is used in the New Jersey barrier. As shown in Figure 5, the CMB barrier was constructed in two longitudinally reinforced continuous length sections of 150 ft. and 50 ft. The construction joint between the two sections offers no lateral restraint.

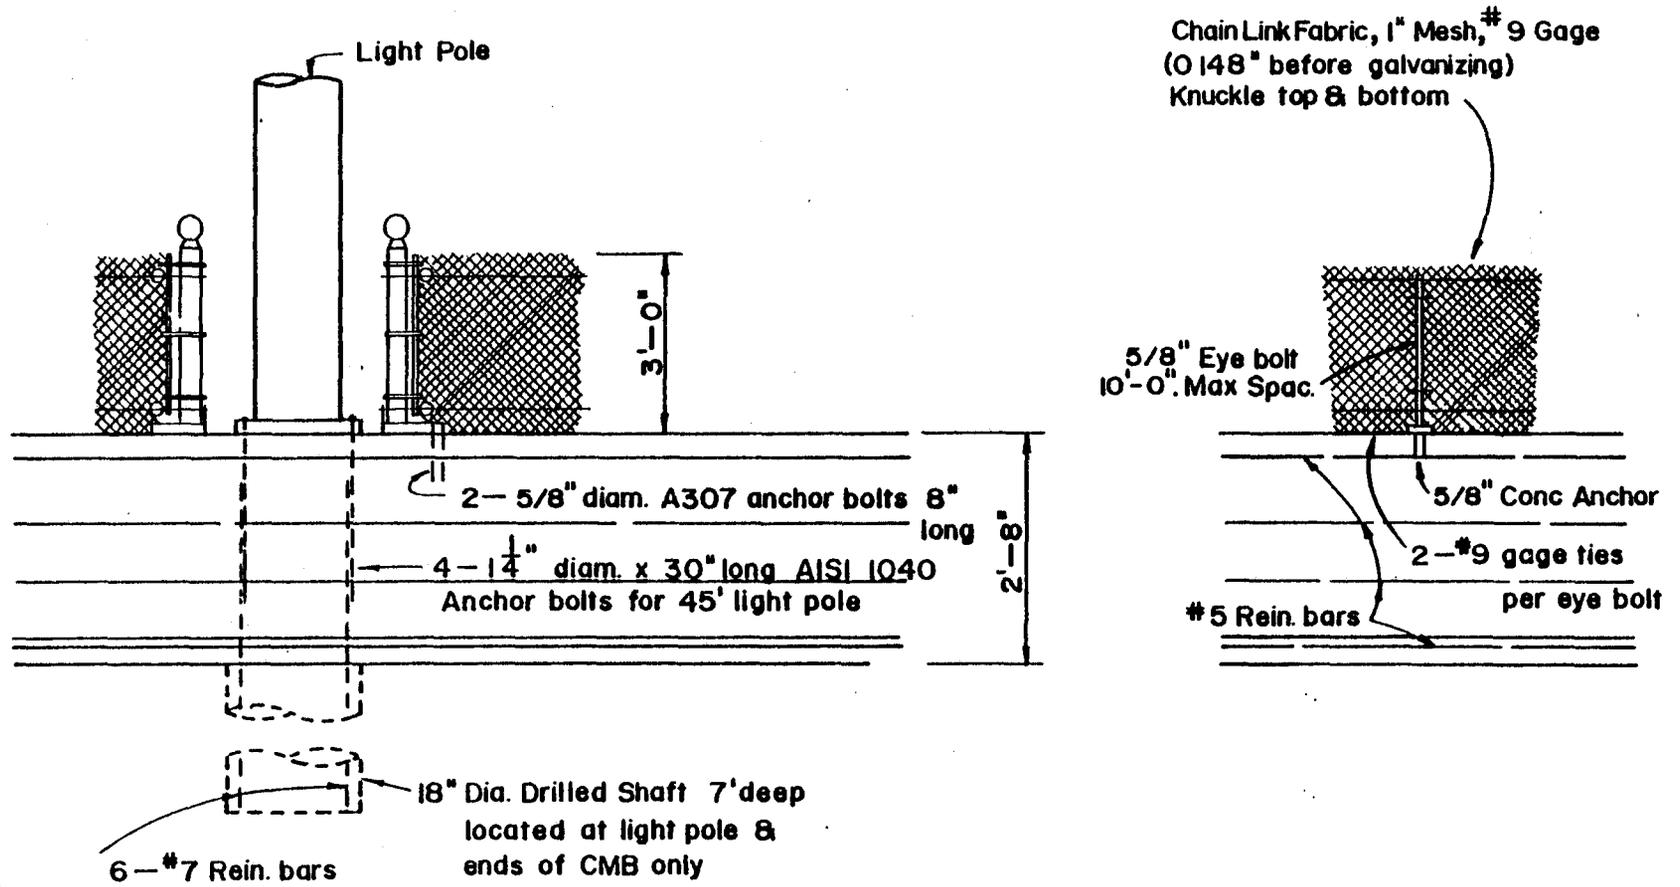
FIGURE 6. TEXAS HIGHWAY DEPT. CONCRETE MEDIAN BARRIER (CMB 70)

Details of the chain link fabric fence and of the luminaire pole connection is shown in Figure 6.

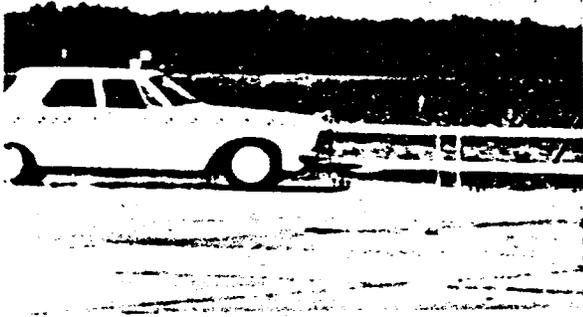
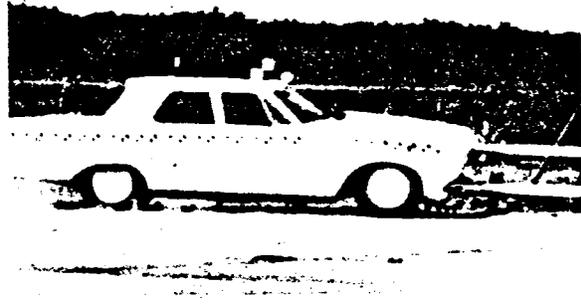
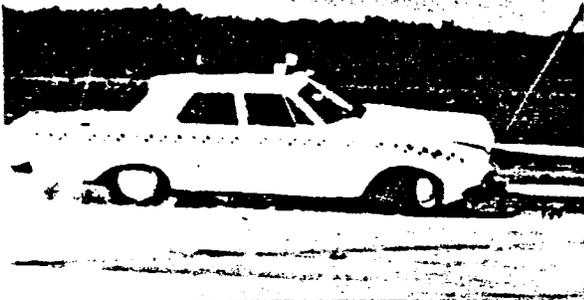
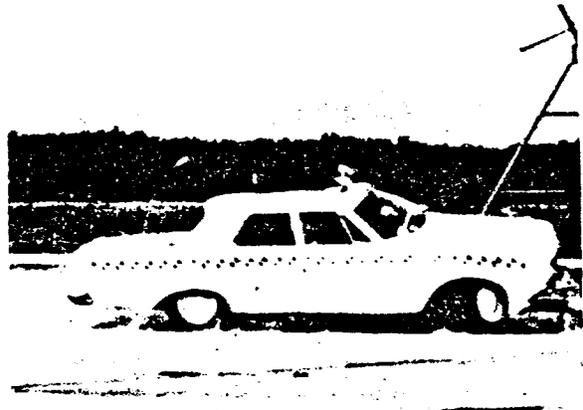
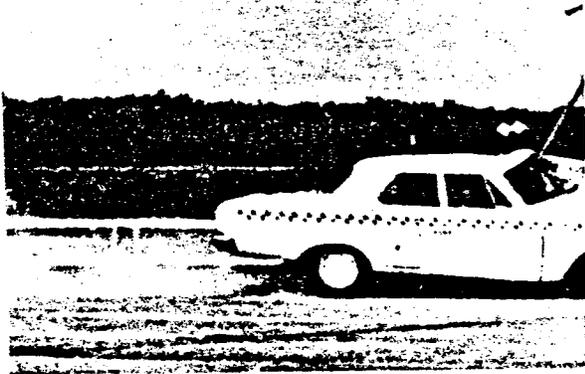
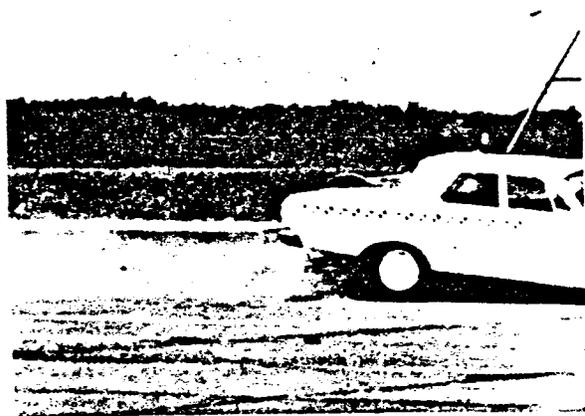
FIGURE 10, SEQUENCE PHOTOGRAPHS OF E-3 BARRIER TEST
(View Perpendicular To Initial Path of
Vehicle Prior to Impact)

The longitudinal accelerometer traces on the right and left frame members of the vehicle in Figures 36 and 37 (see appendix) indicate that snagging occurred on a support post during the time interval of 100 to 160 milliseconds after impact. The peak acceleration was 21.3 G's. The tire marks in Figure 7 and the motion of the vehicle in Figure 10 show that the vehicle had climbed on the lower rail member. It is the

It can be seen in Figure 10 that the right front wheel of the vehicle was pulled left toward the barrier. This pulling effect in combination with the severely damaged left wheel caused the vehicle after redirection to travel in a circular arc back toward the barrier as shown in Figure 11. This phenomenon, which is typical of high speed and large angle barrier collisions, is certainly desirable because it minimizes the danger to other vehicles in the vicinity of the collision.

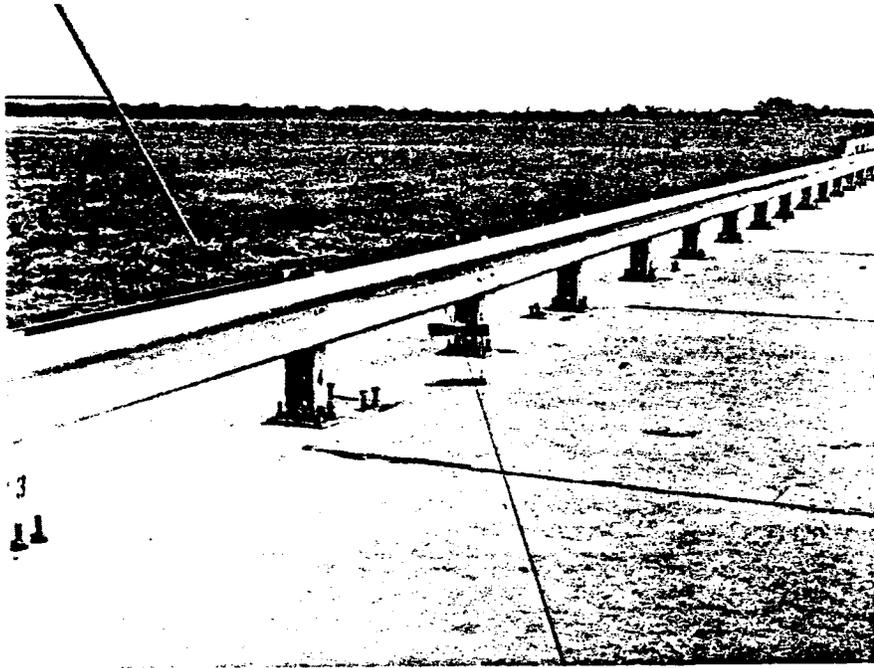
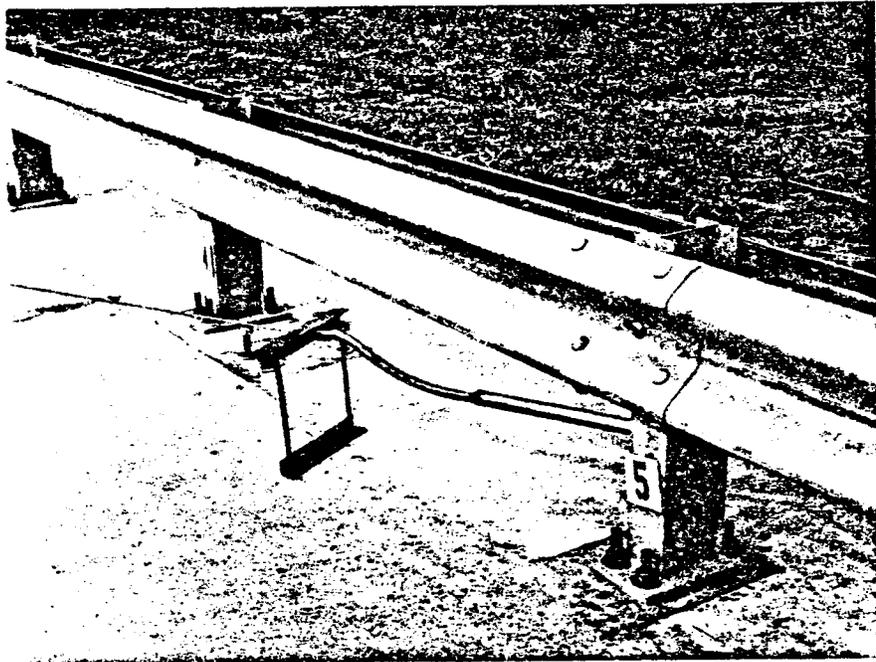
FIGURE 12, VIEWS OF MBGF BARRIER BEFORE TEST.

The MBGF Median Barrier test was conducted at an impact speed of 57.3 mph and an impact angle of 25 degrees using a standard size 1963 Plymouth weighing 3,640 lbs., with instrumentation and dummy. The point of impact was near a support post as shown by the location of the vehicle control cable in the photographic views of the barrier before testing in Figure 12.

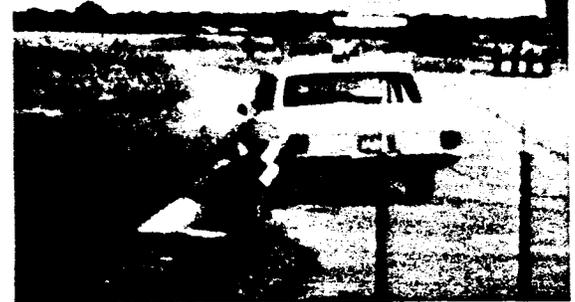
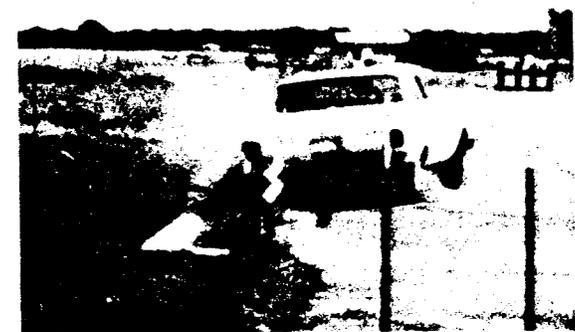
FIGURE 13, SEQUENCE PHOTOGRAPHS OF MGF BARRIER TEST.
(View Parallel To Rail Member)

Sequential photographs of the vehicle collision and its redirection are shown in Figures 13 and 14 from two camera positions. And, a summary of the test results from an analysis of the film data and accelerometer traces are presented in Table 1.

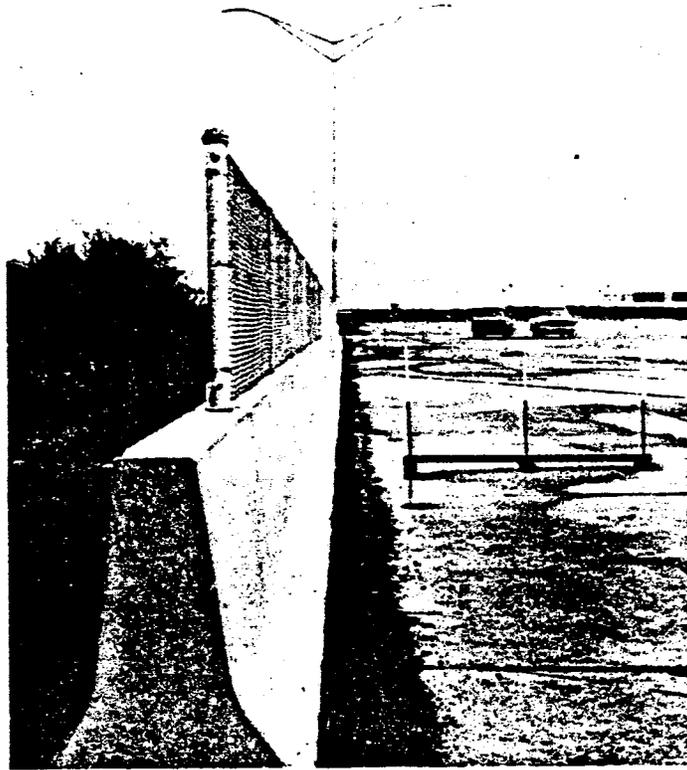
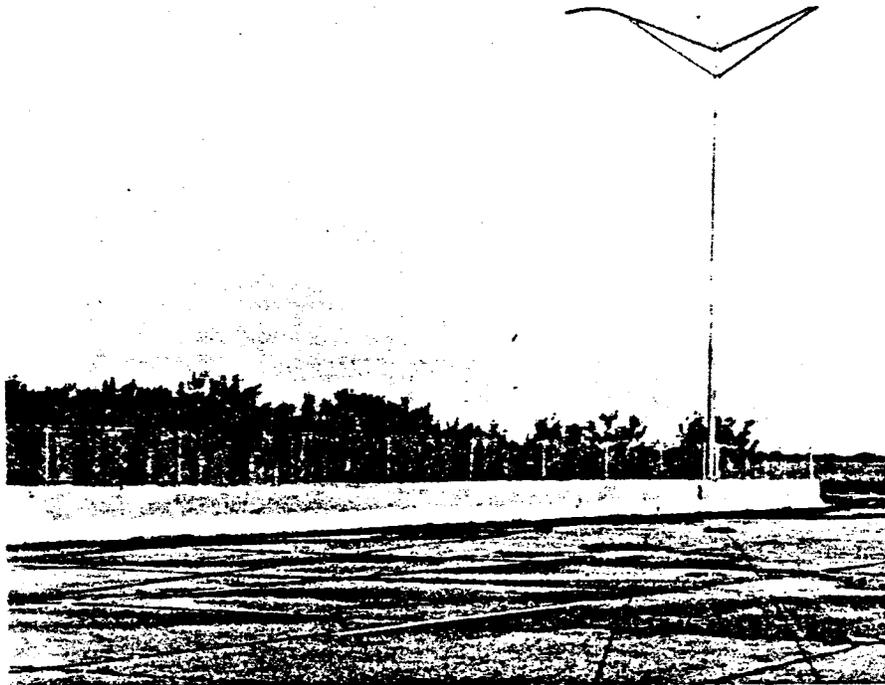
FIGURE 17. CONCRETE MEDIAN BARRIER BEFORE TEST CMB-1.

The first rigid concrete median barrier test, designated CMB-1, was conducted to determine if a standard size 4,000 lb. vehicle would snag and knock down the luminaire pole mounted on top of the barrier under the impact conditions of about 60 mph and 25 degrees. The centerline of the vehicle was directed at the center of the luminaire support, thus placing the initial contact point of the left front fender with the median barrier approximately 9 ft. upstream from the luminaire pole position. Photographs of the barrier and vehicle before the crash are shown in Figures 17 and 18.

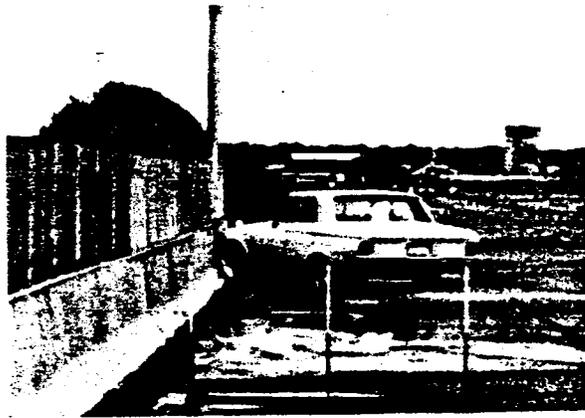
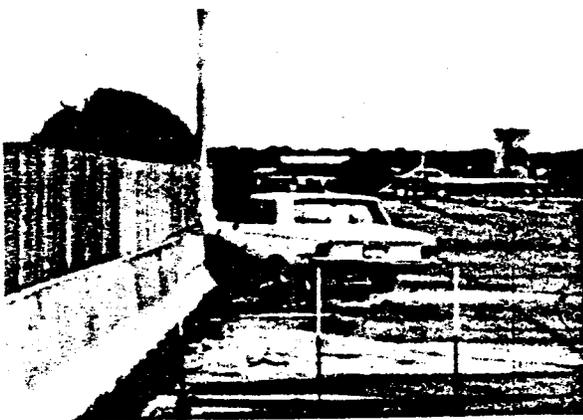
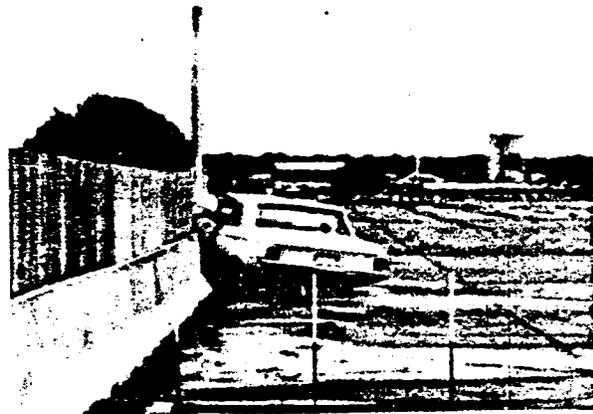
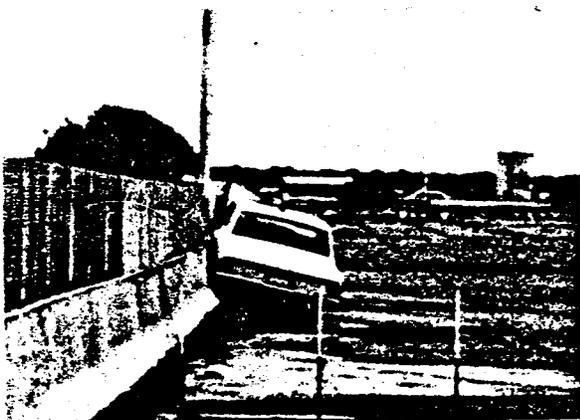
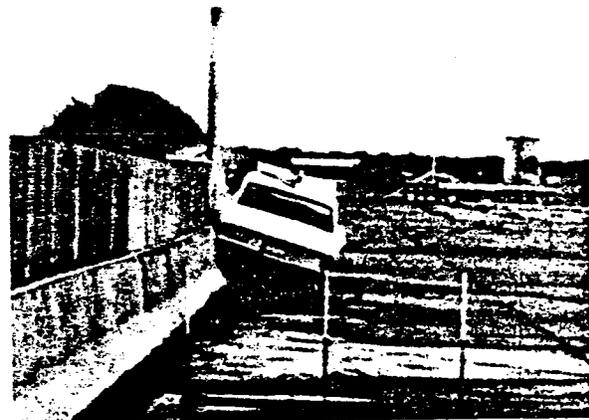
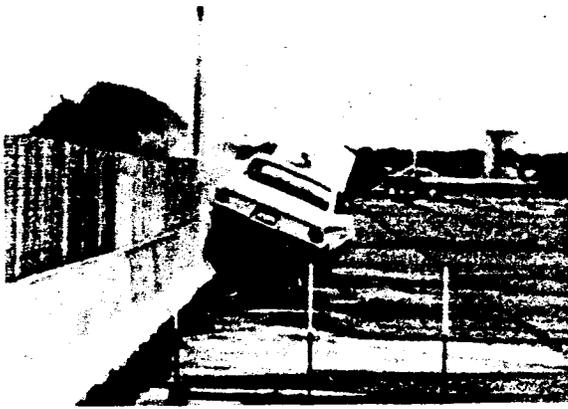
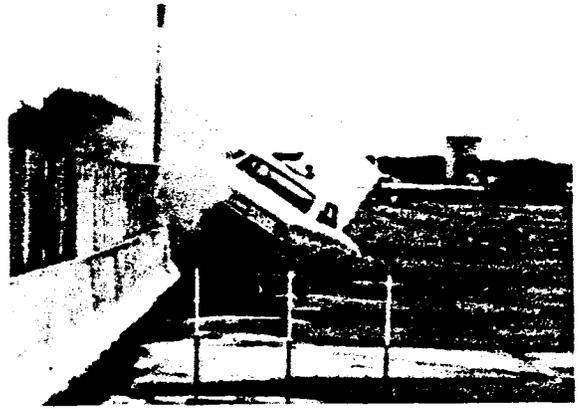
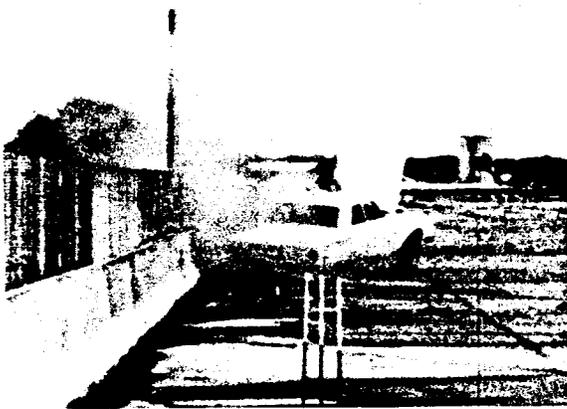
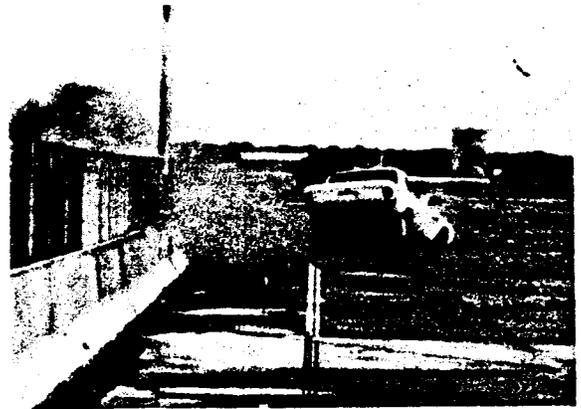
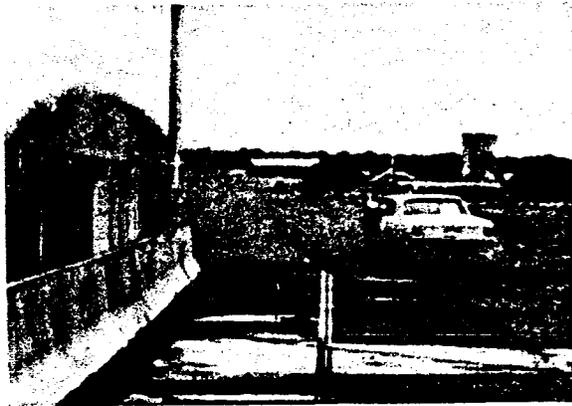
FIGURE 19. SEQUENCE PHOTOGRAPHS OF TEST CMB-1.
(View Parallel To Concrete Median Barrier)
(Continued)

Initially, the left front fender was crushed; then, as the vehicle was redirected, it rode partially up the side of the barrier lightly scraping the attached fence and luminaire pole. When the vehicle lost contact with the barrier, it was airborne until landing on the edge of the right front tire as shown in the sequential photographs in Figures 19 and 20. The vehicle took two more severe bounces, alternately lifting the front and back ends of the vehicle off the ground. The severely damaged left front quarter and wheel of the vehicle caused it to swerve back toward the barrier. The final position of the vehicle was approximately 155 ft. downstream of the initial point of impact and it was facing back toward the point of impact.

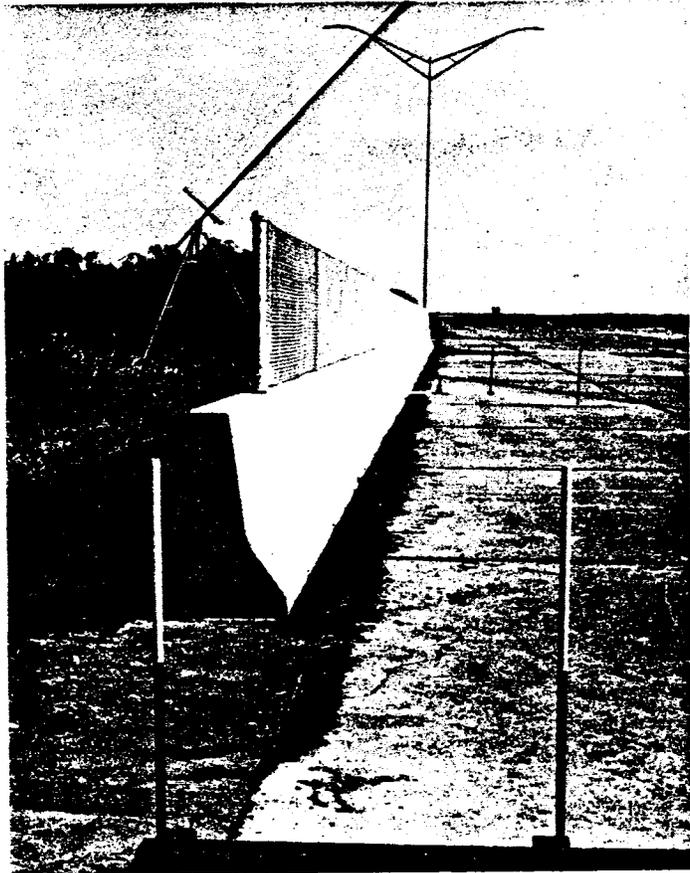
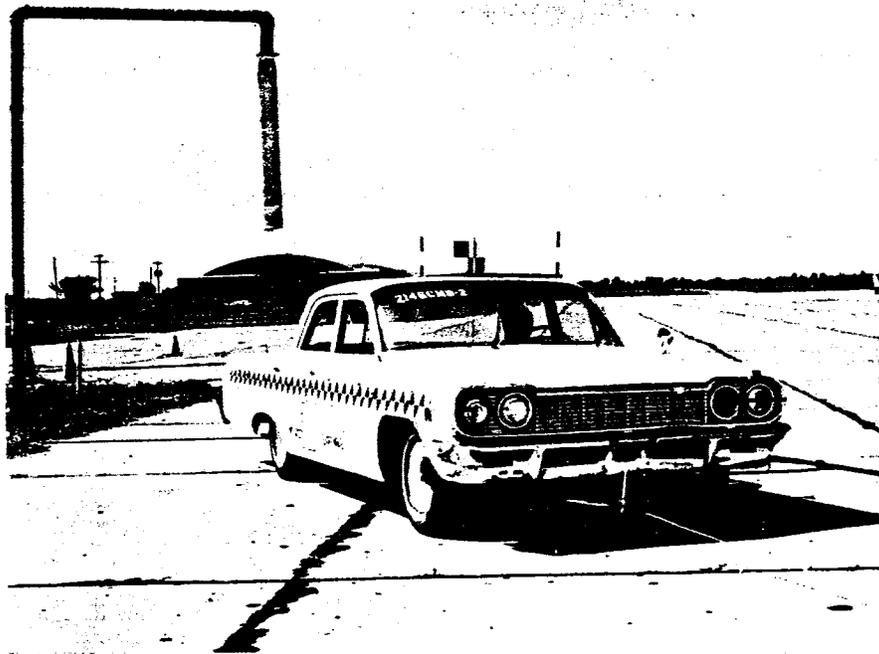
FIGURE 21. CONCRETE MEDIAN BARRIER AND VEHICLE BEFORE TEST CMB-2.

This test, designated CMB-2, was conducted to determine if the 150 ft. unanchored section of the CMB barrier, with continuous steel reinforcement, would slide and/or rotate in restraining and redirecting a standard size 4,000 lb. passenger vehicle under the impact conditions of about 60 mph and 25 degrees. Photographs of the barrier and vehicle prior to impact are shown in Figure 21.

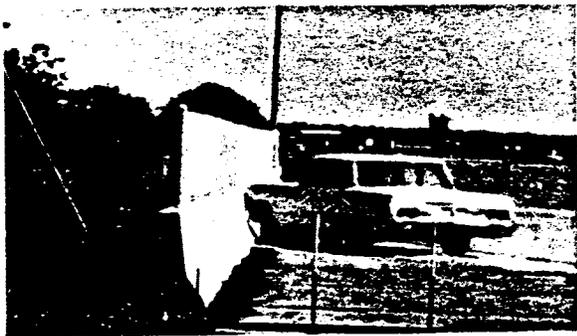
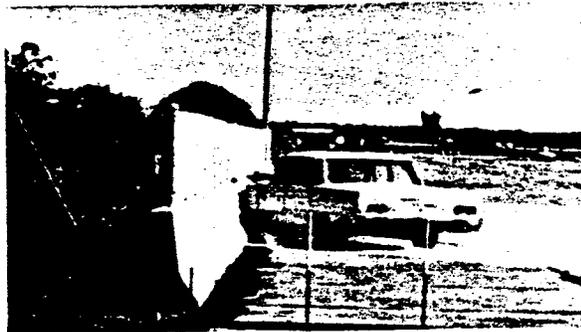
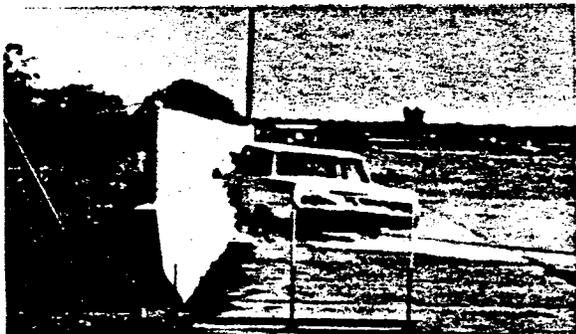
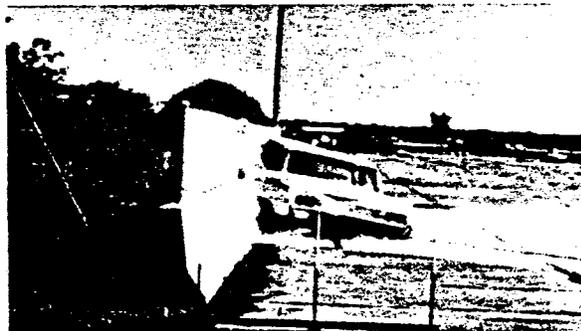
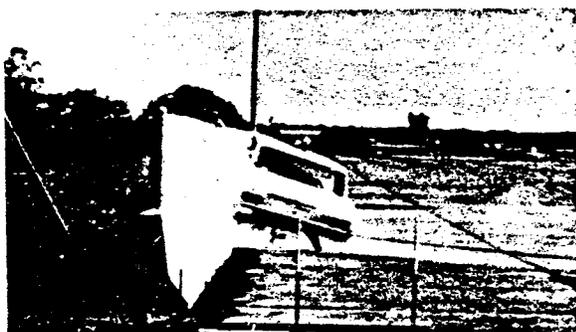
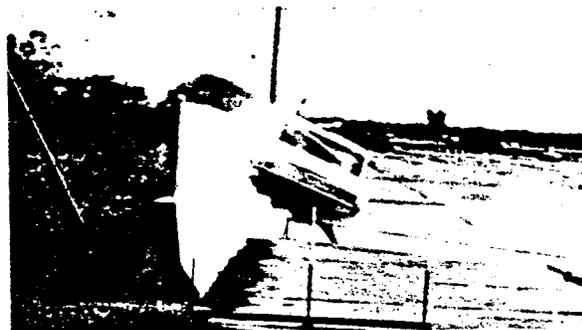
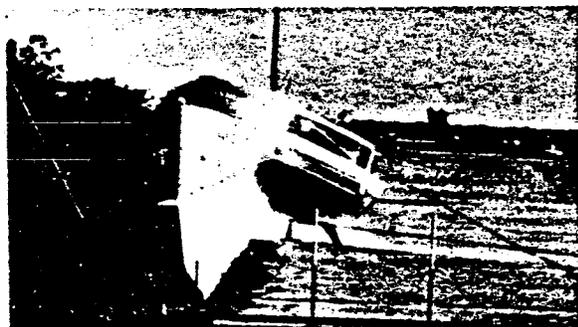
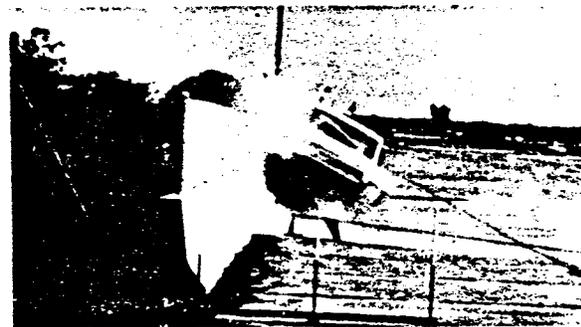
FIGURE 22. SEQUENCE PHOTOGRAPHS OF TEST CMB-2.
(View Parallel to Concrete Median Barrier)

The vehicle-barrier interaction in the CMB-2 test was similar to that of the first test, CMB-1. While the vehicle was being redirected, the left front fender was crushed and the vehicle rode up the side of the barrier. The tire marks go all the way up the side of the concrete barrier as can be seen in Figure 24. At loss of contact with the barrier, the right front wheel had already recontacted the pavement. Two more severe bounces followed this, alternately lifting the front and rear of the car off the ground. The drag forces from the severely damaged left front quarter caused the vehicle to swerve back toward the barrier. Sequential photographs of the vehicle collision and redirection are shown in Figure 22.

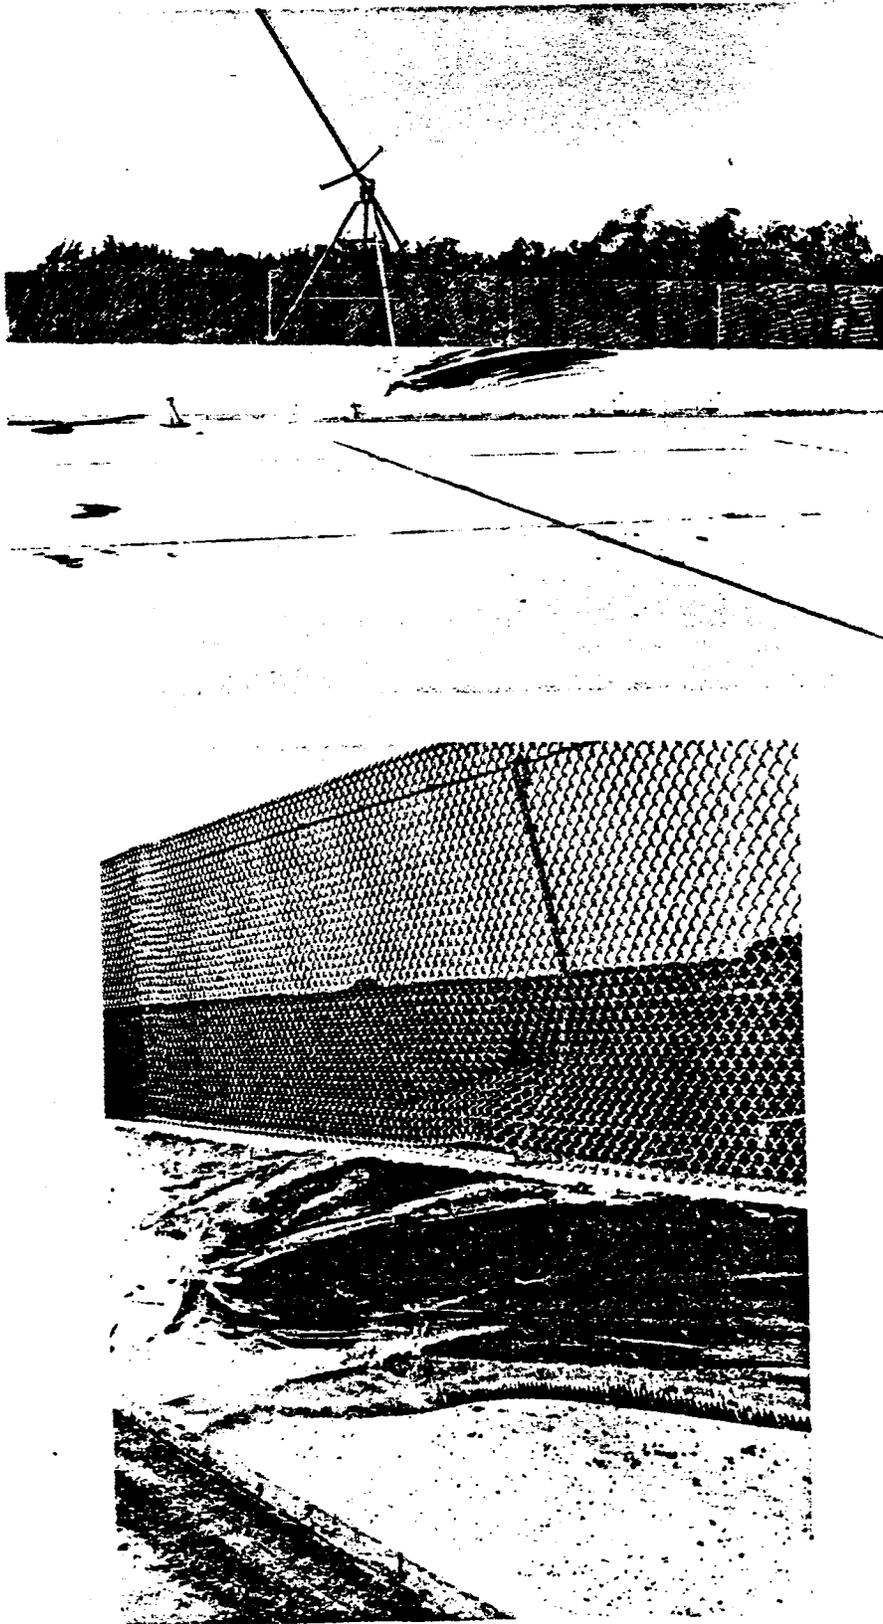
FIGURE 24. DAMAGE TO CONCRETE MEDIAN BARRIER AFTER TEST CMB-2.

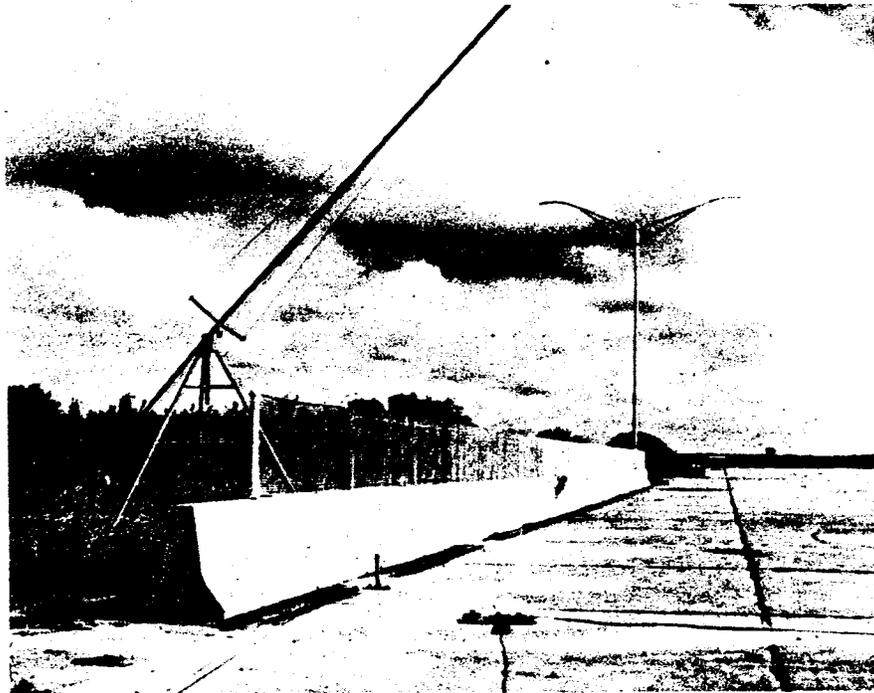
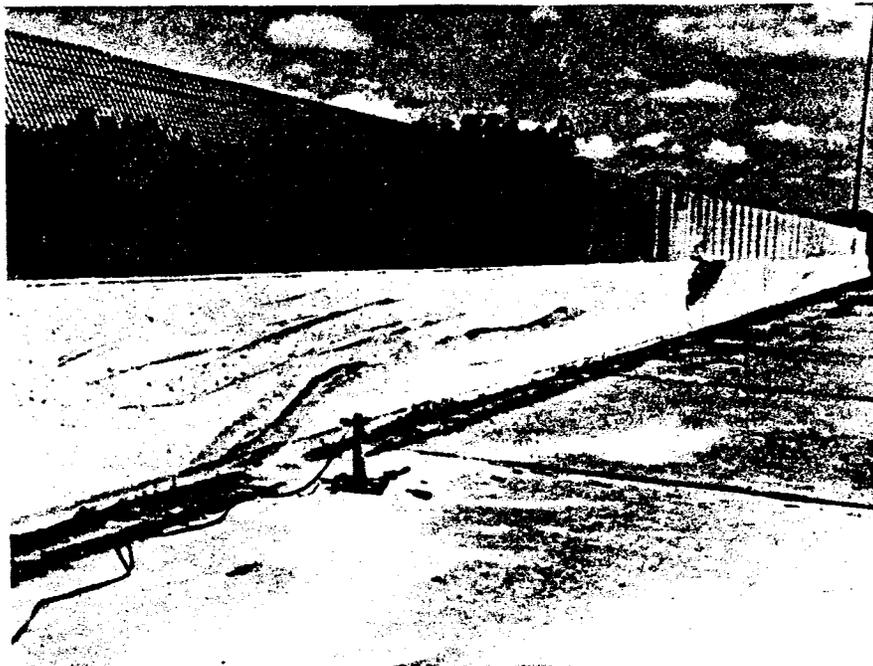
Sequential photographs of the vehicle collision and redirection are shown in Figures 27 and 28. As can be seen by the tire scrub markings in Figure 25, the vehicle quickly climbed up the lower face of the barrier and was redirected when the tire contacted the steeper upper face of the barrier. The maximum height of climb was approximately 18 in. The vehicle lost contact with the barrier after 46 ft. of travel. At a point 72 ft. downstream from the point of impact, the vehicle again recontacted the barrier.

FIGURE 25. CONCRETE MEDIAN BARRIER BEFORE AND AFTER TEST CMB-3.
(Darkest Tire Mark is from Test CMB-2.)

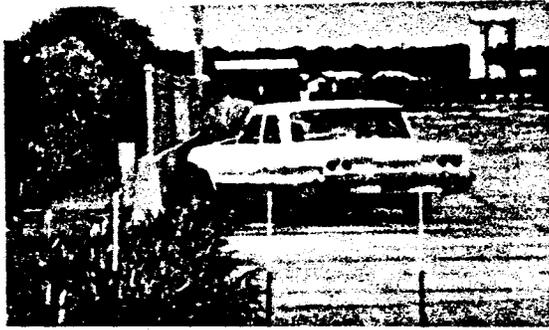
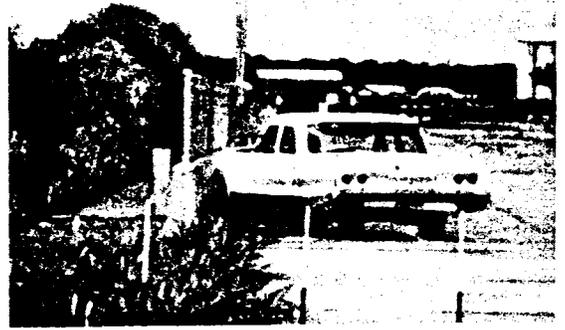
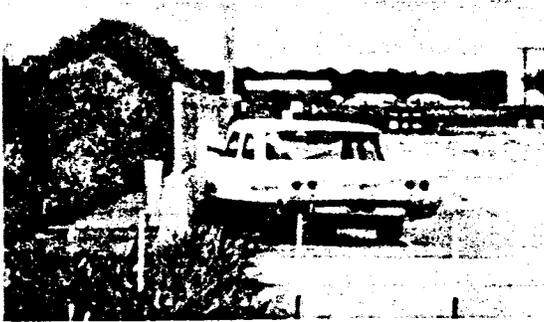
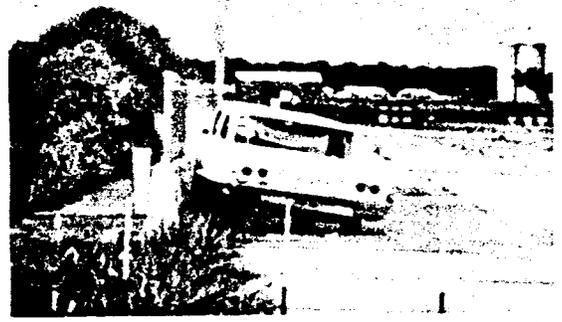
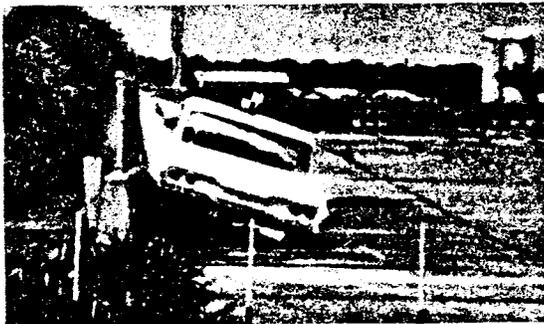
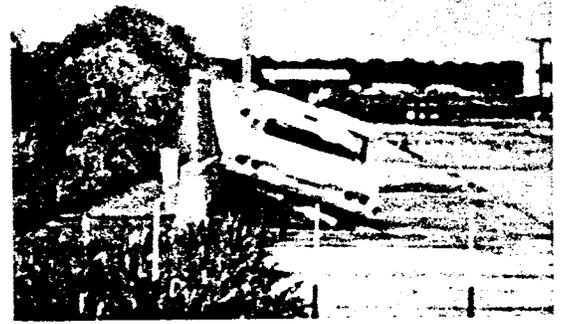
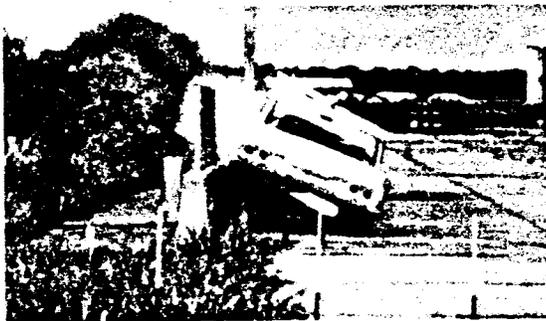
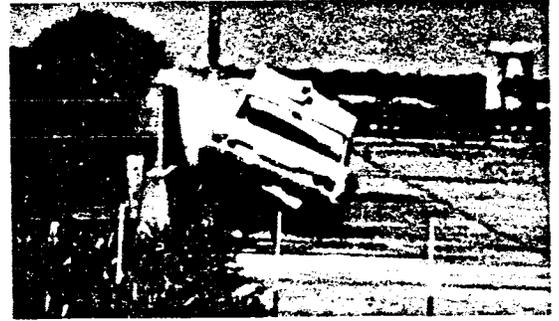
FIGURE 31. SEQUENCE PHOTOGRAPHS OF TEST CMB-4.
(View Parallel to Concrete Median Barrier)

Sequential photographs of the vehicle collision and redirection are shown in Figures 31 and 32. The sequential photographs and the photograph of the tire scrub markings in Figure 29 show that the vehicle climbed all the way to the top of the barrier. Sheet metal contact caused relatively minor damage to the fence as can be seen in Figure 29. After losing contact with the barrier, the vehicle took two more severe bounces, alternately lifting the right side and the back end off the ground.

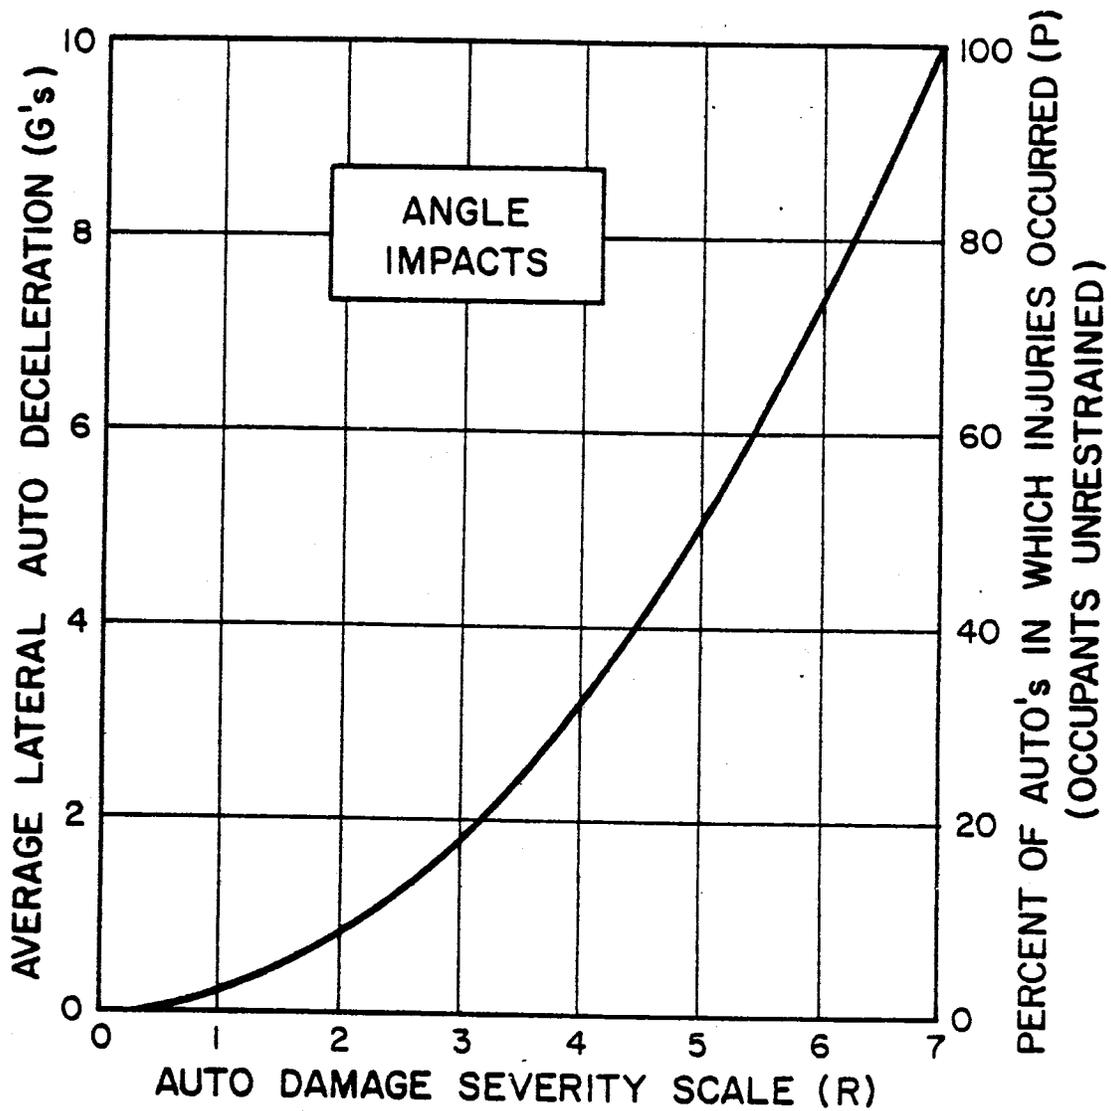
FIGURE 33 CURVE RELATING AUTO LATERAL DECELERATION, INJURIES, AND DAMAGE SEVERITY (Refs. 3,4)

In addition, Michalski (3) determined upon examining only those accidents in which injuries occurred that injury accidents corresponded to a *mean* damage rating of $R = 4.73$. Referring to Figure 33, this mean damage rating corresponds to a mean average lateral deceleration of about 4.6 G's and a mean probability of injury considering *all* accidents of 46 percent. Probability is used as a shorthand notation for the "percentage of vehicles in which injuries occurred". Since the injury type accidents ranged from minor (not defined by Michalski) to fatalities, it is reasonable to regard the above *mean* values as representing a division between minor and major injuries.
