VEHICLE CRASH TEST AND EVALUATION OF
MEDIAN BARRIERS FOR
TEXAS HIGHWAYS

Research Report Number 146-4
Studies of Field Adaptation of Impact Attenuation Systems

September 1972
Texas Transportation Institute
Texas A&M University
College Station, Texas

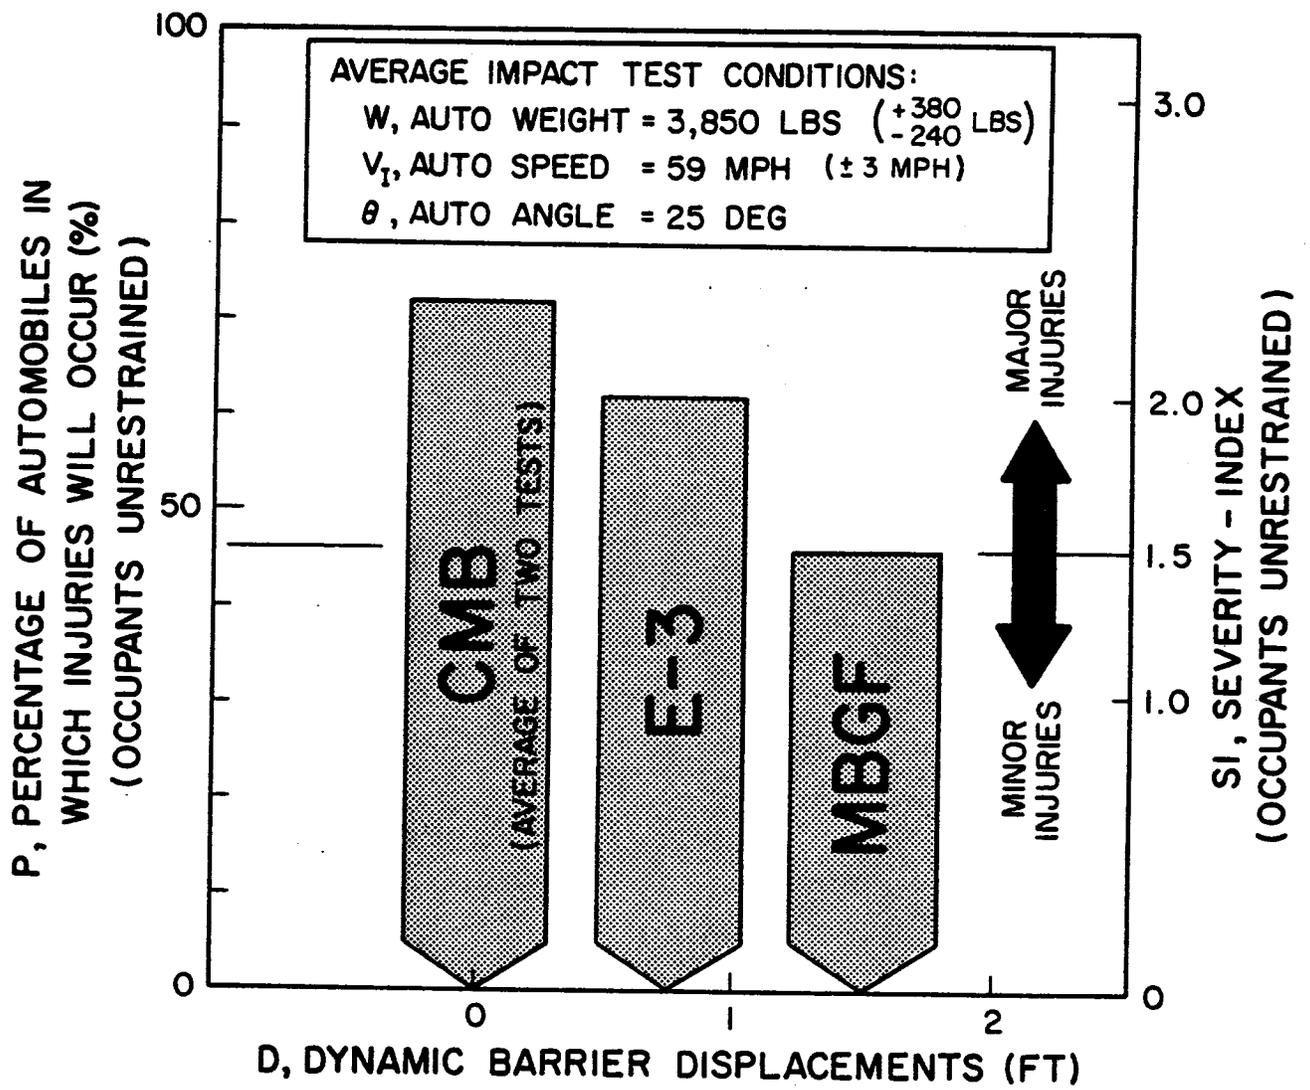
FIGURE 34 COMPARISON OF SELECTED BARRIERS FROM A VIEWPOINT OF INJURY SEVERITY

Predictions on the probability and severity of injuries on the three barriers of different configuration and lateral stiffness are shown in Figure 34. The probability of injury values were computed from Eq. 2 using the average lateral vehicle decelerations in Tables 1 and 2 obtained by an analysis of high speed film. The corresponding severity-index

values were obtained from Eq. 3. It can be seen in Figure 34 that the probability of injury (46%) and severity-index (1.5) were lowest for the semi-rigid MBGF barrier undergoing the largest displacement of 1.5 ft.; whereas, the probability of injury (72%) and severity-index (2.3) were highest for the rigid CMB barrier undergoing negligible displacements. The E-3 barrier, undergoing a lateral displacement of 0.7 ft., had a probability of injury (62%) and severity-index (2.0) in between that of the CMB and MBGF barriers. The comparison of the three barriers in Figure 34 clearly illustrates the desirable effect of barrier displacements in enhancing safety. However, under the severe impact conditions suggested by HRB Circular 482 (1) and used in this study, it can be predicted that major injuries will occur during collisions with the CMB and E-3 barriers, whereas, major injuries may or may not occur during collisions with the MBGF barrier. A small decrease in the lateral stiffness of the MBGF barrier appears desirable from a viewpoint of safety.

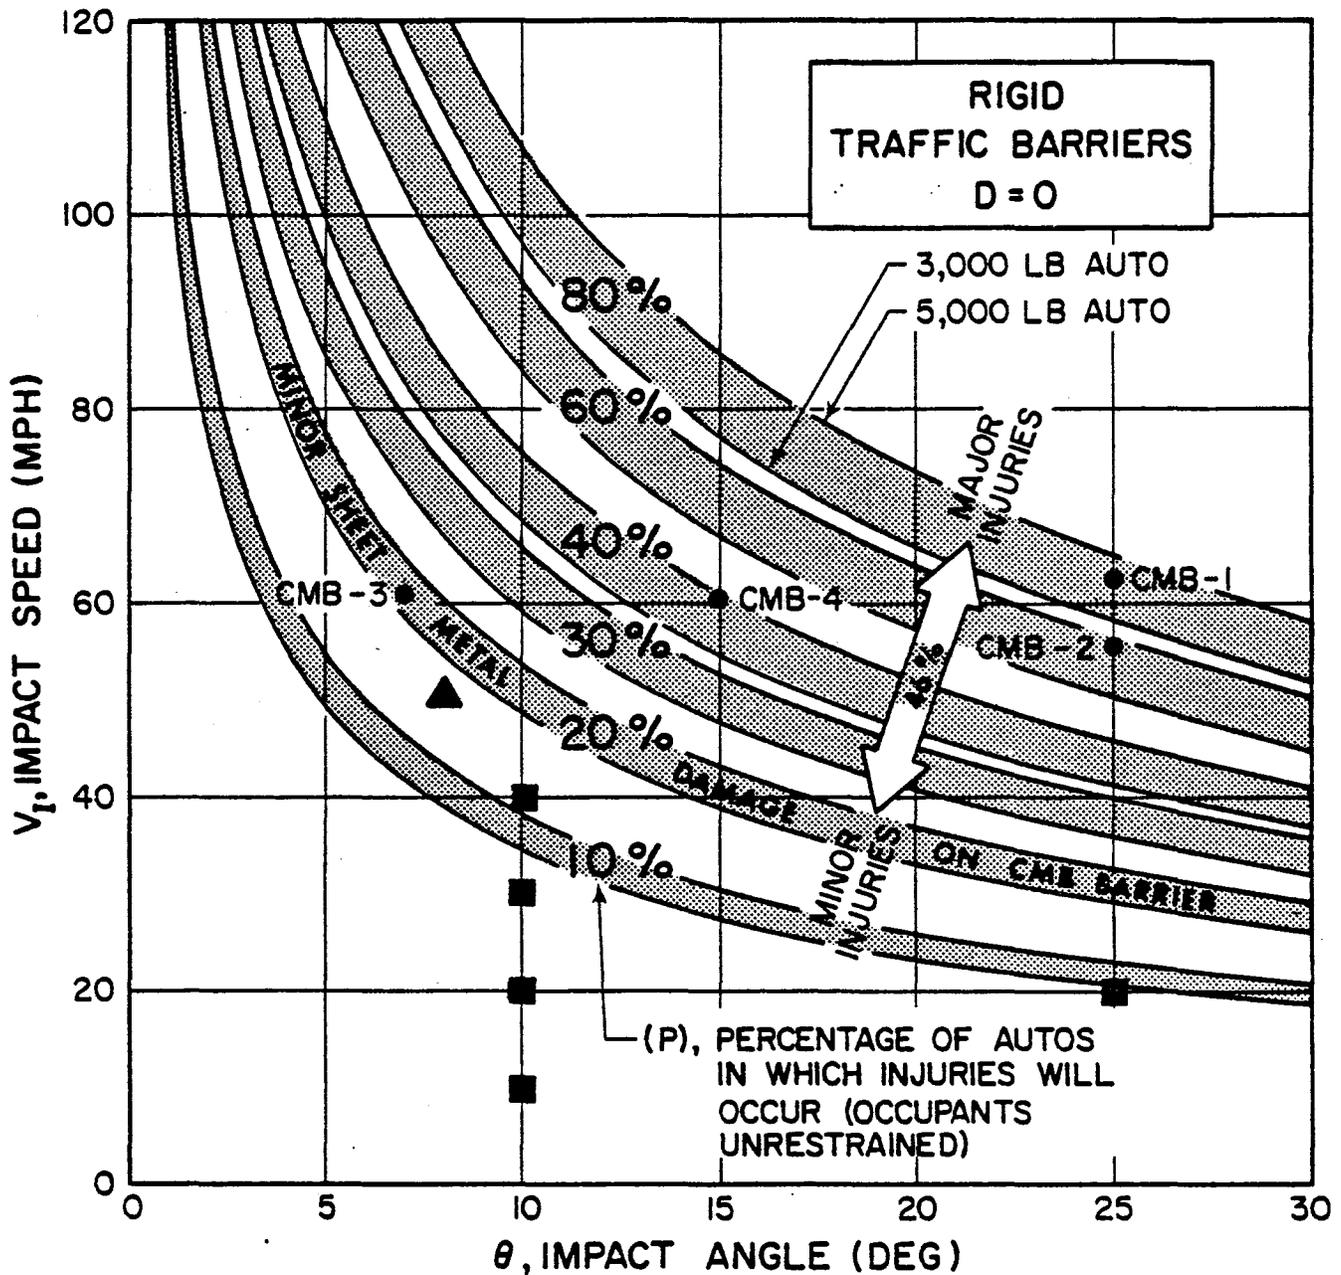
FIGURE 35 PREDICTED PROBABILITY AND INJURY SEVERITY UNDER VARIOUS IMPACT CONDITIONS INVOLVING RIGID BARRIERS

Predictions on the probability and severity of injuries associated with *rigid* traffic barriers in general under various conditions of impact speed, impact angle, and vehicle weight are presented for simplicity in one overall view in Figure 35. The probability curves were obtained from Eq.'s 1 and 2. The relationships between the vehicle dimensions in Eq. 1 and vehicle weight were obtained from a recent NCHRP 86 continuation study by Olson (12).

The four full scale test runs on the rigid CMB barrier at different impact speeds and angles are plotted in Figure 35. Knowing the weight

1. A large 5,000 lb. passenger vehicle can strike a rigid barrier at a larger angle than a compact 3,000 lb. vehicle with no difference in injury probability. Interpolation can be used for intermediate weight vehicles.
2. Major injuries will occur under impact conditions exceeding an injury probability of 46 percent and a severity-index of 1.5. For example, major injuries may occur during a rigid barrier redirection of a 4,000 lb. vehicle under the impact conditions of about 60 mph and 17 degrees; to reduce the probability and severity of injury for possible angles of impact greater than 17 degrees, one would need to consider a semi-rigid barrier.

3. A probability injury level of about 20 percent ($G_{lat} = 2$ from Eq. 2) corresponds to impact conditions in which minor sheet metal damage occurs during collisions with the CMB barrier. Further verification of this fact can be easily obtained by examining the results of tests conducted by California (14, 15). The effectiveness of the CMB barrier beyond this level is similar to that of a vertical concrete barrier.

4. *Live driver* tests lend considerable support to the probability and injury severity predictions of Michalski (3) and Olson (4) in Figure 35. Tests run by Lunstrom (16) on the General Motors (GM) rigid concrete barrier at 50 mph/8 deg. resulted in minor vehicle damage and no driver concern. The GM test conditions in Figure 35 would correspond to a low injury probability of about 15 percent and an injury severity of minor. The tests conducted by the Ontario Department of Highways (19) on the New Jersey concrete median barrier at 10, 20, 30, 40 mph/10 deg. and 20 mph/25 deg. resulted in minor vehicle damage, little driver discomfort, and good driver control of the vehicle both when in contact with the barrier and on exit. The test conditions of Ontario (19) in Figure 35 would correspond to a low probability of about 11 percent and less and an injury severity of minor.

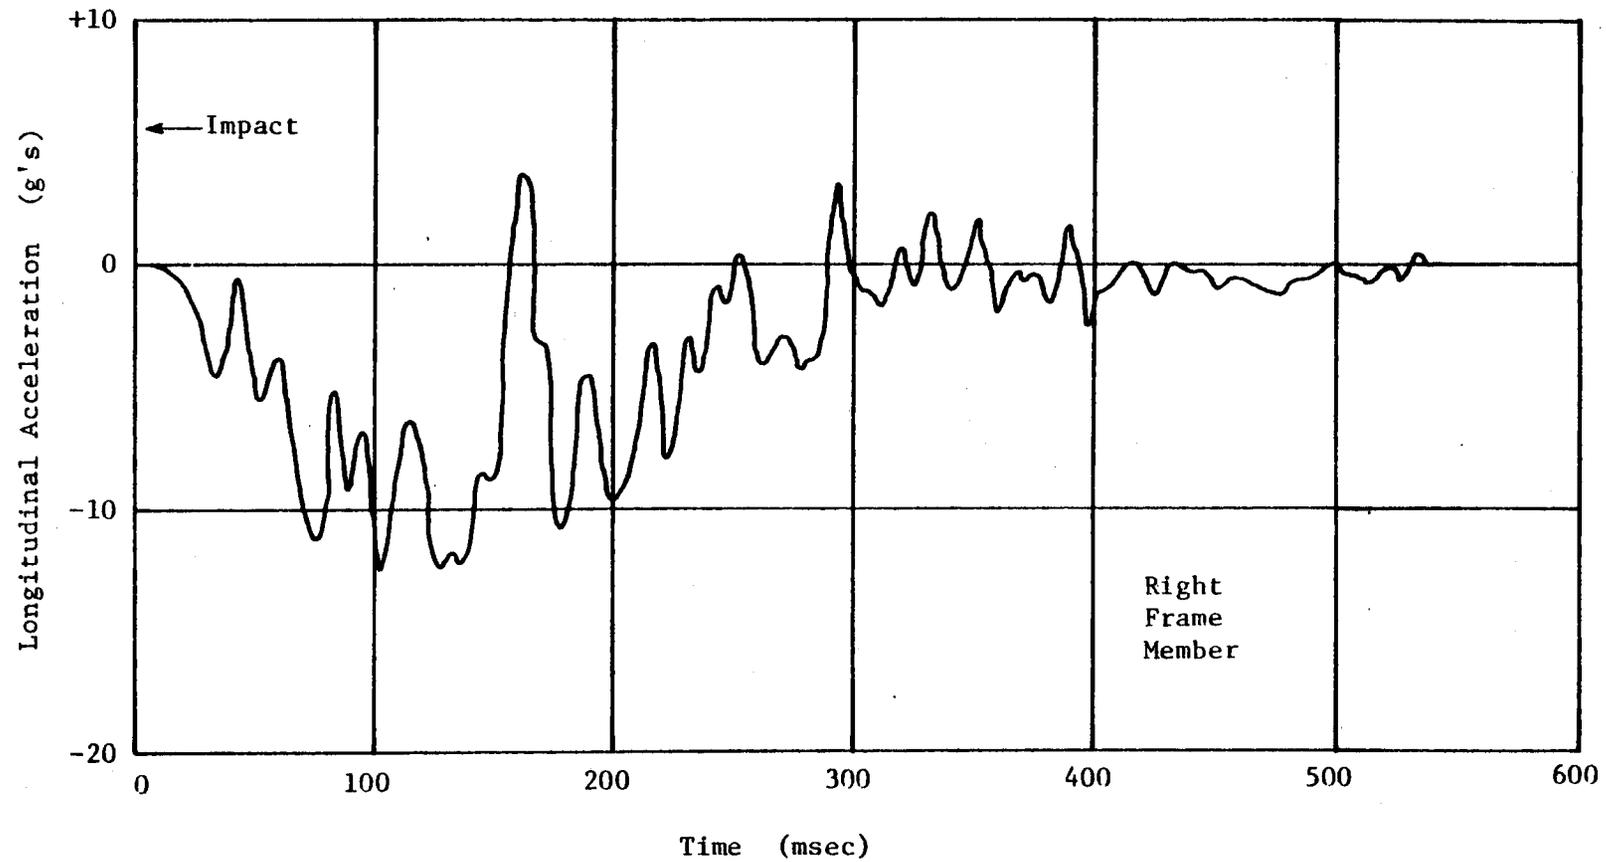
FIGURE 40. LONGITUDINAL ACCELEROMETER DATA FOR MBGF BARRIER TEST.

The longitudinal accelerometer traces on the right and left frame of the vehicle in Figures 40 and 41 (see appendix) indicate that the snagging on the weak breakaway posts was not of any great concern. The peak longitudinal acceleration was 12.8 G's.
