1. Report No.		2. Government Accession No.		3. Recipient's Catalog No.	
4. Title and Subtitle <b>TRUCK TESTS ON TEXAS CONCRETE MEDIAN BARRIER</b>				5. Report Date <b>August 1972</b>

TRUCK TESTS  
ON  
TEXAS CONCRETE MEDIAN BARRIER

Research Report 146-7  
Studies of Field Adaptation of Impact Attenuation Systems

Texas Transportation Institute  
Texas A&M University  
College Station, Texas

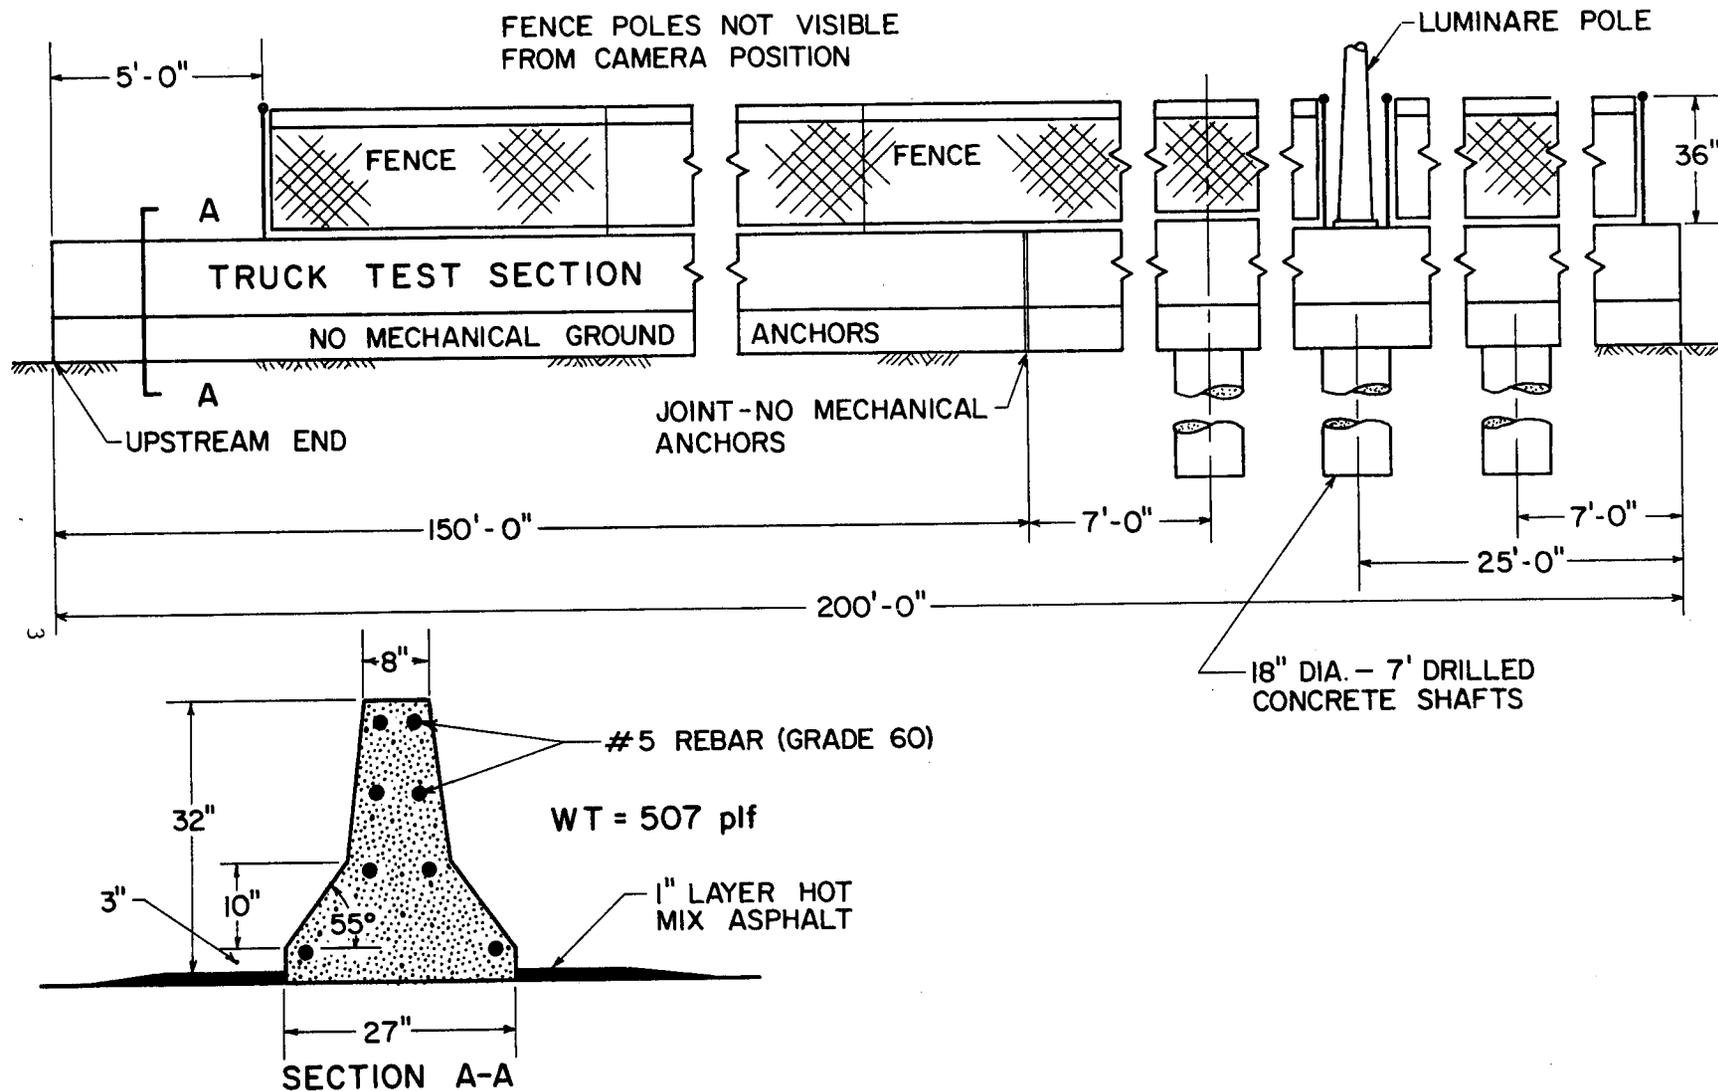
FIGURE 1 TEXAS CONCRETE MEDIAN BARRIER (CMB-70)

It is to be noted that the 150 ft. longitudinally reinforced CMB barrier test section (see Figure 1) contained no mechanical anchors between the ground and the barrier. A 1 in. layer of hot mix asphalt was placed, however, at the base of the barrier to help resist lateral translations.

The CMB barrier, shown in Figure 1, has: a weight of 507 plf.; a height of 32 in. above the roadway; a lower 10-in. high inclined surface of 55 degrees; a base width of 27 in.; and a top width of 8 in.

The CMB barrier was constructed in two continuous length sections of 50 ft. and 150 ft. as shown in Figure 1. The construction joint between the two sections offers no lateral restraint. The luminaire pole was mounted on top of the shorter 50 ft. section. Three 18-in. diameter drilled concrete shafts were used to support the shorter 50 ft. section against possible overturning due to wind and vibratory forces on the luminaire pole. The longer 150 ft. section, on which the truck tests were conducted, contains no mechanical anchors to the roadway. The 1-in. layer of hot mix asphalt at the base of the CMB barrier was used to provide some restraint to sliding during a vehicle collision. Details of the chain link fabric fence and luminaire pole were discussed by Hirsch (3).

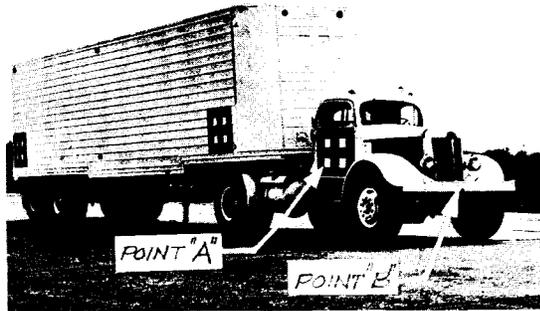
FIGURE 2a  
FRONT OBLIQUE VIEW

The location of the lumped center-of-mass of the tractor, determined by a trial and error process, is approximately 2.6 ft. above the level roadway as shown in Figure 3. Referring to Figure 2a, the tractor center-of-mass lies about 7 in. below and slightly to the rear of the lower left hand checker-board white square painted on the tractor door.

An Impact-O-Graph was used to record the longitudinal, lateral, and vertical acceleration components of the truck tractor compartment at a location on the floor and directly under the passenger occupant. The lower left white square painted on the door of the tractor, and designated as point "A" in Figure 2a, was approximately normal to the location of the Impact-O-Graph.

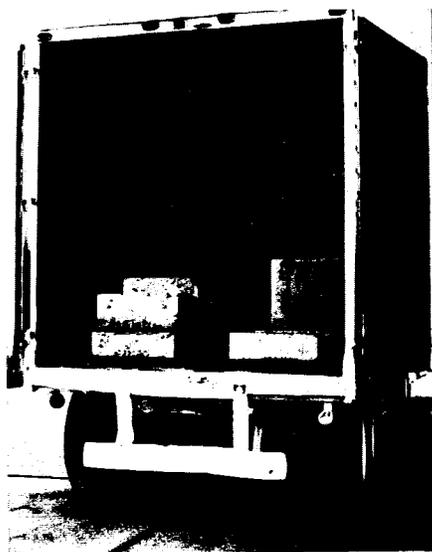
FIGURE 2c  
END VIEW ARRANGEMENT  
OF CONCRETE BLOCKS  
IN TRAILER

The truck-trailer was loaded with concrete blocks weighing 22,800 lbs. The arrangement of the concrete blocks are shown in the end-view of Figure 2c and the side-view of Figure 3. The blocks were staked to an average height of about 24 in. over a distance of about two-thirds the length of the trailer.

NOTE: AFTER THIS PHOTOGRAPH  
WAS TAKEN, THE CONCRETE  
BLOCKS WERE TIED DOWN  
PRIOR TO TESTS.

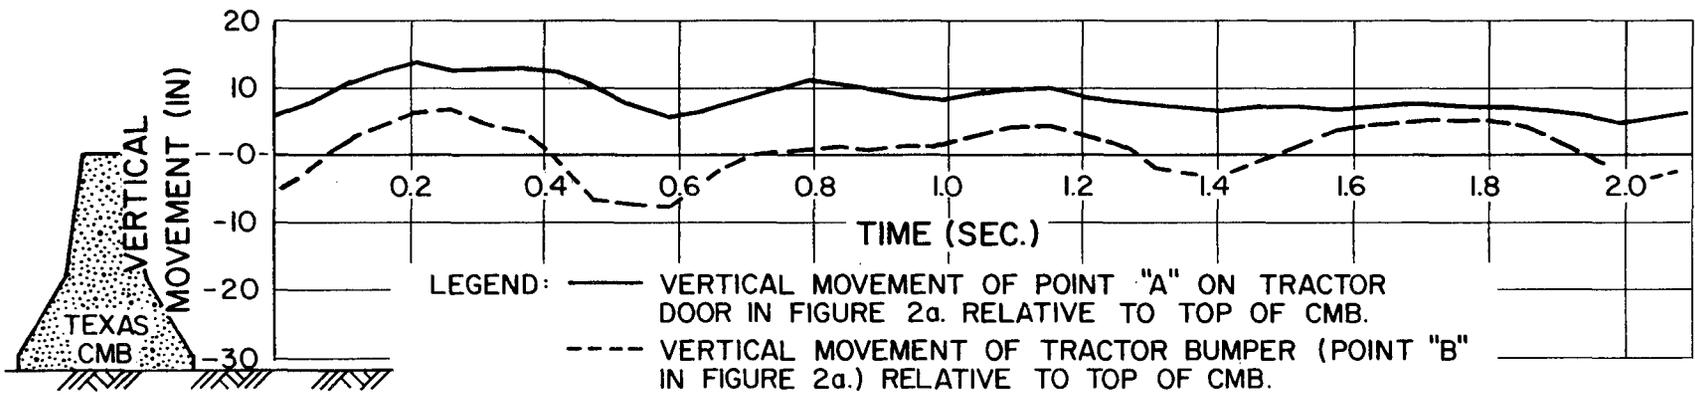
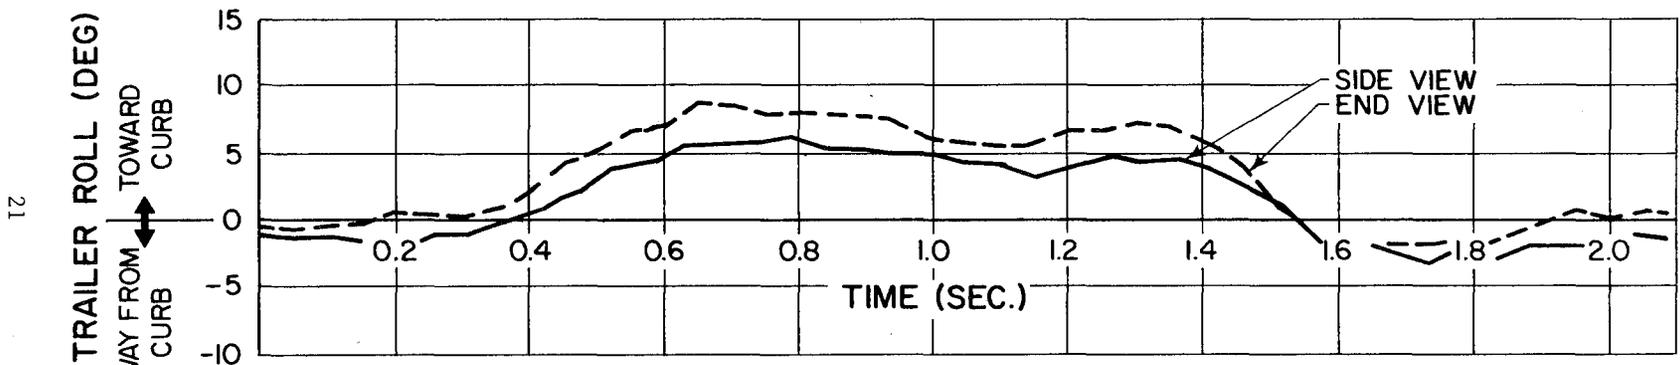
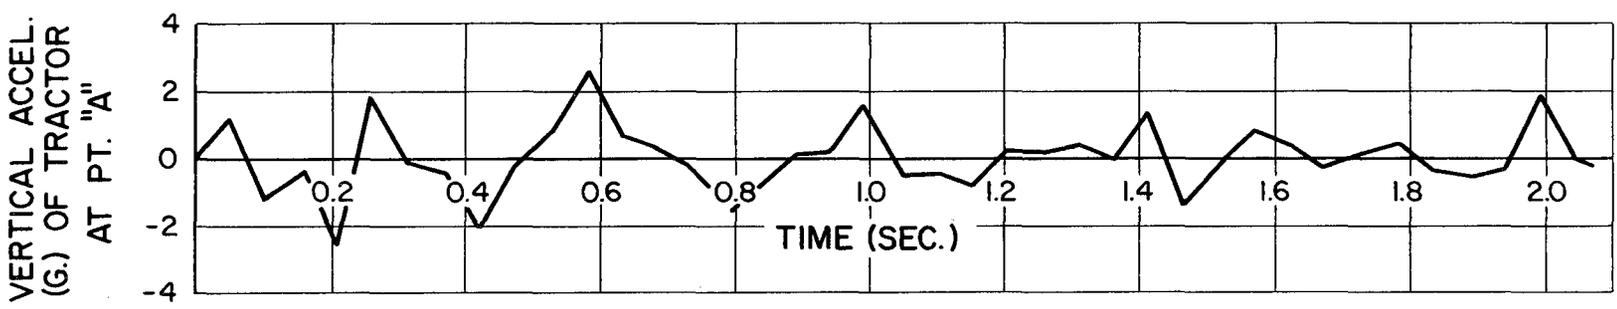
FIGURE 8 CMB-5 RESULTS FROM FILM ANALYSIS

an analysis of film from the end-view and side-view cameras is shown in Figure 8 for the CMB-5 test. This comparison indicates that a reasonable estimate of the trailer rolling motion can be obtained from a side-view film analysis.

Measurements of the tractor-trailer truck swivel connection showed that the rolling motion of the trailer was independent of the tractor for angles of about 10 deg. and less. As shown in Figures 8 and 10, the trailer rolling motion in the CMB-5 and CMB-6 tests were less than 8 deg., and hence, independent of the tractor rolling motion. In the CMB-7 test, however, the trailer rolling motion was not independent of the tractor rolling motion. The trailer in the CMB-7 test reached a maximum roll angle of 17 deg. at a time of 1.2 sec. after impact as shown in Figure 12. It can also be seen in the sequence photographs of Figure 11, that at a time of 1.2 sec. the tractor rear dual wheels on the passenger side were lifted off the ground for a height of about 7 in. as a result of the trailer roll angle exceeding the unrestrained swivel roll angle of 10 deg. This observation may be significant for the selected truck under a higher impact speed of say 50 to 55 mph, in that:

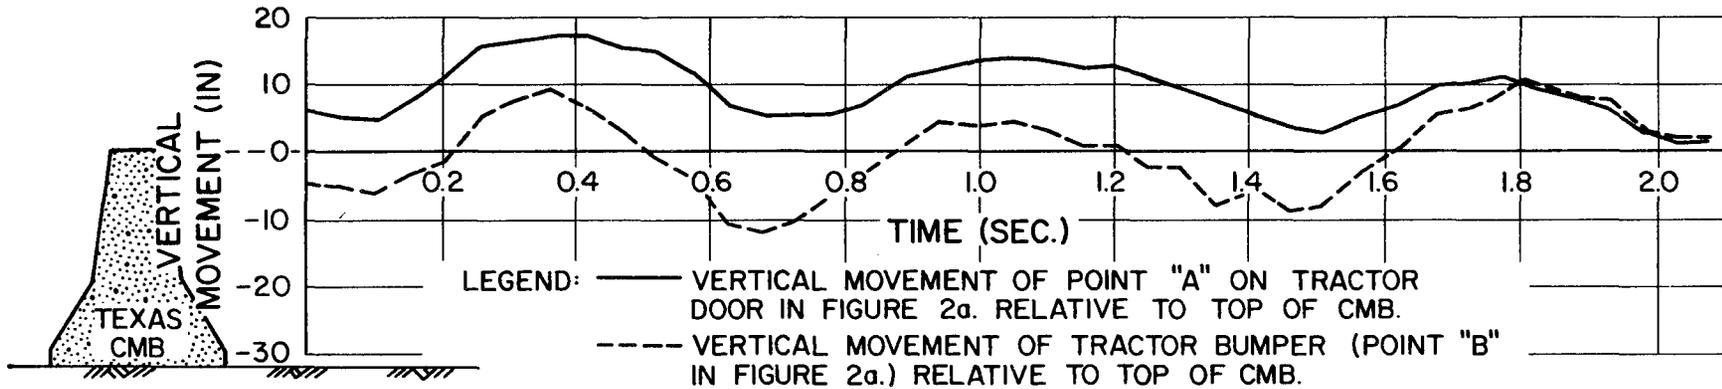
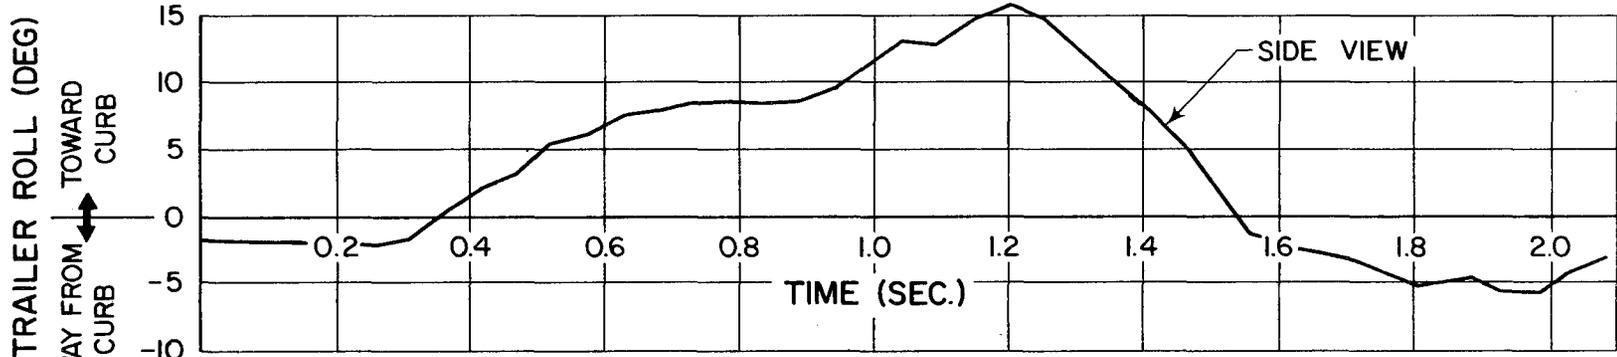
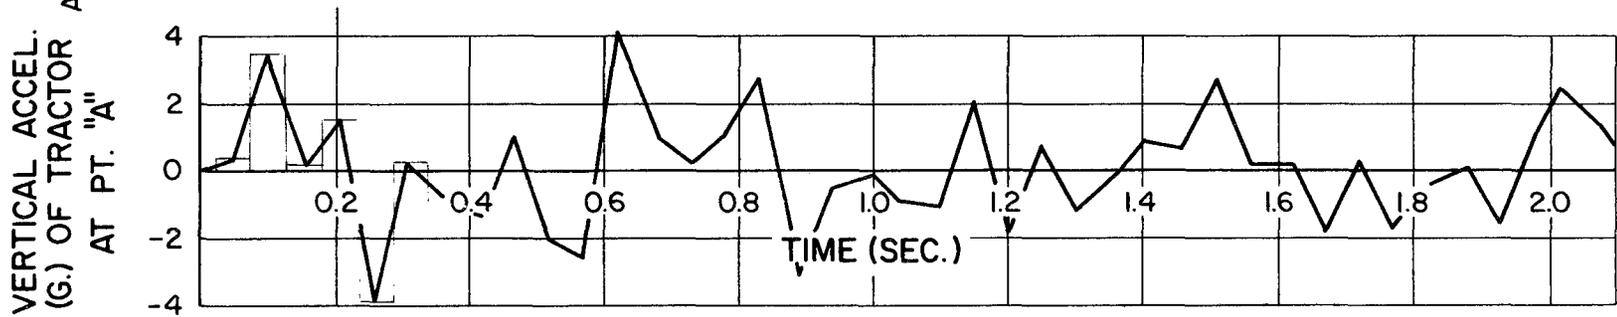
FIGURE 12 CMB-7 RESULTS FROM FILM ANALYSIS

In addition to the Impact-O-Graph accelerations, the vertical accelerations of the truck were computed by taking the *second central differences* of the vertical displacements obtained from a high speed film analysis. As discussed earlier, the vertical displacements were measured for a point on the tractor door designated as point "A" in Figure 2a. This point was selected because it was normal to the Impact-O-Graph mounted on the floor under the passenger seat. Graphs of the computed accelerations are shown in Figures 8, 10 and 12. The straight line segments connect the midpoints of the acceleration differences averaged over a time duration of 50 milliseconds as illustrated in Figure 12.

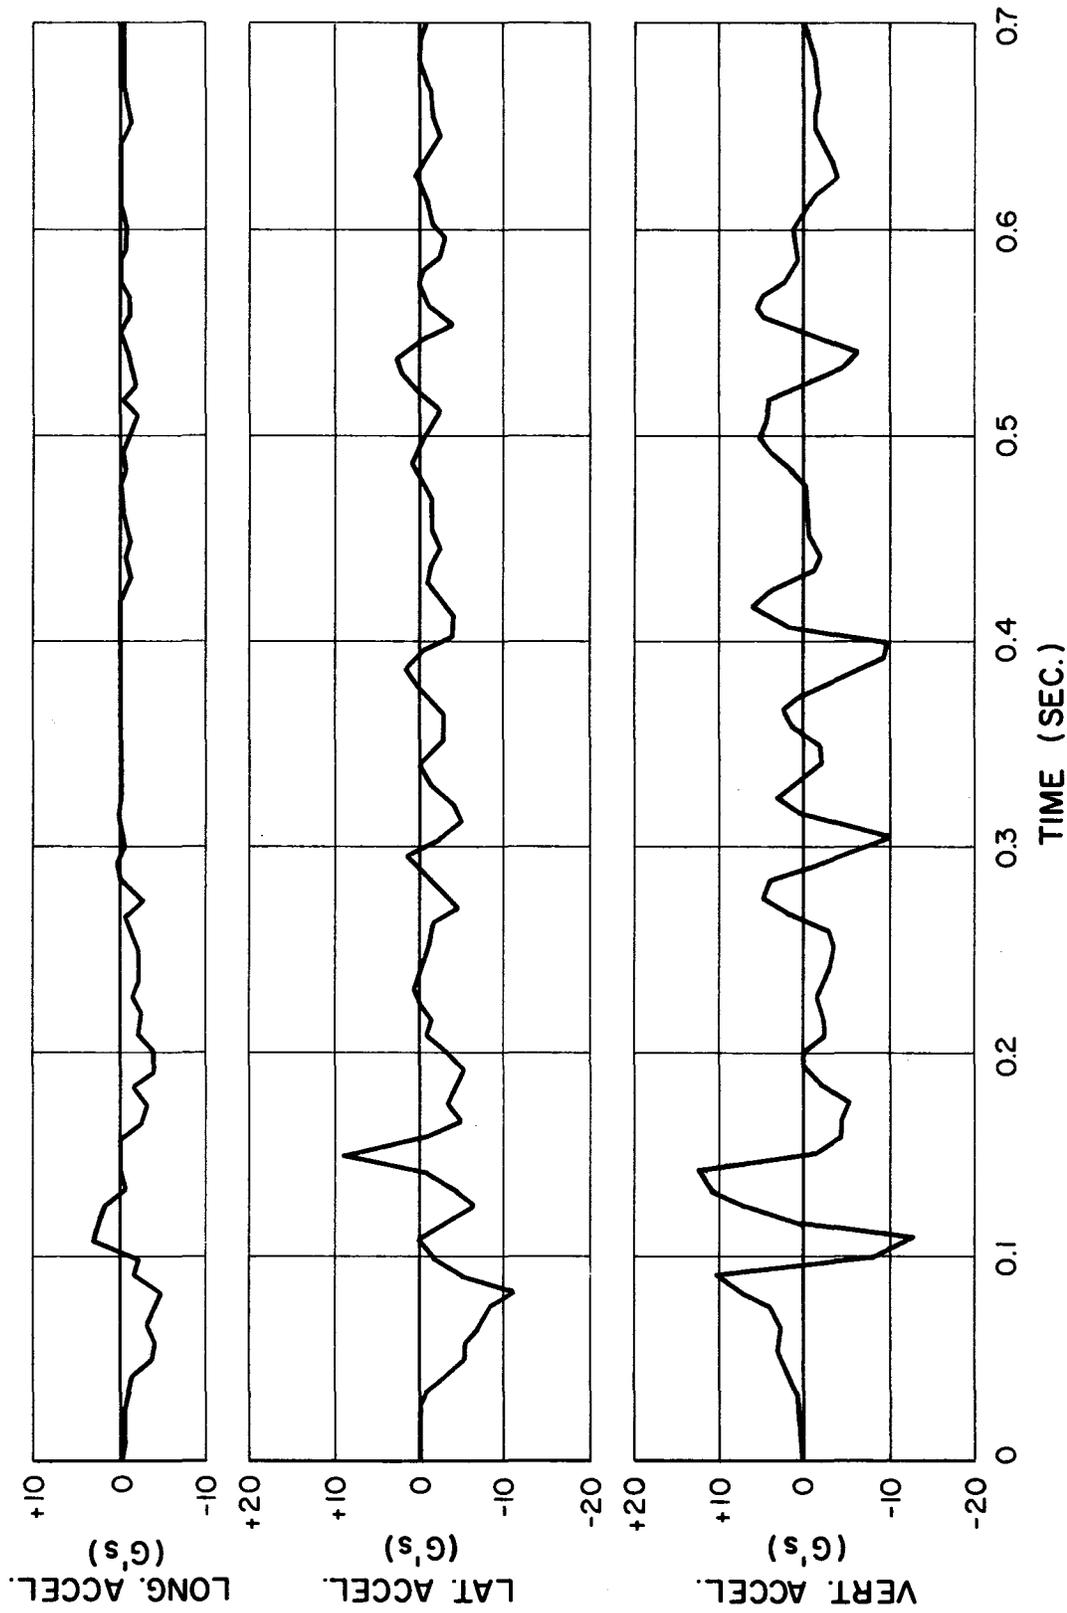
FIGURE 13 TRUCK-TRACTOR ACCELERATION COMPONENTS  
DURING CMB-5 TEST (IMPACT-O-GRAPH)

The longitudinal, lateral and vertical truck accelerations obtained by use of an Impact-O-Graph are shown in Figure 13 for the CMB-5 test; Figure 14 for the CMB-6 test; and, Figure 15 for the CMB-7 test. The Impact-O-Graph was mounted on the floor of the tractor directly under the passenger seat.

The Impact-O-Graph acceleration traces in Figures 13, 14 and 15 appear to be fairly accurate judging from the magnitude of the computed severity-indices in Table 1. That is, one could have predicted that the severity-index in the CMB-6 test would have been slightly lower than the severity-index of the CMB-5 test because of the flatter 4 deg. impact
